Paper No. 1335

### LITTLE ROCK JUNCTION RAILWAY BRIDGE,

### OVER THE ARKANSAS RIVER

### AT LITTLE ROCK, ARKANSAS, 1883-1914\*

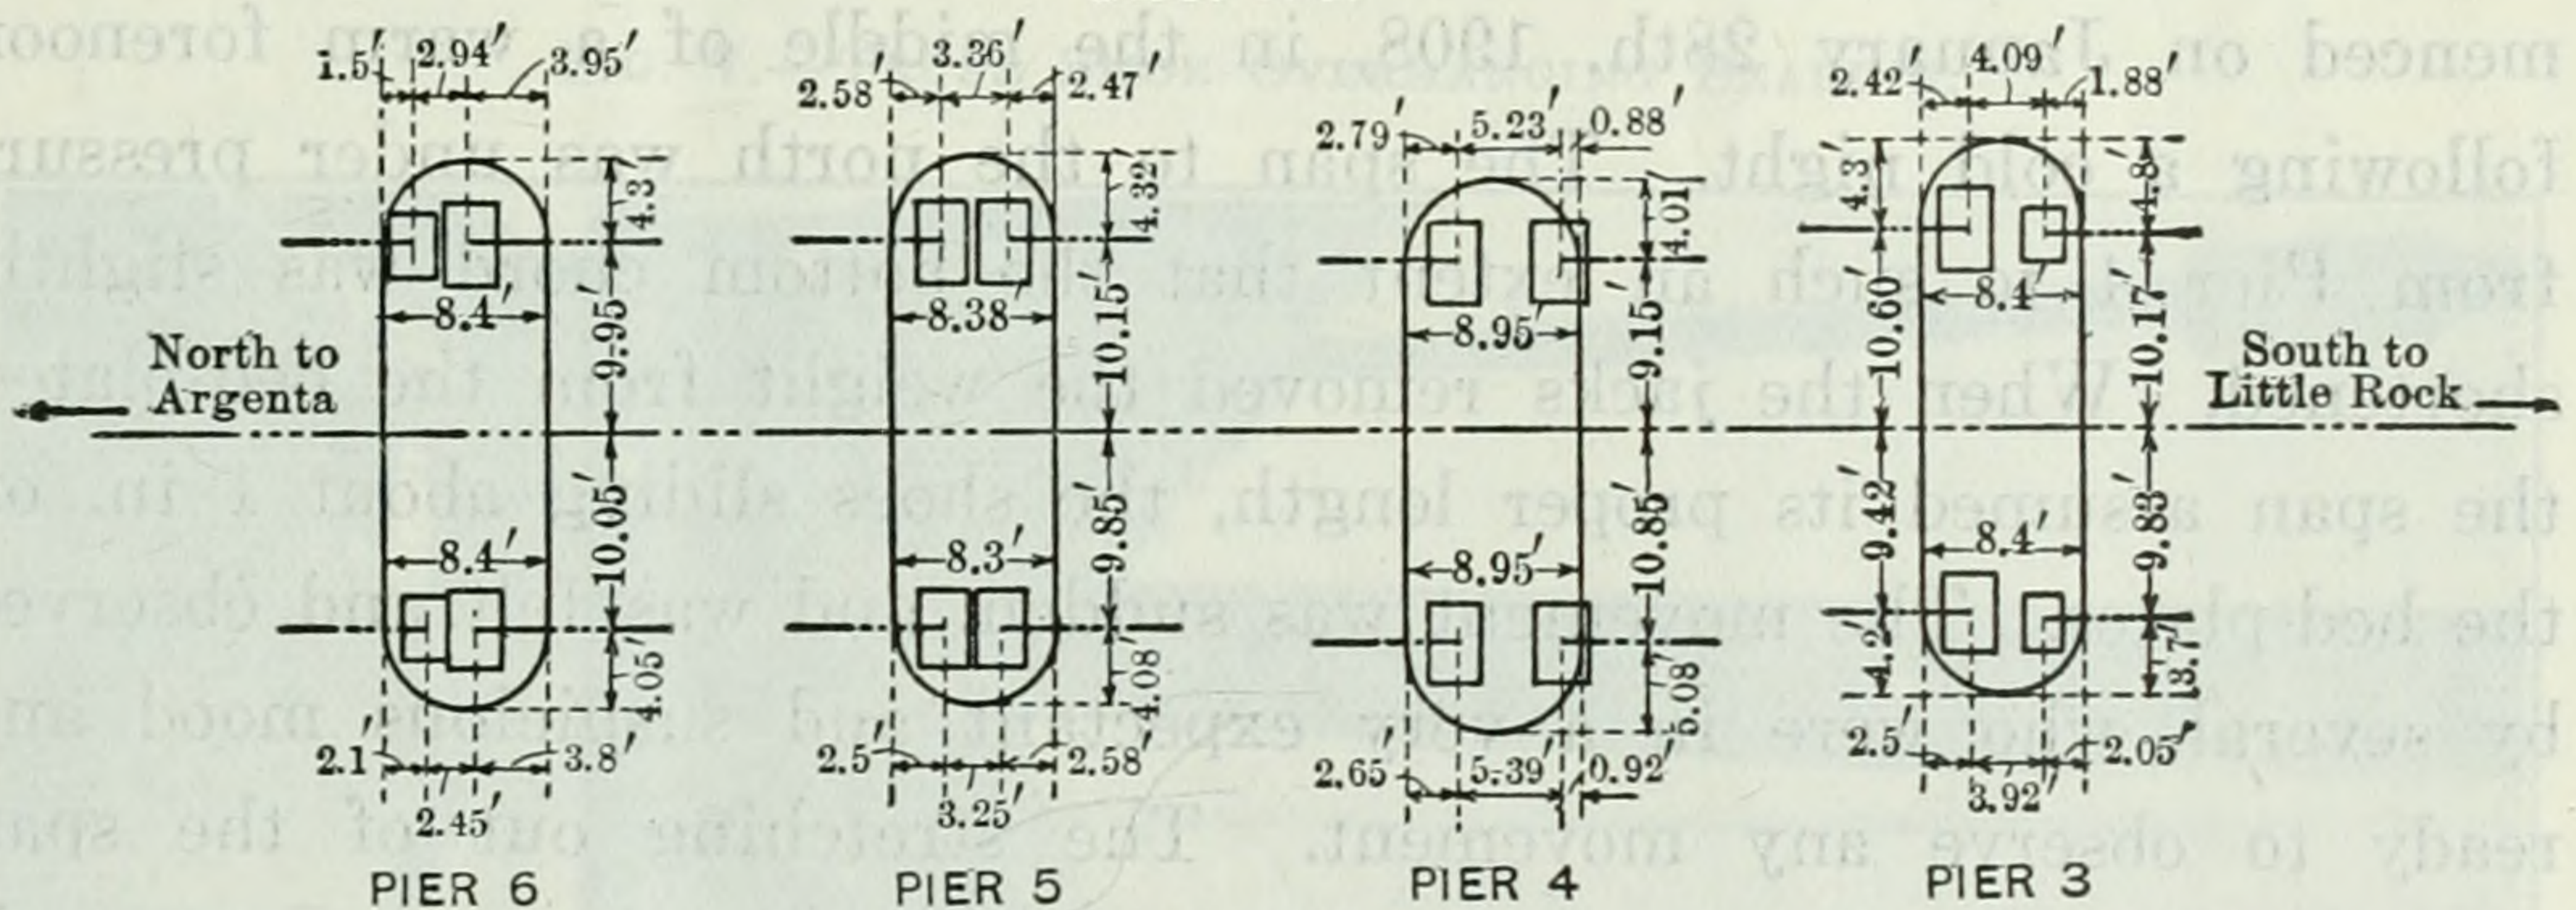
FIG. 6.

The roller end of the span to the south, being on Pier 4, permitted the pier to move out from under. The fixed end of the span to the north being on Pier 4, the thrust caused by the leaning of the pier in that direction had crowded the roller end of this span on Pier 5 hard against the fixed end of the next span. This thrust, added to the similar, though less, defective construction of Pier 5, caused the latter to lean north, crowding the roller end of the next span to the north, hard against the fixed end of the north span on Pier 6, bringing three spans in hard contact. On hot days, when the bridge was not loaded, the chord bars in the end panels of these spans could be seen to be more or less buckled, but they always straightened out

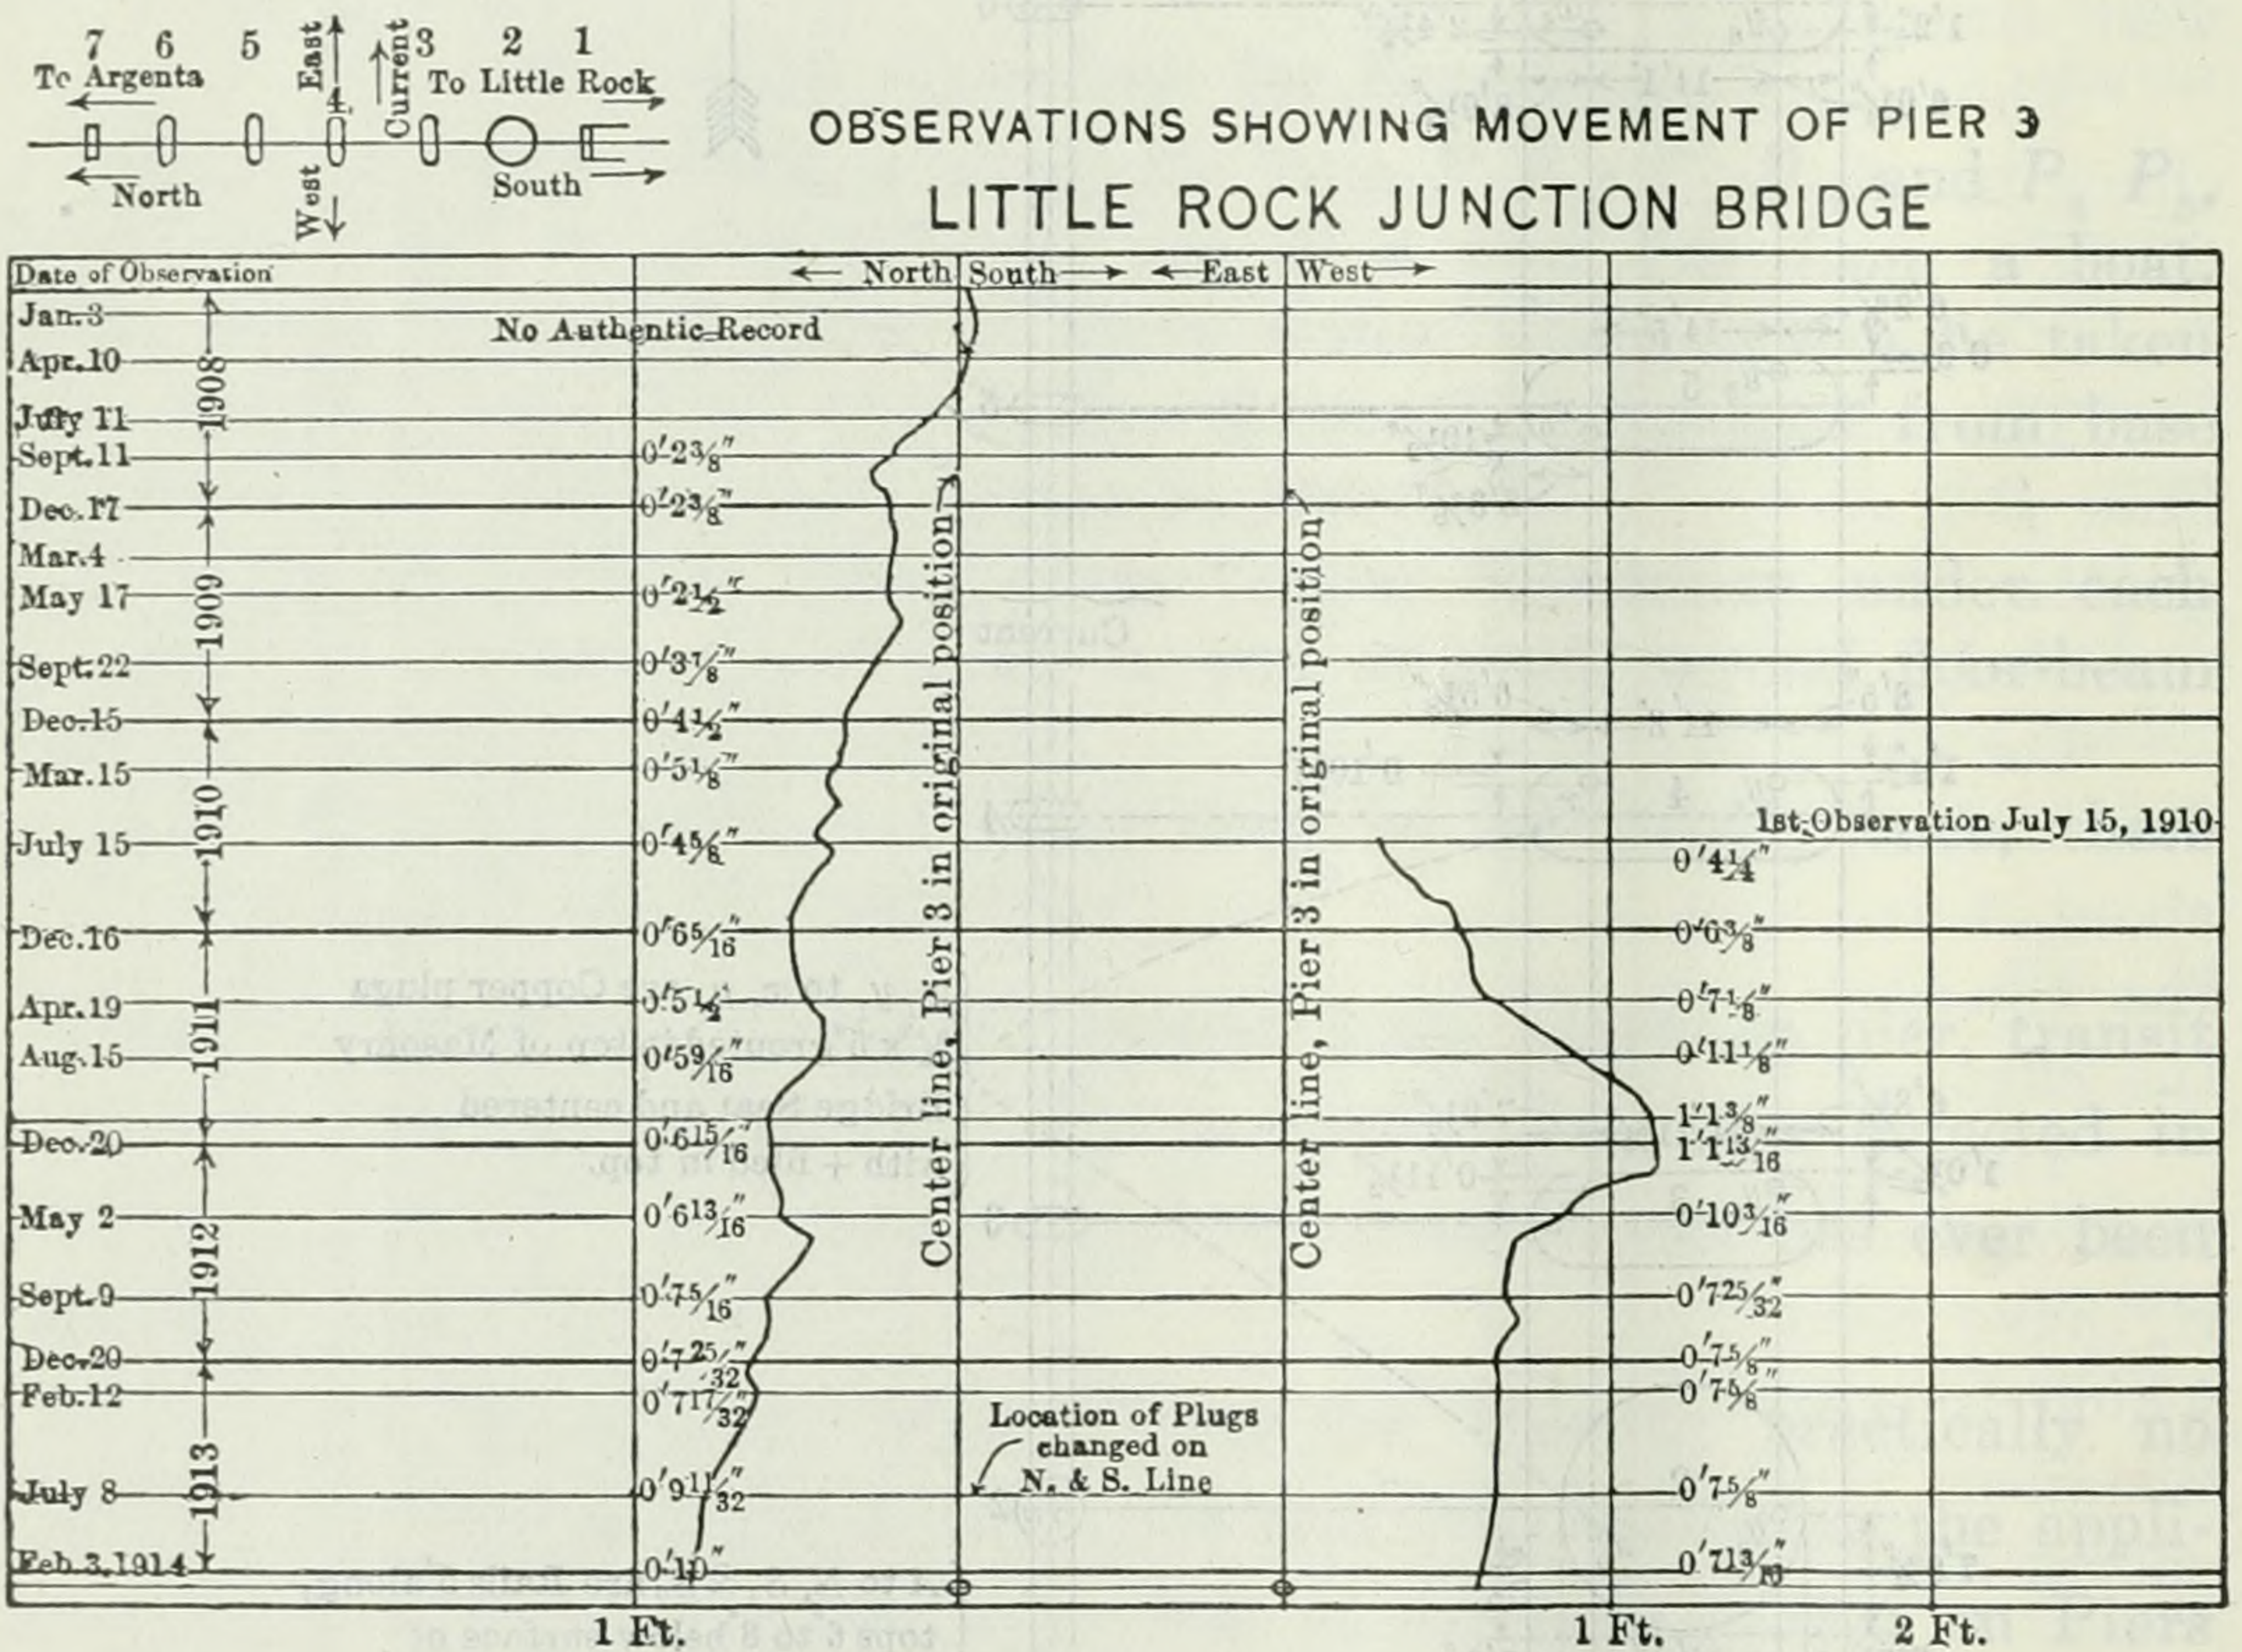
FIG. 34.

Fig. 34 shows the movement curve for Pier 3; practically no movement was detected up to 1908. In that year, following the application of the rods and yokes to the ends of the span resting on Piers 3 and 4, Pier 3 moved north (parallel to the bridge) about 10 in. from 1908 to 1913, during which period the reconstruction was carried out, since which work the pier has been stationary. No movement east or west (at right angles to the bridge) was detected in Pier 3 until the summer of 1910, when, for no apparent reason other than the deep scour of the river around the pier, it started up stream at the rather rapid rate of 9 in. in 14 months, the up-stream end settling several inches. This movement brought about the reconstruction of the pier in 1911 and 1912, during which it was found possible, by controlling the underpinning, to make the pier partly right itself, the curve showing that the top moved back (east) about 6 in. during the work.

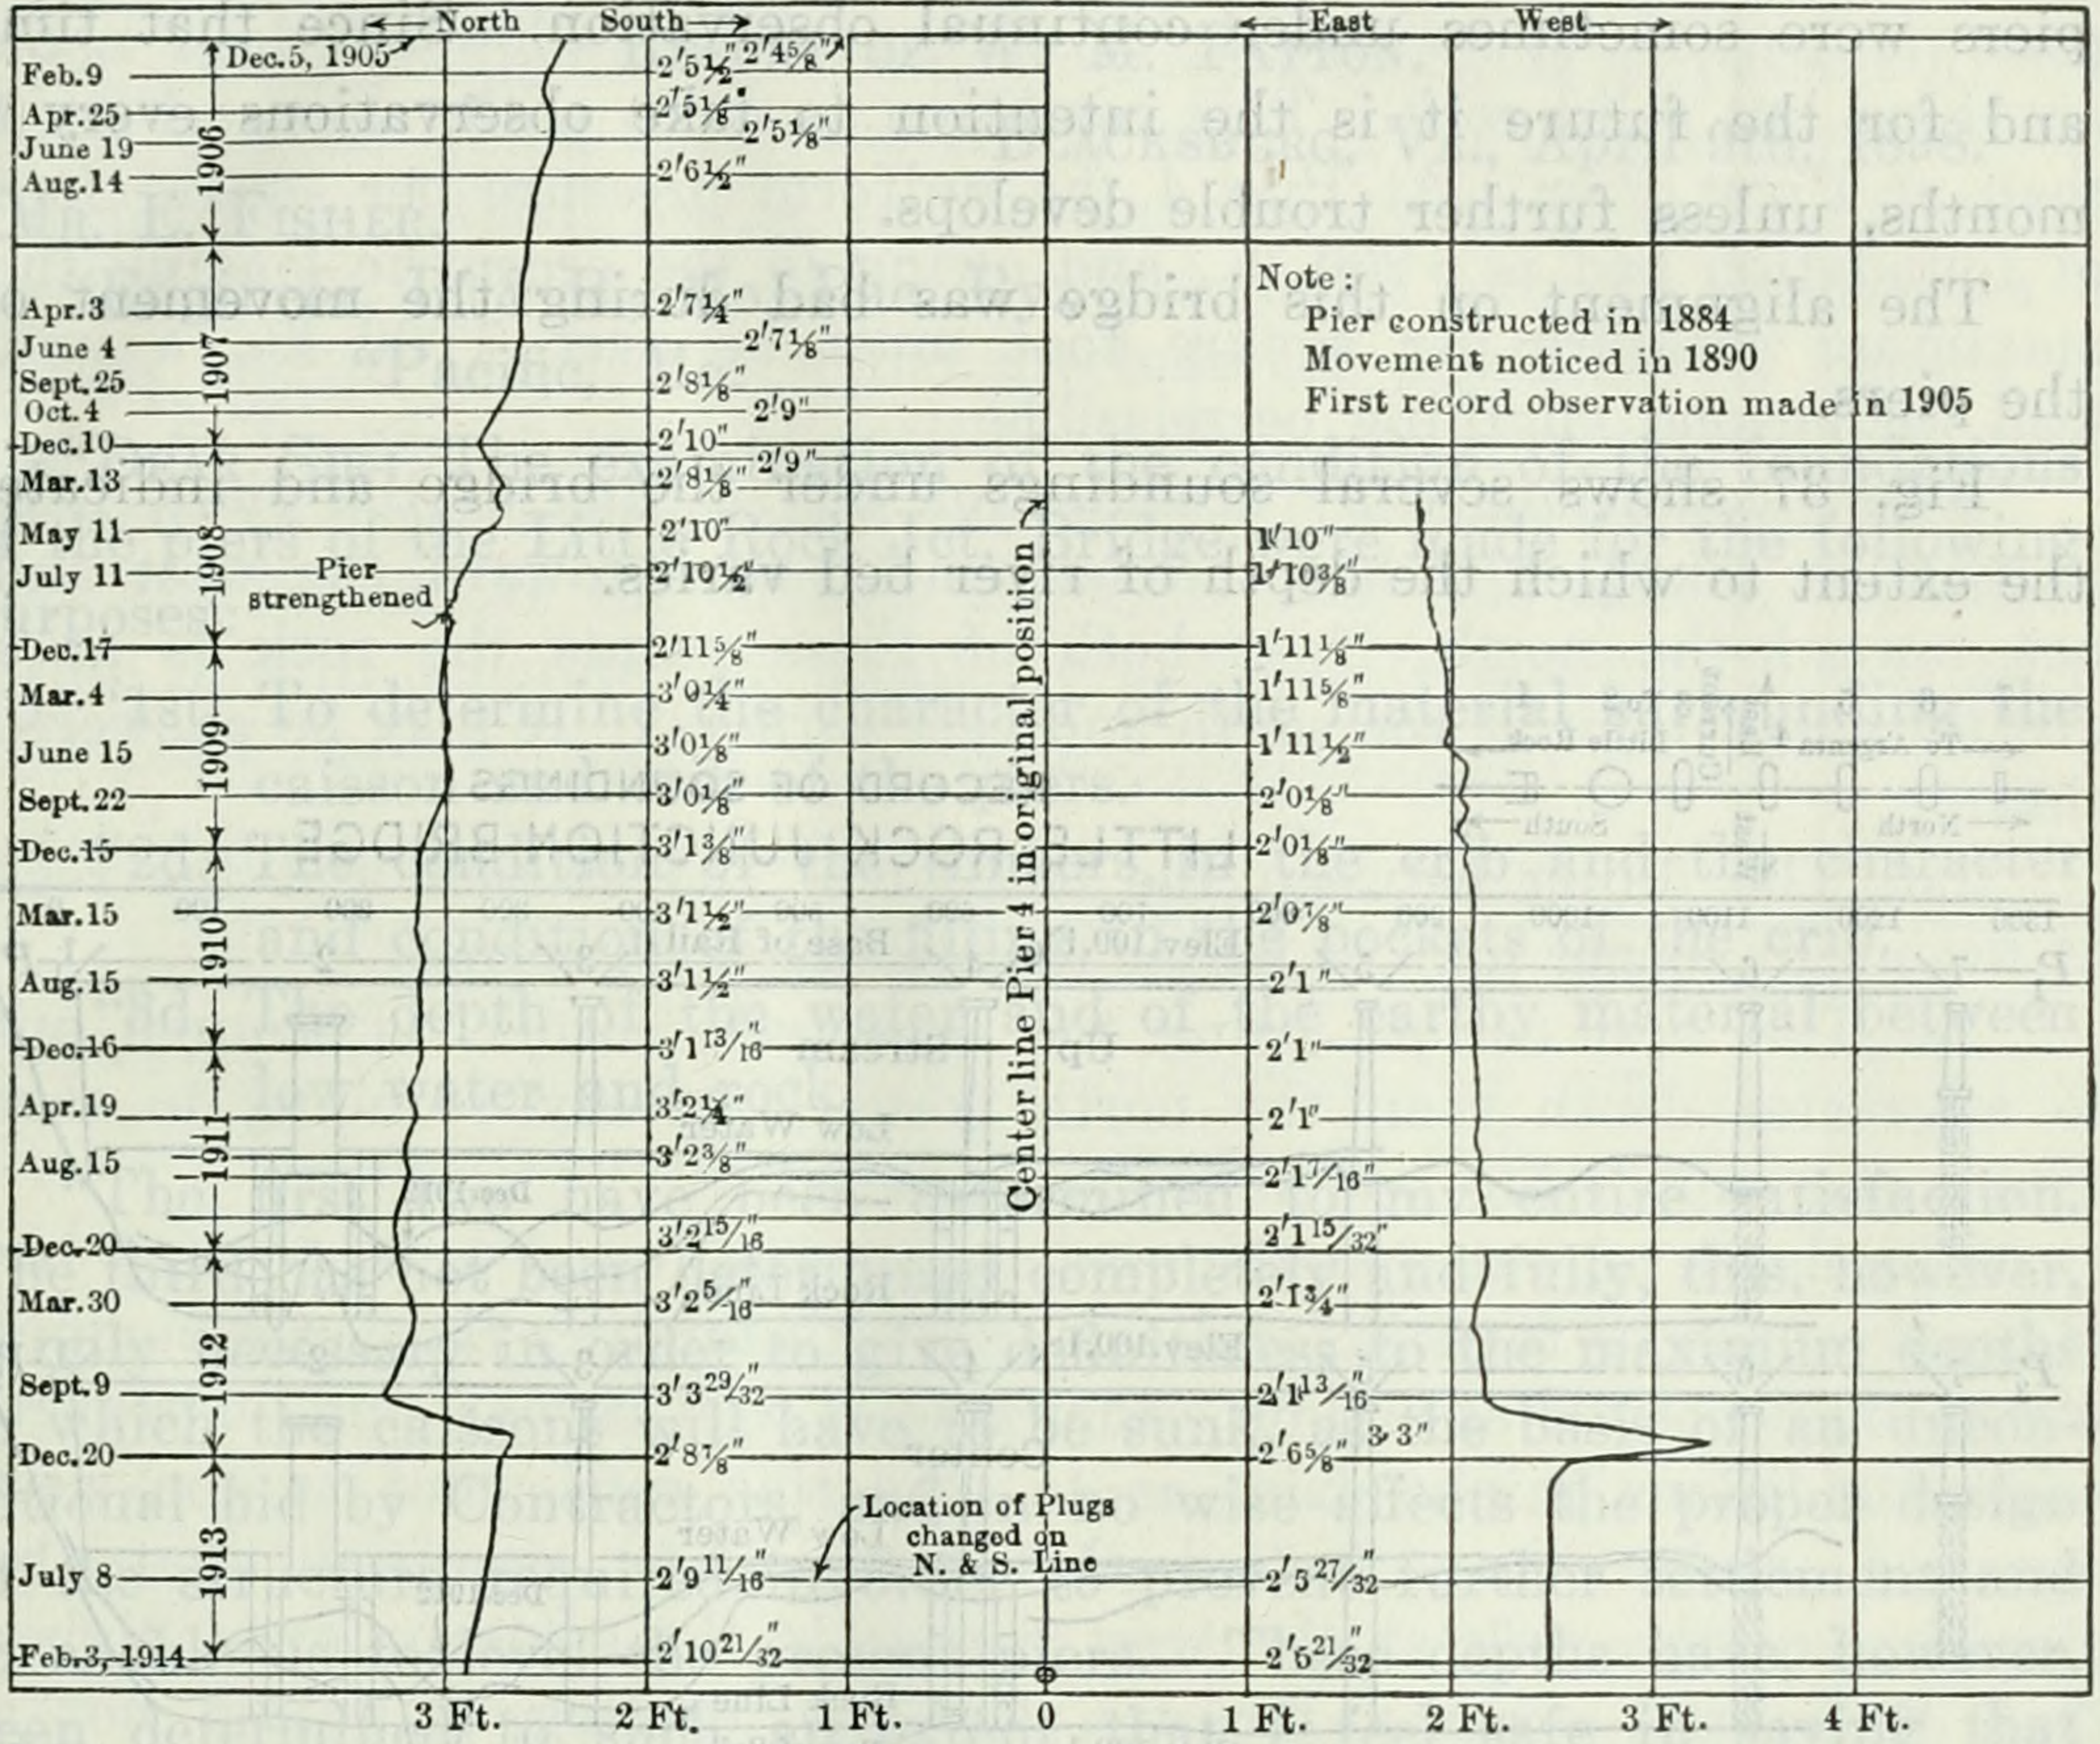
FIG. 35.

Fig. 35 shows the movement curve for Pier 4. The position of the pier in 1898 made it evident that the movement had taken place for a long time, but no record exists prior to December, 1905, at which time the pier was more than 2 ft. out of place in the direction of the bridge and more than 1 ft. out of place at right angles to it. The curve shows that the movement continued and increased about 12 in. parallel to the bridge and several inches at right angles to it up to September, 1912, when the reconstruction was so well under way that the movement was well within control, as indicated by

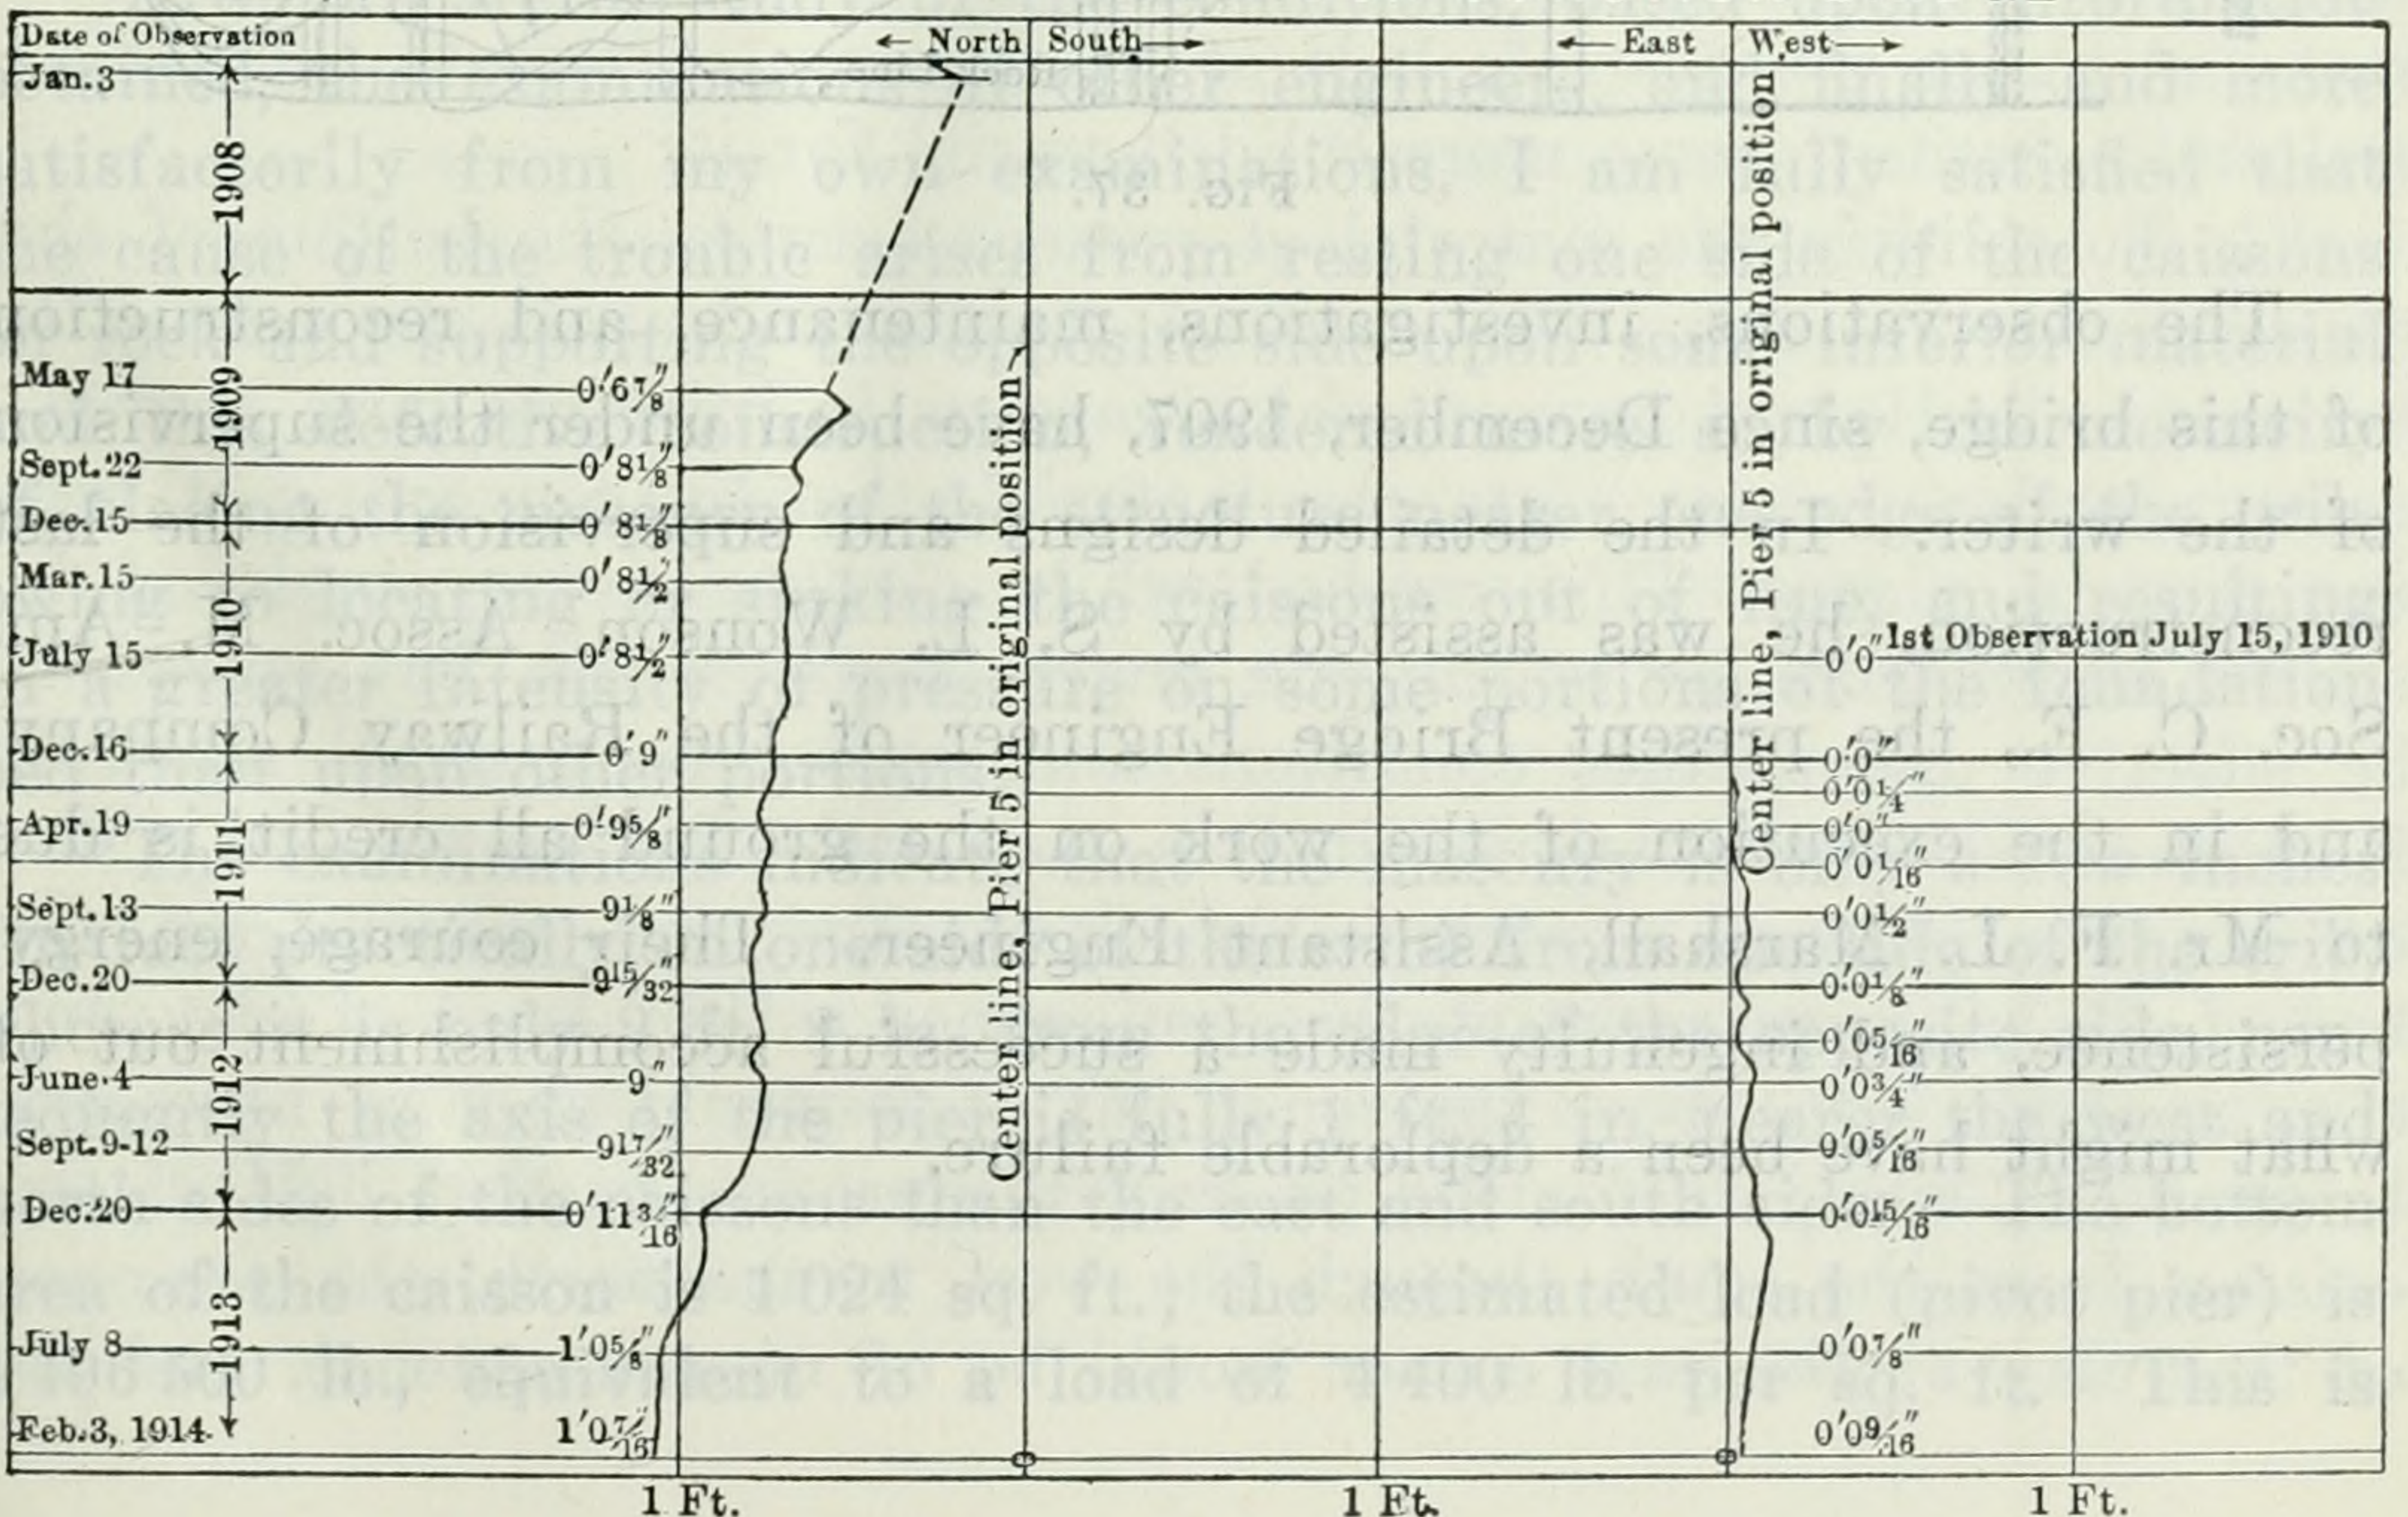
FIG. 36.

Fig. 36 shows the movement curve for Pier 5. No movement has ever been detected at right angles to the bridge, but there has been intermittent movement parallel with it. No movement has been detected since the application of the cables anchoring this pier to Pier 4, and no further movement is expected.

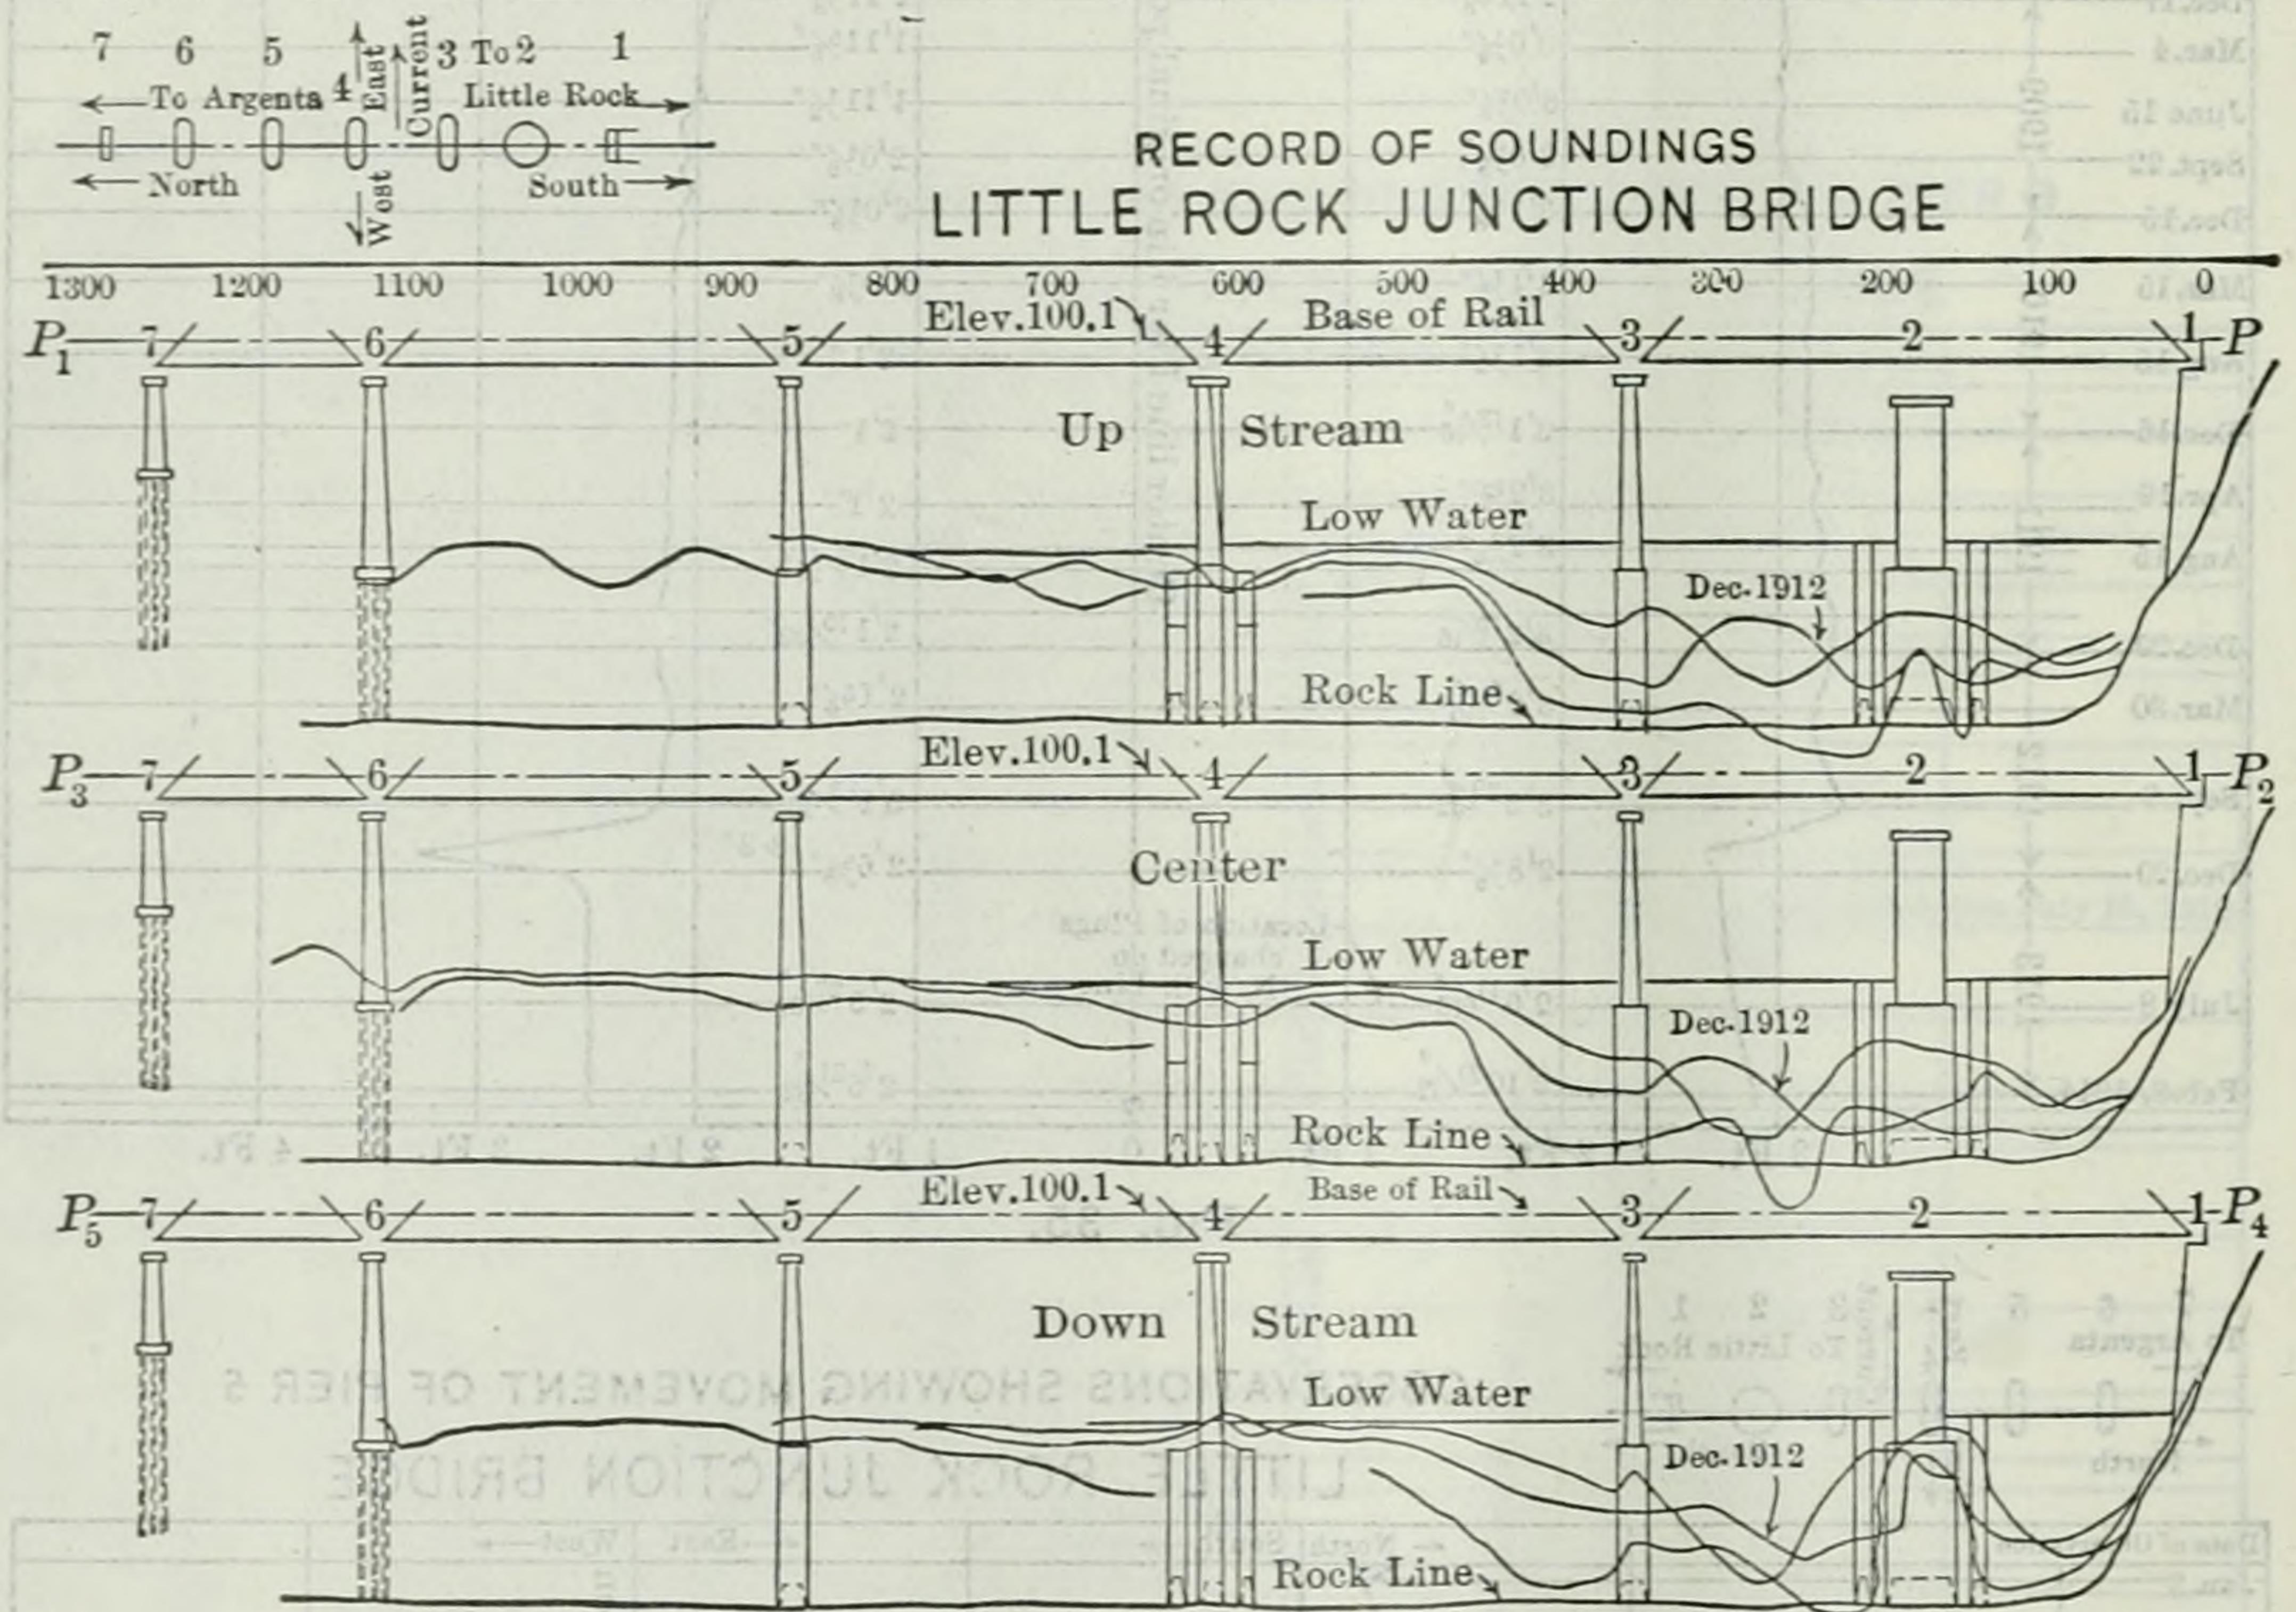
FIG. 37.

Fig. 37 shows several soundings under the bridge and indicates the extent to which the depth of river bed varies.
