## Tab E. Current Description and Conditions Assessment

### 1. Memorial Bridge

## Memorial Bridge Historic Structures Report

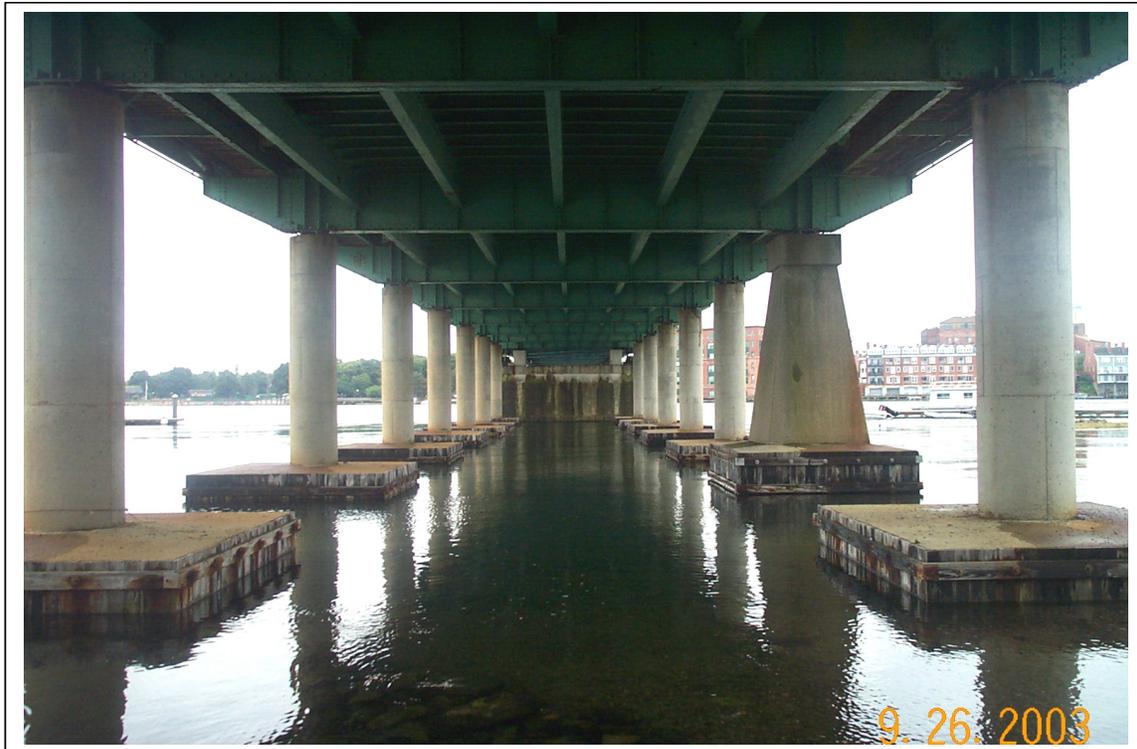
*Plate E-3: Understructure of Kittery Approach showing 1984 rehab. Note single remaining truncated pyramid support, and new cylindrical columns.*

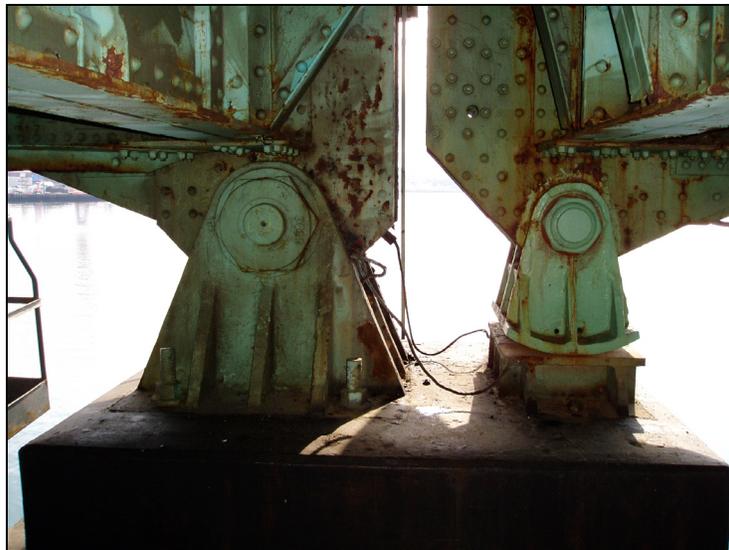
*Plate E-4: Rocker Bearing (right)*

Given the articulation of the structure, the most vulnerable pier is pier 2 since both span 1 and span 2 have a fixed connection to this pier. However, due to the massive size of these substructure units, they have sufficient shear and flexural strength to resist seismic forces, provided that the concrete strength approaches 3000 psi. However, it is likely that a large seismic event would cause significant damage to these unreinforced substructure units and it is recommended that the installation of grouted post-tensioning bars (similar to rock anchors) be
