**INSPECTION AND REHABILITATION
OF
THE JOHN A. ROEBLING BRIDGE
FORMERLY KNOWN AS
THE COVINGTON-CINCINNATI SUSPENSION BRIDGE**

ABSTRACT

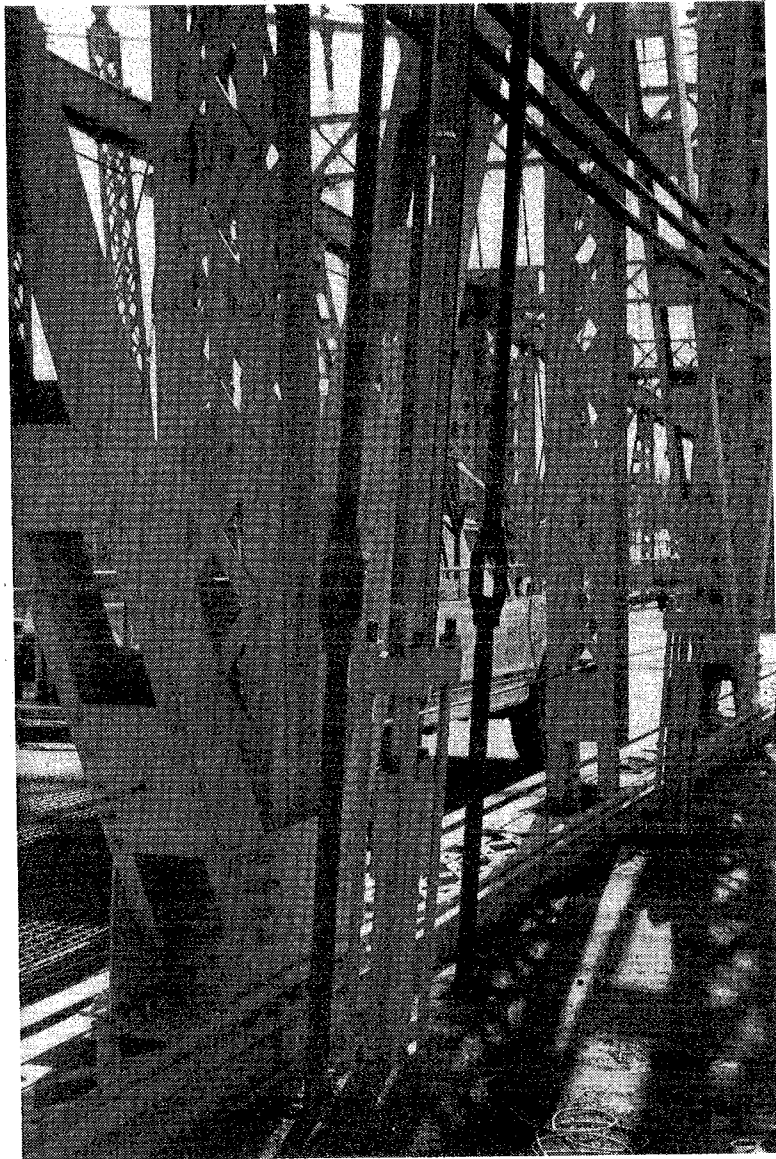
FIGURE 5. TEMPORARY FLOORBEAM HANGER IN POSITION,
READY FOR REMOVAL OF SUSPENDERS

The first set of plans prepared during Phase II dealt specifically with the removal of four sets of suspenders and tie-rods from roughly the third points of the mainspan (panel points L40 and L'40). Suspenders and tie-rods were removed intact by using floorbeam hangers to temporarily sustain the loads usually carried by the suspenders and tie-rods (Figure 5). Four tie-rods and twelve suspenders were shipped for testing to Construction Technology Laboratories and Fritz Engineering Laboratory at Lehigh University for modal analysis and destructive testing, respectively. Results of the modal analysis of the tie-rods enabled non-destructive testing of any number of similar tie-rods on the bridge to determine actual loads in those members. Results of the destructive testing were used in determining the ultimate strength of these members, the mode of failure, and the extent of internal deterioration of the wire rope and sockets.

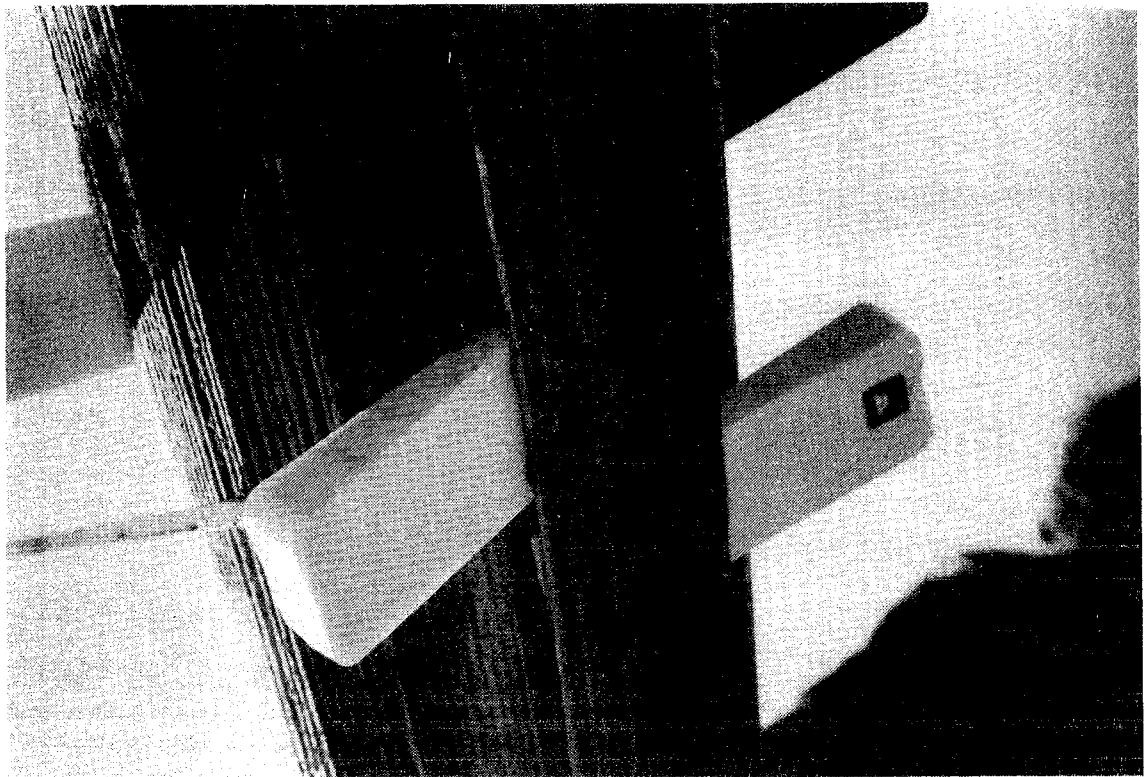
FIGURE 6. PLASTIC WEDGES USED TO EXAMINE THE
INTERNAL WIRES OF THE SECONDARY SUSPENSION CABLE

Once the investigations were completed, the suspension cables were rewrapped with galvanized steel wire. Replacement components for the suspender ropes, sockets, tie-rods and cable bands have been designed similar to the original elements based on exact field measurements of the original pieces. The replacement components were installed and the temporary floorbeam hangers removed. The newly installed elements were painted to match the adjacent color, and are indistinguishable from the other elements to the untrained eye.

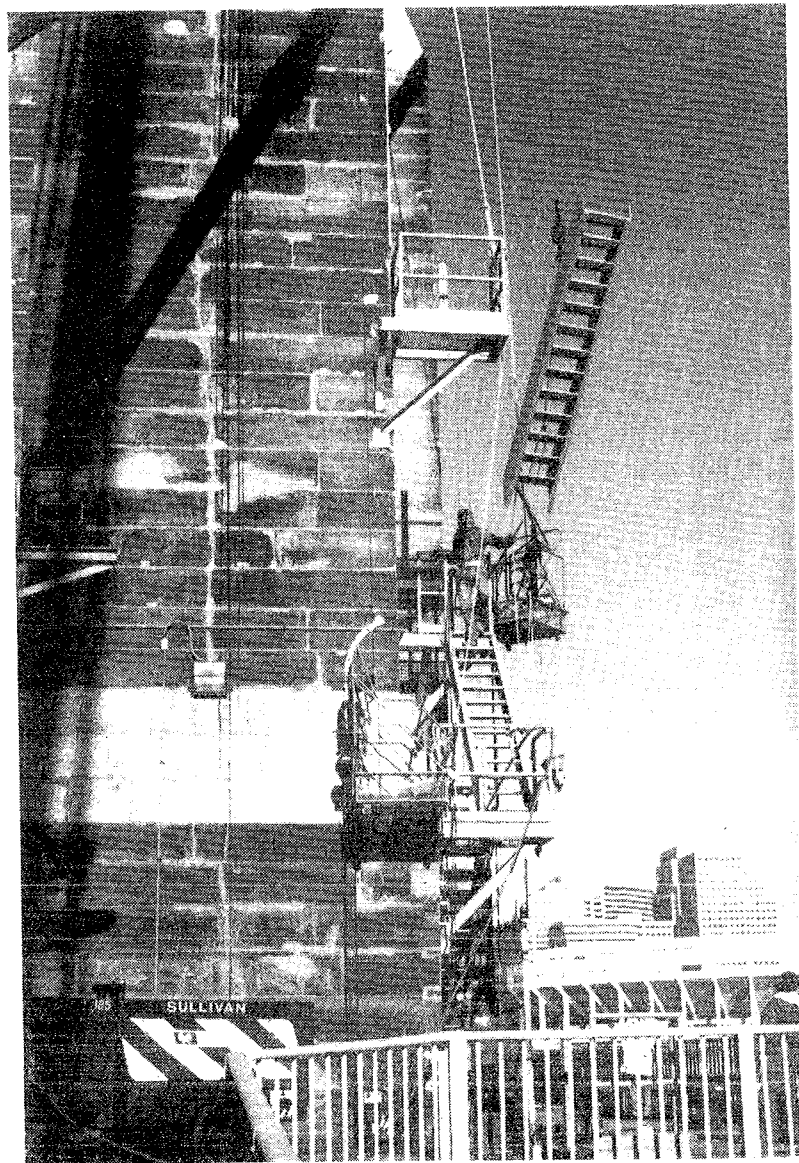
FIGURE 7. INSTALLATION OF THE NEW STAIRWAY
ON THE COVINGTON TOWER

A similar system of stairways and landings was designed based on extensive field measurements (Figure 7). Certain safety improvements were made, such as the replacement of steel plate treads and landings with an open grid design for better traction and less retention of water, the addition of toeboards to the landings, and the use of steel tubing in the handrails for appearance and more comfortable gripping.

Upon removal of the existing stairways, old anchor bolts were removed, and the voids were filled with a non-shrink grout. The new stairways were anchored by stainless steel threaded anchor rods. Upon completion, the new stairways were painted with an earth-tone color to blend with the color of the sandstone masonry. From a distance, the towers do not appear materially different, but their graceful form is enhanced by the subdued appearance of the stairways.

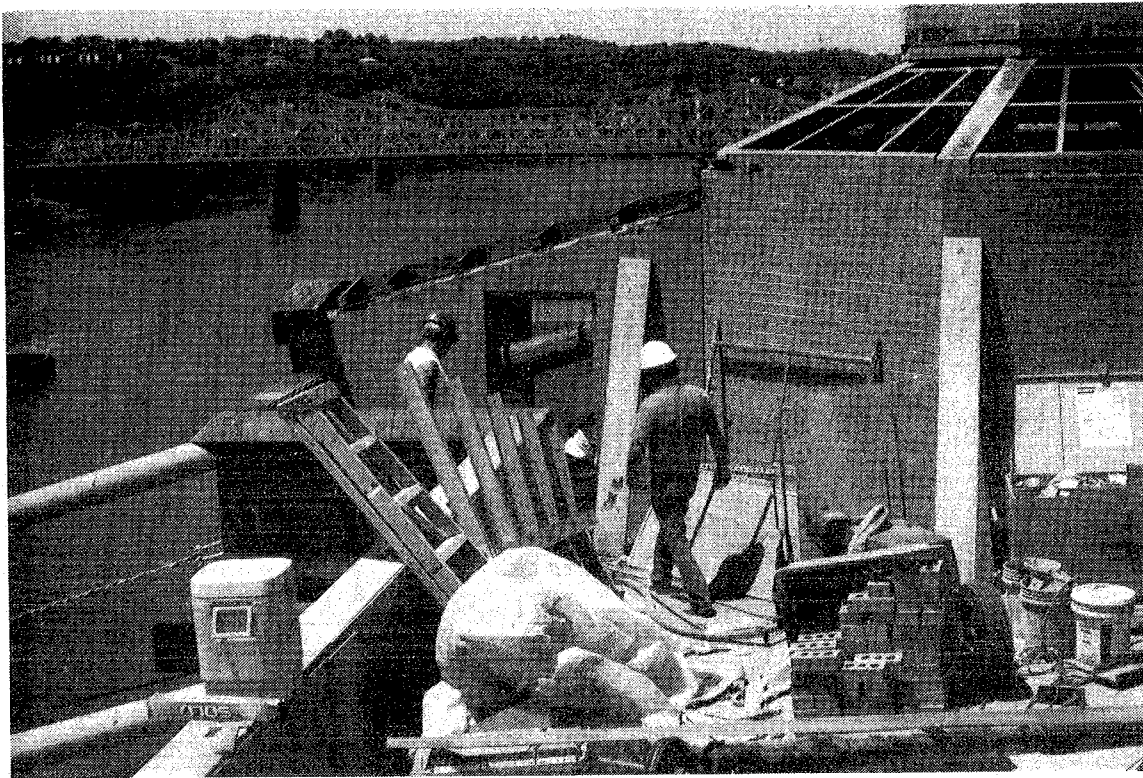
Severe deterioration of the domes, wooden sheds, tower roofs, and cornices was discovered during the 1987 inspection. The brick domes and wooden sheds were of such dilapidated condition that pigeons had converted the housings into rookeries which had a detrimental effect on the suspension cables therein.

FIGURE 10. NEW TURRET HOUSINGS UNDER CONSTRUCTION

During construction, the existing domes and housings were removed first. At the same time, the cement encasement on the floor between the domes was removed along with loose sandstone near the railings. All surfaces were then thoroughly cleaned of pigeon waste and other residue by vacuuming, water jets, and sandblasting as appropriate. At this time, additional photographic documentation was obtained for the rooftop and saddles in their uncovered and cleaned condition. Many parts indicated in old drawings were previously unseen due to encasement, inaccessibility, or coverings of debris.

Once removal was complete, the center portion of the rooftop was protected with concrete encasement formed to the same lines and grade as the original encasement. Metal gutters, similar in design to another sketch found in the Roebling Library files, were inserted into the sandstone near the railing above the roadway and grouted into place. Gutter flumes extend through the masonry railing to direct the runoff away from the cornice. This drainage system should be effective at reducing the rate of deterioration of the masonry below the cornices. The entire roof was then given an application of waterproofing material.

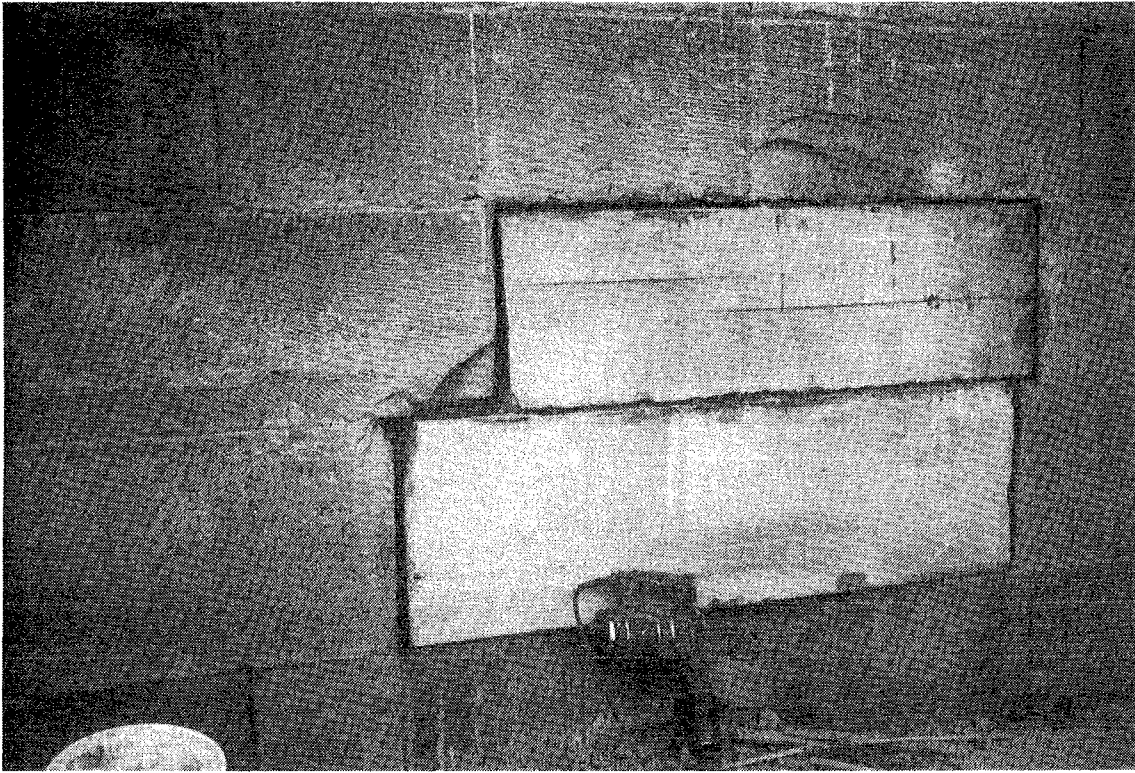
FIGURE 13. NEWLY INSTALLED MASONRY BLOCKS PRIOR TO APPLICATION OF A BUSHHAMMERED FINISH

- installation of new masonry blocks or portions of blocks
- reattachment of delaminated and spalling masonry using epoxy injection techniques
- grouting of cracks
- pointing deteriorated joints
- patching deteriorated masonry areas with colored concrete
- refacing intact but weathered blocks by bushhammering
- resetting loose blocks

New sandstone and limestone blocks used in the various repairs were selected to match the existing blocks in color and texture (Figure 13). The original stones were obtained from quarries in Buena Vista, Ohio (sandstone) and North Vernon, Indiana (limestone). The source of replacement sandstone, found near the bridge site, was one of the old unused Ohio approach piers of the L&N Railroad Bridge located about 4,000 feet upstream from the bridge site. These stones were of similar size and texture to the stones in the Roebling Bridge.

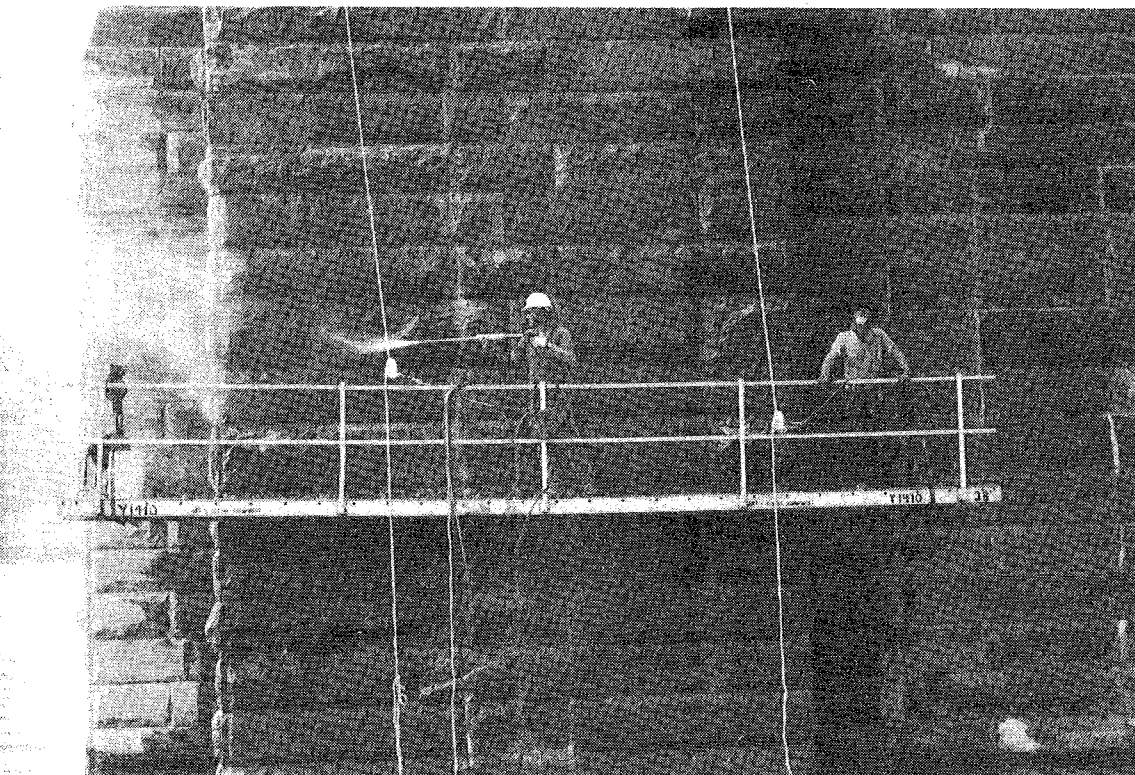
FIGURE 14. CLEANING TOWER MASONRY WITH WATER JETS

After the masonry repairs were completed, the entire surface of the towers and anchorages were cleaned from the top down to the river or ground level. Cleaning entailed a variety of methods including removal of tar with solvents, removal of spattered paint using paint stripping agents, and general washing of the entire surface with water jets and hand scrubbing with brushes (Figure 14). Prior to the use of any of these methods, test cleaning was performed on a representative area in an inconspicuous location. The most effective methods that removed accumulated grime yet did not damage the surface texture of the masonry blocks were employed. Sandblasting of sandstone was not permitted. The intent was to retain the mottled appearance of the sandstone masonry blocks caused by the variation in sandstone color and the natural crust that develop on the petroleum impregnated stones. Light sandblasting of limestone surfaces was permitted due to its greater degree of hardness.
