County of Simcoe

**Replacement of Collingwood Street Bridge
(Structure No. 000141)
on Collingwood Street over the Mad River
Municipal Class Environmental Assessment
Study Completion Report**

AECOM

January 2012

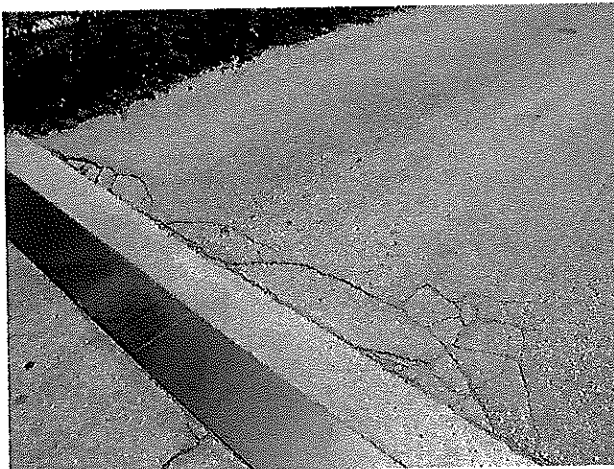
South Side. Showing cracking.

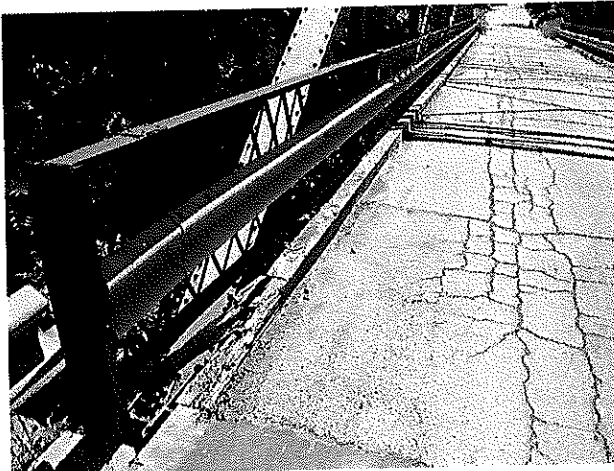
East Side. Showing severe deterioration.

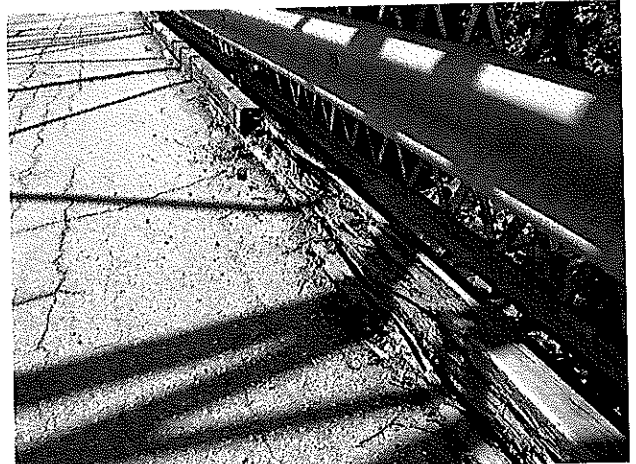
West Side. Showing severe deterioration.

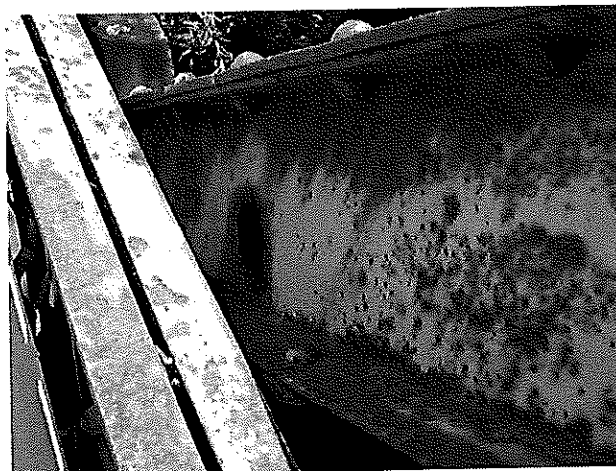
Southwest Side. Showing isolated very severe corrosion.

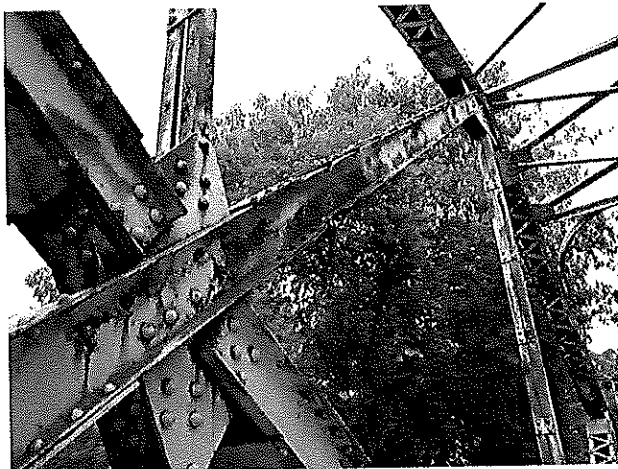
Northwest Side. Showing isolated light deterioration.

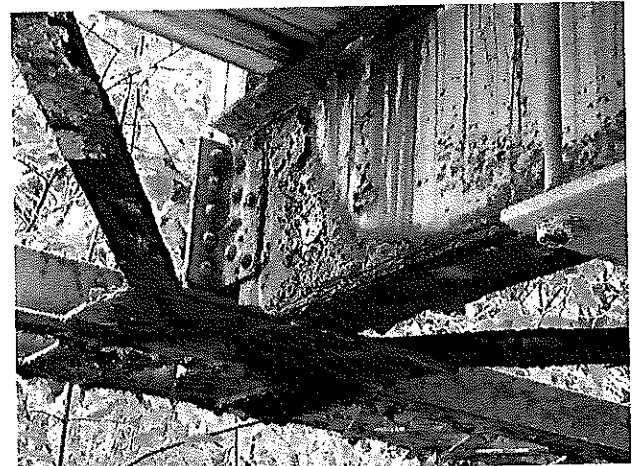
Underside Surface. Showing very severe corrosion.

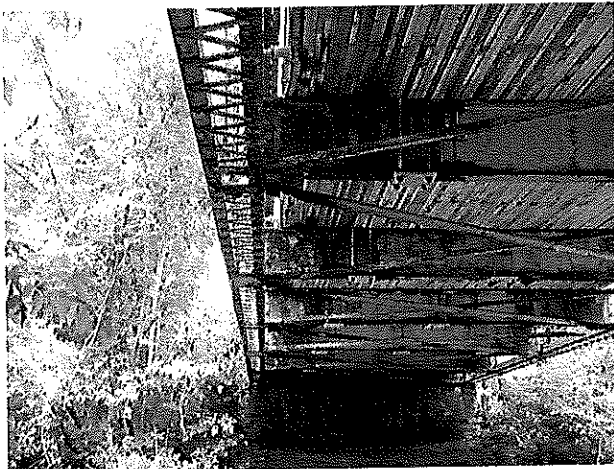
Underside Surface. Showing very severe corrosion.

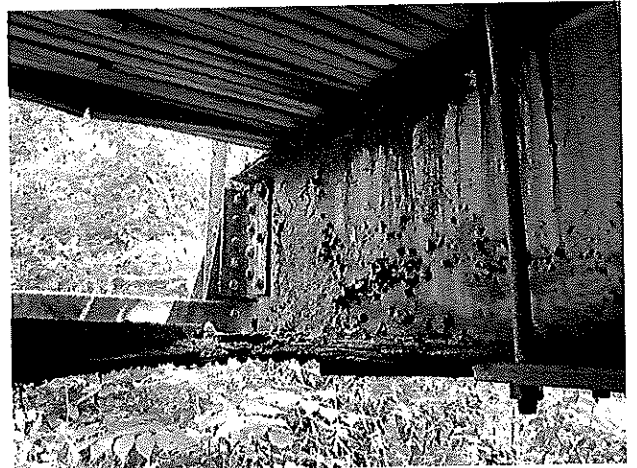
Underside View. Showing very severe corrosion.

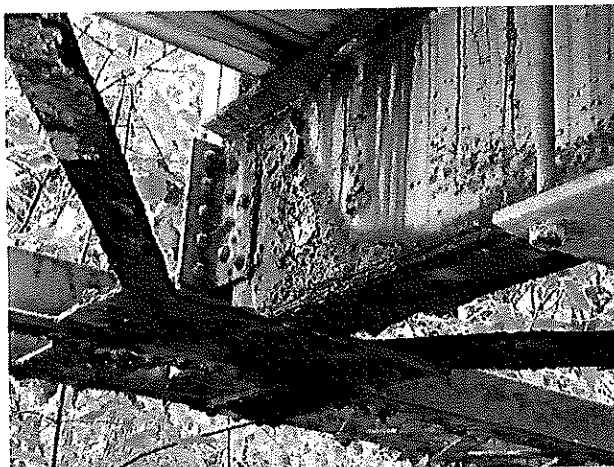
Underside View. Showing very severe corrosion.

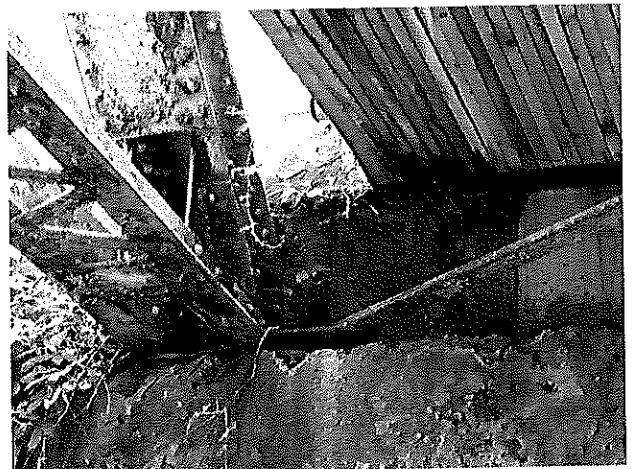
Underside View. Showing very severe corrosion.

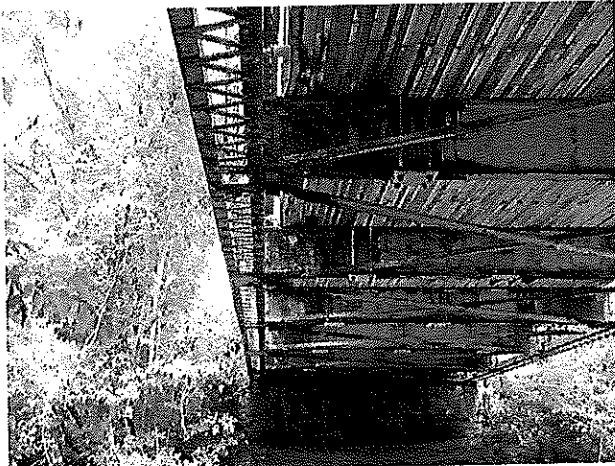
Underside View. Showing very severe condition.

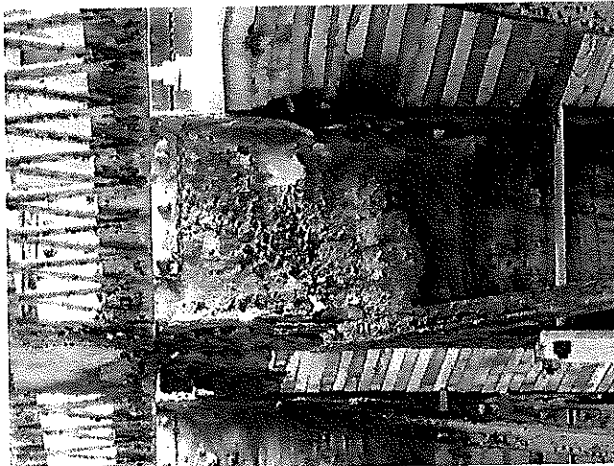
West Side. Showing failure.

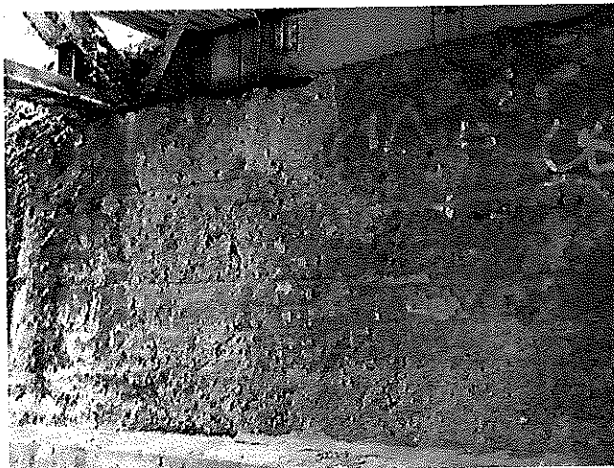
South Side. Showing very severe corrosion.

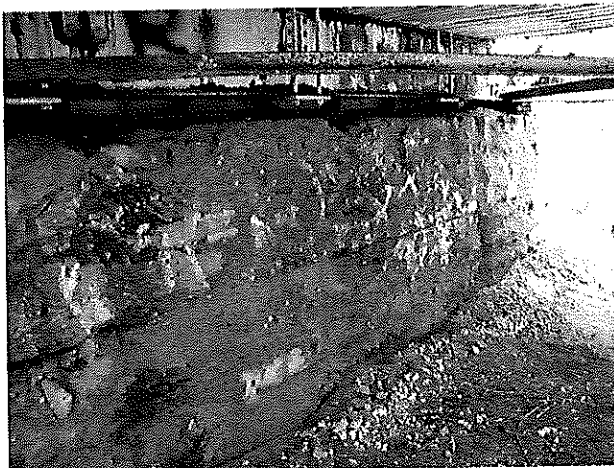
North Side. Showing poor condition.

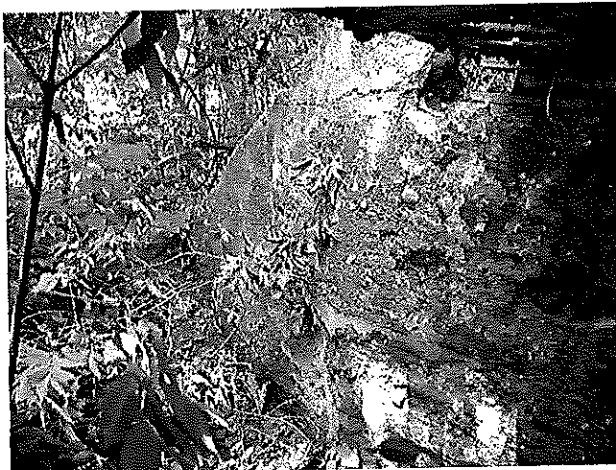
Northwest Side. Showing very severe scaling.

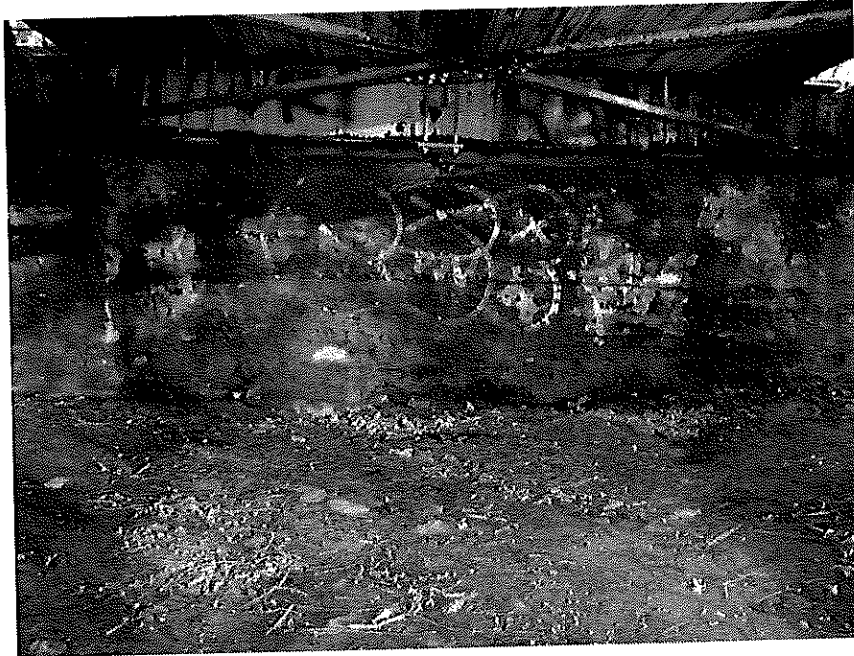
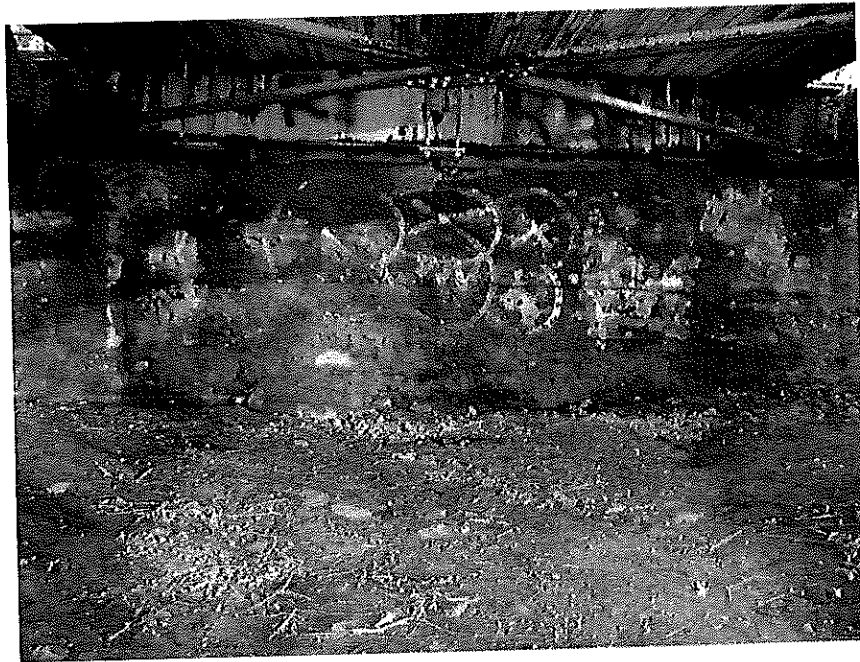
**Plate 5 Heavy Corrosion of Supporting Members below the Deck and
Condition of the South Abutment**

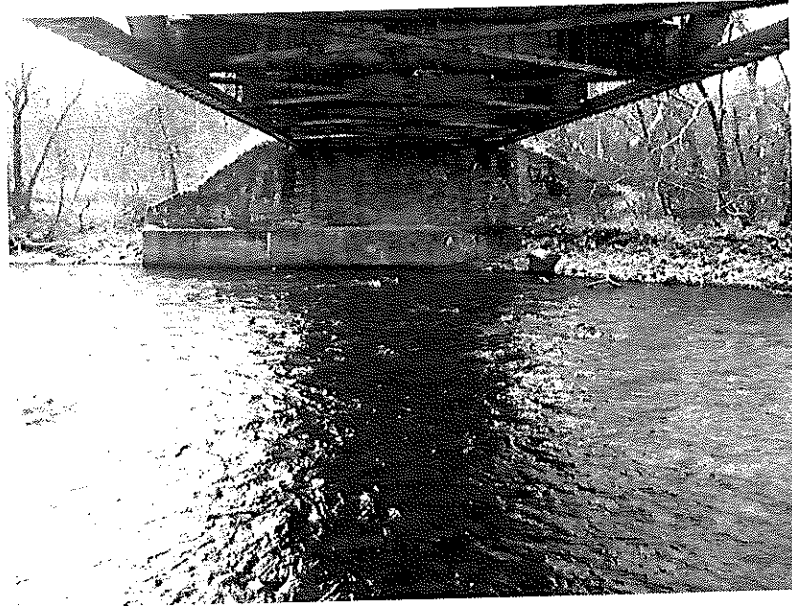
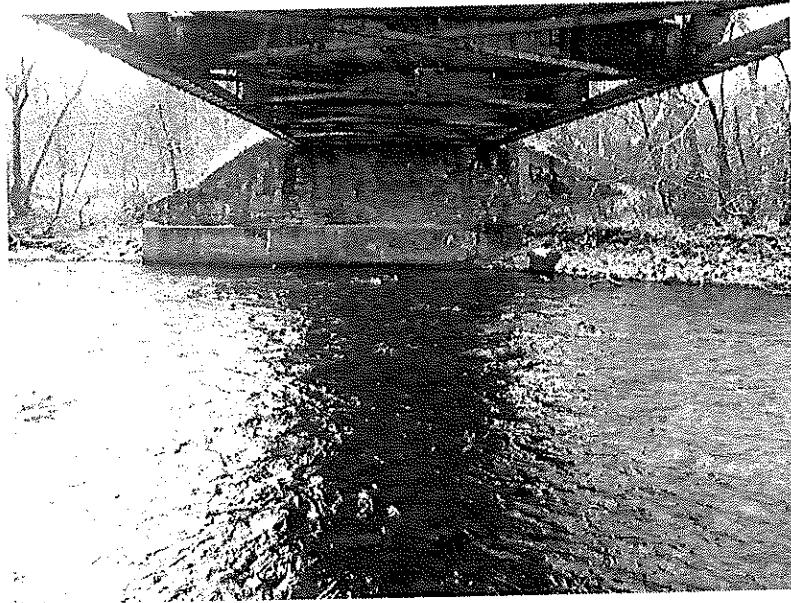
Plate 7 View to the North from the South Bank showing Corrosion of Supporting Members below the Deck and Condition of the North Bank Abutment

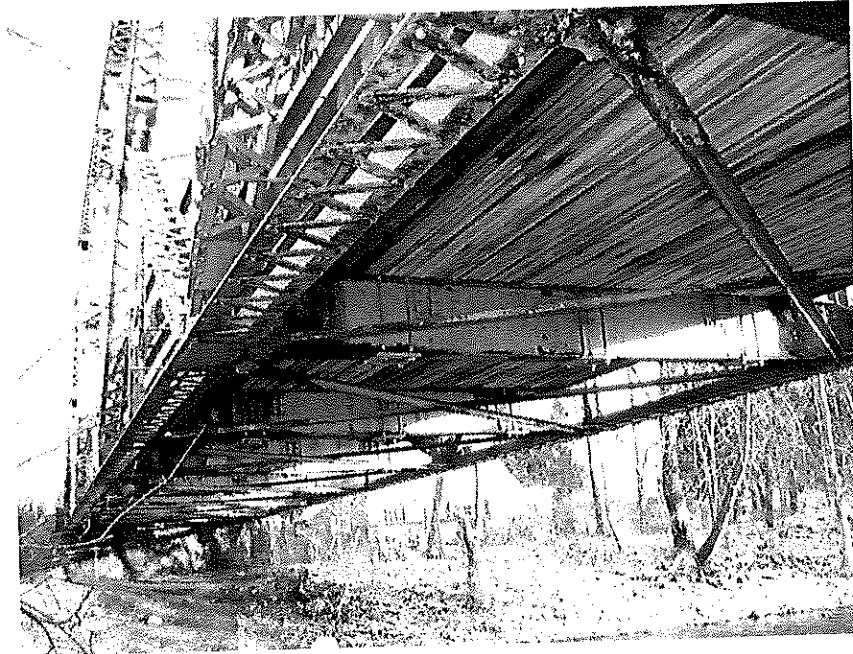
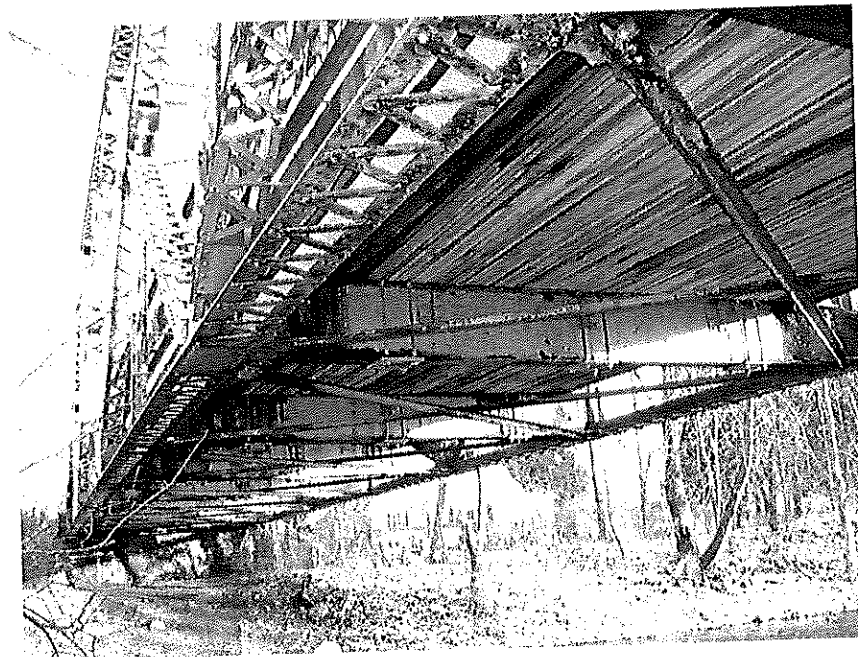
Plate 11 Oblique View from Northeast to Southwest below the Deck of the Collingwood Street Bridge showing Heavy Corrosion of Supporting Members

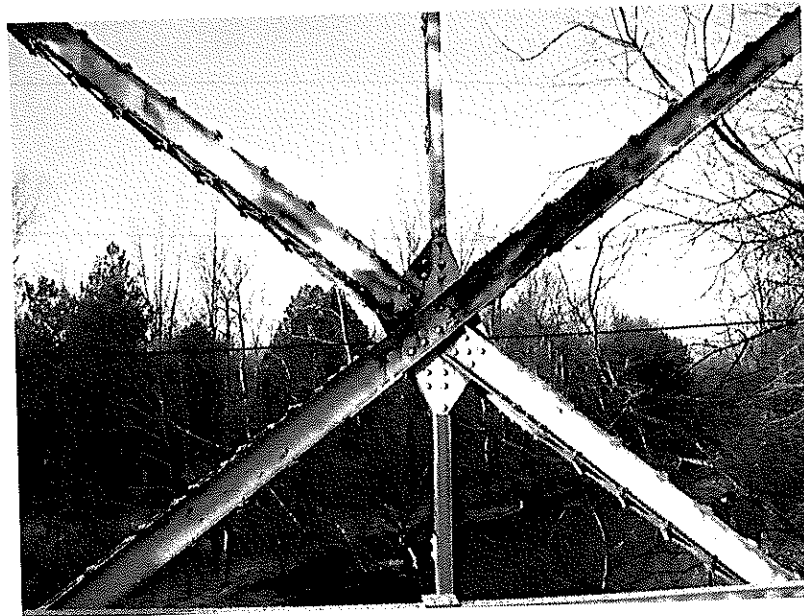
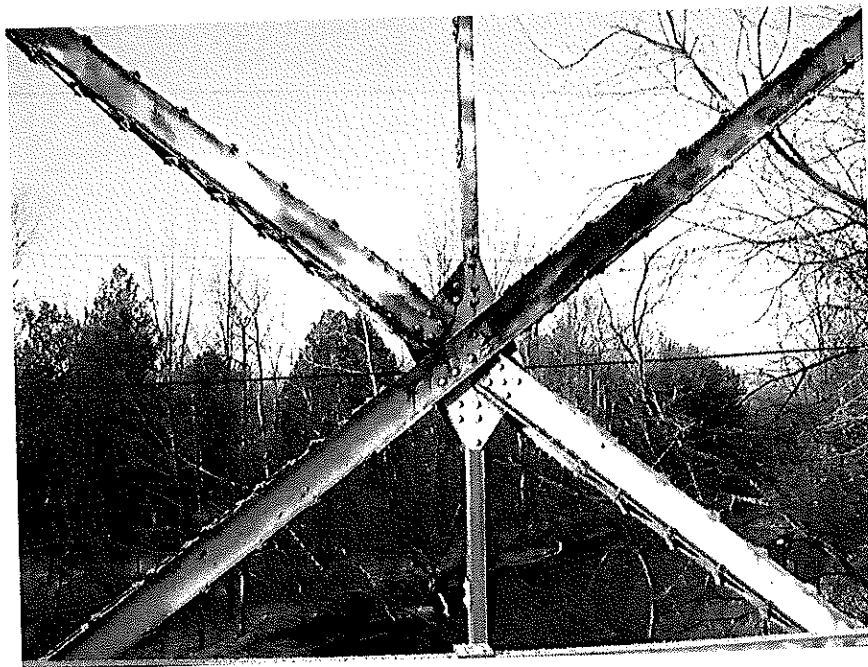
Plate 12 View to the West from the Midpoint Centreline of the Collingwood Street Bridge Showing Superstructure Detail and Corrosion
