250-Ft. Concrete Arch Across Spokane River Collapses During Construction

Report on Collapse of Falsework on Spokane Concrete Bridge

SYNOPSIS—The 250-ft. twin-rib reinforced-concrete arch bridge on the line of Post St., across the Spokane River at Spokane, Wash., collapsed during construction on Feb. 6. The following report gives the details of the falsework that failed.

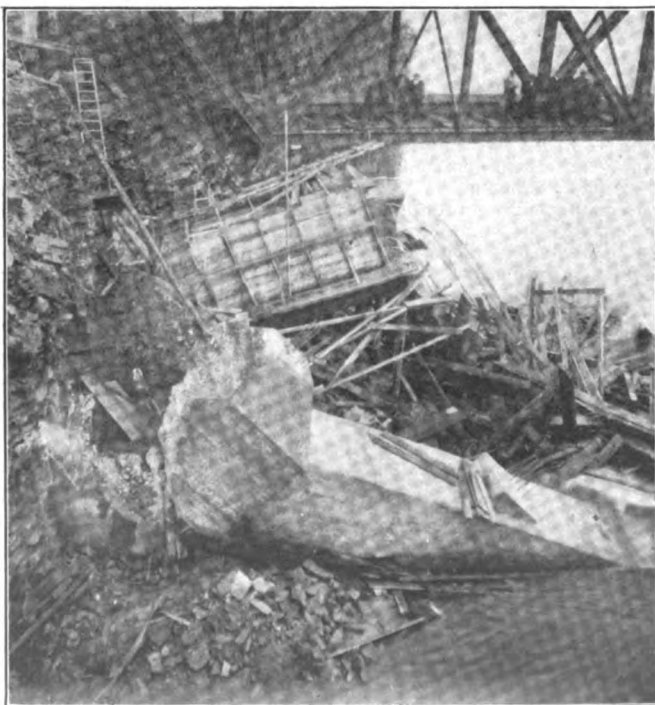
FIG. 1. POST ST. COLLAPSE AT EAST ABUTMENT

The two views herewith were taken immediately after the collapse of the structure and show the conditions at each end of the bridge.

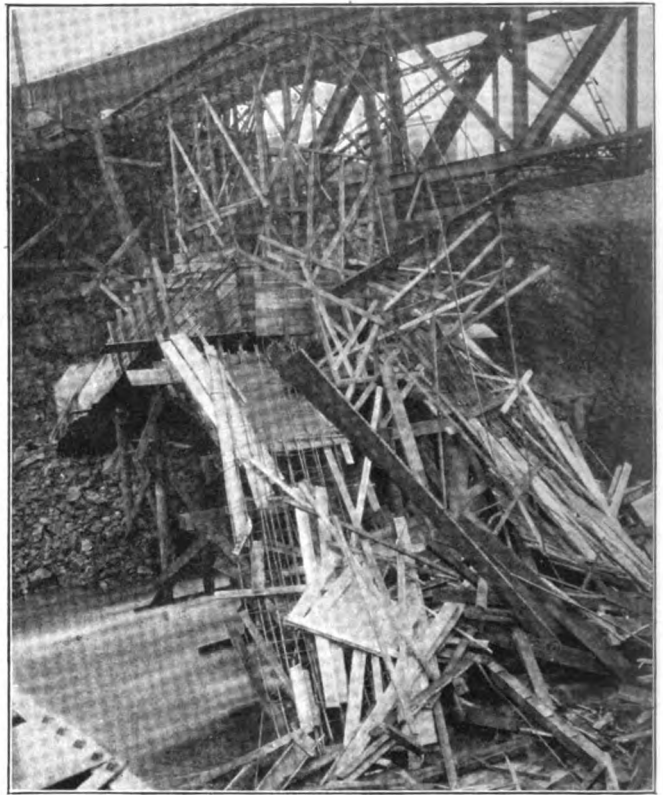
FIG. 2. LOOKING TOWARD WEST END OF THE FALLEN POST ST. BRIDGE

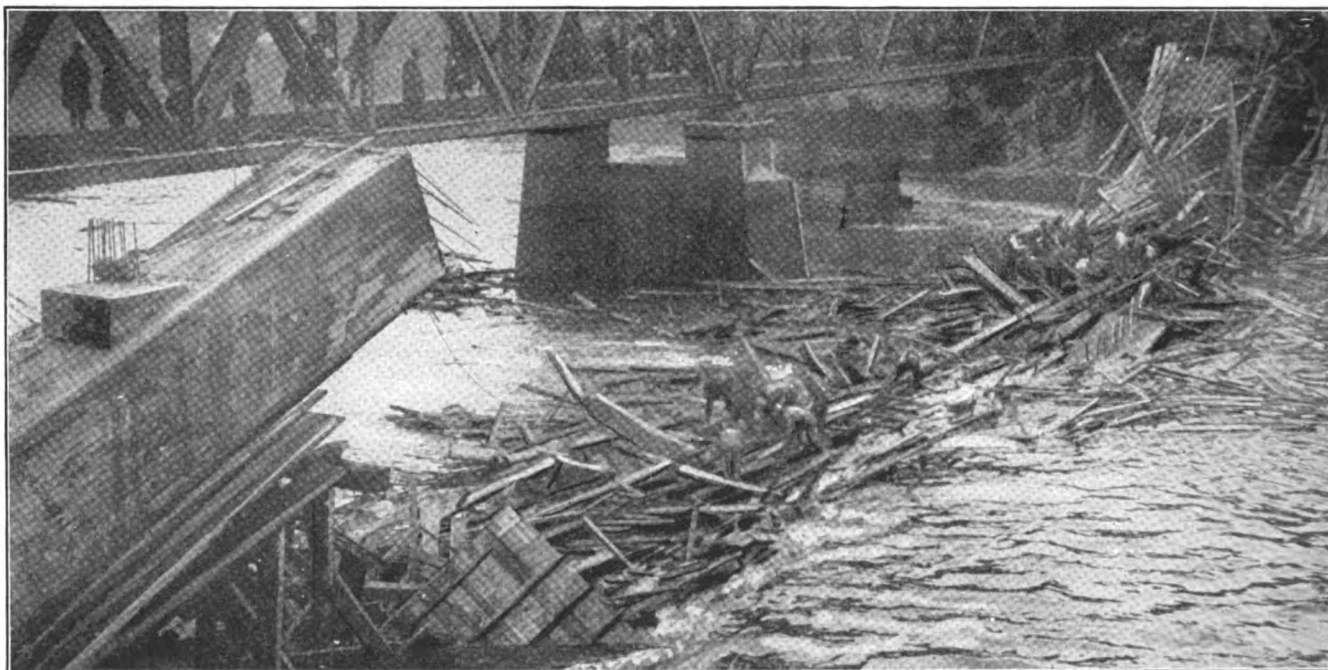
FIG. 1. VIEW OF POST ST. BRIDGE LOOKING WEST AFTER COLLAPSE
The projecting rib in the foreground fell some three hours after the initial collapse

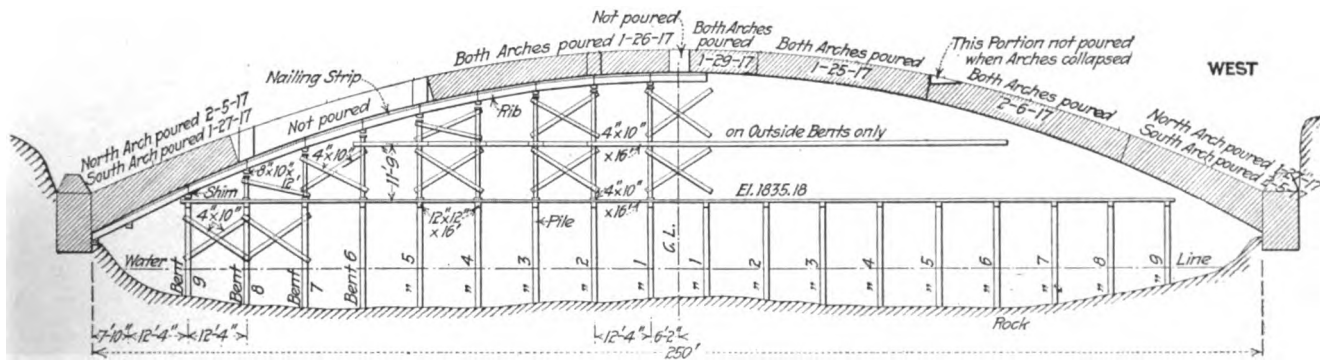
FIG. 2. OUTLINE OF POST ST. BRIDGE FALSEWORK, SHOWING PROGRESS OF PLACING CONCRETE

The accompanying elevation (Fig. 2), compiled on Feb. 8, 1917, by the city engineer's office from sketches in the contractors' office, shows that four lines of longitudinal sway bracing were carried from end to end. Existing evidence shows that this system of sways, with possibly two exceptions at the east end, was spiked to

The elevation (Fig. 2) shows the sequence of sectional pouring. It will be noticed that all but a small part of the rib had been poured over Bent 5 west, when the collapse occurred. Half-yard batches were trammed from

the mixer and dumped onto an inclined chute, from which the concrete floated or was spread to place. The writer's information from the workmen is that the dump over this bent was nearly a vertical drop. This would give a drop ranging from about 9 to 15 ft.

withstanding that the drop distance was gradually being decreased as the forms filled, it was from this point, in his judgment, he stated, that the collapse started. It is possible that the cumulative result of the impacts finally developed the critical weakness in the falsework and thus tumbled the whole structure into a mass of inextricable débris.

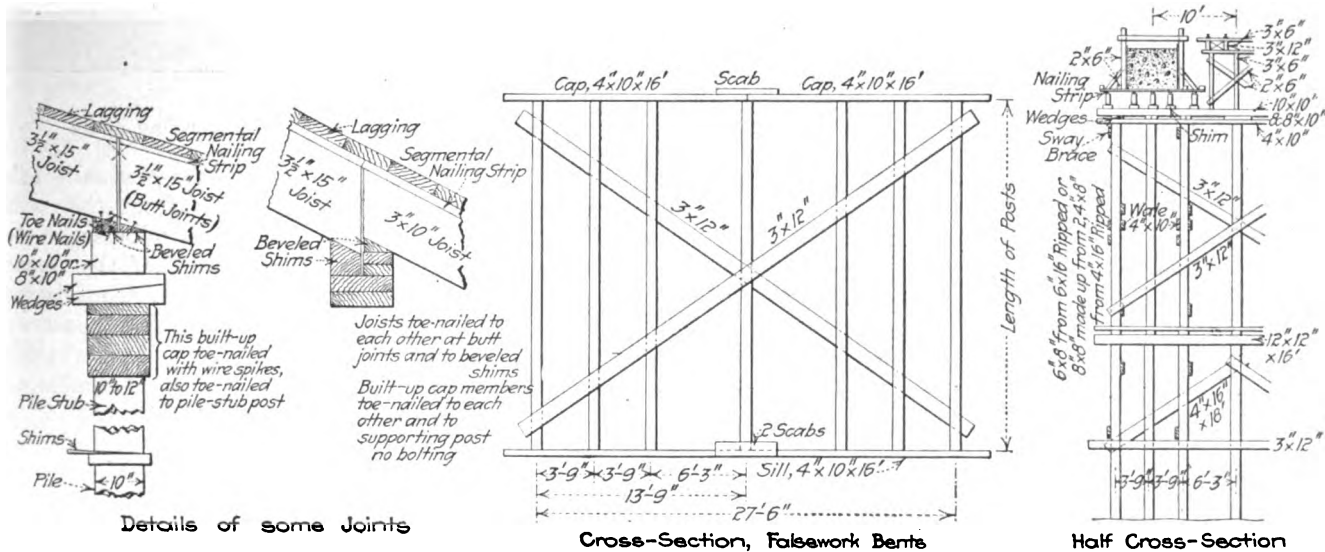
FIG. 3. DETAILS OF THE FALSEWORK DESIGN OF POST ST. BRIDGE AT SPOKANE

the piles instead of being bolted. One workman stated that from one to three spikes were used. Fig. 3 shows that two or three spikes were used, but no bolts. None of the piles now standing nor any of those enmeshed in the debris that could be seen had been barked, so that clearly the sways were spiked through the bark, which generally is about 1 in. thick. This thickness, together with from 1 to 2 in. of soft sapwood, plus the thickness of the sway brace, gave a very insecure hold to an 8-in. spike and practically no holding value to a 6-in. spike, if such were employed.

The second story of the falsework (Fig. 3) was made up of 6x8-in. and 8x8-in. posts, built up of 4x8's, and in lengths from 4 ft. 8 in. to 22 ft. 11 1/8 in., according to the schedule in the accompanying table. It does not appear how the two pieces making up the member were fastened, whether with spikes or bolts. The ordinary

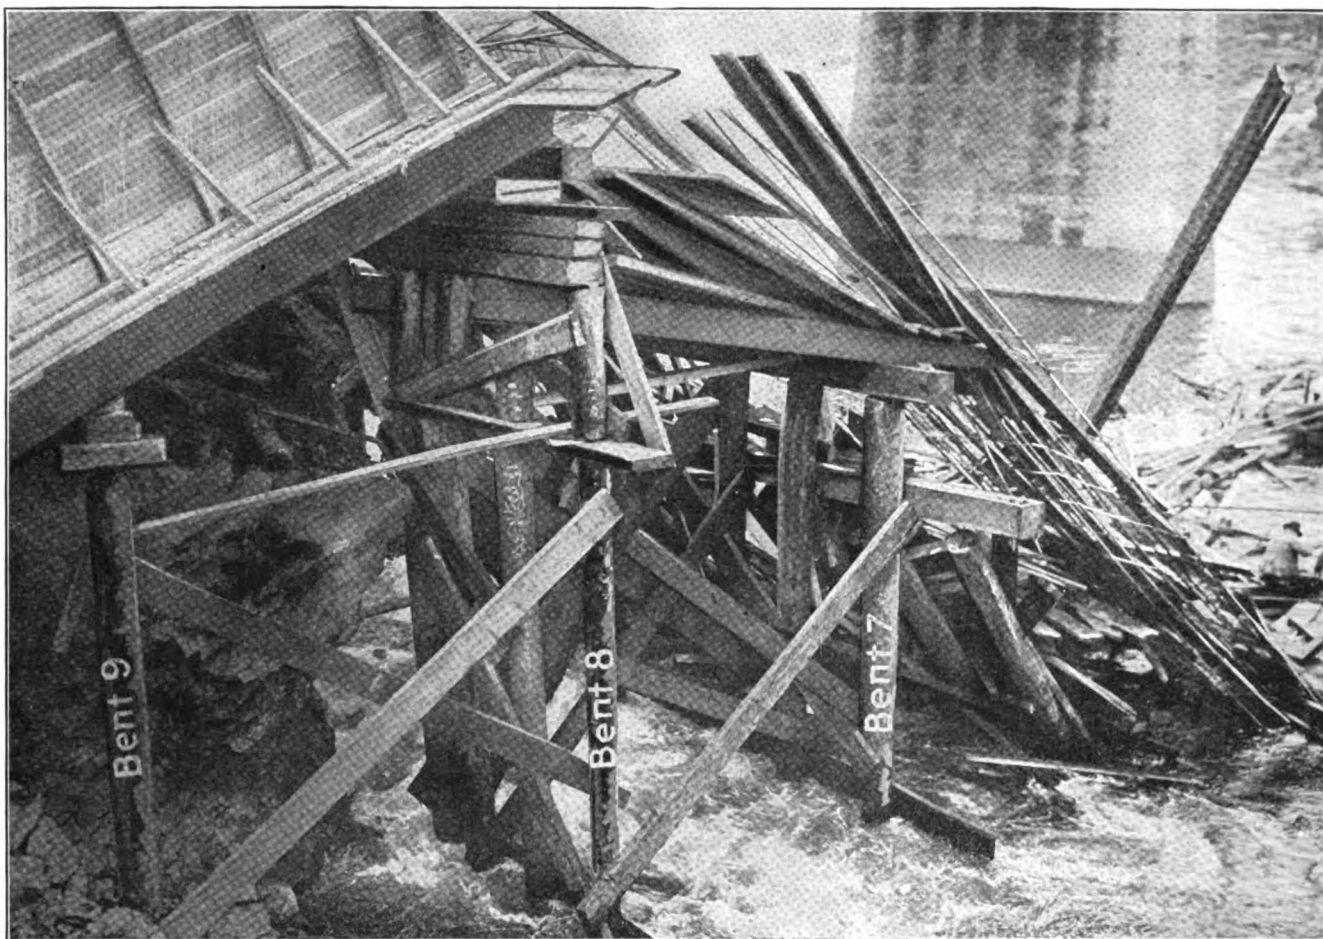
laid flat, over each pile, presumably continuous, constituted the longitudinal ties of all the bents at the top of the first story. This tie, however, seems to have been omitted between Bents 8 and 9 west, as shown by Fig. 4, although a partial substitute was put in in the form of a flat sway brace and spiked to the posts. This substitute seems to have been an unfortunate one. It is not apparent that the flat bolsters were drift bolted to each cap. On the contrary, it would appear from such meager evidence as now exists that the connections were made by toe-nailing with wire spikes these insufficient bolster members.

FIG. 4. CLOSE VIEW OF BENTS 7 TO 9 ON WEST SIDE OF POST ST. BRIDGE
Pile tops from 9 to 12 in. diameter. Note absence of bolts and presence of shims under half-story round posts

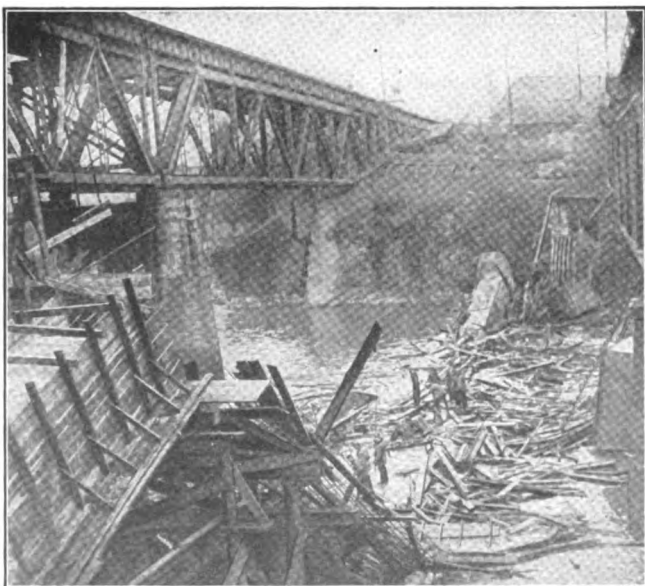
FIG. 5. LOOKING EAST OVER BRIDGE RUINS
