Johnson Street Bridge Condition Assessment Report

EXECUTIVE SUMMARY

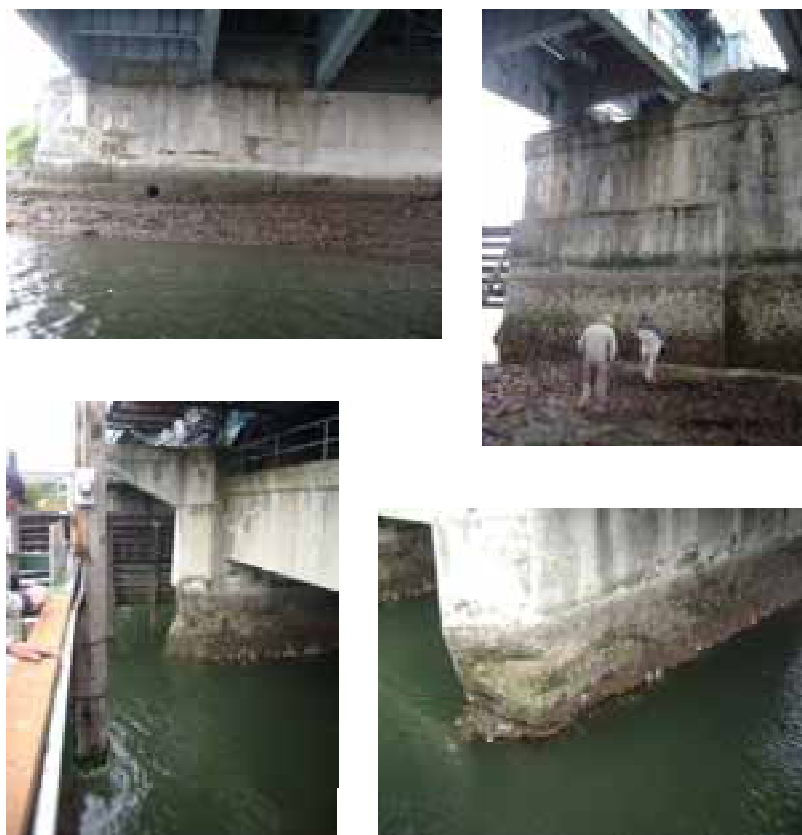
Several substructures have minor cracks, see **Figure 3.3.2**. The substructures were not designed to withstand current earthquakes conditions. Substructures have minor cracking and efflorescence but almost no spalling. All bearing seats were inspected and found to be in good condition.

Figure 3.3.1 – Substructures at low tide (a) Pier 1 looking west (b) Pier 1 looking east (c) Pier 2 looking west (d) Pier 2 showing erosion of concrete on the south side

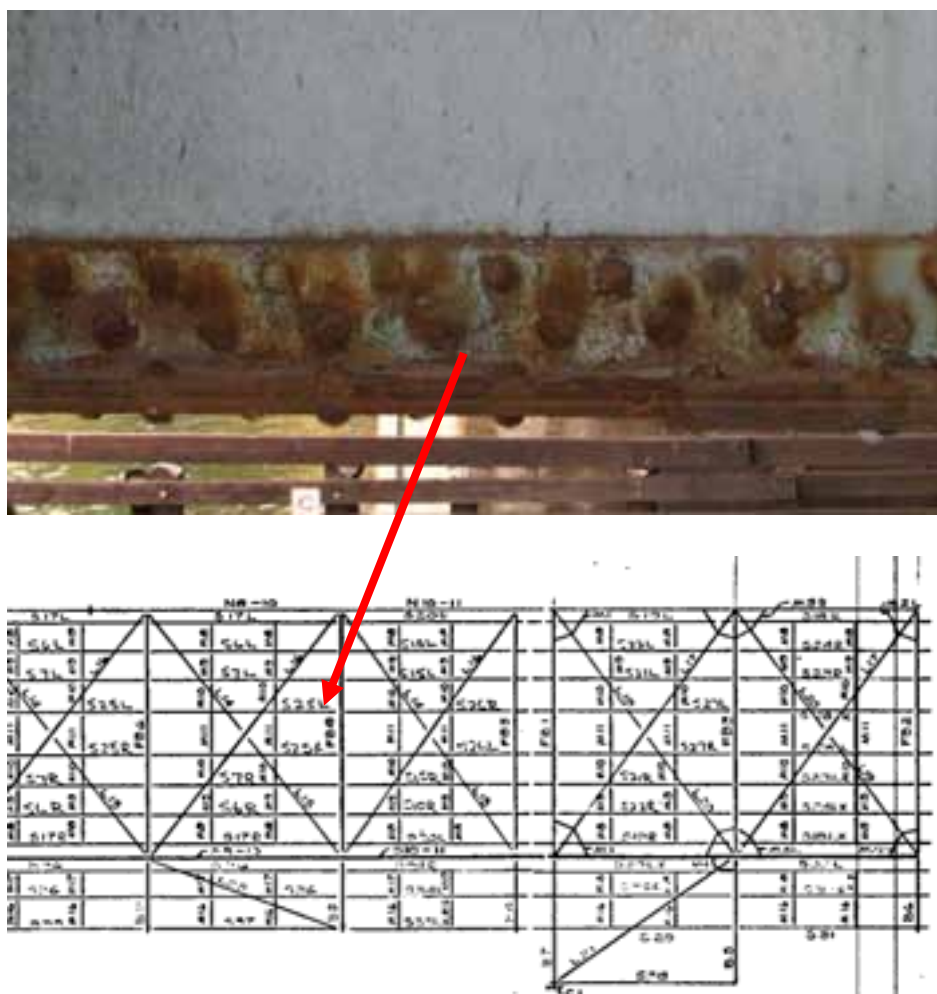
Extensive member corrosion was observed in many areas along the bridge – especially in the floor beams and stringers. The joints along the bridge are in good condition and minimal water and debris is coming through. Corrosion and paint deterioration is visible throughout the bridge on most members. However, most of the bridge components were found to be in fair to good condition. Member corrosion was observed in many areas along the bottom flange of the stringers and floor beams of the road bridge shown below in **Figure 3.3.3**, **3.3.4** and **Appendix A**.

Figure 3.3.3 – Typical corrosion on bottom flange of bascule span (Member S25L)

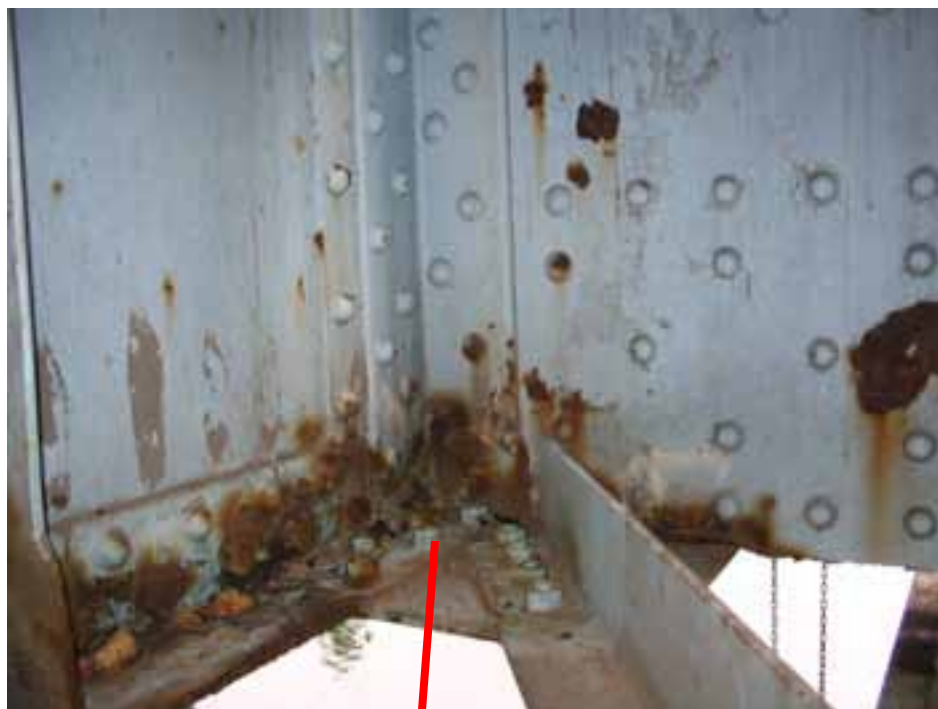
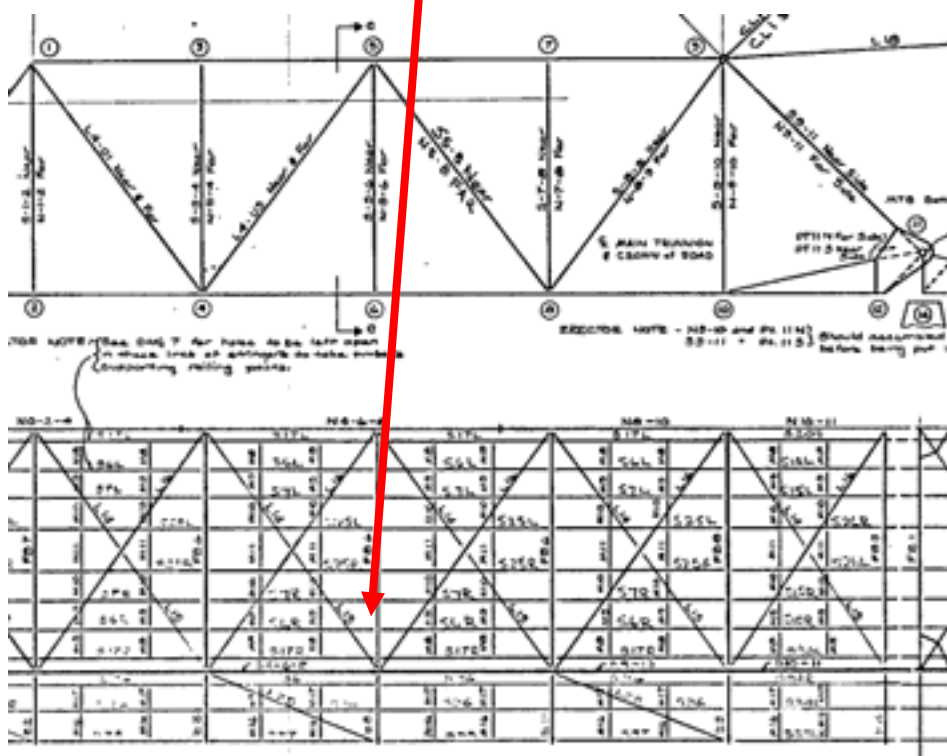
Figure 3.3.4 – Typical corrosion on bottom flange and gusset plate (Bracing Member L15 to Floor Beam FB6)

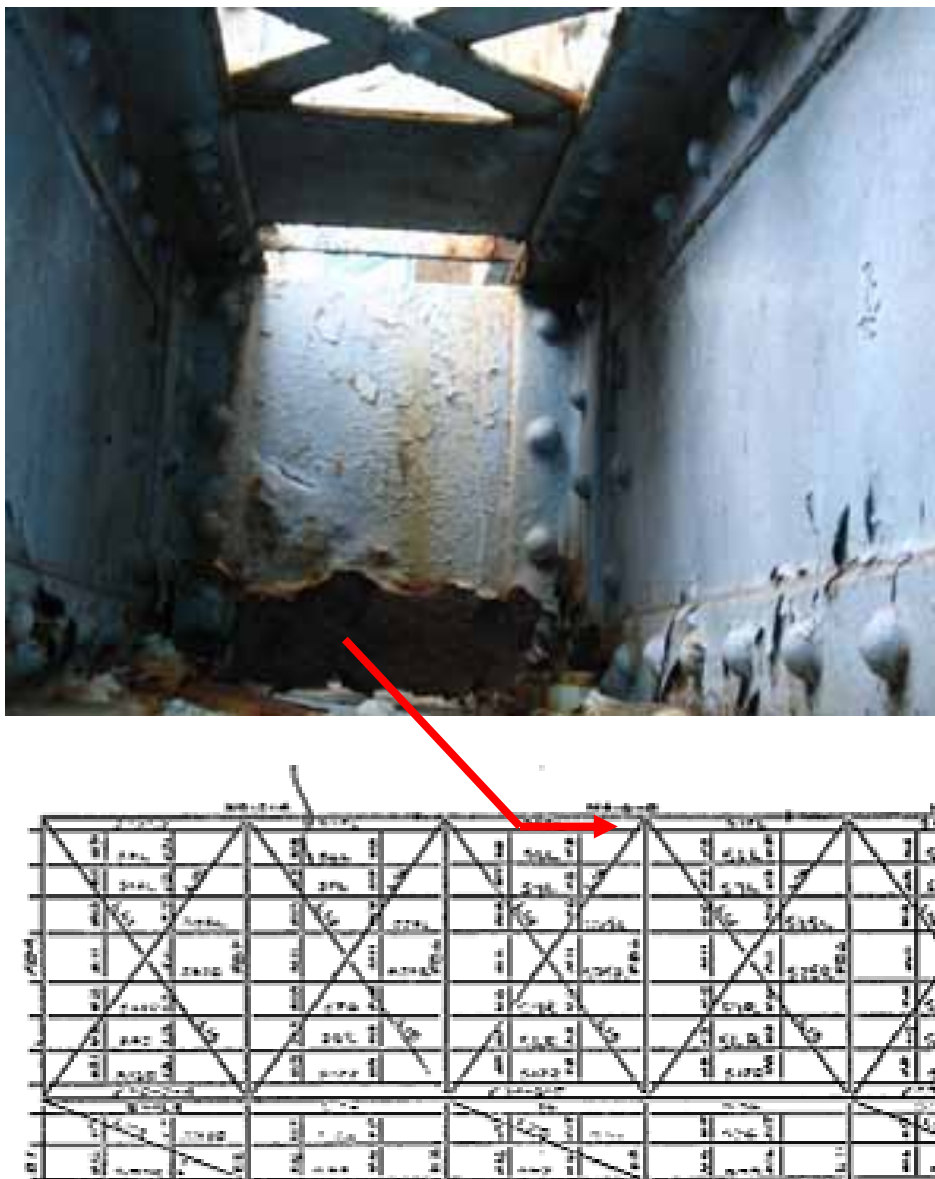
The structural integrity of the bridge appears to be intact and performing as originally intended with no signs of major distress. However, it was noticed that the paint coating in many areas along the bridge has failed or is beginning to fail. Other than the obvious corroded areas, the paint coating is peeling in areas on the top and bottom and interior surfaces of the diagonals, verticals and girders. Paint coating deterioration is estimated to cover approximately 30-35% of the bridge. Typical interior section paint deterioration is shown in **Figure 3.3.5** below.

Figure 3.3.5 – Typical condition inside built-up truss member

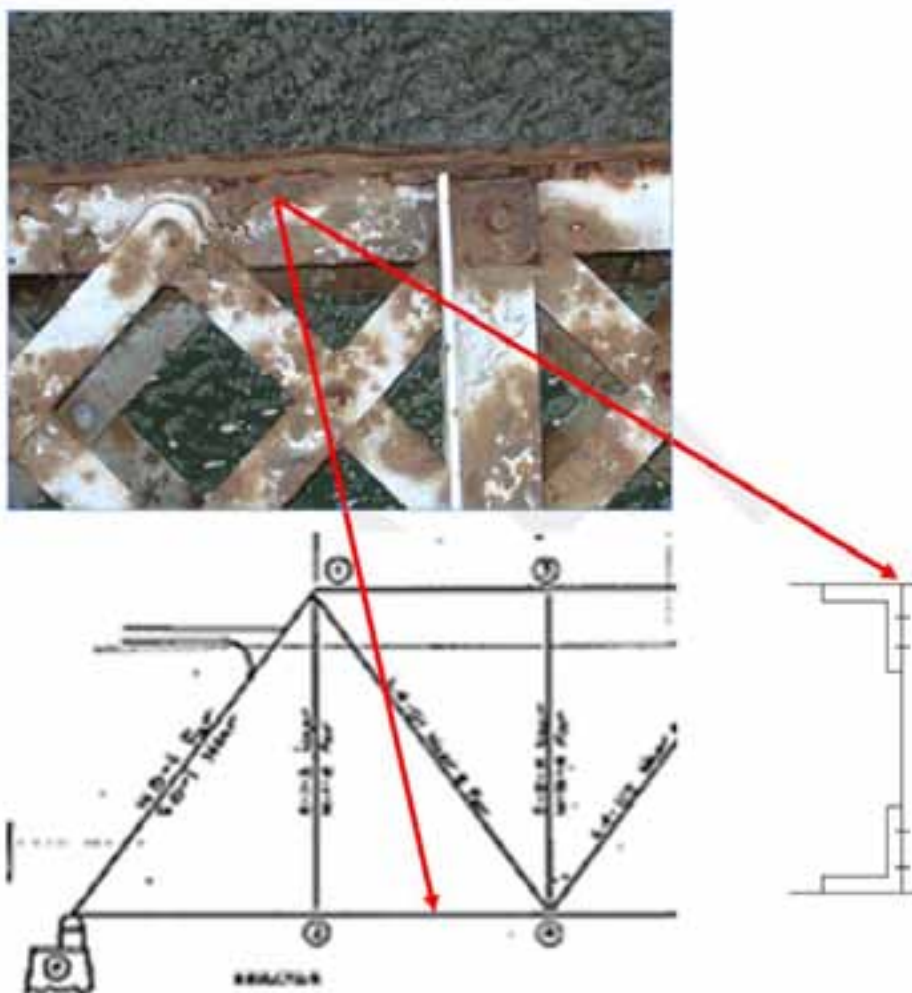
The vertical and diagonal truss members are in generally good condition. There are some localized areas where the steel coating has deteriorated and pack rust is forming between the members built-up plates. This can be seen in **Figure 3.6.4**. The pack rust, over time, can induce undesirable tensile stresses on the rivets and if the resultant stress becomes too high, rivets can break or tear through the parent material. Pack rust can typically not be eliminated although its rate of growth can be reduced.

Figure 3.3.6 – Typical condition on top surface of laced member.

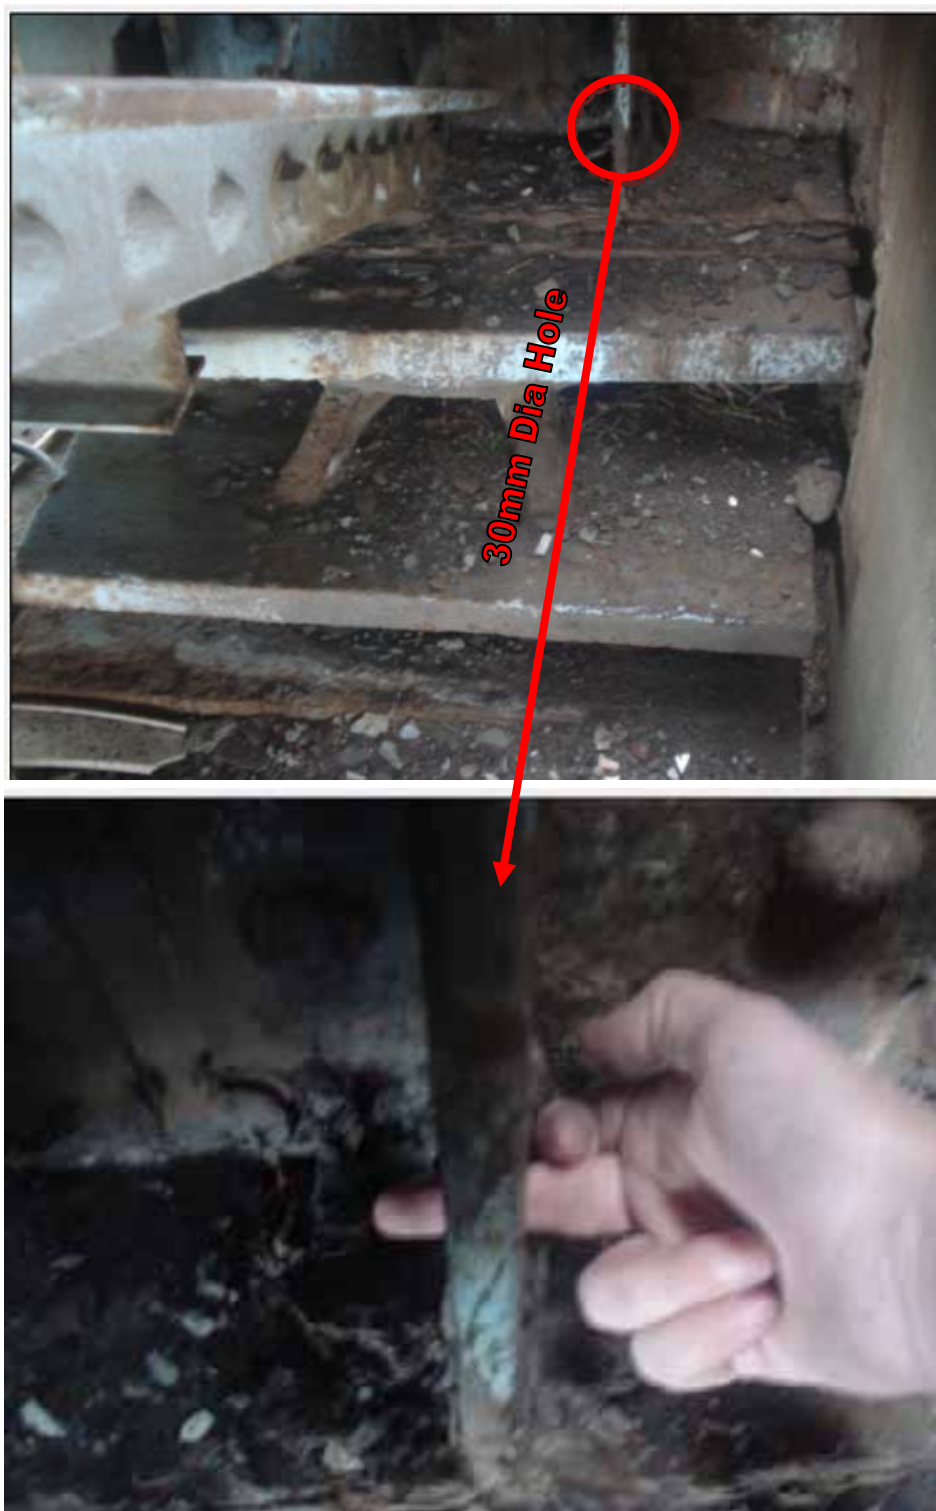
Members with 100% section loss were observed in areas where debris and moisture were trapped such as at gusset plates and bracing connections, see **Figures 3.3.7** and **3.3.8**. These affected areas are the result of severe corrosion due to paint loss and/or water accumulation on the member surfaces. It should be noted that this level of deterioration was found in localized areas and is not widespread on the bridge.

Figure 3.3.7 – 100% section loss on bearing stiffener, Northeast bearing, Span 1

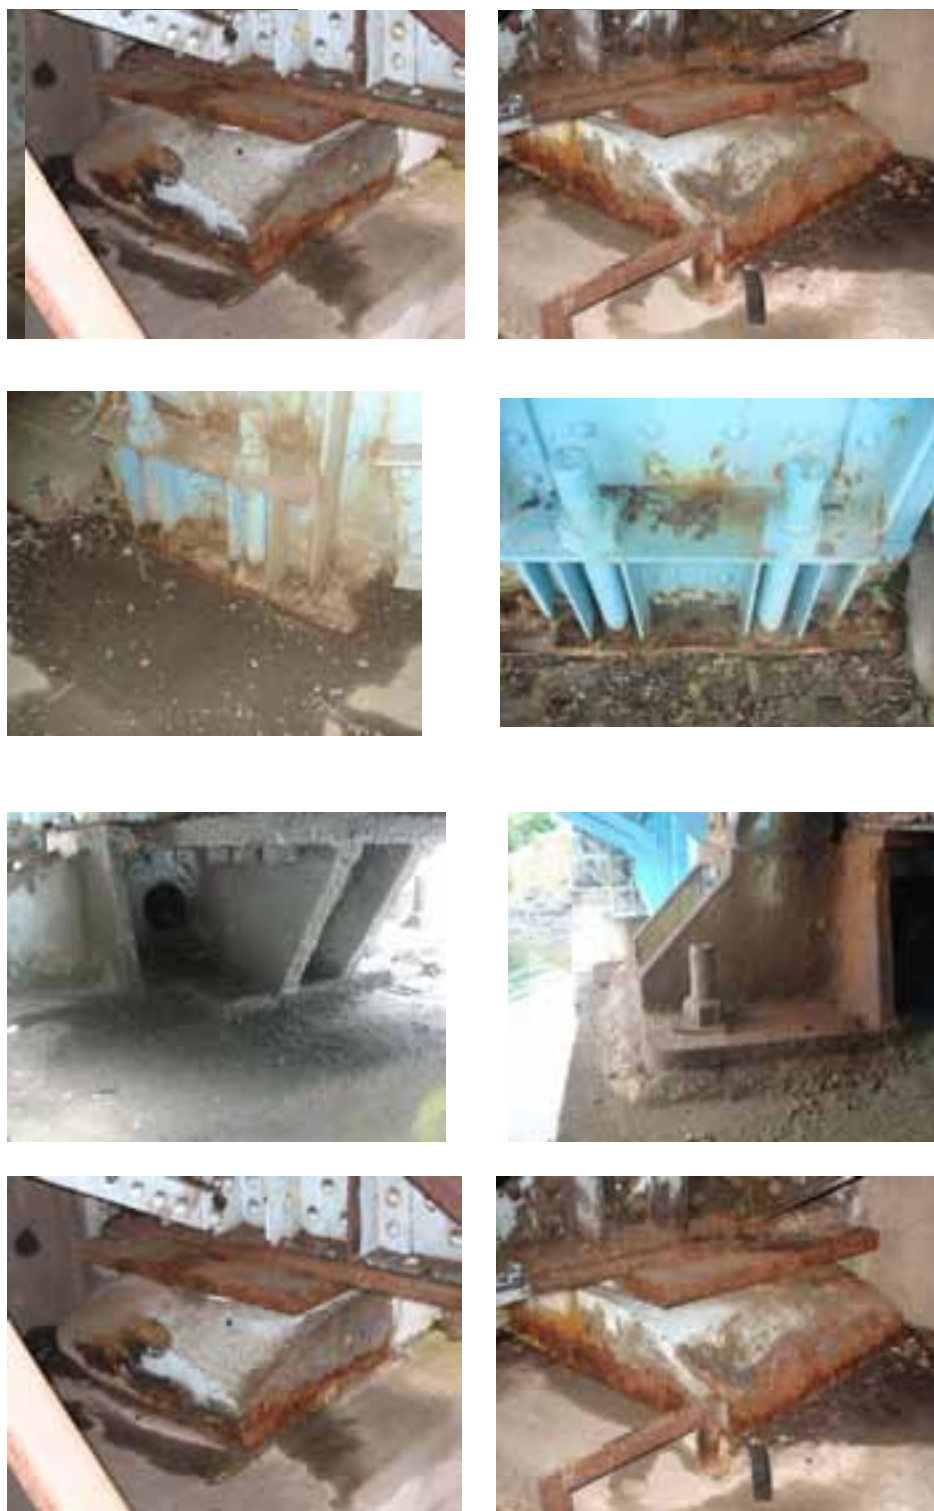
Although there is only minor dirt and debris accumulation on the bridge bearing seats, significant corrosion of the bearing plates was observed as shown in **Figure 3.3.9**.

Figure 3.3.9 – Bearing Plate Deterioration

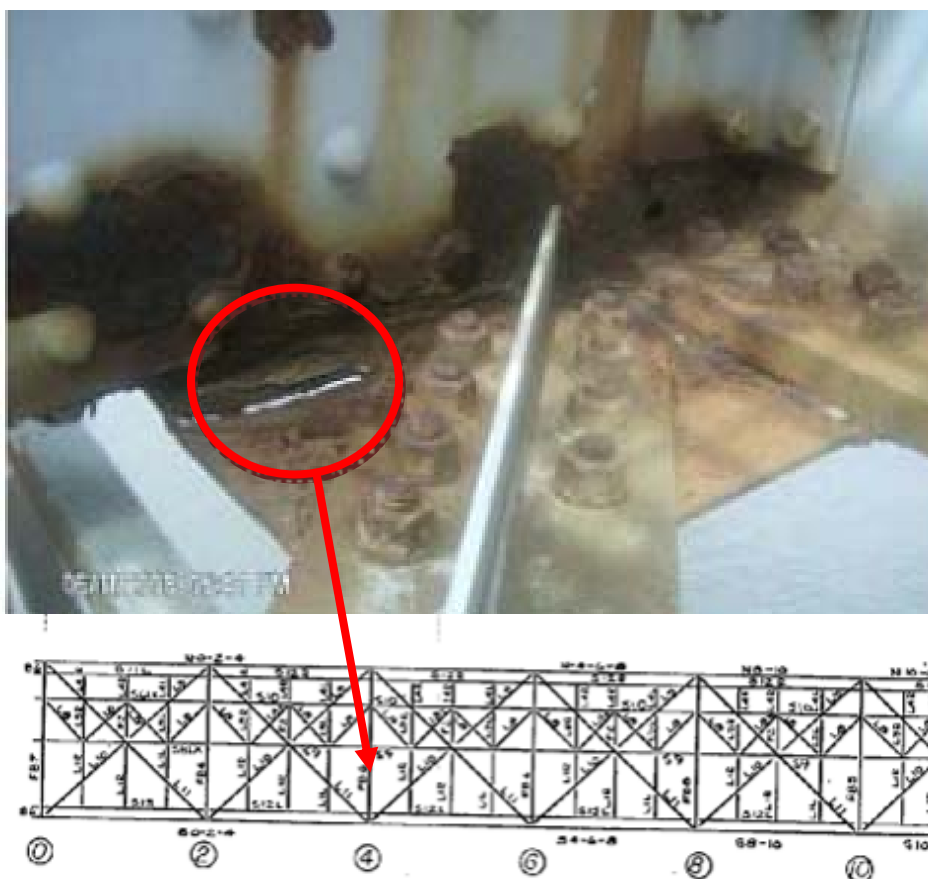
Figure 3.3.14 – Perforation in horizontal gusset plate between bottom chord and lateral bracing

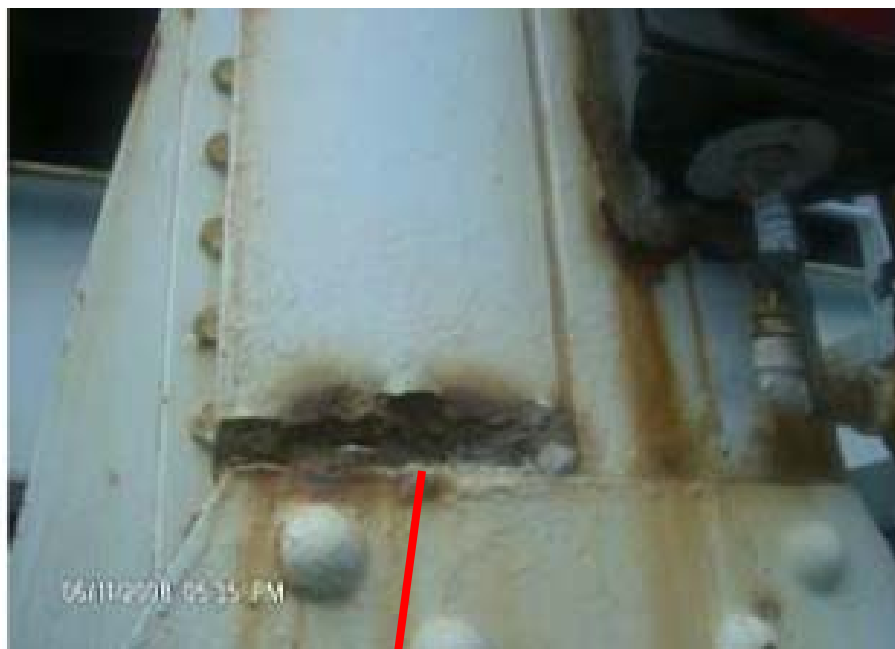
Figure 3.3.15 – South vertical at east end of Panel 3, 50% section loss

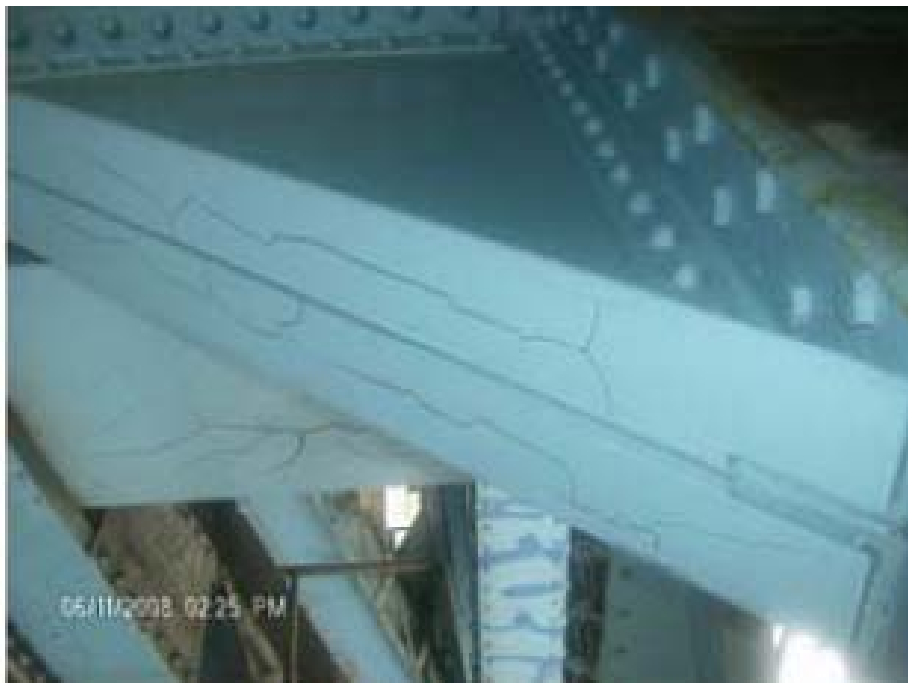
The paint coating is generally in poor condition and has failed, see **Figure 3.3.16**.

Figure 3.3.16 – Typical cracks in paint system, Span 3

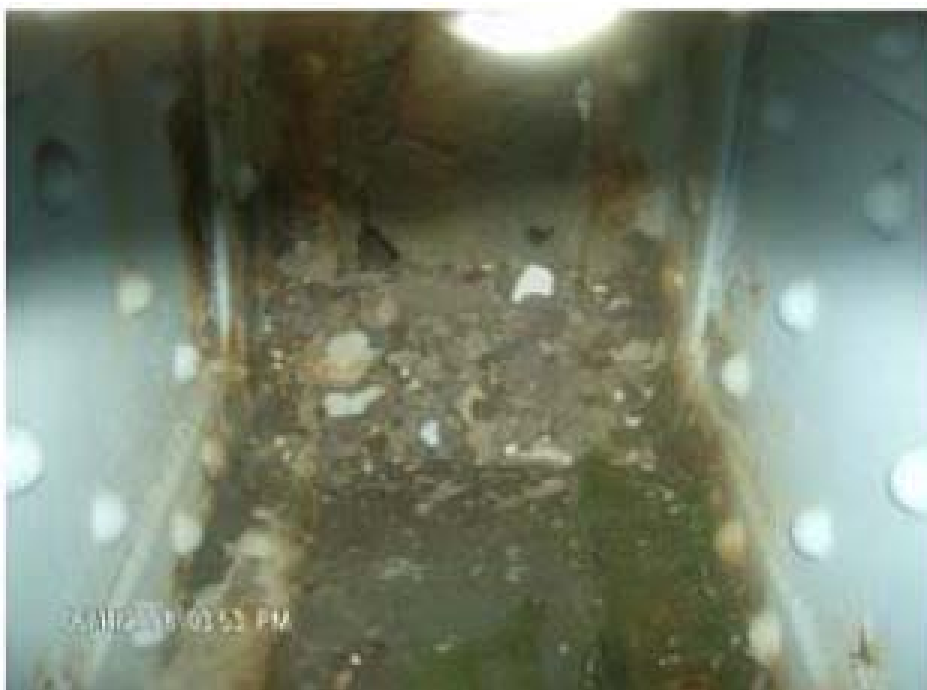
Figure 3.3.17 – Typical debris build-up inside of truss bottom chord at verticals

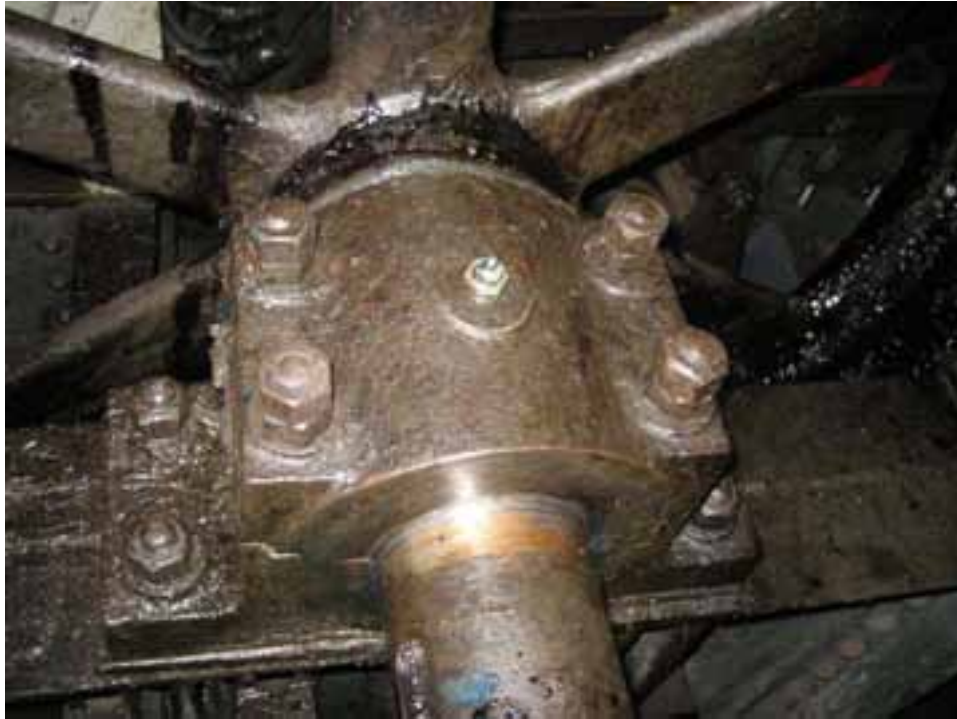
Photo M-1.1. Highway Bridge, Bearing B3. Note the deformation of the bearing cap and the degradation of the shaft.

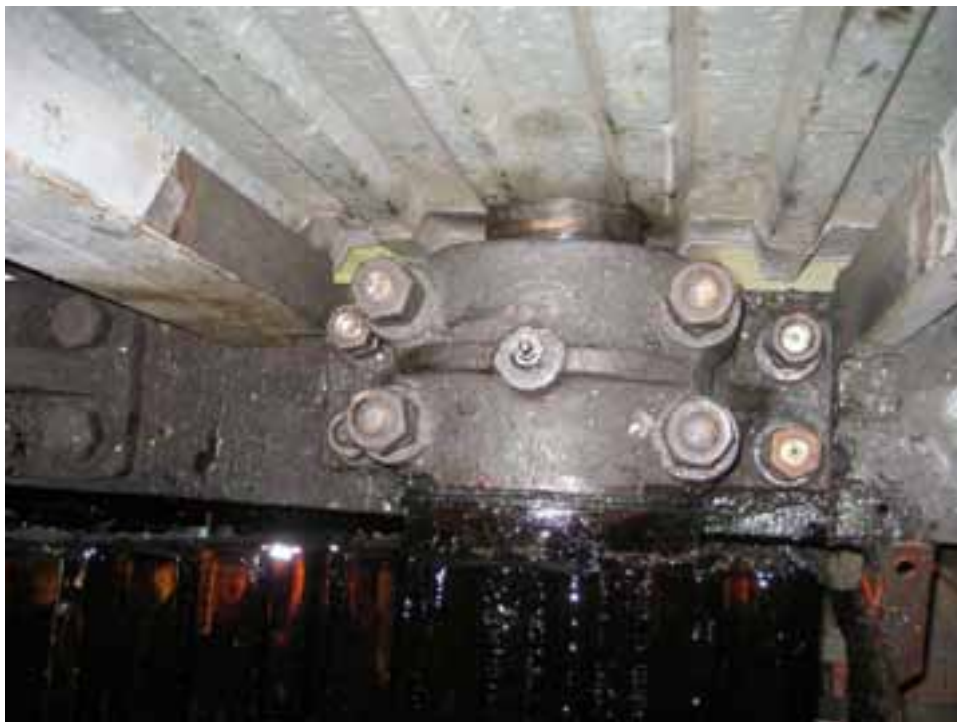
Photo M-2. Highway Bridge, Bearing B12. This bearing oscillates during operation of the machinery. Note that the base bolts have been replaced.

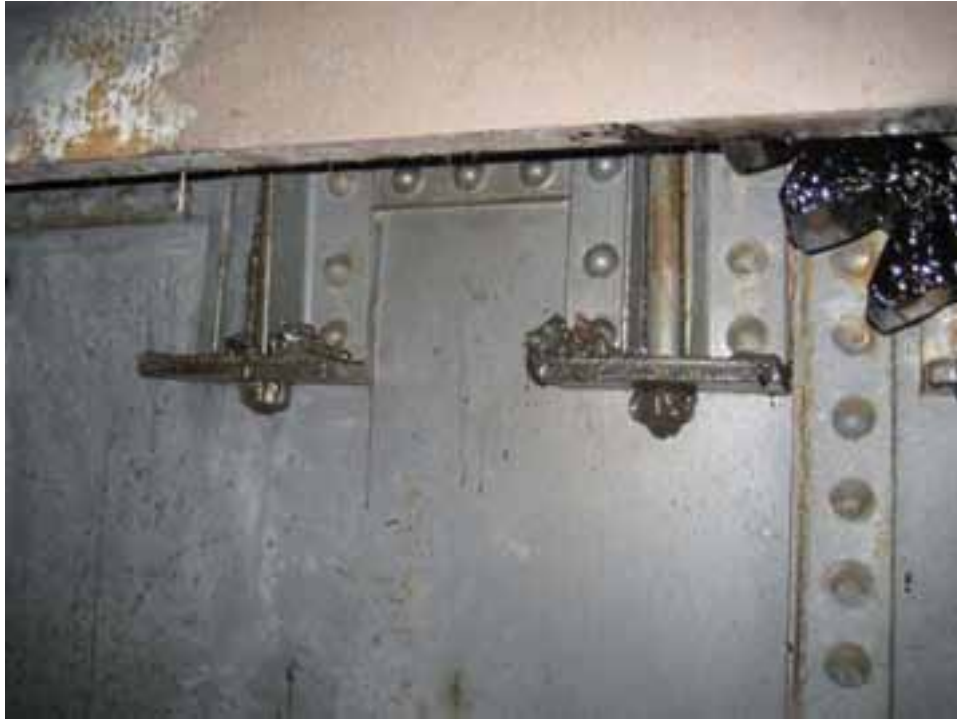
Photo M-3. Highway Bridge, Bearing B13. Note the gap between the nuts and the support indicating that the bolts are loose.

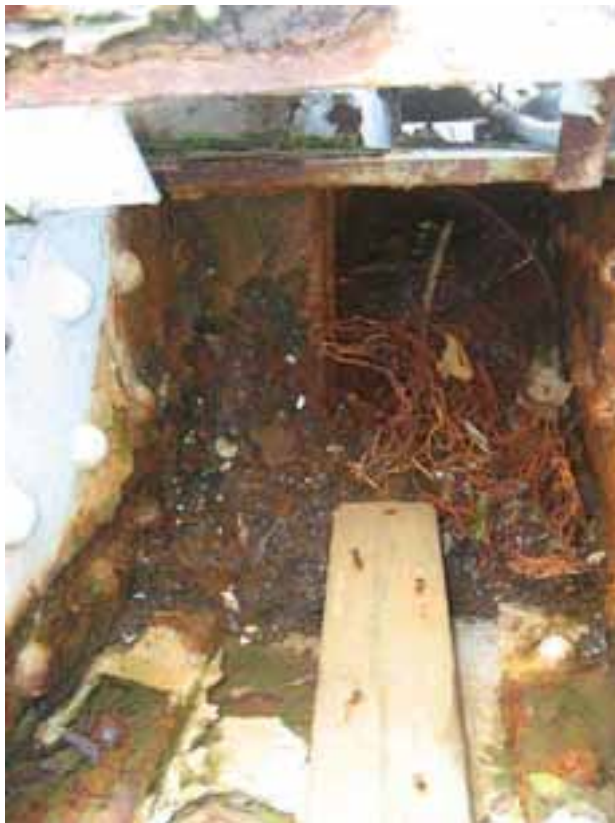
Photo M-4. Highway Bridge, Bearing B14. The body of the upper inboard bearing mounting bolt is behind the heavily corroded stiffener. Note the accumulated debris.

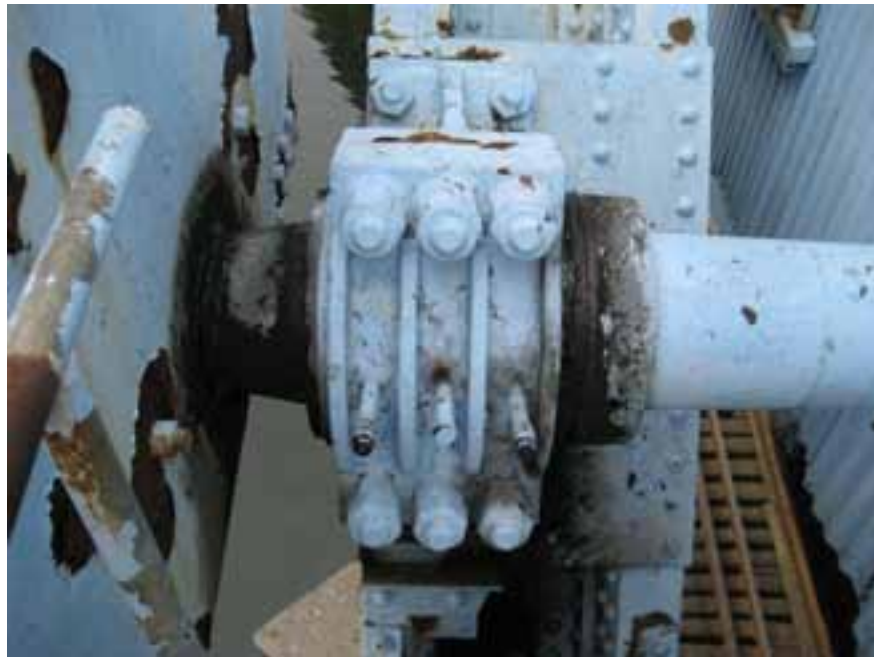
Photo M-6. Railroad Bridge, Bearing B14. Note the center lube fitting has been replaced with a pipe cap.

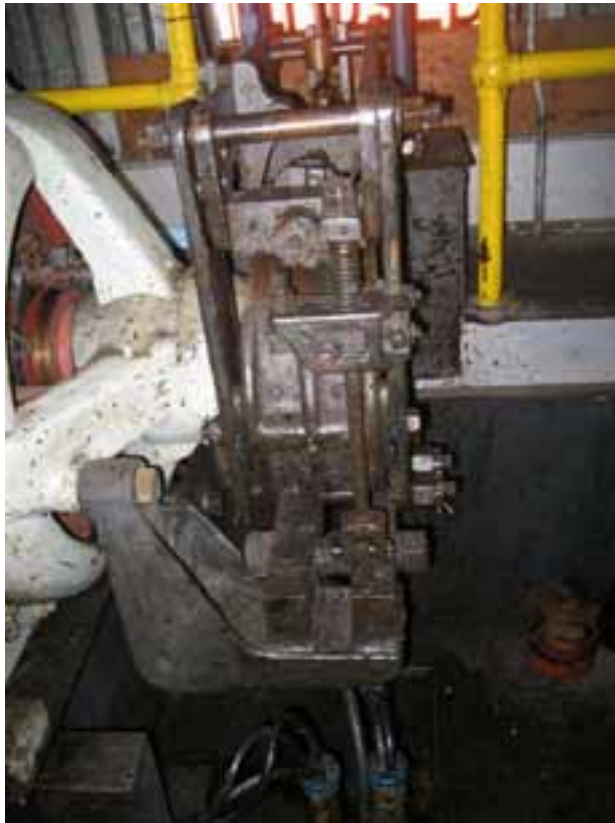
Photo M-7. Highway Bridge, North Motor Brake. The brake assembly is covered with lubricant and lubricant has contaminated the brake wheel.

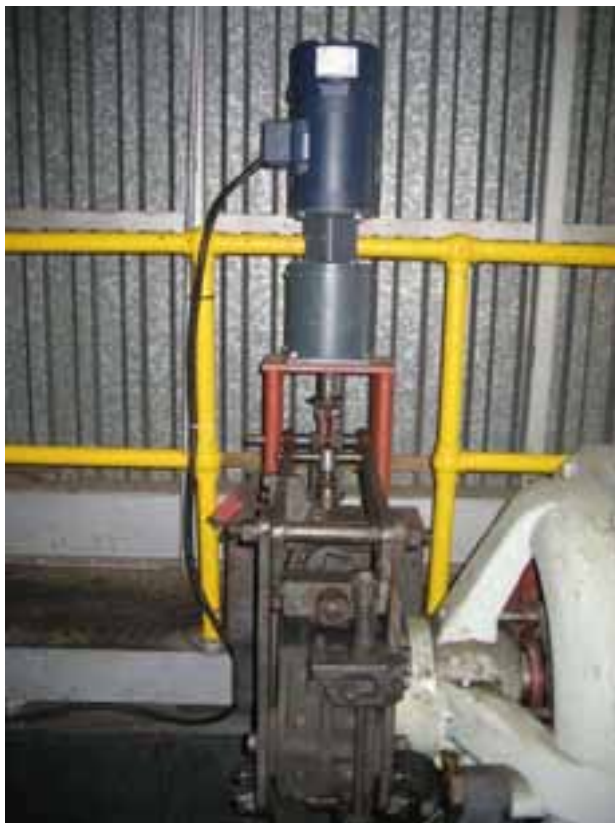
Photo M-8. Highway Bridge, South Motor Brake. The brake has been retrofit with a custom actuator. A cotter pin is missing from one of the pins near the actuator.

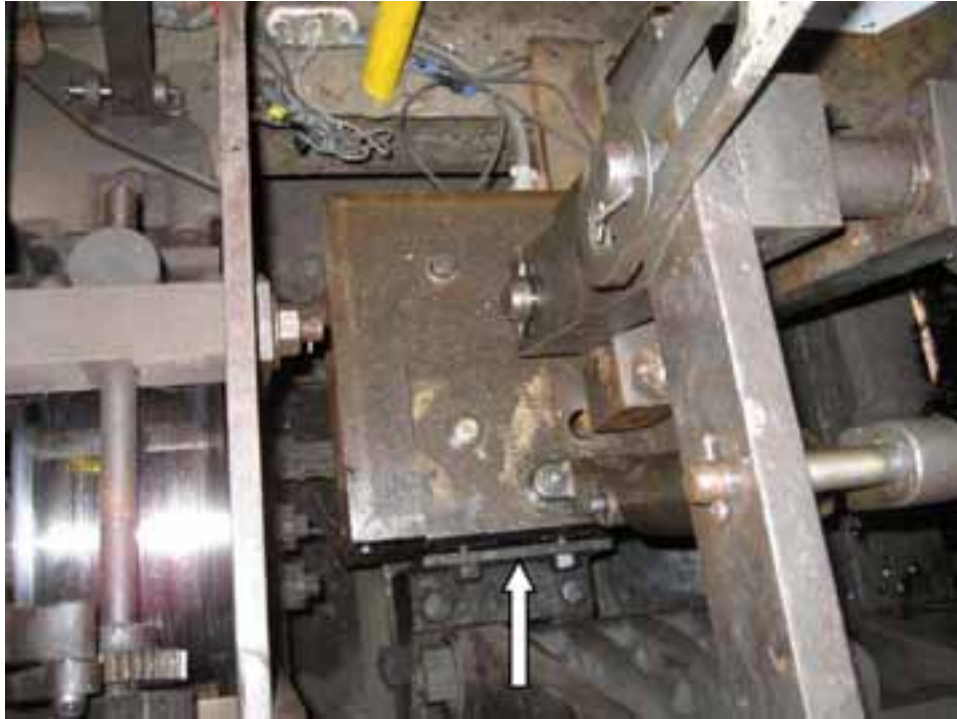
Photo M-9. Railroad Bridge, North Emergency Brake. Note the loose bolts (arrow) at the solenoid.

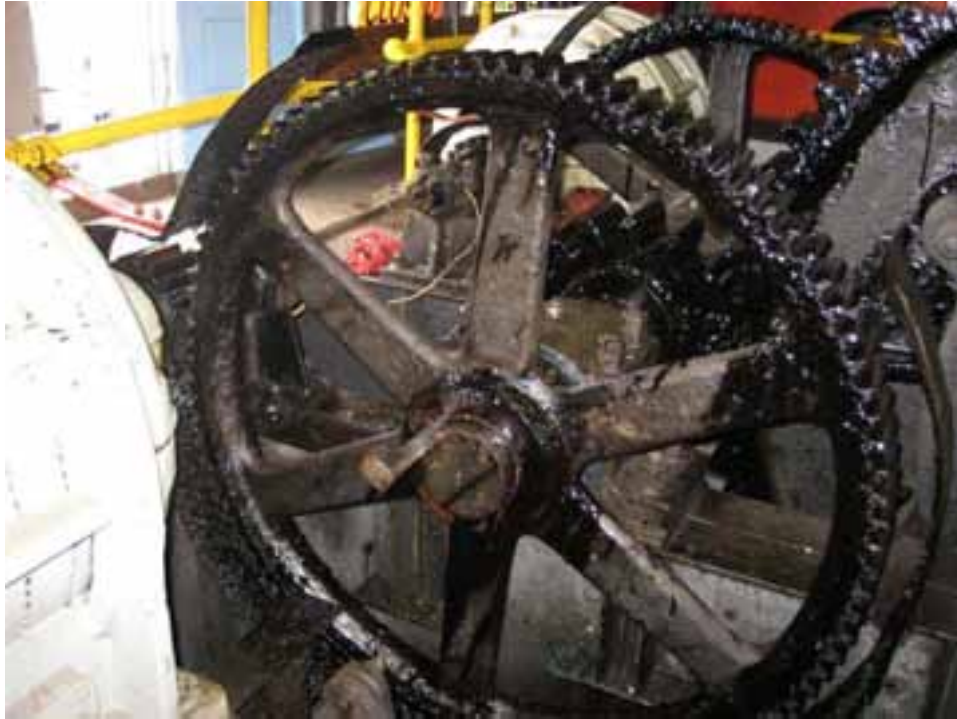
Photo M-11. Highway Bridge, Gear G2. The key for this gear is loose. The key was pulled out by hand to take this photo and then returned to its original position.

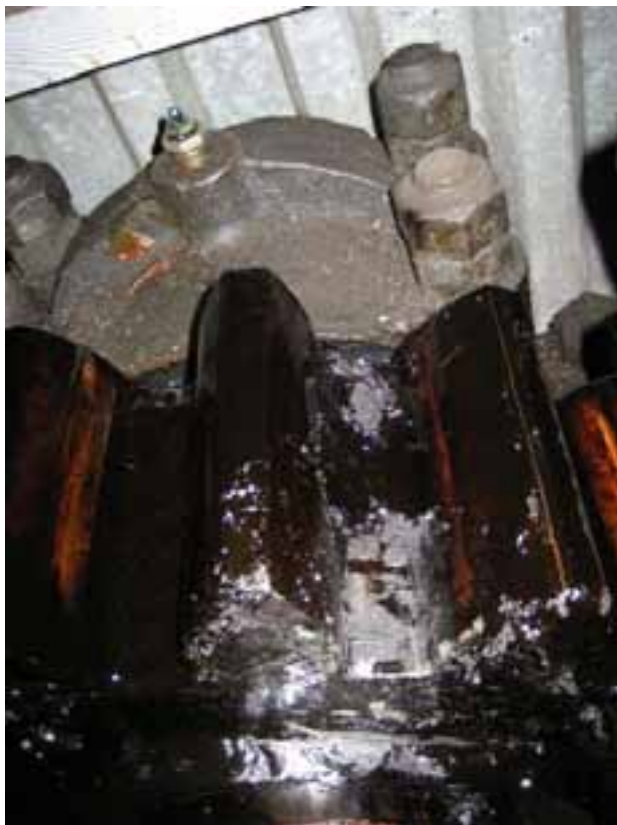
Photo M-12. Highway Bridge, Gearset G7/G8. Note the heavy accumulation of hardened lubrication deposits in the root of the teeth. Some of the lubricant was scraped away prior to taking the photo.

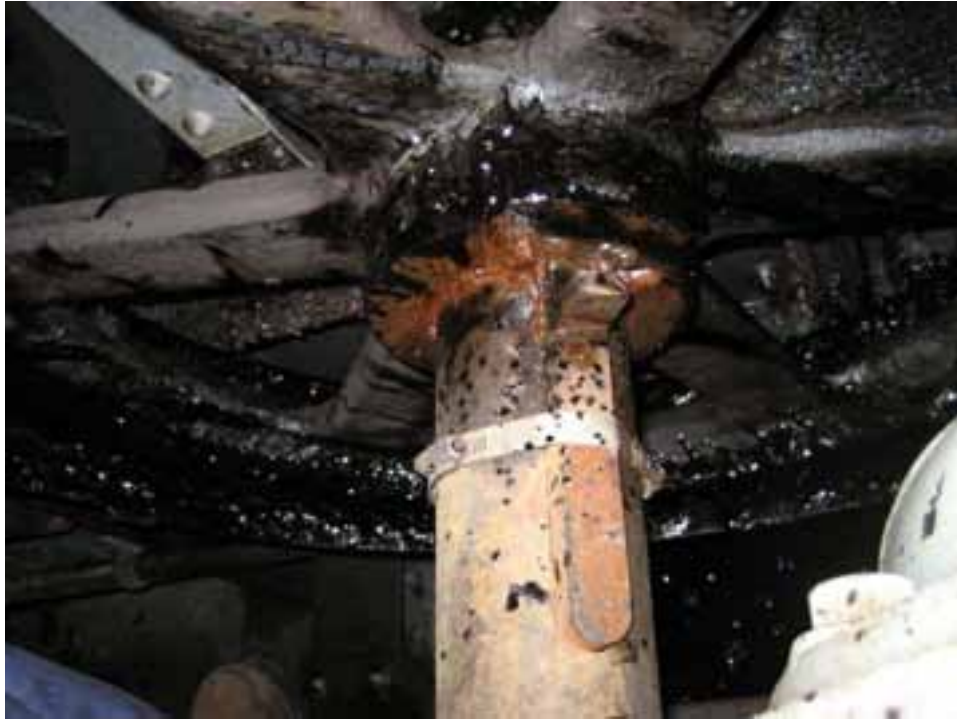
Photo M-13. Railroad Bridge, Gear G4. Note the addition of a second key secured by a hose clamp to restrain the primary key. Also note the fretting corrosion at the interface of the shaft and gear hub.

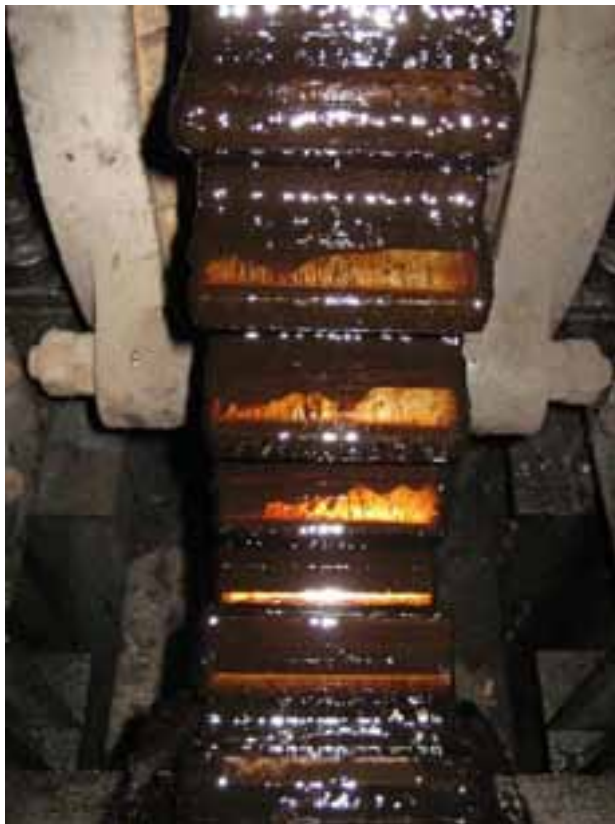
Photo M-14. Railroad Bridge, Gearset G5/G6. The abrasive wear and scoring seen on this gearset was the most severe surface degradation found at any of the gears.

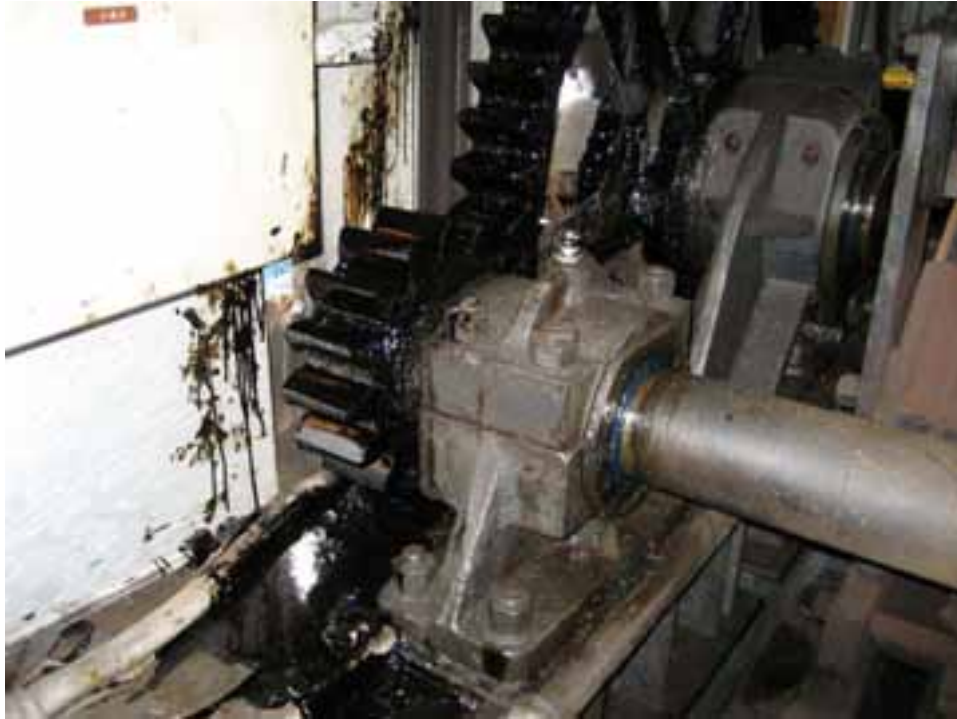
Photo M-15. Railroad Bridge, Gearset G7/G8. Note the accumulated lubricant below Gear G7.

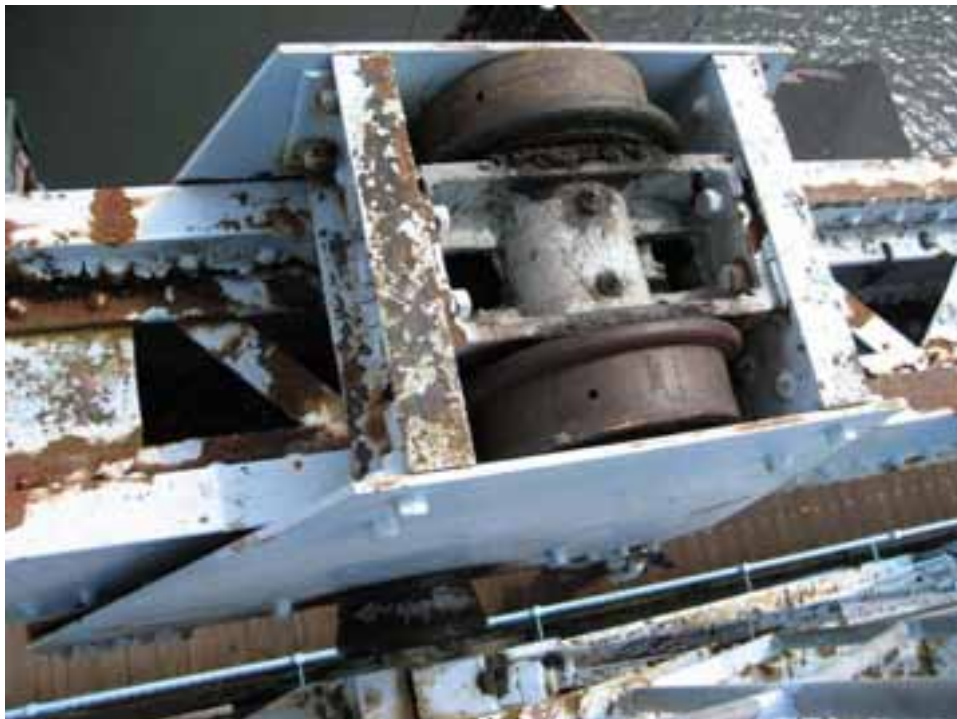
Photo M-16. Highway Bridge, South Operating Strut Guide. Note the paint deterioration and light to moderate corrosion.

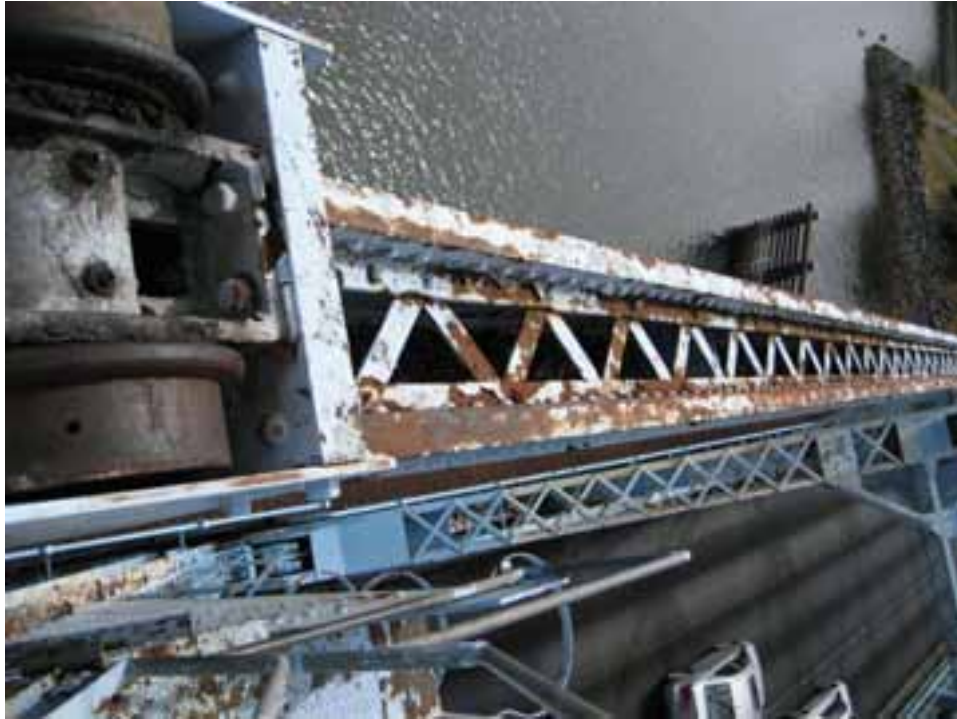
Photo M-17. Highway Bridge, South Operating Strut. Note the paint deterioration and light to moderate corrosion.

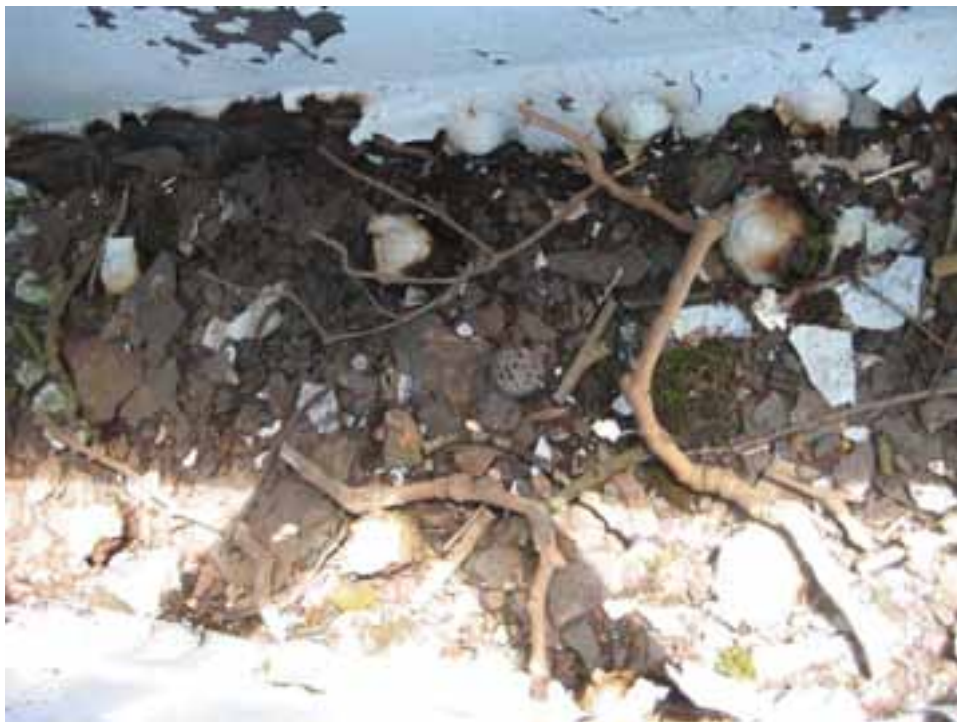
Photo M-18. Highway Bridge, South Operating Strut. This is the area between the structural channels that form the operating strut. Note the accumulated debris.

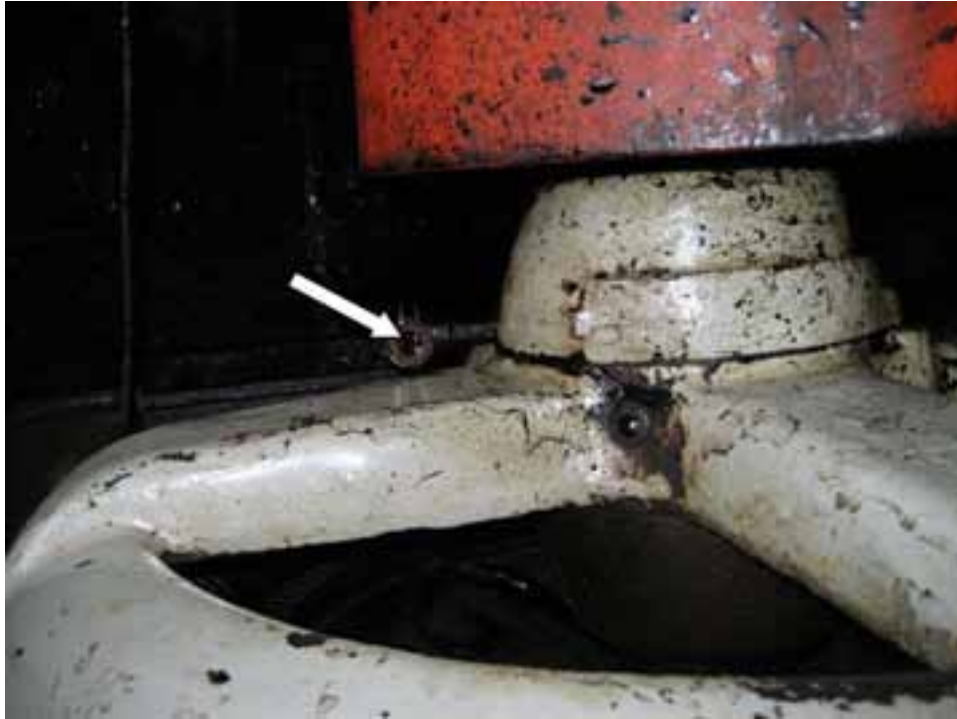
Photo M-21. Railroad Bridge, Motor M1. The cover for the oil check fitting (arrow) is missing.
