Johnson Street Bridge Condition Assessment Report

EXECUTIVE SUMMARY

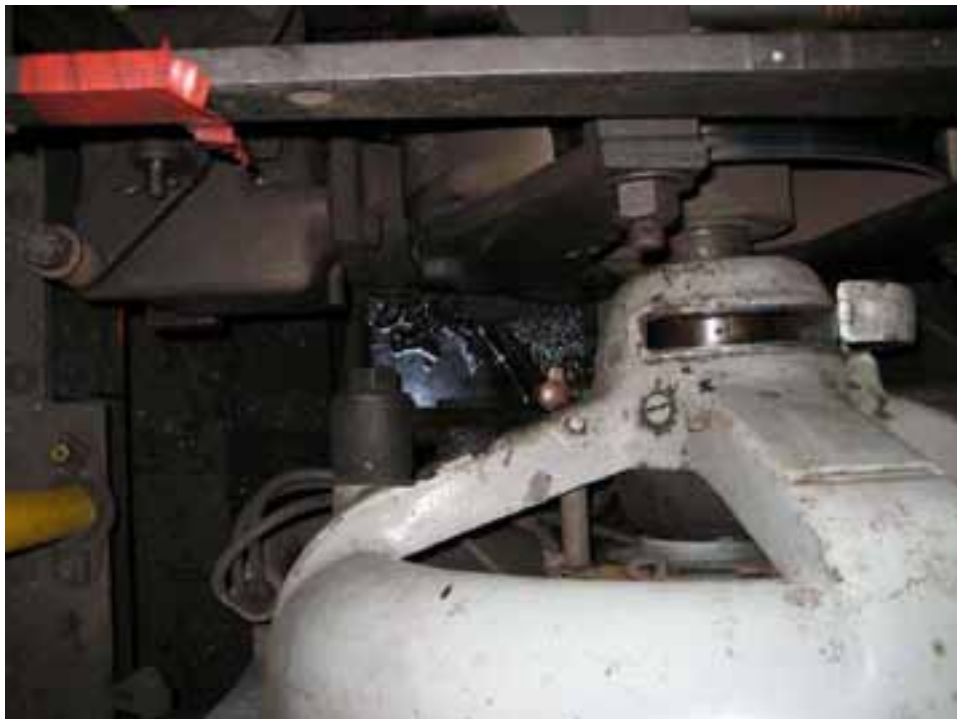
Photo M-22. Railroad Bridge, Motor M2. The opened cover provides access to the motor bearing. The bearing appears severely damaged but could not be photographed due to limited access. Also note the puddle of oil to the left of the motor bearing.

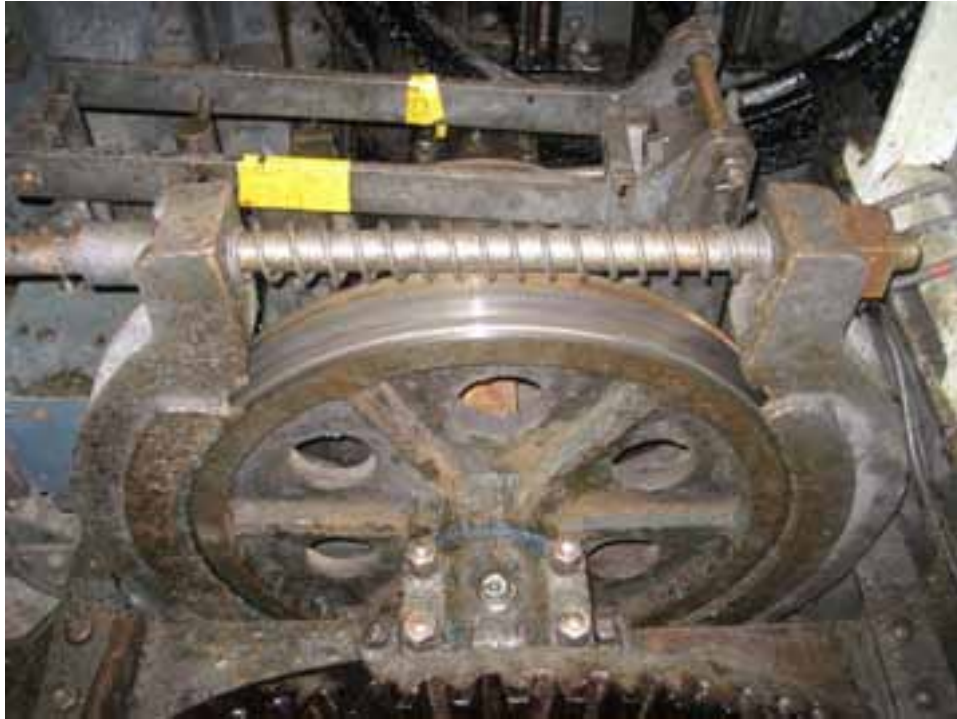
Photo M-23. Highway Bridge, Hand Brake. The brake assembly is coated with lubricant and there is oil on the brake wheel.

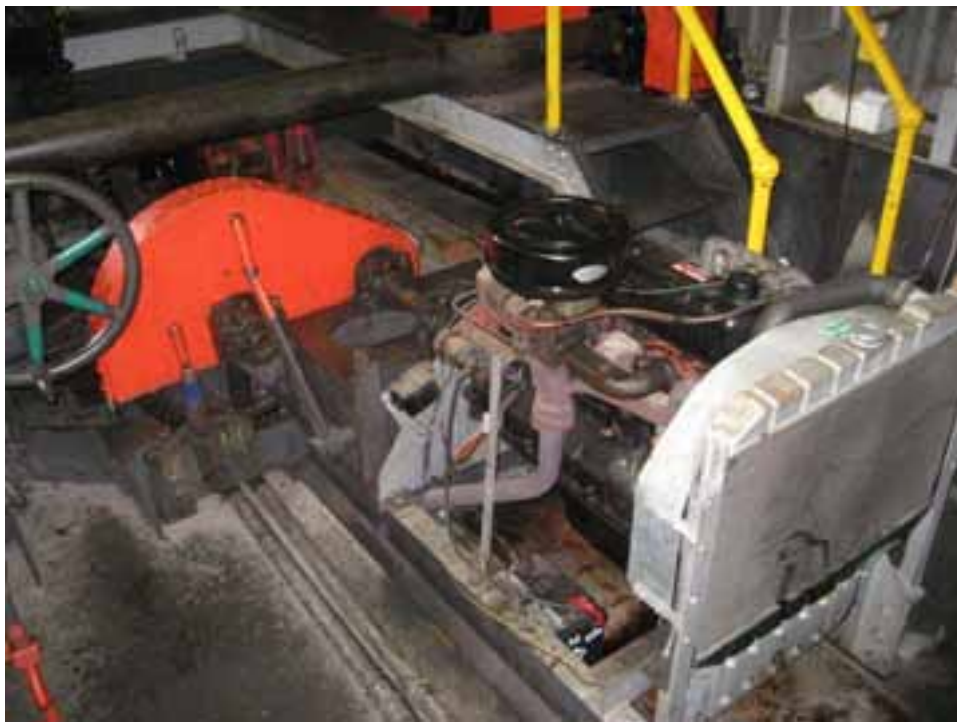
Photo M-24. Highway Bridge, Auxiliary Bridge Engine. The engine has a significant oil leak.

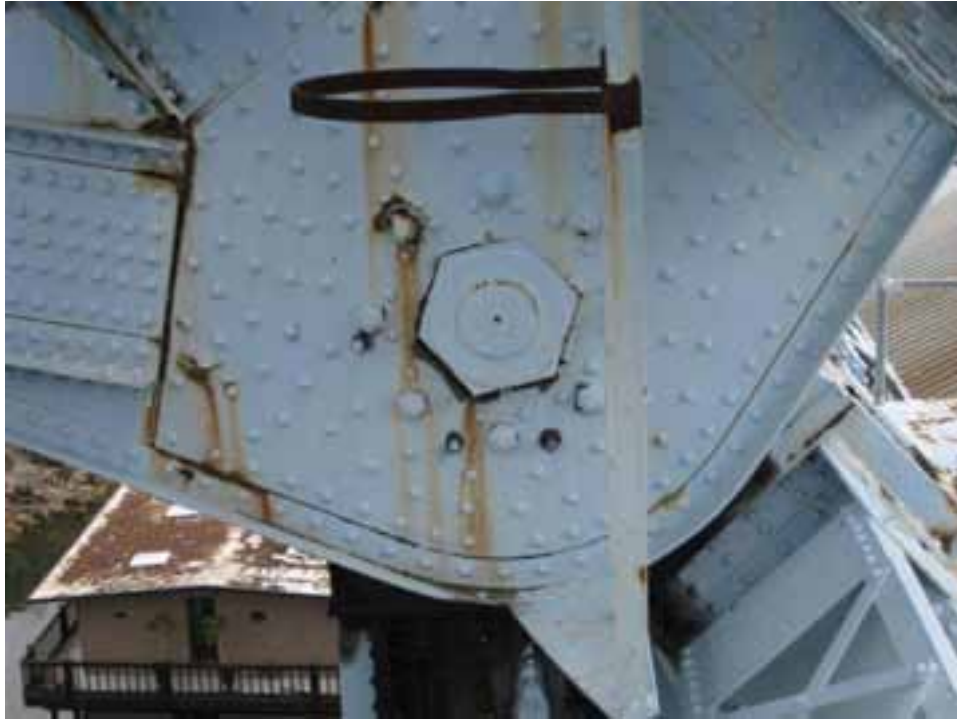
Photo M-25. Railroad Bridge, South Counterweight Trunnion. All of the lube piping is capped at this side (south) of the bearing and there is no indication that the caps have been removed recently. Proper maintenance requires removal of the caps to purge old lubricant.

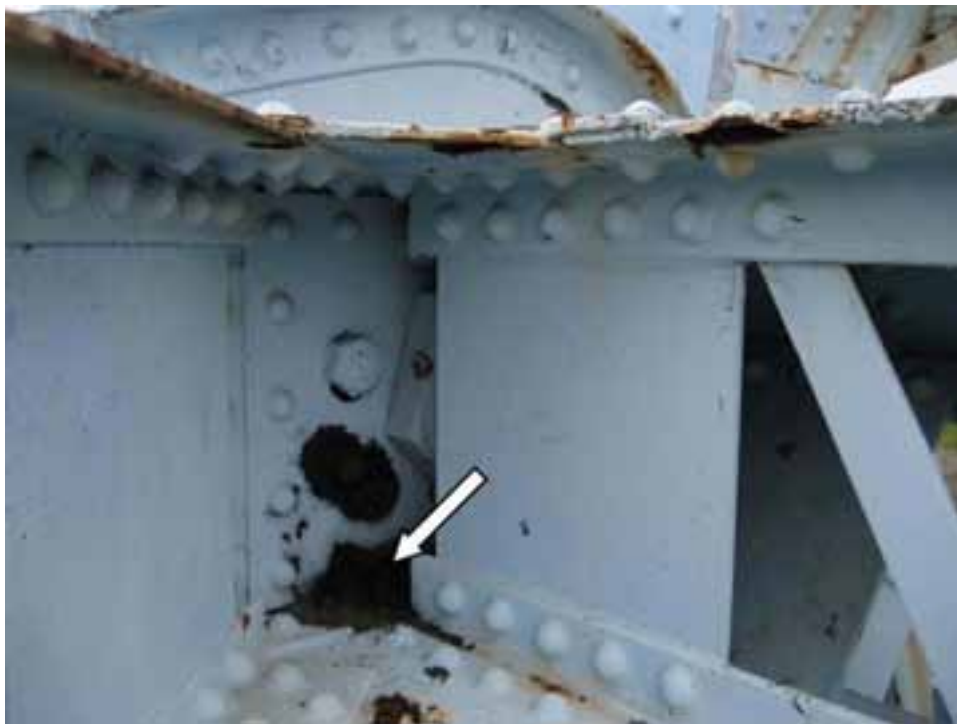
Photo M-26. Railroad Bridge, North 2nd Link Pin. The accumulated lubricant (arrow) at the south side of the pin may indicate a loose or failed lube pipe connection.

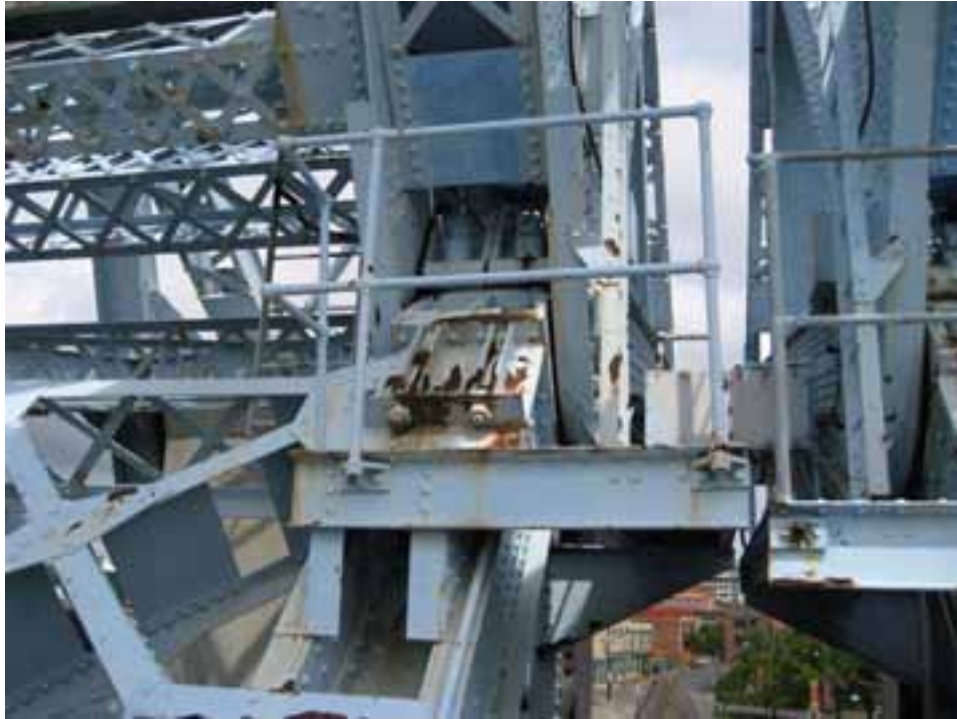
Photo M-27. Railroad Bridge, South Counterweight Trunnion. The condition of this trunnion is typical of all the counterweight trunnions. Note the paint deterioration and corrosion.

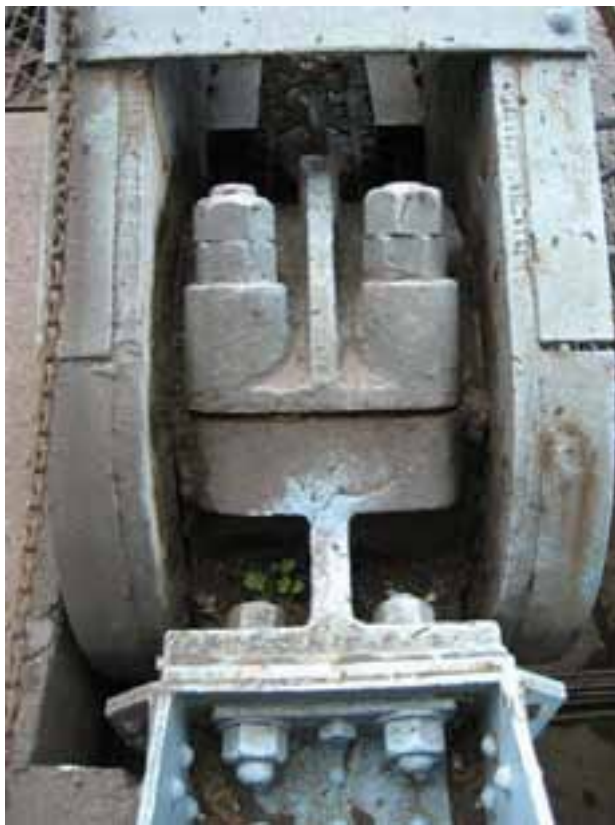
Photo M-28. Highway Bridge, North Main Trunnion Bearing. The condition of this trunnion is typical of all the main trunnions. Note the accumulated debris.

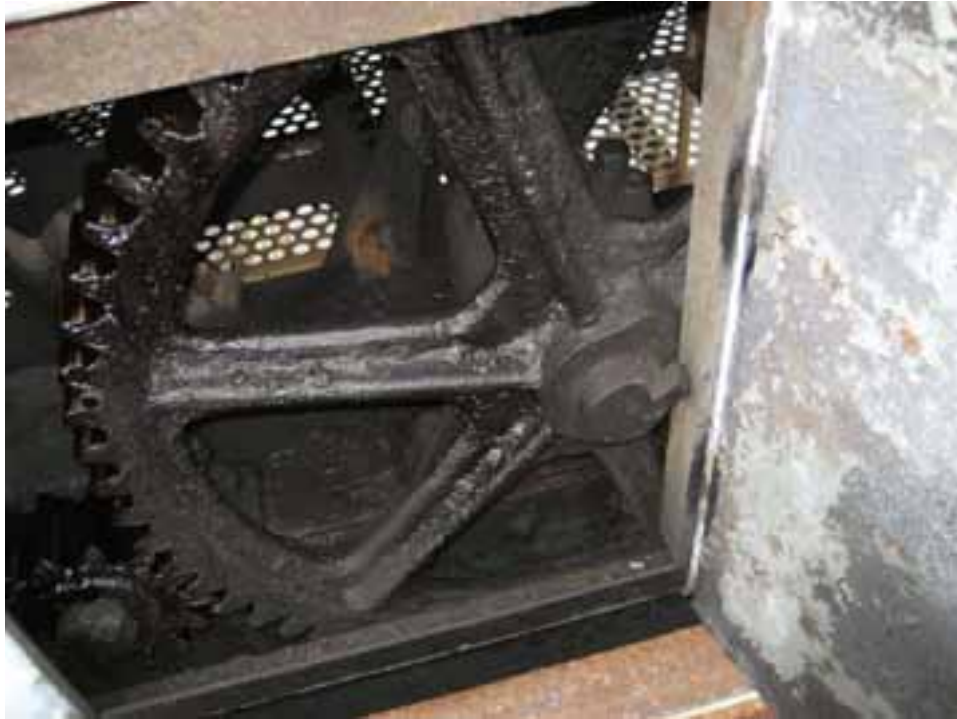
Photo M-29. Highway Bridge and Railroad Bridge. The key for Gear G1 contacts the machinery enclosure. This photo is of the railroad bridge however the condition exists at both bridges.

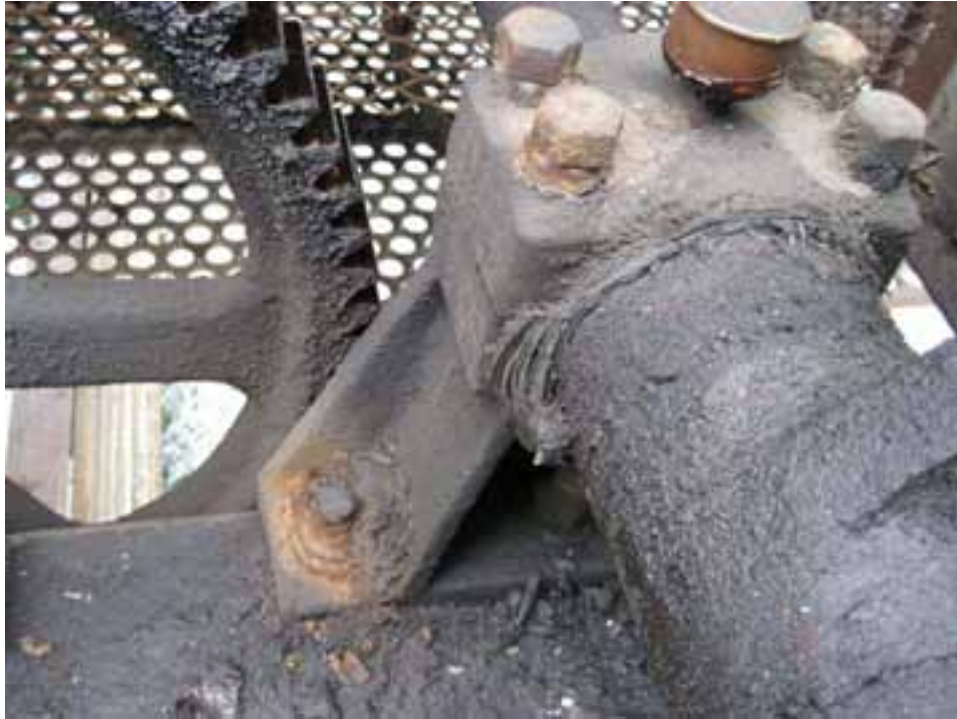
Photo M-31. Railroad Bridge, Span Lock Machinery Bearing B1. The nut for the bearing bolt has complete section loss due to corrosion.

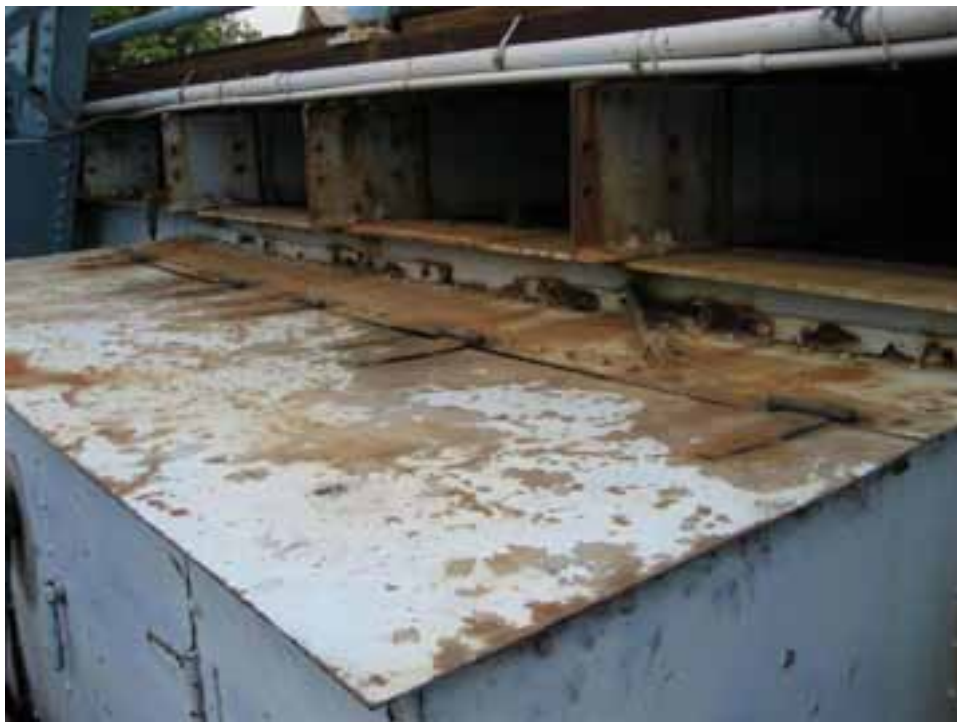
Photo M-32. Railroad Bridge, Span Lock Machinery Enclosure. The enclosure is in poor condition.

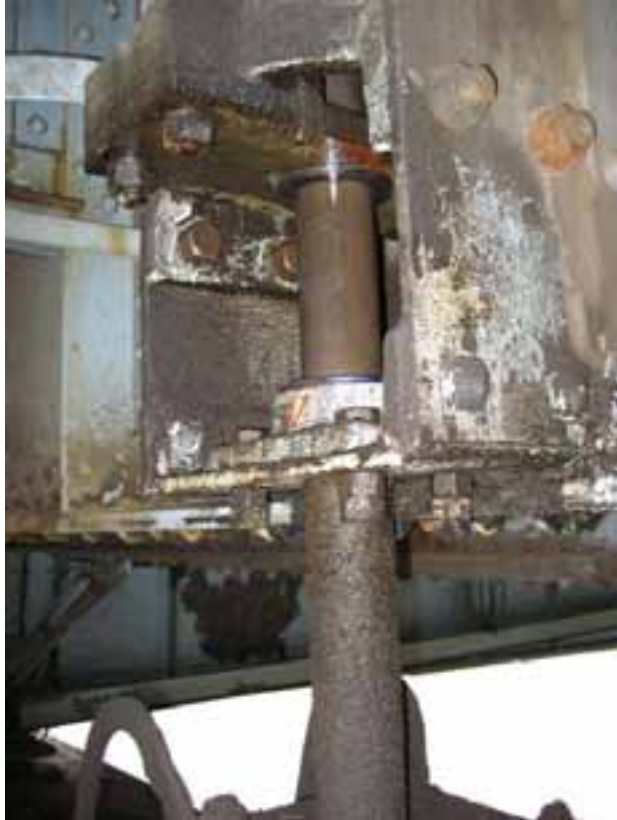
Photo M-33. Highway Bridge, Air Buffer. The four mounting bolts for the bottom bearing are loose.

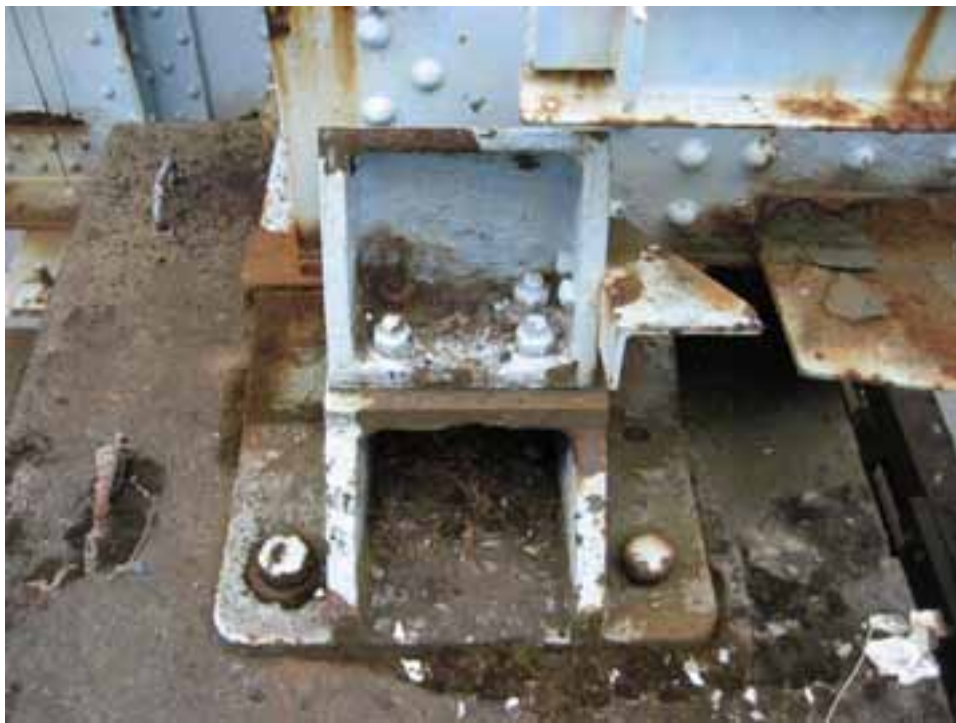
Photo M-34. Railroad Bridge, South Live Load Support. Three of the four anchor bolts for this support are loose. Note the paint deterioration and corrosion.

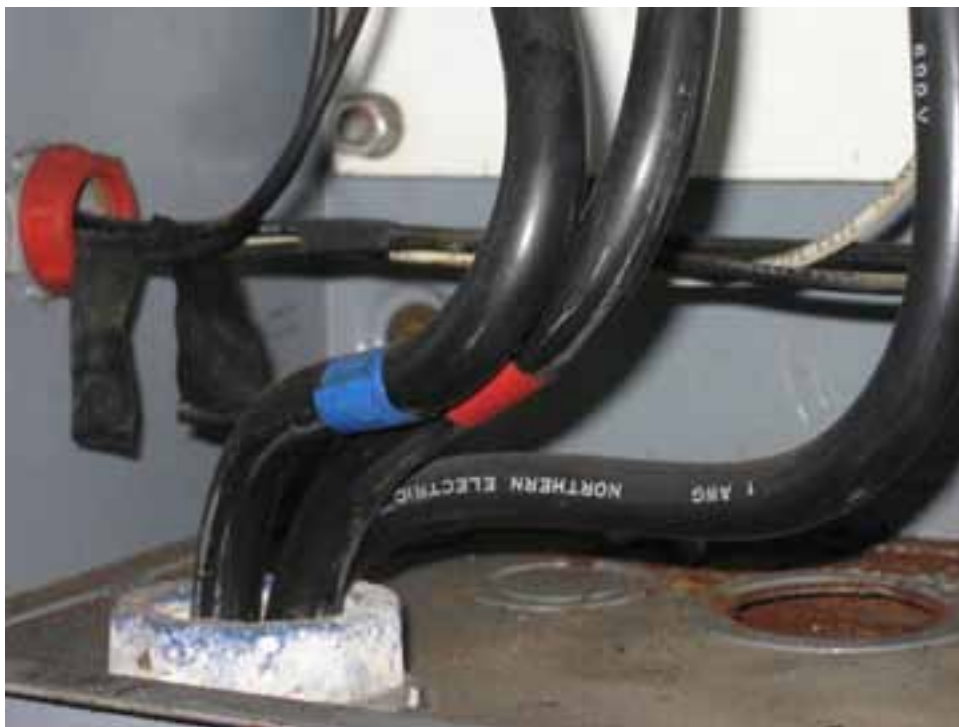
Photo E1.1.2. Highway South Drive Contactor Panel. Note improper color coding of conductors.

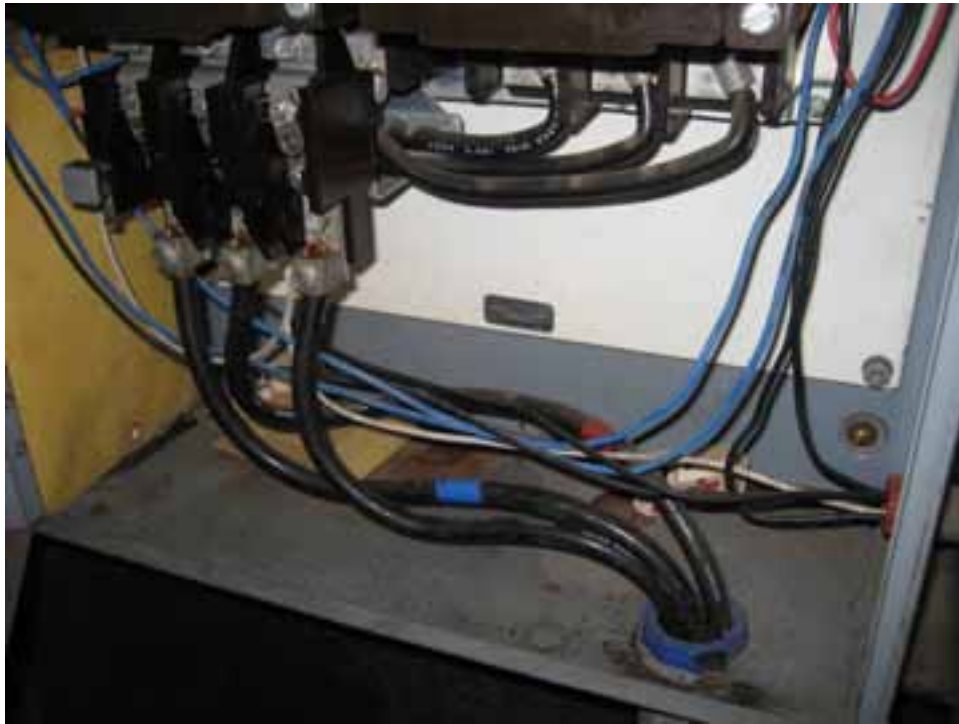
Photo E3. Highway North Drive Motor Contactor. Note improper color coding of conductors.

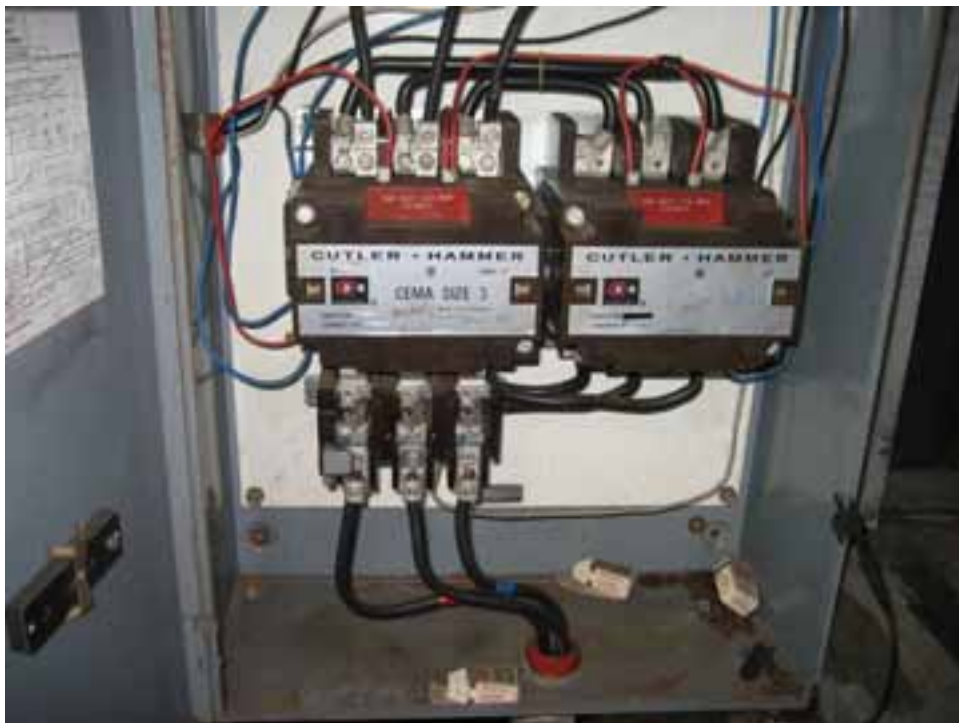
Photo E4. Railway South Drive Motor Contactor. Note improper color coding of conductors.

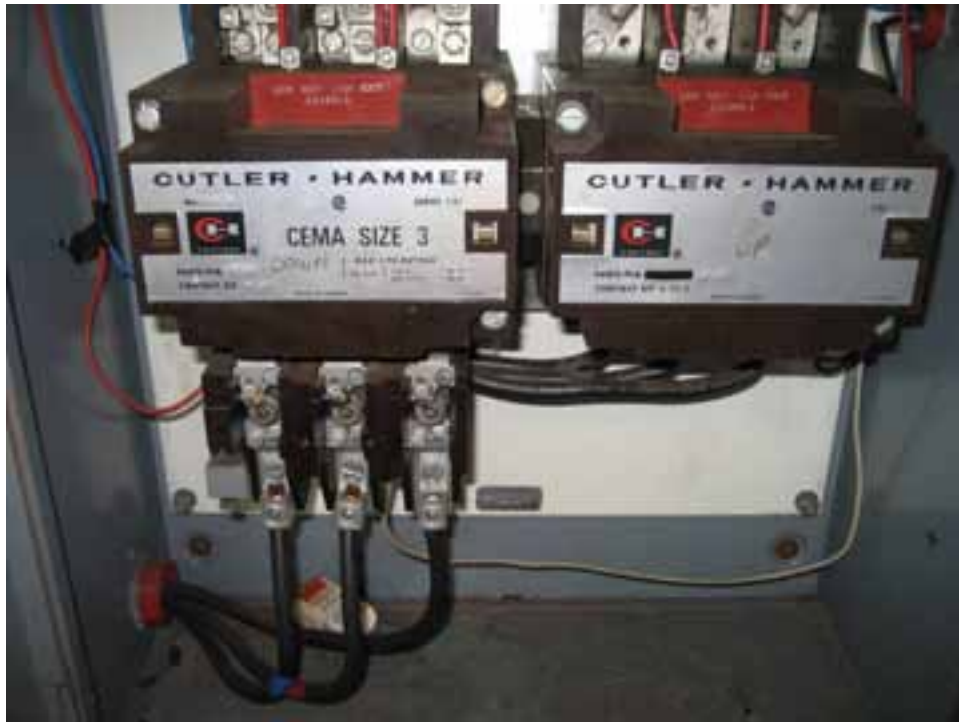
Photo E5. Railway North Drive Motor Contactor. Note improper color coding of conductors.

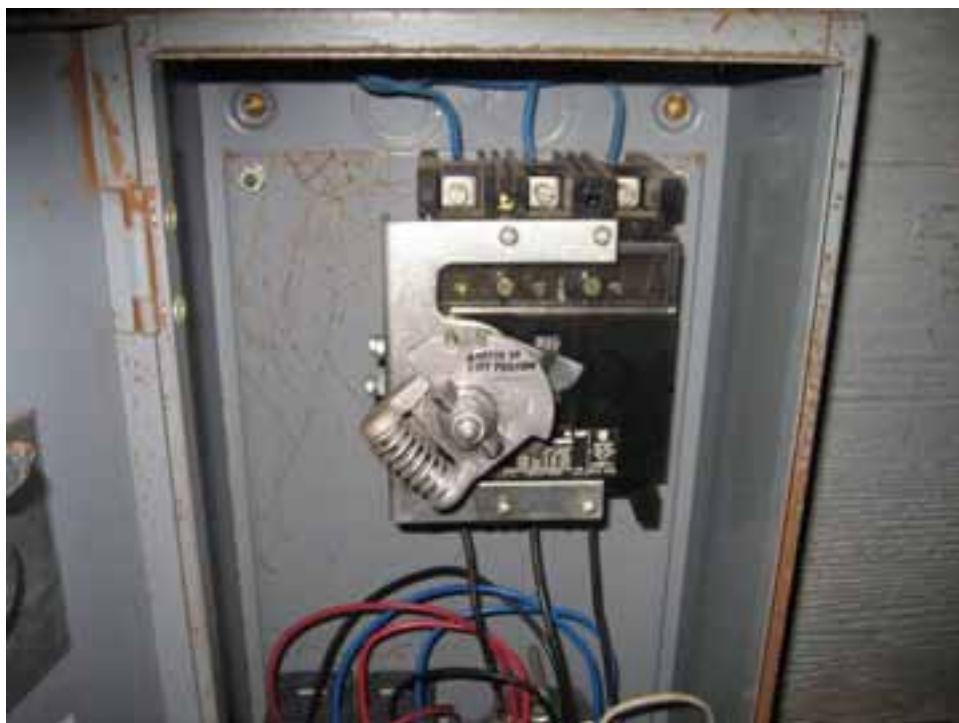
Photo E6. Typical Motor Brake Enclosures. Note improper color coding of conductors.

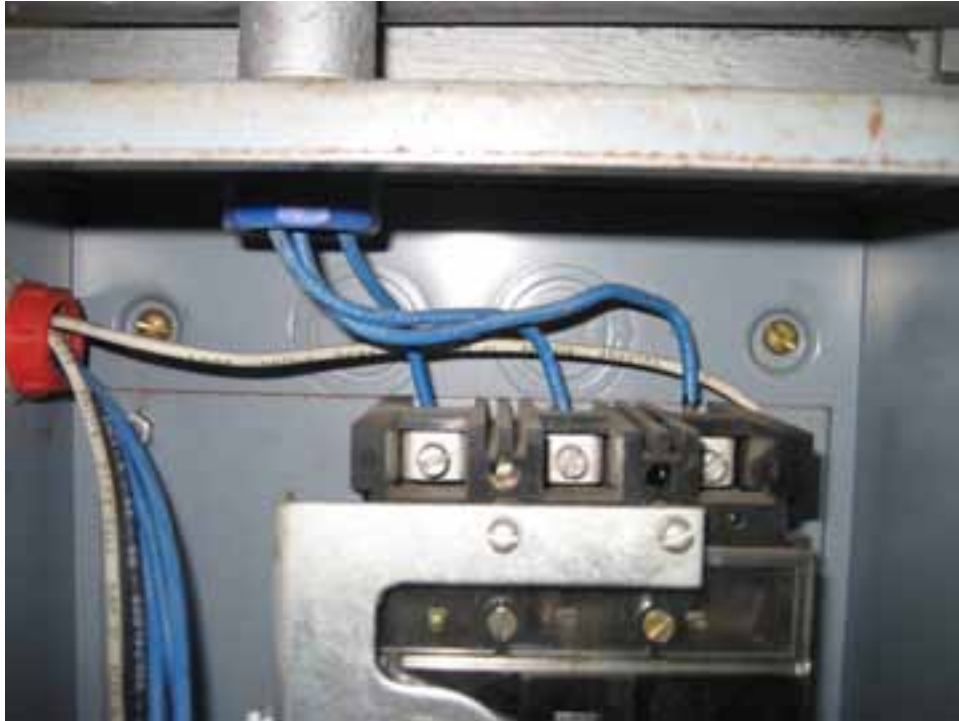
Photo E7. Typical Emergency Brake Enclosures. Note improper color coding of conductors.

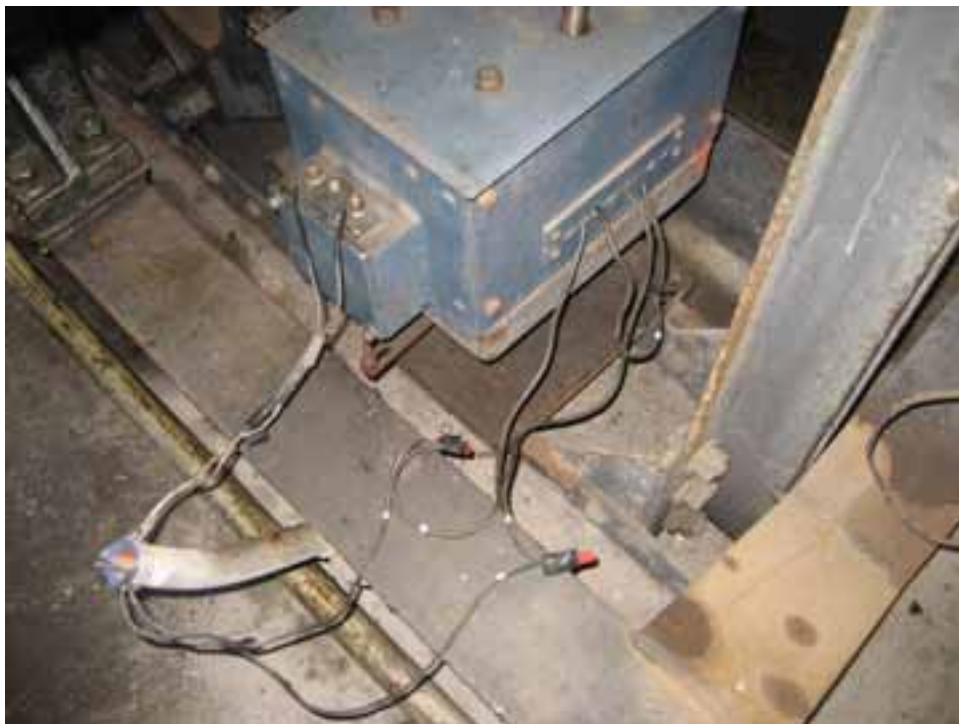
Photo E8. Typical Emergency Brakes. Note conductors not properly protected from accidental contact.

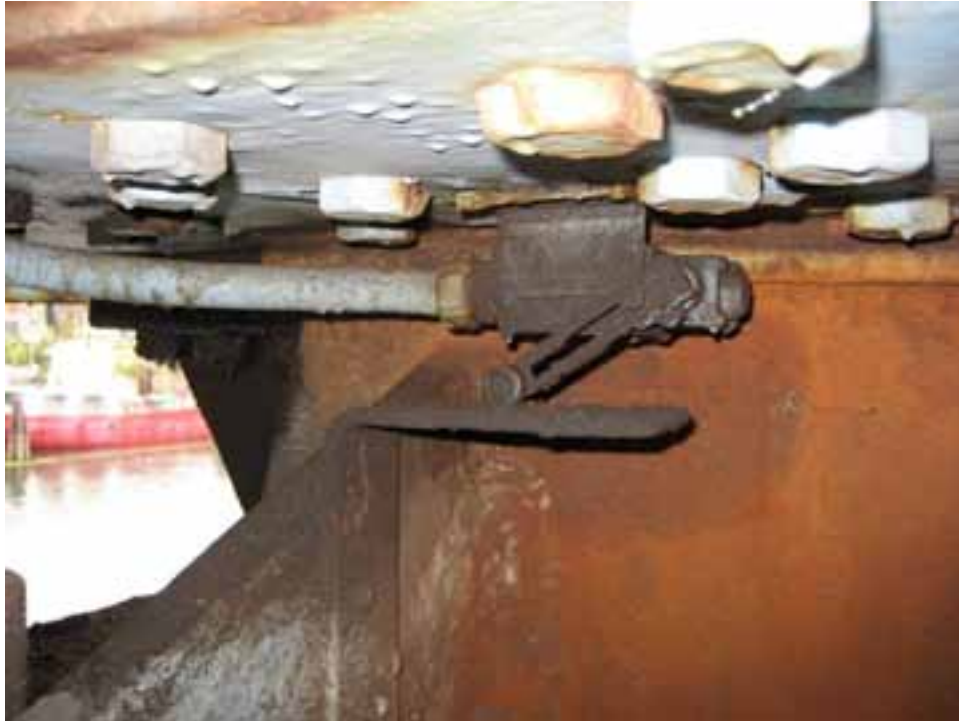
Photo E15. Typical Span Position Limit Switch. Note the fair to poor condition of the limit switch.

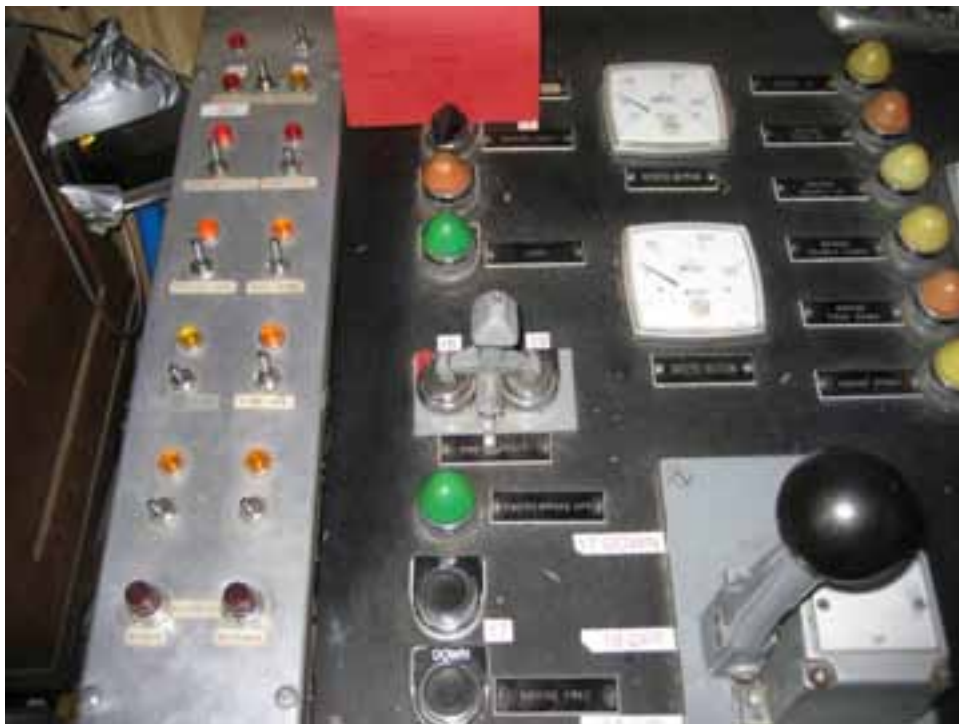
Photo E16. Control Desk. Note age and condition of span lock indicators.

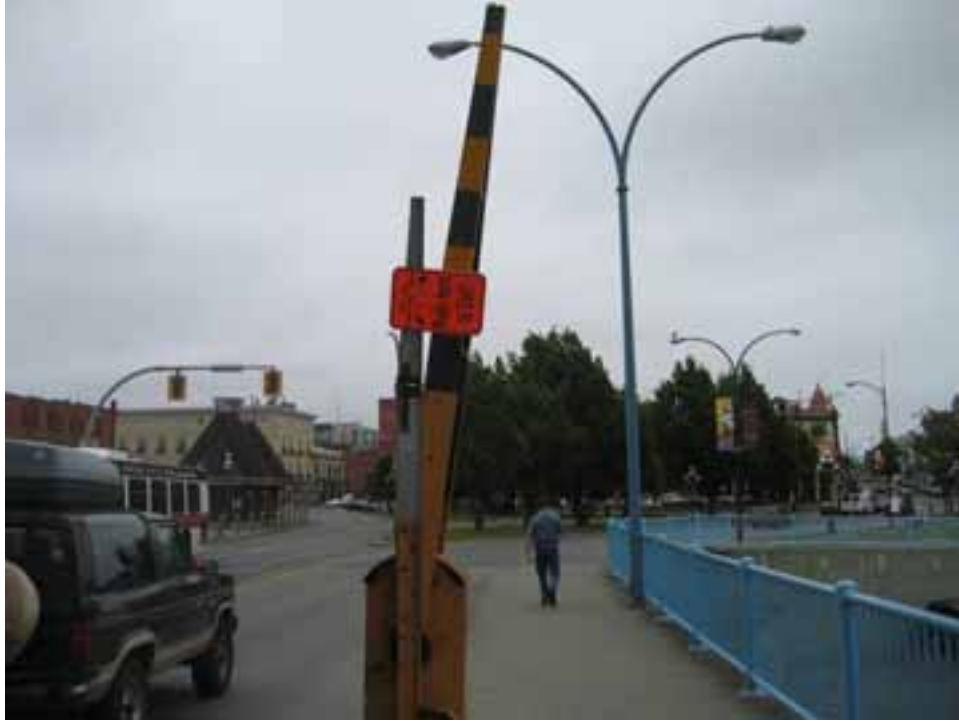
Photo E17. Southeast Traffic Gate. Note traffic gate arm does not set at 90 degrees vertical.

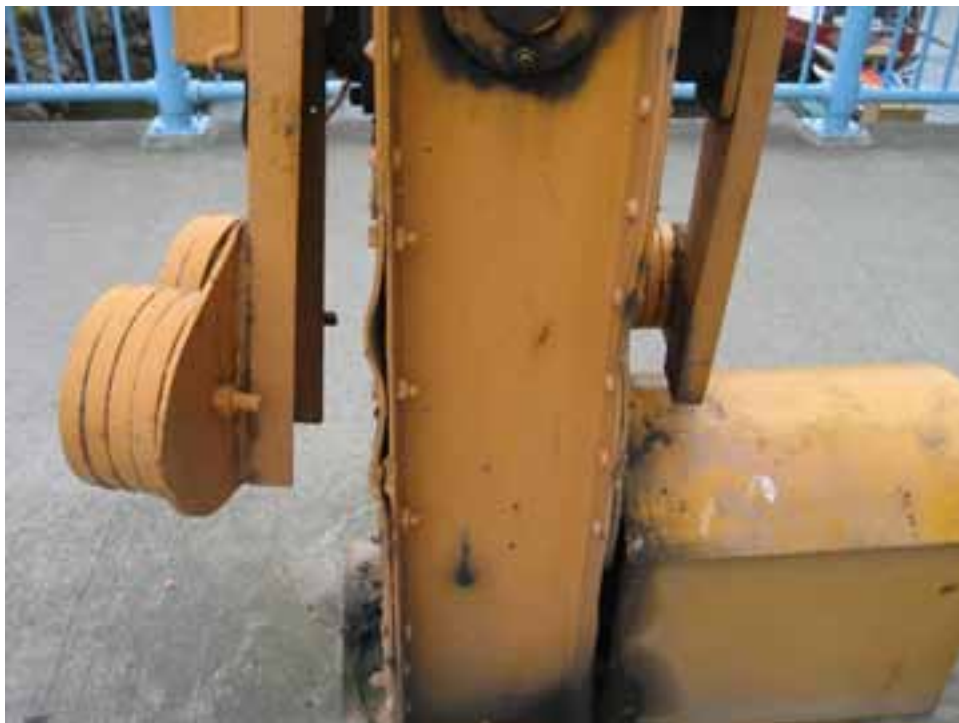
Photo E18. Southeast Traffic/Pedestrian Gate. Note damage of both gate housing and arm.

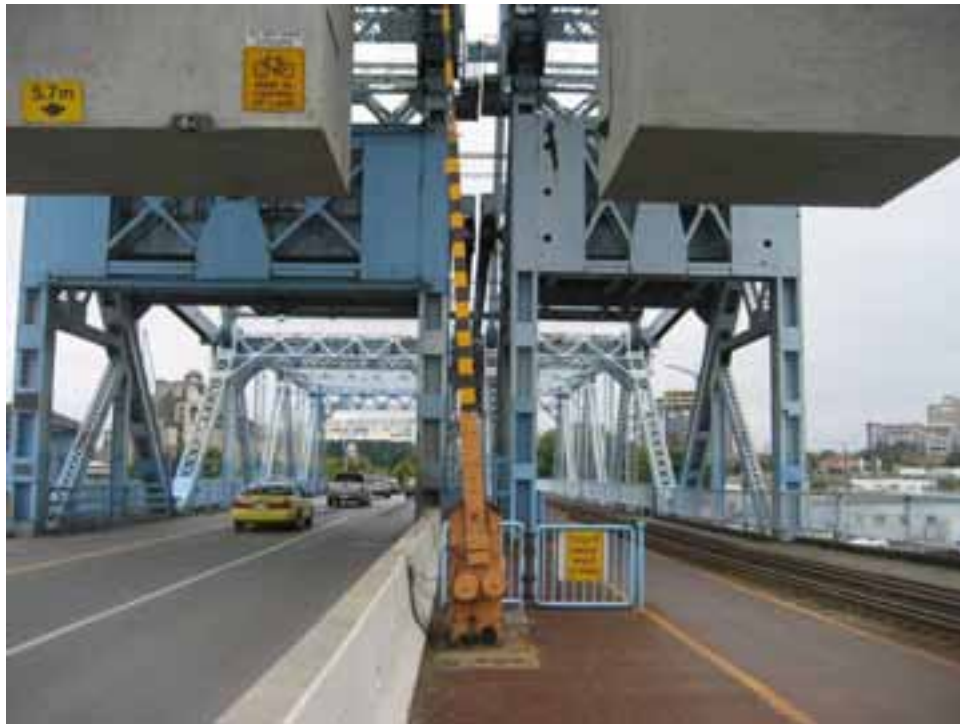
Photo E19. Northeast Traffic Gate. Note traffic gate arm does not set 90 degrees vertical.

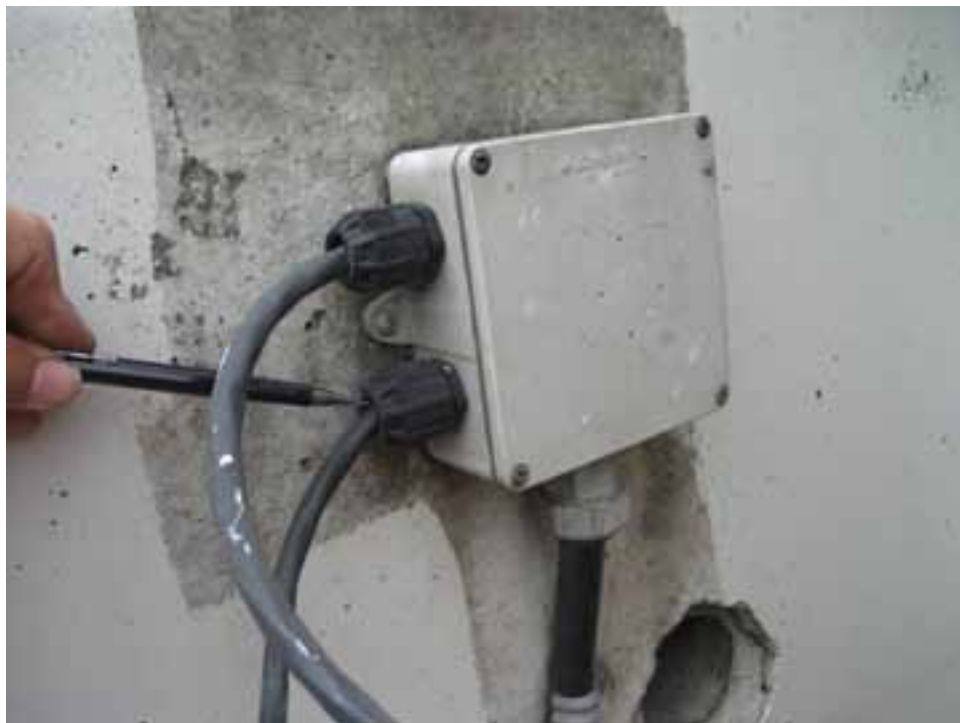
Photo E20. Conduit Box. Note the water-tight connection is damaged.

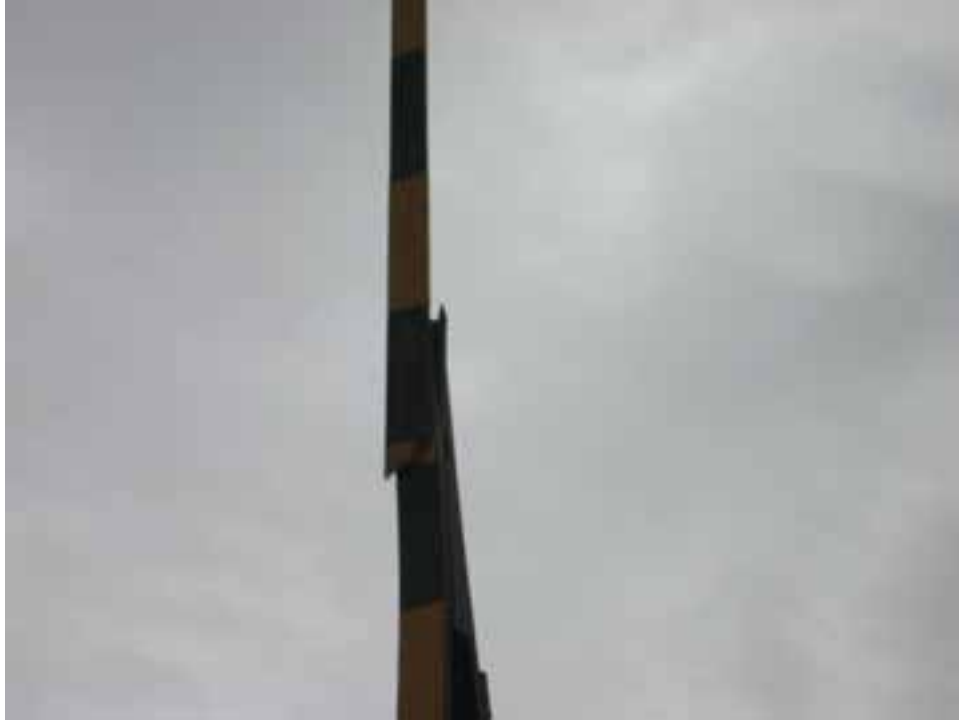
Photo E21. Northwest Traffic Gate. Note damaged traffic gate arm.

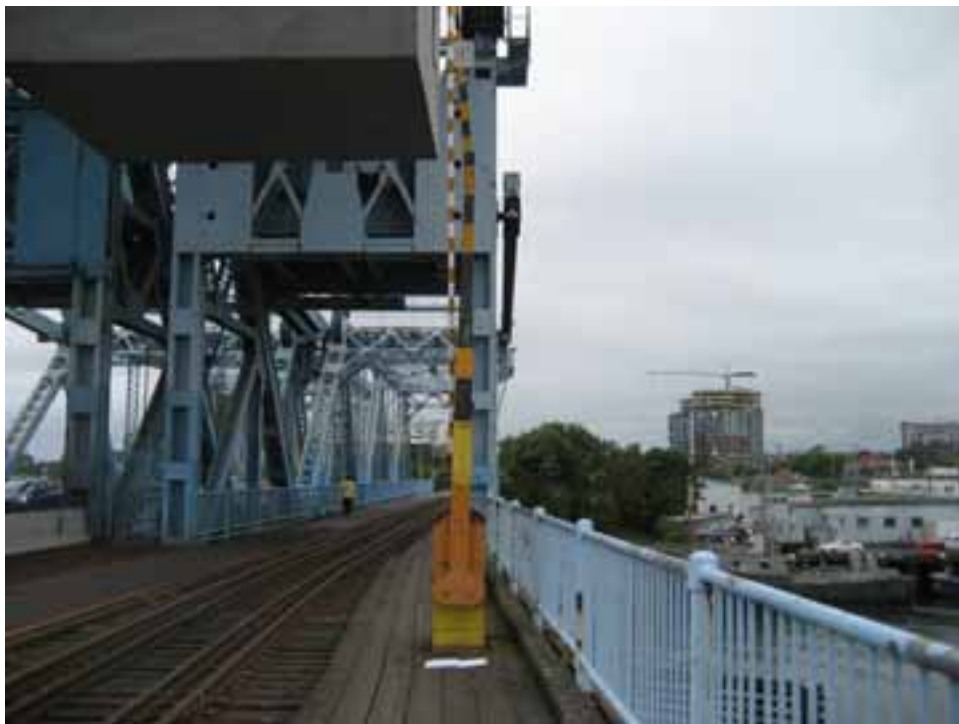
Photo E22. Northeast Railway Pedestrian Gate. Note the northeast railway pedestrian gate is over 90 degrees.

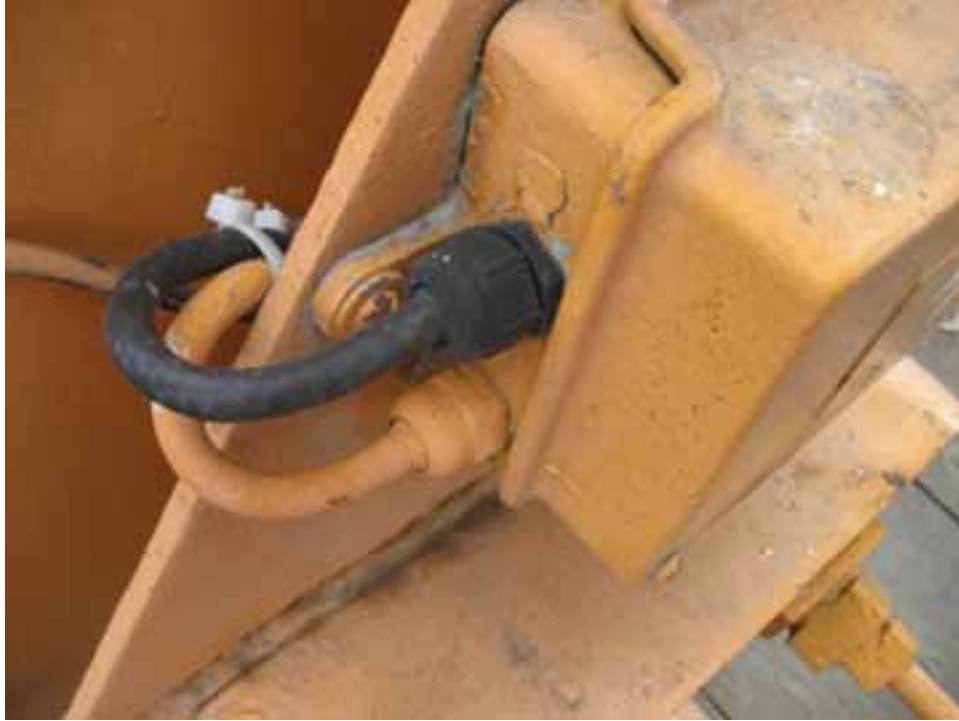
Photo E23. Northwest Railway Gate. Note the water-tight fitting for the SO cord is cracked.

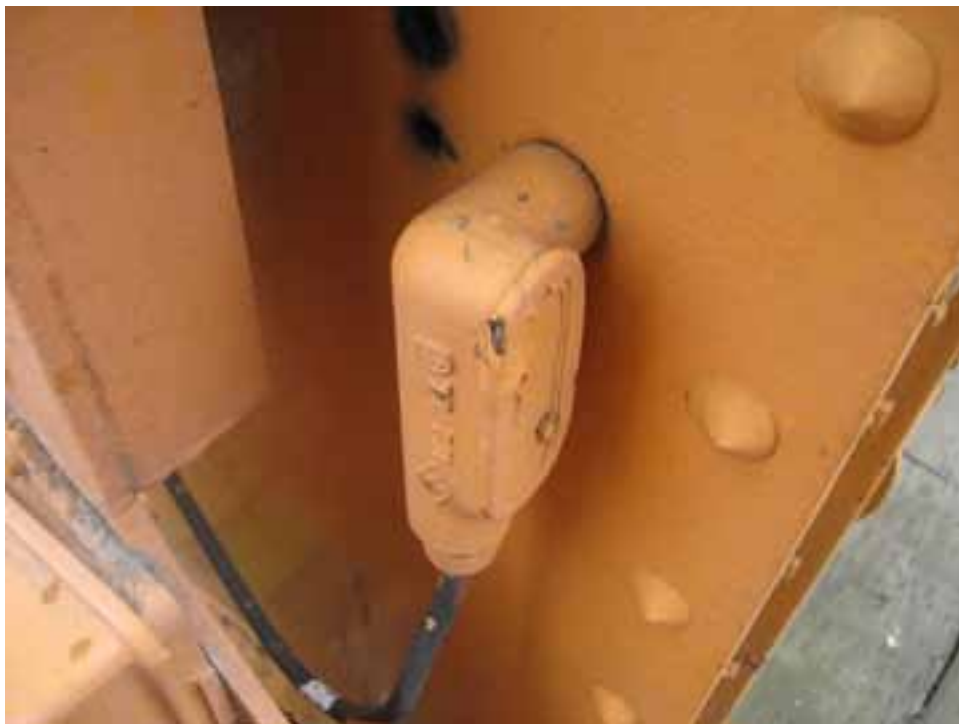
Photo E24. Northeast Railway Gate. Note the water-tight seal for the conduit "LB" is damaged.

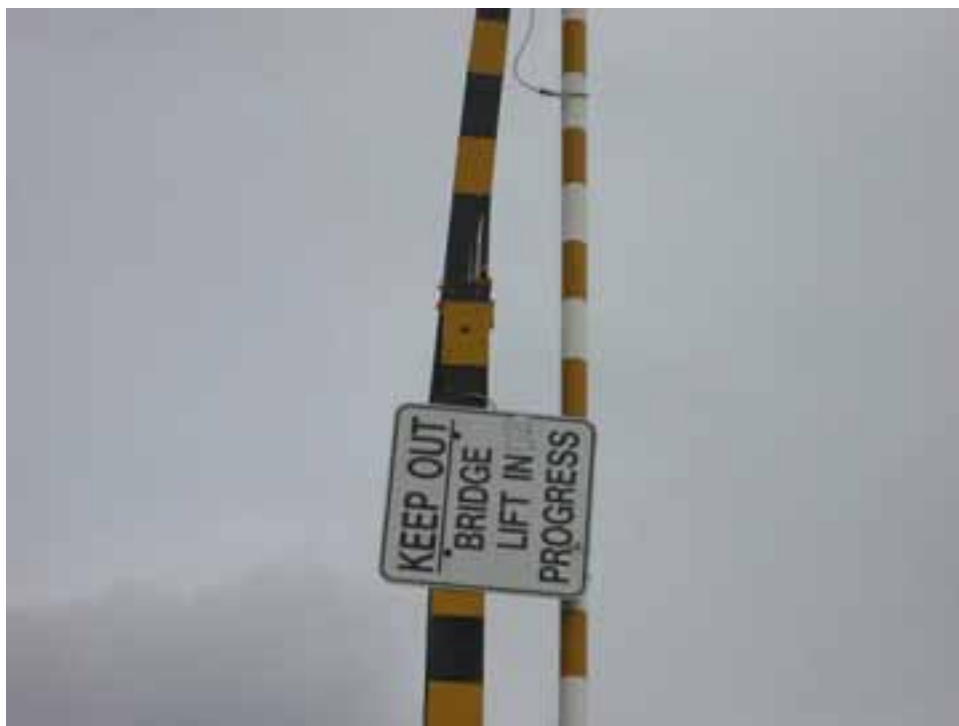
Photo E25. Northwest Railway Gate. Note the gate arm shows evidence of being damaged.

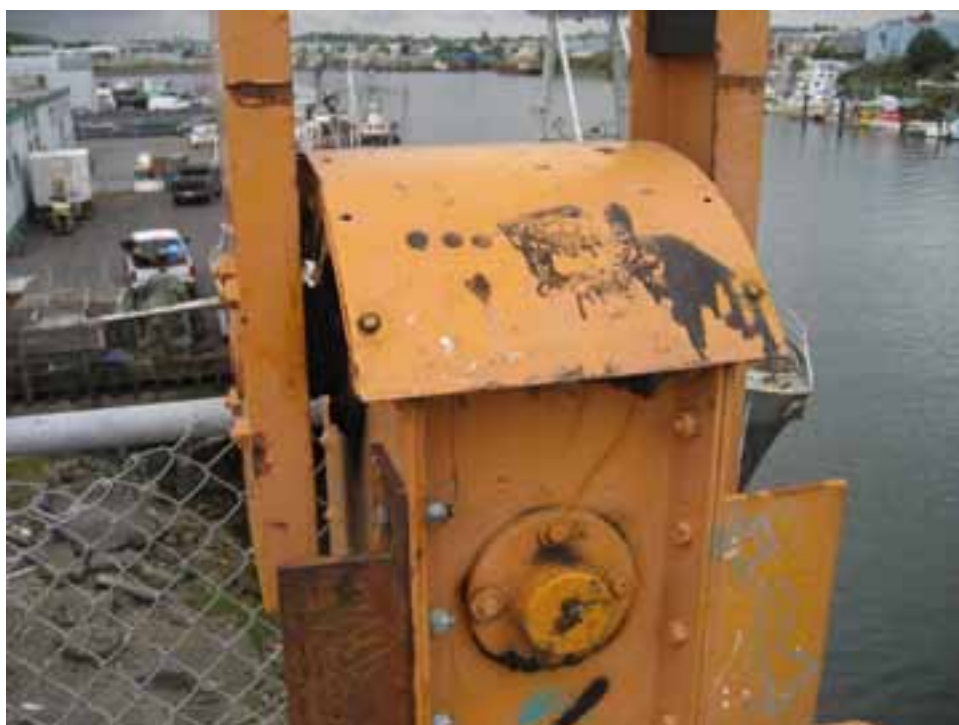
Photo E26. Northwest Railway Gate. Note minor surface corrosion on gate housing.

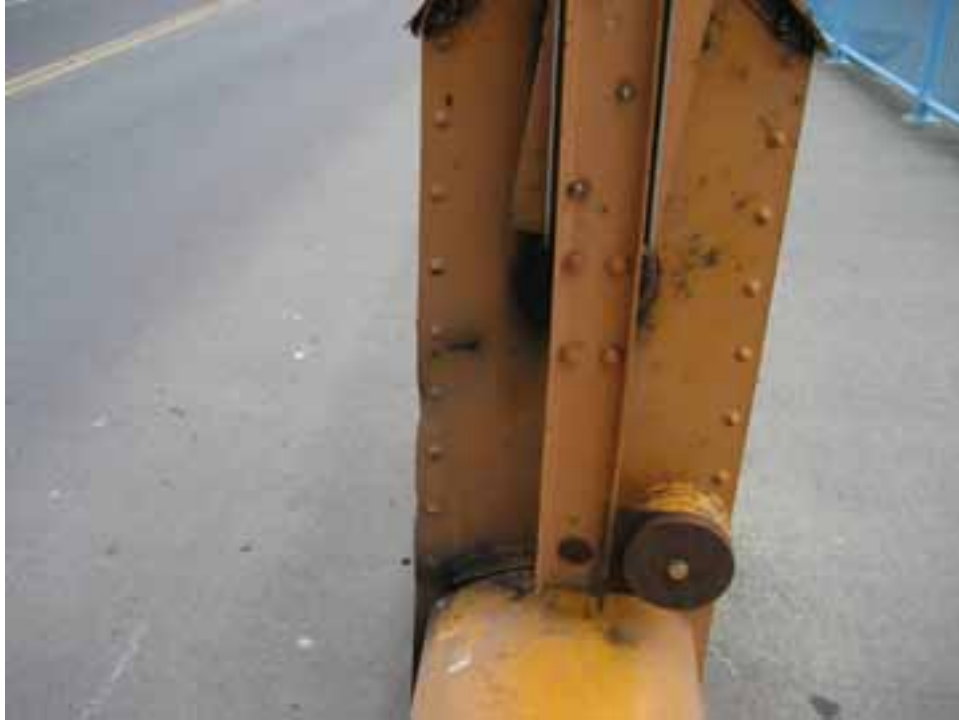
Photo E27. Southeast Traffic Gate. Note housing for the gate motor is not secured. Non-qualified personnel can access the electrical and mechanical equipment.
