Johnson Street Bridge Condition Assessment Report

EXECUTIVE SUMMARY

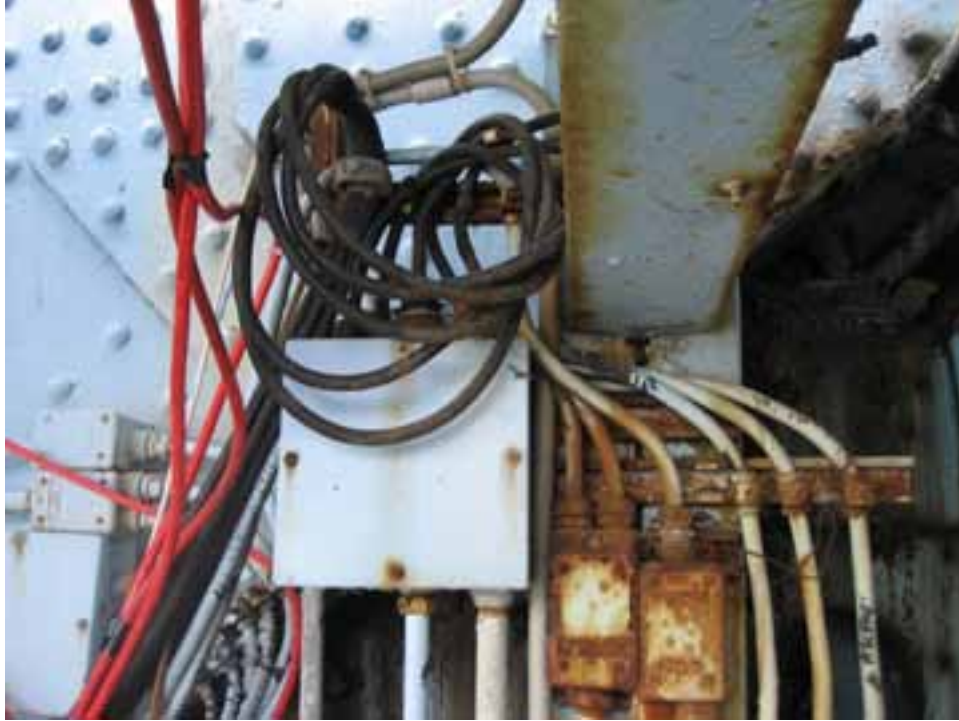
Photo E29. Typical Bascule Span SO Cables. Note the poor condition of both the SO cables and their associated junction boxes.

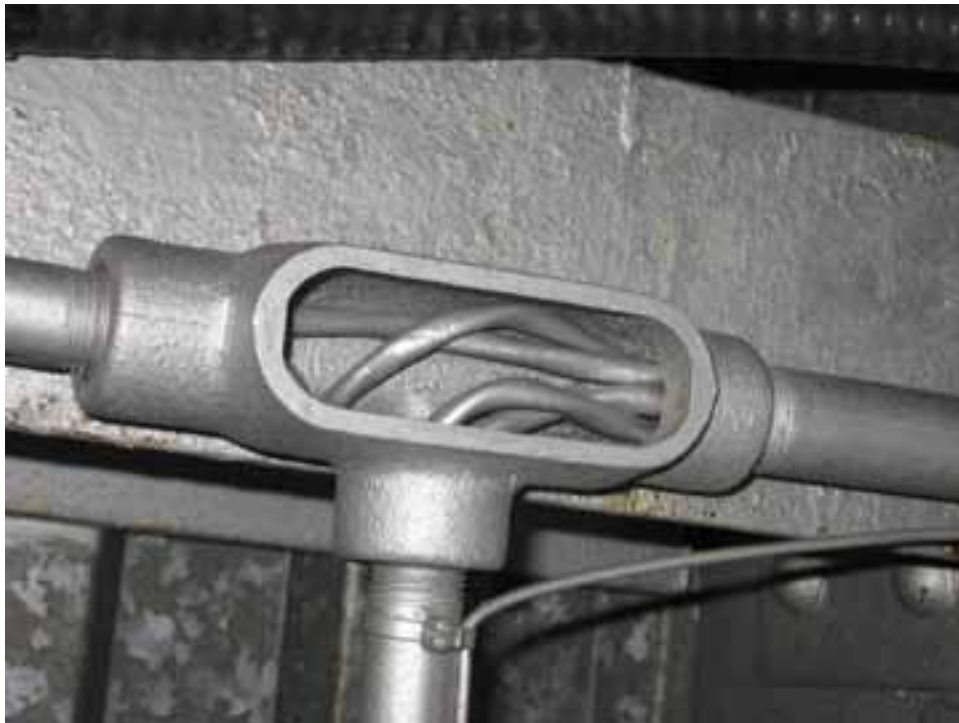
Photo E30. Highway Machinery Room. Note missing cover for the conduit tee body.

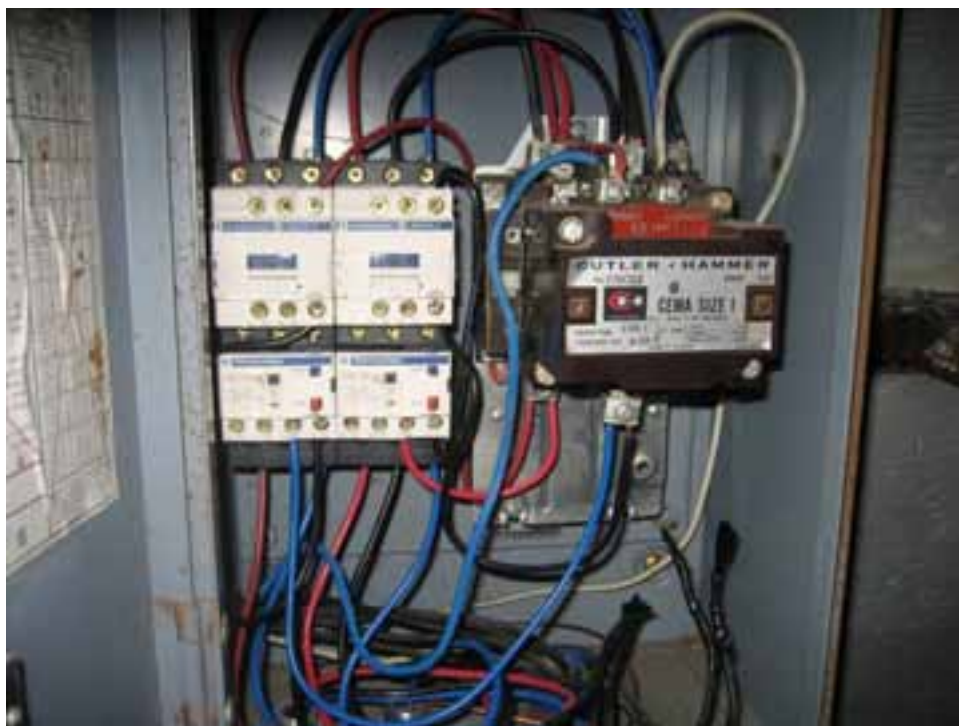
Photo E31. Highway Machinery Room. Note the use of solid conductors in the distribution equipment for power circuits.
