# **BRIDGE CONDITION REPORT**

<b>REGION:</b>	<b>1</b>
<b>DISTRICT:</b>	<b>1</b>
<b>ROUTE:</b>	<b>Fox River Trail North Island Bridge</b>
<b>OWNER:</b>	<b>Geneva Park District</b>
<b>COUNTY:</b>	<b>Kane</b>
<b>JOB NUMBER:</b>	<b>P-91-057-07</b>
<b>STRUCTURE NUMBER:</b>	<b>None</b>
<b>LOCATION:</b>	<b>Fox River Trail North Island Bridge (IL 38 at IL 25)</b>
<b>PREPARED BY:</b>	<b>Mark S. Wylie, Farnsworth Group, Inc.</b>
<b>DATE PREPARED:</b>	<b>October 17, 2007</b>
<b>PROPOSED LETTING DATE:</b>	<b>Unknown</b>

Structure Number:	None
County:	Kane
Route Carried:	Fox River Trail
Feature Crossed:	Backwater Channel of Fox River
Section:	06-P0005-00-BR
Station:	12+92.00
Roadway Classification:	Pedestrian/Bike Trail
Design/Posted Speed:	10 mph
ADT (current/design):	N/A
ADTT (current/design):	N/A
DHV:	N/A
Inventory Rating HS:	None
Operating Rating HS:	None
Sufficiency Rating:	None

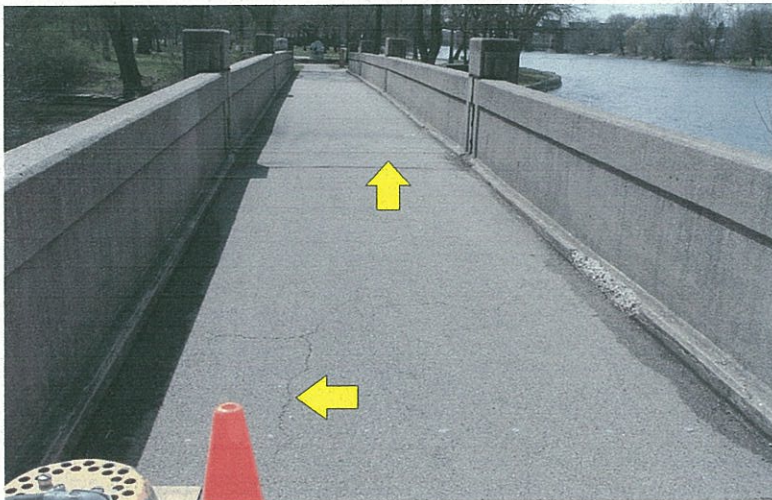
The work was necessitated by numerous cracks manifested on top bridge surface as is shown on photo below.

Photo 1 - The investigated bridge deck exhibits numerous cracks traveling in both north-south and east-west directions.

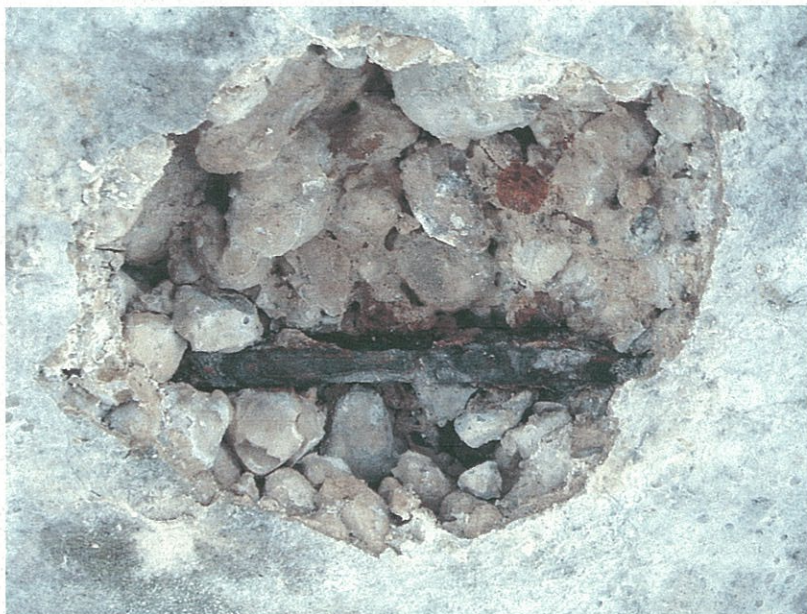
The slab itself manifests concrete delamination through its entire depth, particularly pronounced in the areas immediately below the interface zone with asphalt and in the lower portion. The latter can be attributed to poorly consolidated concrete exhibited by the slab underside (see photo 2 below and attached Figure 1) .

Photo 2 - Pockets of exposed aggregate particles with no cement paste bond were found in several areas of bridge underside.

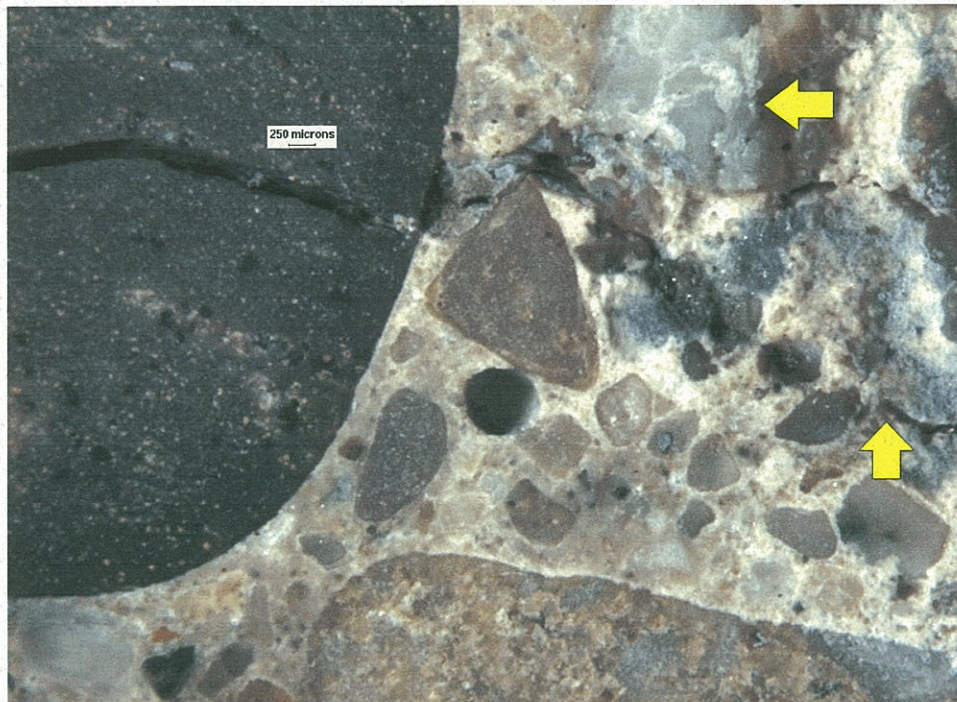
The cracks are visual size (macro-cracks) and microcracks. The majority of the cracks travel horizontally and thus appear to be result of typical cycling freezing-thawing deterioration.

Secondary cracks due to ASR (alkali-silica reaction) are present. The reactive rocks are chert, silt stone (in the fine aggregate), granodiorite (in the coarse) and argillaceous lime stone in the coarse and fine aggregate.

The cracks are lined with ettringite and silica gel. Both the coarse and fine aggregates are in a state of ASR.

Photomicrograph of Core C-4 shows extensive cracking due to freeze-thaw damage along with ASR and ettringite deposits in voids and cracks.

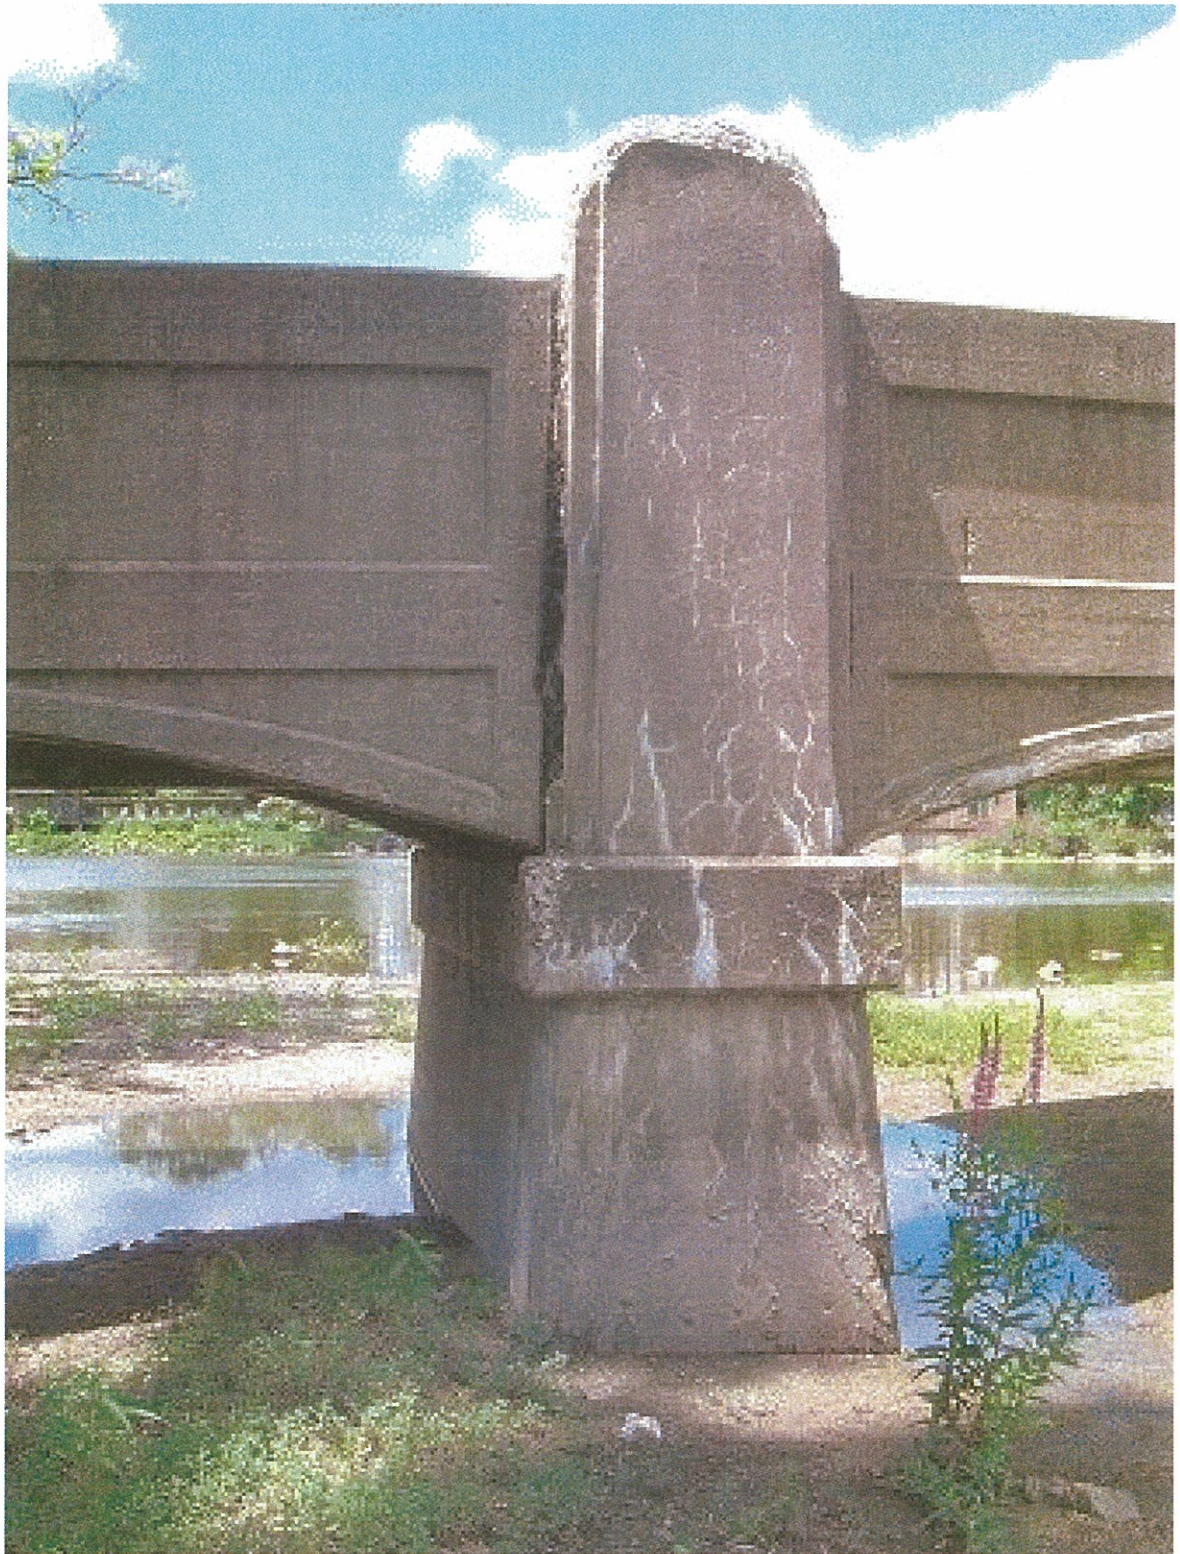
**Fig. 7**    **East Face of Pier 1**

Pier No. 1: There is staining and efflorescence throughout the pier cap. There also is some cracking which extends thru the cross section according to TSC's report in 2005. One of the cores did not show any deterioration. According to TSC's report in July 2007 the footing for this pier is not founded on bedrock but on fractured gravel.

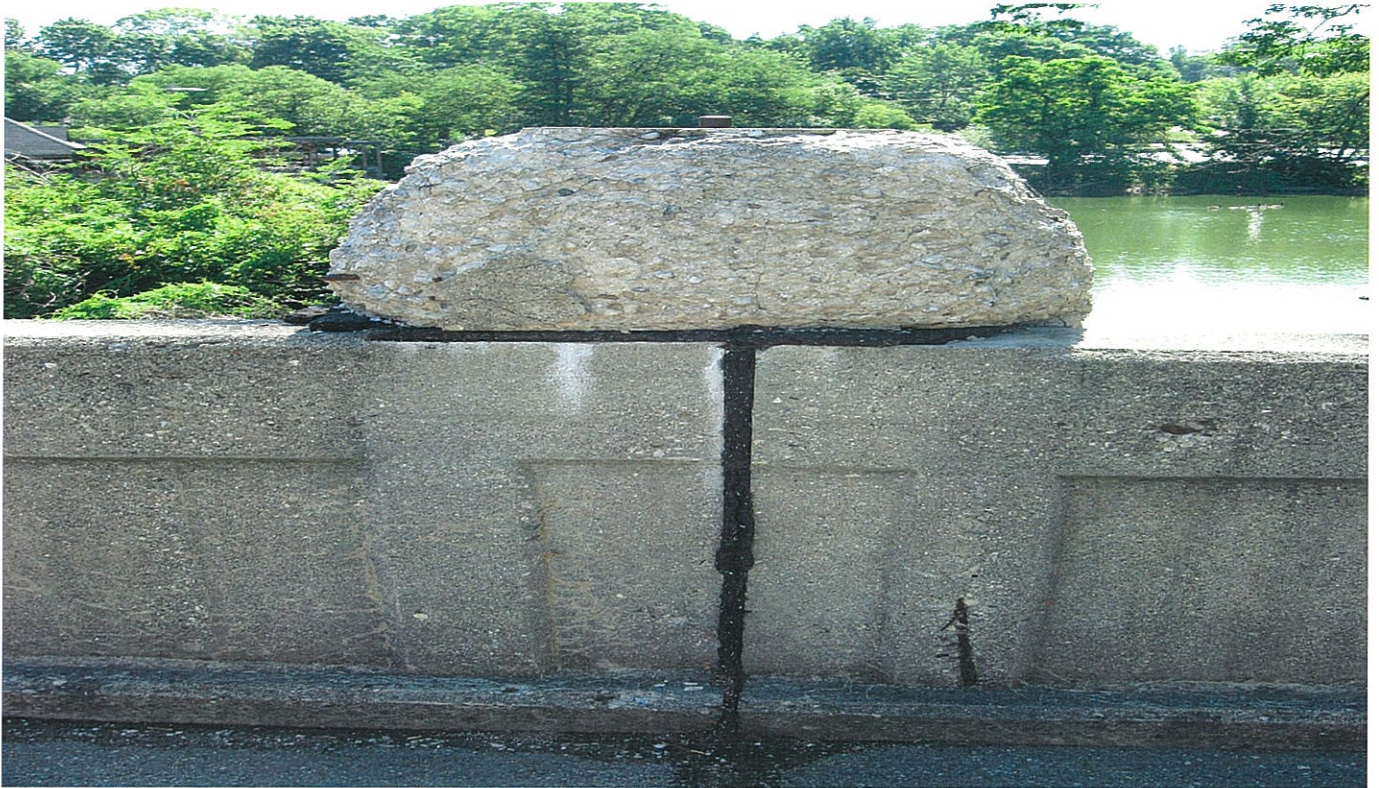
Damaged Pilaster East Side Pier 1

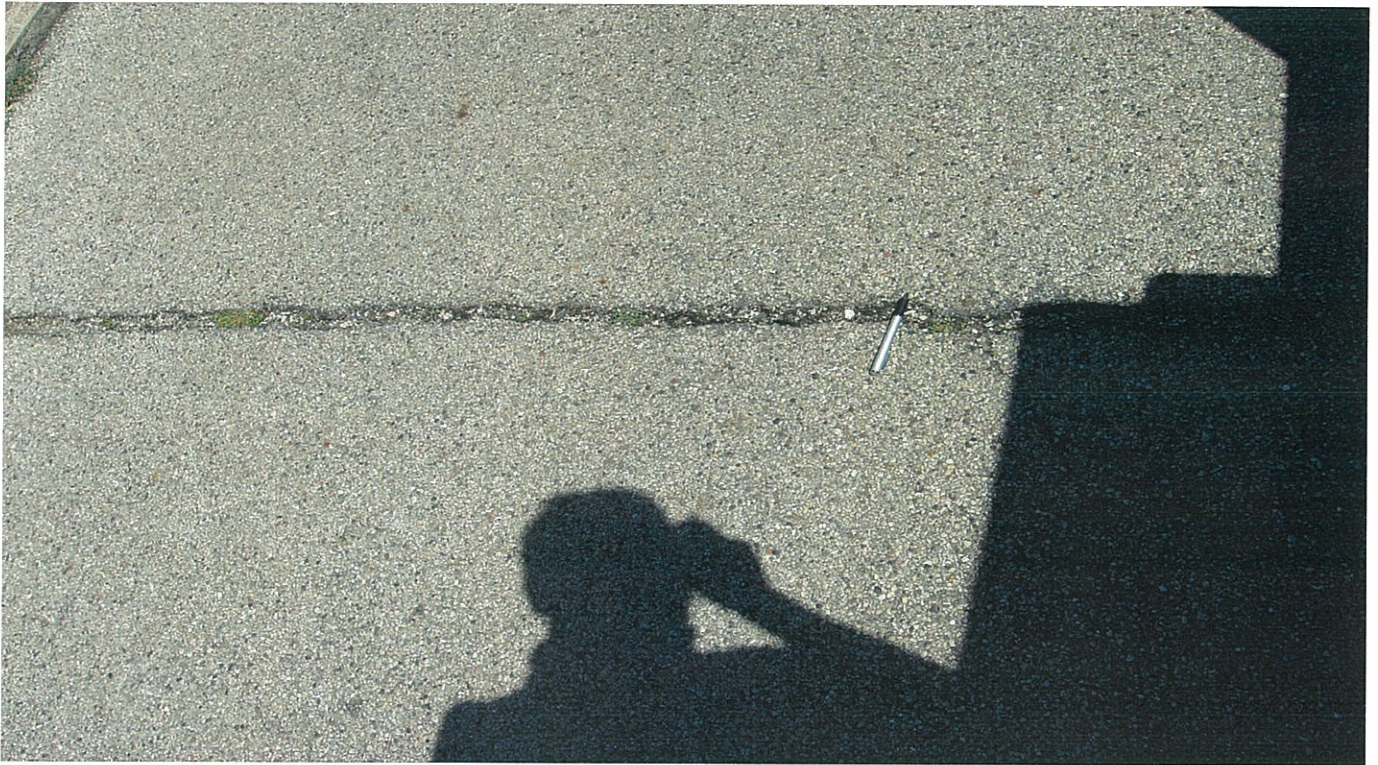
Crack North of Pier  
(no joint at Pier 3)

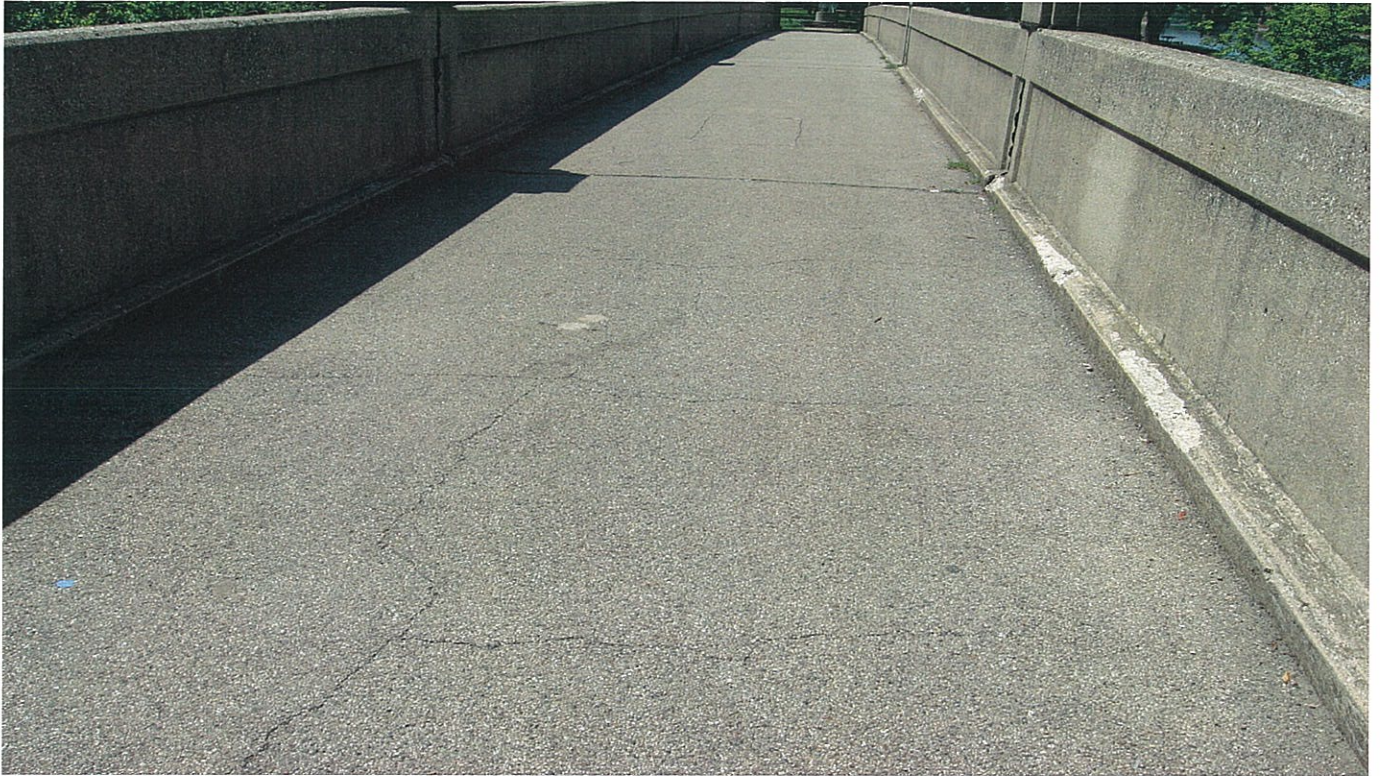
The bituminous wearing surface is in fair to poor condition with map cracking that covers the entire length of the deck. Transverse cracks have also formed along the joints over the piers. In March and April of 2005 field tests were constructed by Universal Construction Testing, Ltd. On the bridge deck using Non-destructive Ground Penetrating Radar (GPR) and core samples. According to these tests and a subsequent report dated April 25, 2005 the concrete deck was constructed with non-air entrained concrete. Because of this lack of air-entraining the deck has deteriorated due to freeze-thaw action (see Attachment B for a copy of this report). The bridge railing which is part of the thru-girders does meet currently acceptable AASHTO Standards and are in fair to poor condition (because of the lack of air-entraining).

Typical Cracking in Deck

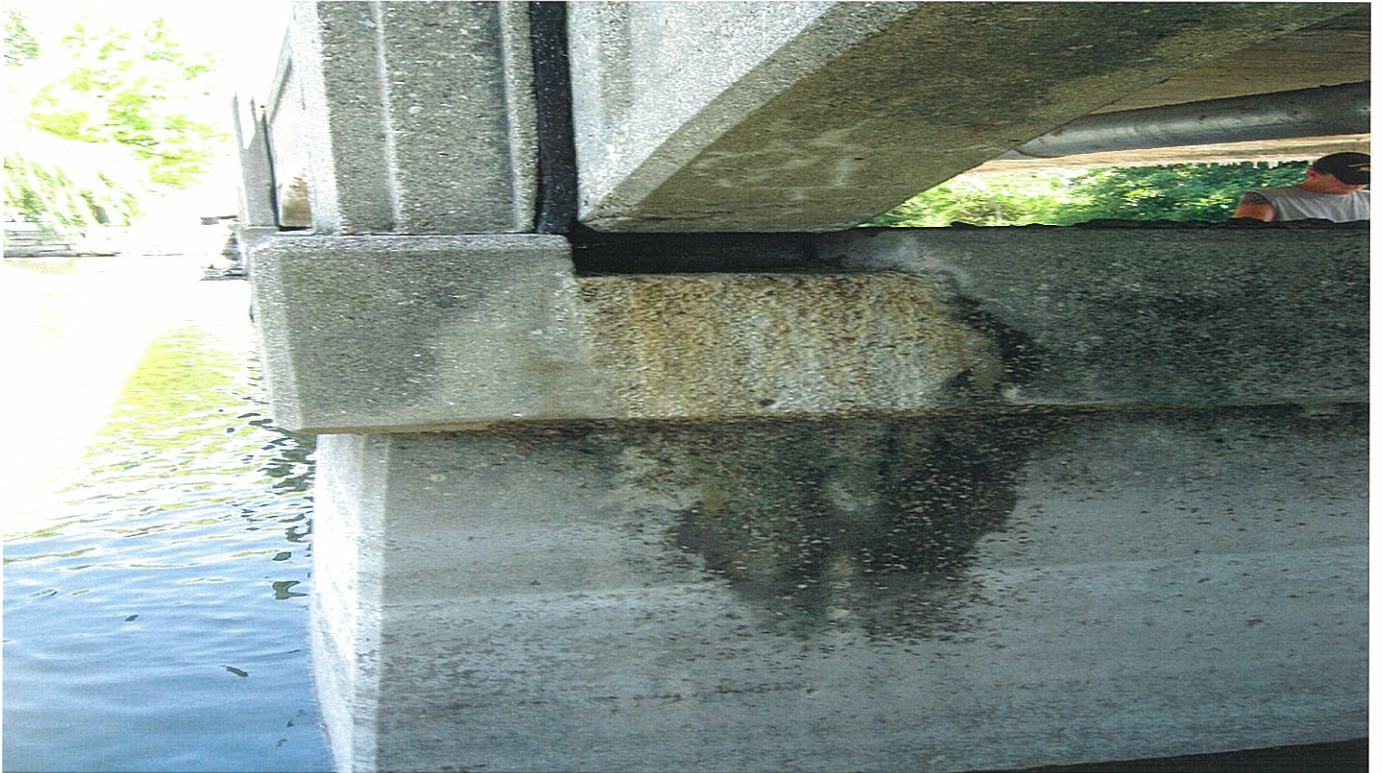
Pier 1 Southwest Corner Deterioration

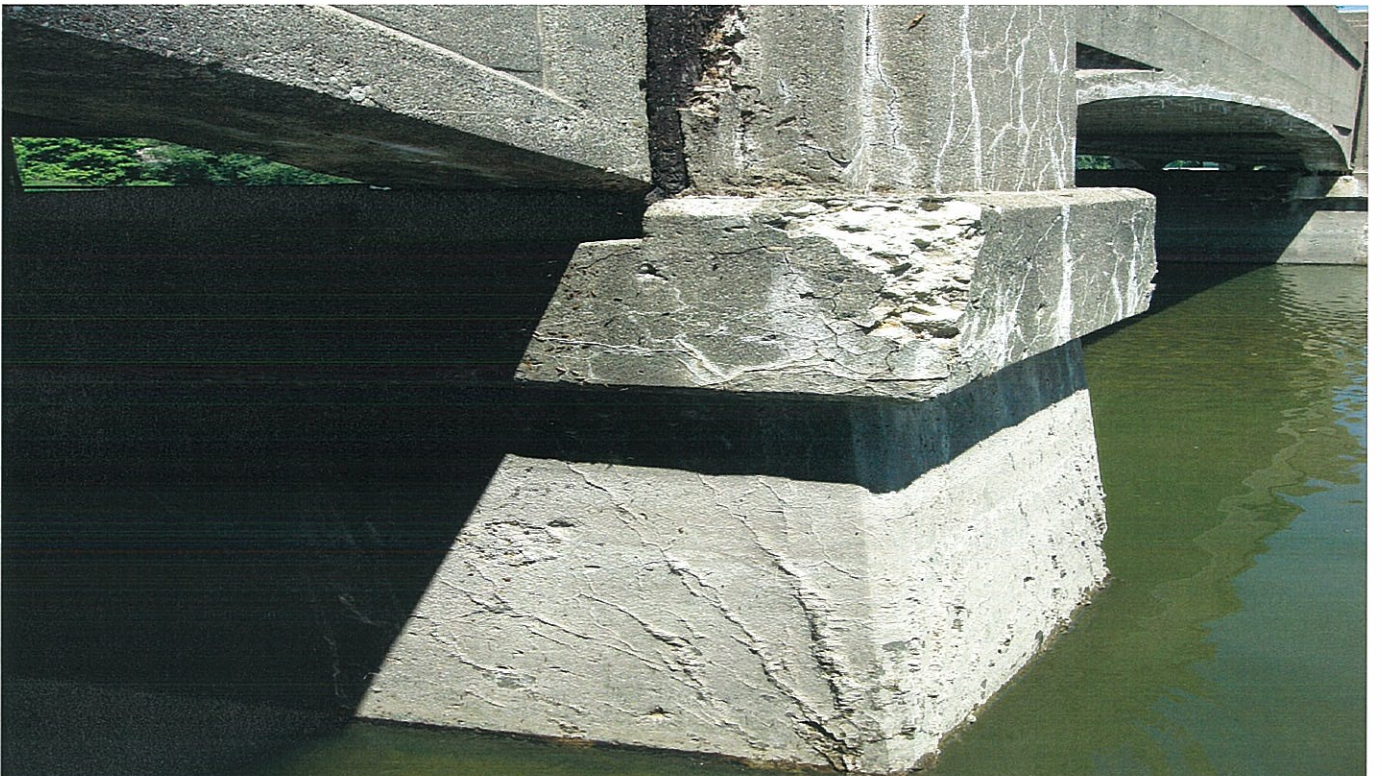
Pier 1 Southeast Corner Deterioration

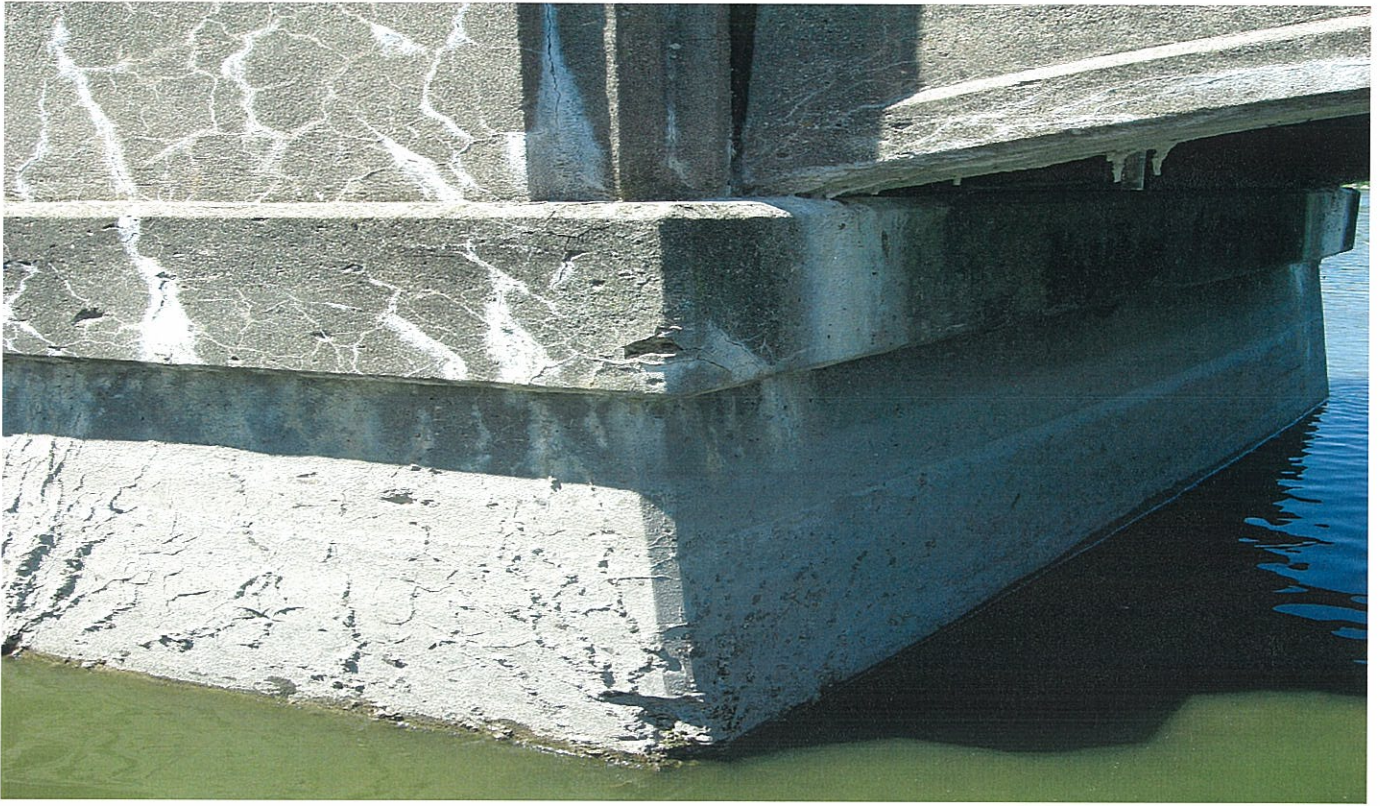
Pier 1 Northeast Corner Deterioration

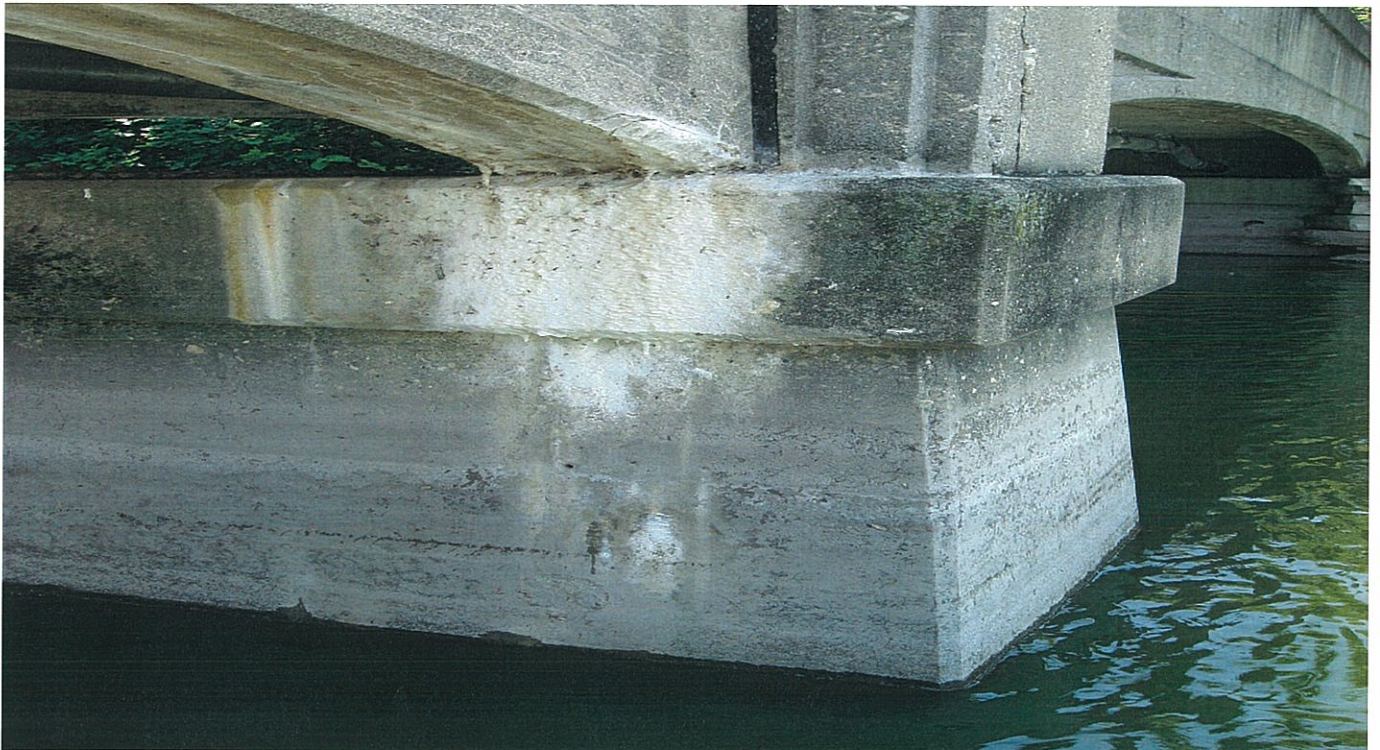
Pier 1 Northwest Corner Deterioration

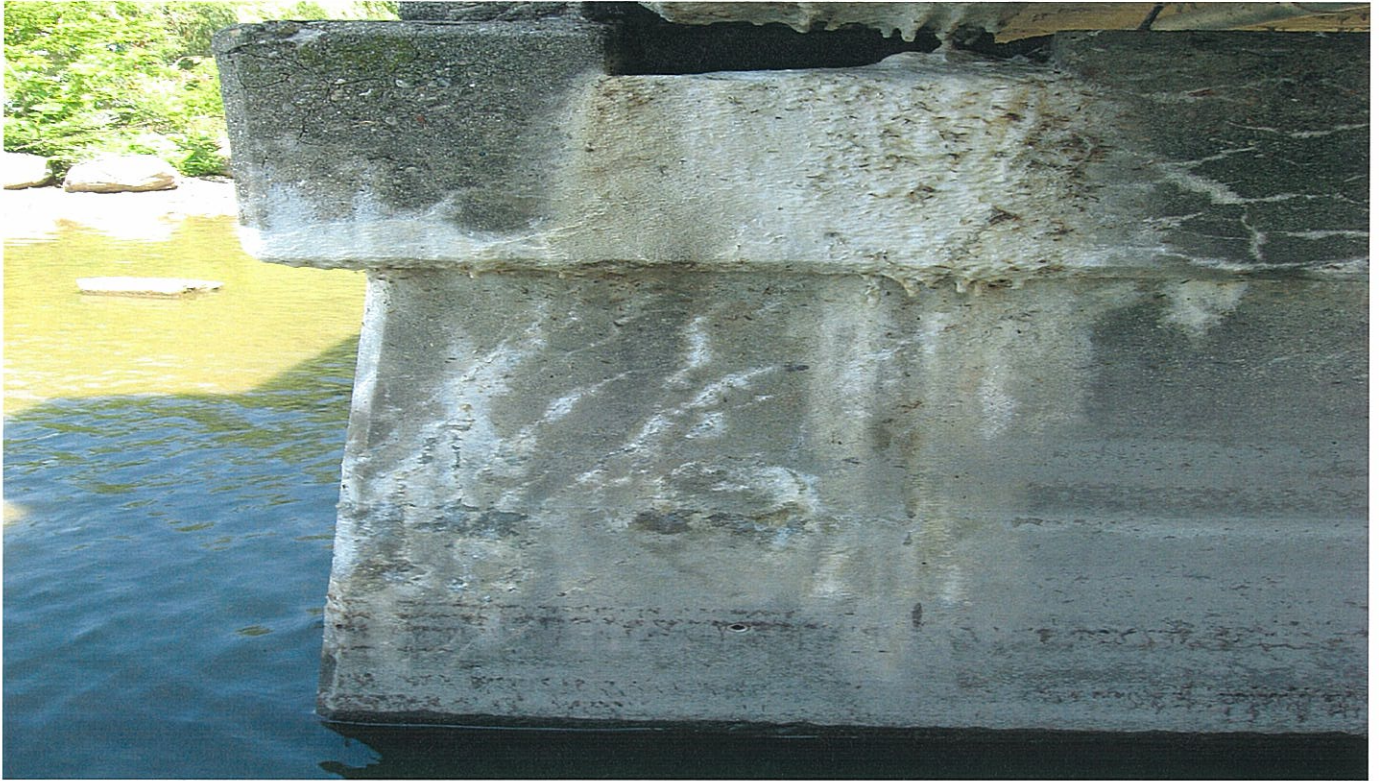
Pier No. 2: There is staining and efflorescence throughout the pier cap. There is some minor cracking on the pier stem, according to the cores performed by TSC in 2007. One of the cores did not show any deterioration. According to TSC's report in July 2007 the footing is founded on bedrock.

Pier 2 Southwest Corner Deterioration

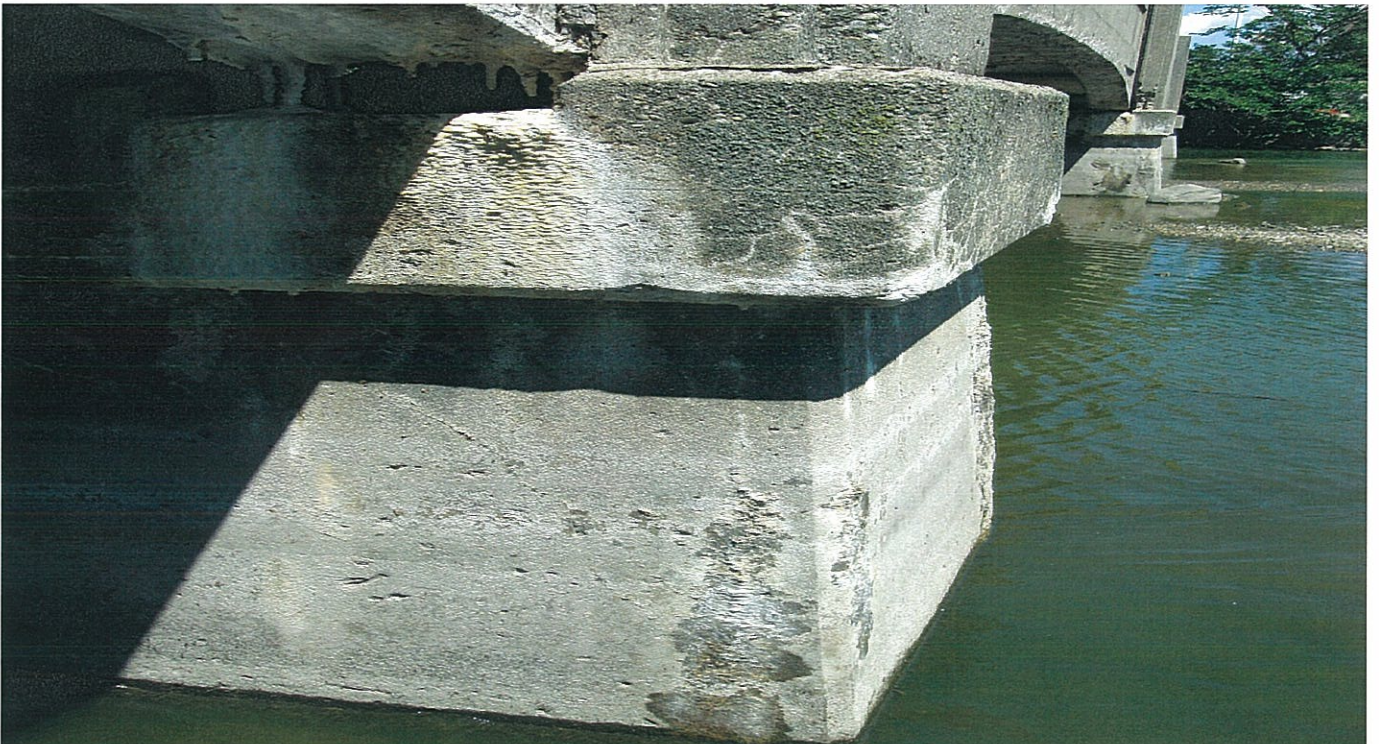
Pier 2 Southeast Corner Deterioration

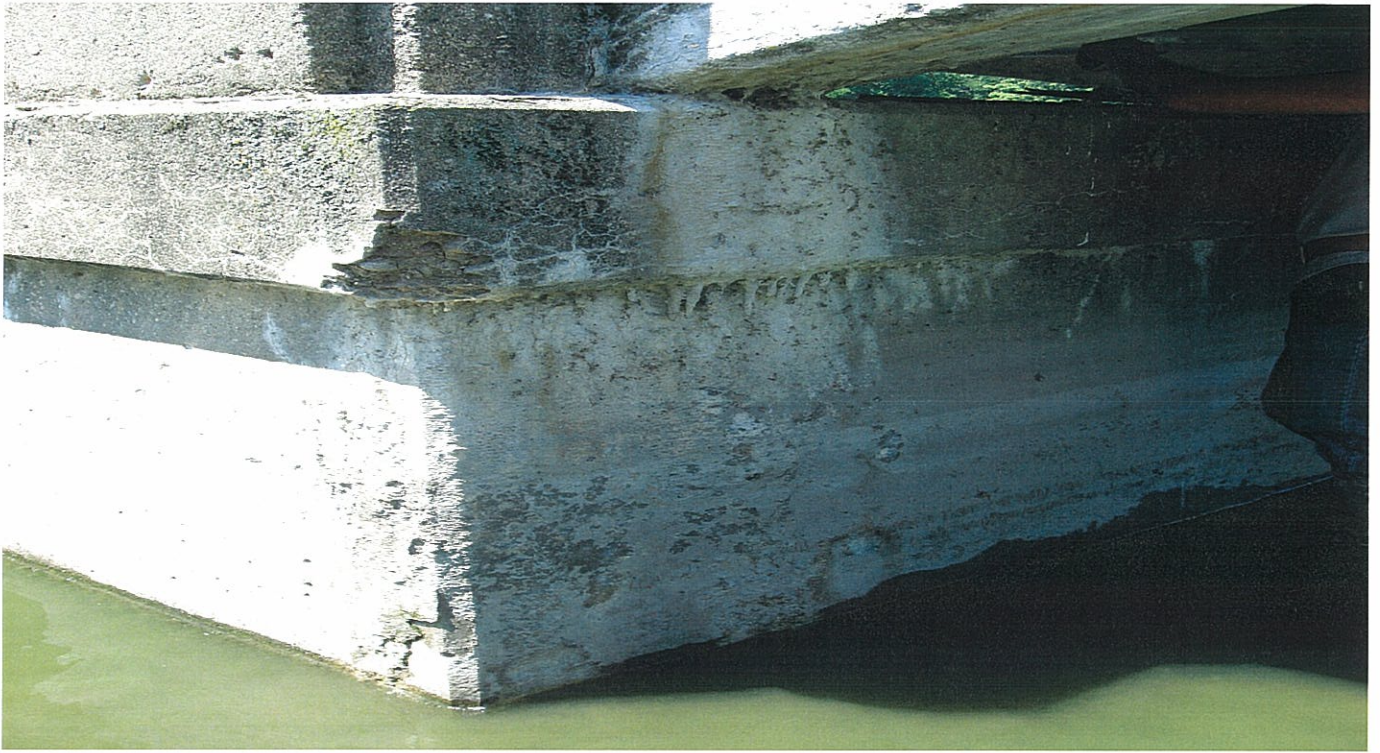
Pier 2 Northeast Corner Deterioration

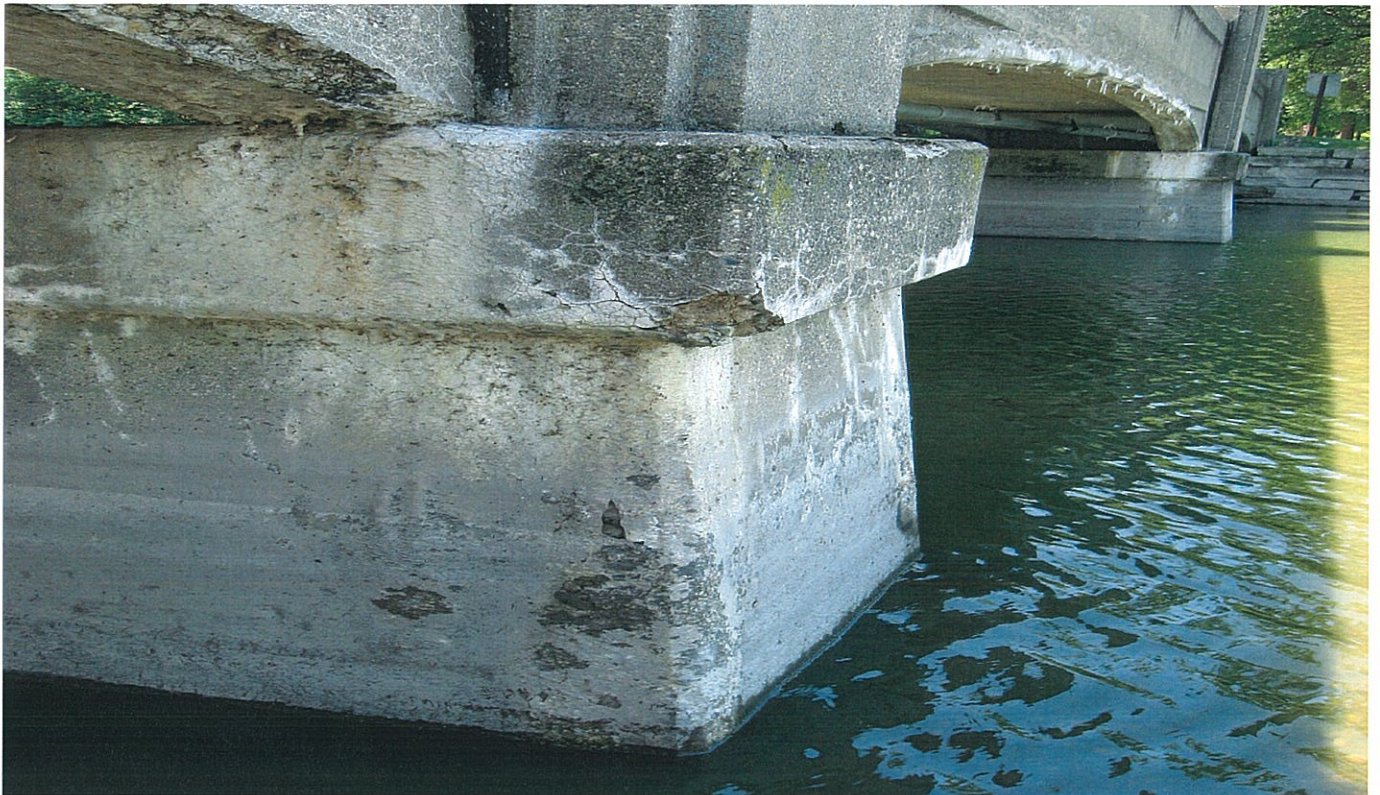
Pier 2 Northwest Corner Deterioration

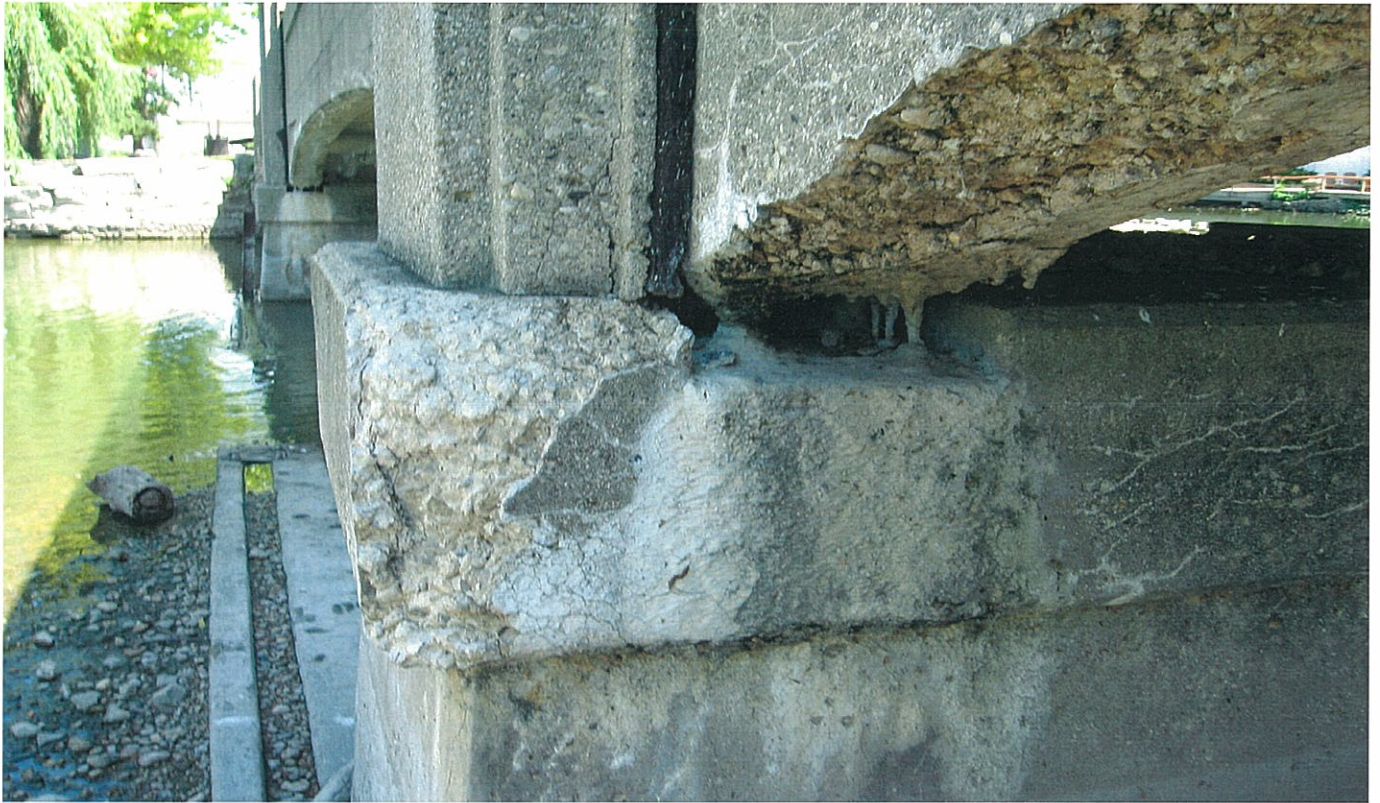
Pier No. 3: There is staining and efflorescence on the pier cap. There is also some efflorescence staining on the east side of the pier. There is a 3' x 3' deteriorated area on the east end of the south side of the pier. According to the cores performed by TSC in 2005 there were some cracks which extended through the cross-section of the cores. According to TSC's report in July 2007 the footing is founded on bedrock.

Pier 3 Southwest Corner Deterioration

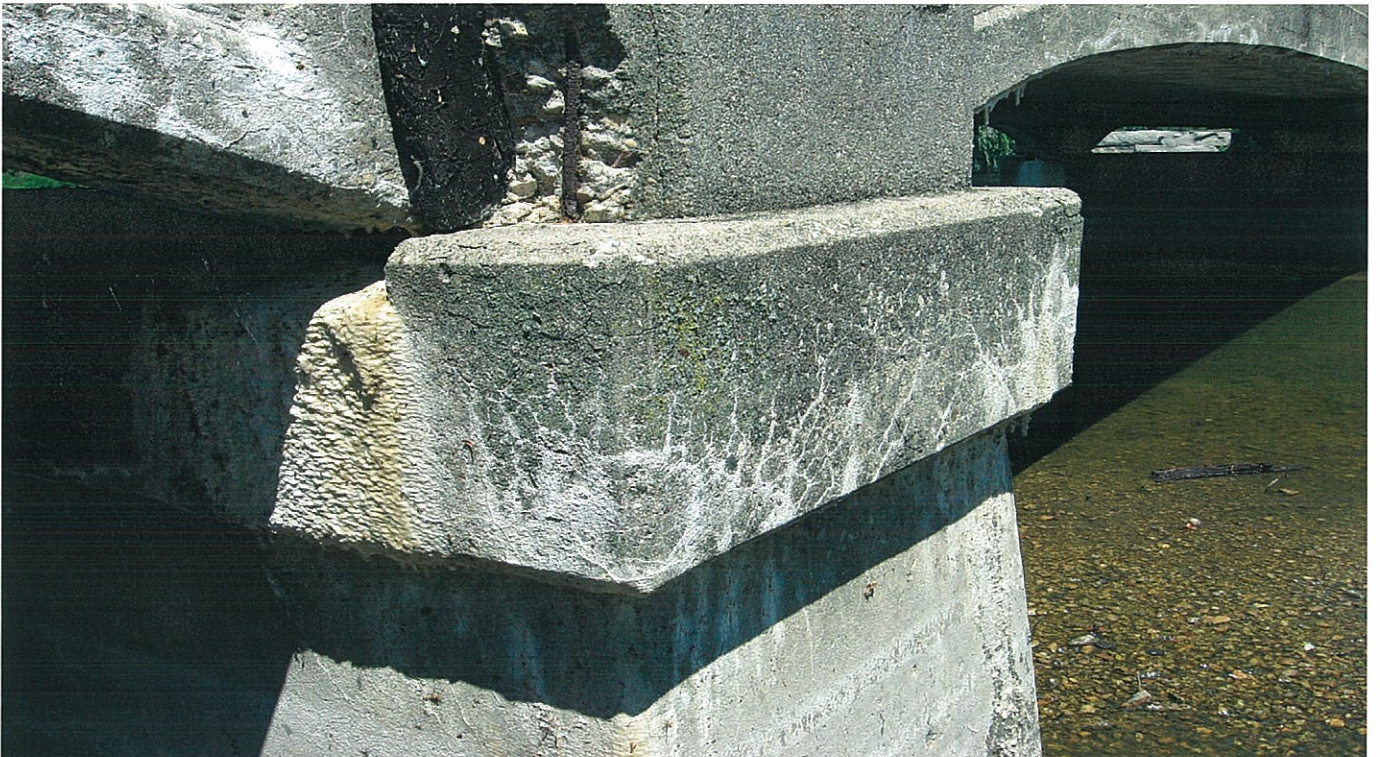
Pier 3 Southeast Corner Deterioration

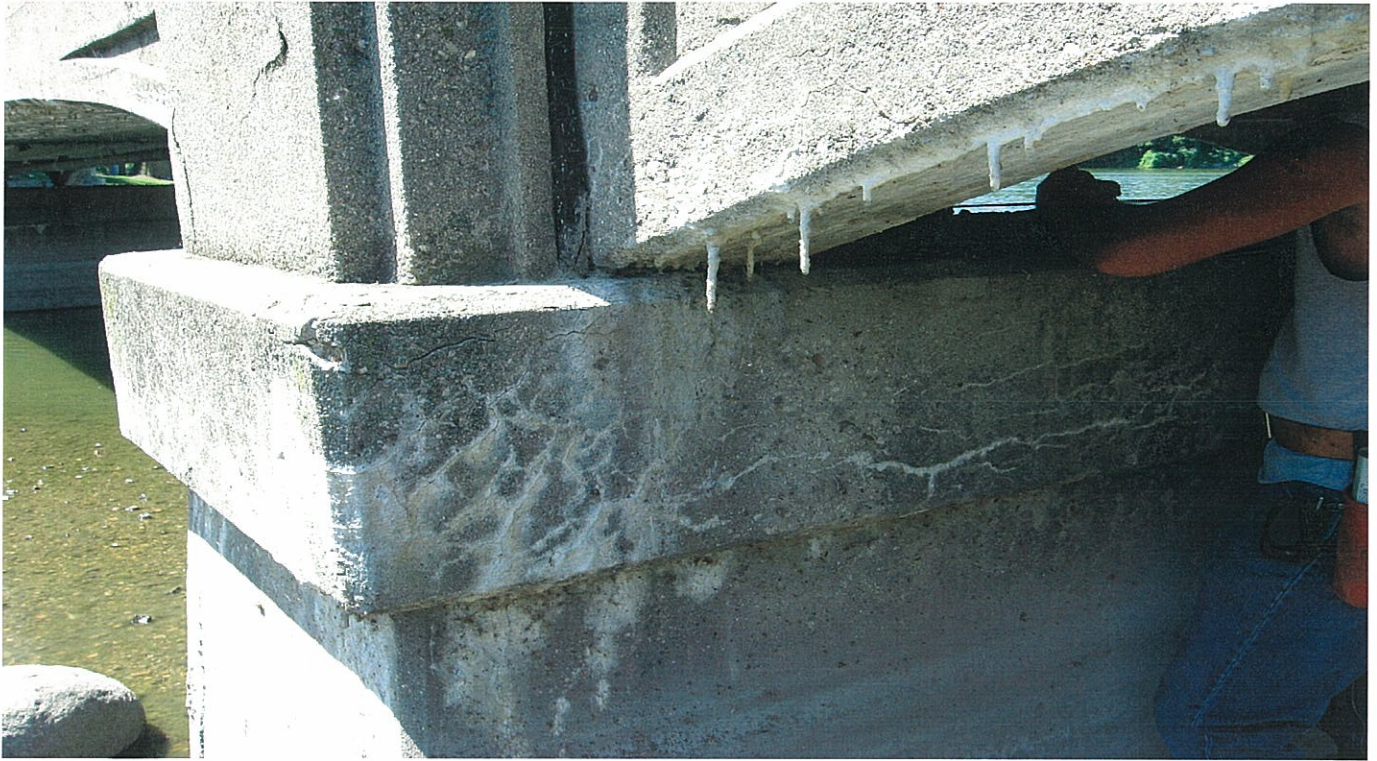
Pier 3 Northeast Corner Deterioration

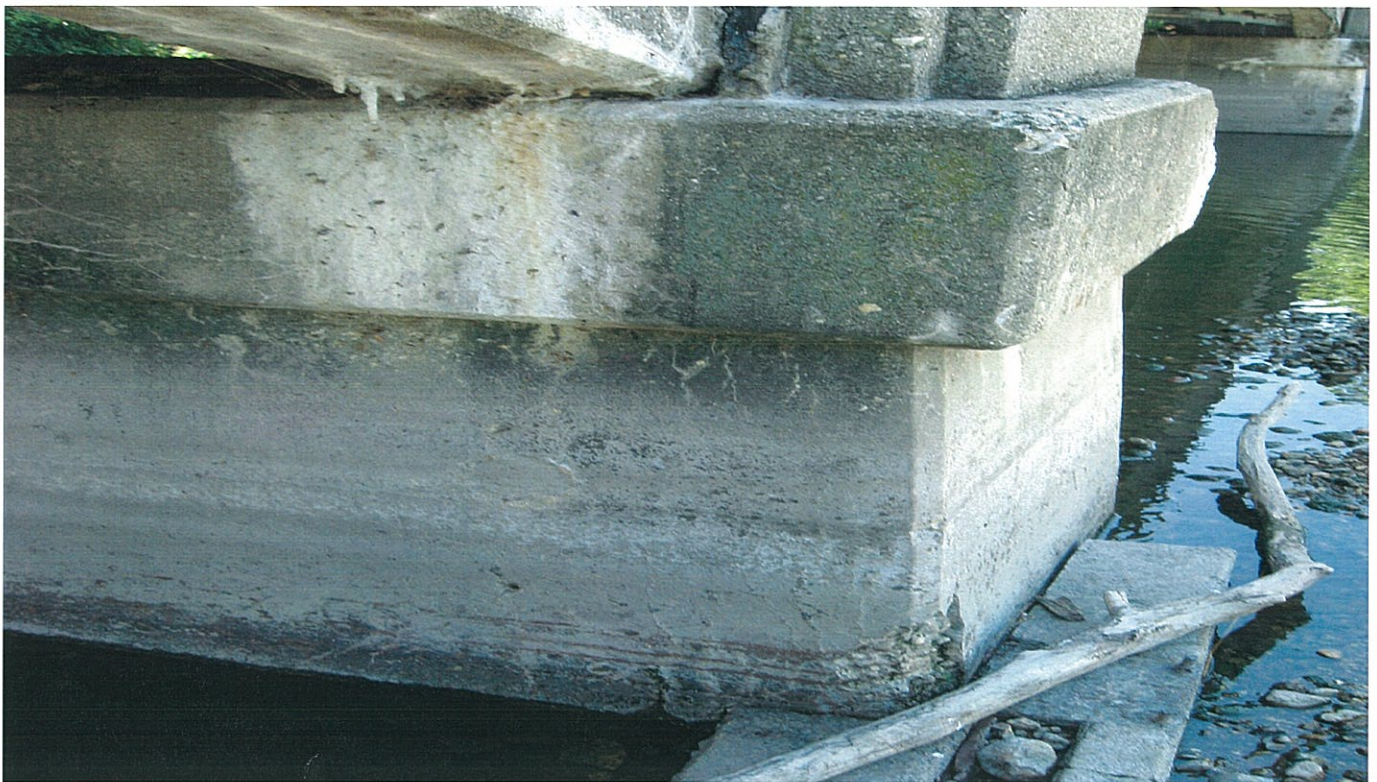
Pier 3 Northwest Corner Deterioration
