Bridge Falsework Washed Out; Kansas City, Mo.

Further Notes on Kansas River Bridge Falsework Collapse

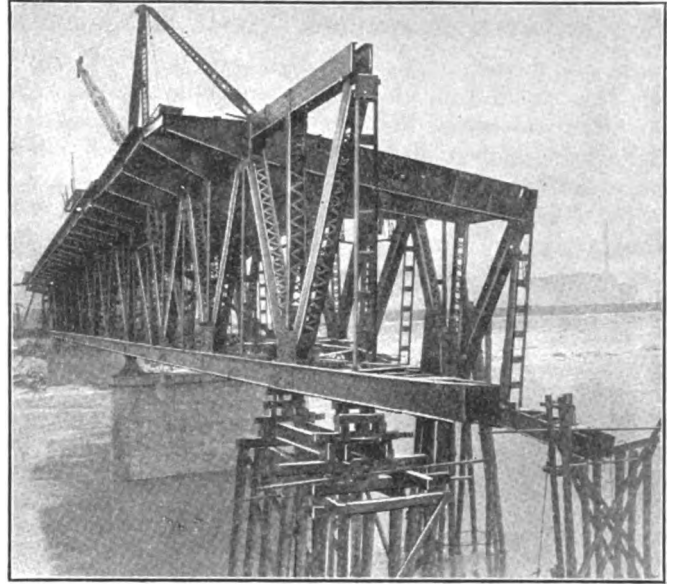
The north truss (on the left, Fig. 1) had been practically all assembled to its bent, which held sufficiently to prevent any visible damage to this truss; but the south truss had only the lower chord member resting on the falsework. This dropped 7 or 8 ft., eventually coming to rest on the two inner piles of the bent, the cap being

FIG. 1. KANSAS AVE. BRIDGE AFTER WASHOUT OF FALSEWORK

Looking toward Missouri shore. North truss on left

raised from the tops of the other three piles as shown in the views. The fall of the south truss caused the loss of six stringers and a 50-ton jack, which were on the superstructure, sheared off several pin plates and badly twisted the end floor-beam and crossbracing of the two end panels. These members had not been riveted, or the damage would have been greater, as the structure dropped by shearing off the bolt heads and breaking of pin plates without distorting many of the main members.

For the week following the collapse, rain and freezing weather made it impossible to work on the structure, and to Jan. 27 nothing had been done save to assemble some groups of piles under the distorted truss. The contractor proposes to drive groups of piles under this truss, cap them and bring the truss back into line by jacks.

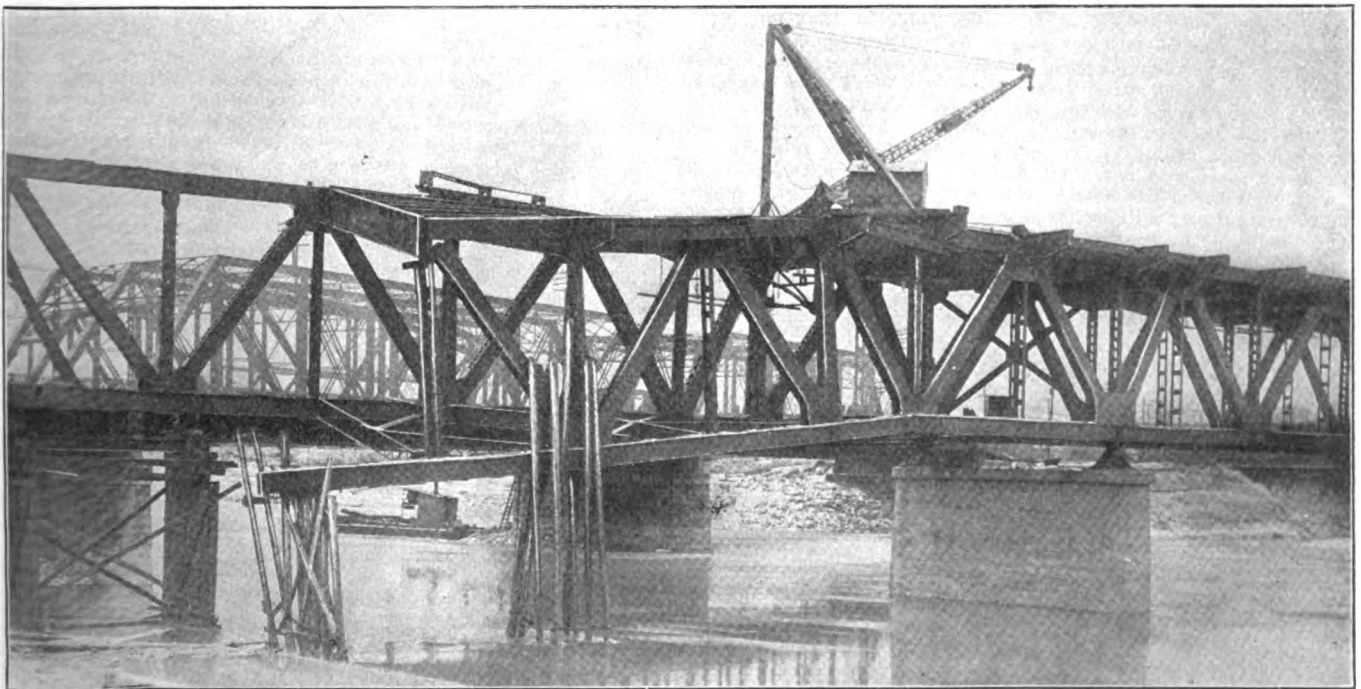
FIG. 2. LOOKING NORTHERLY TOWARD KANSAS AVE. BRIDGE AT KANSAS CITY
