Historic Bridge Management Plan for the Lea Joyner Bridge

Recall Number: 024400

June 2017

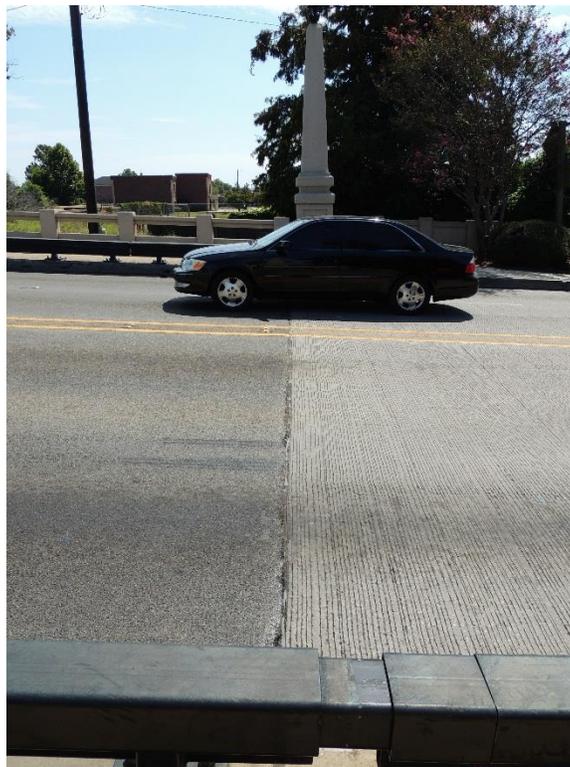
Condition Photo 12: The relief joint between the approach span 1 and the west approach slab.

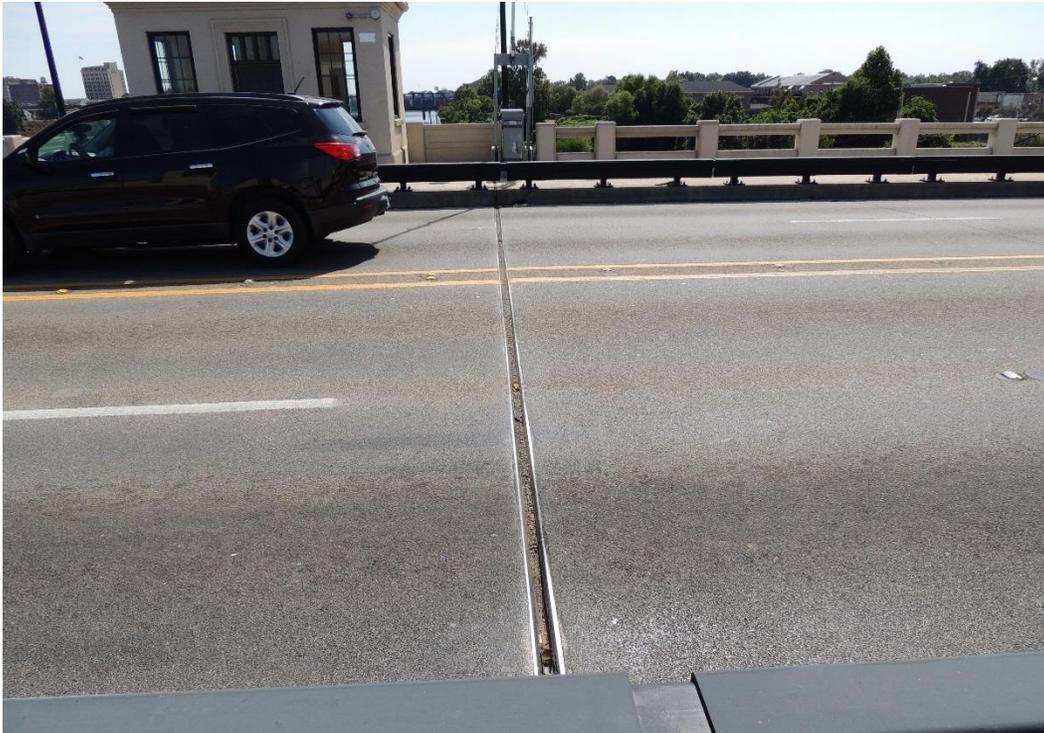
Condition Photo 13: Pier 4, compression joint full of dirt and debris, typical condition.

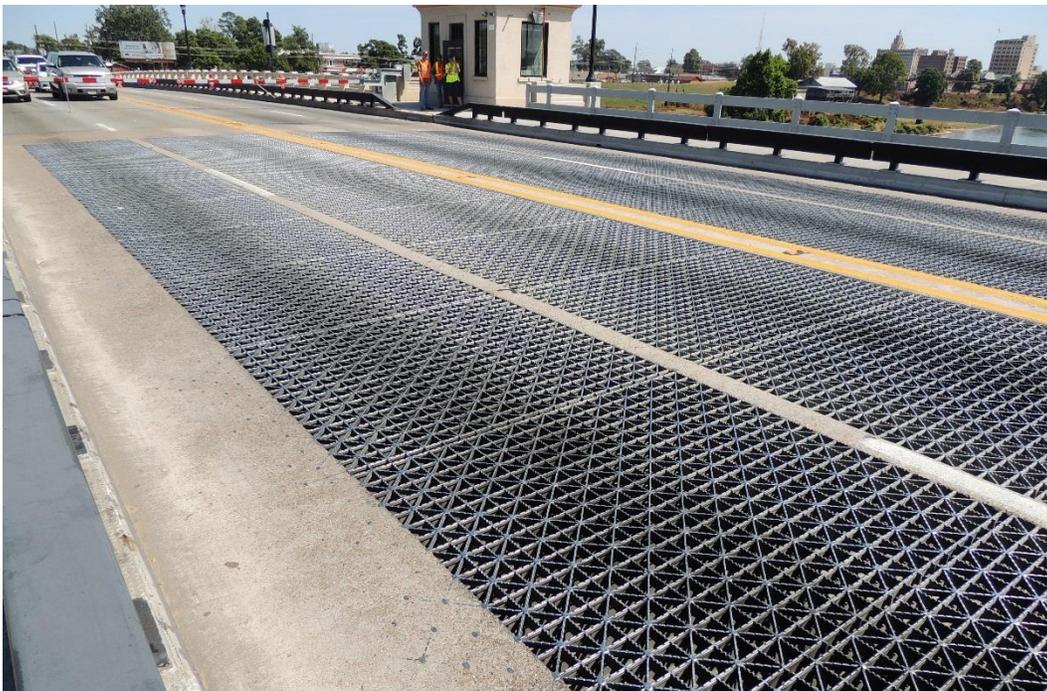
The superstructure is in satisfactory condition. The steel open grid deck is in satisfactory condition with missing bolts from the joint that is causing vibration. The steel deck with concrete filled grid is in good condition with no deficiencies. The two steel plate girder systems, steel trusses, and steel floorbeams are in good condition. Steel floorbeam 1, span 6 has a small hole. The steel stringers have been replaced and are in good condition. The metal railing is in good condition with no deficiencies. The counterweight and the counterweight support are in good condition with no deficiencies. The counterweight trunnion bearing assembly was replaced during the 2013 rehabilitation. The operating machinery and the control console were replaced in the 2008 rehabilitation. Both are functional and in good condition.

Condition Photo 16: Steel open grid deck on the bascule span.

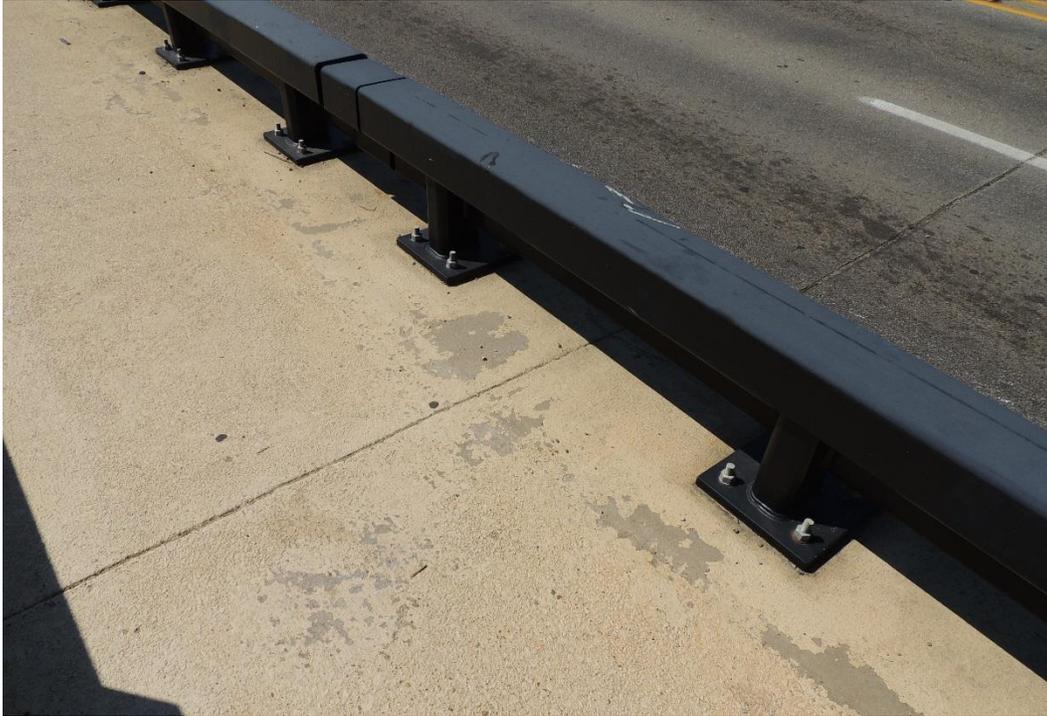
Condition Photo 17: Vehicular scratches/damage to the metal curb rails on the sidewalk.

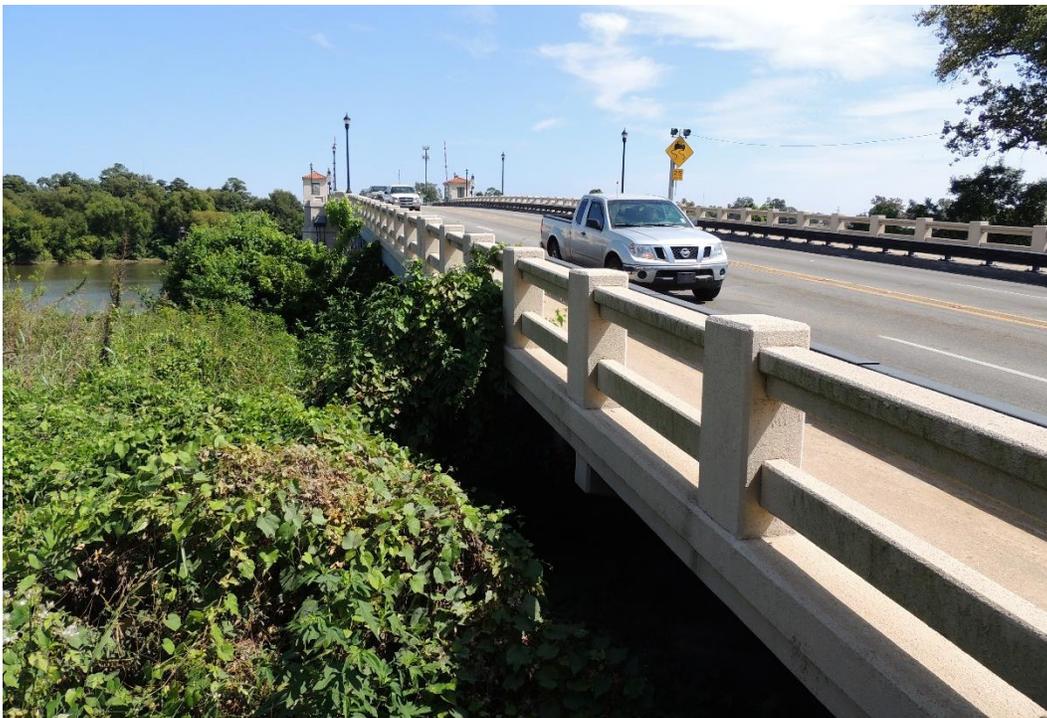
Condition Photo 22: West approach spans covered with vegetation.

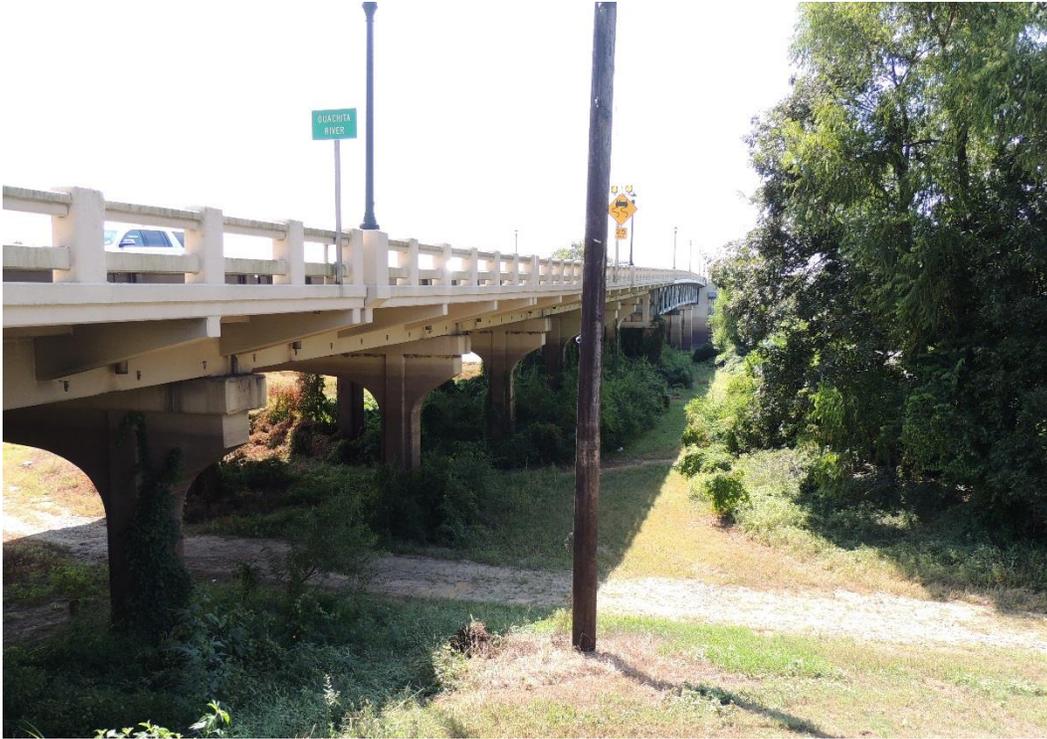
Condition Photo 23: Approach spans 11 through 18, staining on bents, looking west, typical.

1. Clean the concrete substructure units to remove water staining discoloration with low pressure water spray.
2. Repair spalls and cracking in the concrete substructure units with concrete patches or epoxy injections.
3. Repair spalls and cracking on the concrete beams of spans 11 through 18 at the bearing areas, where the beams are haunched, with concrete patches and epoxy injections.
4. Replace missing and sheared bolts on the connection plates in spans 4, 10, and 11.
5. Paint the unpainted areas on the steel bracing under the deck in span 10.
6. Moveable bearing rehabilitation.

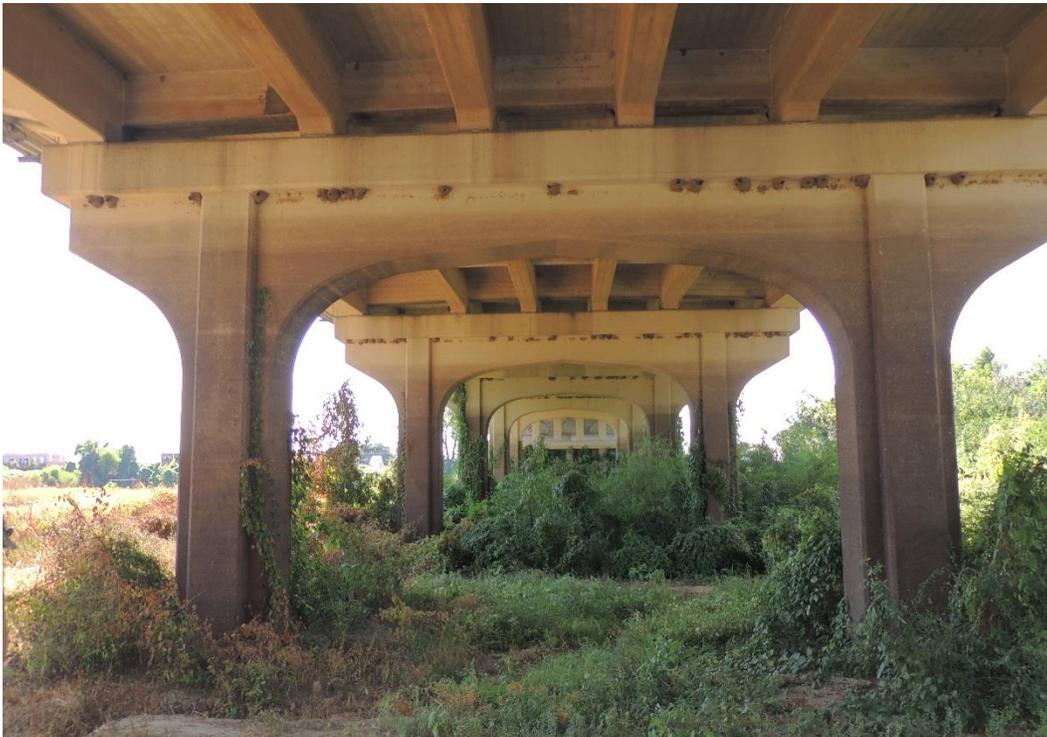
Condition Photo 24: Vegetation, water staining, and dirt daubers on the substructure units, typical.

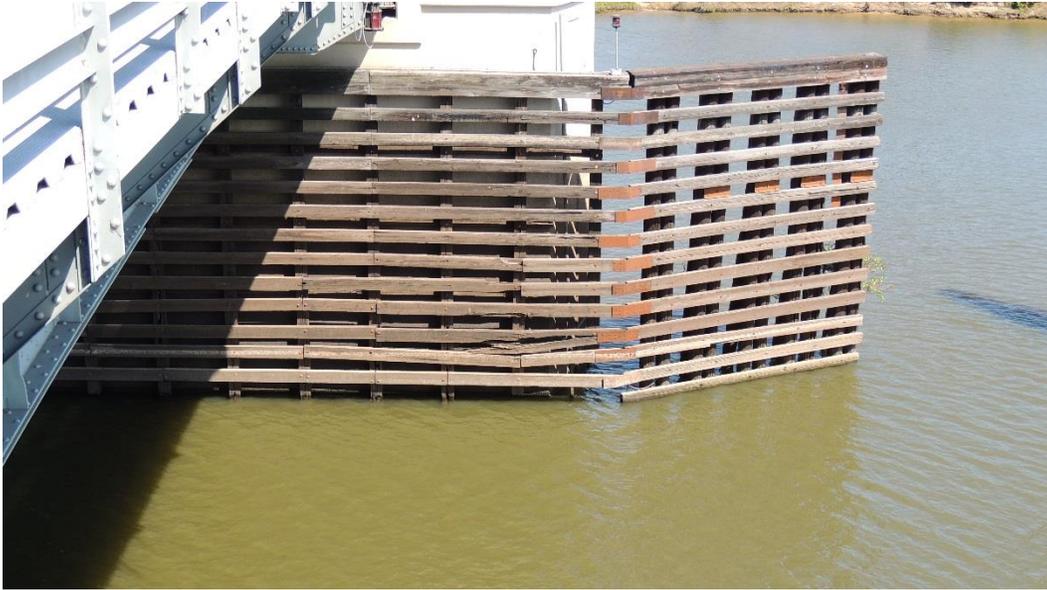
Condition Photo 27: Damaged east timber fender system.

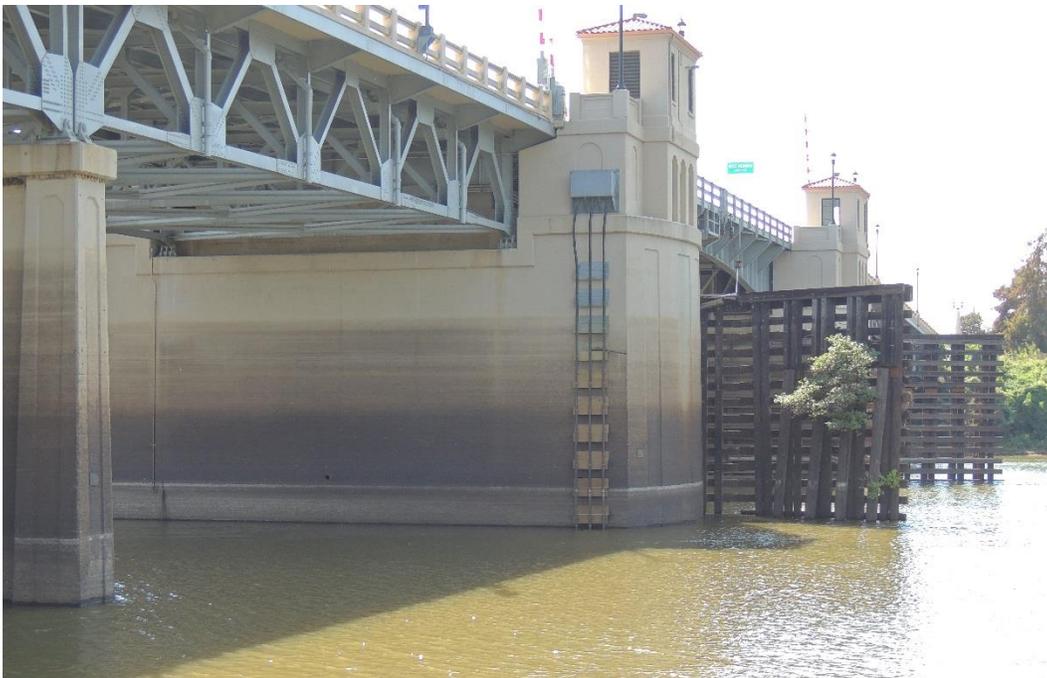
Condition Photo 28: Pier 5 of the bascule span and vegetation growth in the east timber fender system.

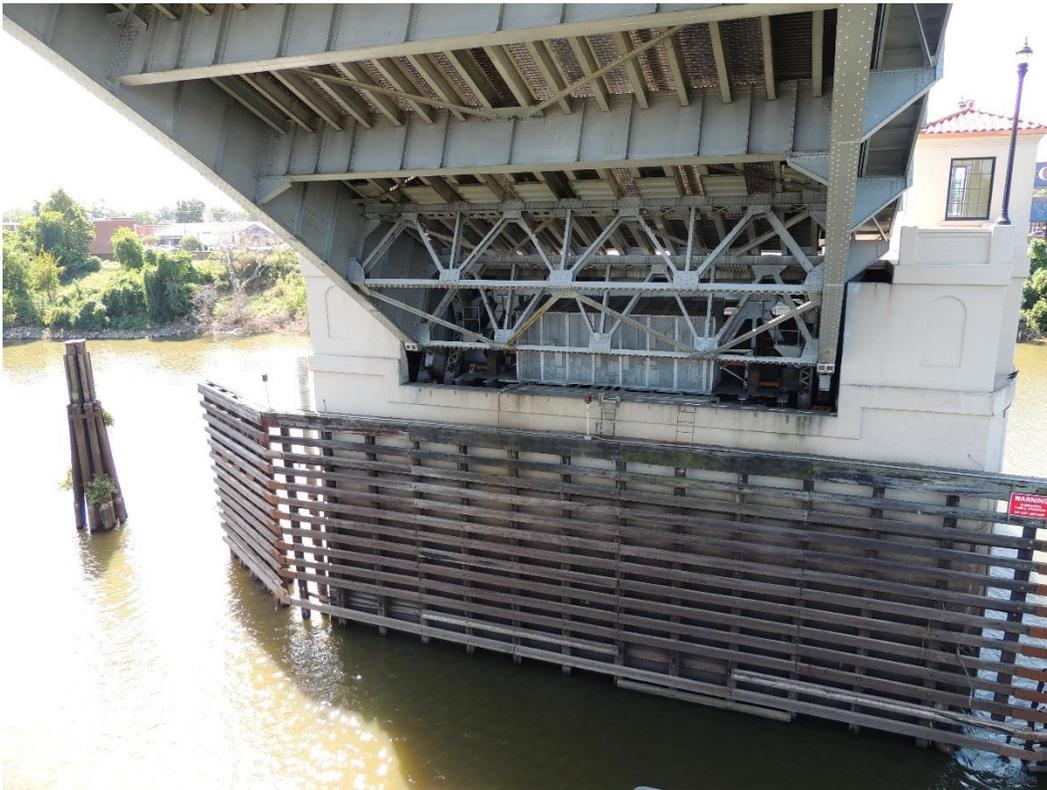
Condition Photo 30: The west timber fender system, missing members and damaged and the lowering of the bascule span, looking west.
