# Michigan Department of Transportation

## Historic Bridge Inventory Update

**Feature On:** M-43

**JN 204337 M-43 Coldwater River Bridge Condition Report,**  
**Rehabilitation Assessment, and Photos**

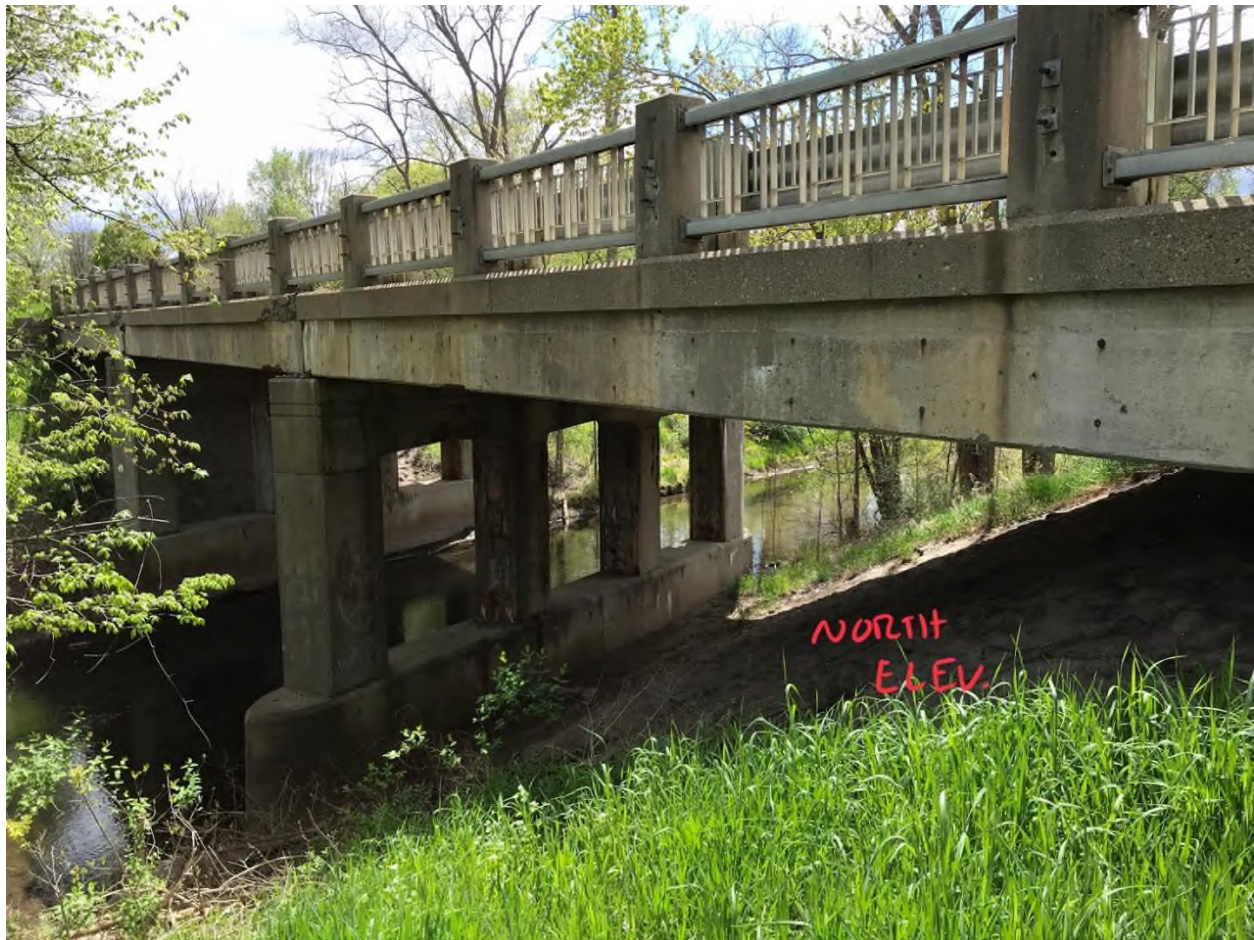
Photo 1—North elevation of the bridge.

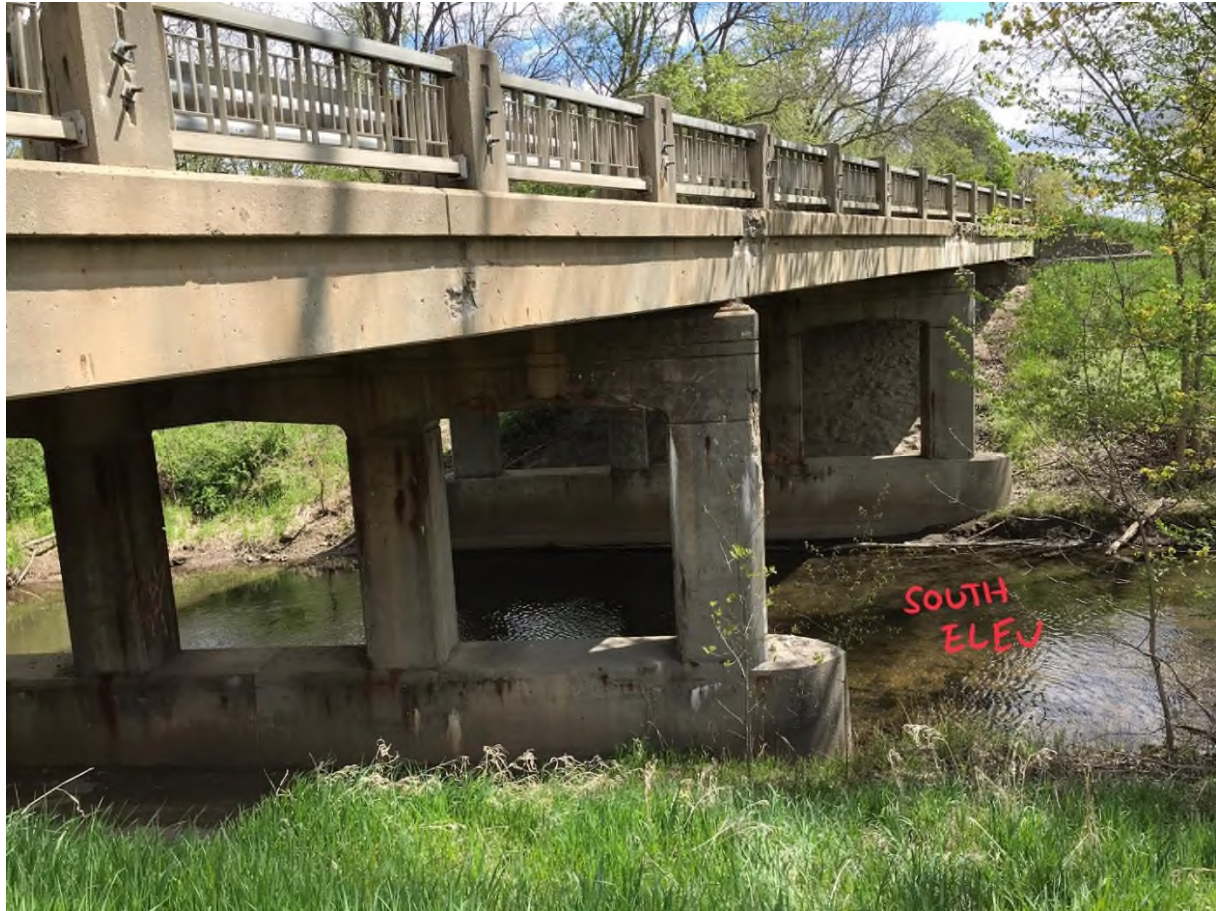
Photo 2—South elevation of the bridge.

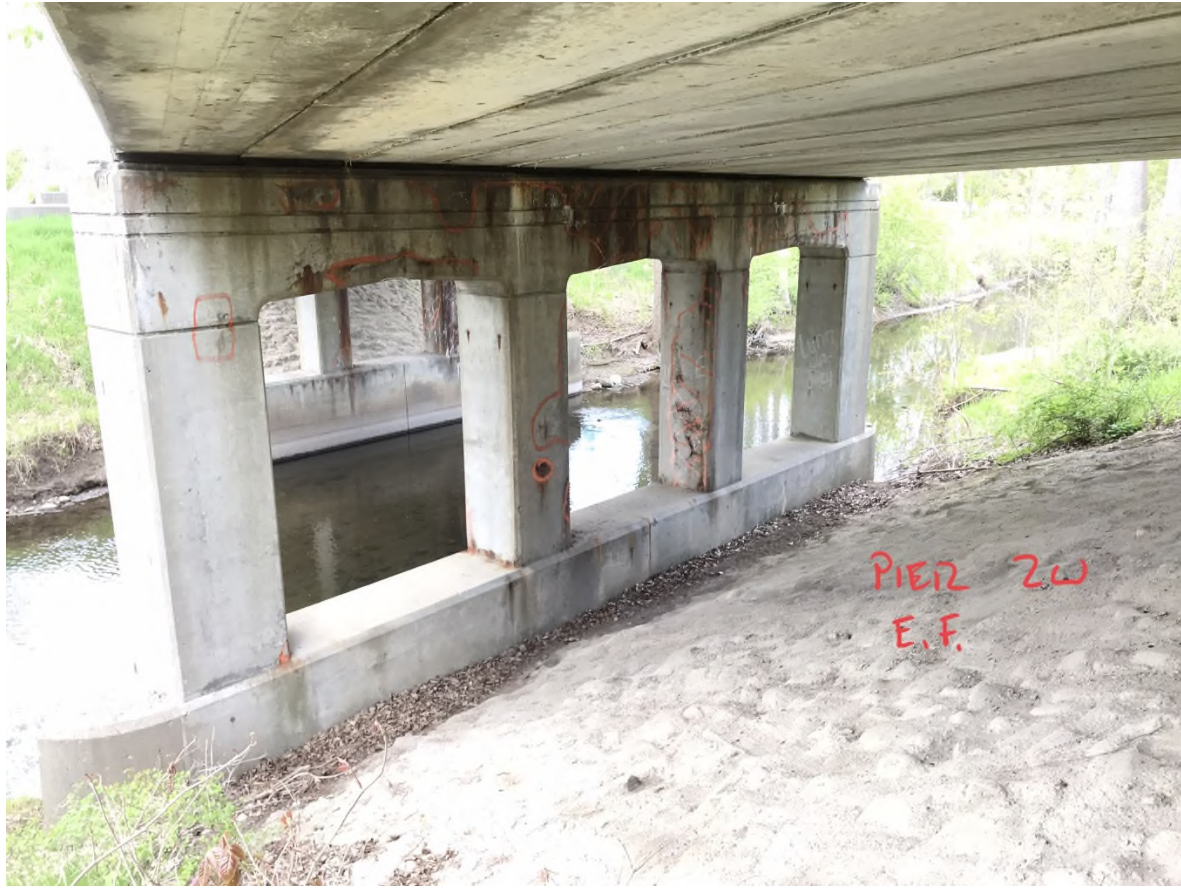
- Pier caps have approximately 50% of the entire length spalled or delaminated with scattered delamination to the pier walls. In addition, the pier columns have cracks and delaminated areas with some locations exhibiting exposed reinforcement. There are also delaminated areas and cracks that were observed on the pier walls.

Photo 3—East elevation of the east pier.

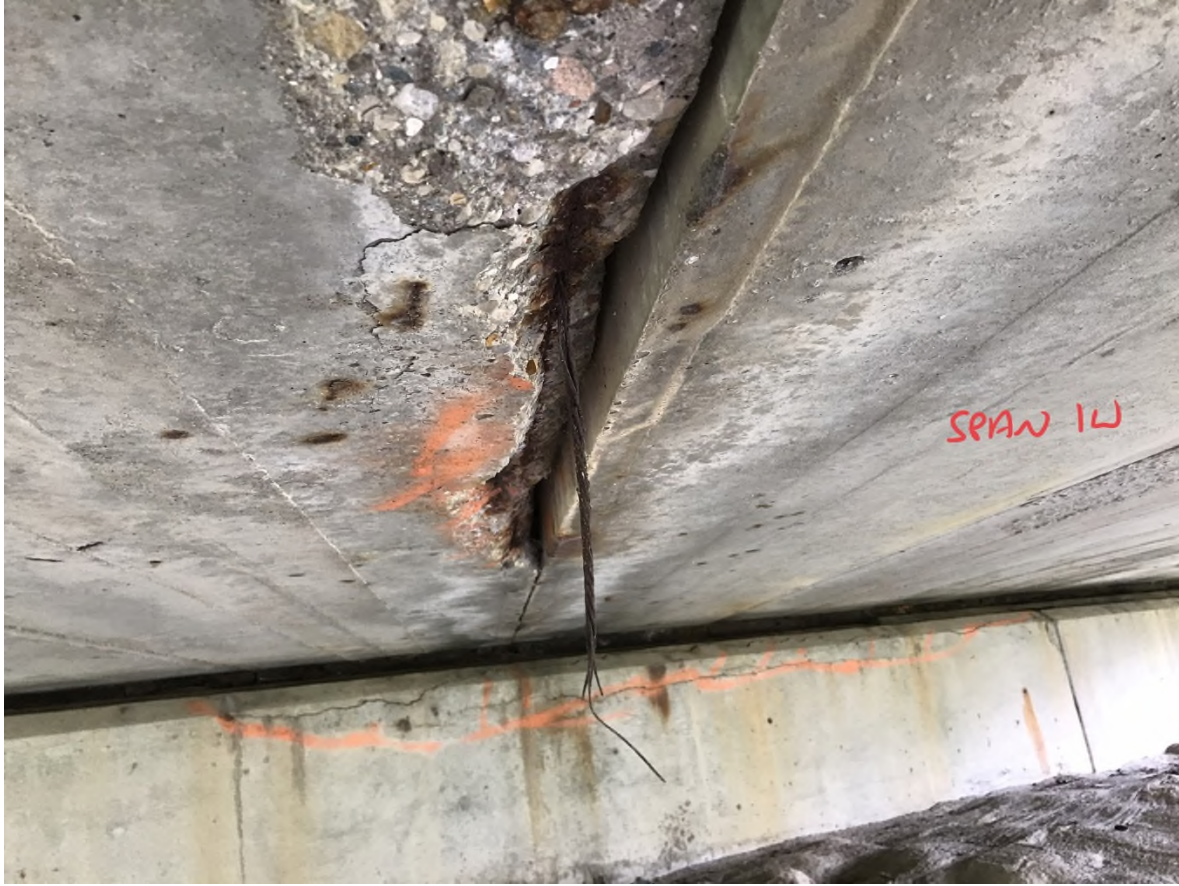
- Side-by-side concrete box beams have scattered longitudinal cracks and spalling.
- At least 5 beams have multiple broken strands (main reinforcement) and exposed strands. One of the beams, as an example, has 6 broken strands at different locations and another 2 exposed strands. The broken strands cannot be fixed or repaired and the load carrying capacity has been reduced, resulting in a serious deficiency for the overall structure.

Photo 4—Detail of the underside of the bridge showing a broken and exposed beam reinforcing strand.

- The broken strands in the concrete box beams cannot be fixed as the prestressed steel is embedded in the concrete beams. Once a strand is broken, that reinforcement is no longer effective, and this in turn affects the load carrying capacity of the beam and the entire structure.

- To rehabilitate the bridge would require the replacement of all beams with broken strands. In order to replace the beams, the entire superstructure (everything above the abutments and piers) will require removal to access the beams. Rehabilitation would therefore result in the physical destruction of much of the bridge. The historic integrity of the bridge would be lost as a result of any rehabilitation project.
- The piers are in poor enough condition that a rehabilitation could not address them sufficiently. In addition, while currently there is little known scour at the bridge piers, rehabilitation would require the installation of micropiles to address any future scour and work on the abutments as well. Micropiles cannot be installed in the piers without removing the superstructure due to the lack of headroom.

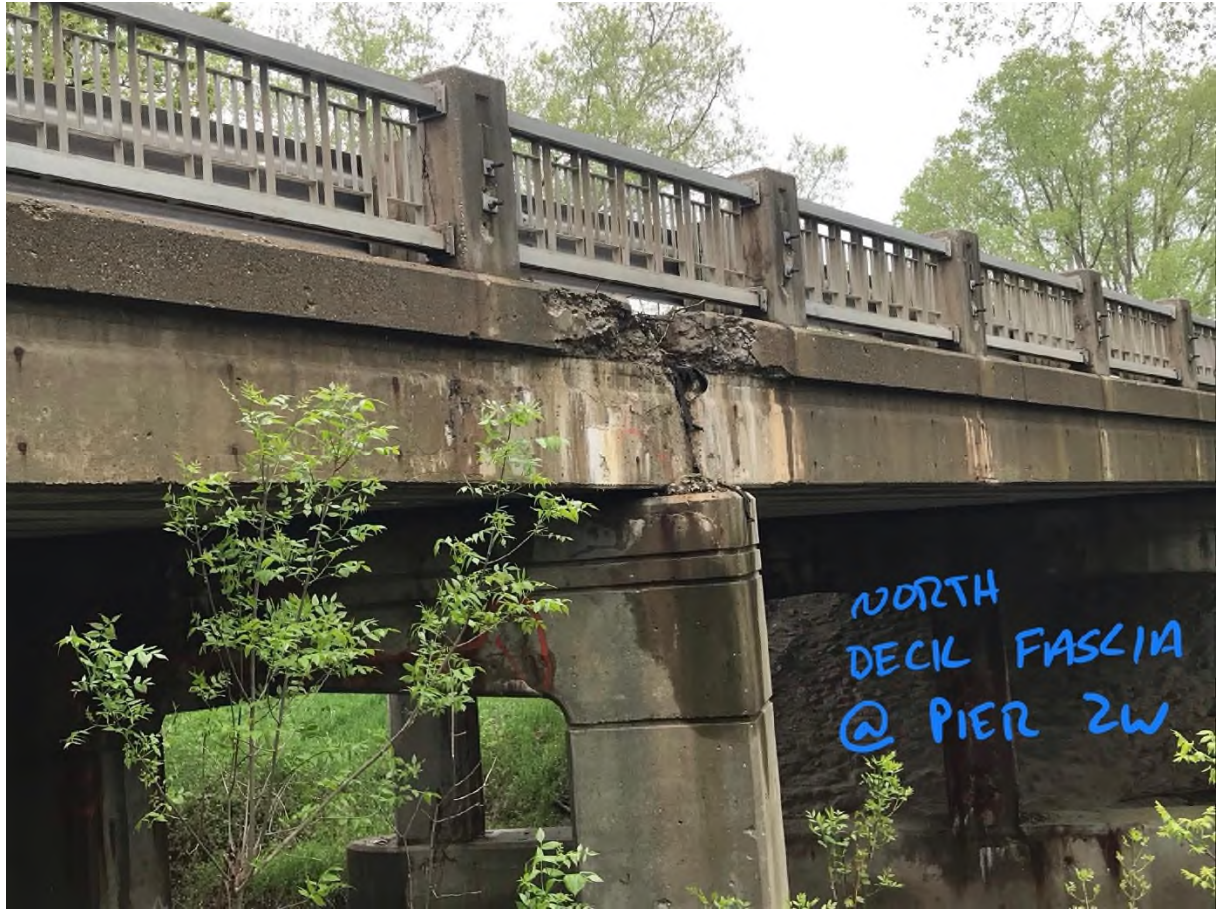
Photo 5—Fascia at the north elevation of the west pier.

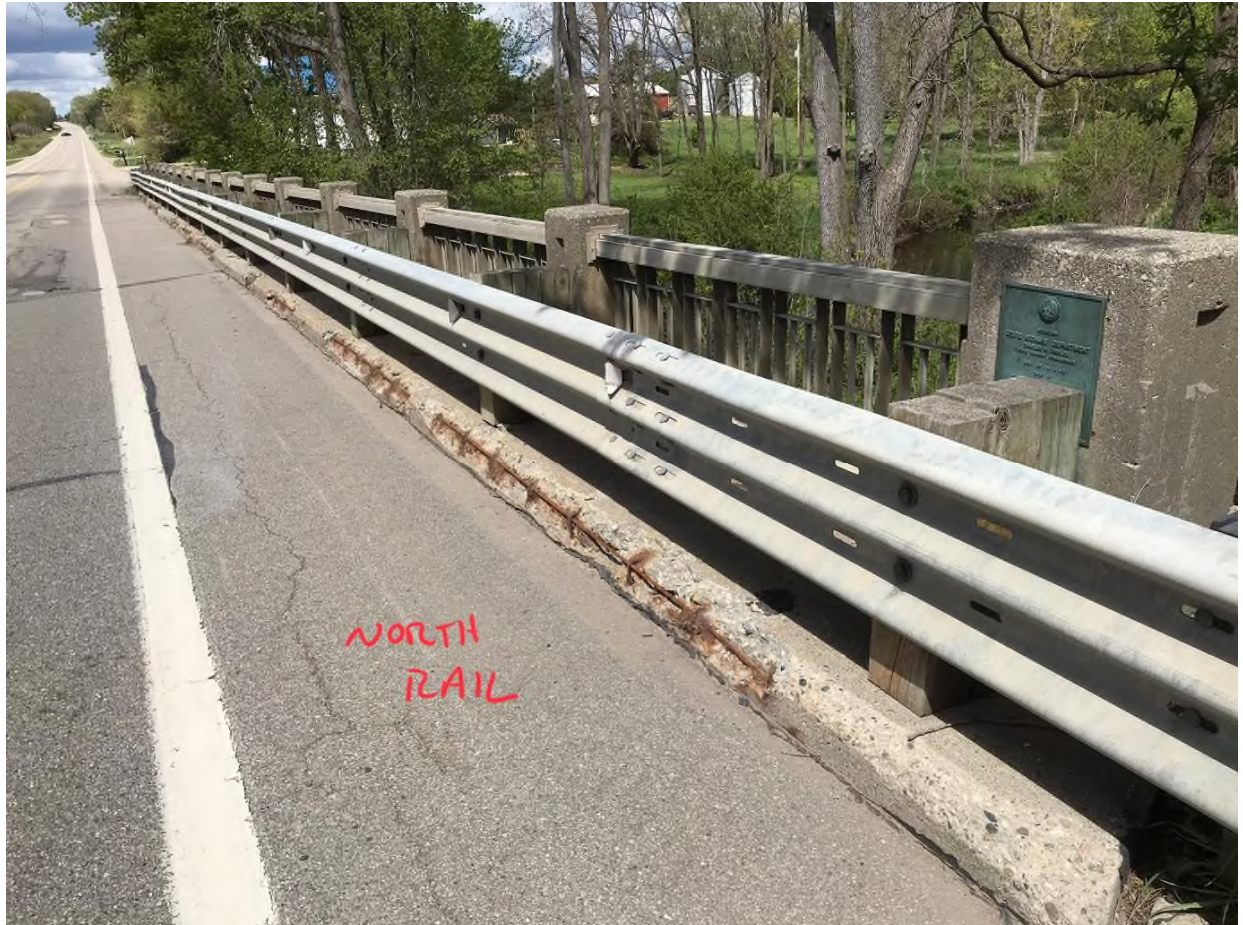
- Structure has been rated as scour critical due to the pier spread footing foundations and the short length of the timber piles at the abutments.
- Steel panel bridge railing with concrete posts and a three beam retrofit has some deficiencies. Most of the concrete posts have cracks and the brush block has extensive cracks with the north railing brush block having approximately 70% of its area with spalled and delaminated areas and exposed reinforcement.

Photo 5—North railing and spalled brush block.
