Approaches to Historic Bridge Rehabilitation

Rehabilitation of the Phalen Park Arch Bridge

Saint Paul, Minnesota

Historic Bridge Rehabilitation Strategies – 3 Project Examples

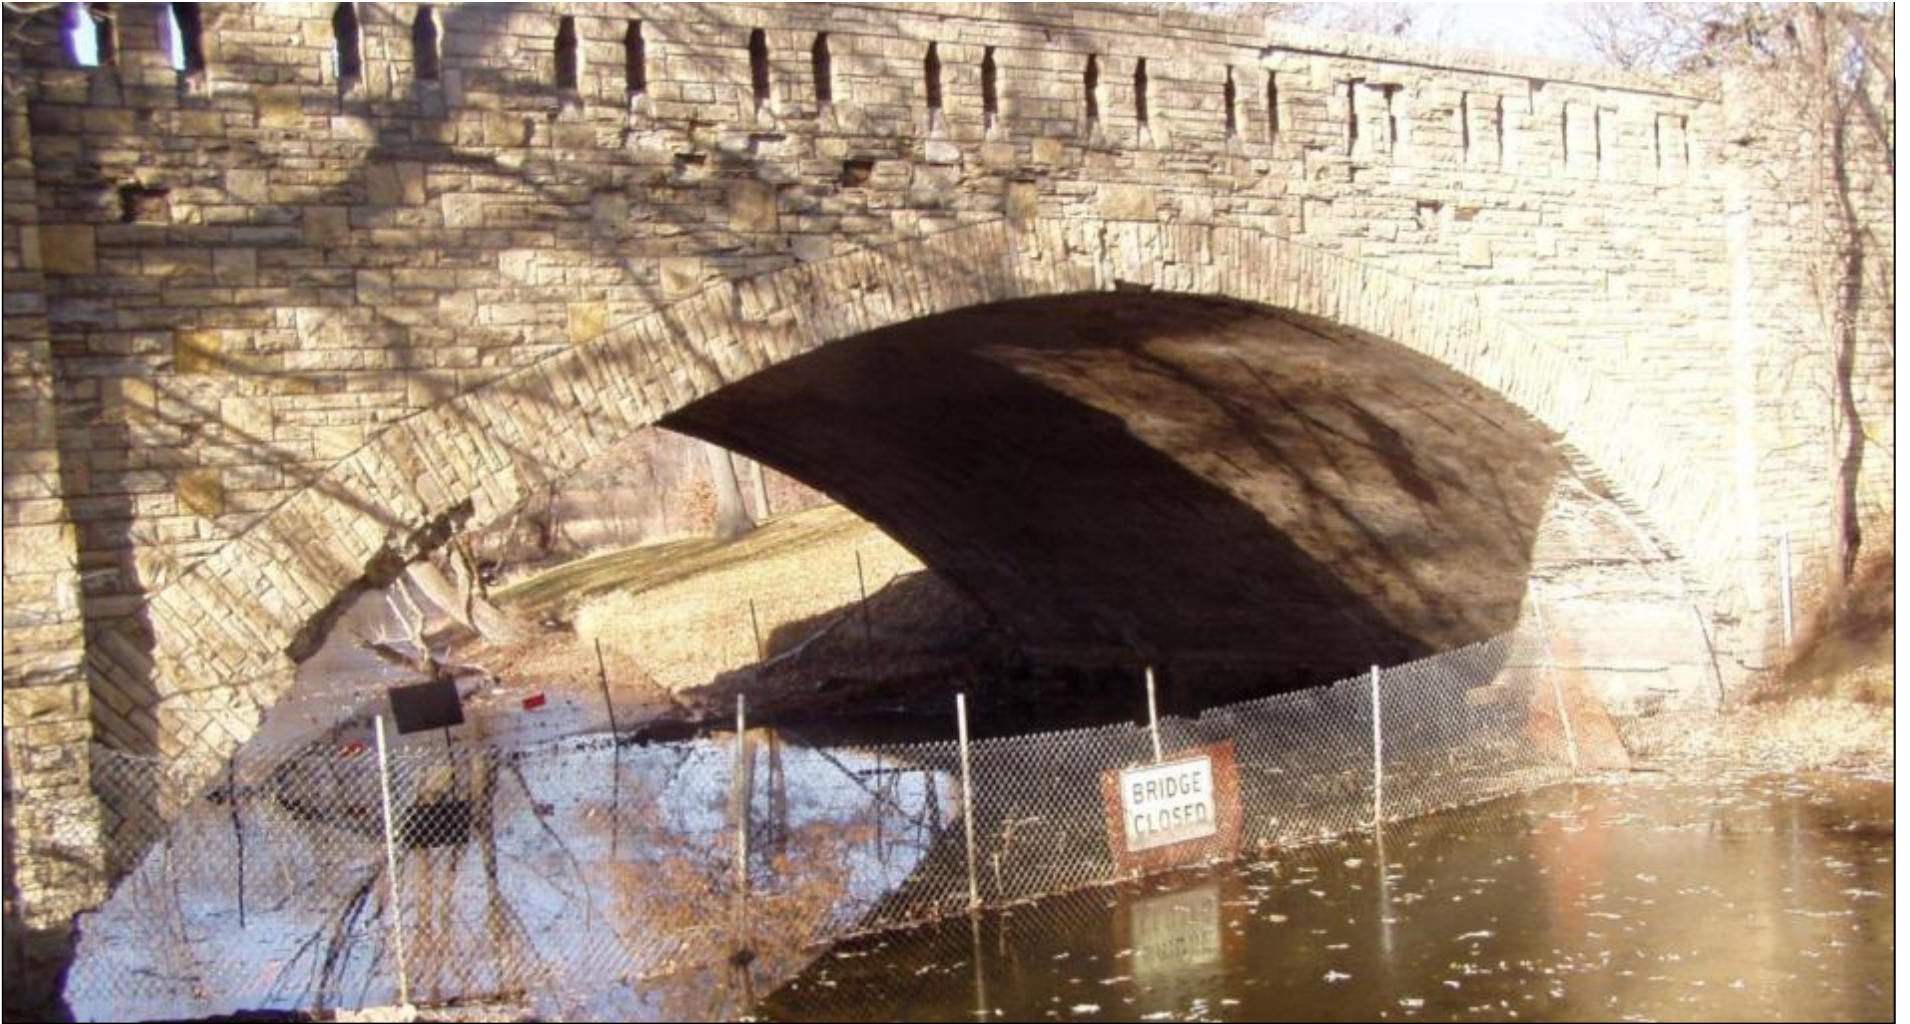
Deteriorated components forced the City to close the waterway below the bridge.

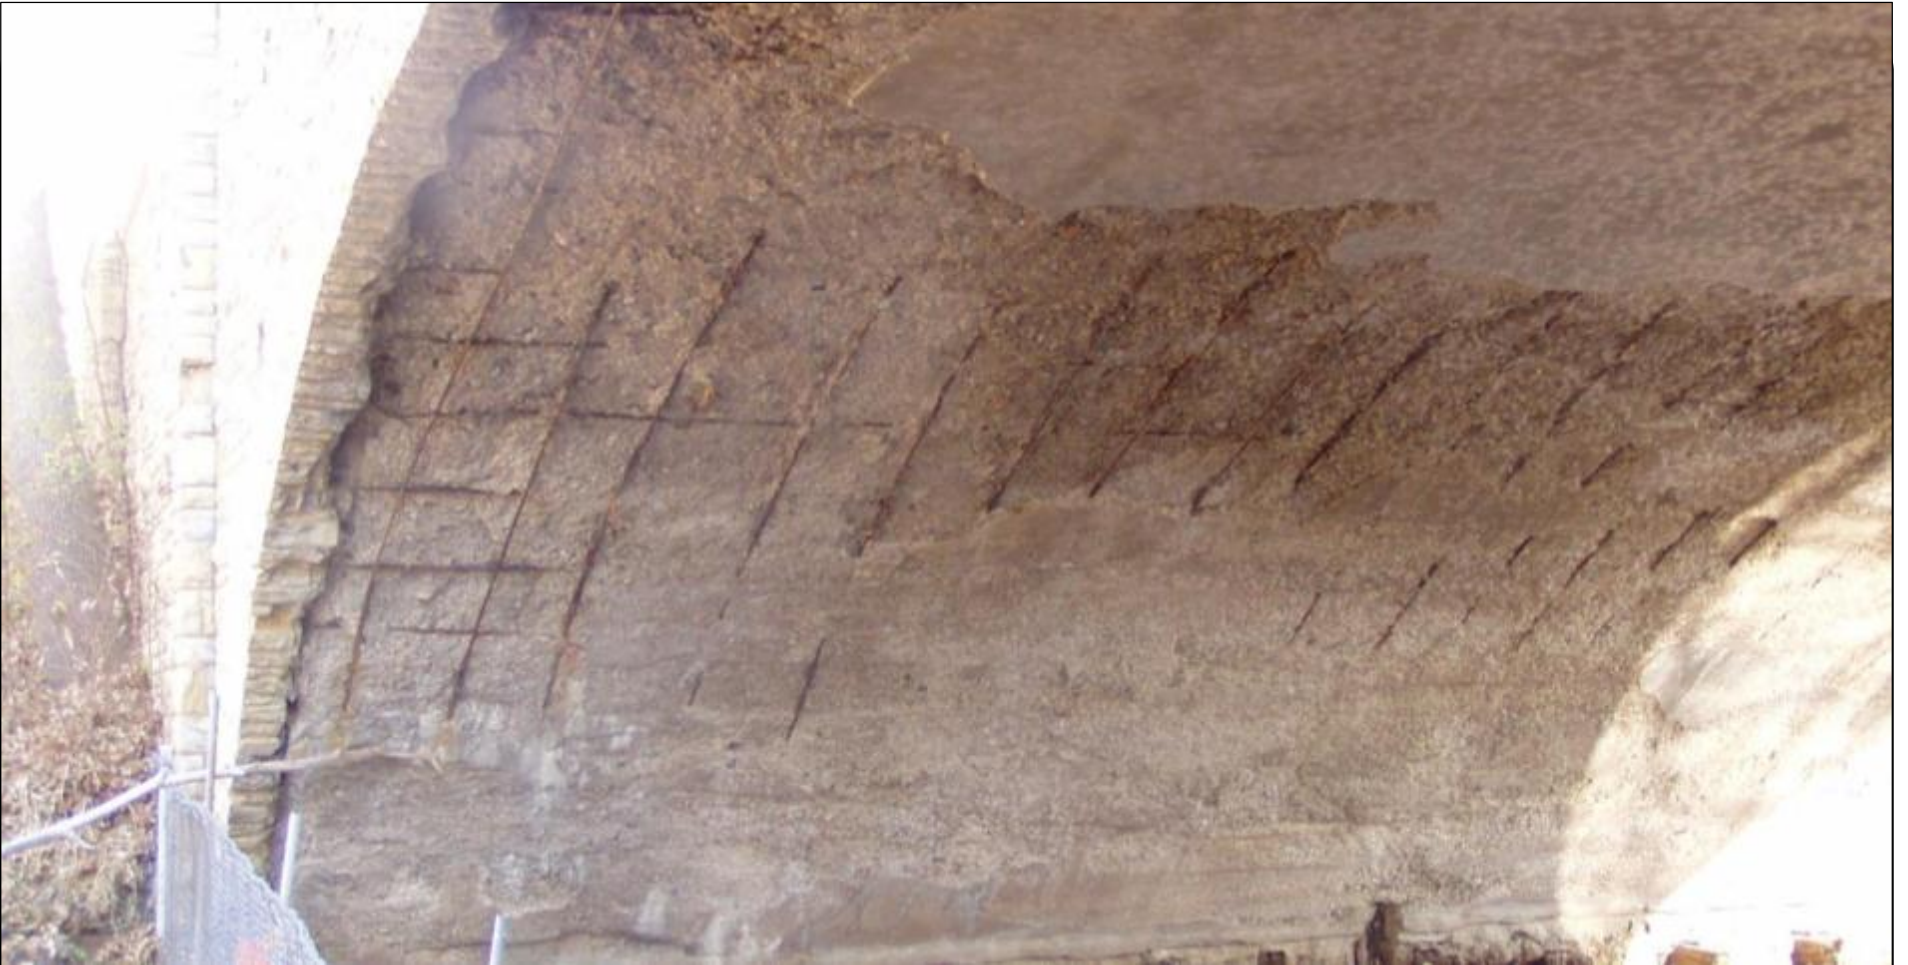
Extensive deterioration of the concrete barrel

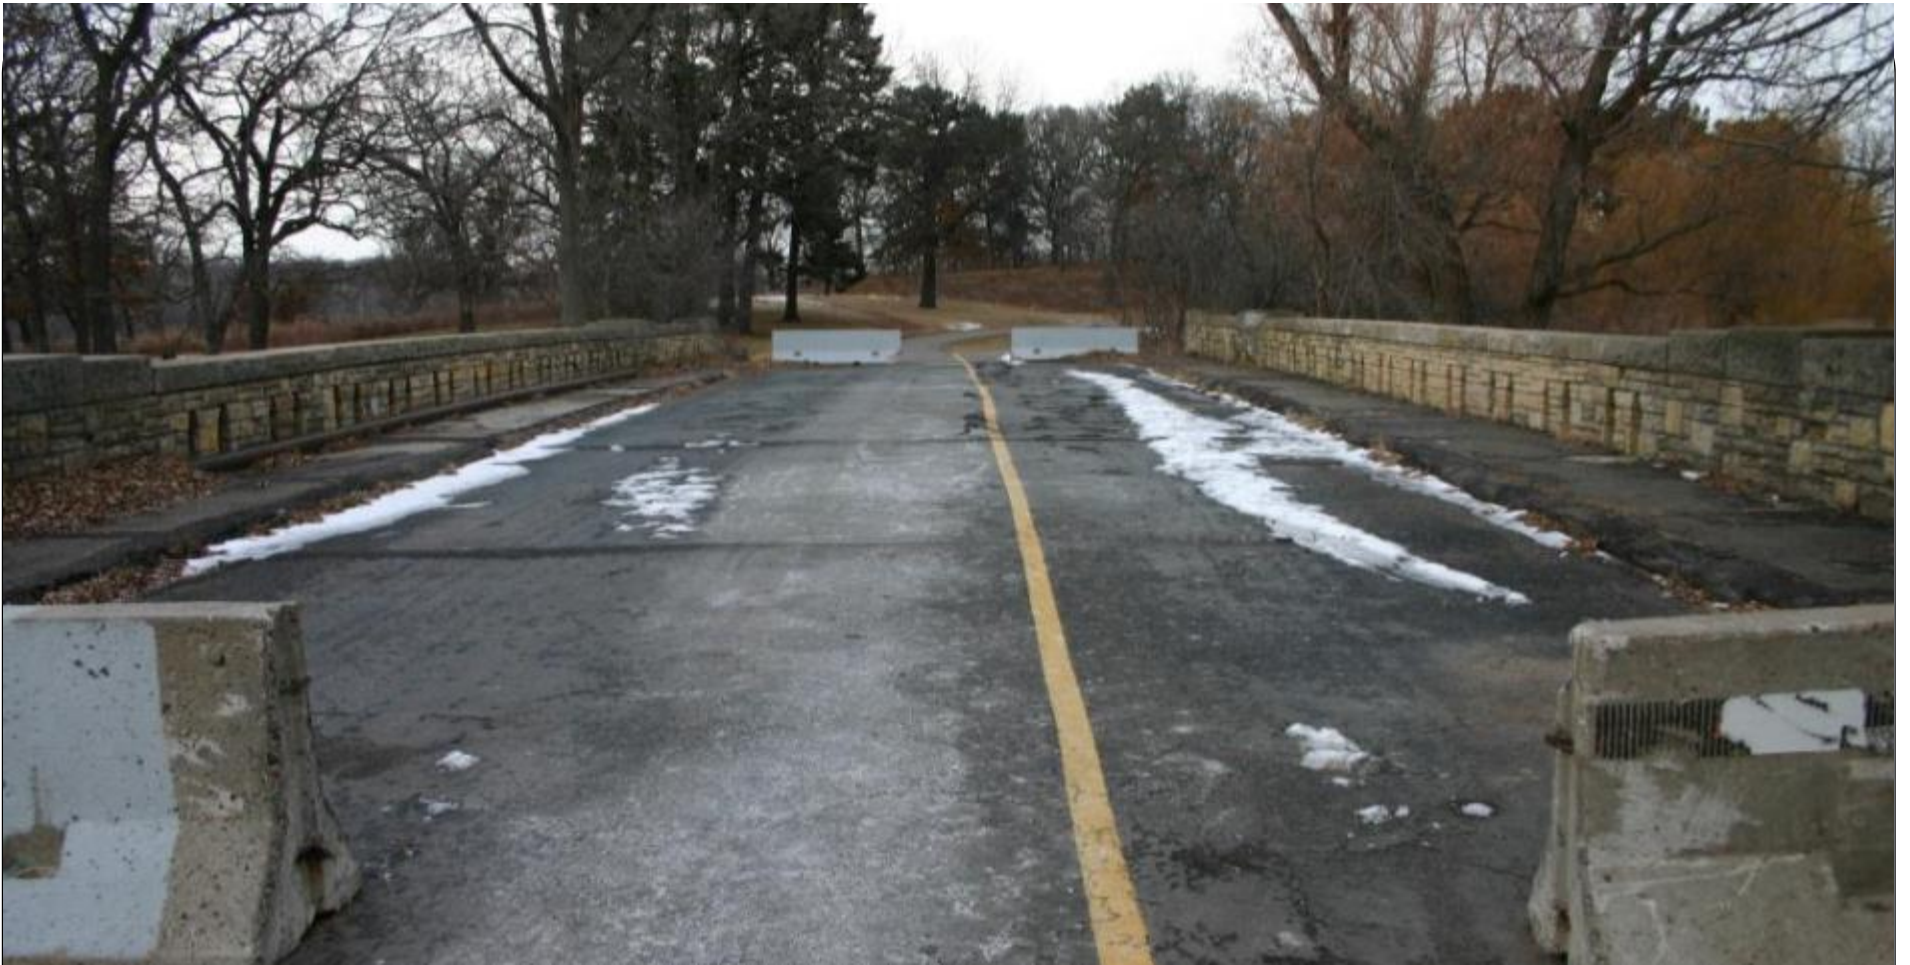
Due to barrel deterioration and deterioration near each edge, no vehicles were permitted on the bridge

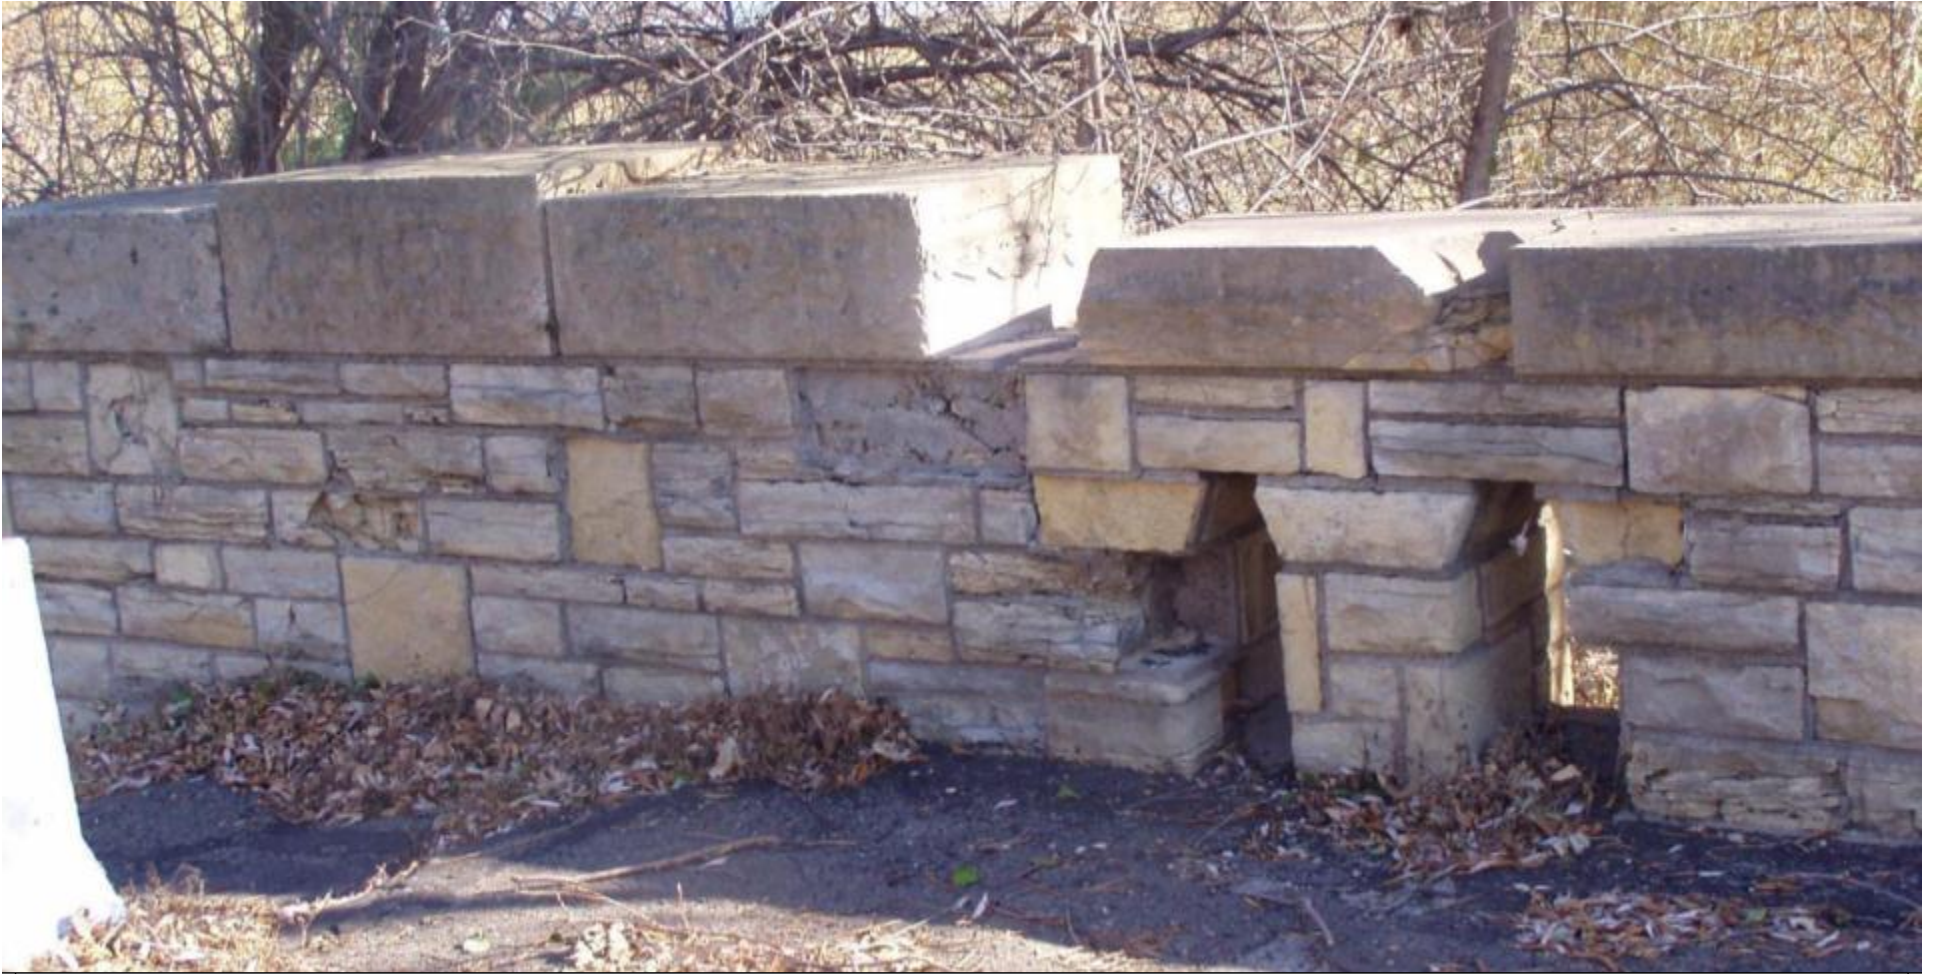
Stone railing was in poor condition. It was too short for current standards and had openings that were too large for current standards.

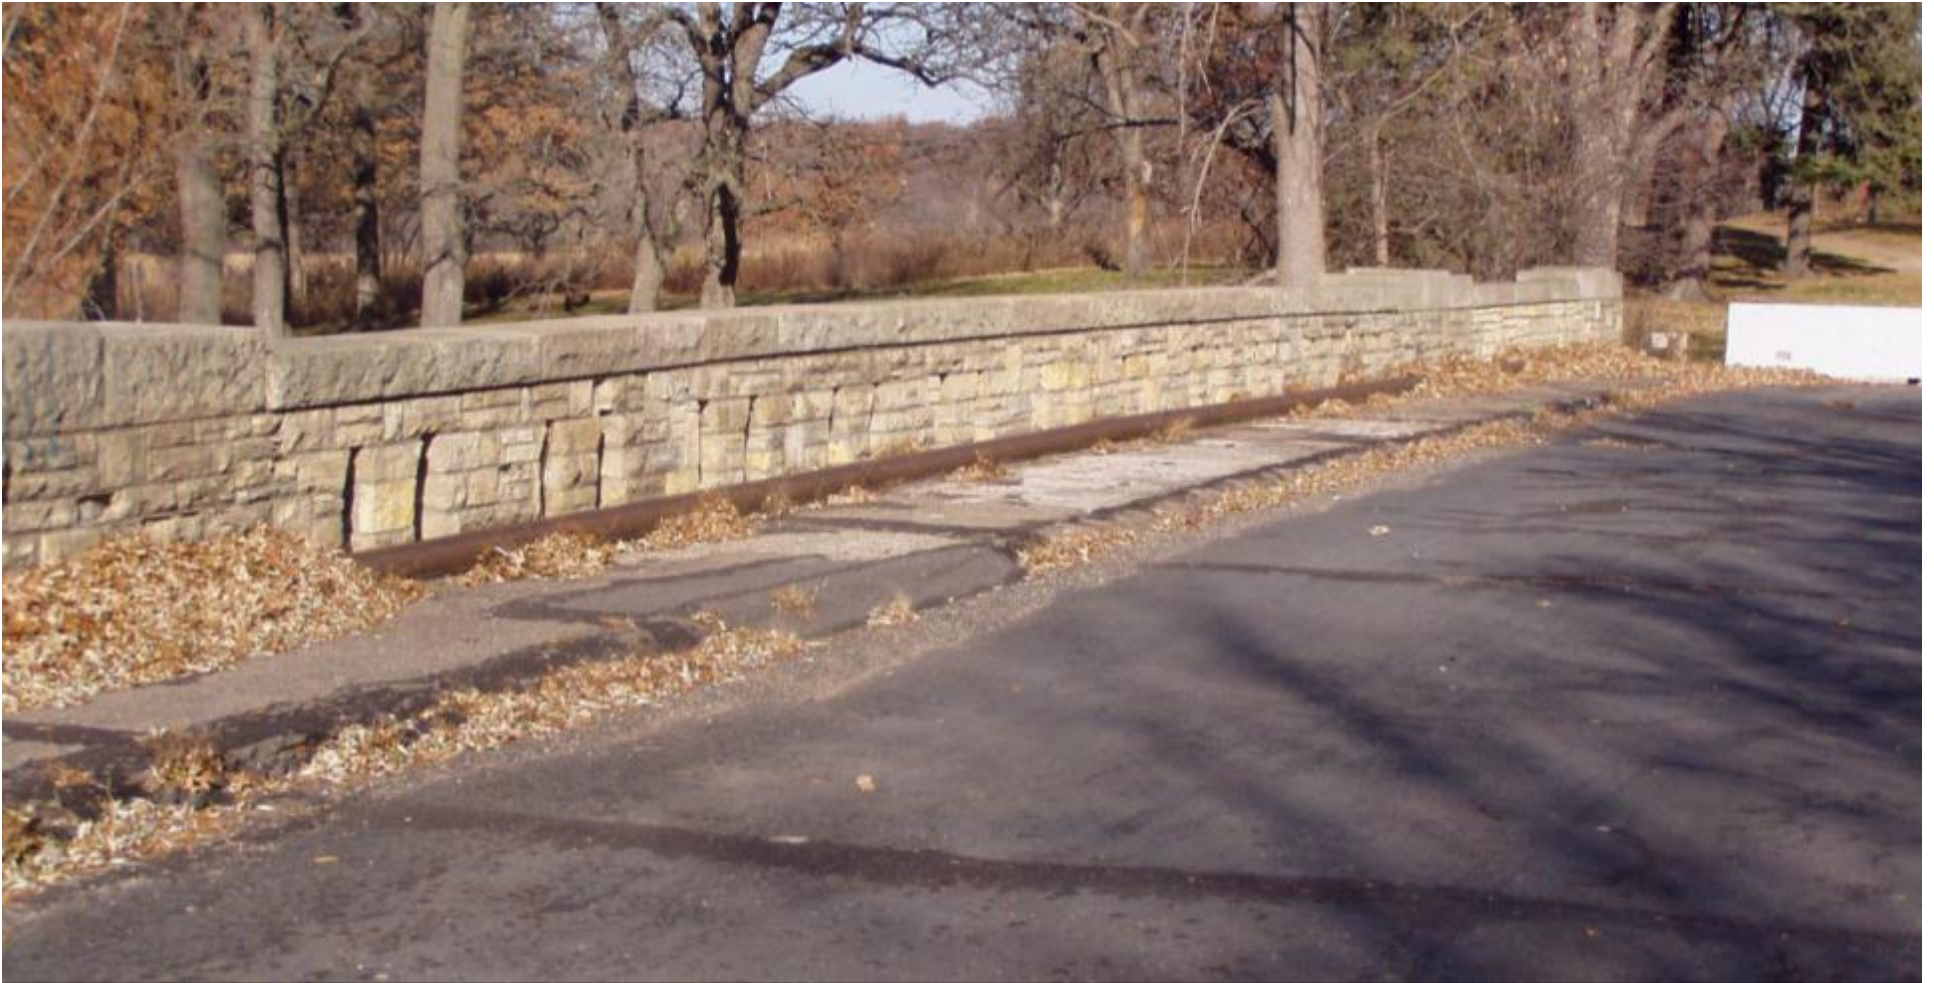
“Pervious” pavement led to the deterioration of the lower bridge components at concrete joints. A water main sat on the west sidewalk.

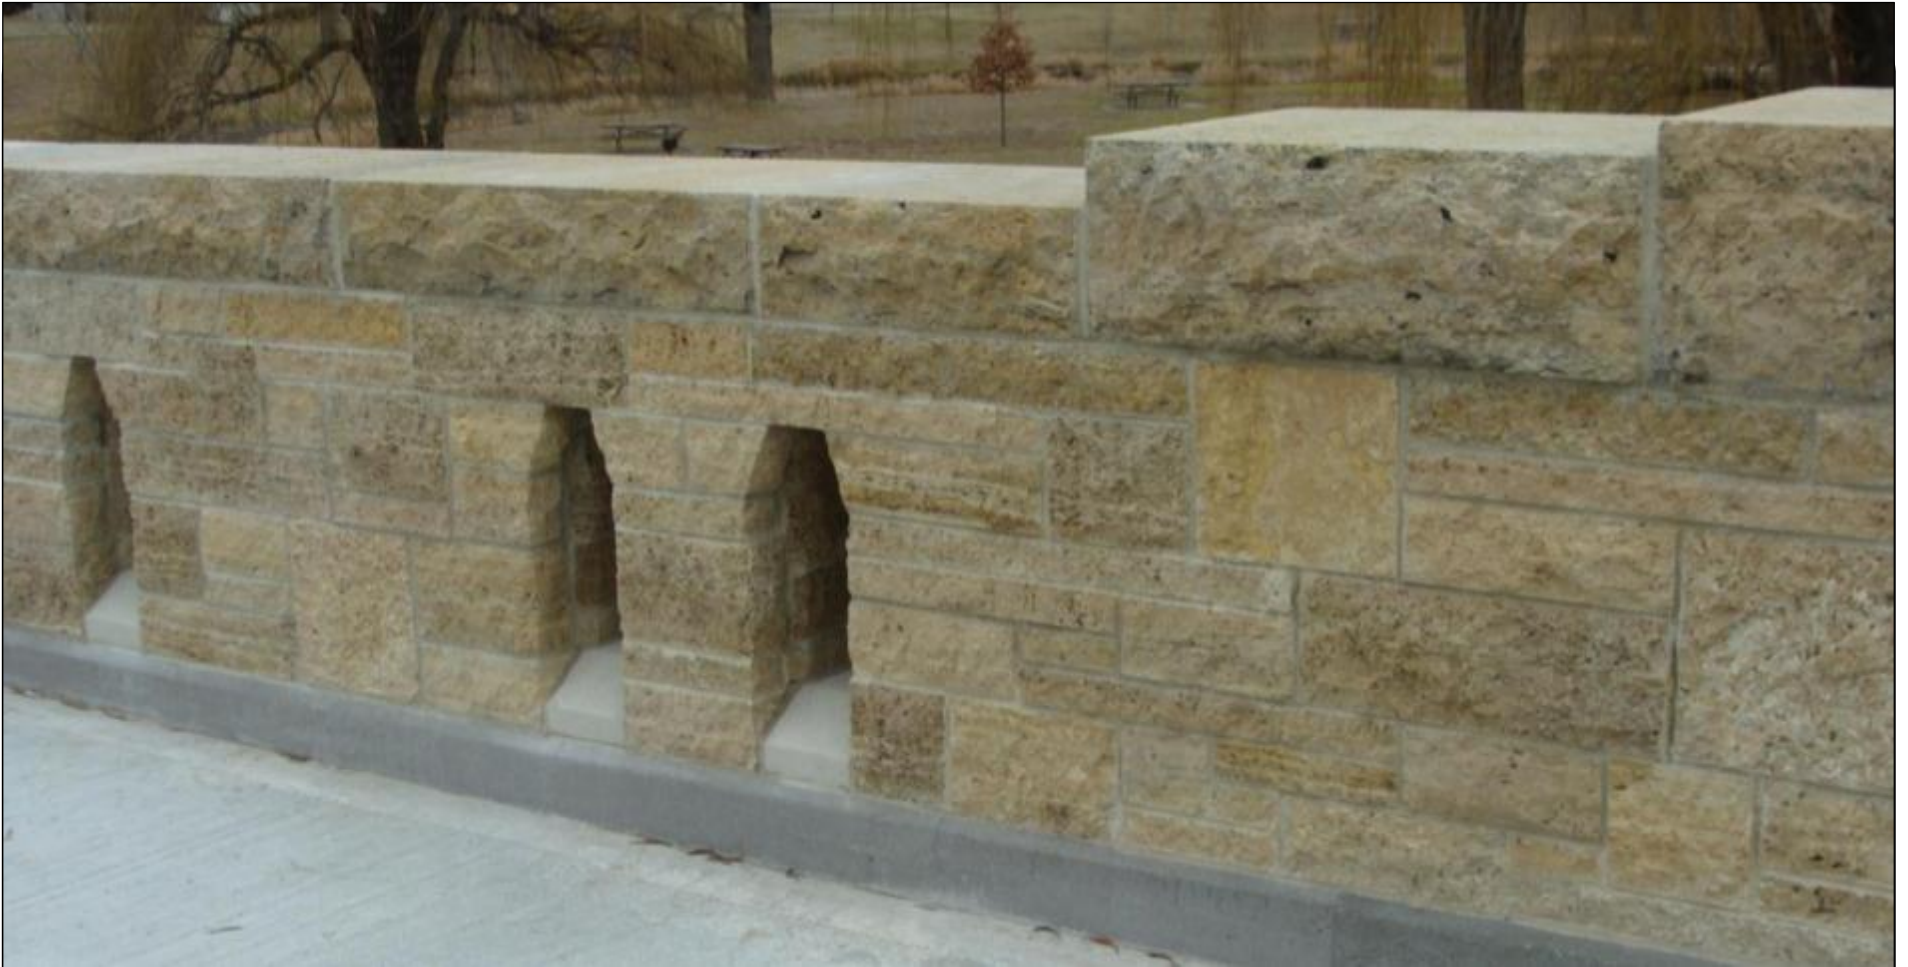
Railing Details

Old opening size “too big” to meet standards. Inner stones pinch in to reduce opening size.

Reused cap stones. Curb integrated into the bottom of the railing for the vertical curve.

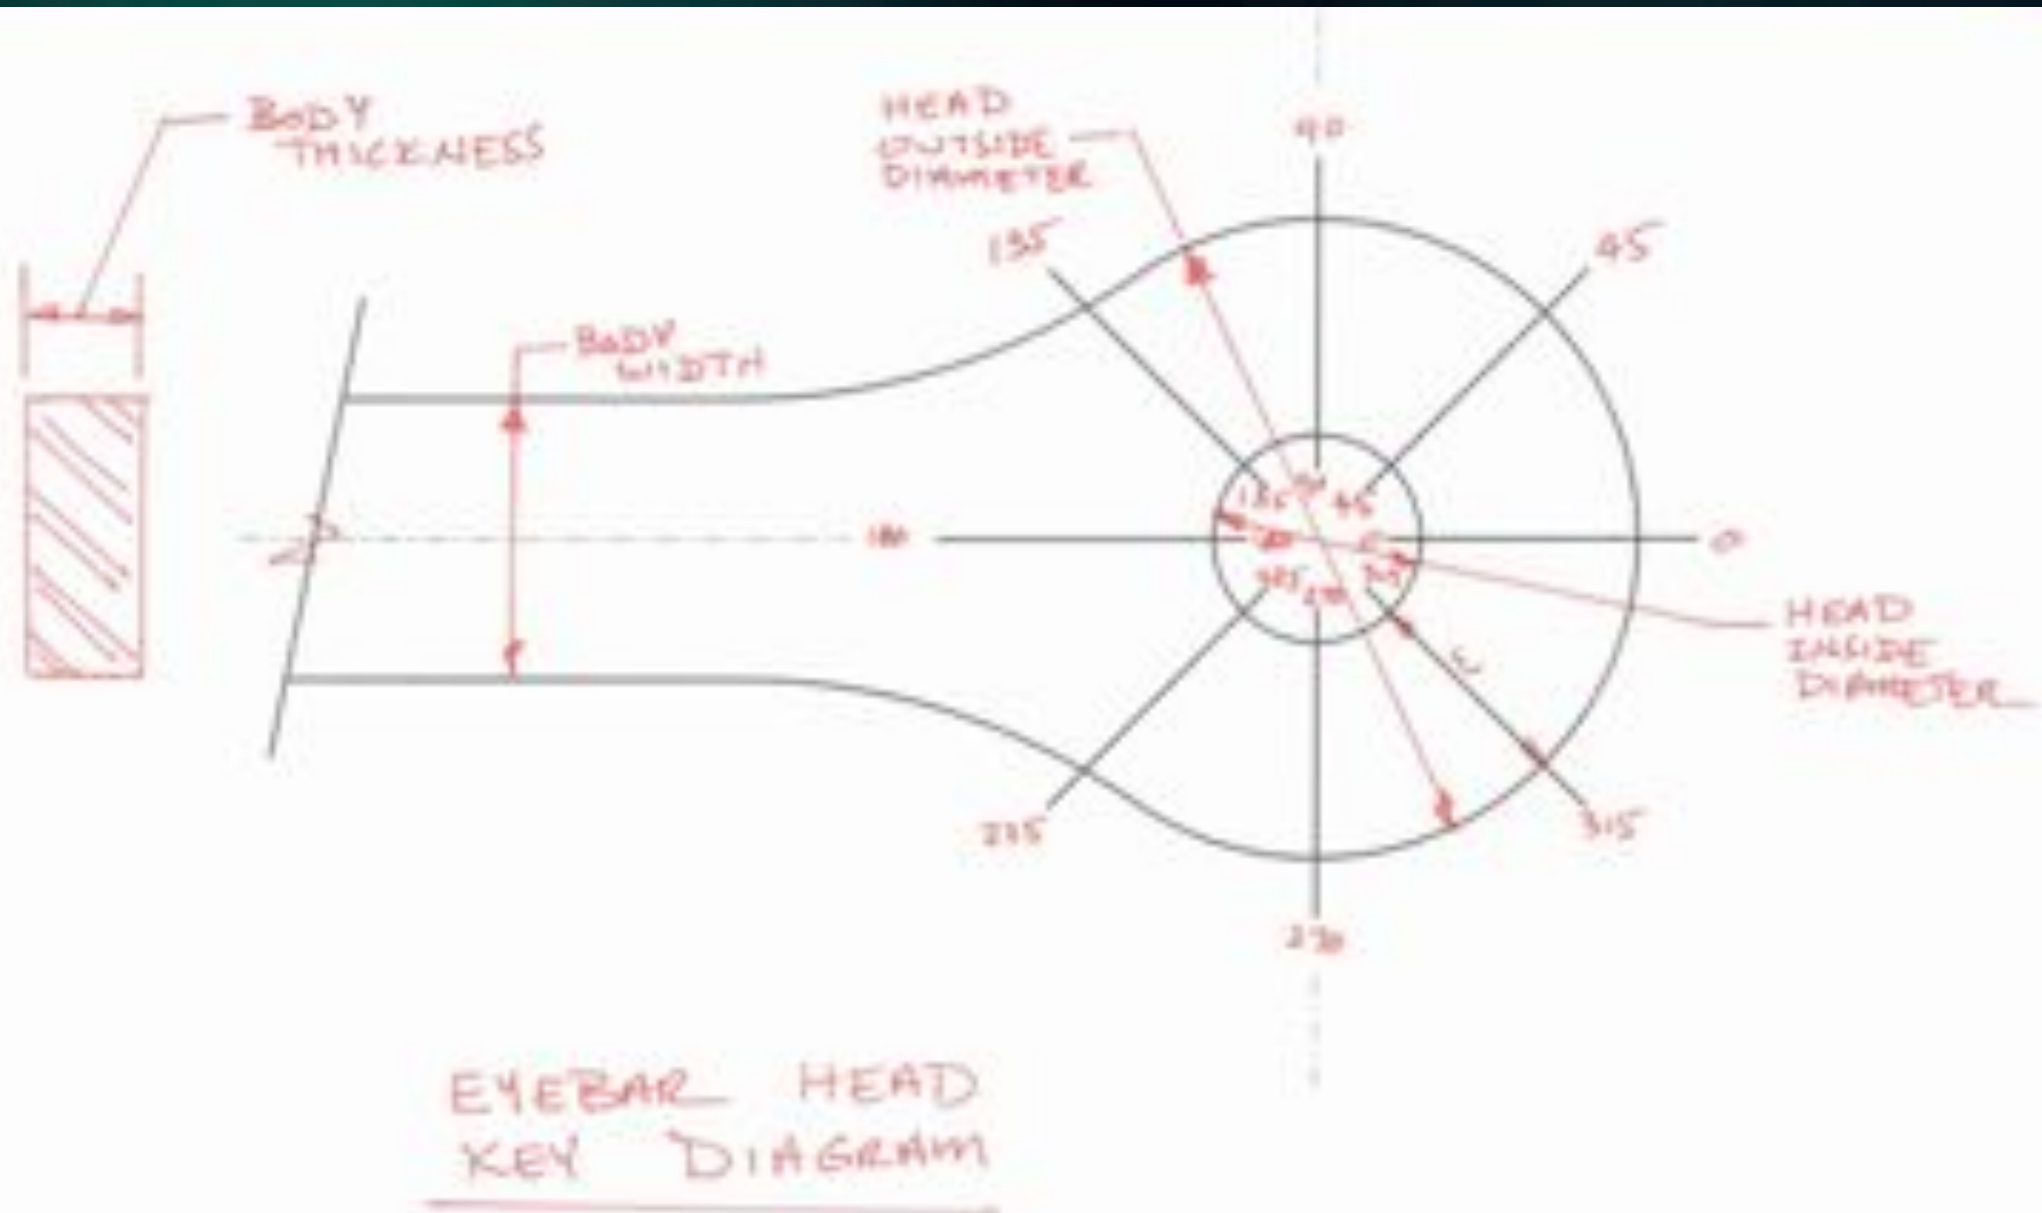
Scan of an eyebar head

- Started out assuming a stress approach would be used
- Conversation with Dr. Galambos
- Computed some stresses with Timoshenko equations. But what is an acceptable stress?
- Reversed course and ended up using a geometric criteria based on AASHTO/AISC specs
 - Area at the sides needs to be at least 135% of body area
 - Area behind pin needs to be at least 75% of body area

90-90 - 1" wide x 1/2" wide gitting x 1/8" deep; 0-0 2" transverse to body x 2" along body x 1/8" deep; diameter at 0-0 is 3-5/16"
