# Sewalls Falls Bridge 2012 In-Depth Inspection

Prepared for the  
**CITY of CONCORD, NEW HAMPSHIRE**  
**ENGINEERING SERVICES DIVISION**

March 2012

## **SEWALLS FALLS BRIDGE** **2012 IN-DEPTH INSPECTION**

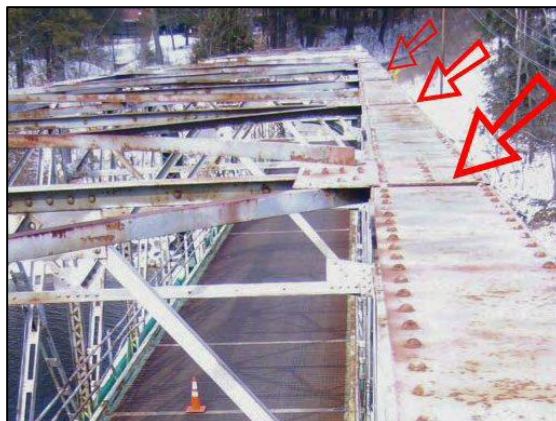
**Figure 7: Typical horizontal gusset plates along upper chord (Span 1 Right Truss shown)**

Above the travelway, no deficiencies were observed in any upper truss panel point gusset plates or member connections; however, the top chords of the truss exhibit minor deterioration in their top plates due to crevice corrosion ("pack rust"). This corrosion is typically present between the horizontal bracing gusset plates and the top plates of the upper chords at each panel point (see Fig. 7). These were not accessible for direct measurement, but pitting is typically visible along and just under the edges of the horizontal gusset plates. Based on what is visible, a conservative estimate of 33% section loss in the top plates of the upper chords is recommended for load rating purposes. Because this loss typically occurs over very short lengths along the member ( $<1"$ ), it applies only to local bearing/compression stress, and not to slenderness or buckling modes of analysis. No losses were evident in the channel components of the chords, so the resulting weighted maximum effect of the top plate losses on the gross section is 12% for the section with the lightest channels (chord members U1U2 and U7U8). See Photos 1 through 4.

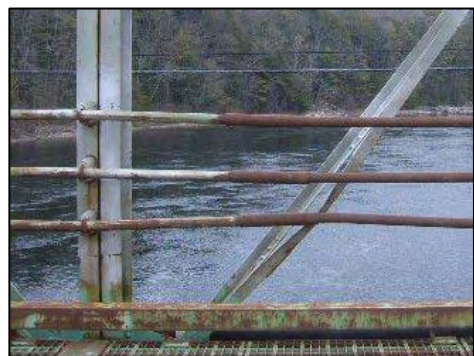
**Figure 8: Truss member impact damage**

Along the travelway envelope, numerous truss members exhibit impact damage in the form of large-scale twisting and out-of-plane deformations in numerous truss diagonals (Fig. 8).

Much of the worst structural damage coincides with bridge railing damage, and appears consistent with typical impact damage from a snowplow blade. Also, there are numerous small dents and localized bends in various projecting member legs and flanges. No cracks or tears were observed in any truss component. See Table 1 for a detailed summary of observed impact damage to truss members, with photo references.

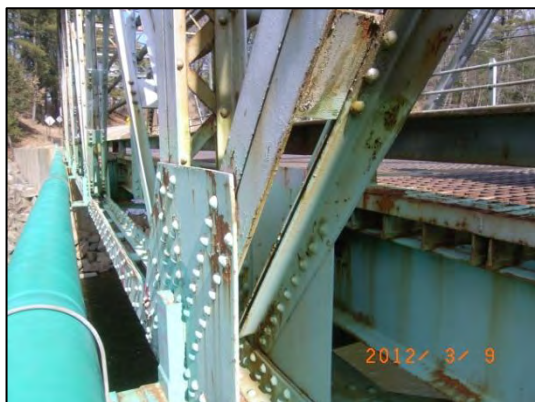
Figure 9: Typical lower chord gusset plate conditions (Span 2 Left Truss at L3).

Truss gusset plates are typically in good condition throughout, with generally minor and/or localized non-critical corrosion and section loss. Most have minor distortions along the upper edges due to pack rust at the truss verticals and diagonals, and in some cases due to

distortions carried into the plates from the most severely impact-damaged diagonals. If the trusses are to remain in service, removal of selected distortions should be considered. Most of these locations are where the degree of pack rust and/or impact damage would already warrant disassembly and cleaning of the connection.

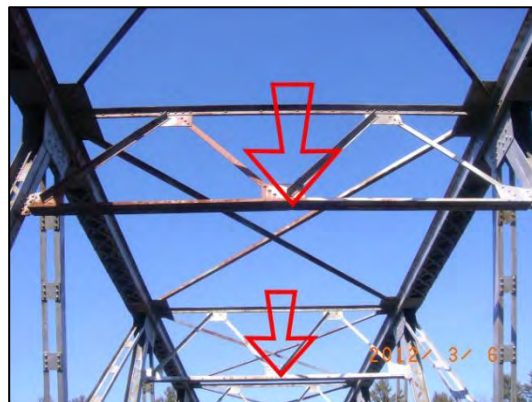
Figure 9: Damaged sway-bracing chords

Along the bridge centerline there is evidence of impact damage resulting from an over-height vehicle or load hitting the lower chord of the transverse sway bracing (Fig. 9). No impact damage was observed at the "portal" bracing at each end of each of the truss spans. At the intermediate

sway bracing, several low chords exhibit minor to moderate bends, with little effect on other components, including connections to the corresponding truss verticals. No cracks or tears were observed in any of these components. See Table 2 for a summary of maximum longitudinal displacements of these chords, with photo references.

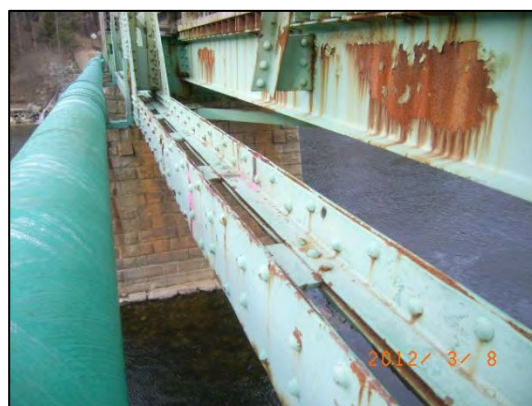
Figure 10: Typical truss bottom chord

Along the truss bottom chords, there is intermittent crevice corrosion and section loss in each truss panel (Fig. 10). Some panels have their worst losses at the panel point gusset plates, others occur between panel points. The greatest section losses found among all truss bottom chords was 27% on Span 1 Right Truss member L0L1. Similar losses were encountered at Span 1 Left Truss member L6L7 (26% SL); and Span 2 Left Truss member L2L3 (26% SL). See Table 2.

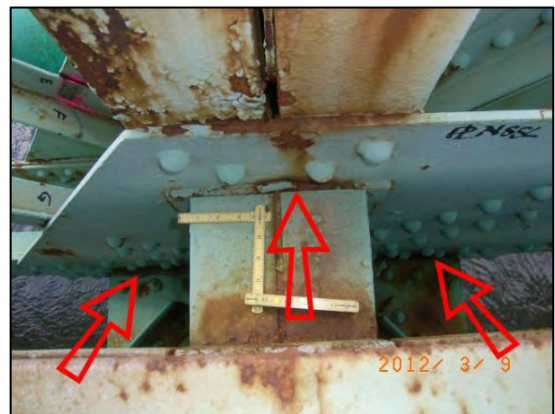
Figure 10: Typical pitting lines, from top

Also along the bottom chord, most inboard truss gusset plates have a line of deep pitting and active corrosion just above the intersection with the horizontal gusset plates for the lower lateral (under-deck) bracing. This is located in a horizontal plane corresponding to the centerline of the intersecting bottom chord members, with connecting rivets above and below the pitting - so that the chord member itself effectively knits the gusset plate across the pitted zone. This condition is considered as not seriously compromising the truss. Similar localized pitting occurs where the tops of the floorbeams intersects the inboard plates. In these locations, the truss verticals similarly knit the gusset plate across the pitted regions. See Figure 12.

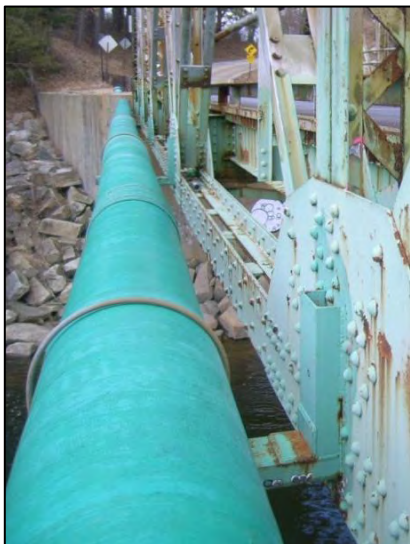
Figure 11: Utility brackets welded to gusset plates (Left side shown, Right side similar)

Finally, almost all bottom chord gusset plates have utility support brackets welded to the outboard plate, along both sides of the bridge. These brackets support a municipal sewer line along the left (upstream) side of the bridge, and a natural gas main on the other. Each bracket has a vertical leg welded directly to the outboard truss gusset plate with intermittent field-made fillet welds. No cracked or broken welds were observed in these connections; however, these welds compromise the gusset plates, the truss, and thus each entire span by creating points of stress concentration, introducing potential point sources for propagation of fatigue cracks, and altering the old gusset plates metallurgically due to the heat of welding. If the existing trusses are to remain in service, removal and post-removal testing of these welds should be considered as part of any superstructure repair scheme.

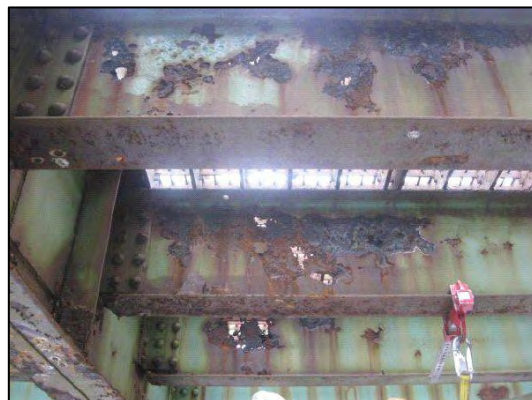
Figure 12: Stringer deterioration (from 2011 NHDOT (Draft) Inspection Report, Image No, D077-28)

Stringer beams typically exhibit moderate to serious deterioration throughout the bridge, with few instances of severe deterioration (Fig 14). All 144 stringers were assessed on a binary basis to distinguish between members with or without relatively obvious severe deterioration. As these members were inspected through the open grating deck rather than hands-on, our assessment is mostly qualitative, with only a rough and not necessarily complete estimation of the magnitude of deterioration. See Table 3 for a summary of findings.

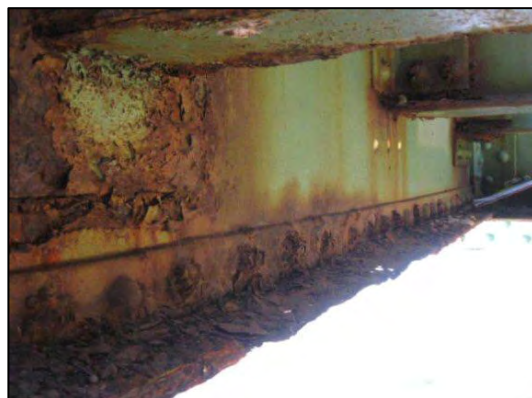
Figure 13: Floorbeam deterioration (from 2011 NHDOT (Draft) Inspection Report, Image No, D077-62)

Floorbeams typically exhibit moderate to serious deterioration throughout the bridge, with few instances of severe deterioration (Fig 15). All 16 floorbeams were assessed on a binary basis to distinguish between members with or without relatively obvious severe deterioration. As these members were inspected through the open grating deck rather than hands-on, our assessment is mostly qualitative, with only a rough and not necessarily complete estimation of the magnitude of deterioration. See Table 4 for a summary of findings.

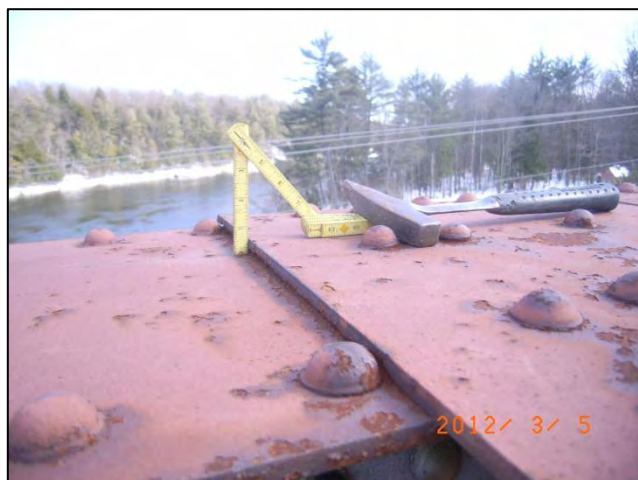
Photo 1: Span 1 Right Truss at U1: Pack rust at top chord and bracing gusset plate <12-0042>

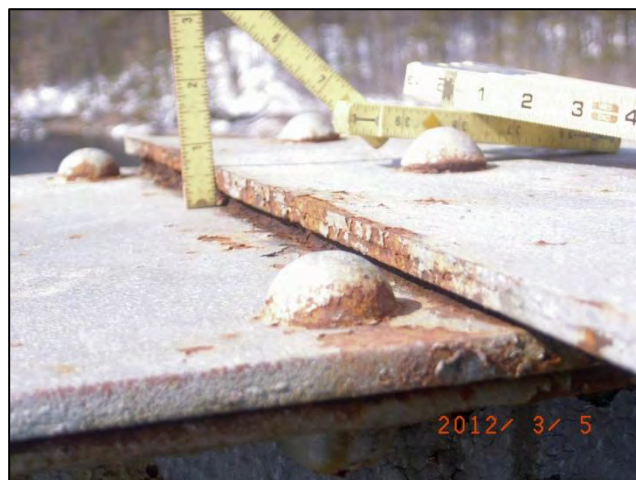
Photo 2: Span 1 Left Truss at U6: Pack rust at top chord and bracing gusset plate <12-0033>

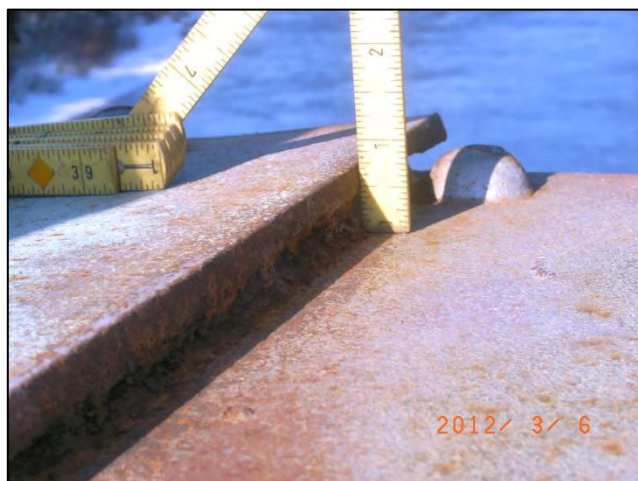
Photo 3: Span 2 Left Truss at U1: Pack rust at top chord and bracing gusset plate. <12-0066a>

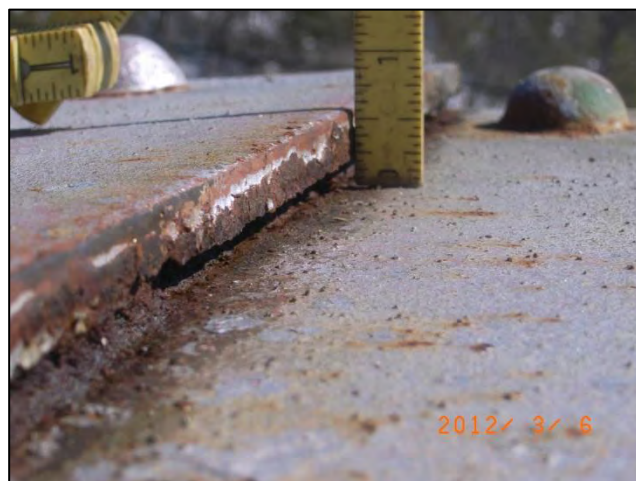
Photo 4: Span 2 Right Truss at U7: Pack rust at top chord and bracing gusset plate. <12-0105>

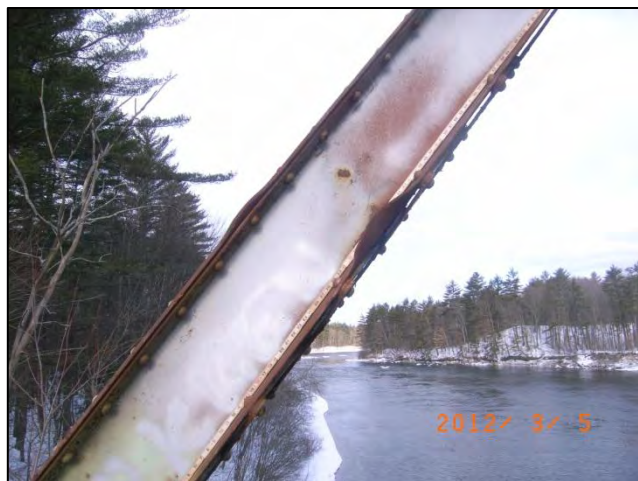
Photo 5: Span 1 Left Truss at L0U1: Localized impact damage <12-0003>

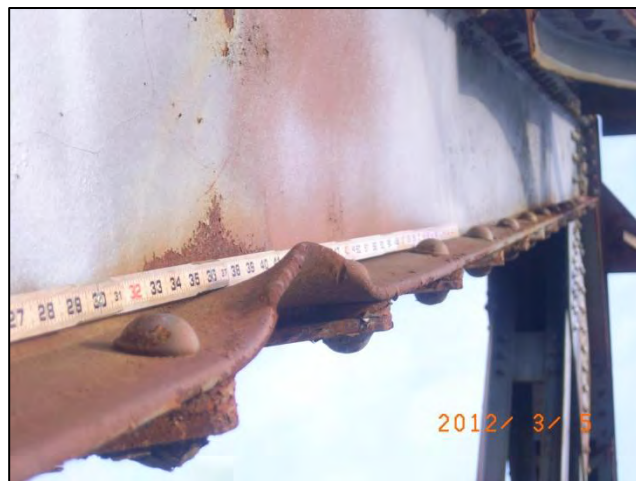
Photo 6: Span 1 Left Truss at L0U1: Localized impact damage <12-0004>

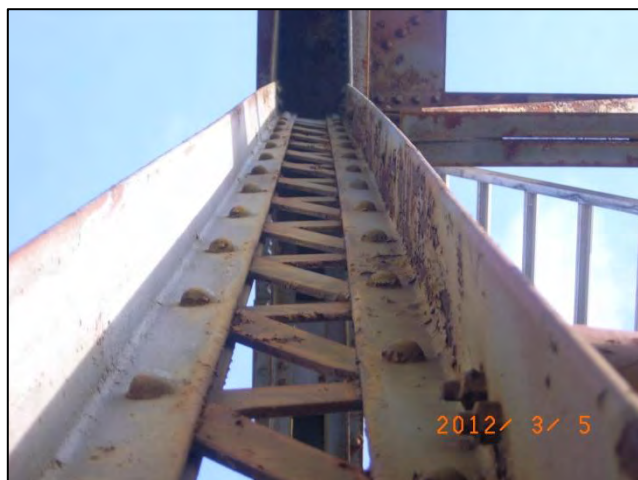
Photo 7: Span 1 Left Truss at U2L2 (Begin side looking up): Impact damage: axial rotation <12-0008>

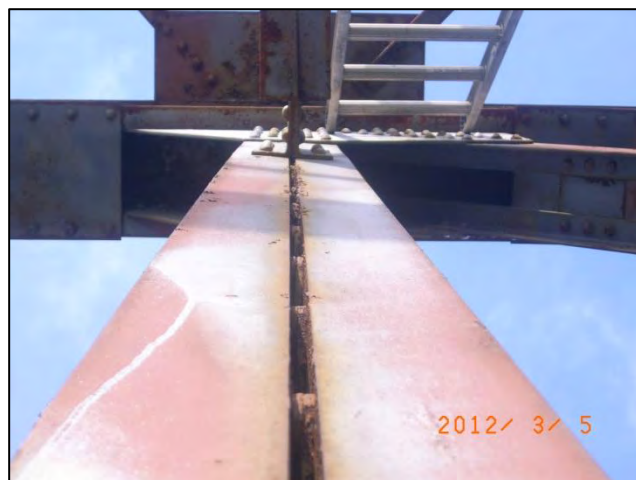
Photo 8: Span 1 Left Truss at U2L2 (Right side looking up): Impact damage: axial rotation <12-0009>

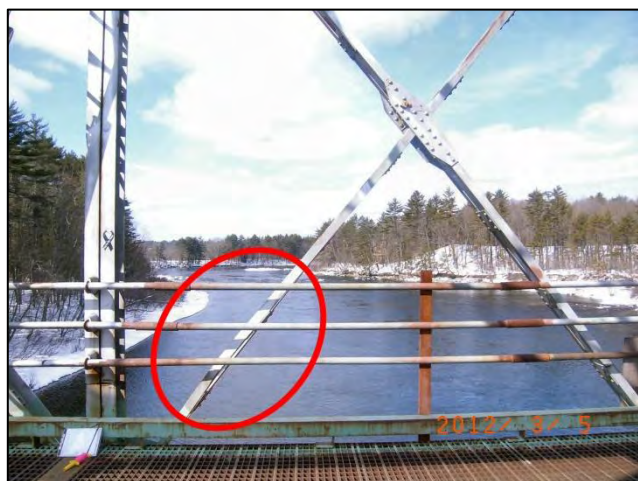
Photo 9: Span 1 Left Truss - L1U2: Impact damage. <12-0016a>

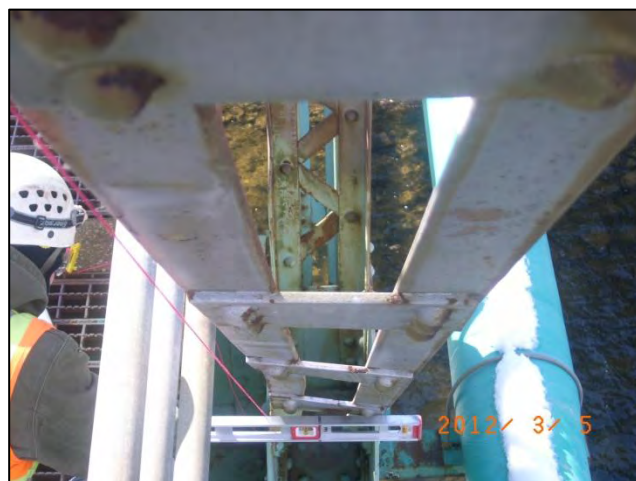
Photo 10: Span 1 Left Truss - L1U2: Impact damage. <12-0019>

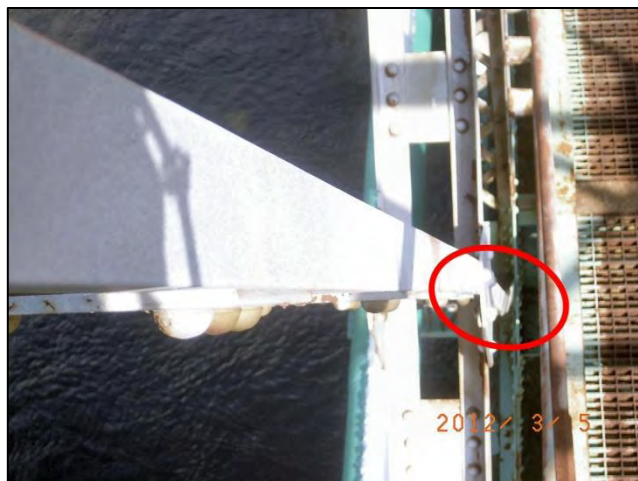
Photo 11: Span 1 Left Truss at U5L6: Impact damage in lower half, looking from U5 <12-0024a>

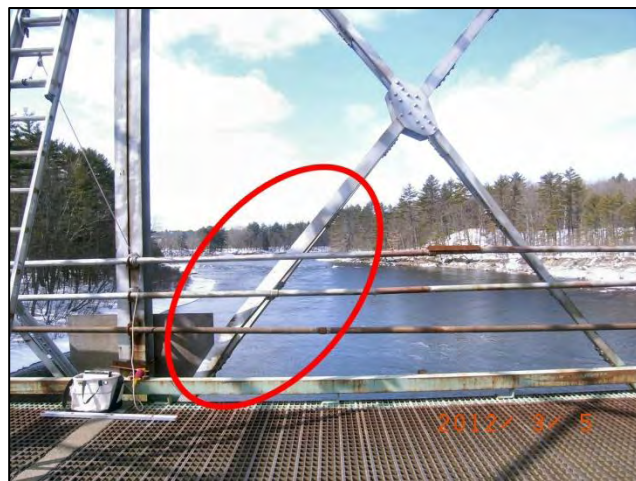
Photo 12: Span 1 Left Truss - L5U6: Impact damage <12-0030>

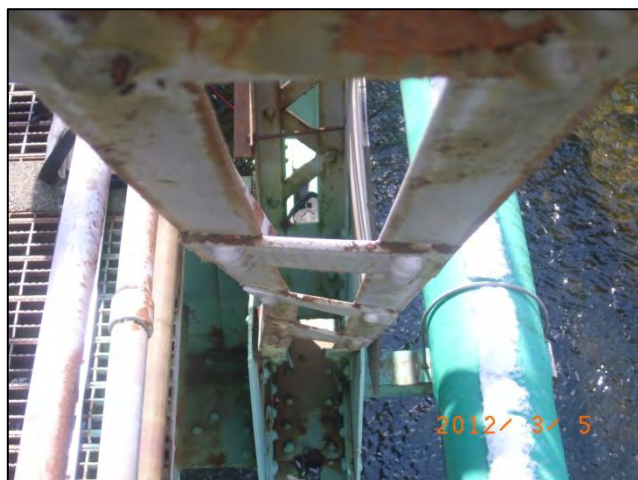
Photo 13: Span 1 Left Truss – L5U6: Impact damage in lower half of member <12-0031>

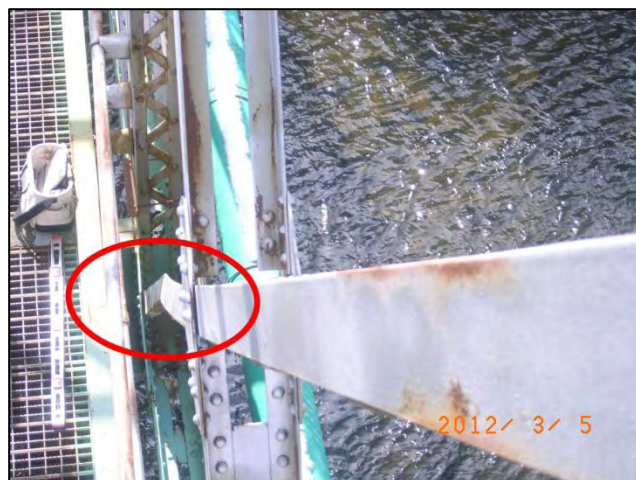
Photo 14: Span 1 Left Truss – L5U6: Impact damage looking back from U6 <12-0032a>

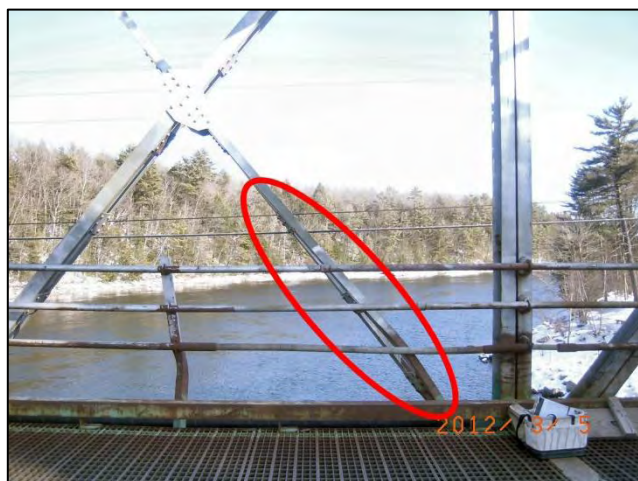
1	Right	L1U1	Local damage only: Inboard railing bracket is detached and the angle leg is bent ½" over 6" length.			At rail post connections.	(None)
1	Right	L3U4 Inboard Member	5¼"	2¼"	21° CCW	4.5' to L3	Photos 15, 16 <12-0047a, 48>
1	Right	L3U4 Outboard Member	⅜"	1⅜"

Photo 15: Span 1 Right Truss - L3U4: Impact damage <12-0047a>

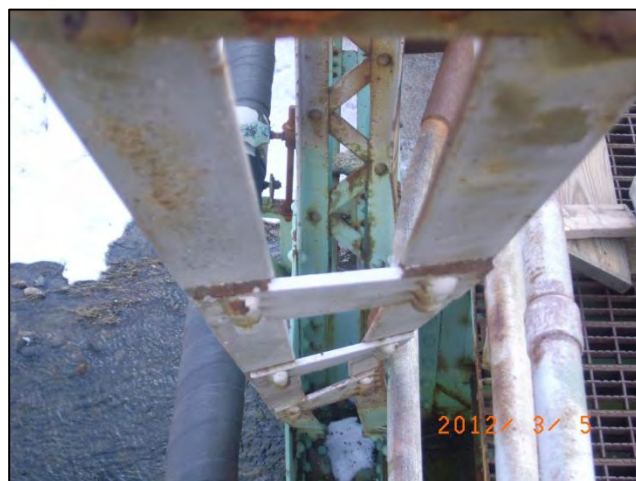
Photo 16: Span 1 Right Truss – L3U4: Impact damage in lower half, looking toward L3 <12-0048>

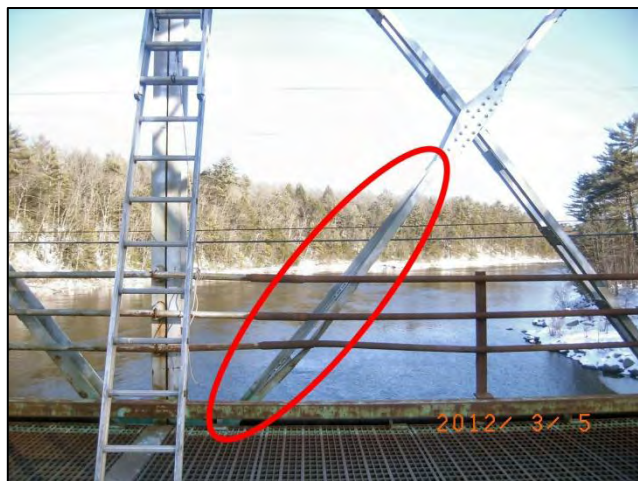
Photo 17: Span 1 Right Truss – U4L5: Impact damage <12-0053a>

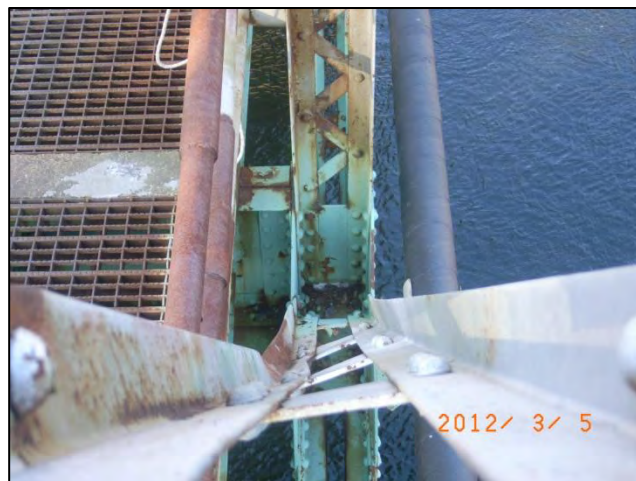
Photo 18: Span 1 Right Truss – U4L5: Impact damage, looking toward L5 <12-0055>

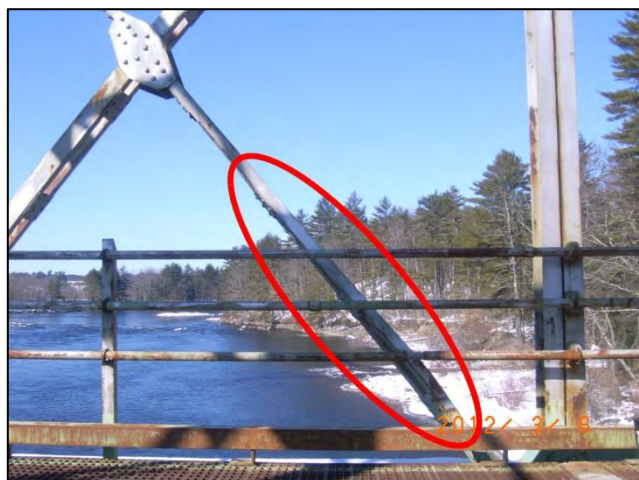
Photo 19: Span 2 Left Truss - U5L6: Impact damage.  
<12-0071a>

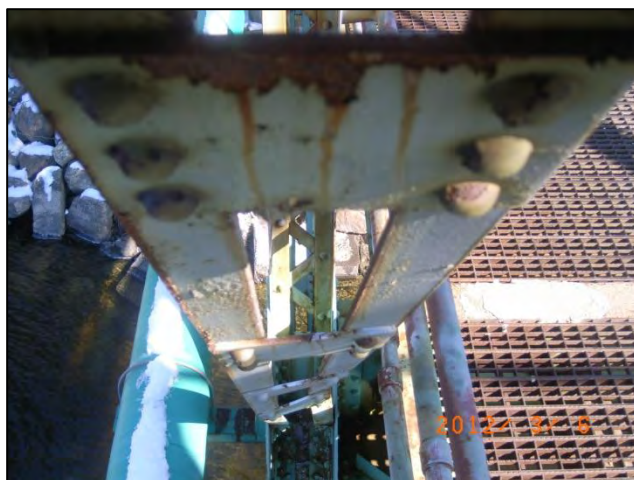
Photo 20: Span 2 Left Truss - U5L6: Impact damage,  
looking toward L6. <12-0072>

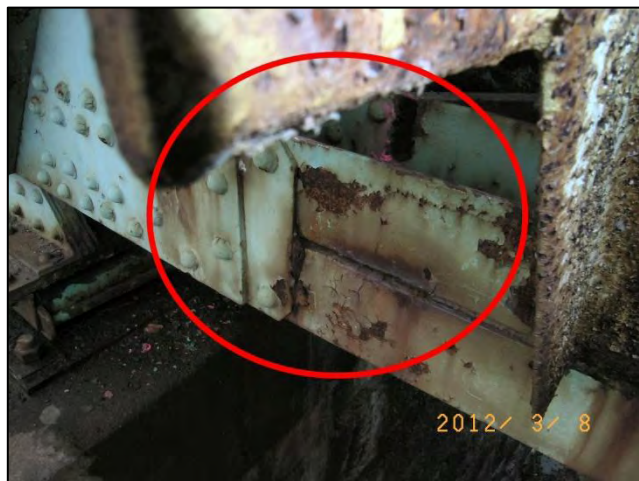
Photo 21: Span 1 Right Truss - L0L1 at L0, from  
Right: Section loss <12-0202a>

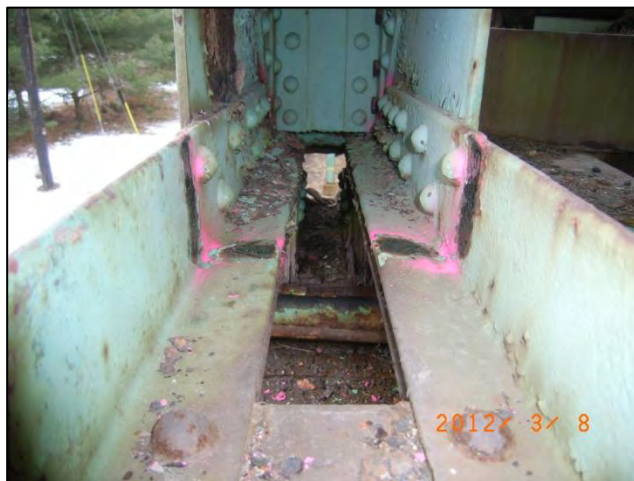
Photo 22: Span 1 Right Truss - L0L1 at L0, looking  
into L0: Section loss <12-0203>

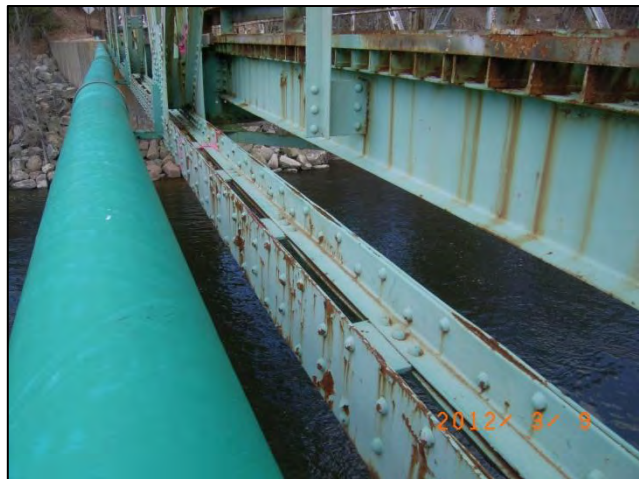
Photo 23: Span 2 Left Truss - L2L3 looking from L2:  
Section loss <12-0314>

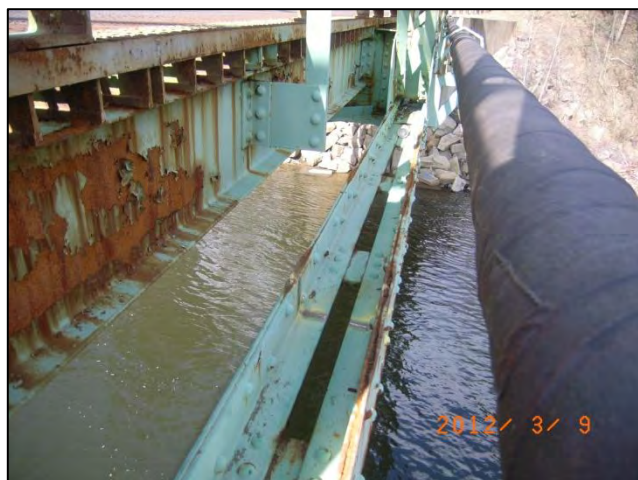
Photo 25: Span 2 Right Truss - L3L4 looking toward panel point L4: Section loss <12-0413>

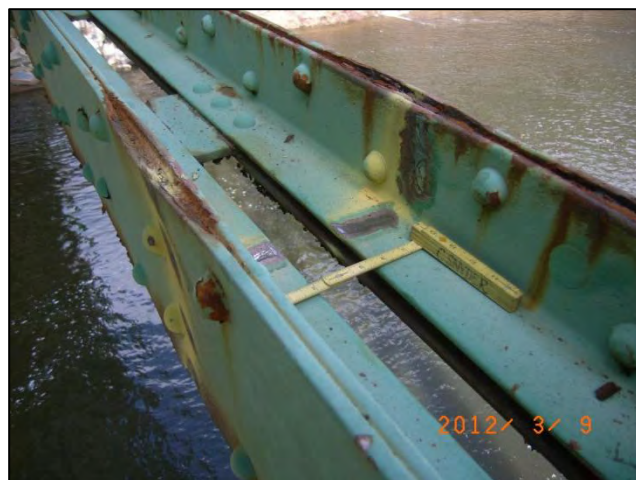
Photo 26: Span 2 Right Truss - L3L4 between tie plates #2 & #3: Section loss <12-0413>

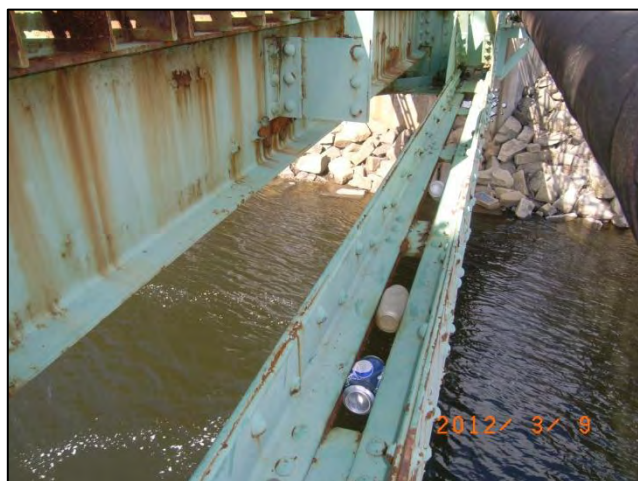
Photo 27: Span 2 Right Truss - L4L5 looking toward panel point L5: Section loss <12-0423>

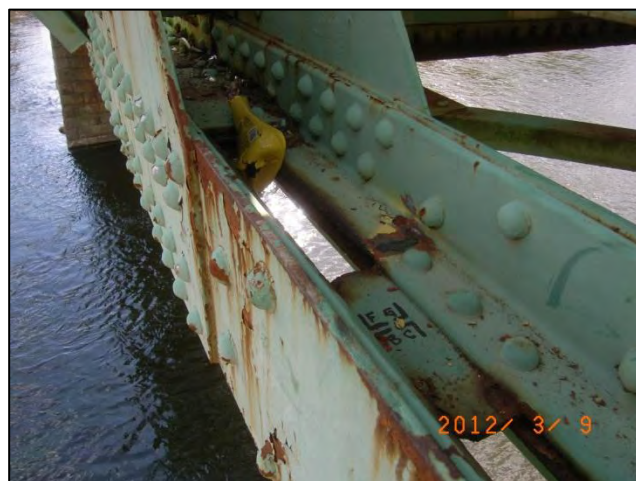
Photo 28: Span 2 Right Truss - L4L5 looking back at panel point L4: Section loss <12-0424>

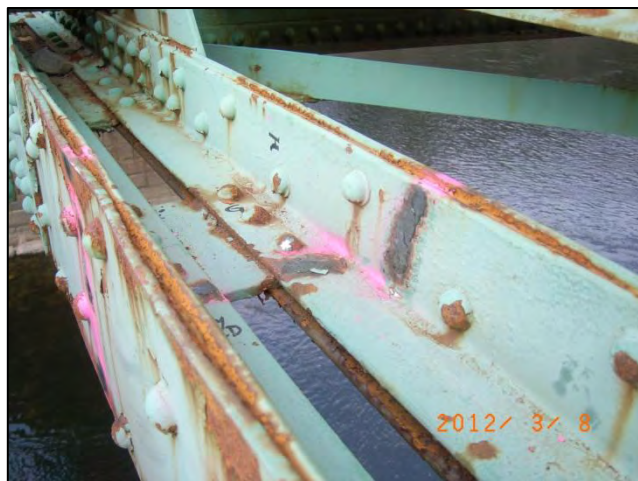
Photo 29: Span 1 Left Truss - L5L6 at tie plate #5 (near L6): Section loss <12-0169>

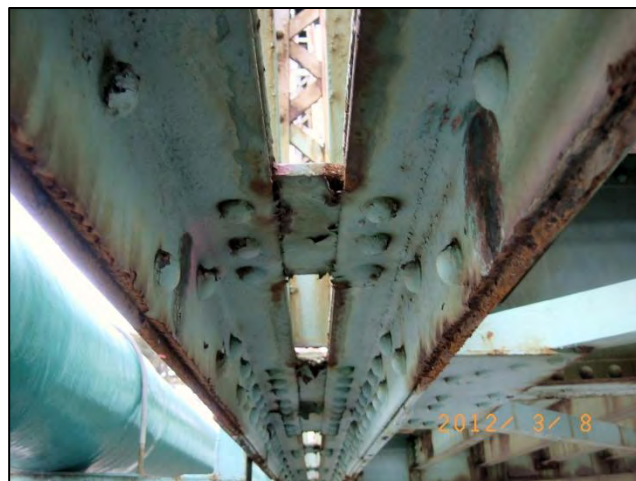
Photo 30: Span 1 Left Truss - L5L6 at tie plate #5, underside: Section loss <12-0172a>

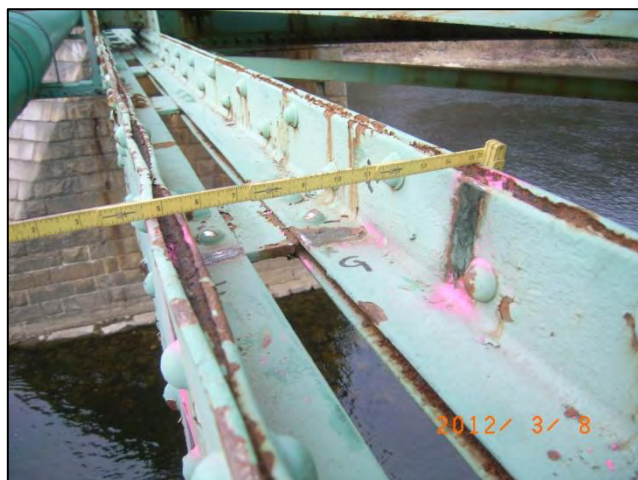
Member	Type	Size <sup>2</sup>	Span 1 Left Truss	Span 1 Right Truss	Span 2 Left Truss	Span 2 Right Truss
L0U1 & U8L9	End Posts	2-C12 x 25 plus plate 18 x $\frac{3}{8}$ "	No significant section loss (NSSL), or impact damage			
U1 through U8	Top Chords	2-C12 x 20.5 or 35 plus plate 18 x $\frac{3}{8}$ "				
L0L1 & L1L2	Bottom Chord	4-L5 x 3 x $\frac{5}{16}$ "	4%	<b>27%</b> Photo 21, 22	3%	3%
L2L3	Bottom Chord	4-L5 x 3½ x $\frac{5}{16}$ " plus 2-Pl. 11 x $\frac{5}{16}$ "	17%	15%	<b>26%</b> Photo 23, 24	16%
L3L4	Bottom Chord	4-L5 x 3½ x $\frac{7}{16}$ " plus 2-Pl. 11 x $\frac{3}{8}$ "	5%	10%	10%	<b>11%</b> Photo 25, 26
L4L5	Bottom Chord	4-L5 x 3½ x $\frac{1}{2}$ " plus 2-Pl. 11 x $\frac{3}{8}$ "	NSSL	NSSL	≤5%	<b>5%</b> Photo 27, 28
L5L6	Bottom Chord	4-L5 x 3½ x $\frac{7}{16}$ " plus 2-Pl. 11 x $\frac{3}{8}$ "	<b>18%</b> Photo 29, 30	9%	8%	10%
L6L7	Bottom Chord	4-L5 x 3½ x $\frac{5}{16}$ " plus 2-Pl. 11 x $\frac{5}{16}$ "	<b>26%</b> Photo 31, 32	24%	10%	18%

Photo 31: Span 1 Left Truss - L6L7 at tie plate #3 (mid-panel): Section loss <12-0182>

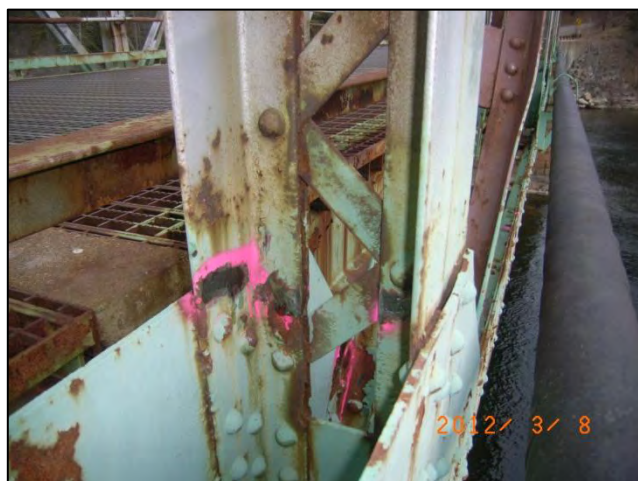
Photo 33: Span 1 Right Truss - U3L3 at L3: Section loss <12-0227>

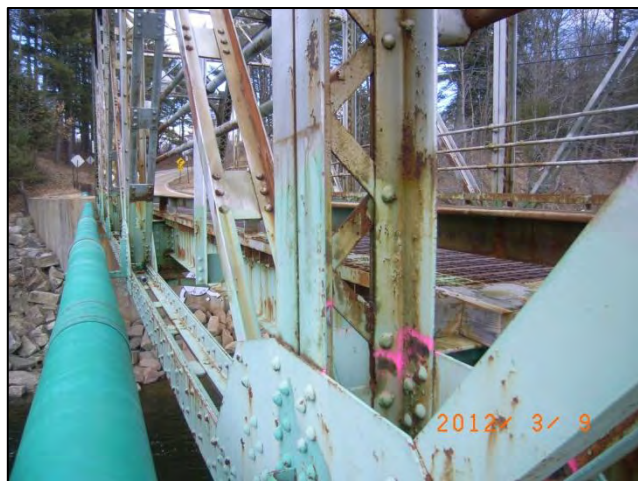
Photo 35: Span 2 Left Truss - U4L4 at L4: Section loss <12-0333>

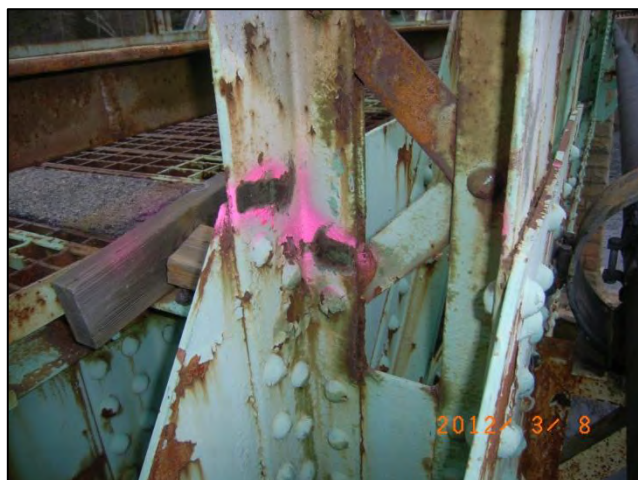
**Photo 37: Span 1 Right Truss – U6L6 at L6: Section loss <12-0264>**

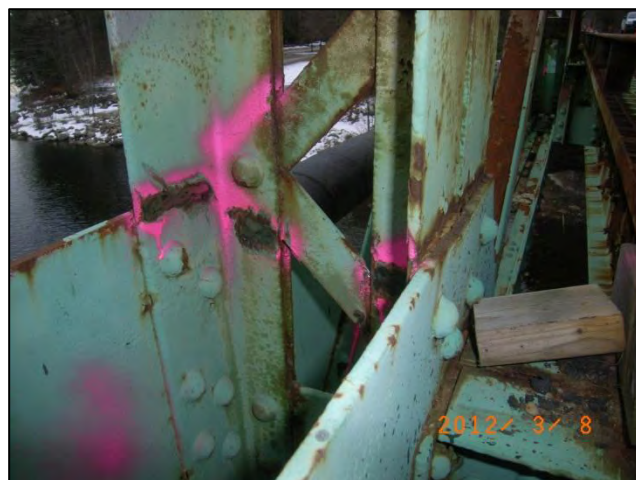
**Photo 38: Span 1 Right Truss – U6L6 at L6: Section loss <12-0267>**

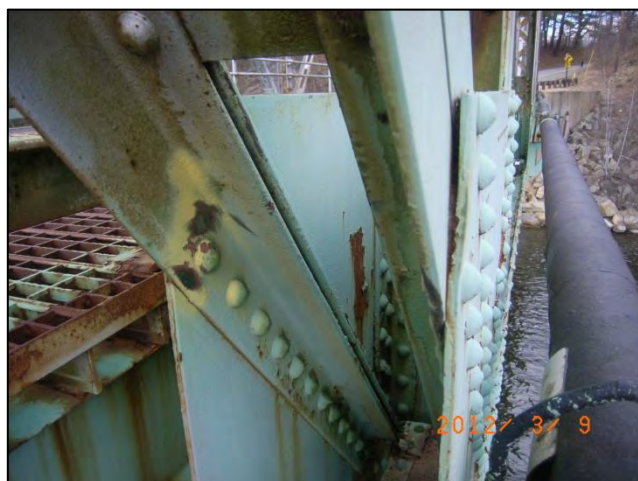
L7L8 & L8L9	Bottom Chord	4-L5 x 3 x $\frac{5}{16}$ "	NSSL	1%	<b>13%</b>	9%
U1L1	FB Hanger	4-L3 x 3 x $\frac{5}{16}$ "	NSSL			
U2L2	Vertical	4-L5 x 3½ x $\frac{3}{8}$ "	NSSL	NSSL	NSSL	NSSL
U3L3	Vertical	4-L5 x 3 x $\frac{5}{16}$ "	7%	<b>15%</b> Photo 33, 34	10%	6%
U4L4	Vertical		NSSL	9%	<b>13%</b> Photo 35, 36	9%
U5L5	Vertical		<b>9%</b>	7%	*≤5%	*≤5%
U6L6	Vertical		NSSL	<b>10%</b> Photo 37, 38	*≤6%	9%
U7L7	Vertical	4-L5 x 3½ x $\frac{3}{8}$ "	NSSL	*≤4%	*≤2%	<b>*≤5%</b>
U8L8	FB Hanger	4-L3 x 3 x $\frac{5}{16}$ "	NSSL			
U1L2	Diagonal	4-L4 x 3 x $\frac{7}{16}$ "	NSSL	NSSL	≤1%	<b>5%</b> Photo 39, 40

**Photo 39: Span 2 Right Truss - U1L2 at L2: Section loss <12-0396>**

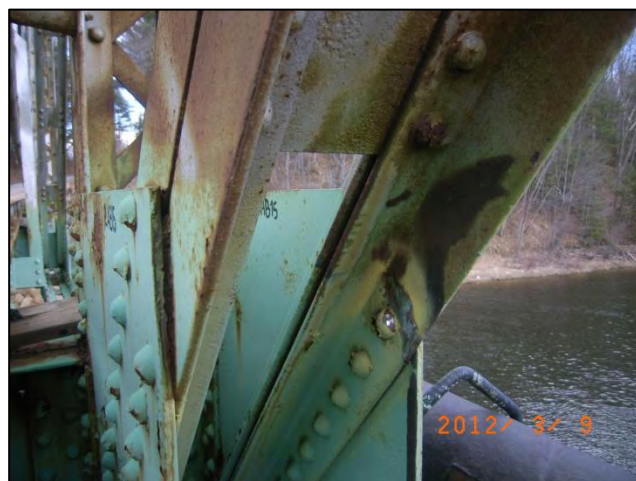
**Photo 40: Span 2 Right Truss - U1L2 at L2: Section loss <12-0397>**

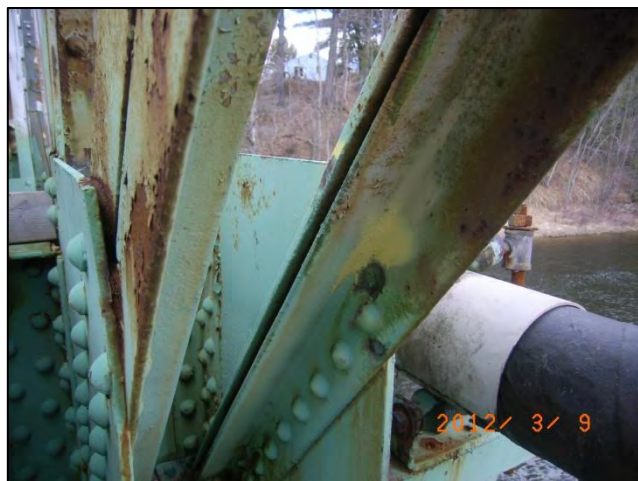
Member	Type	Size <sup>2</sup>	Span 1 Left Truss	Span 1 Right Truss	Span 2 Left Truss	Span 2 Right Truss
U2L3	Diagonal	4-L4 x 3 x 5/16"	NSSL	3%	3%	<b>5%</b> <b>Photo 41, 42</b>
U3L4	Diagonal	2-L5 x 3 x 5/16"	NSSL	<b>7%</b>	4%	4%
L3U4	Counter	2-L3 x 3 x 5/16"	NSSL	<b>6%</b> <b>Photo 43, 44</b>	3%	4%
U4L5	Counter		NSSL			
L4U5	Counter		NSSL			
U5L6	Counter		1%	2%	*≤4%	<b>6%</b>
L5U6	Diagonal	2-L5 x 3 x 5/16"	<b>9%</b> <b>Photo 45, 46</b>	5%	3%	<b>12%</b> <b>Photo 47, 48</b>
L6U7	Diagonal	4-L4 x 3 x 5/16"	1%	*≤5%	4%	<b>8%</b> <b>Photo 49, 50</b>
L7U8	Diagonal	4-L4 x 3 x 7/16"	NSSL	*≤5%	*1%	NSSL

**Photo 41: Span 2 Right Truss - U2L3 at L3: Section loss <12-0406>**

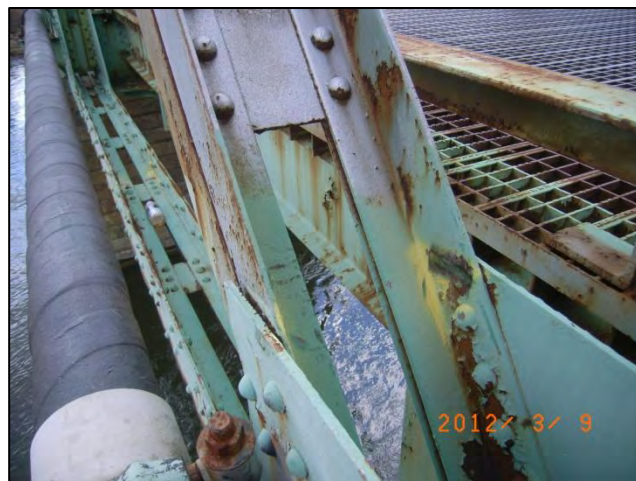
**Photo 42: Span 2 Right Truss - U2L3 at L3: Section loss <12-0407>**

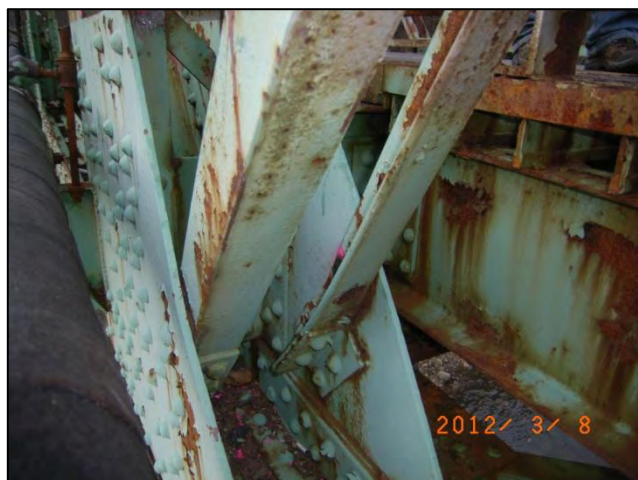
**Photo 43: Span 1 Right Truss - L3U4 at L3: Section loss <12-0230>**

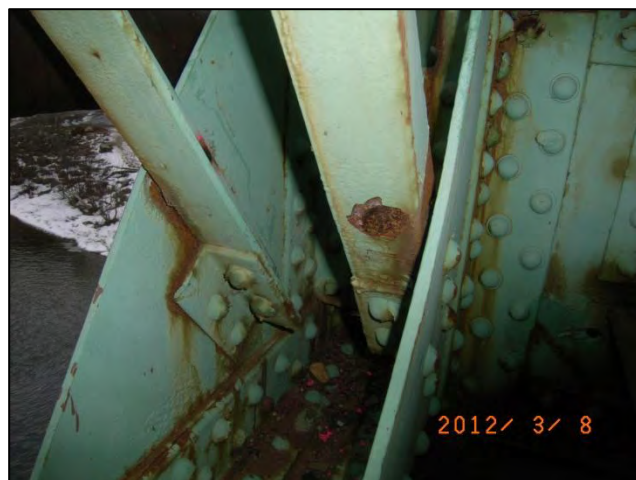
**Photo 44: Span 1 Right Truss - L3U4 at L3: Section loss <12-0232>**

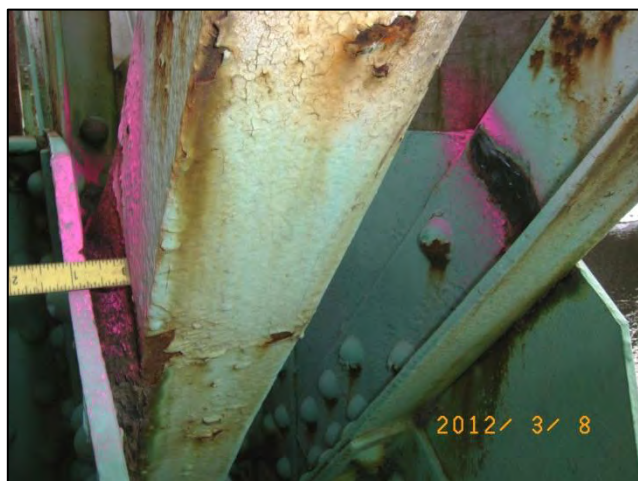
**Photo 45: Span 1 Left Truss - L5U6 at L5: Section loss <12-0166>**

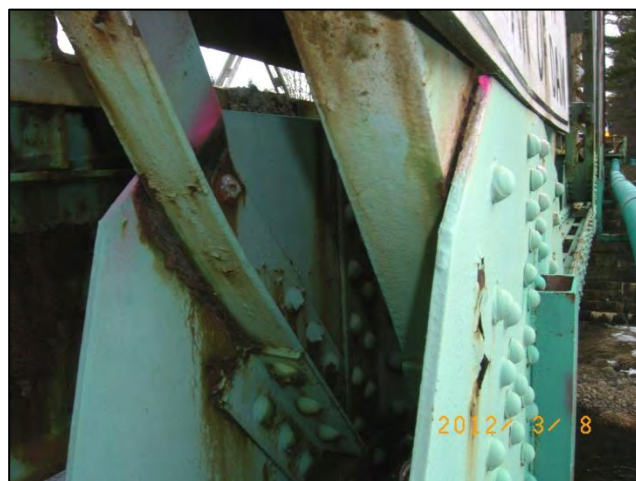
**Photo 46: Span 1 Left Truss - L5U6 at L5: Section loss <12-0167>**

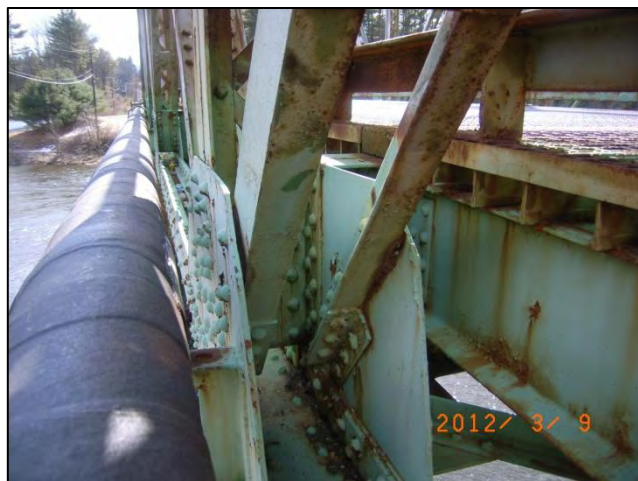
**Photo 47: Span 2 Right Truss - L5U6 at L5: Section loss. <12-0431>**

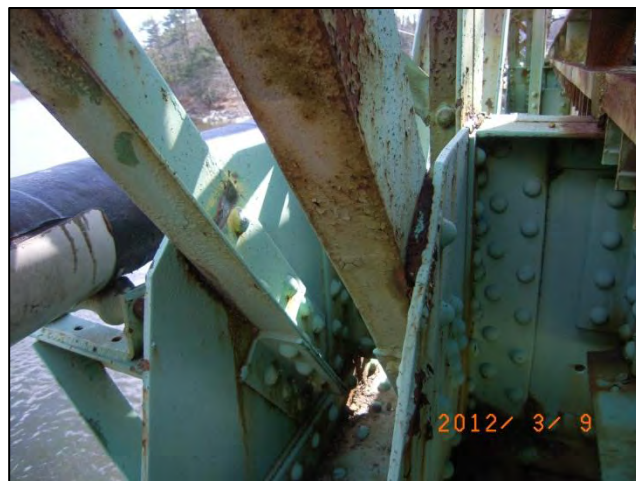
**Photo 48: Span 2 Right Truss - L5U6 at L5: Section loss. <12-0432>**

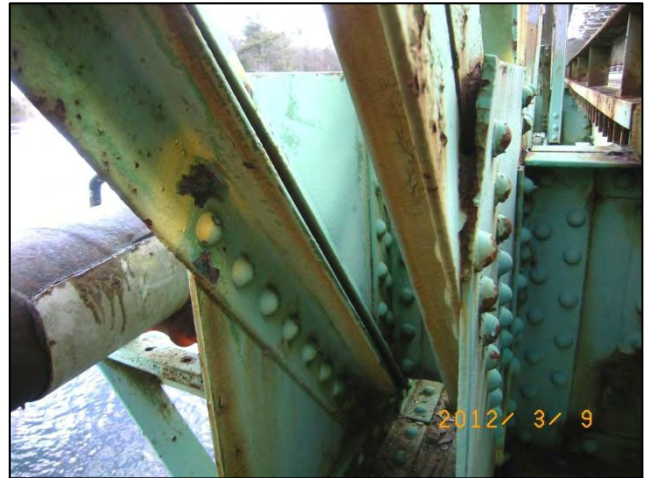
**Photo 50: Span 2 Right Truss - L6U7 at L6: Section loss. <12-0445>**
