APPENDIX 2. 2009-2010 Digital Photographs of the Lake Champlain Bridge

APPENDIX 3. 2009 Inspection Photographs by the New York State Department of Transportation

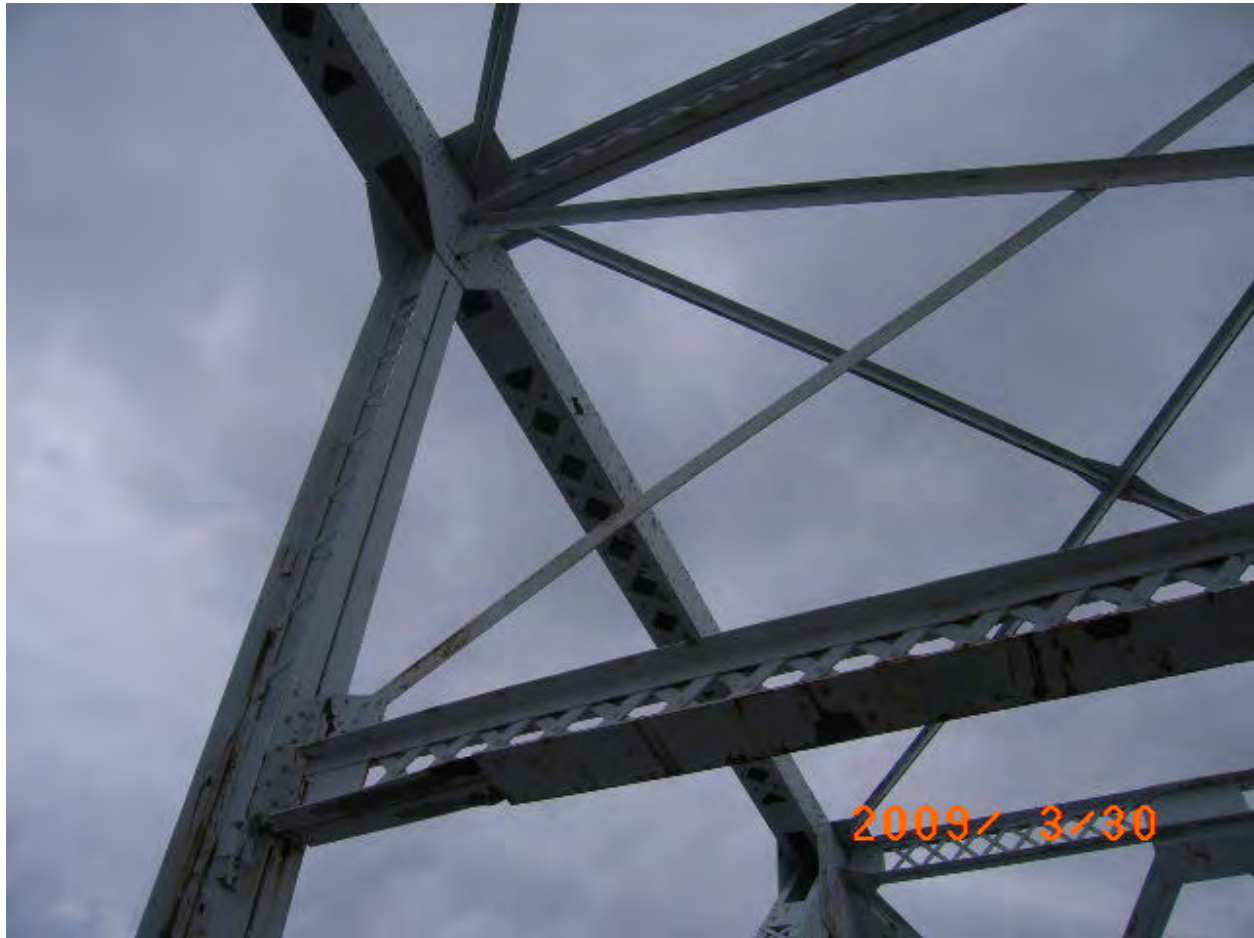
Figure 111. Span 7 strut, upper chord, and sway bracing at Panel Point 16.

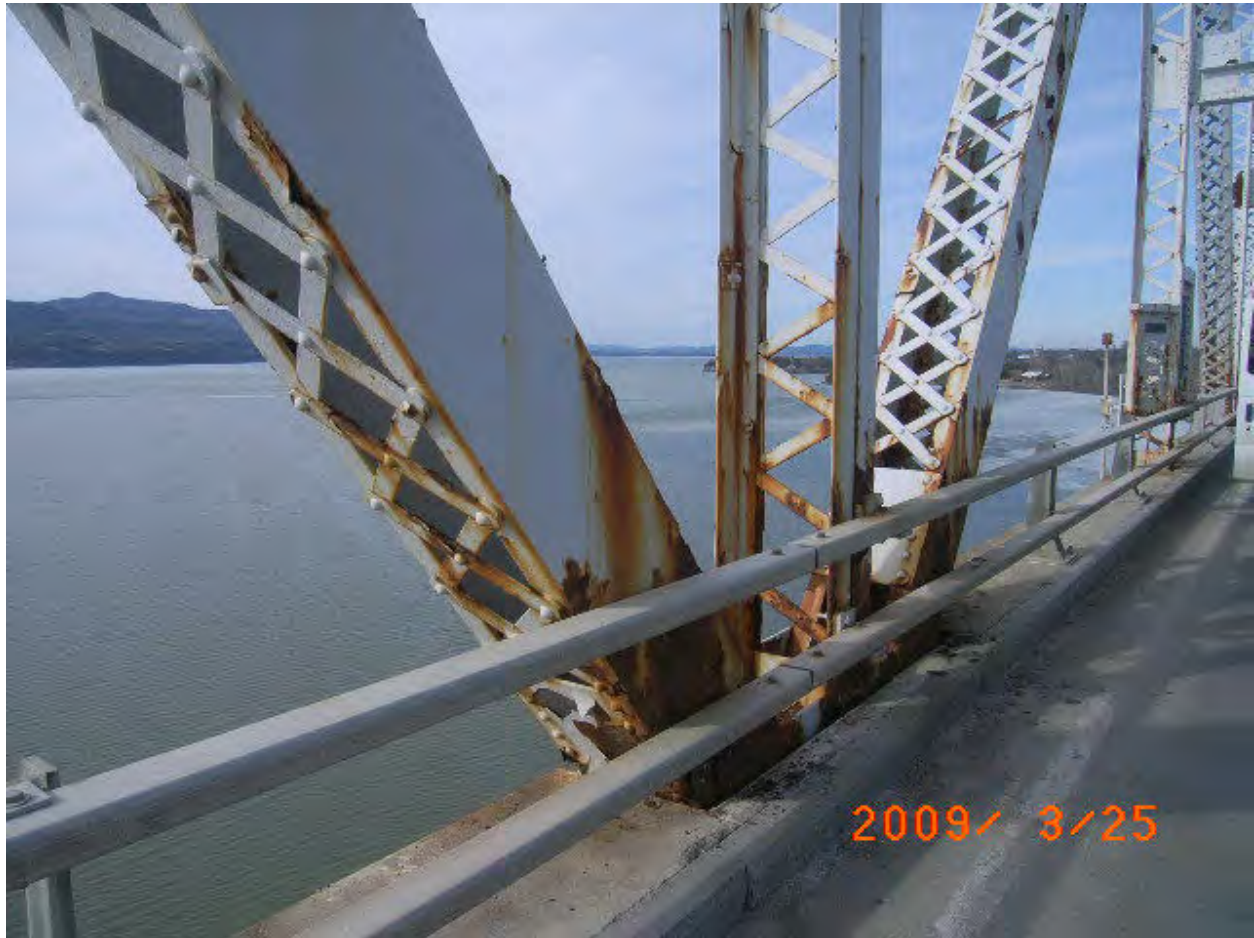
Figure 112. Span 7 deck at connection L16.

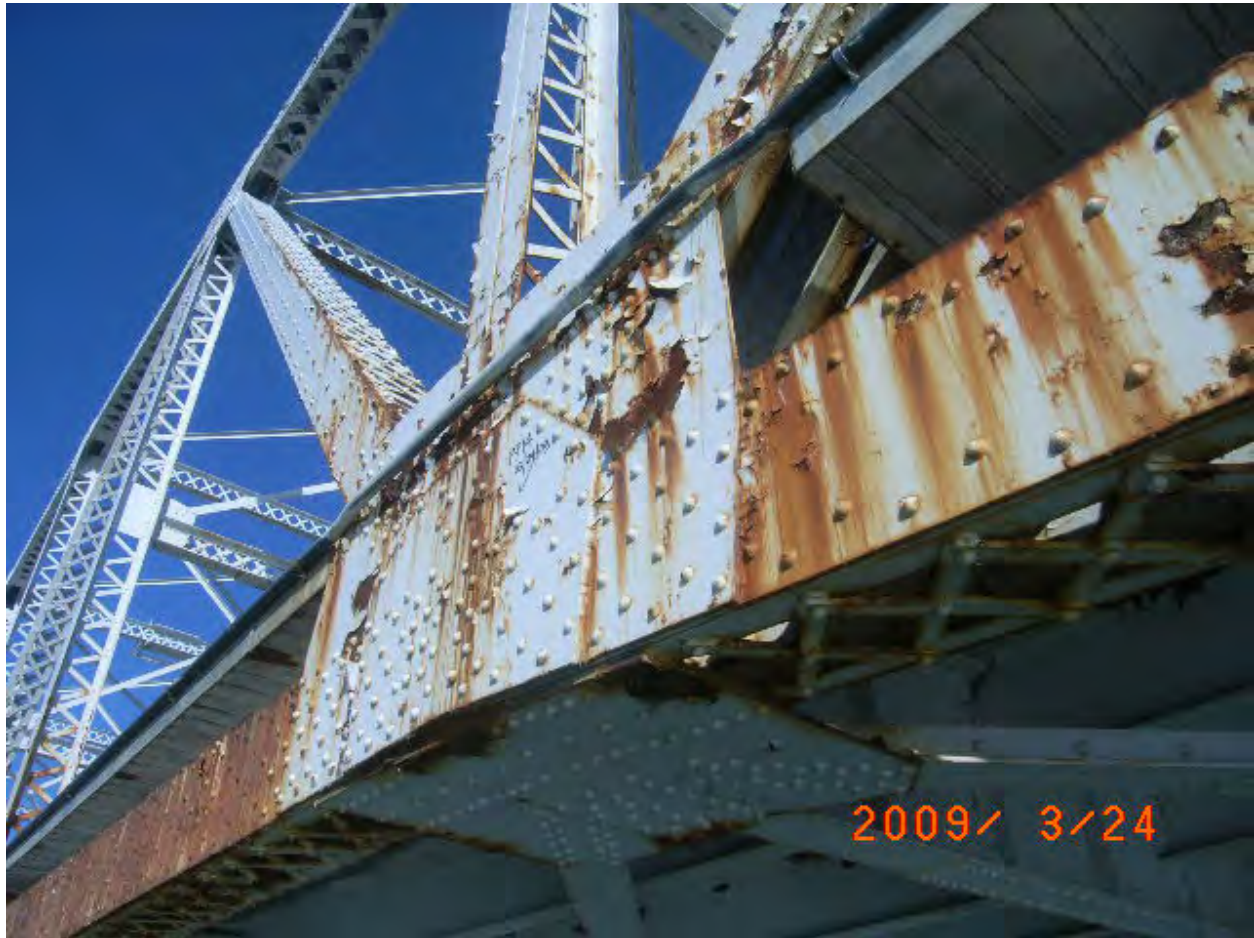
Figure 113. Span 7 lower chord connection at L14.

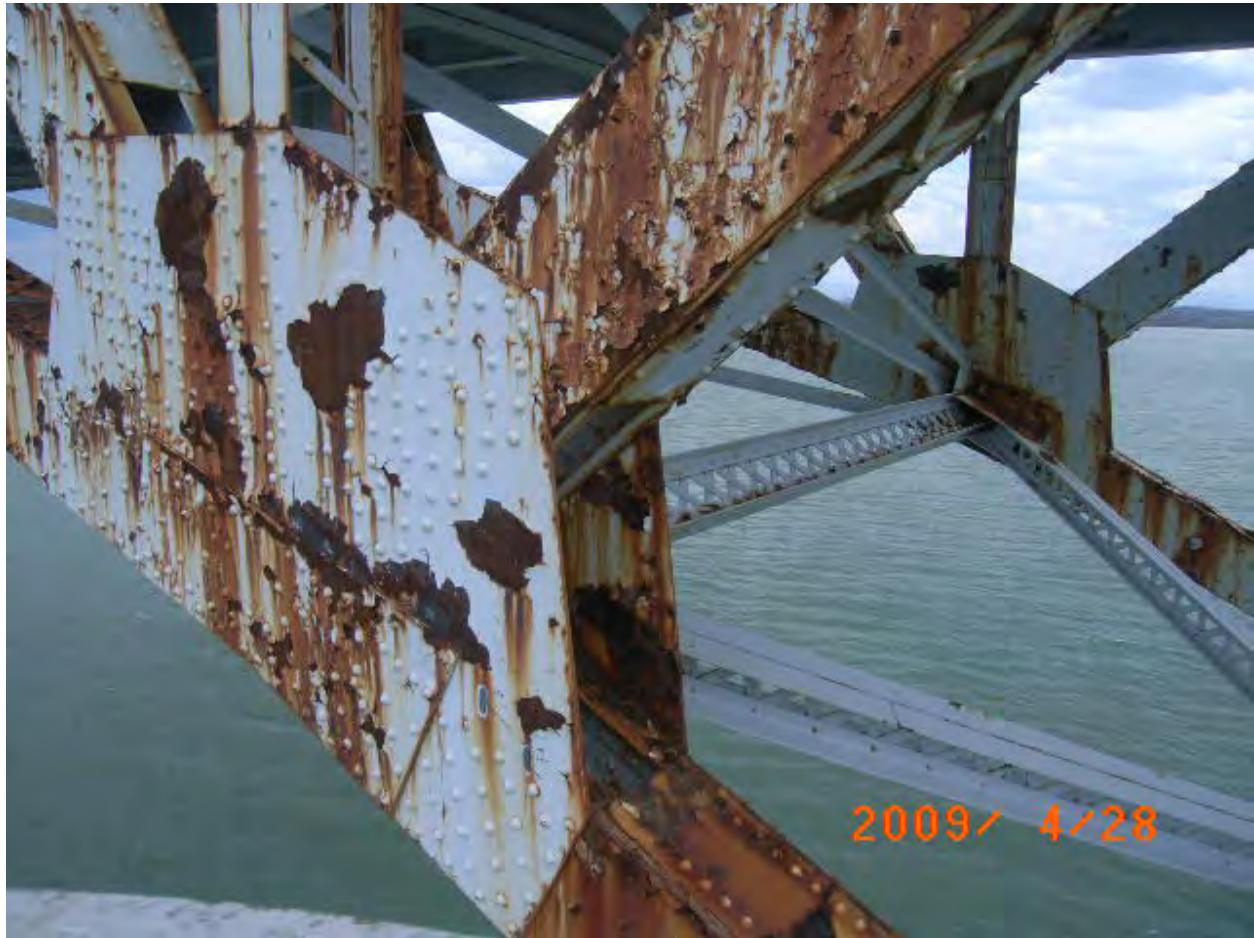
Figure 114. Span 7, lower chord connection at L12.

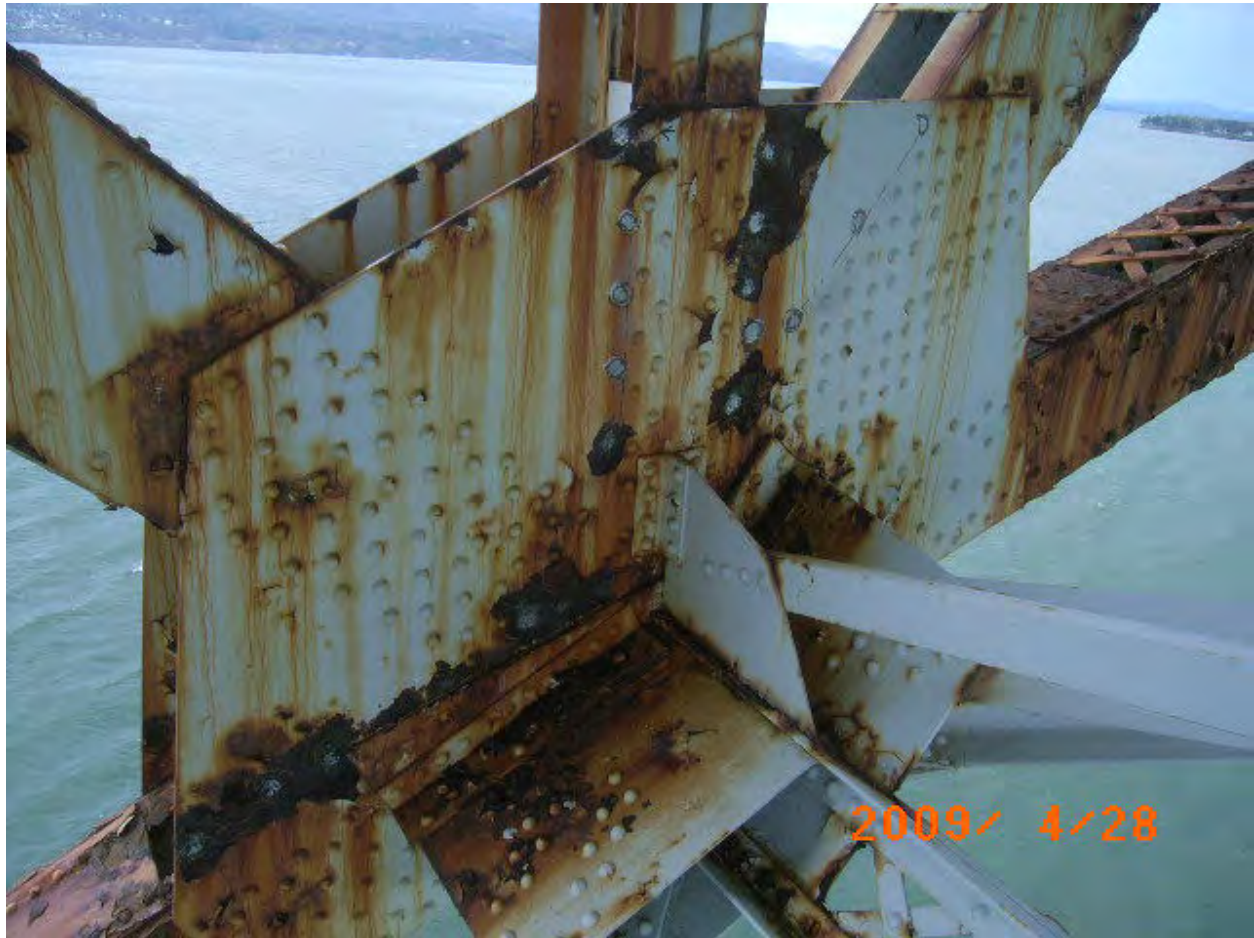
Figure 115. Span 7 lower chord connection at L12, interior side.

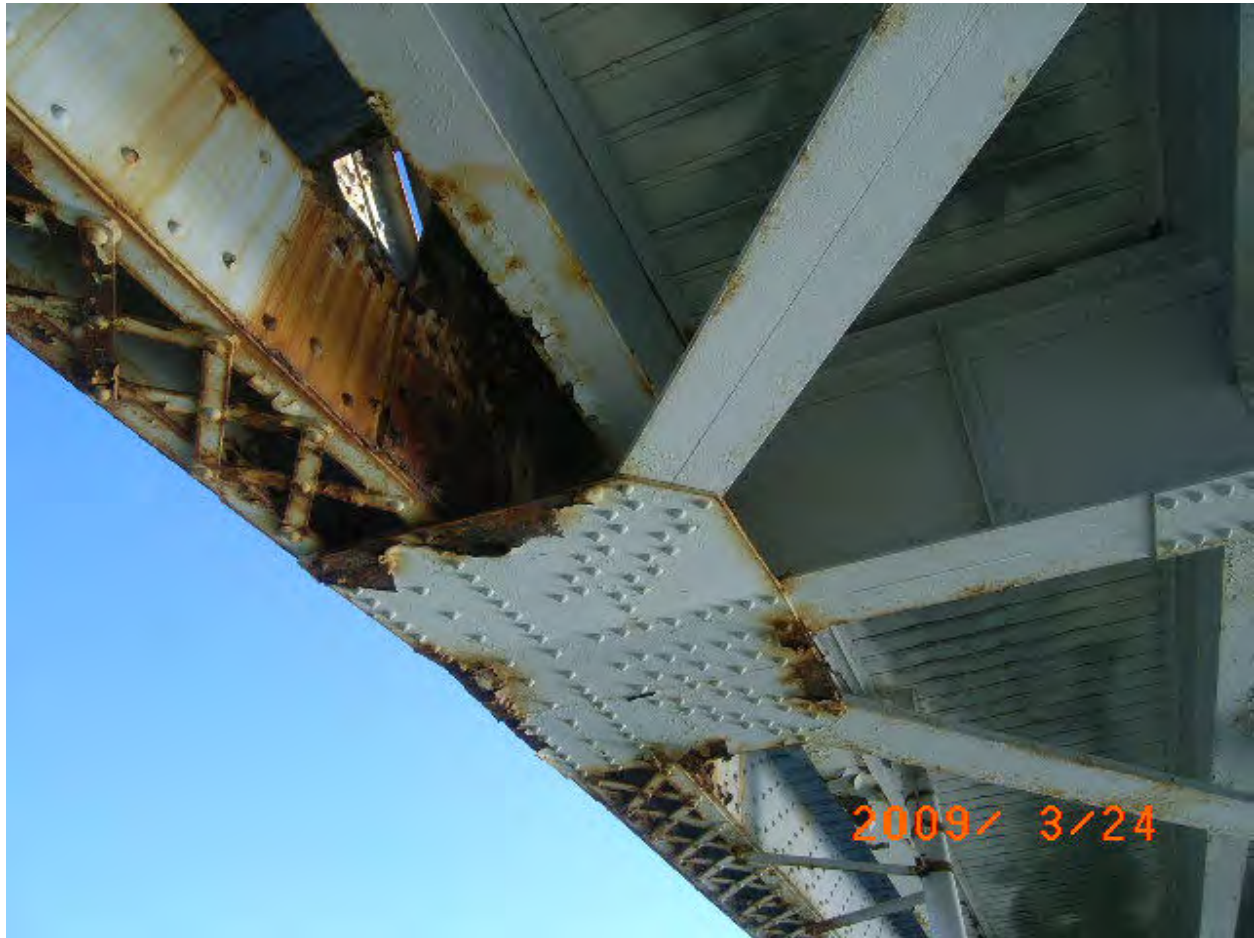
Figure 116. Span 7 lower chord lateral connection at L14.

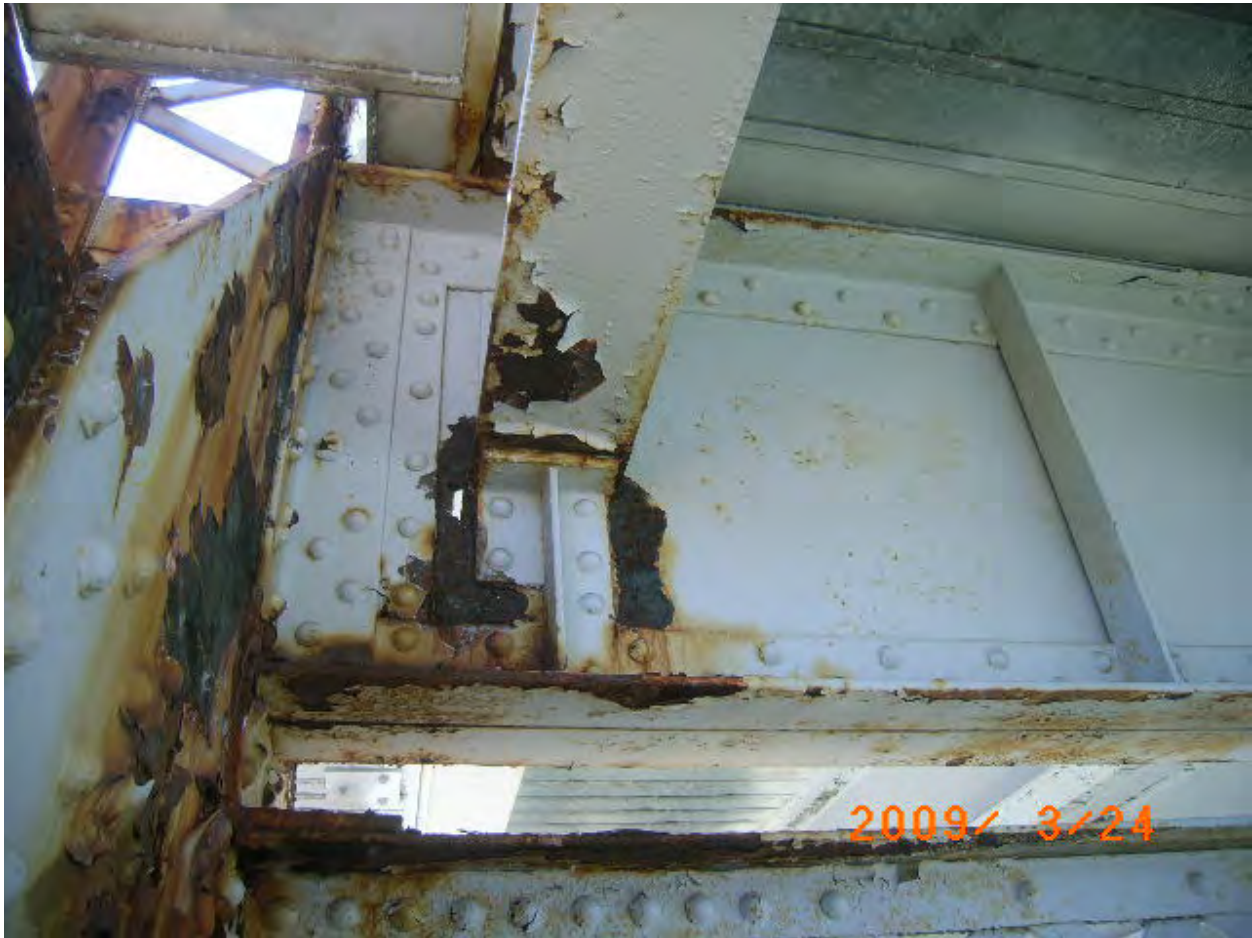
Figure 117. Span 7 Floor Beam 13.

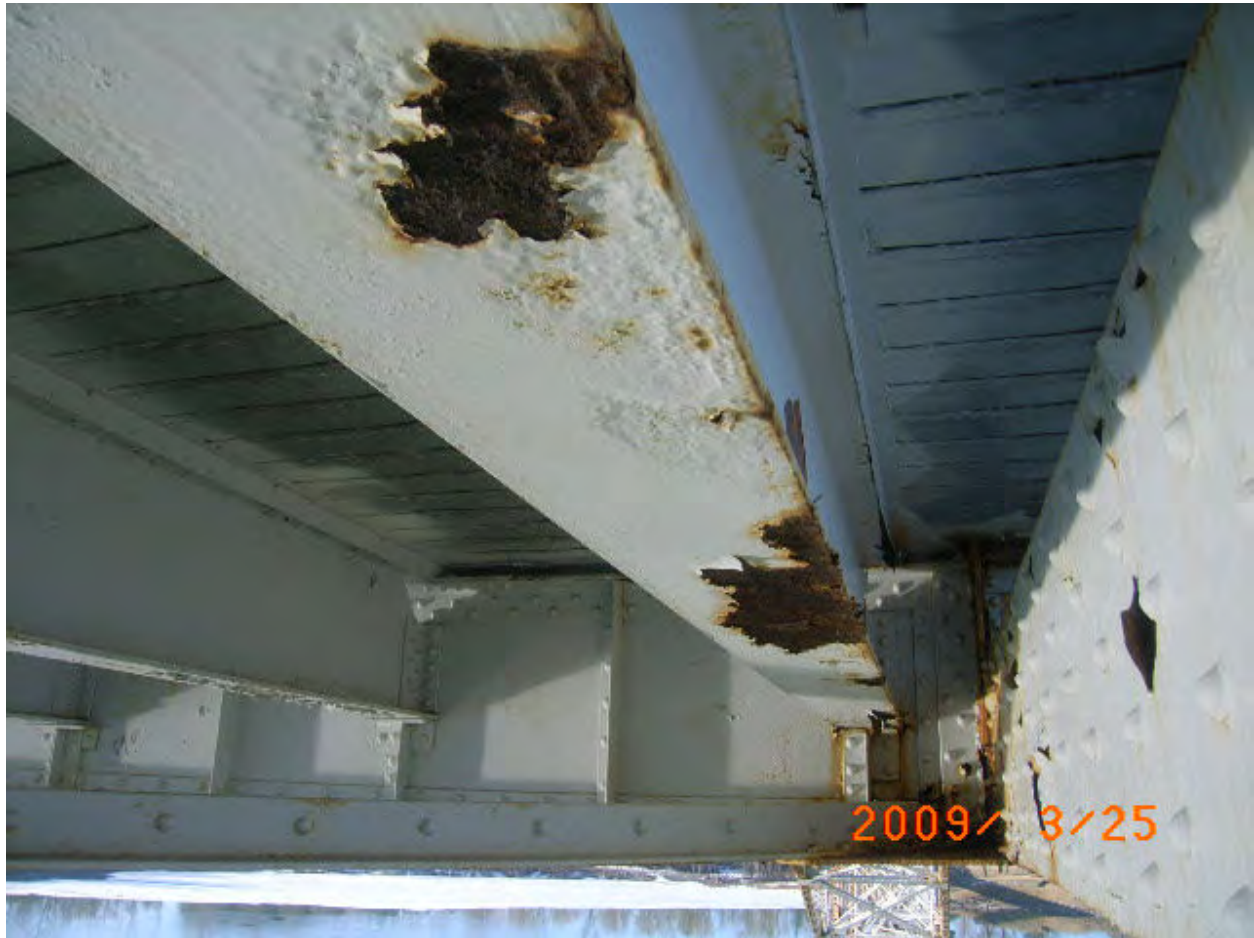
Figure 118. Span 7 Panel 20 stringer.

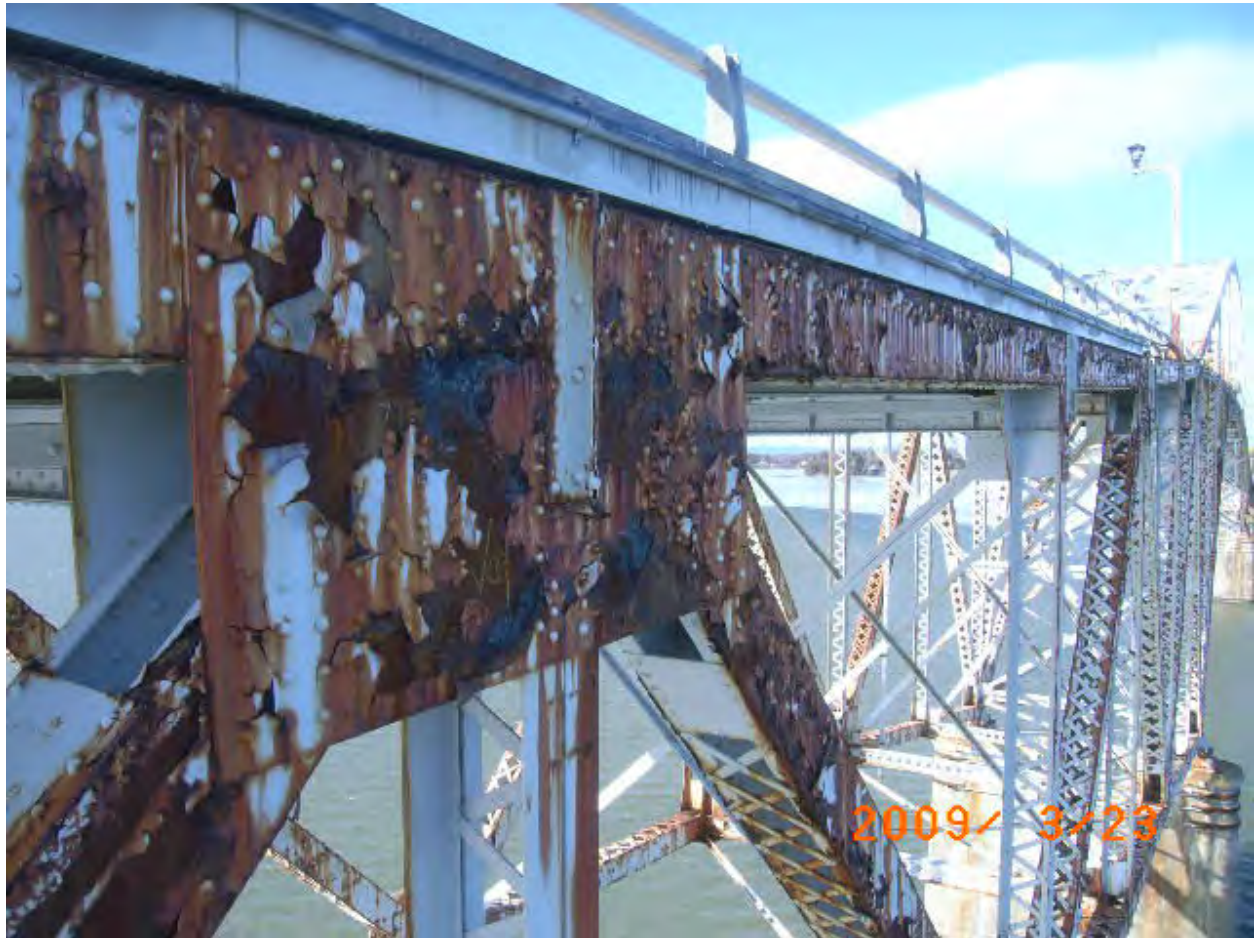
Figure 119. Span 6 upper chord connection at U05.

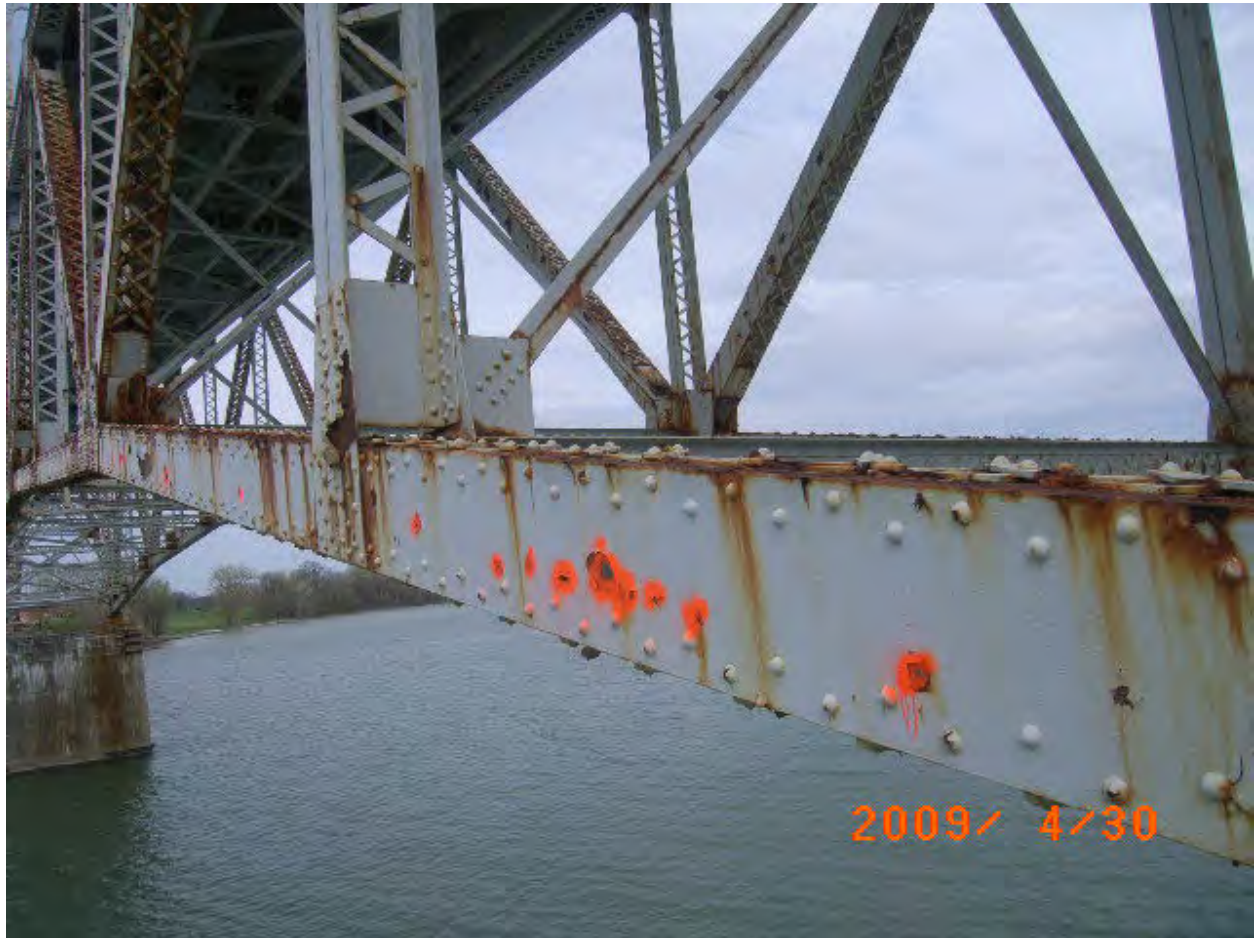
Figure 121. Span 6 lower chord at L00-L02.

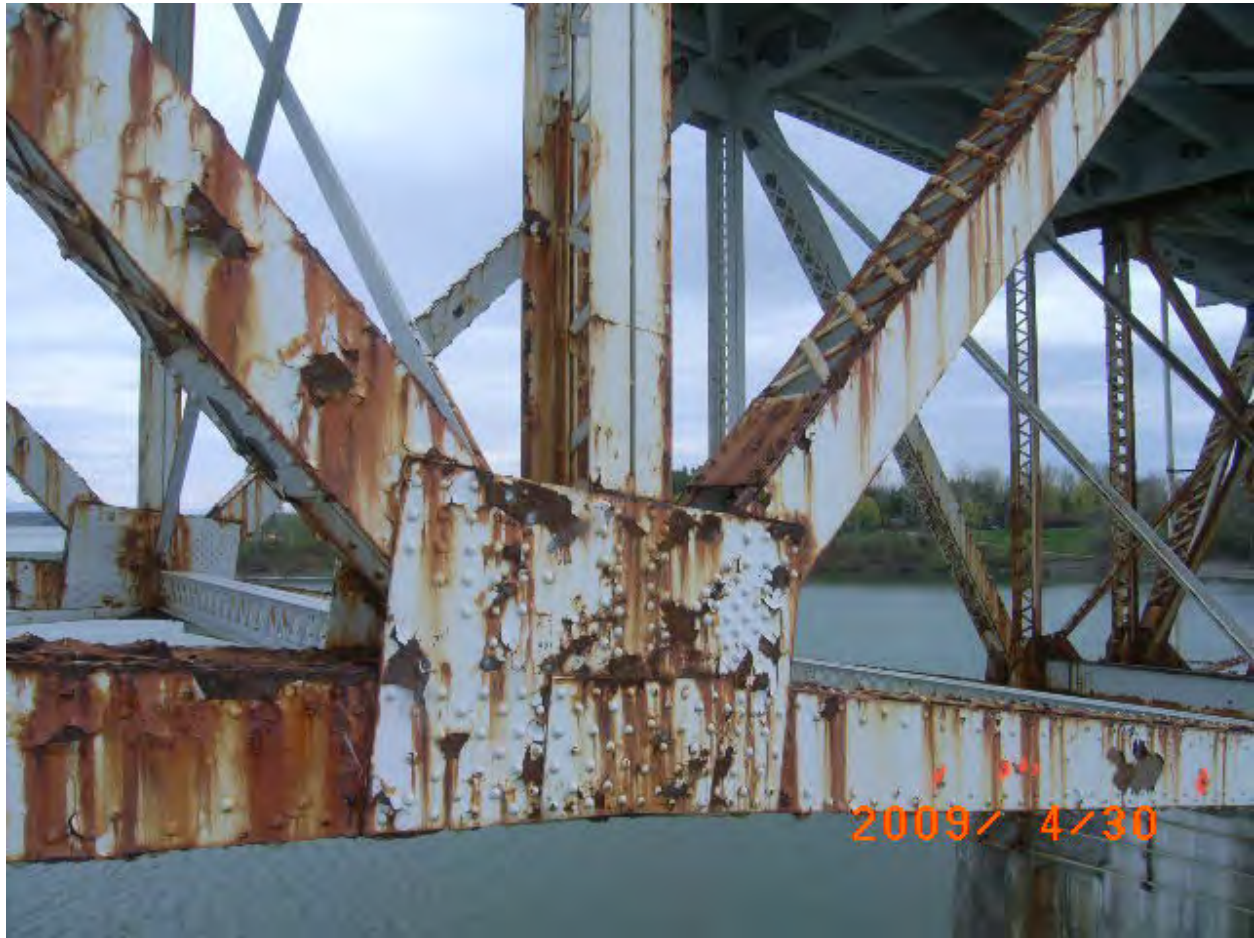
Figure 122. Span 6 lower chord connection at L02.

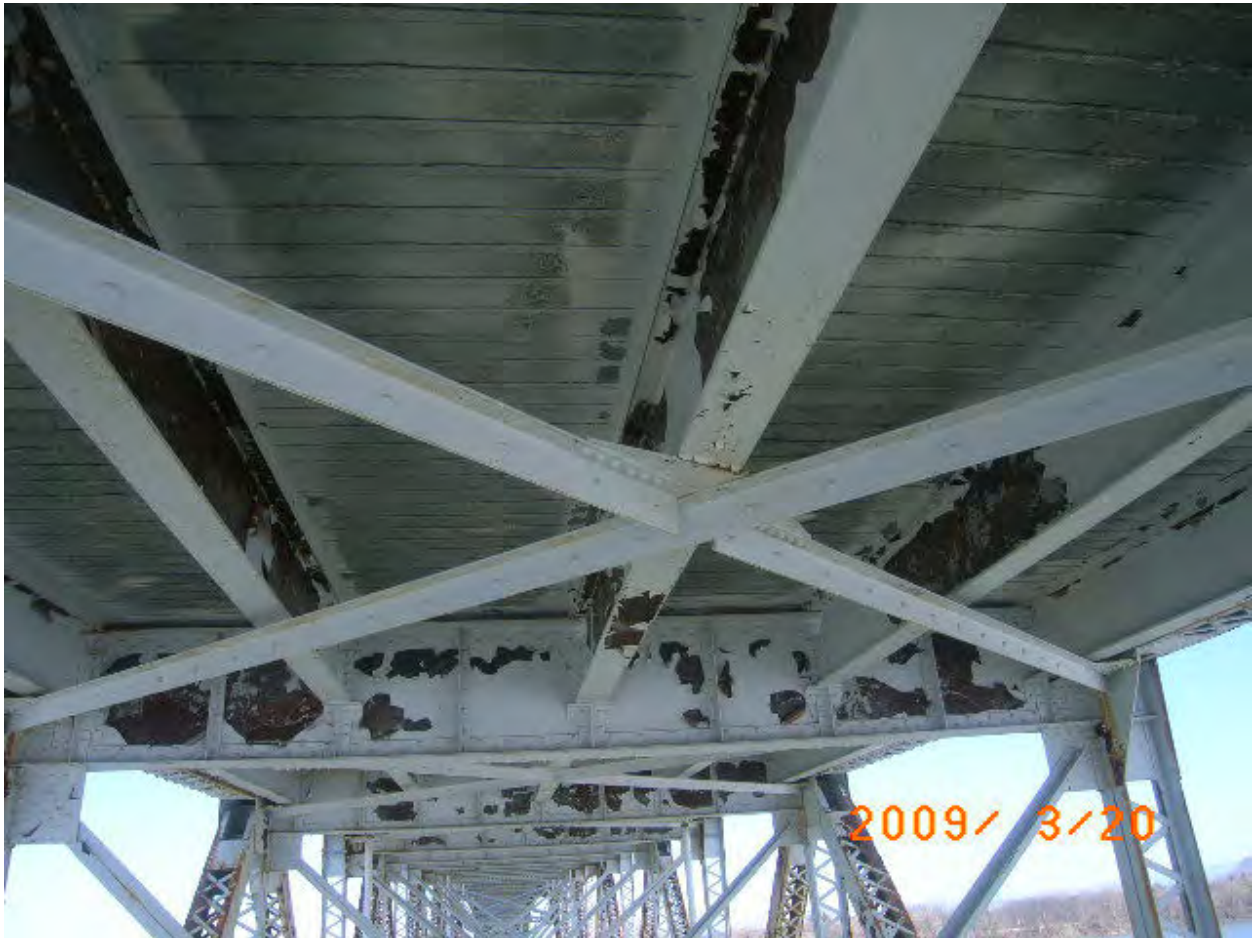
Figure 123. Span 6, Panel 2, laterals, stringers, and floor beam (Spans 4, 5, 6, 8, 9 are similar).

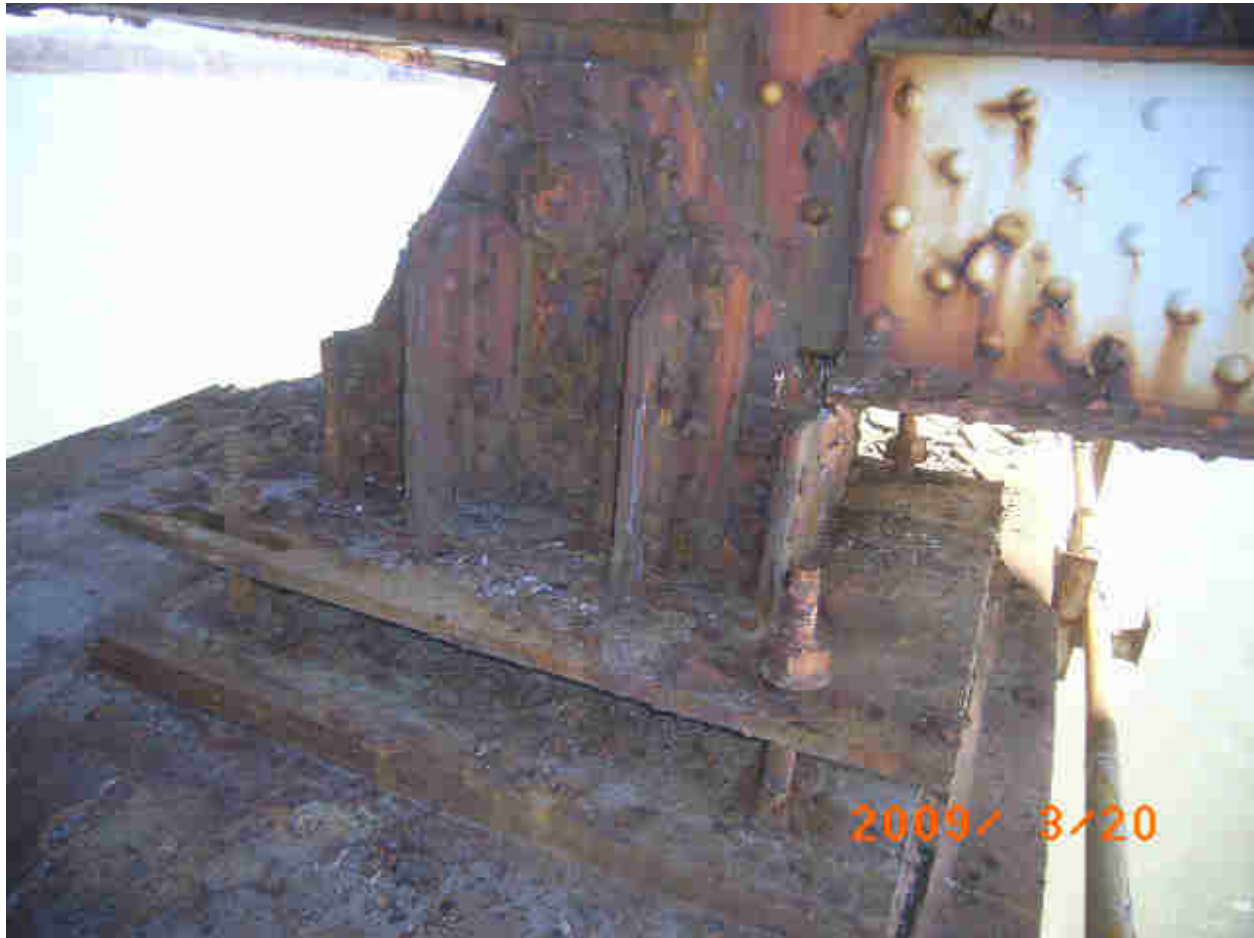
Figure 126. Span 5 at Pier 5, right truss roller bearing.

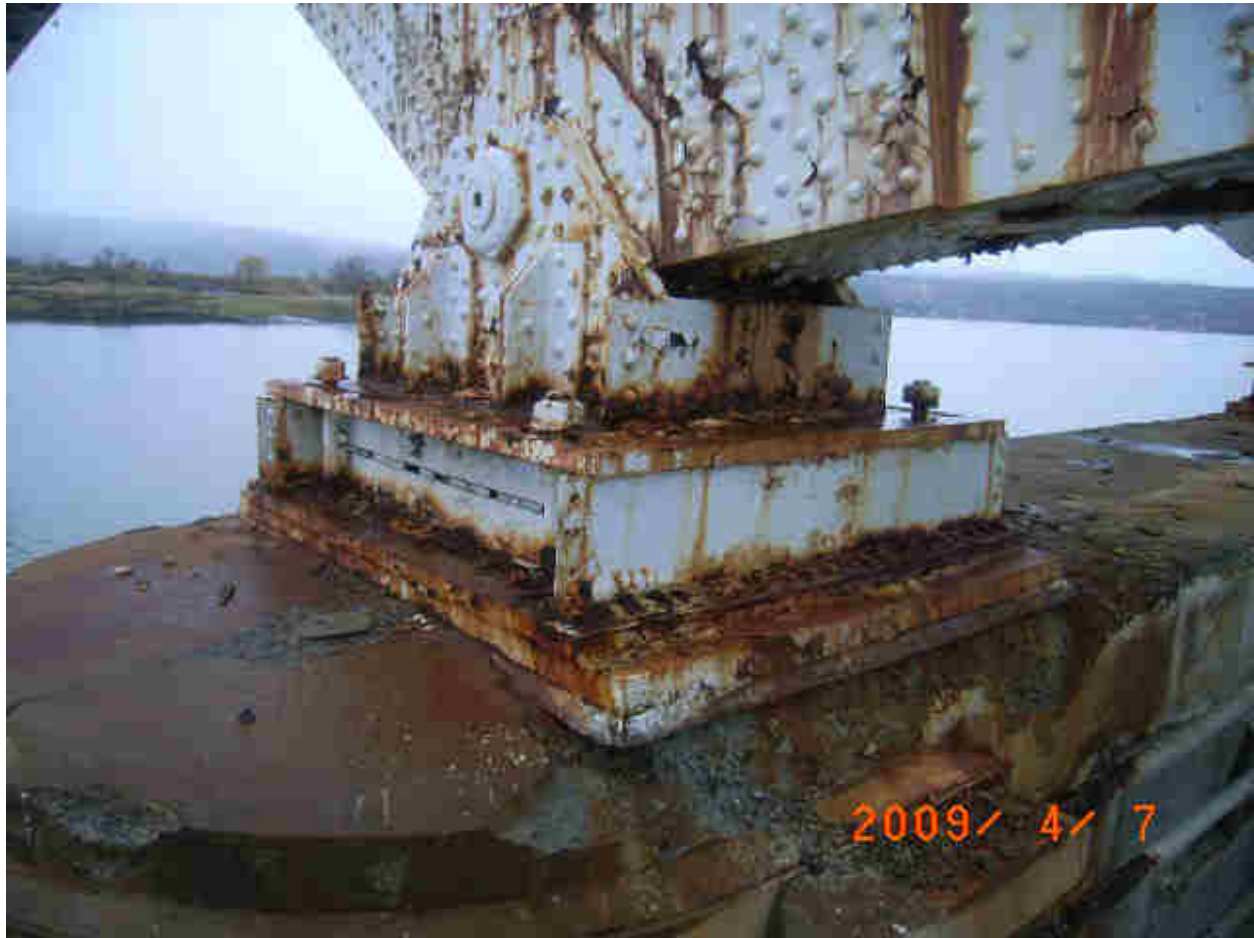
Figure 128. Spans 7/8 at Pier 7, right truss rocker bearing.

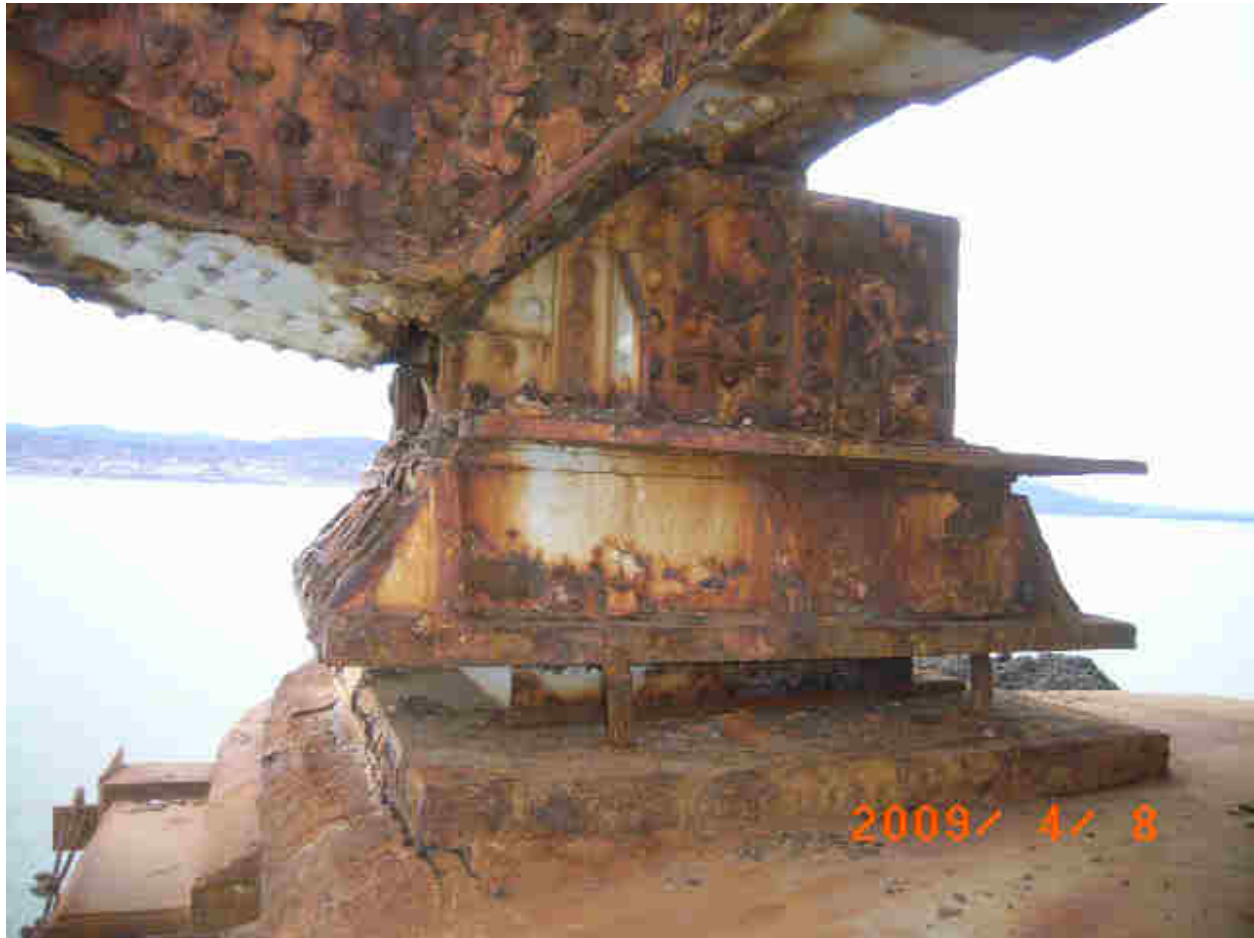
Figure 129. Span 8 at Pier 8, left truss roller bearing.

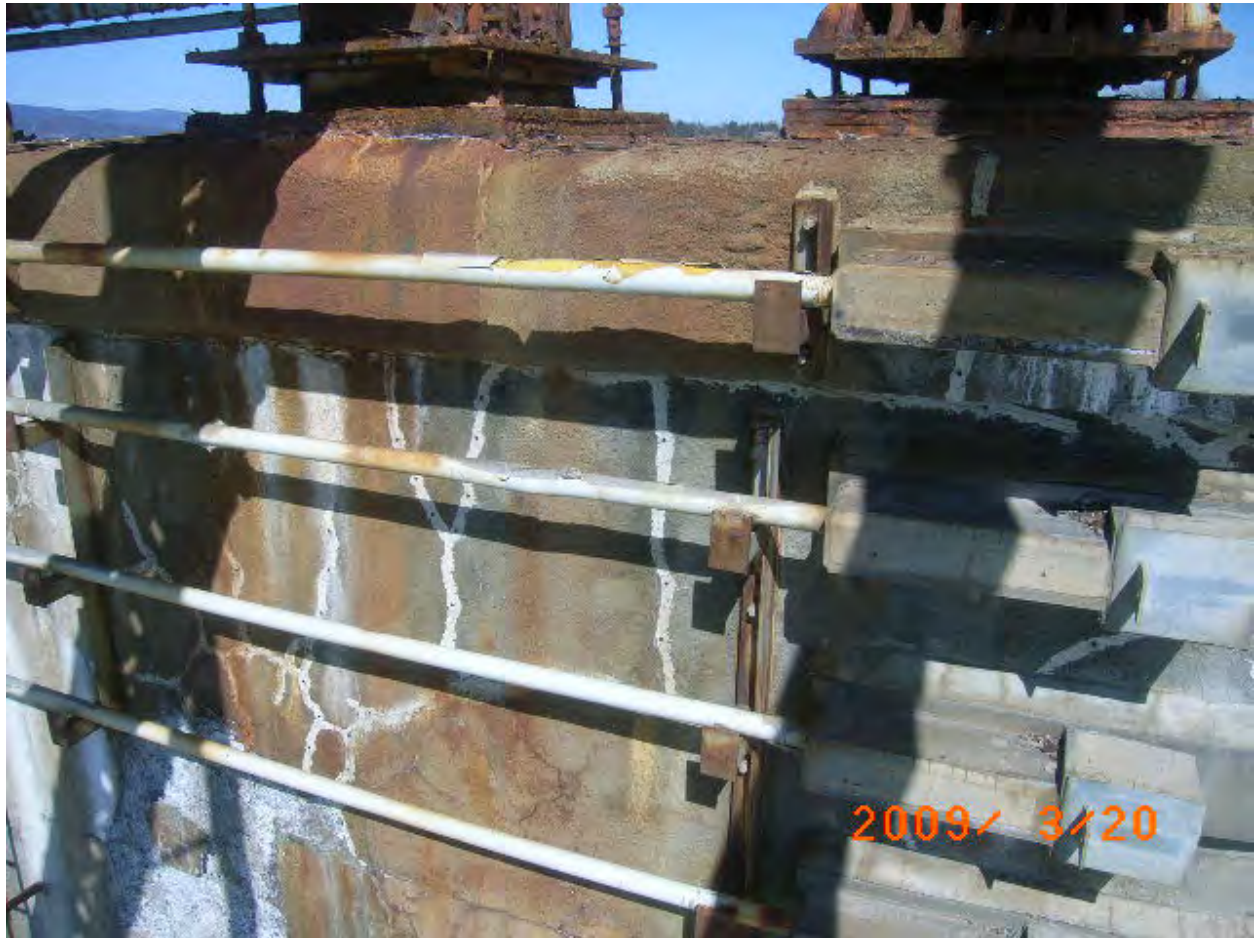
Figure 131. Pier 5 upper south side of stem, cap and tensioners.
