**LOWER TODDSVILLE BRIDGE**

**BIN #2227960**

Existing Conditions Survey

Recommended Rehabilitation Steps  
To Convert Bridge from a Vehicular Bridge to  
A Pedestrian and Bicycle Bridge

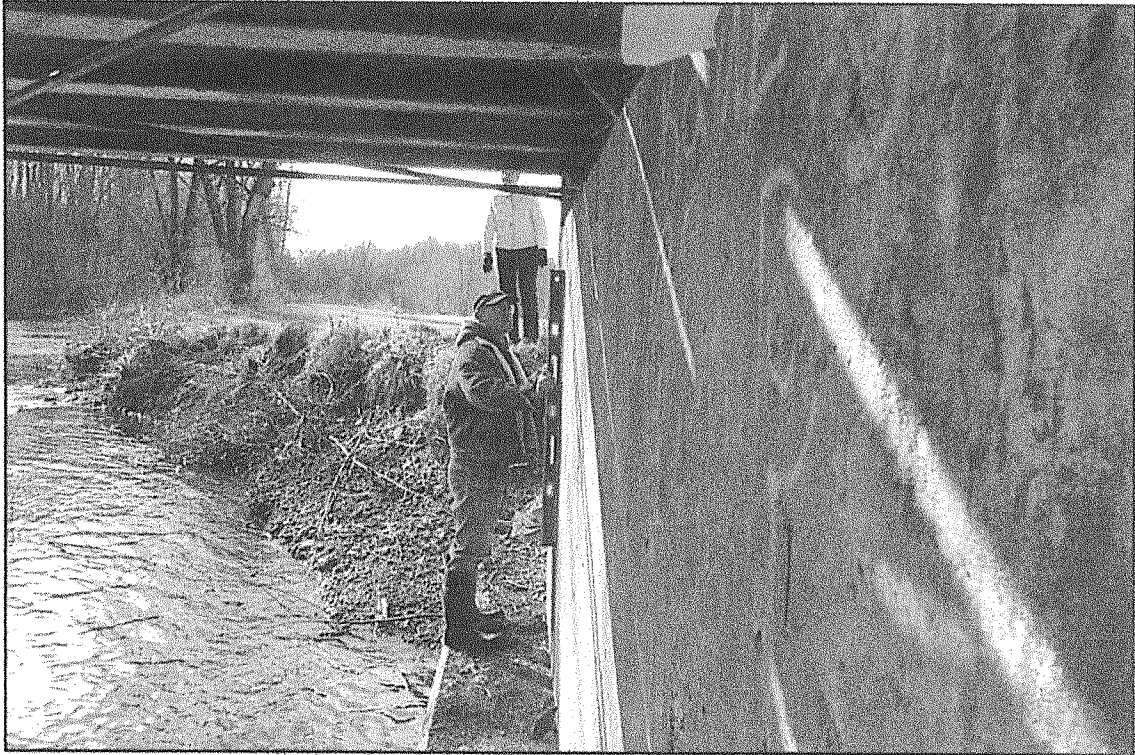
**West Abutment looking southerly**

- c. Westerly abutment - Chip out concrete along upper edge at southerly end of abutment. Drill and grout two #4 rebars approximately 12” apart. Tie a #4 rebar to each dowel. Place a damp (drypack) concrete filling in void ensuring that the southwesterly bearing plate has full support.

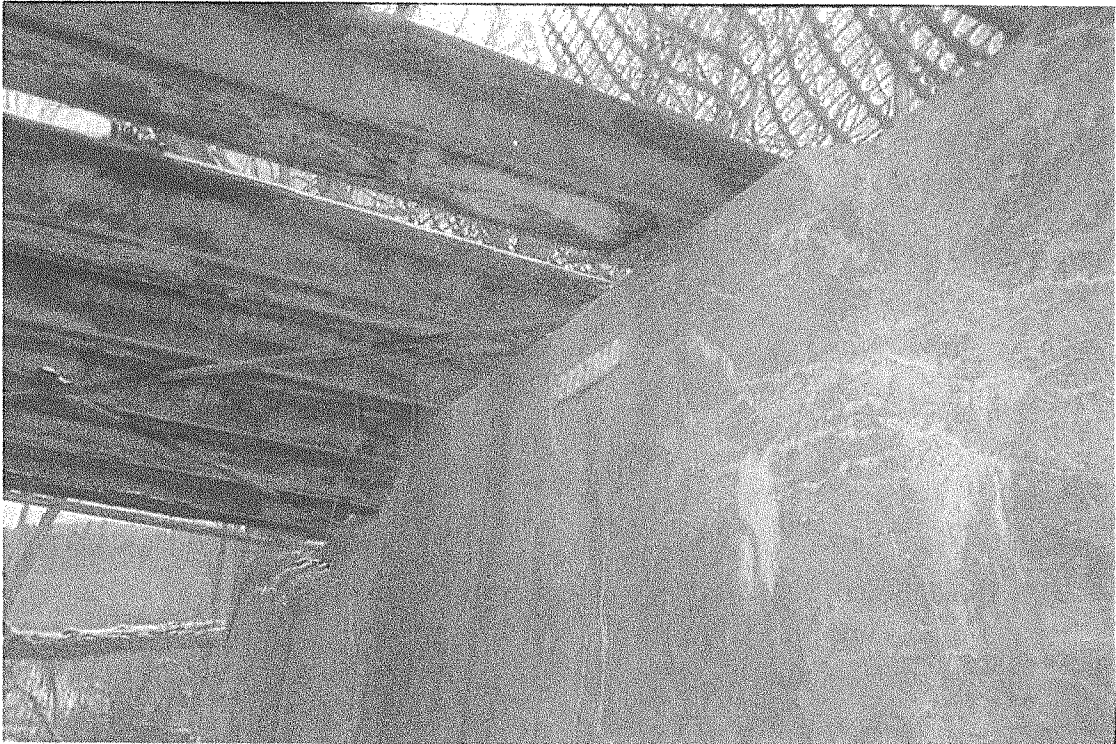
Abutments: the easterly abutment remains in same condition as 1995. Spalled concrete along top edge, hollow sounding area on vertical face in mid wall, probably due to some erosion behind concrete at boundary of original masonry wall. Wall is generally plumb except for buldge area at middle of wall. Concrete footing is intact and level with no signs of settlement or scour. This footing is the most susceptible to scour, as the stream turns to the right at this abutment. The westerly abutment has some spalling along the top edge. Wall is plumb with no signs of scour. Wingwalls of both abutments in good condition.

**East Abutment looking northerly showing chipping and hairline cracking**

- a. Easterly abutment – Inject grout, under pressure, to fill in apparent voids behind face of wall.
  - b. Chip out concrete along upper edge at northerly and southerly end of abutment. Drill and grout two #4 rebars approximately 12” apart. Tie a #4 rebar to each dowel. Place a damp (drypack) concrete filling in void ensuring that each bearing plate has full support.

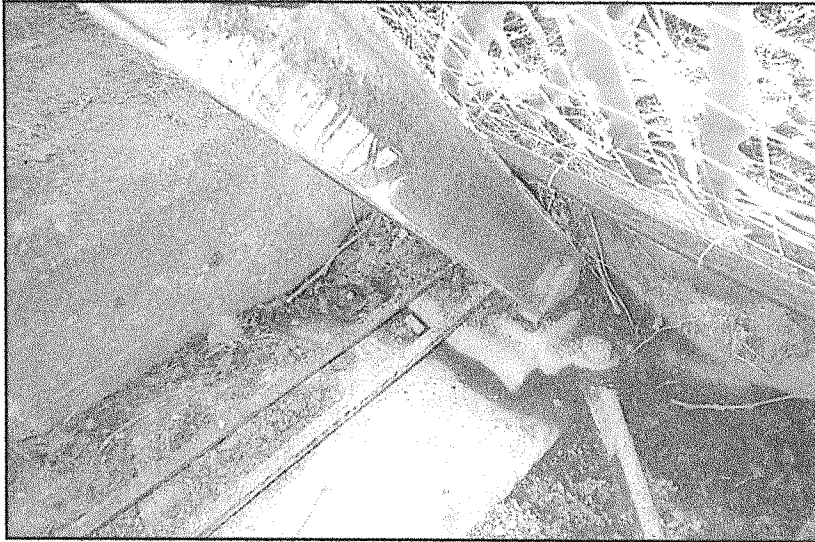
Northeast Bearing Detail  
Bearing and truss end chord  
hard up against concrete  
backwall. Roller ineffective.

Lower chord tension rods  
show some loss of section  
near ends.

Concrete spalling at face of  
abutment. Bearing area  
good.

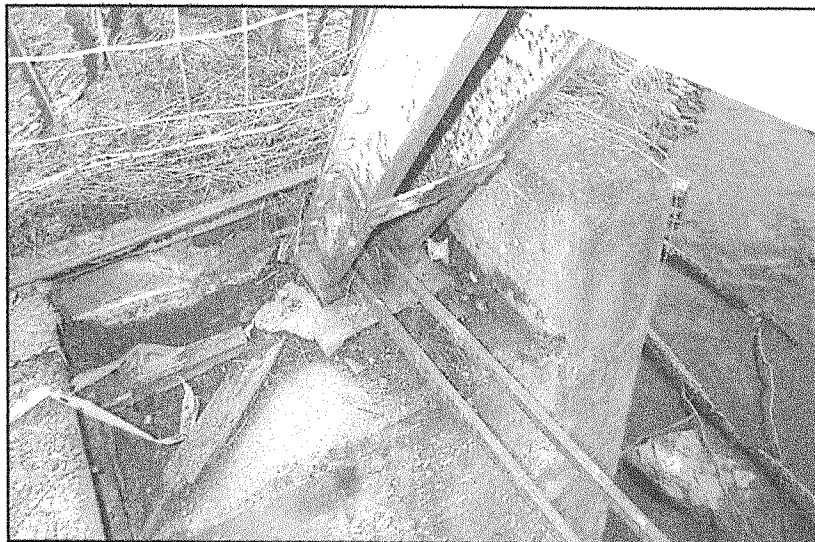
Northwest Bearing Detail

Lower chord tension rods  
show some section loss.

Diagonal underdeck bracing  
repaired with welded loop  
added at an unknown date.

Concrete in good shape.

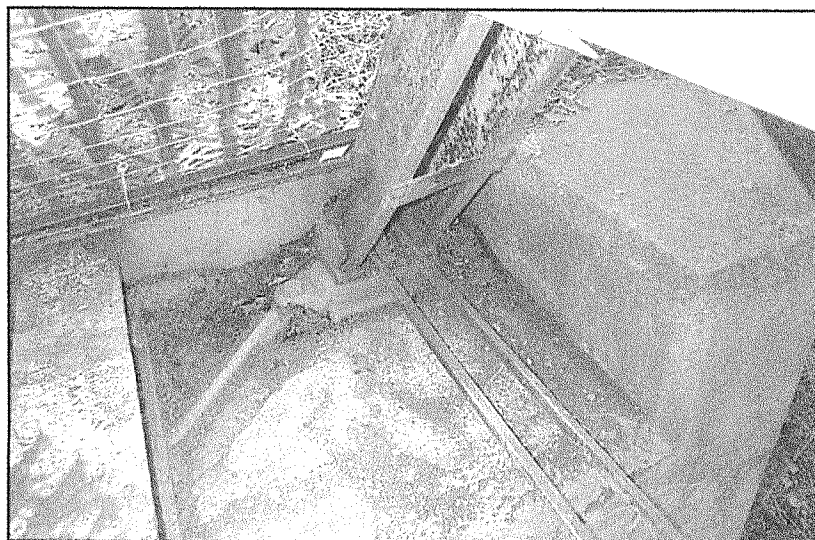
Southeast Bearing Detail

Lower chord tension rods  
show some section loss.

Bearing hard against  
backwall. Roller bearings  
ineffective.

Concrete in good shape,  
some spalling at edge.

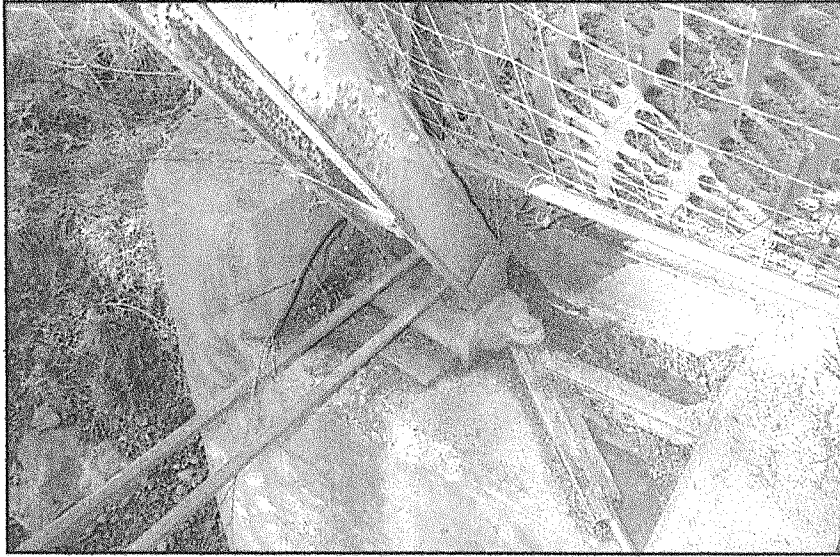
#### Southwest Bearing detail

Little section loss of tension bars. Diagonal bracing bars updated with welded loop.

Concrete broken at top edge of abutment extending to base plate.

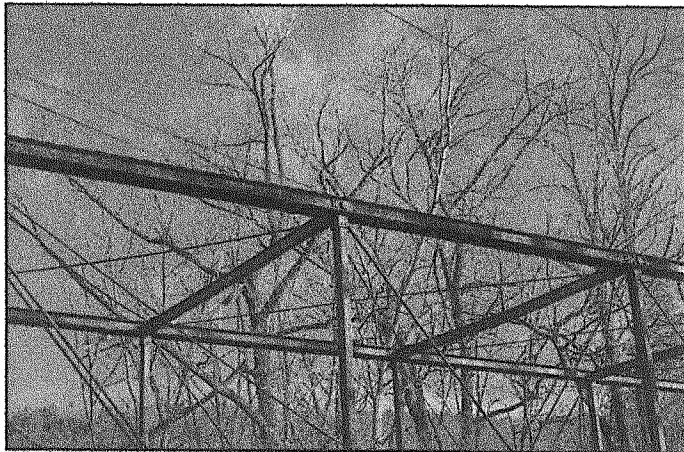
U4 Upper Chord Connection and cross bracing

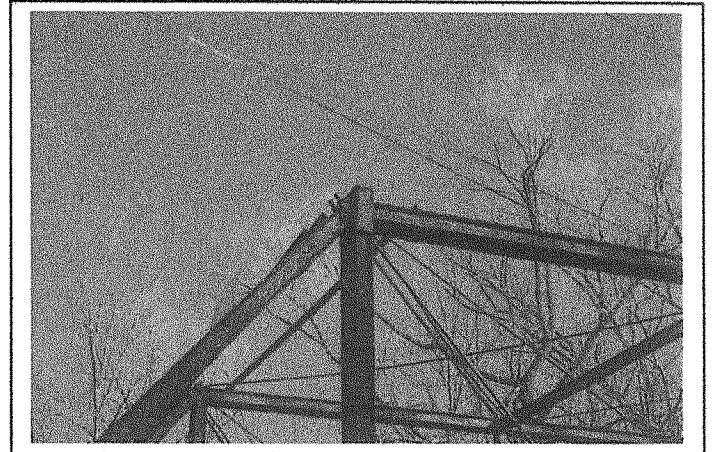
U5 South End post and upper chord detail

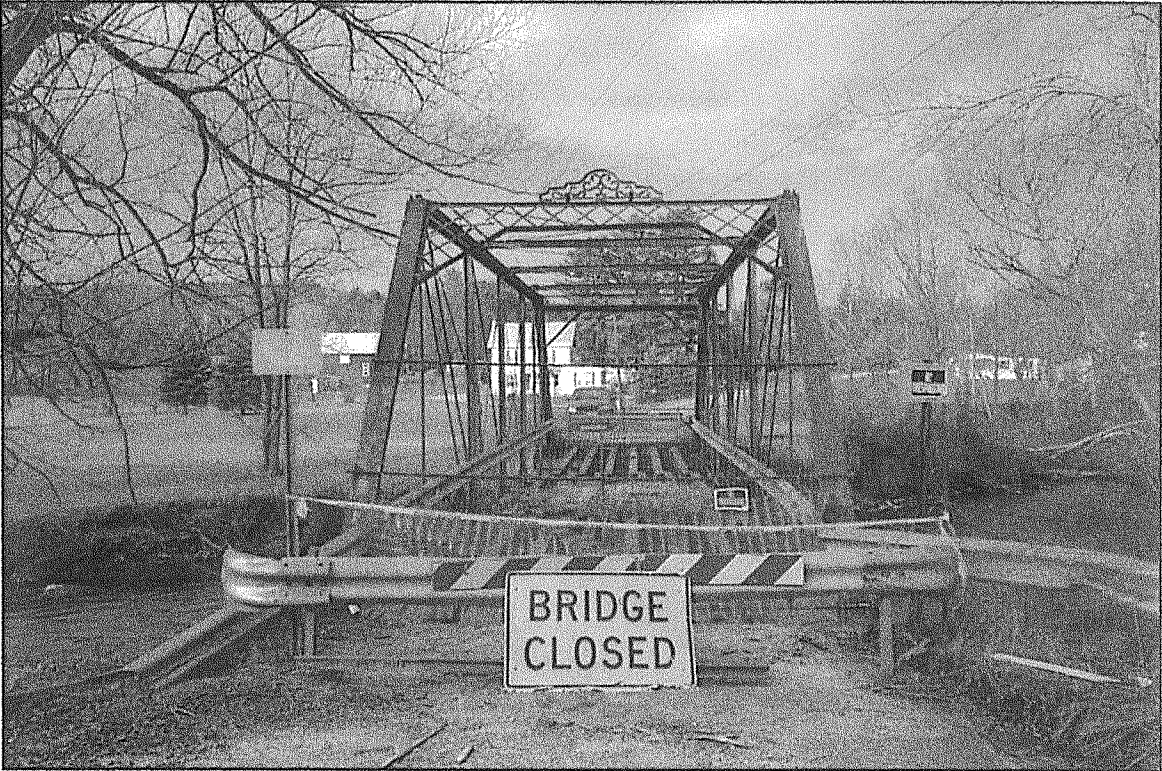
East Portal

1. The easterly portal has been replaced with welded steel members.

not an original design feature it is apparently performing its role to keep the trusses vertical and parallel. As such it should be cleaned and painted with a primer and two coats of paint since it is built up with steel members that corrode and welds that corrode rapidly in the atmosphere. The easterly portal is in good condition and needs no work other than a possible cleaning and painting. This work can be done now or postponed to some future time. In order to maintain a similar appearance it may be wise to paint both portals at this time.

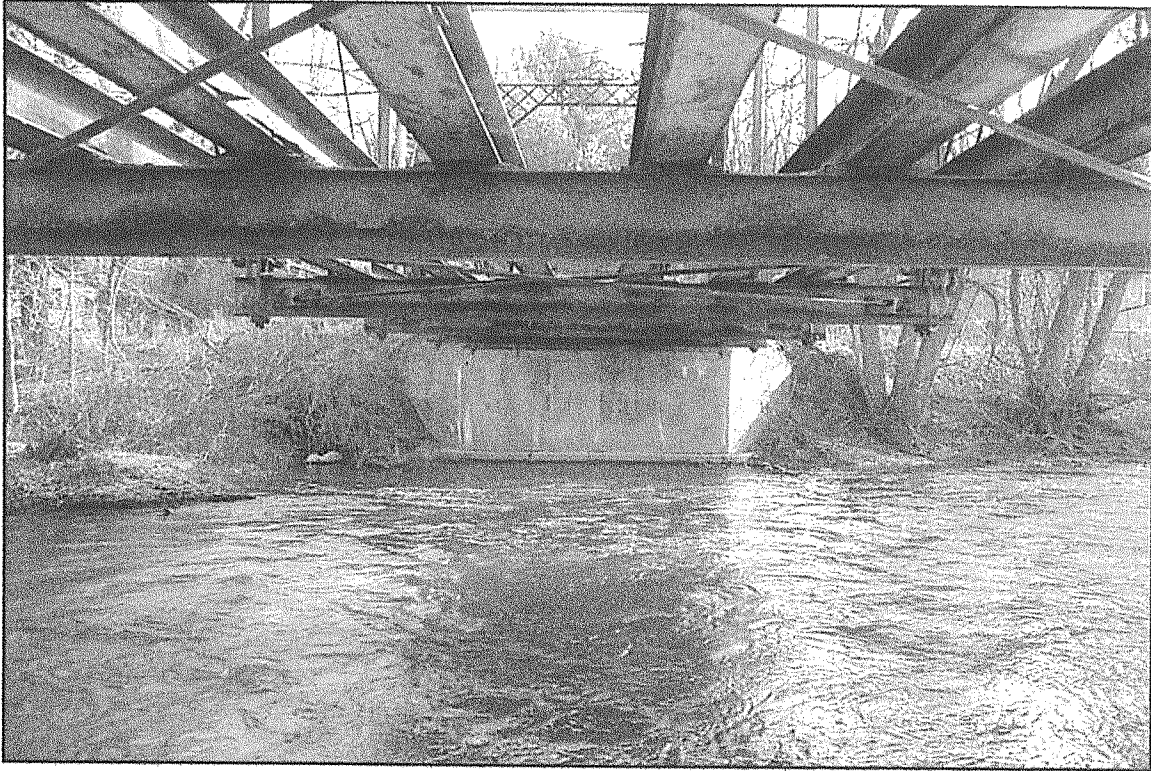
Cross beams, stringers and diagonal bracing

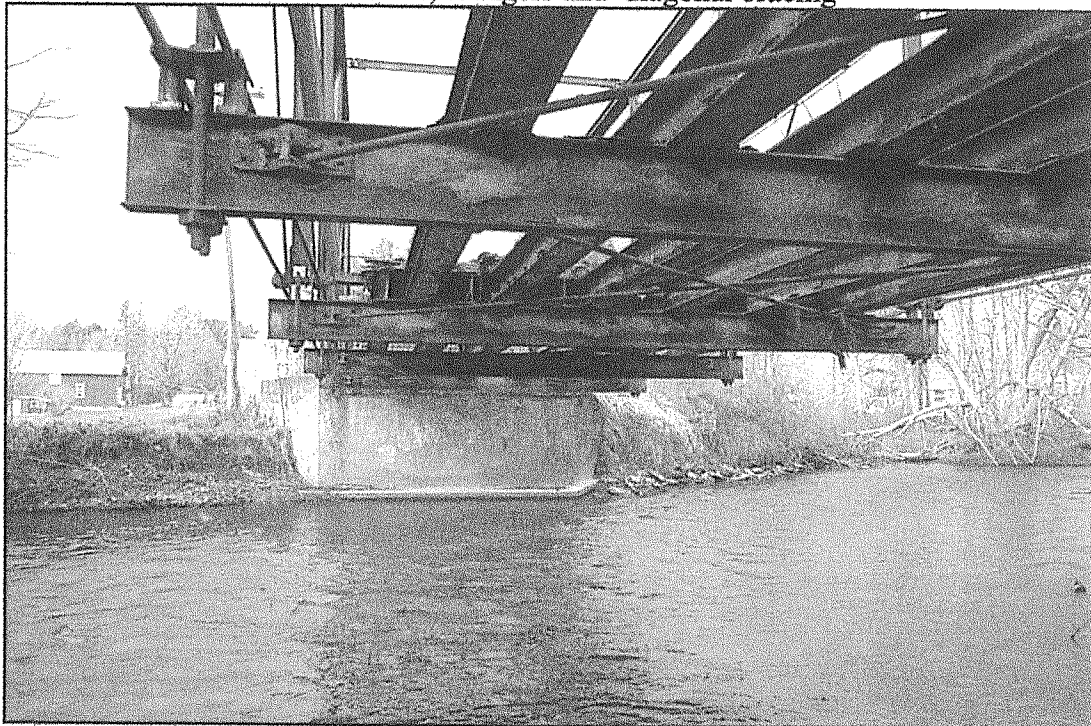
Underdeck framing and joint L1 South Looking westerly
