The Oxford Road Bowstring Arch Truss is a bridge engineer's equivalent to putting on last year's winter coat and finding a crumpled ten dollar bill in the pocket. Discovering this historic structure provided the opportunity to glimpse into the past, and enjoy the craftsmanship that is difficult to find on modern bridges. The bridge went from an ignored, run down old structure buried in the woods to a practical, useful structure serving as a reminder that we don't build them today like they used to.

By Brian Rhodes, P.E.

Structure Background

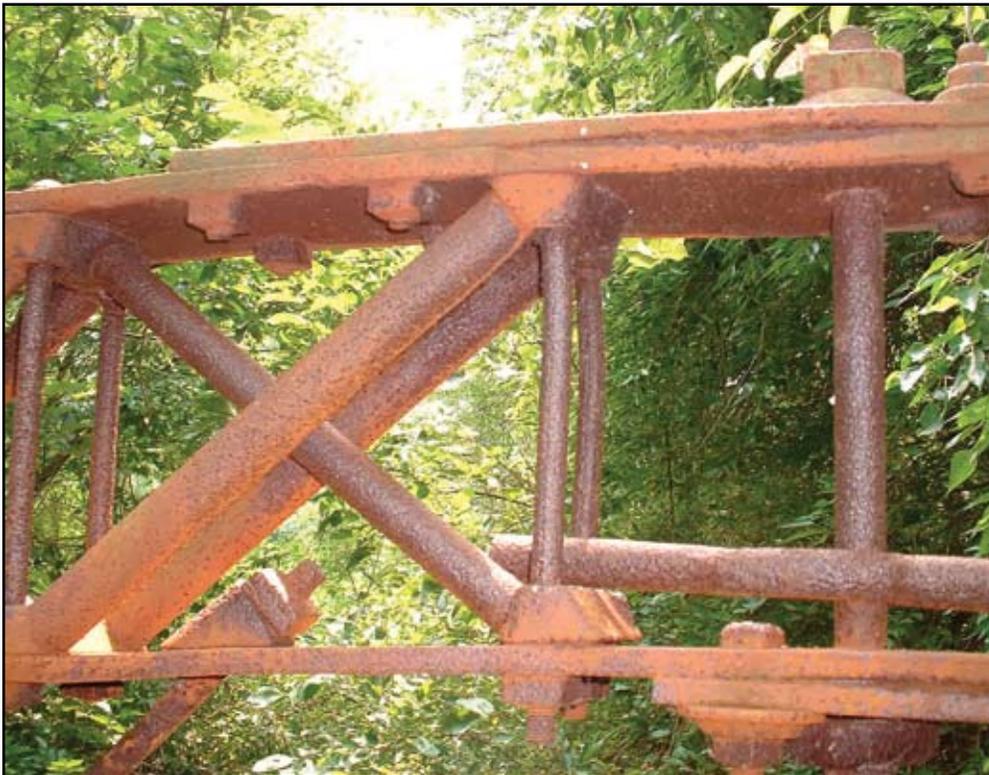
Figure 2: Arch detail at mid-span splice prior to rehabilitation.

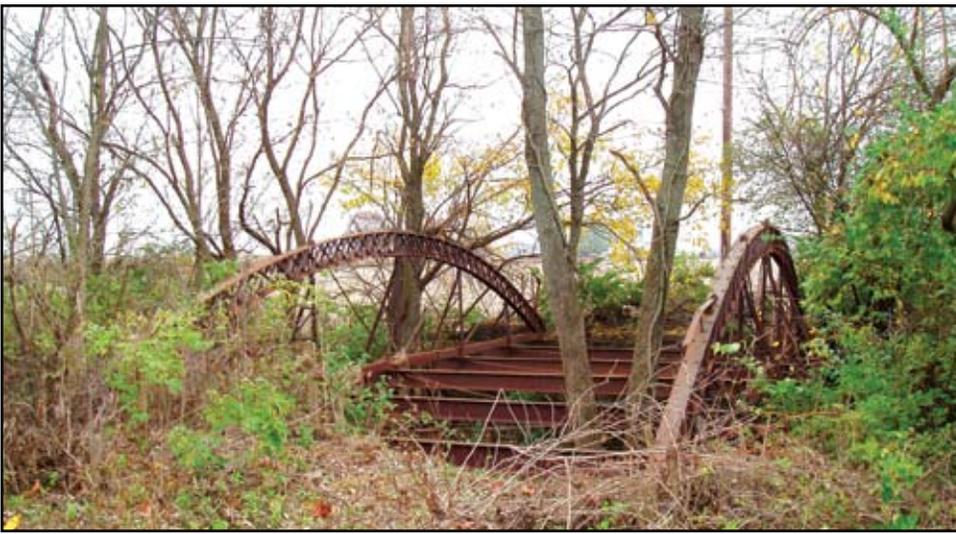
Figure 3: Structure as discovered adjacent to Oxford Road.

The first phase of the structural evaluation and design involved a detailed inspection of the existing bridge. No maintenance had been performed on the bridge, no deck was in place, heavy vegetation and full size trees were growing between the floorbeams, and some members were missing (Figure 3). Of particular interest, the external bracing was missing at one of the floorbeams, and the railings, once located at the four bridge corners, were mostly gone. Parts of one of the railings remained, offering a glimpse as to what the original railing may have looked like. Many of the members had failed. The diagonal bracing connection at each floorbeam had failed in two locations. The hollow compression tubes that make up the arch section were mostly in tact. It was obvious, however, that during the sandblasting required for rehabilitation, additional deterioration would be revealed that was not readily visible in the field.

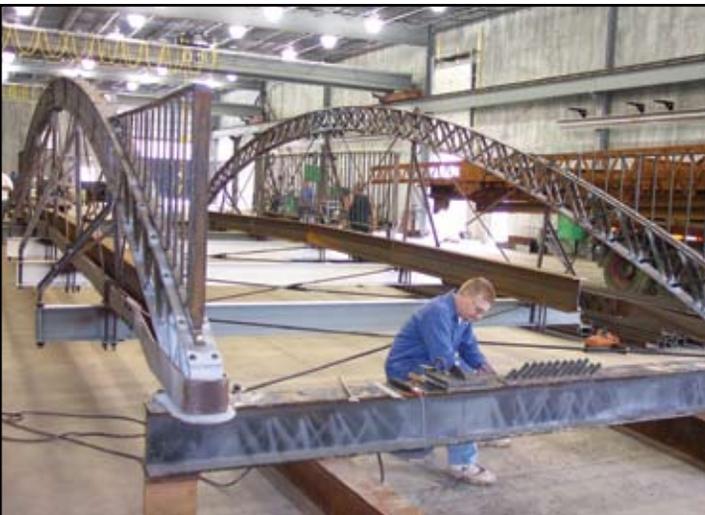
Figure 4: Bridge under rehabilitation at Ohio Bridge Corp.

The contractor awarded the job of arch rehabilitation and construction was the Ohio Bridge Corporation of Cambridge, Ohio. This company has a background in historic bridge restoration, making them a perfect fit for this project. Tom Brayshaw noted, "Ohio Bridge seemed to take real pride in restoring historic bridges." As with any restoration, the preferred option is to save the original bridge components. For bridge components where this was not possible, Ohio Bridge fabricated new steel pieces. Ohio Bridge also fabricated the railing to be placed on the bridge. The original structure had only remnants of bridge railing at each corner. To meet code, a new railing would need to be fabricated for the entire structure length. The new railing was designed and detailed to resemble the makeup of the original railing, while still meeting code requirements for clear openings (Figure 4).

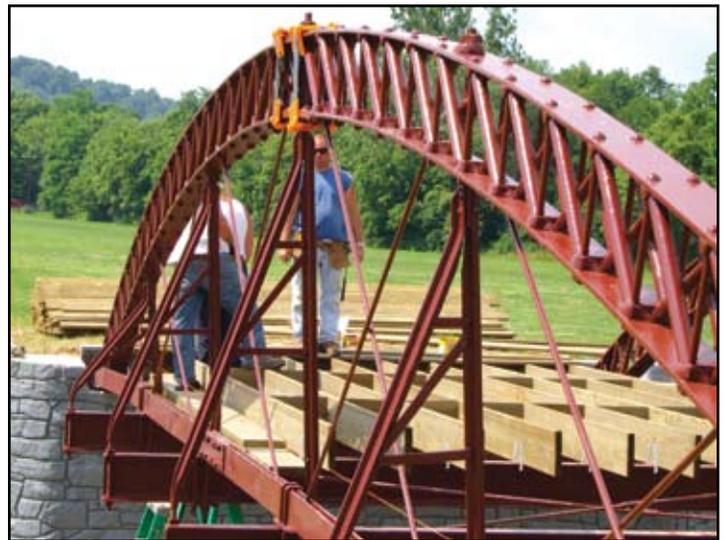
Figure 5: Relocated bridge receiving deck.

The bridge was trucked to the new site, and dropped into place. Timber stringers, decking, and blocking were placed on top of the floor-beams (Figure 5). A timber curb on each side provided a place to mount the new railing (Figure 6). The bridge was dedicated on September 16, 2006. The structure received a County Engineers Association of Ohio Historic Preservation Award, and is being considered for others. ■

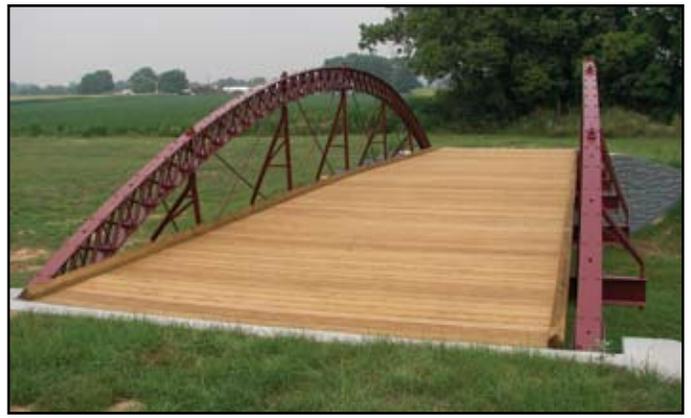
Figure 6: Relocated bridge prior to trail construction and railing installation.
