Sgt. Aubrey Cosens V.C. Memorial Bridge over the Montreal River at Latchford

Investigation of Failure: Final Report

December 1, 2003

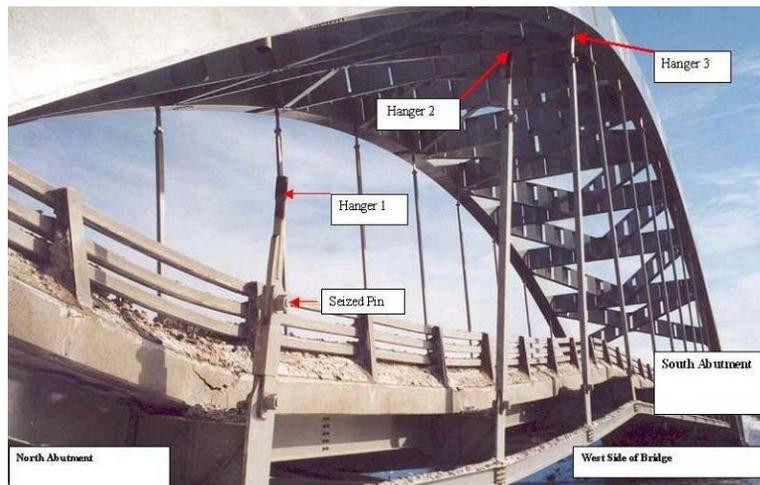
Figure 1: Northwest Corner

- The first three hanger rods (NW) were fractured (See Figure 1)
- Connection plate between floor beam 1 (NW) and exterior stringer was fractured. Some corrosion was noted on fractured surface. (See Figure 4).
- Deck had deflected approximately 2 metres
- Extensive cracking in concrete deck at North end
- Many of the bolts connecting the stringers to the floor beams had failed as a result of the deck deflection
- Several stringers and wind brace members had twisted
- Some spalling of concrete at abutment wall, where stringer ties into abutment
- Some cracks in abutment wall

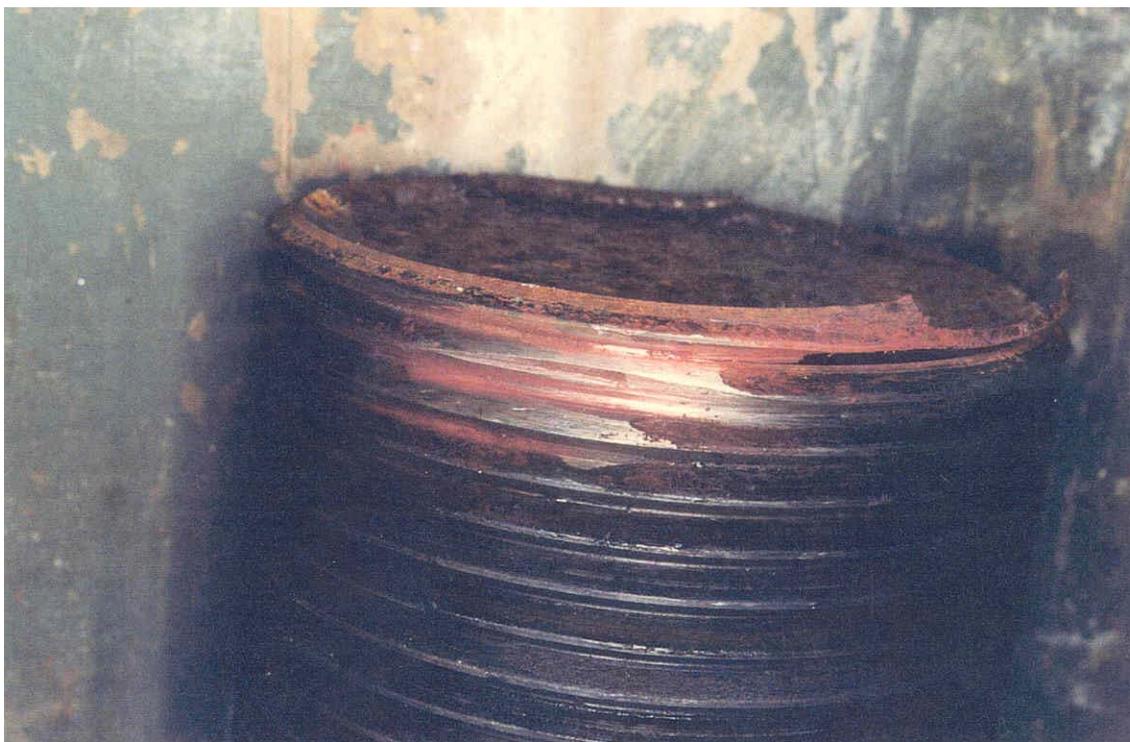
Another contributing factor to the failure relates to defects found on some of the hanger rods. As described in Appendix B, the metallurgist discovered defects in Hanger 1 (NW), when the nut was removed from the threaded rod. Close examination revealed that two-thirds of a thread may have been ground away (probably during construction in 1960), in an unsuccessful attempt to remove defects in the thread (See Figure 2). The defects were not visible once the nut had been placed on the threaded rod. The metallurgist confirmed that the fatigue cracks started at this location. These defects, combined with the seized pins, led to the propagation of the fatigue cracks in Hanger 1 (NW). Fatigue cracks also developed in other hanger rods as is discussed in Sections 6 and 7. However, these cracks propagated more slowly than in locations where defects were found in the threads.

Figure 2: Hanger 1 (NW) – Shiny Area - Ground down threads.

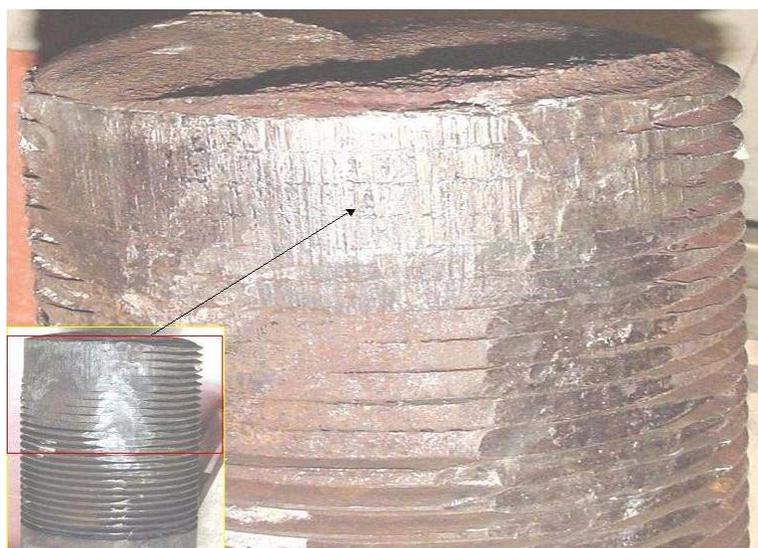
There is additional evidence to suggest that Hanger 1 (NW) had been fractured for several years prior to January 2003. The threaded part of Hanger 1 (NW) shows signs of abrasion and wear caused by rubbing against the steel sleeve (up and down motion), as traffic crossed the bridge (See Figure 3). The wear pattern on the hanger indicates that the vertical deflection of the hanger with respect to the sleeve occurred in two stages. Wear on the upper part of Hanger 1 (NW) is more pronounced and occurred over a longer period of time (It started when Hanger 1 (NW) fractured). Wear on the upper part of the hanger was measured to be about 30 mm along its length. The wear on the lower part of the threads is not as pronounced and occurred over a shorter period of time. (It started when Hanger 2 (NW) fractured). Total wear on the hanger was measured to be about 100 mm along its length. These abrasion values are consistent with the theoretical Live Load deflection values determined using structural analysis (See Section 9 and Appendix D).

Figure 3: Hanger 1 (NW) – Threaded Area Showing Signs of Wear, Abrasion, and Impact Damage

Hanger 1 in the NW corner showed signs of abrasion and wear (described in Section 3 above). Appendix B describes total wear length of 100 to 170 mm that includes some impact damage to the threads that was caused at the time of collapse. Appendix A only considers the length of the hanger subjected to wear (60 to 75 mm). This explains the reason for the length of the total abrasion and wear being different in Appendices A and B.

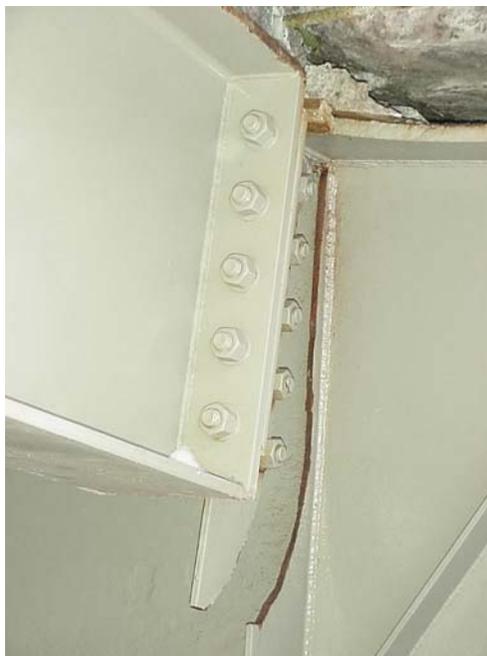
Corrosion product analysis of the fast fracture face of Hanger 2 (NW) indicates that there is a high probability that Hanger 2 (NW) had failed 1 to 3 years prior to January 14, 2003. Fatigue cracks likely started in the connection plate between Stringer 1 and the first floor beam (NW) after Hanger 1 had failed (See Appendix B). Analysis of the corrosion product on the stiffener face indicates that the fatigue crack progressed through the bolt holes over a period of several years (See Figure 4). The fatigue crack extended through 85% of the stiffener cross-sectional area. The very light corrosion on the final fast fracture surface (about 15 % of the cross sectional area) indicates that it probably completely failed on January 14, 2003 (Time of partial collapse of deck).

Figure 4: Exterior stringer to floor beam #1 connection (NW corner)

Corrosion product analysis of the fracture face of the stringer connection plate indicates that the fatigue crack progressed through the bolt holes over a period of several years. (See Appendix B). The fatigue crack extended through 85% of the stiffener cross-sectional area. The very light corrosion on the final fast fracture surface (15 % of the cross-sectional area) indicates that it probably completely failed on January 14, 2003 (Time of partial collapse of deck). It is suspected that the cracks in the plate started after Hanger 1 (NW) had failed (5-7 years ago).

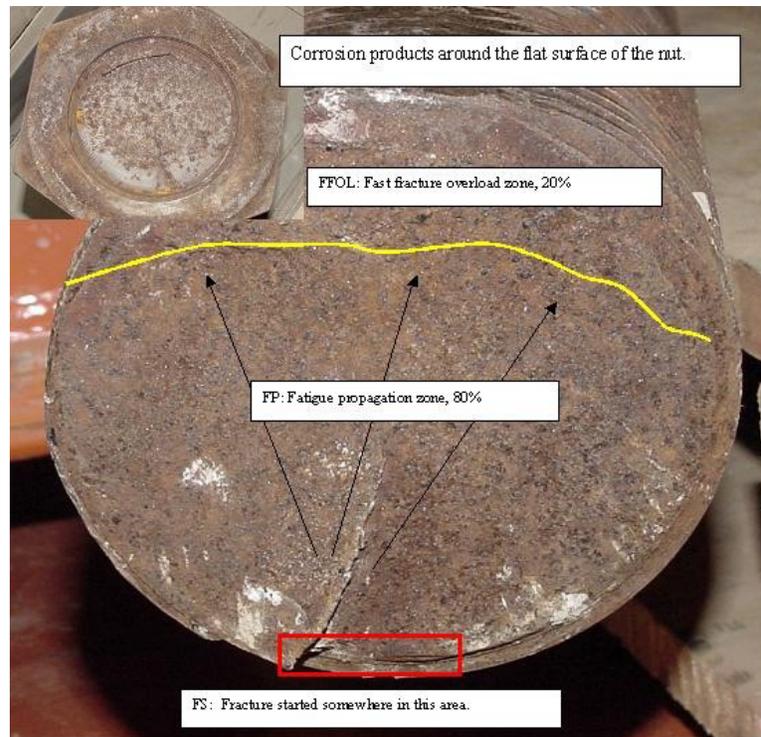
Examination of the fracture faces of Hangers 1, 2 and 3 (NW) revealed two distinct surfaces across each fractured face: a smoother surface where the fatigue crack propagated and a coarse/grainy surface where the fast fracture occurred (See Appendix B). Figure 5 shows the fractured face of Hanger 1 (NW). By examining the fractured faces of the 3 hangers, the metallurgist concluded that a fatigue crack covering 80% of the face for Hanger 1 (NW), 60% of the face for Hanger 2 (NW) and 30% for Hanger 3 (NW) existed prior to final fracture. The fact that the Hanger 1 did not fail until the crack had progressed through 80% of the section, shows that the hanger rods did have a significant factor of safety for carrying traffic loads. Hanger 2 (NW) failed with a smaller percentage of the section cracked since the load on this hanger increased when Hanger 1 (NW) failed. The same pattern holds true for the failure of Hanger 3 (NW).

Figure 5: Hanger 1 (NW) – Fracture Face

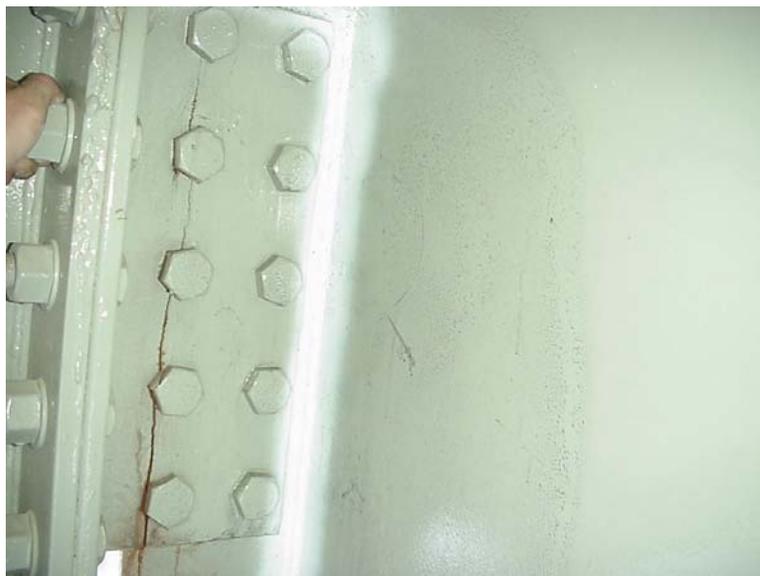
Additional non-destructive testing (See Appendix C – Part 2) has also been done on the remaining structural steel (floor beams, stringers, connections, bracing, etc). During this inspection, a crack was noted in the exterior stringer to first floor beam connection plate at the SW corner (See Figure 6 and Appendix C – Part 2) It is likely that the cracks started to form in this connection plate after Hanger 1 (SW) had failed (5-7 years ago as described in Section 6 and Appendix B). The inspection also revealed a few other minor defects as described in Appendix C.

Figure 6: Exterior stringer to floor beam 1 connection (SW corner)

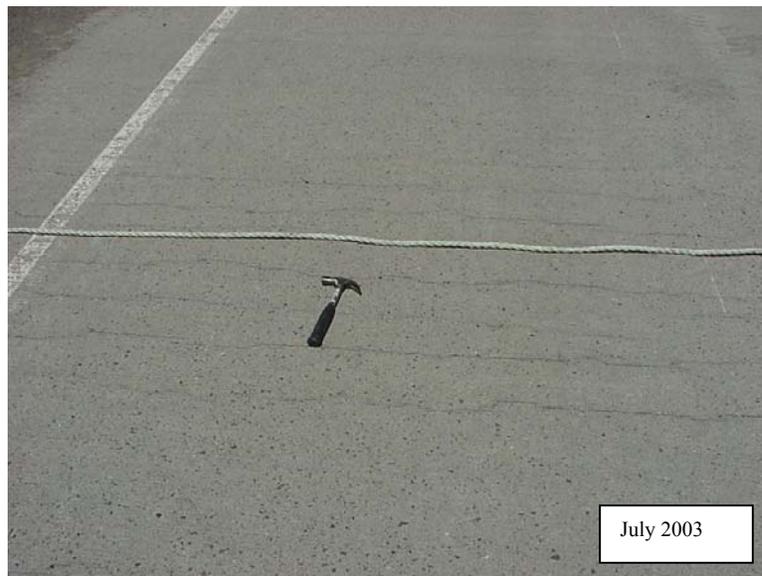
- Transverse cracks throughout deck (0.5 to 1.0mm wide) spaced at 2.0 to 2.5 metres with two cracks at each floor beam location (Close to flange locations).
- Seven transverse cracks (0.5 mm wide, spaced at 200mm) on the western half of the deck, over floor beam 2 (SW corner). Also three transverse cracks in curb. (See Figures 7 and 8).
- A crack and rust staining in the connection plate between stringer 1 and floor beam 1 (SW corner). See Figure 6.
- Sag in handrail and exterior wind bracing at southwest corner (See Figures 9 and 10).
- Some corrosion at pin hanger/bracket interface at several locations (See Figure 11).
- Distortion of some of the washers at the pin/hanger bracket interface (See Figure 12).

Figure 7: Transverse cracks in deck over Floor beam 2 (SW corner)

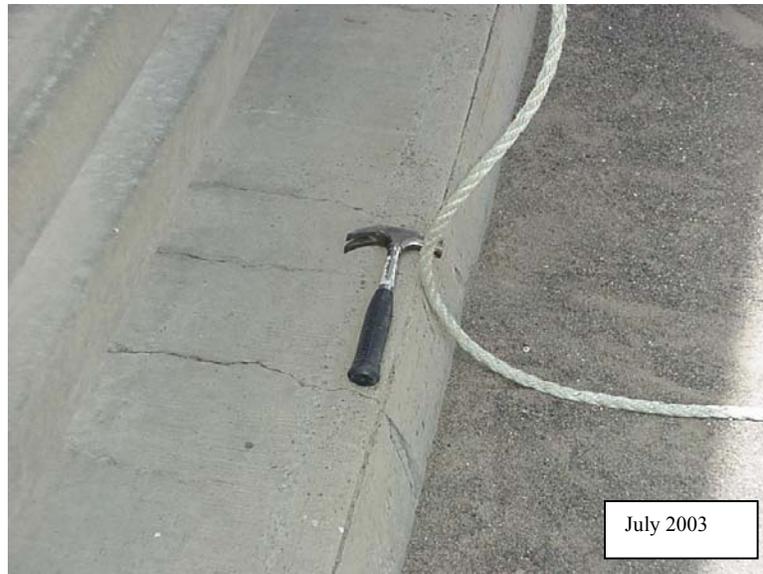
Figure 8: Transverse cracks in curb over Floor beam 2 (SW corner)

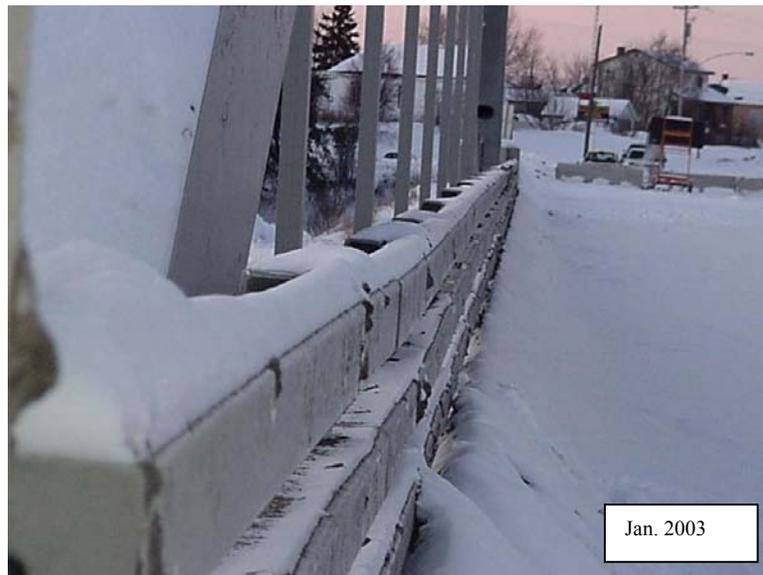
Figure 9: Sag in handrail (SW corner)

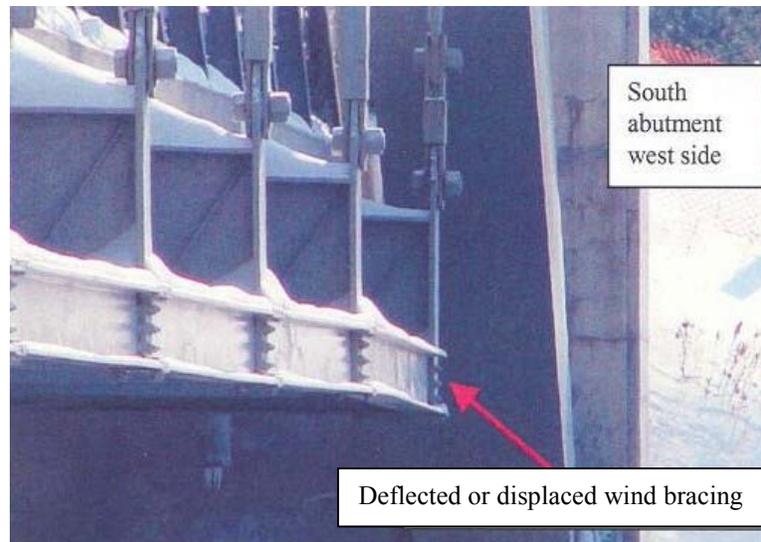
Figure 10: Deflected wind brace (SW corner)

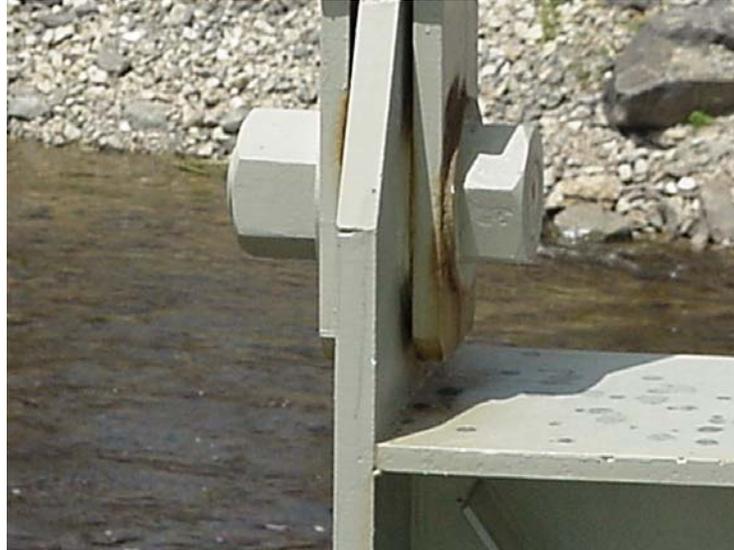
In reviewing the design drawings, it appears that the hangers were originally designed to be free to rotate, about a transverse axis, at the top and bottom through pins. However, recent inspections during the investigation (See Sections 8 and 10) indicate that some of the pins had seized, thus preventing rotation. Once the pins had seized, the hanger rods were subjected to repetitive bending stresses as traffic moved over the bridge. Since the hangers were never designed to resist bending stresses, fatigue cracks subsequently developed in the hangers, and after a period of time, eventually fractured.

Figure 11: Typical seized pin

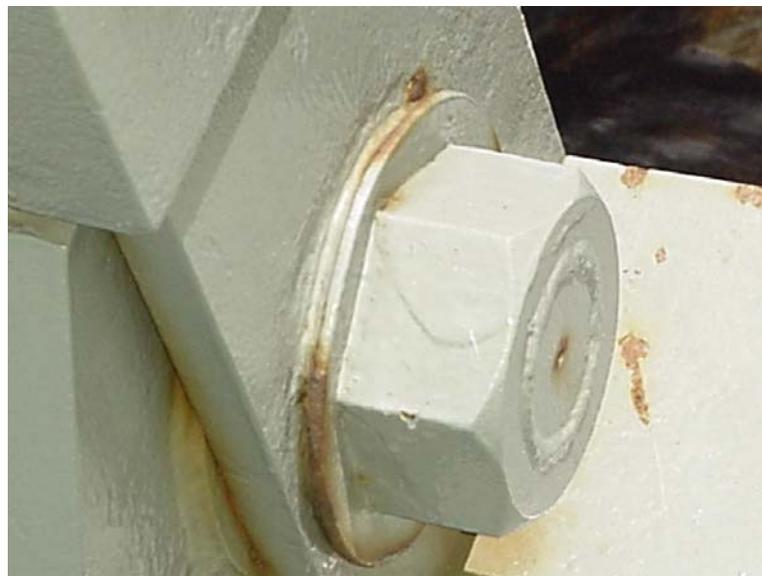
installation (even though the required tightness was not specified on the original contract drawings). The washer distortion could also have been caused by crevice corrosion behind the washer. In either case, rotation of the pin probably would have been prevented. Figure 12 shows the distortion of a typical washer. A number of washers displayed this characteristic.

Figure 12: Possible over-tightened nut or crevice corrosion causing distortion of washer.

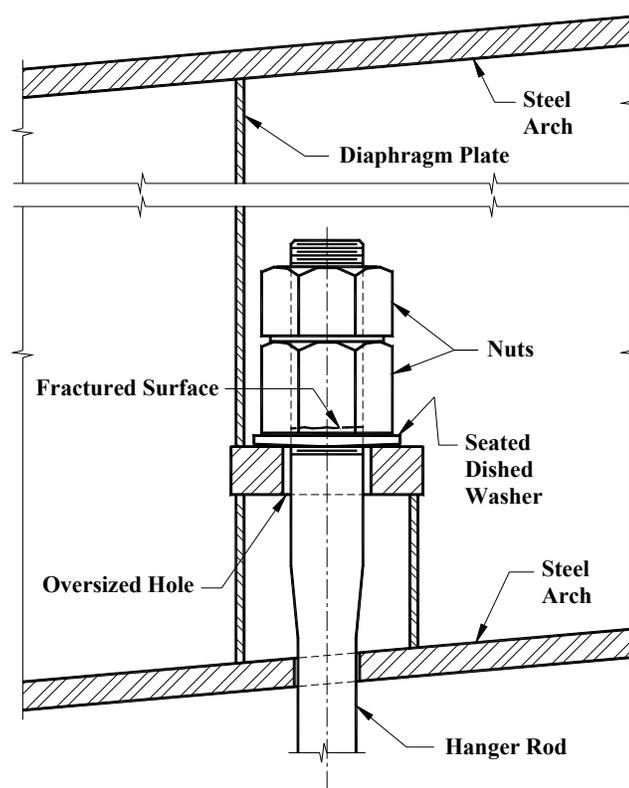
- The threaded rod detail has a poor fatigue stress range rating
- The critical part of hanger assemblies (threaded rods and nuts) were hidden from inspection since the end of the threaded rods were inside the arch
- The dished washers used at the underside of the nuts (inside the arch) did not allow rotation as originally intended. The over-sized holes in the arch caused the washers to seat themselves on the perimeter of each hole, thus restricting rocking or rotation of the hanger rods. The variable vertical stiffness of the hanger support detail, that results largely from the presence of a diaphragm plate to one side of the hanger support, also contributed to eccentric/flexural loading of the critical threaded region of the hanger rod (See Figure 13).

Figure 13: Dished washer used at top of hanger rod (Inside of steel arch)

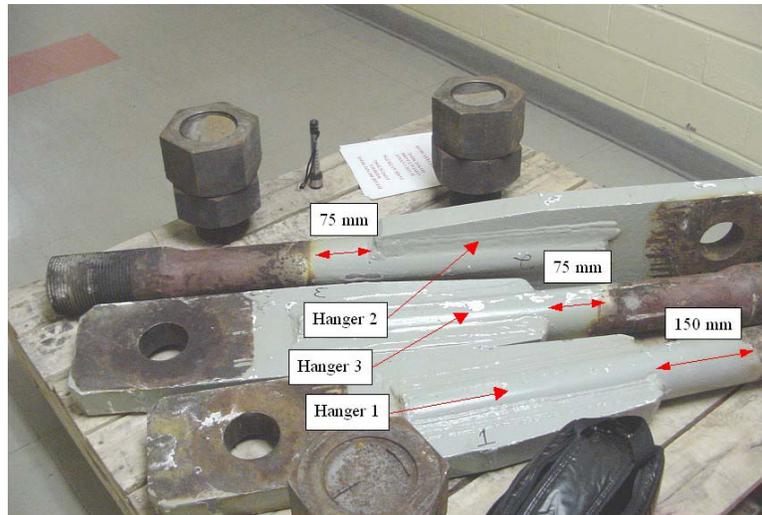
There is evidence to suggest that Hanger 1 (NW corner) was already fractured at the time of the painting contract. Figure 14 shows that the part of the hanger actually painted varies between Hanger 1 (NW) and Hangers 2 and 3 (NW). The length of the round rod that is painted is longer on Hanger 1 (NW) compared to Hangers 2 and 3 (NW). The painted portion of Rod 1, above the shoulder, was measured to be about 150mm. The same length on Rods 2 and 3 was measured to be about 75 mm (See Appendix B). This indicates that Hanger 1 (NW) had already dropped about 75 mm at the time of painting, and is consistent with the theoretical calculation of the sag of the deck (See Appendix D). This is also consistent with the 5 to 7 year timeframe of failure of Hanger 1 based on the age of the corrosion product on the fractured face. Although it is apparent that an additional 75 mm of Hanger 1 was cleaned and painted, the defect associated with this (i.e. fractured hanger) would not have been easy to detect by the personnel normally involved in the inspection of coating contracts.

Figure 14: Paint lines on NW Hangers 1,2 and 3.
