**County of Simcoe
County Road 44 Reconstruction
Environmental Study Report
Addendum – Hart Bridge**

October, 2011

**County Road 44 Reconstruction
Environmental Study Report
Addendum – Hart Bridge
October, 2011**

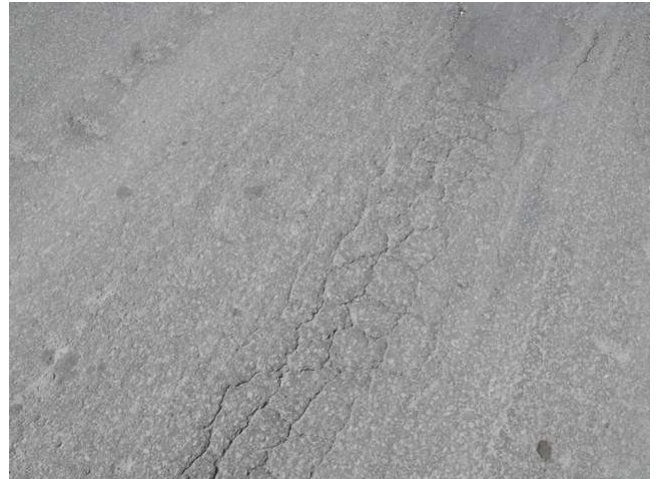
Top Surface. Showing deterioration.

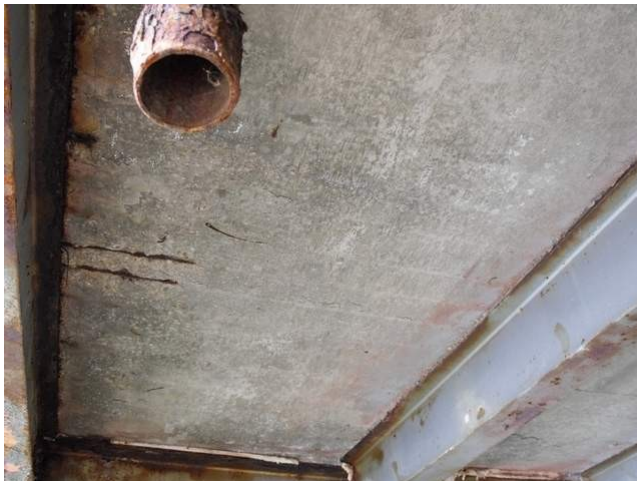
Underside Surface. Showing deterioration.

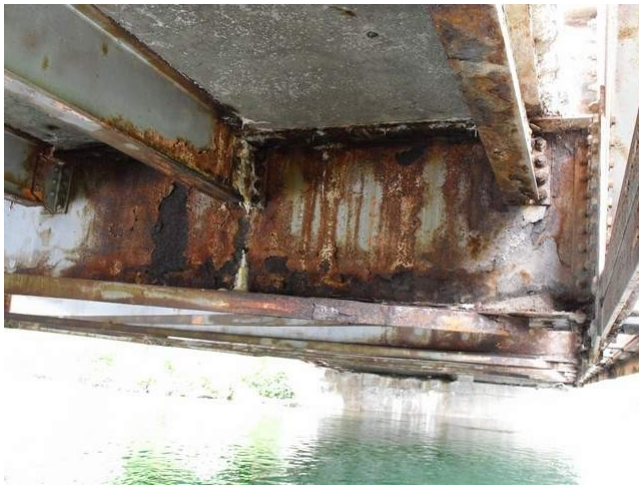
Underside Surface. Showing moisture penetration.

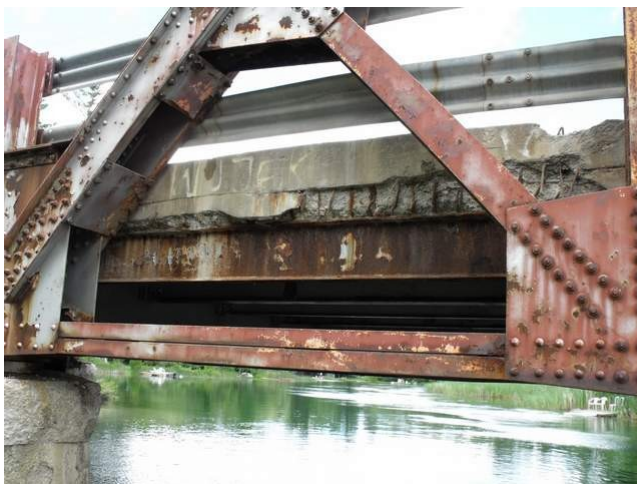
West Side. Showing very severe spalling.

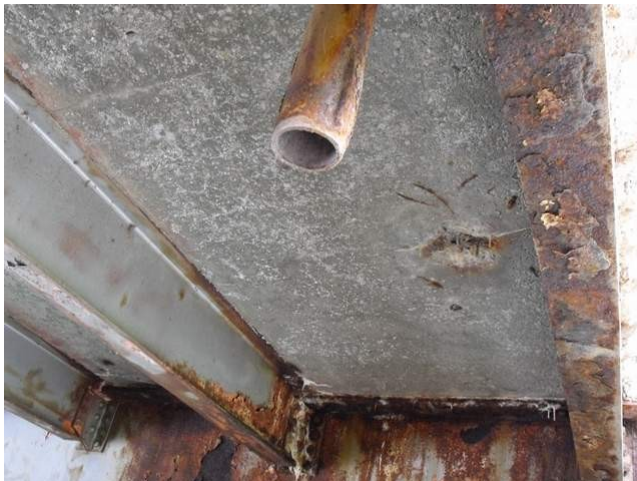
Underside Surface. Showing moisture penetration.

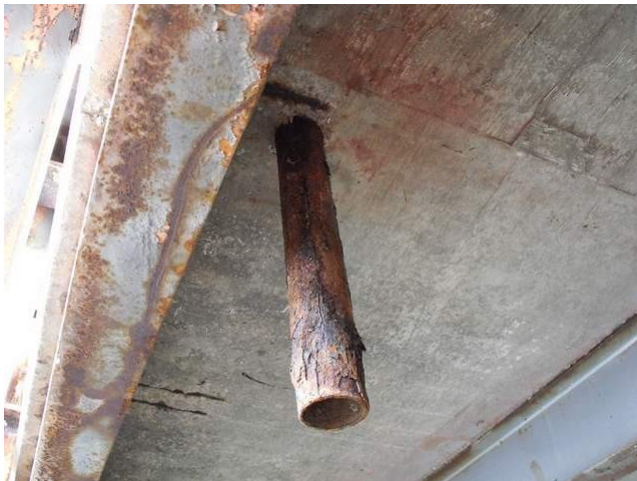
Underside Surface. Showing severe deterioration.

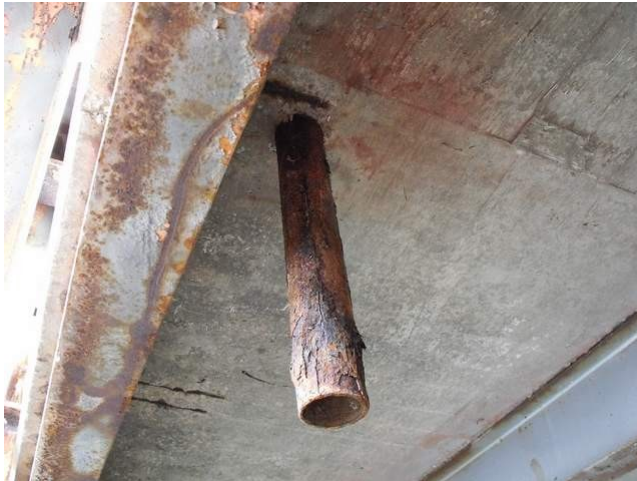
Underside View. Showing severe deterioration.

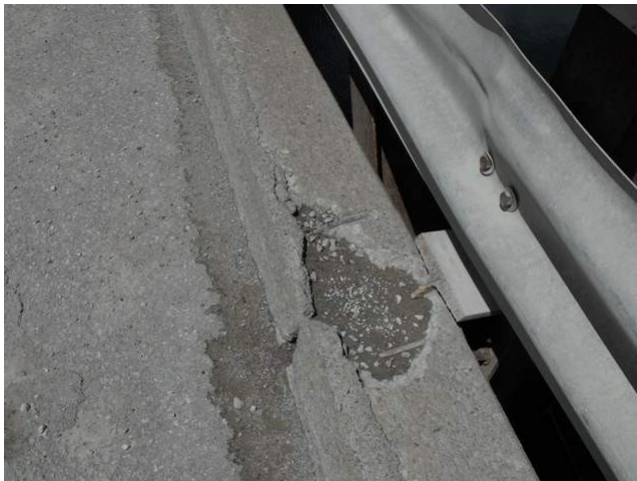
. Showing severe deterioration.

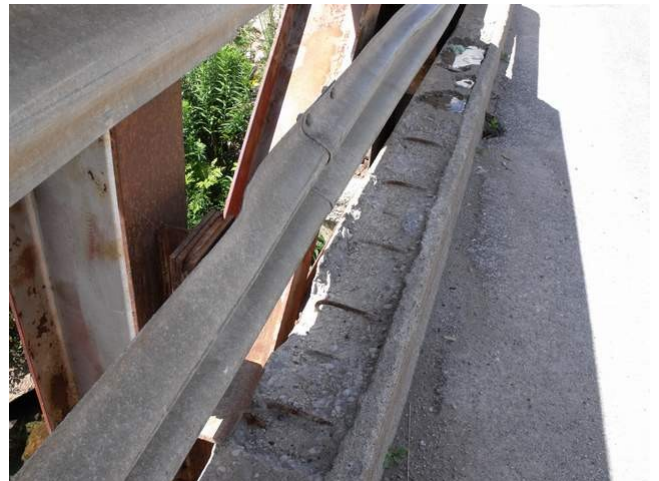
West Side. Showing severe spalling.

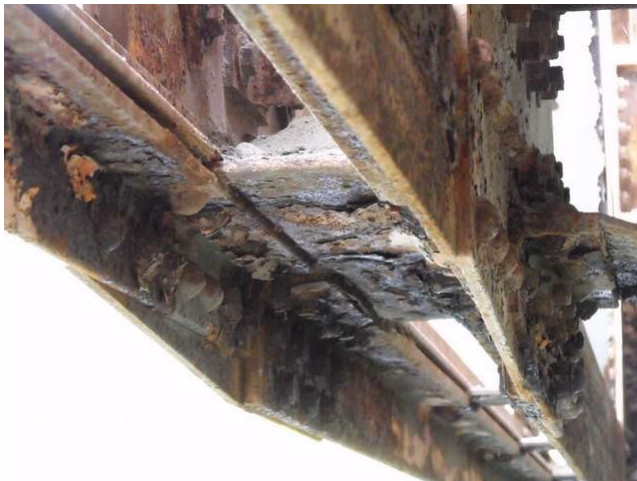
East Side. Showing severe corrosion.

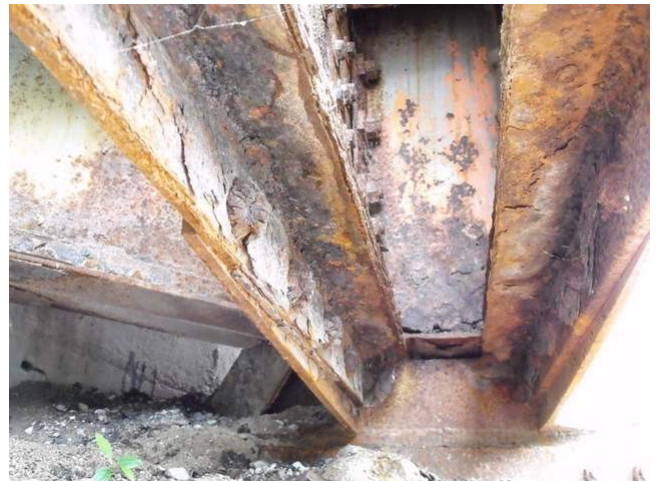
Northeast Side. Showing very severe corrosion.

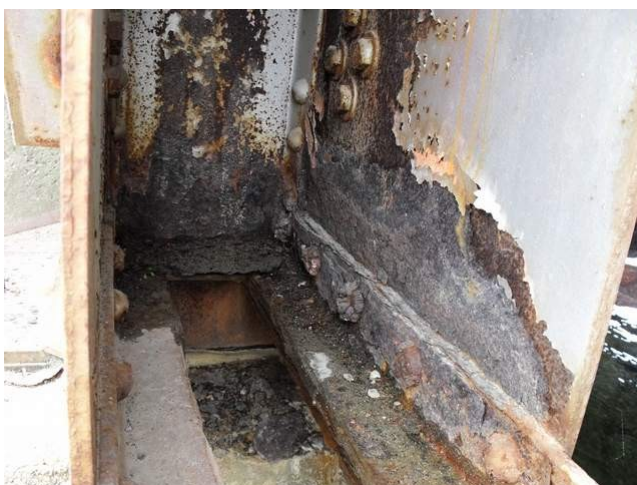
Southwest End. Showing very severe corrosion.

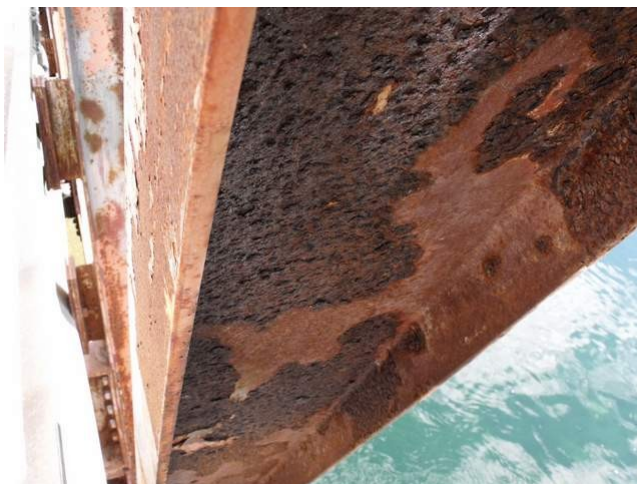
West Side. Showing isolated severe corrosion.

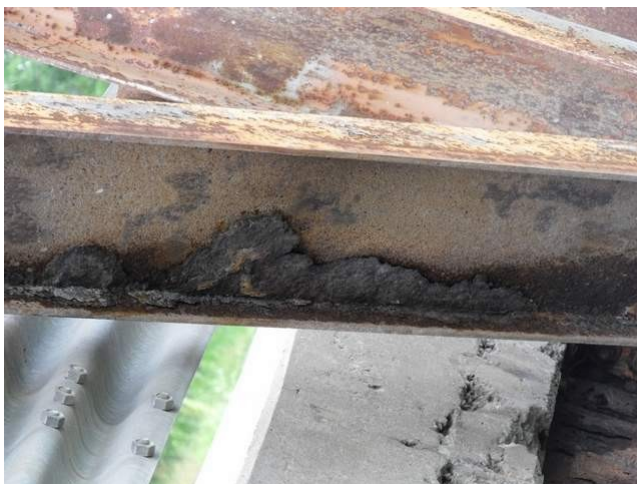
West Side. Showing isolated severe corrosion.

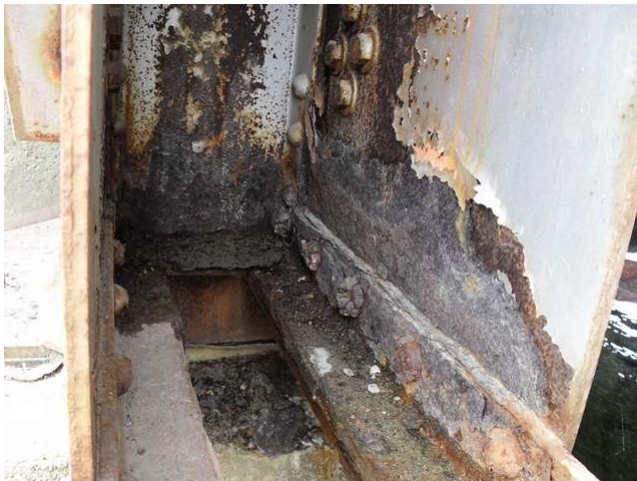
East End. Showing very severe corrosion.

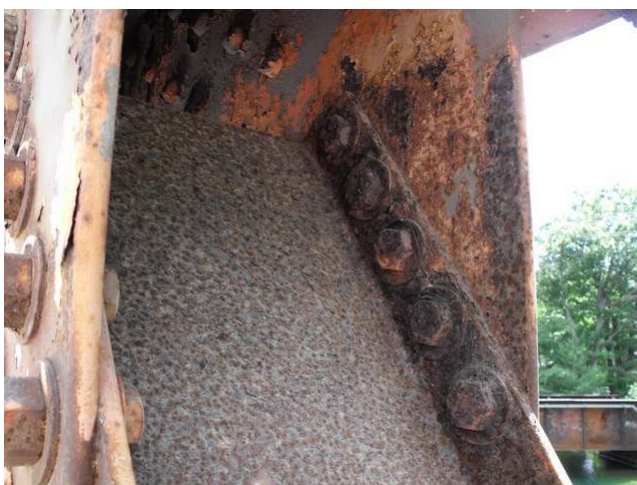
West Side. Showing severe corrosion.

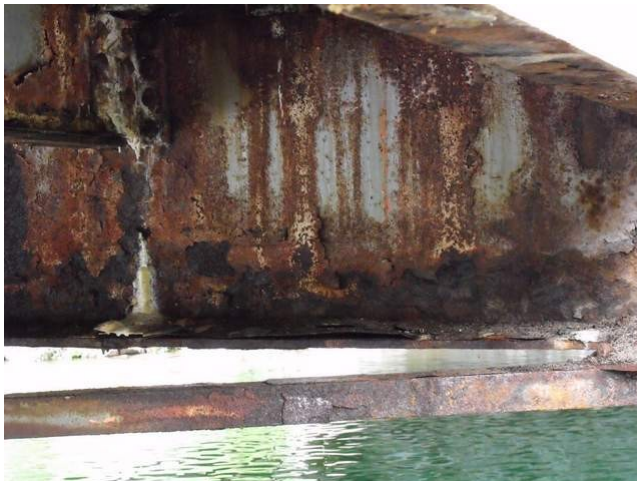
Underside Surface. Showing very severe corrosion.

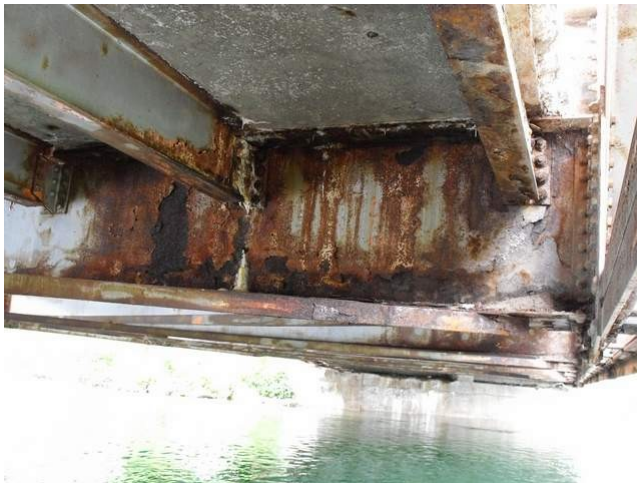
Underside Surface. Showing severe corrosion.

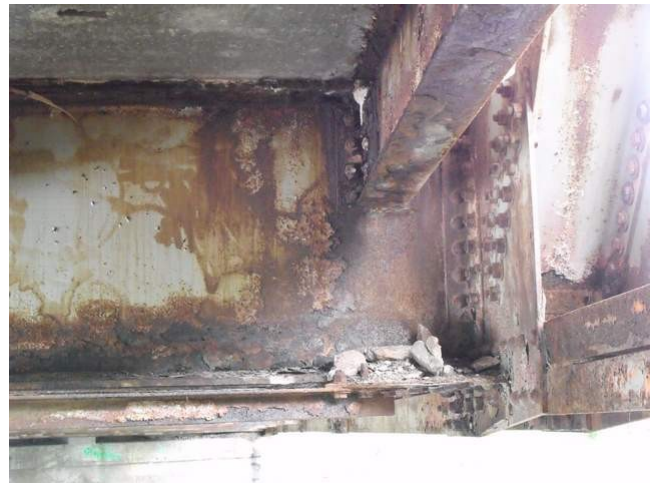
West End. Showing severe corrosion.

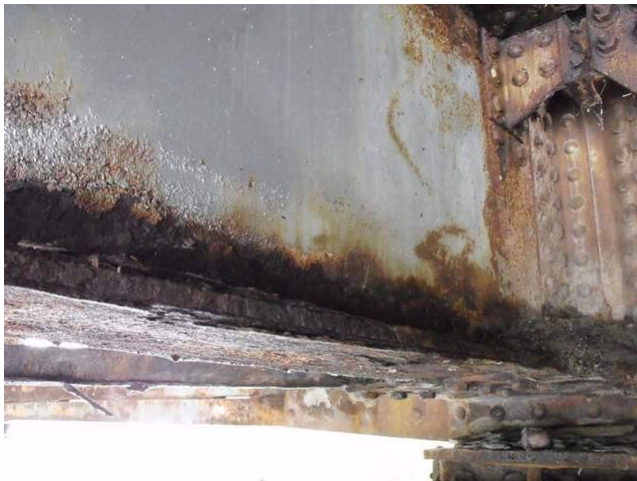
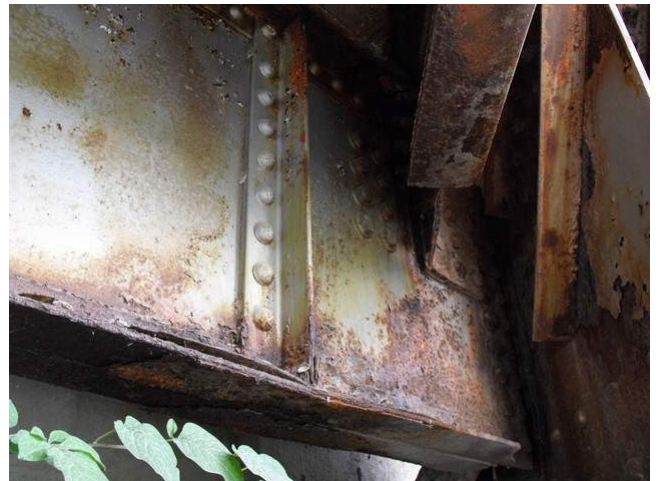
Northeast End. Showing very severe corrosion.

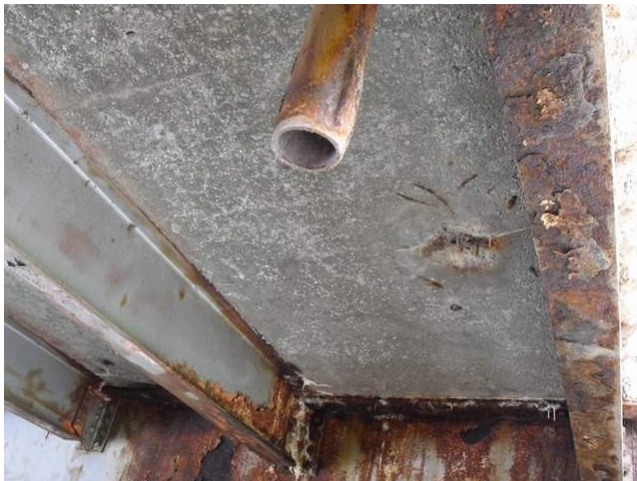
Underside Surface. Showing severe corrosion.

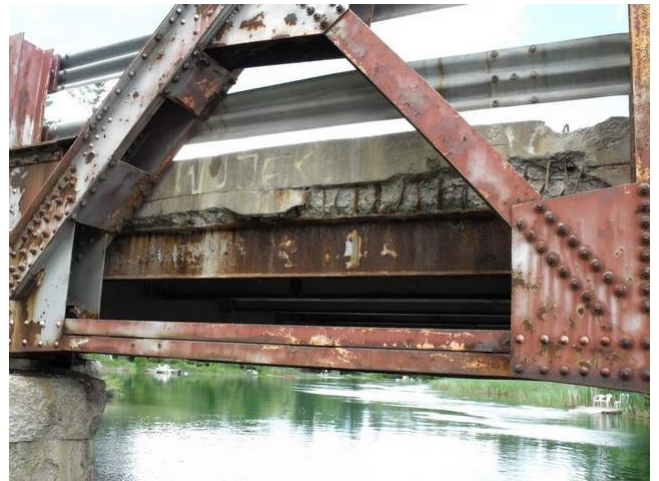
Underside Surface. Showing severe corrosion.

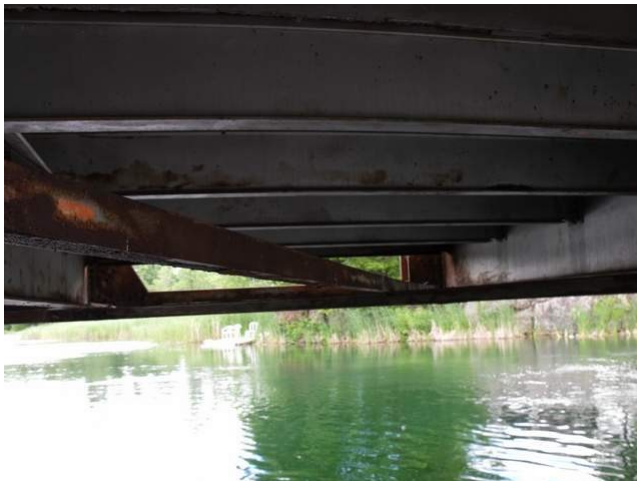
Underside Surface. Showing severe corrosion.

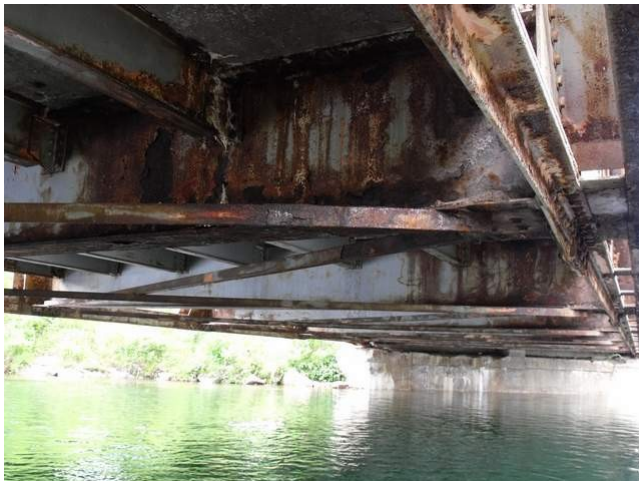
Underside Surface. Showing severe corrosion.

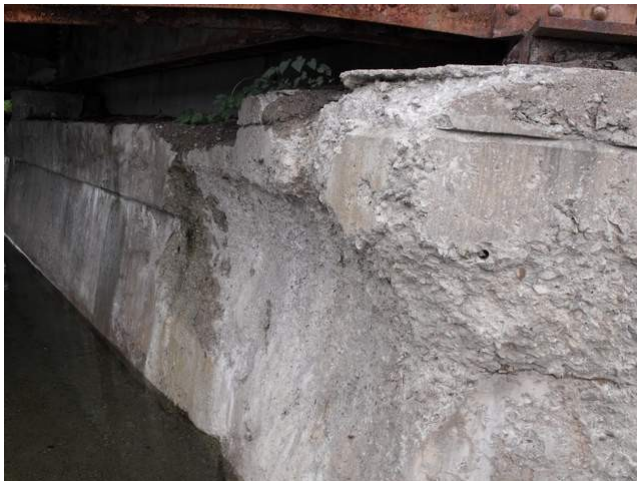
Northeast Side. Showing severe deterioration.

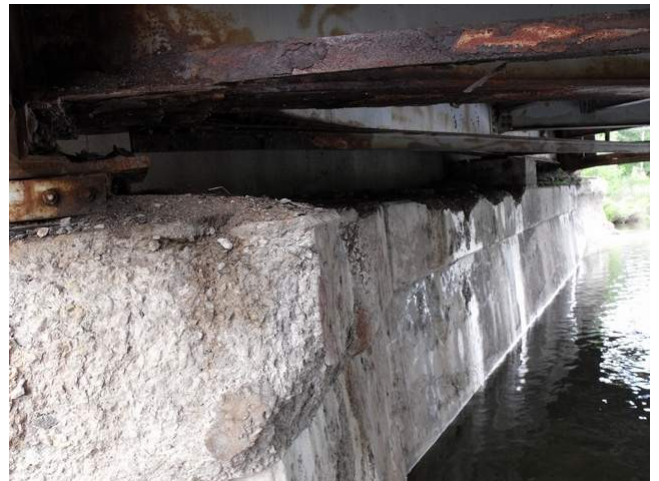
Northwest Side. Showing severe deterioration.

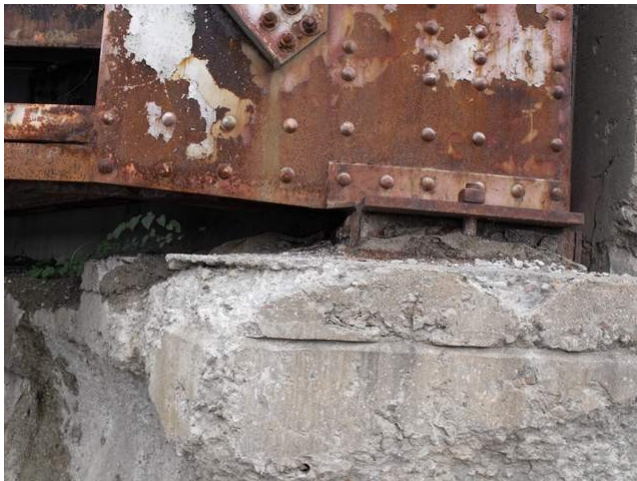
Northeast Side. Showing severe deterioration.

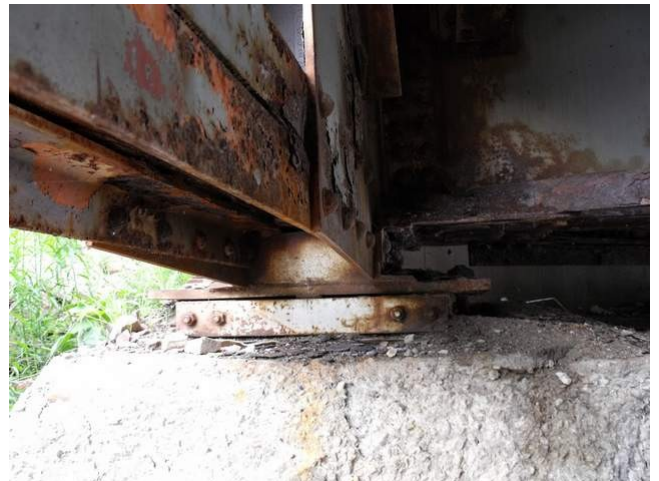
Northwest Side. Showing severe deterioration.

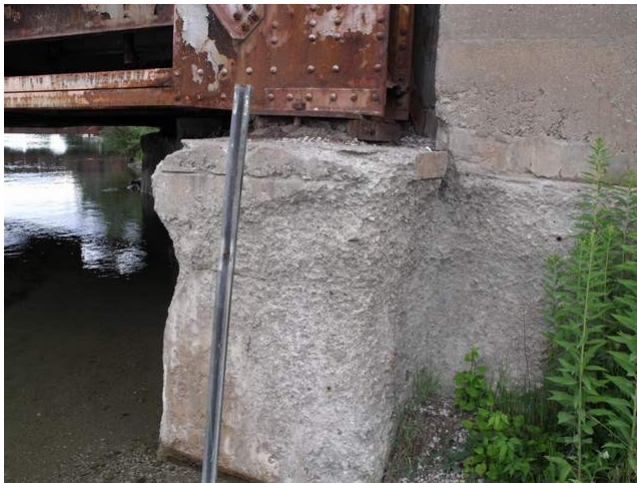
Northeast Side. Showing severe deterioration.

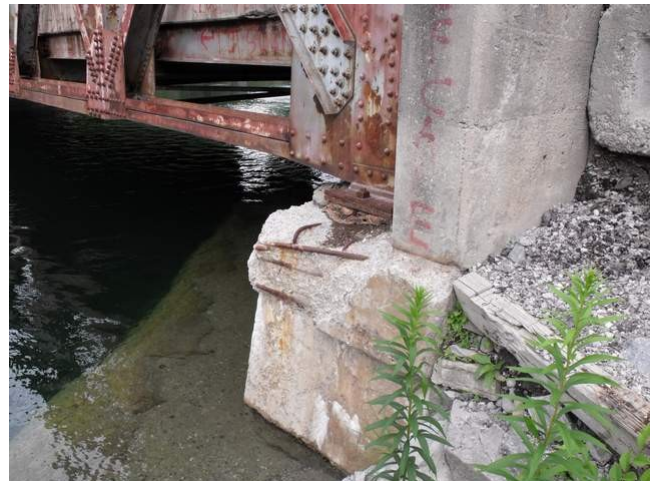
Southwest Side. Showing severe deterioration.

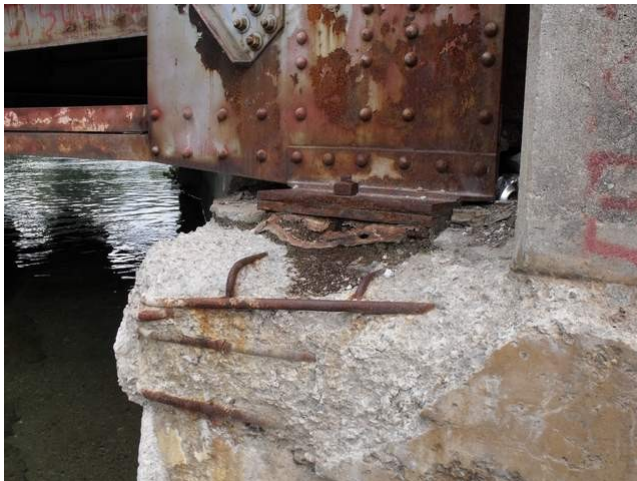
Southwest Approach. Showing poor condition.

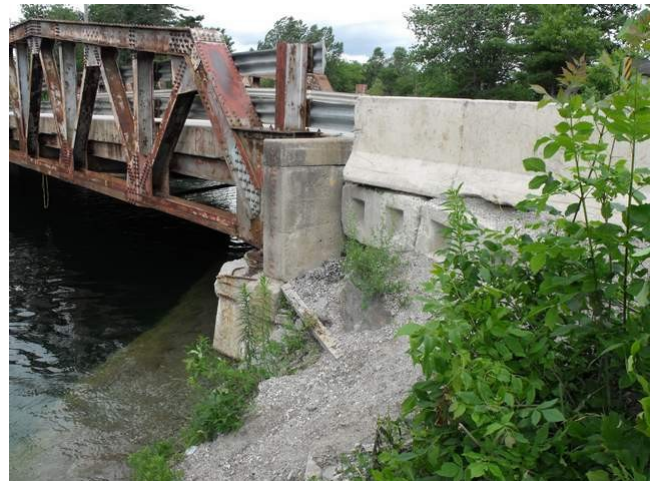
Southwest Side. Showing poor condition.
