ADDENDUM TO SELLWOOD BRIDGE HISTORIC AMERICAN ENGINEERING RECORD HAER NO. OR-103

OCTOBER 2011

SELLWOOD BRIDGE

SELLWOOD BRIDGE: FIELDNOTES

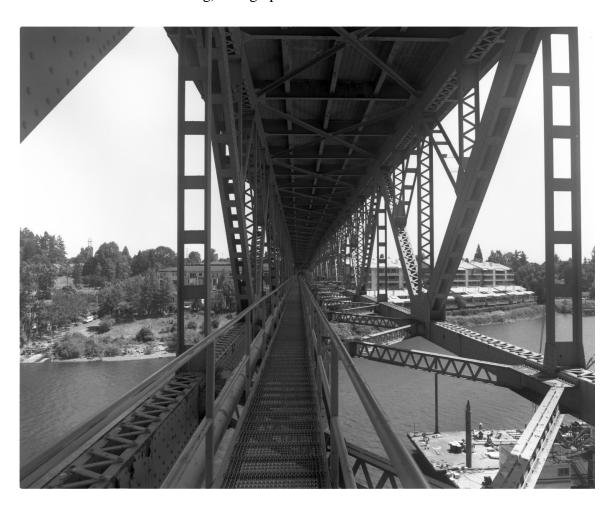
HAER OR-103-19 Interior of truss structure looking east along the catwalk. This view shows the deck construction of lateral elements (floor beams and bracing) lining up with the truss verticals.

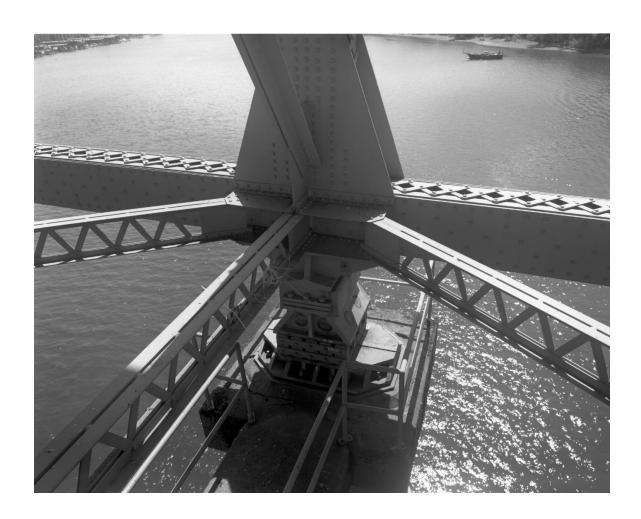
HAER OR-103-20 Pier 18 and south truss expansion bearing from the catwalk. This bearing and its twin under the north truss allow for longitudinal expansion and contraction of the truss structure.

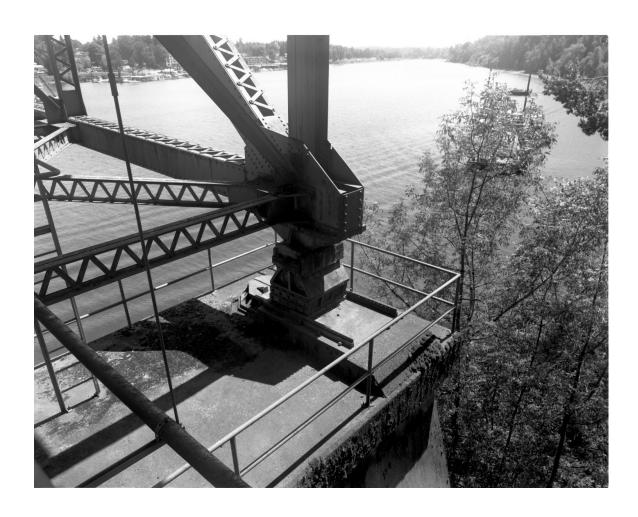
HAER OR-103-21 Pier 21 and south truss bearing on the west end of the truss structure. This pier has been heavily repaired and the bearing/pads modified. This bearing and its twin under the north truss allow for expansion and contraction of the truss structure.

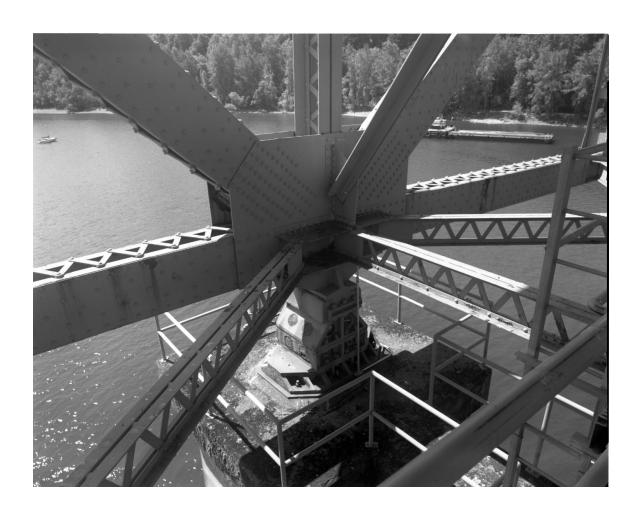
HAER OR-103-22 Fixed bearing at the center point of the truss structure, Pier 19.

The bearing and its twin under the north truss allow for some rotation of the truss at this point, but do not allow for longitudinal movement of the truss at Pier 19.

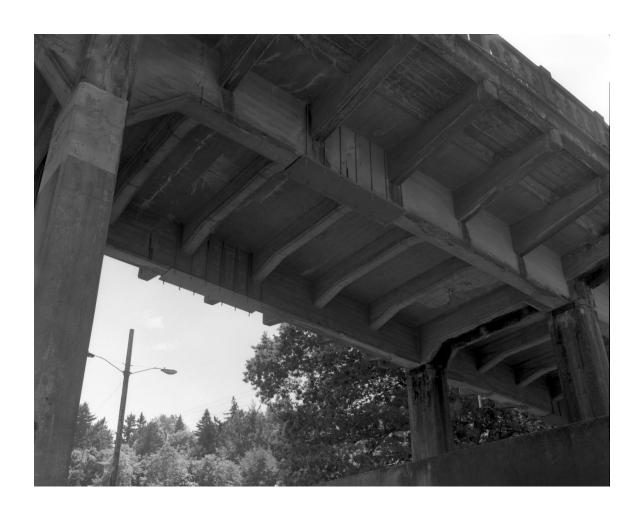
HAER OR-103-23 Steel "band-aid" repairs to severe cracks in the concrete girders on the west approach of the bridge.

- 2003 Exterior steel reinforcement was added to the concrete girders on the west approach to the bridge to repair the severe damage that had occurred on this side due to settling.
- 2008 Epoxy grout injection repairs were carried out on the concrete approach structures at the East and West ends of the bridge. Epoxy grout was injected through drilled holes to fill internal voids and cracks within the concrete structural elements.
- 2012 Expected commencement of construction of the replacement bridge will begin along with the demolition of the existing bridge.⁸

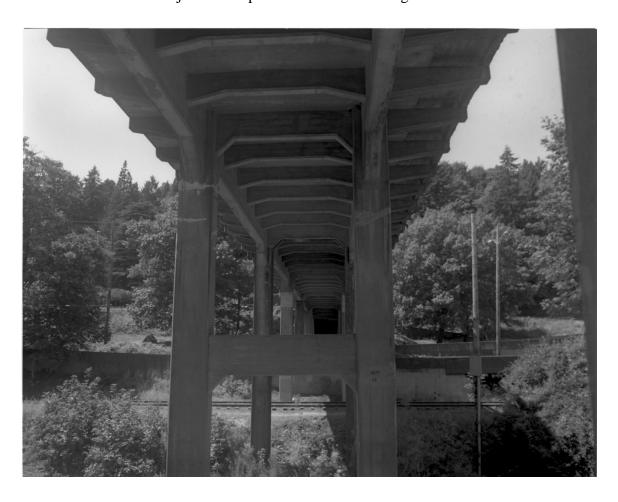
HAER OR-103-24 View of structural concrete frame on the west approach to the bridge looking west from the catwalk. Light horizontal lines on the columns show some of the locations where epoxy grout was injected to repair and reinforce damaged columns.

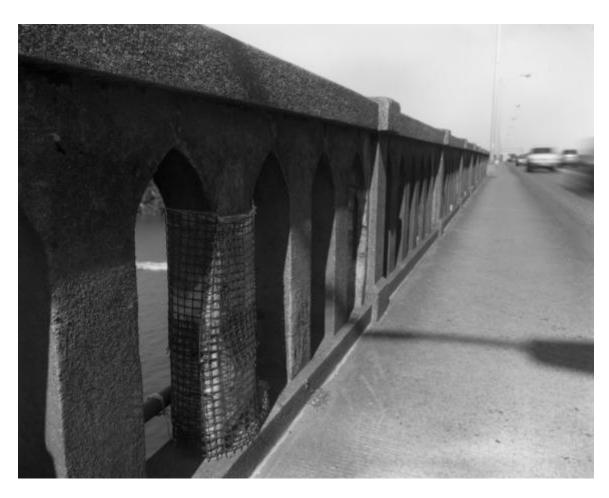
3. Other recent changes to the bridge include spalling and the use of netting/wire mesh to hold together damaged precast concrete guard rail balusters along the bridge deck.

HAER OR-103-32 Detail view showing temporary repair of Sellwood Bridge precast concrete guard rail baluster (see HAER OR-103-16 for 1999 view of intact railing).

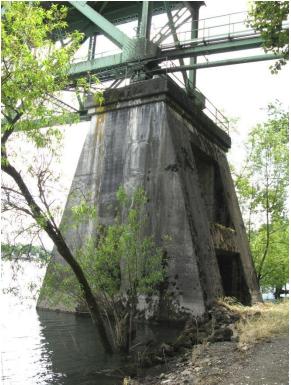
Fig. 4. Reconfigured Pier 21

The five piers that support the four spans of the continuous truss structure use reinforced concrete construction to reduce the overall amount of material in the piers. The Sellwood Bridge piers are made of two tapered rectangular columns joined by a shear wall. All the piers remained stable except Pier 21 (Fig. 4) on the west end of the truss. Pier 21 was redesigned and reconstructed in 1960/61. The trace outline of the original pier can be seen (Fig. 4) within the massive new construction of Pier 21.
