Technical Aspects of Cable Wire Breakages on the Mount Hope Suspension Bridge

Breaks Localized in Strand Shoes—Progressive Breaking Noted in Spite of Load Reduction—Cable Spinning Methods—Characteristics of Wire and Its Manufacture—Temporary Repair Measures

IN MARCH of this year engineering circles were shocked to learn of serious breakages in the cable wires of two important highway suspension bridges then under construction. News of the breakages was followed by a cessation of work on both structures and later by the decision to dismantle the bridges and replace the suspension systems with satisfactory wire. Interesting operations of unprecedented kind were involved in the dismantling. Both structures utilized the same kind of wire, a heat-treated product of high elastic limit, heretofore untried in suspension bridge service. The Mount Hope bridge, near Providence, R. I., which had a center span of 1,200 ft., was within about twelve months of completion, requiring only the placing of the concrete floor slab. The Ambassador bridge at Detroit, whose sus-

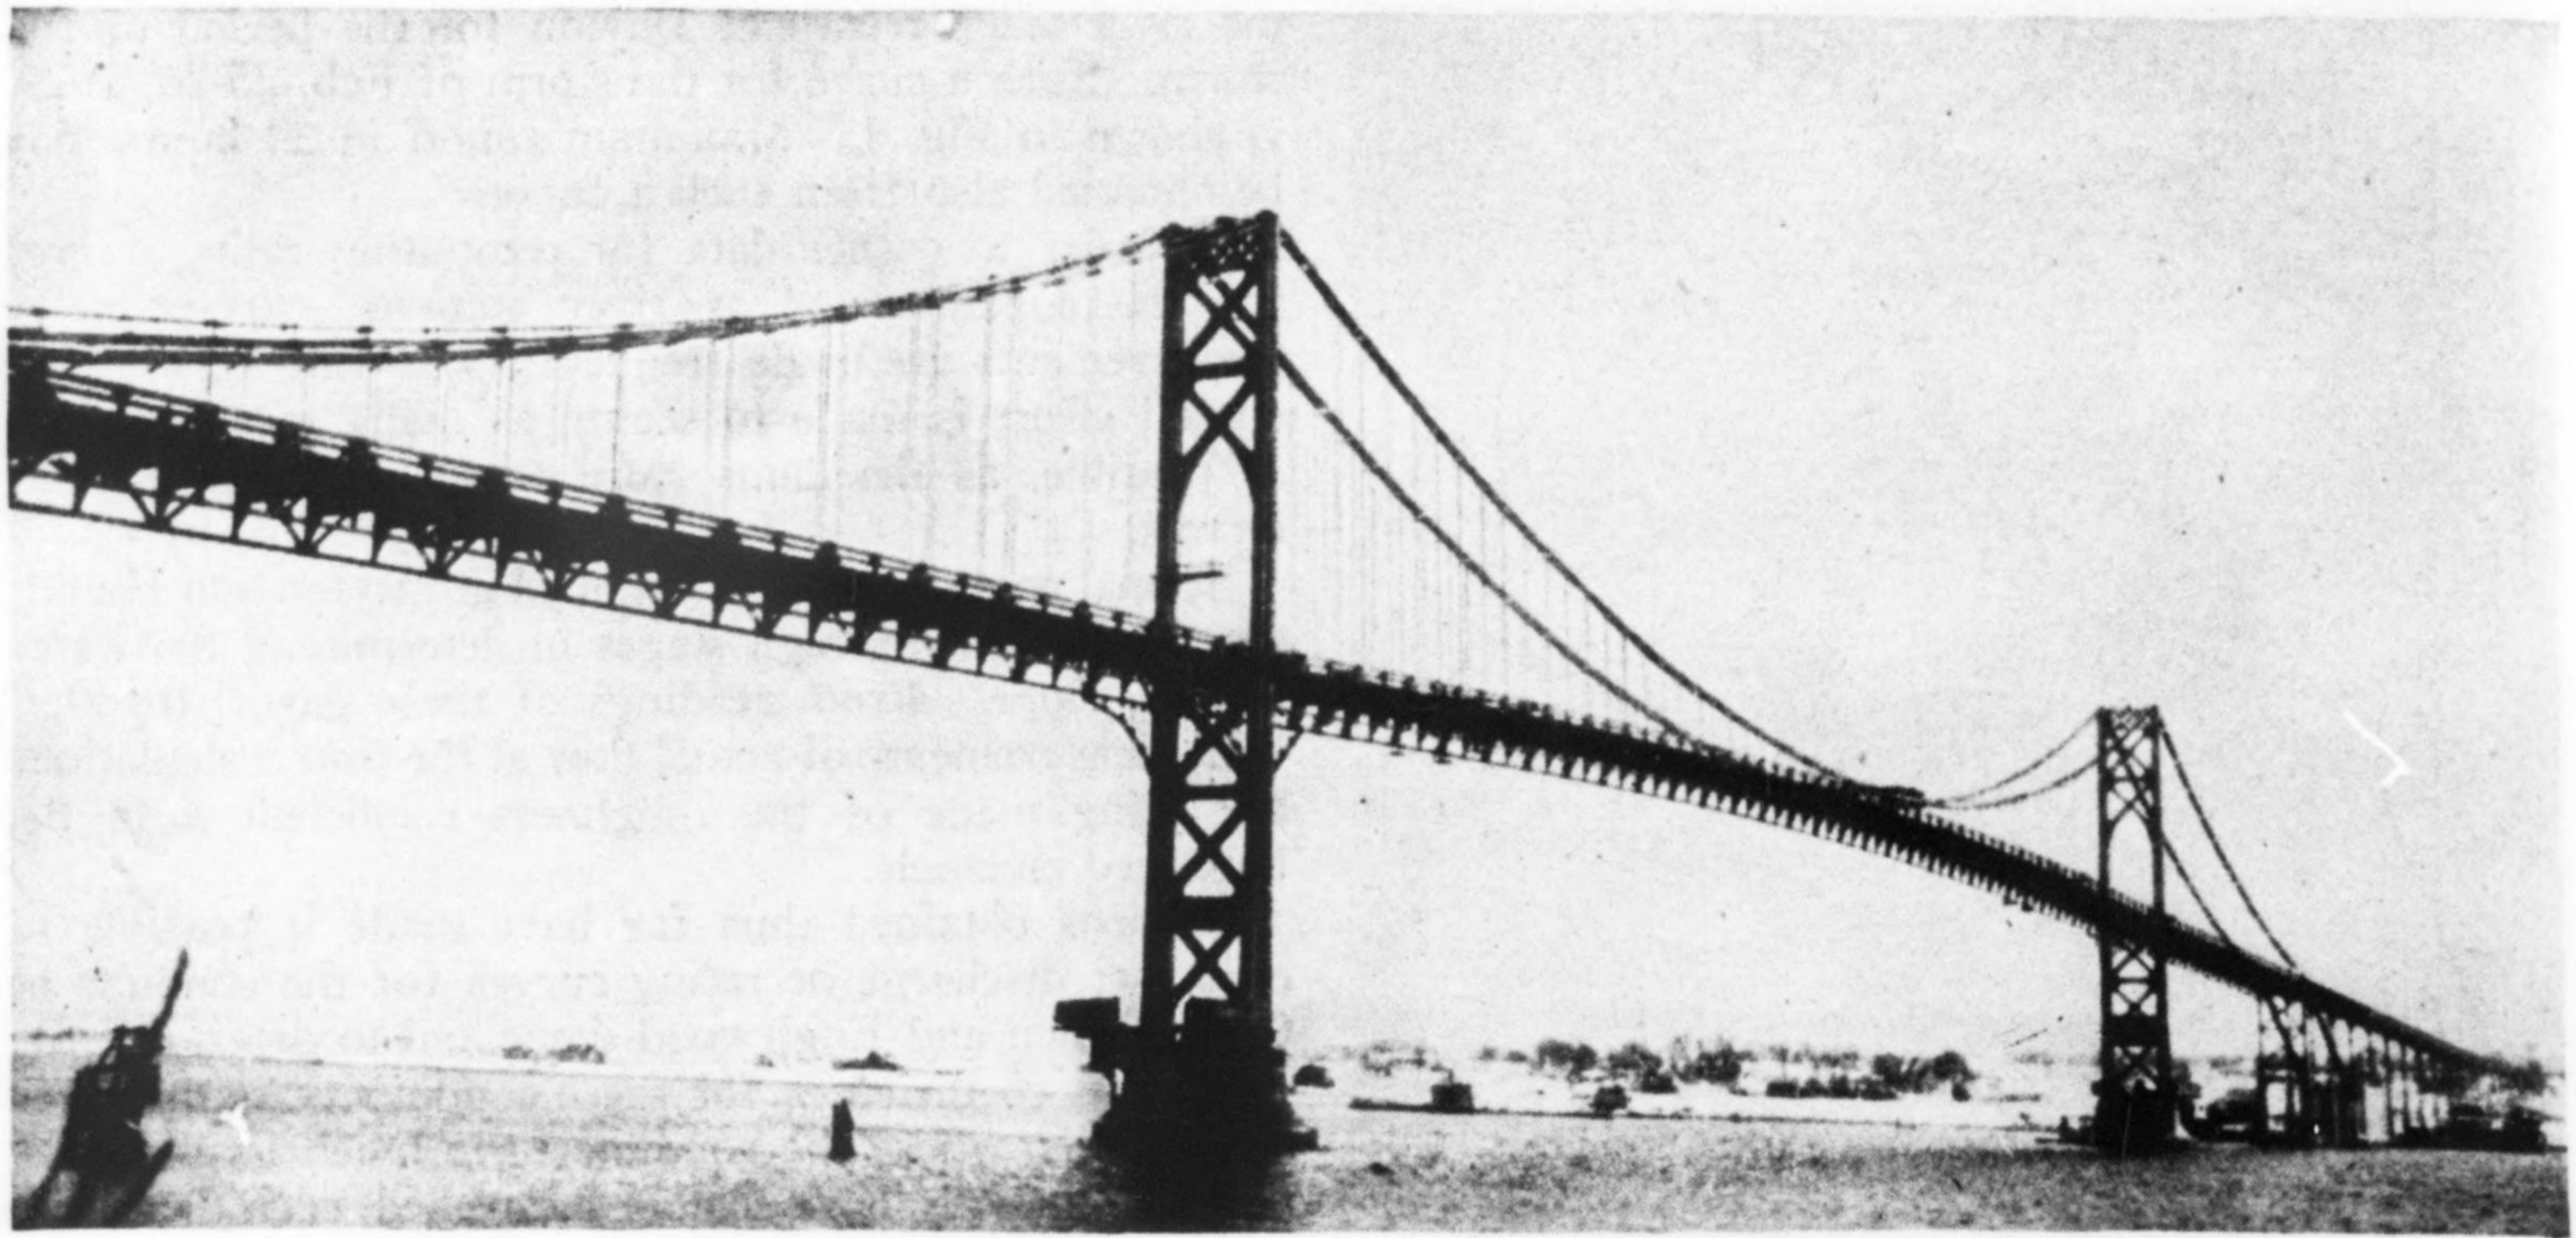
FIG. 1—THE MOUNT HOPE BRIDGE ON FEB. 23 JUST AFTER DISCOVERY OF BROKEN WIRES
Preparations were under way for placing concrete floor slab.

Early in February, at the time of the discovery of the first breaks in the wire, the bridge was completed to the extent shown in Fig. 1. Forms and reinforcing steel in considerable quantities were in place for pouring the concrete floor and the cables were stressed to about 32,000 lb. per sq.in.; their ultimate working stress was to be 80,000 lb. per sq.in.

Discovery of Breaks—During the handling and spinning of the cables nothing unusual occurred. Three broken wires were noticed in January, six on Feb. 8 and eleven additional on Feb. 19. All of these breaks were at the strand shoes (as were later breaks) at or close to the point of tangency of the wire to the curve of the back of the shoe; they did not affect any one strand but were scattered among the 28 shoes of both anchorages.

Repairs—Repair work was immediately begun following the discovery of the first breaks. Precautionary measures consisted in removing the reinforcing steel, 90 tons, and later the floor forms from the bridge, also in painting the red bands around the cables to keep a check on cable slippages. Splicing the breaks began soon after Feb. 23, and by March 3 a number of wires had been repaired. This work was done by inserting "hairpins" around the shoes, splicing them to the ends of the broken wires on each side. These hairpins were made of cold-drawn wire in about 20-ft. lengths and were applied as fast as possible by a crew of men working 24 hours a day. Hairpins had been attached to all broken wires by March 15 and strain-gage readings on some of them showed a stress of

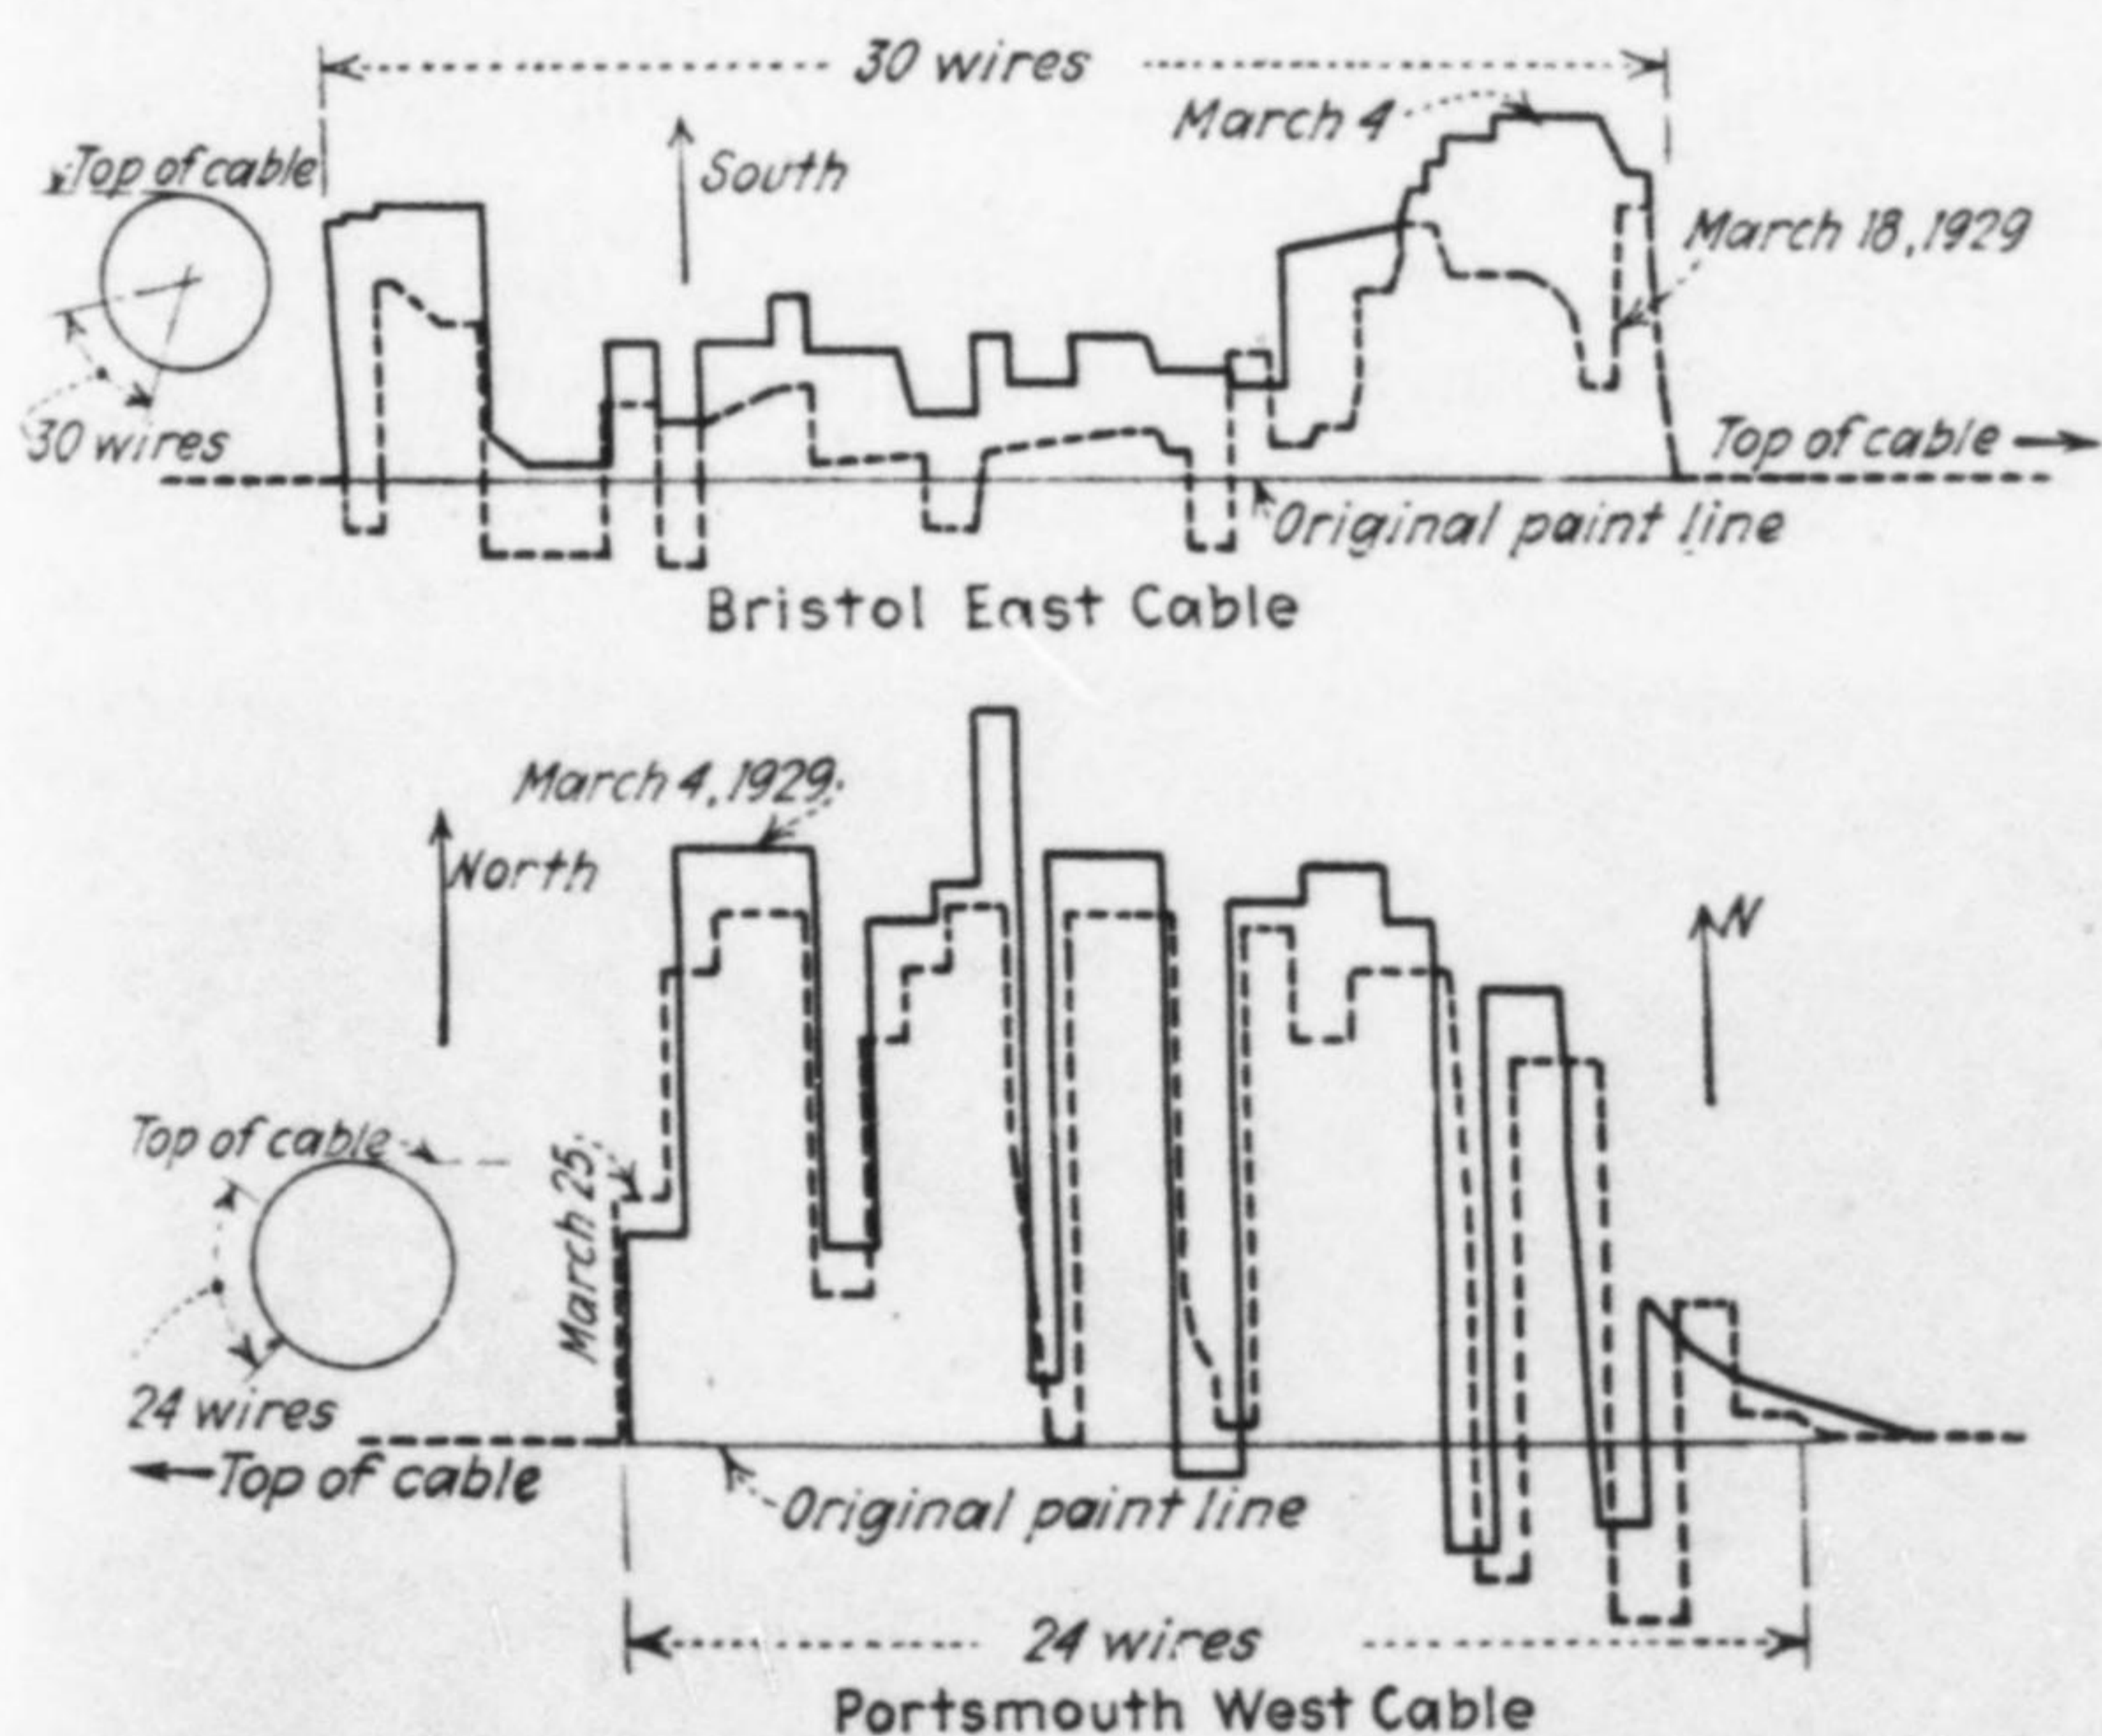
FIG. 2—CABLE SLIPPAGE DIAGRAMS FOR POINTS OF GREATEST FAILURE

Solid lines represent total recorded slip from a paint line applied on Feb. 23 just above the splay casting. Dotted lines show position of wires after hairpins were applied and slipped wires pulled back. Diagram for Portsmouth West cable probably shows all slippage, while at Bristol East anchorage considerable slippage had already occurred when the paint band was applied.

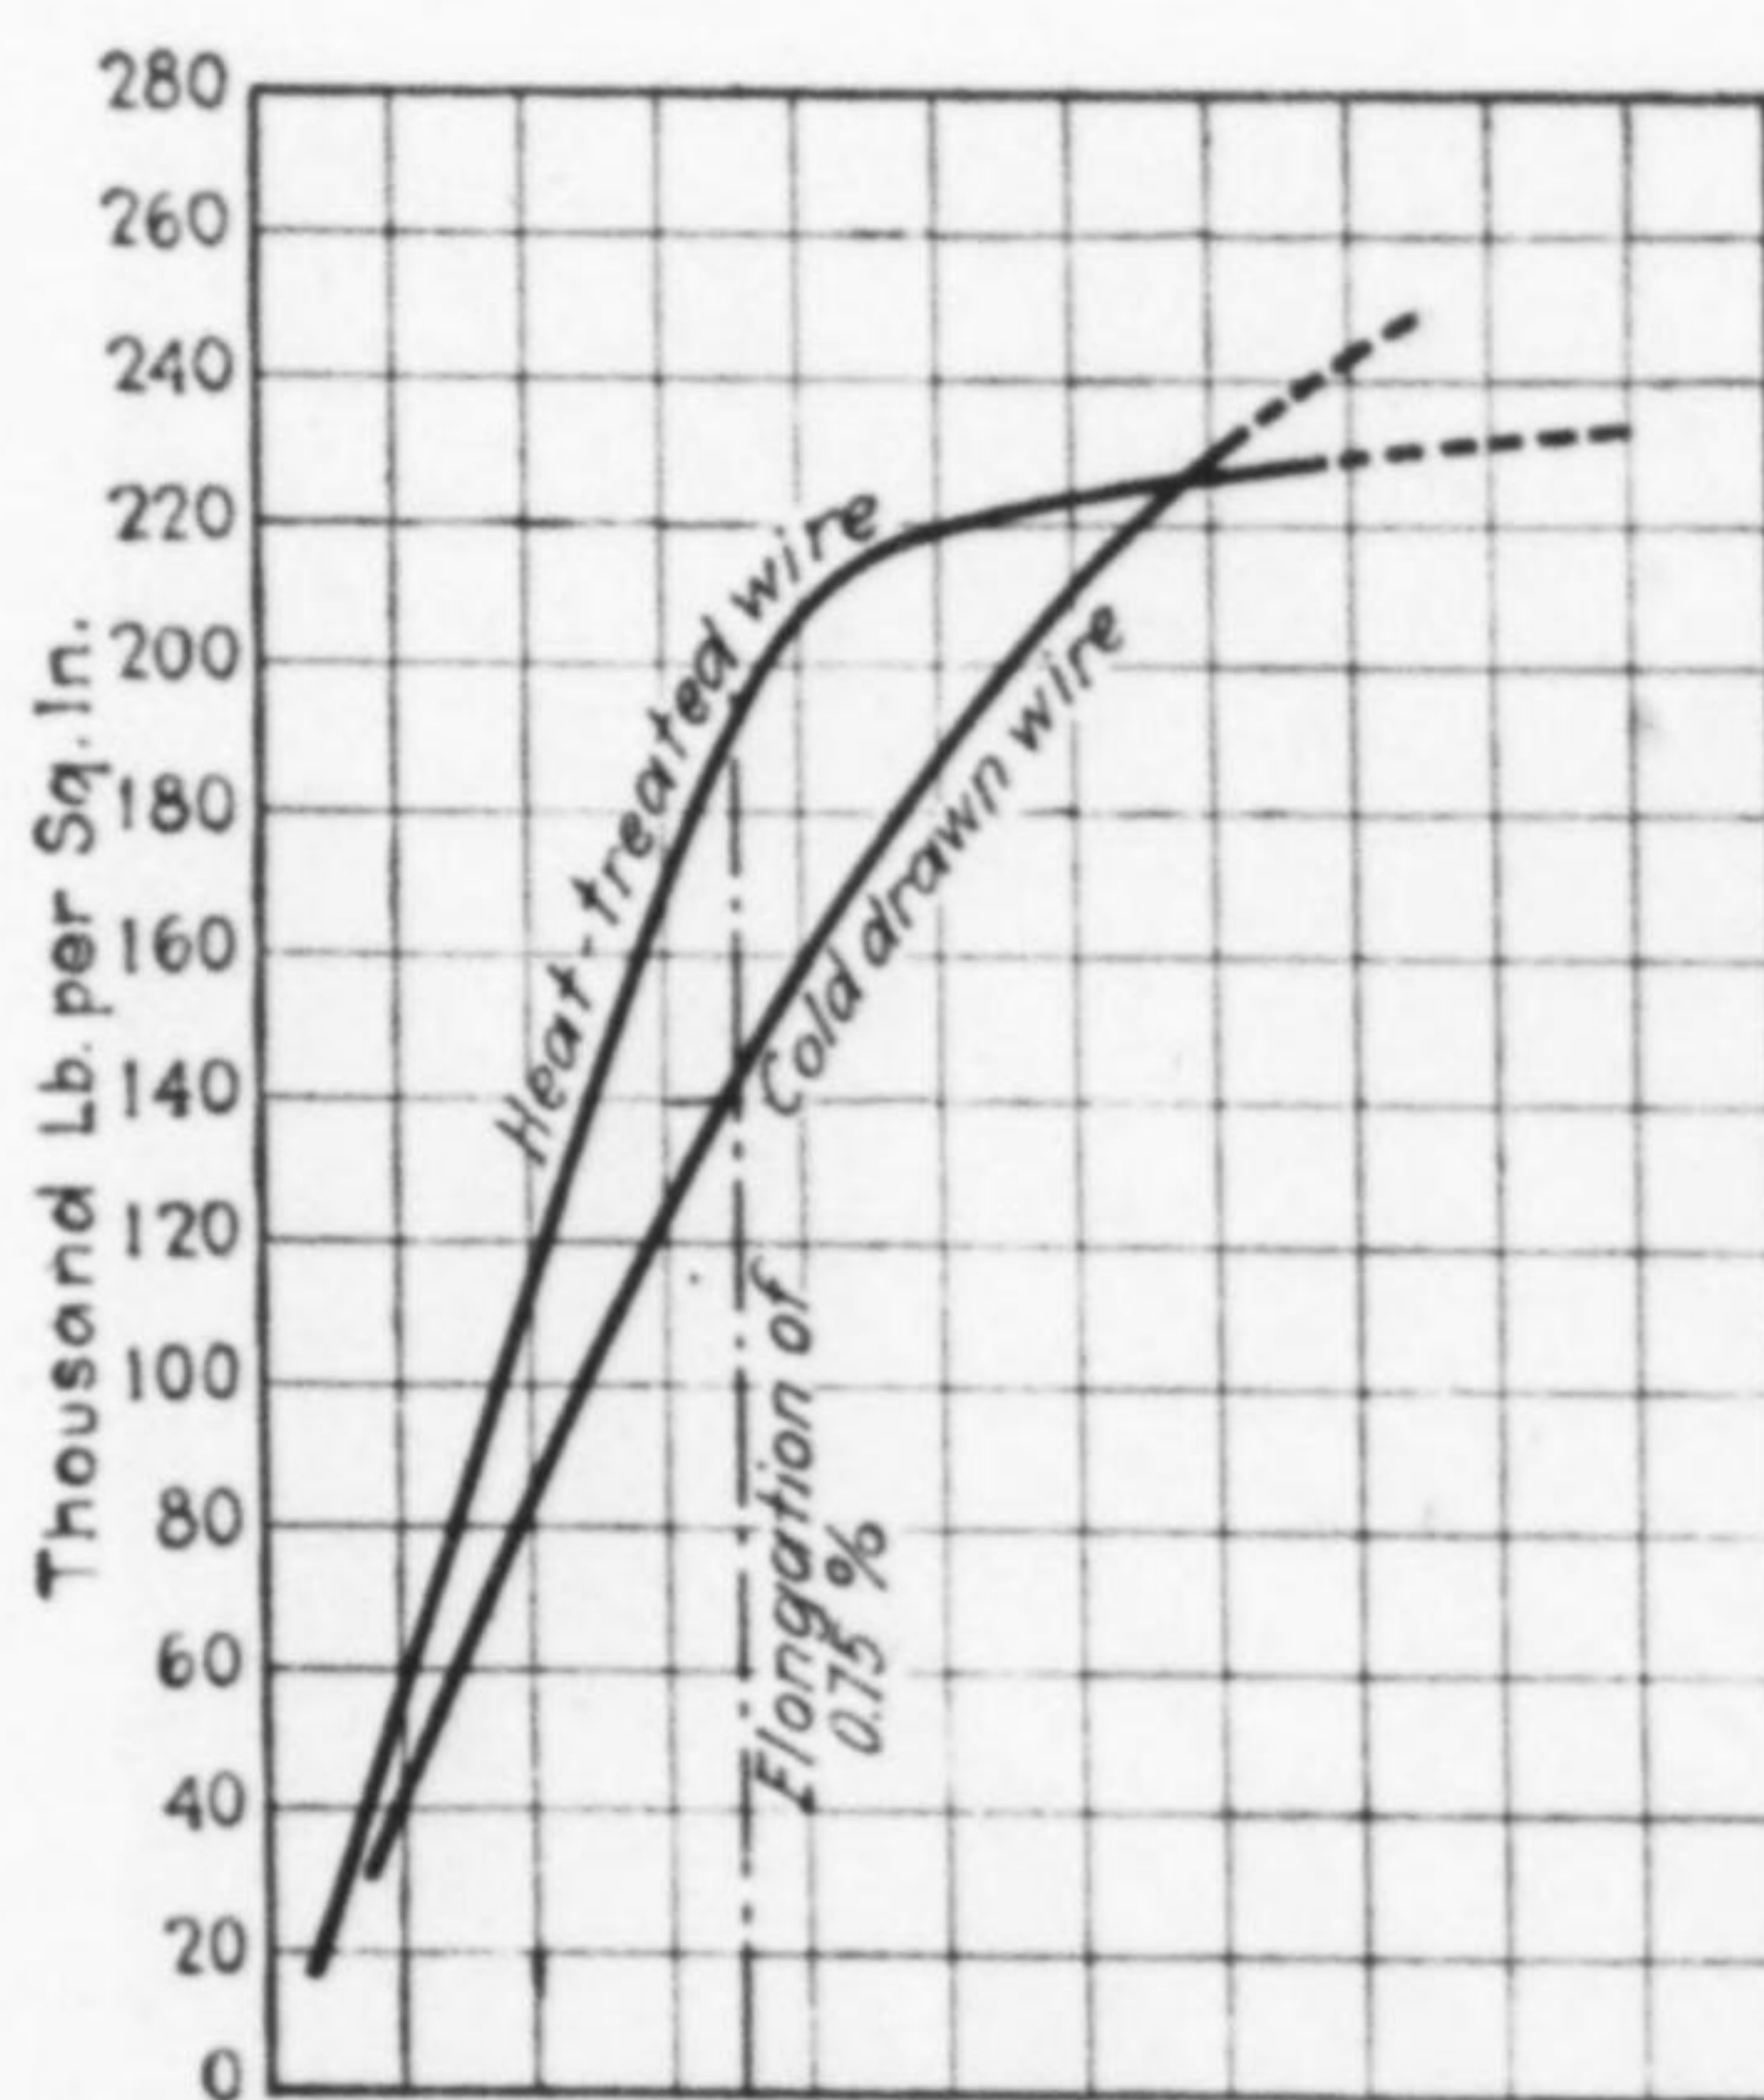
FIG. 3—COMPARATIVE SHAPE OF STRESS-STRAIN CURVES OF COLD-DRAWN AND HEAT-TREATED CABLE WIRE

Note abrupt change in the slope of the curve for the heat-treated wire at about 85 per cent of ultimate strength.

Comparative stress-strain curves of the heat-treated wire and cold-drawn bridge wire are shown in Fig. 3. The yield point, taken (by specification) as the load

necessary to cause 0.75 per cent elongation, is about 190,000 lb. per sq.in. for the heat-treated wire and about 145,000 lb. per sq.in. for the cold-drawn wire. Tests are also reported to have demonstrated that the heat-treated wire has the high modulus of elasticity of 29,000,000, as compared with about 25,000,000 for cold-drawn wire. The manufacturers claim for the heat-treated wire a reduction in area of between 30 and 50 per cent.

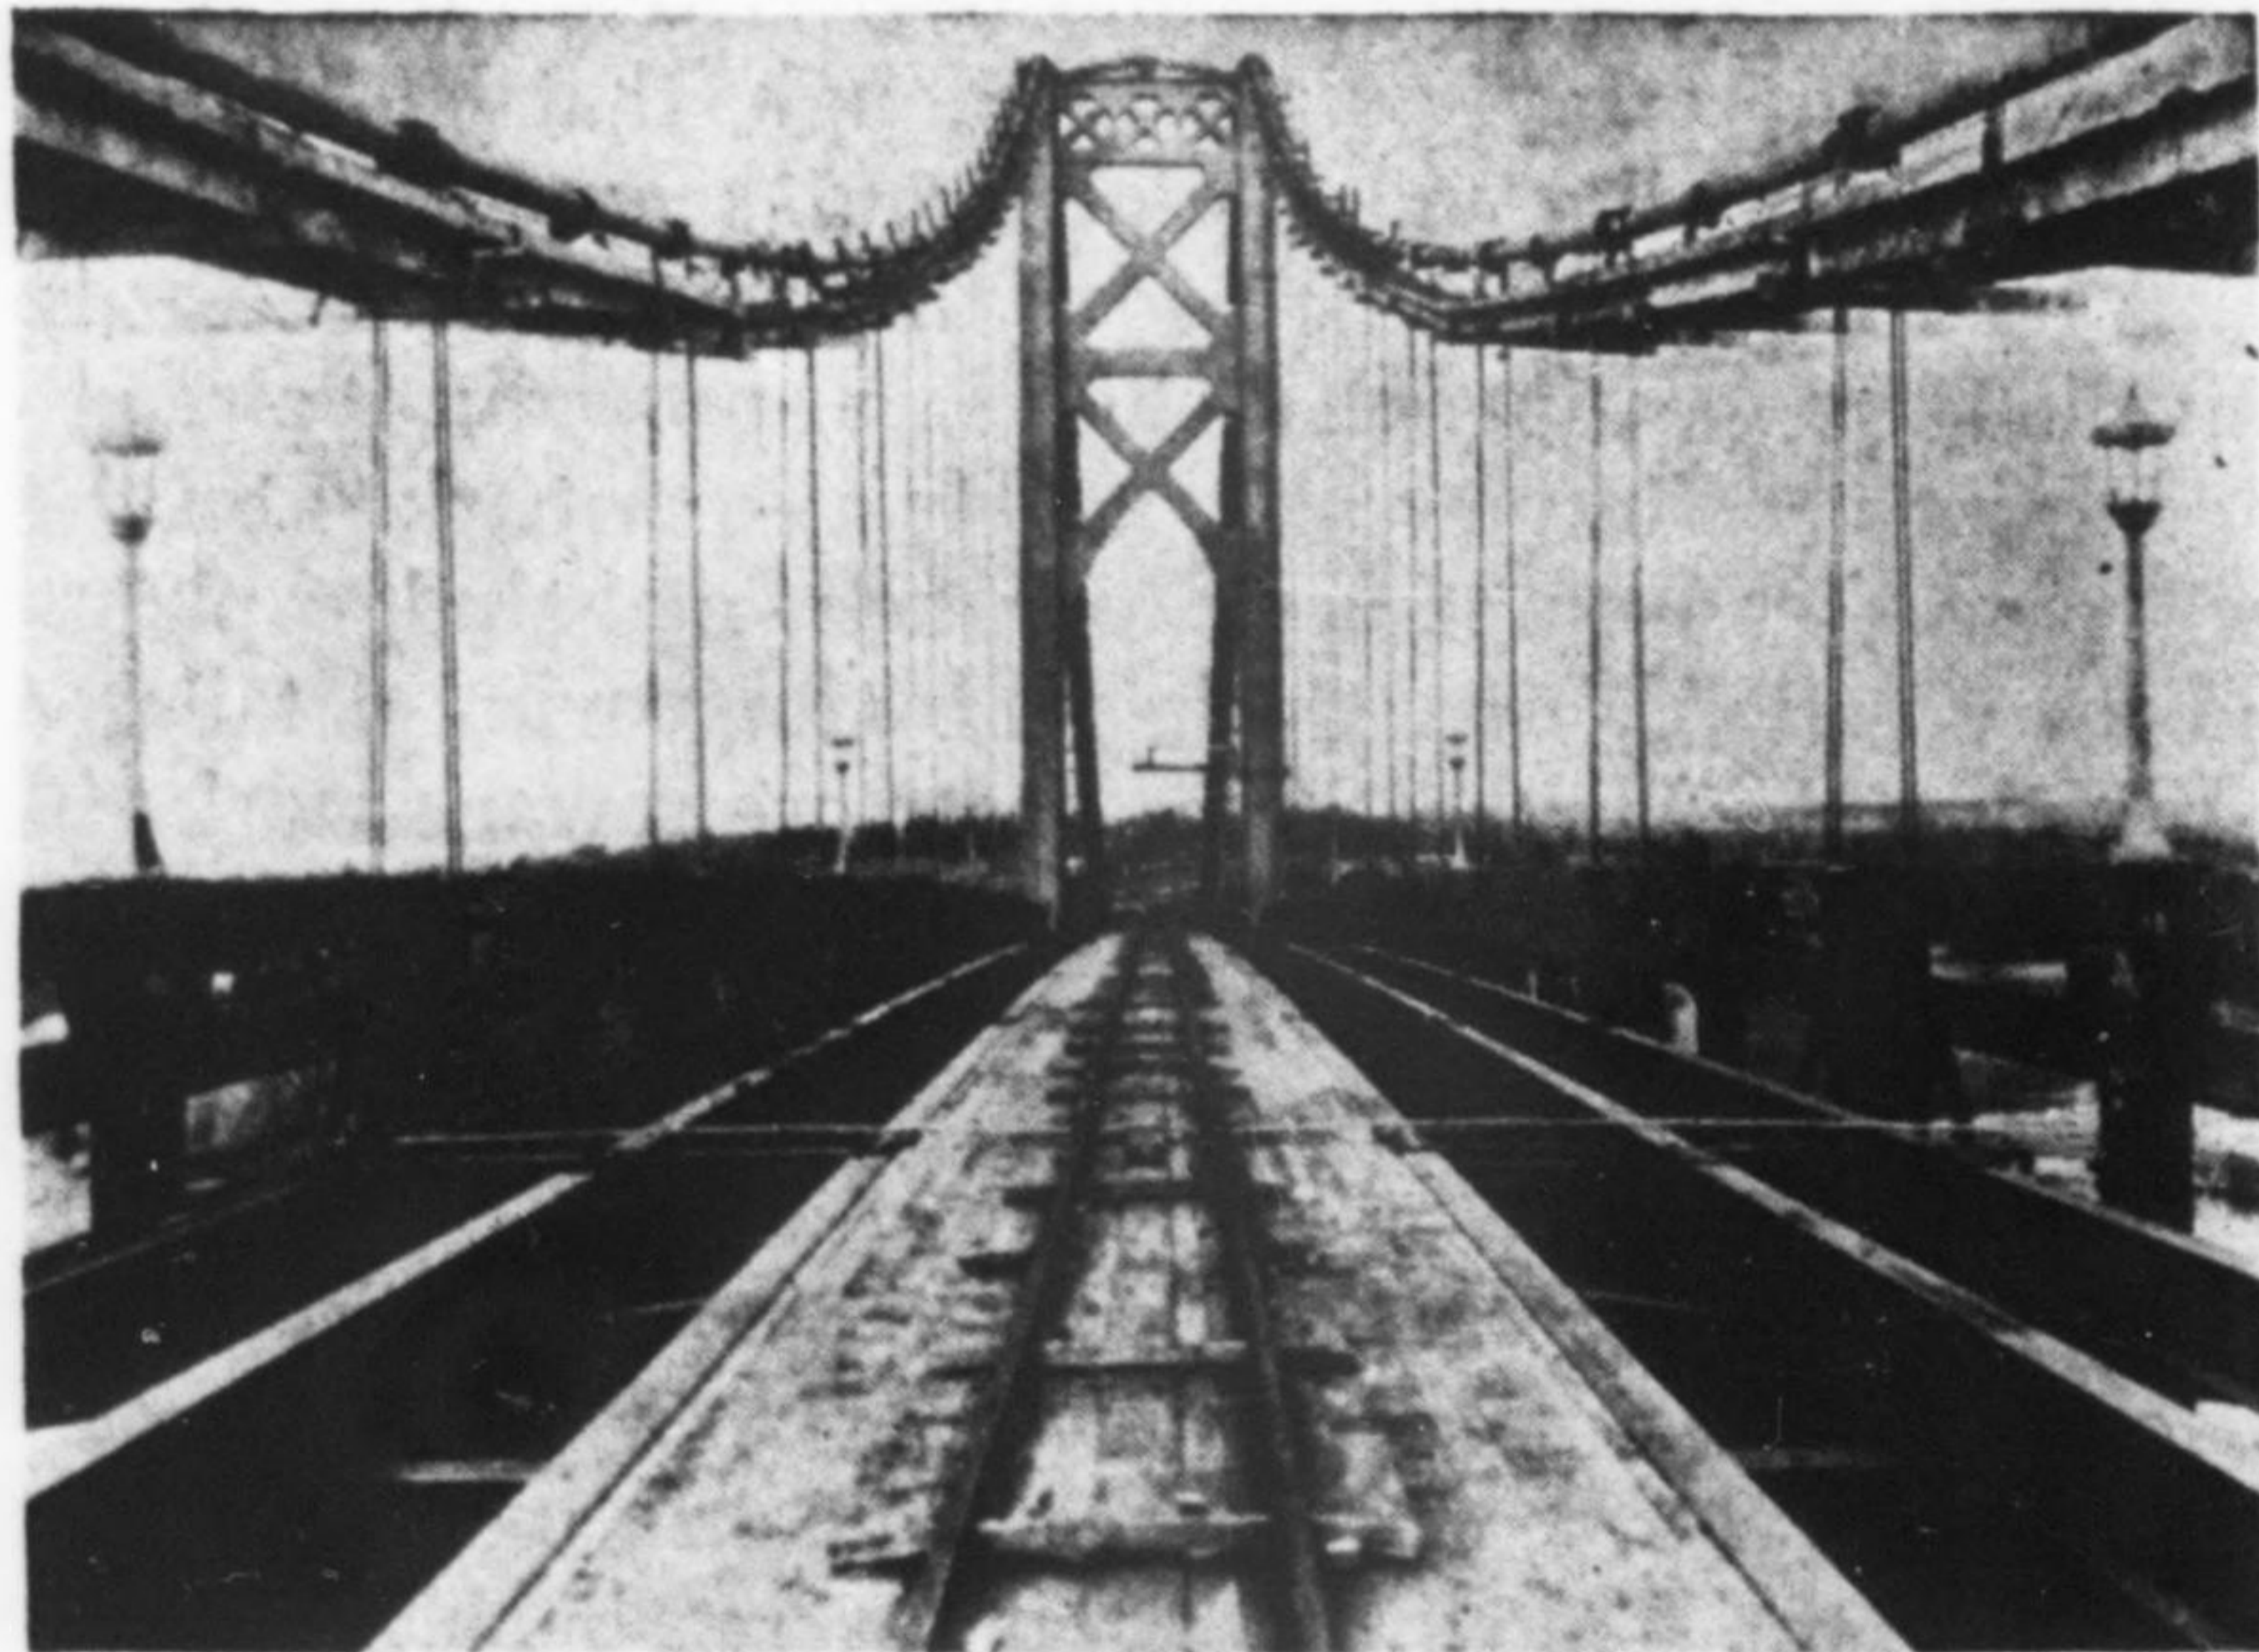
FIG. 1—MOUNT HOPE BRIDGE JUST PRIOR TO DISMANTLING

ures taken to safeguard the structure after the first breaks were discovered. Precautionary measures were not considered necessary at Detroit, since the load being carried was only about one-third of that at Mount Hope.

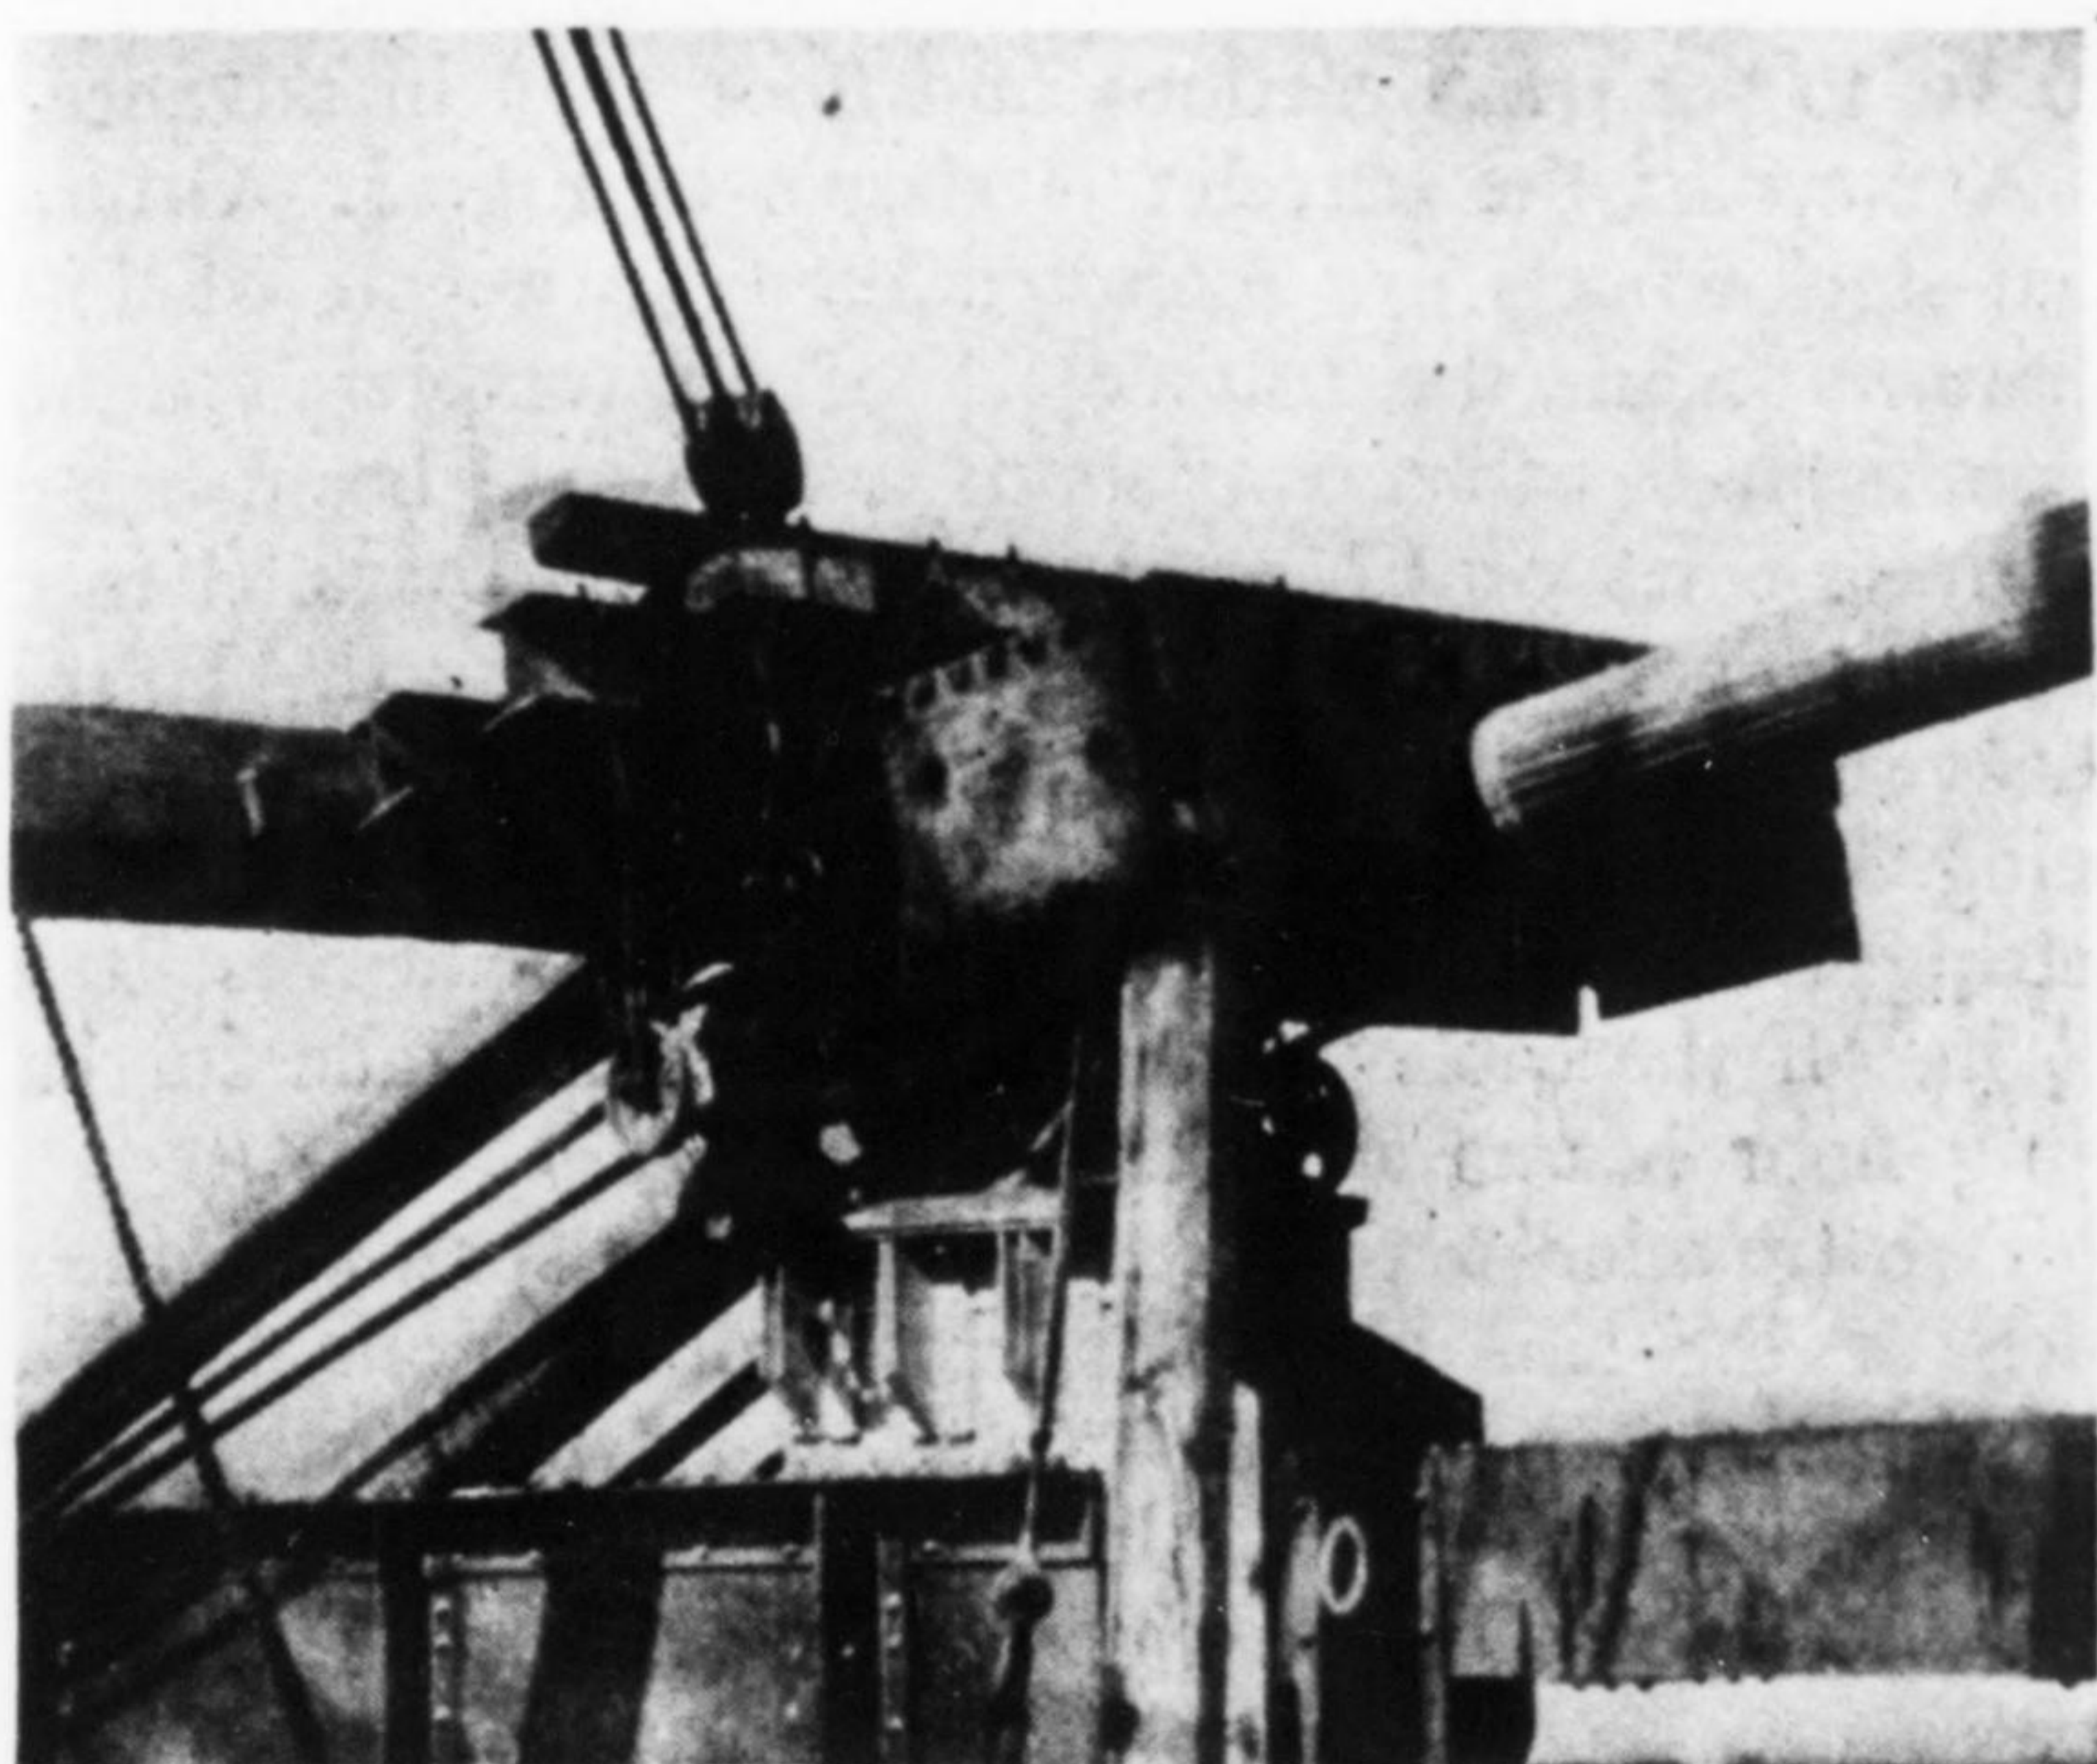
FIG. 3—HOLDBACK YOKE IN FRONT OF CABLE-BENT SADDLE, MOUNT HOPE

Four holdback ropes are visible and four similar ones are attached at the far side of the yoke.

Briefly, this involved placing the yokes around the backstay, connecting them to the anchorage by two-part cables, stressing these cables by means of hydraulic jacks and holding the yokes in a stressed position by heavy cast-steel cable clamps. The apparatus necessary to effect this is shown in Fig. 4. It consisted of three yokes, the upper two of which were for erection purposes only. The top and bottom yokes were connected by angles into a rectangular steel frame; the middle yoke was loose,
