General Bridge Information:

TXDOT District: Brownwood
County: Mills
Structure ID: 231670028903040
Facility Carried: SH 16
Feature Crossed: Colorado River
Bridge Owner: State Highway Agency

Statewide Vehicular Truss Bridge Reevaluation

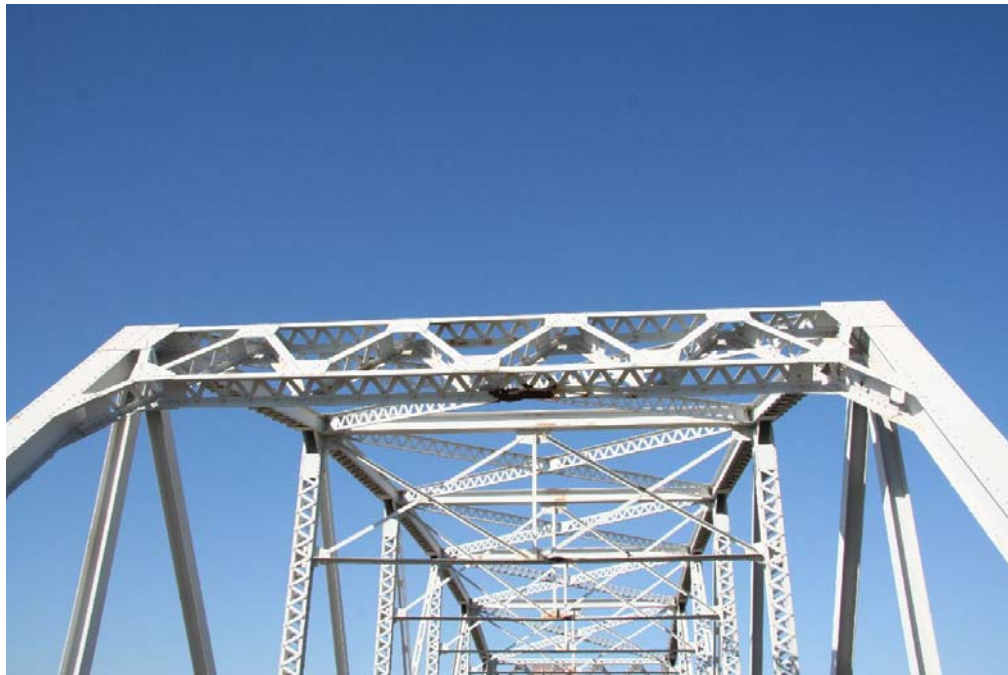
The bridge retains integrity of location as it remains in its historic location. The only visible alterations to the bridge are minor impact damage to the lower, horizontal members of the portal and sway bracing on both trusses and impact damage to the railing on one of the approach spans. While the portal and sway bracing are elements of a Parker through truss’s character-defining features, the impact damage is very minor and does not diminish the bridge’s ability to convey its engineering significance. The bridge railing is of a standard design that does not possess high artistic value, and is not a character-defining feature of the structure. The impact damage to the railing on the approach span also does not diminish the bridge’s ability to convey its engineering significance. As such, the bridge retains integrity of design, workmanship, and materials. It also retains integrity of setting, feeling, and association.

Photo 4: Detail of impact damage on portal and sway bracing; view facing north

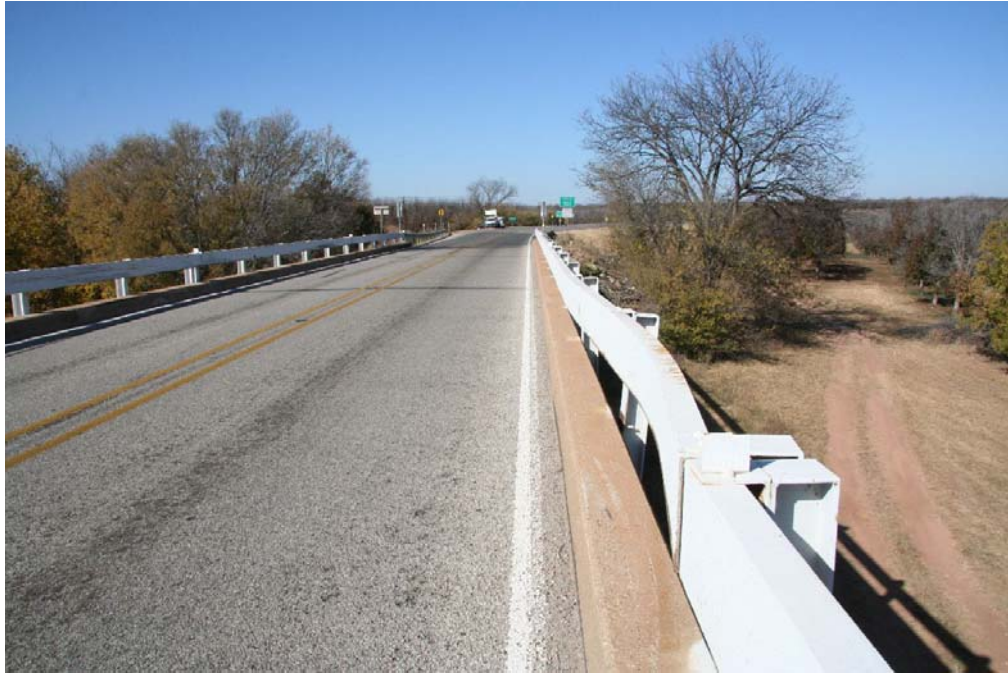
Photo 5: Detail of impact damage on approach span railing; view facing north
