Spanning the Mississippi at Chester, Ill.

Removing a Bridge From the Mississippi

Contents in Brief—Heavy marine blasting removes 500 tons of the wreckage of the Mississippi River bridge at Chester, Ill., to provide a 300-ft. navigation channel. Salvage operations completed in 15 days and without mishap, despite unusual hazards. Reason for failure of bridge in wind still unexplained.

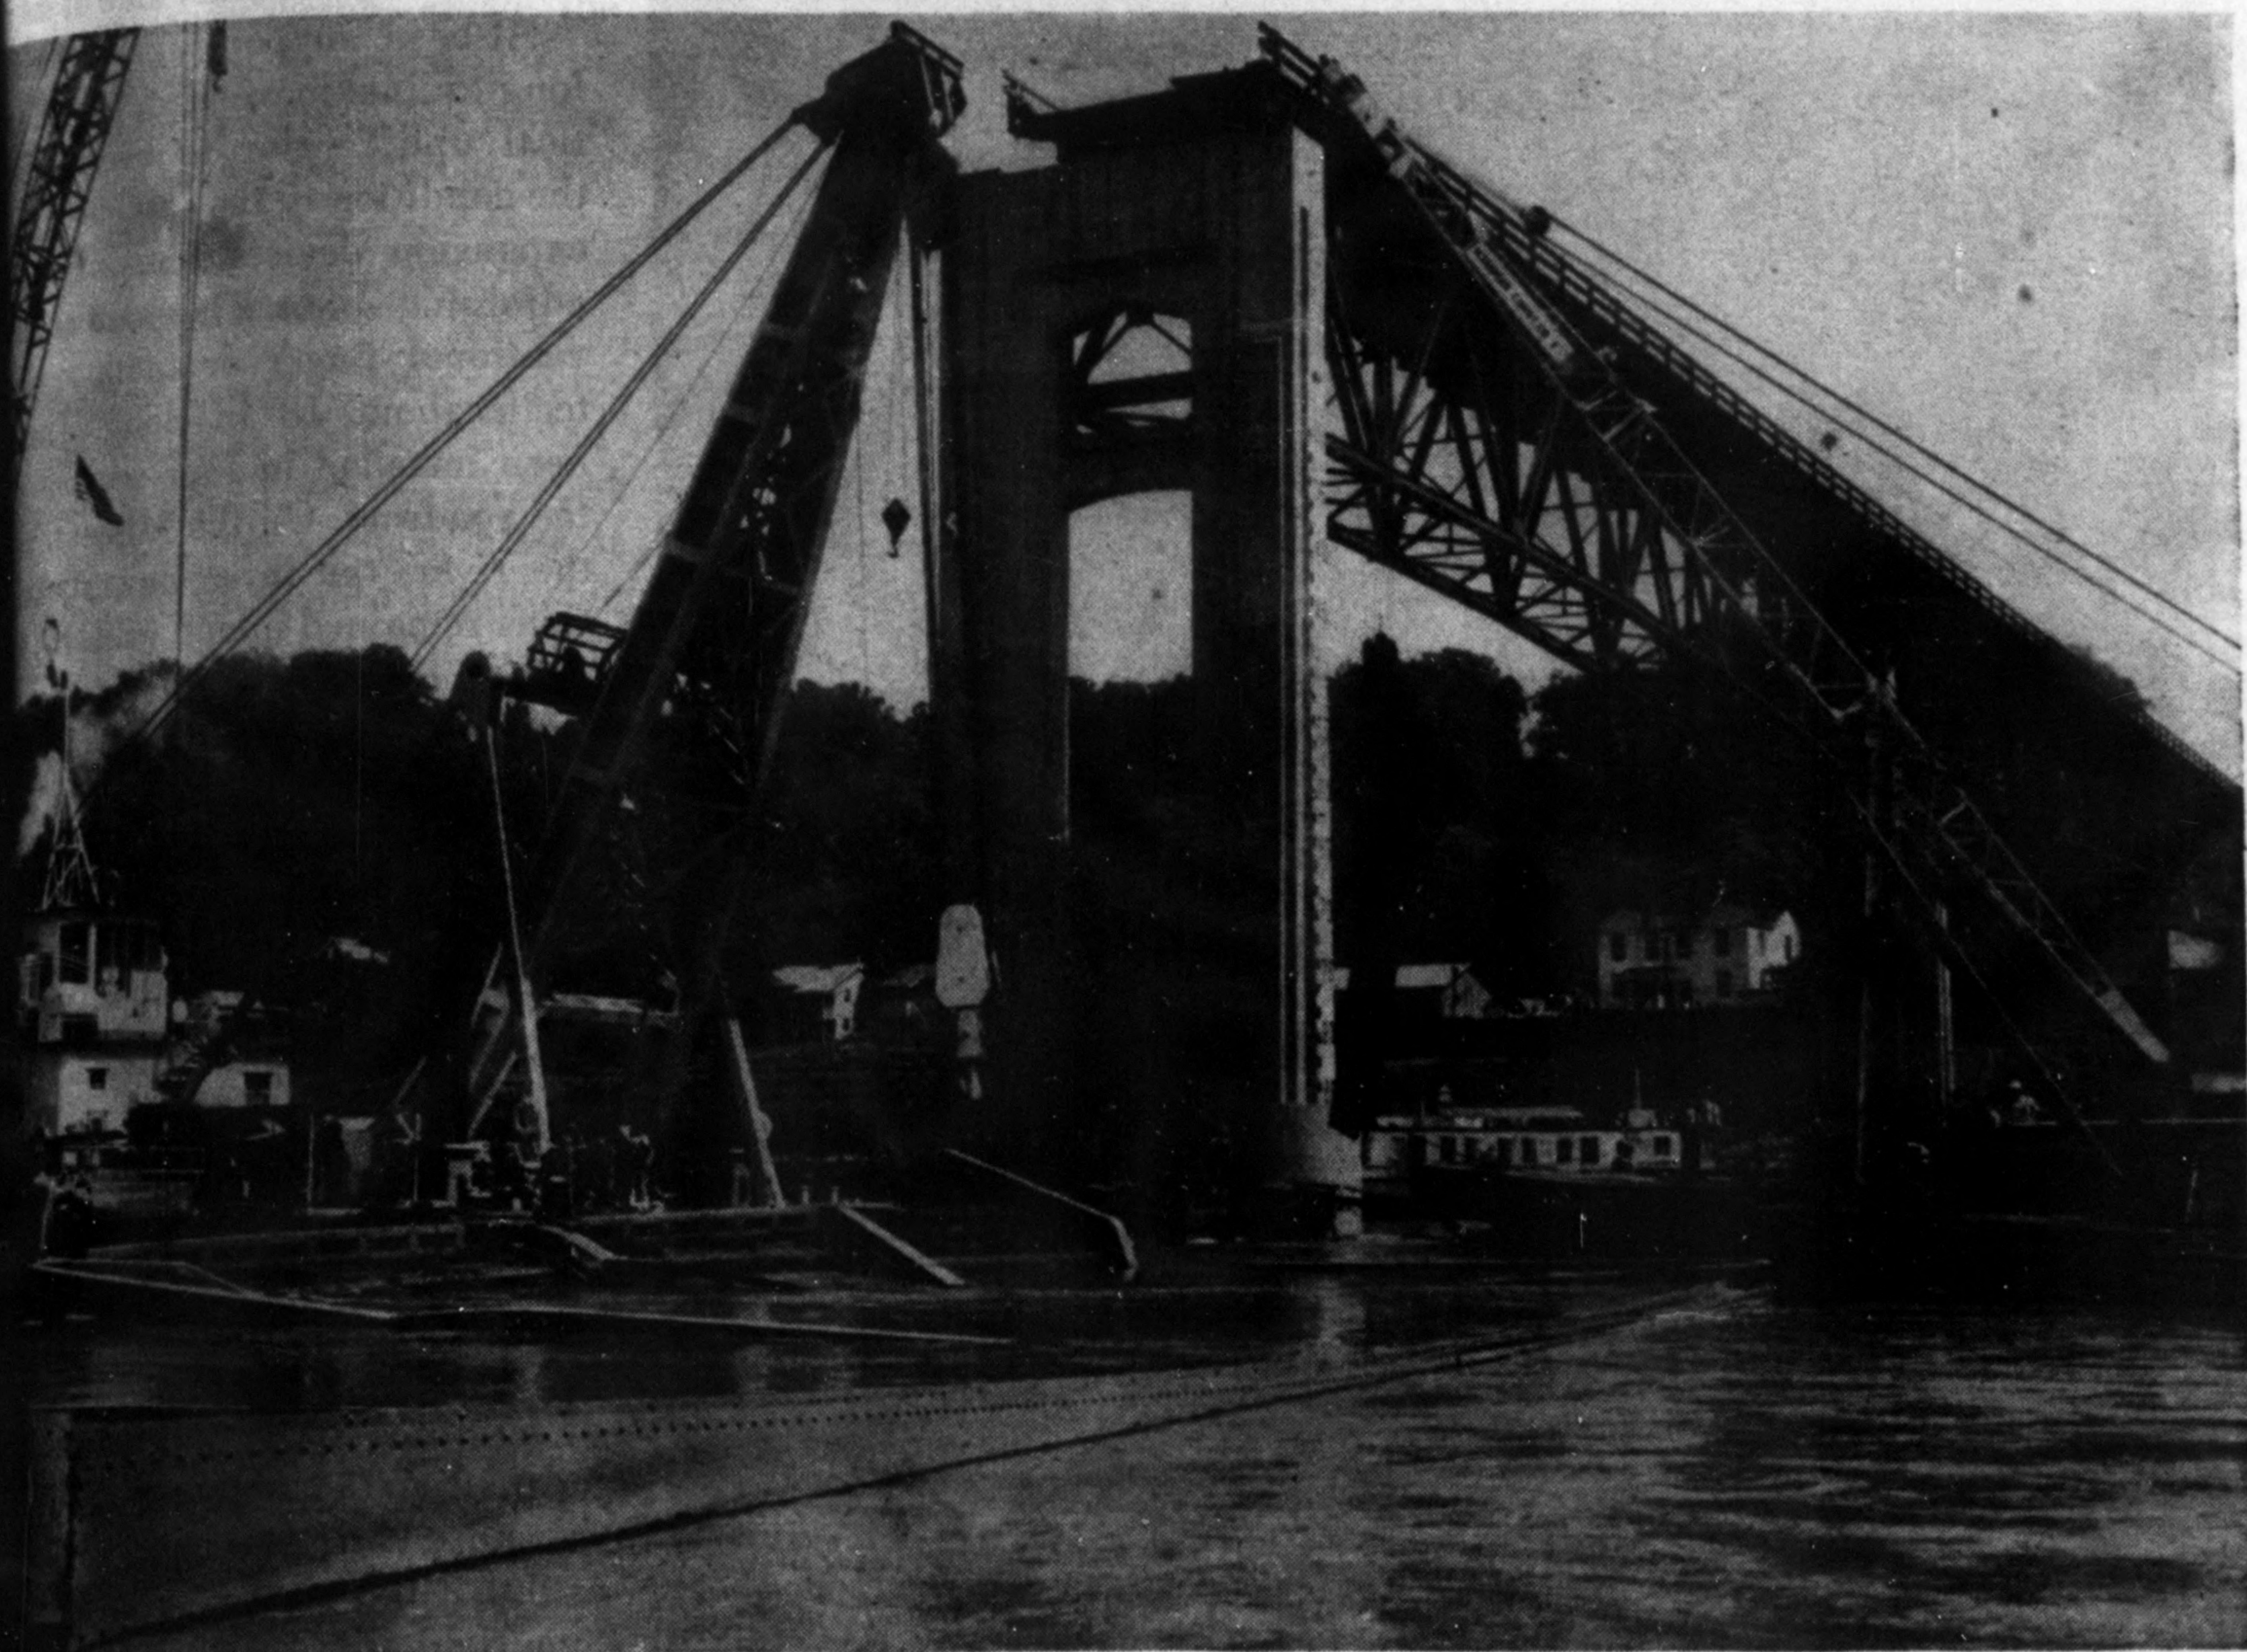
Heavy hoisting equipment removes torn and twisted bridge trusses from the muddy Mississippi at Chester, Ill.

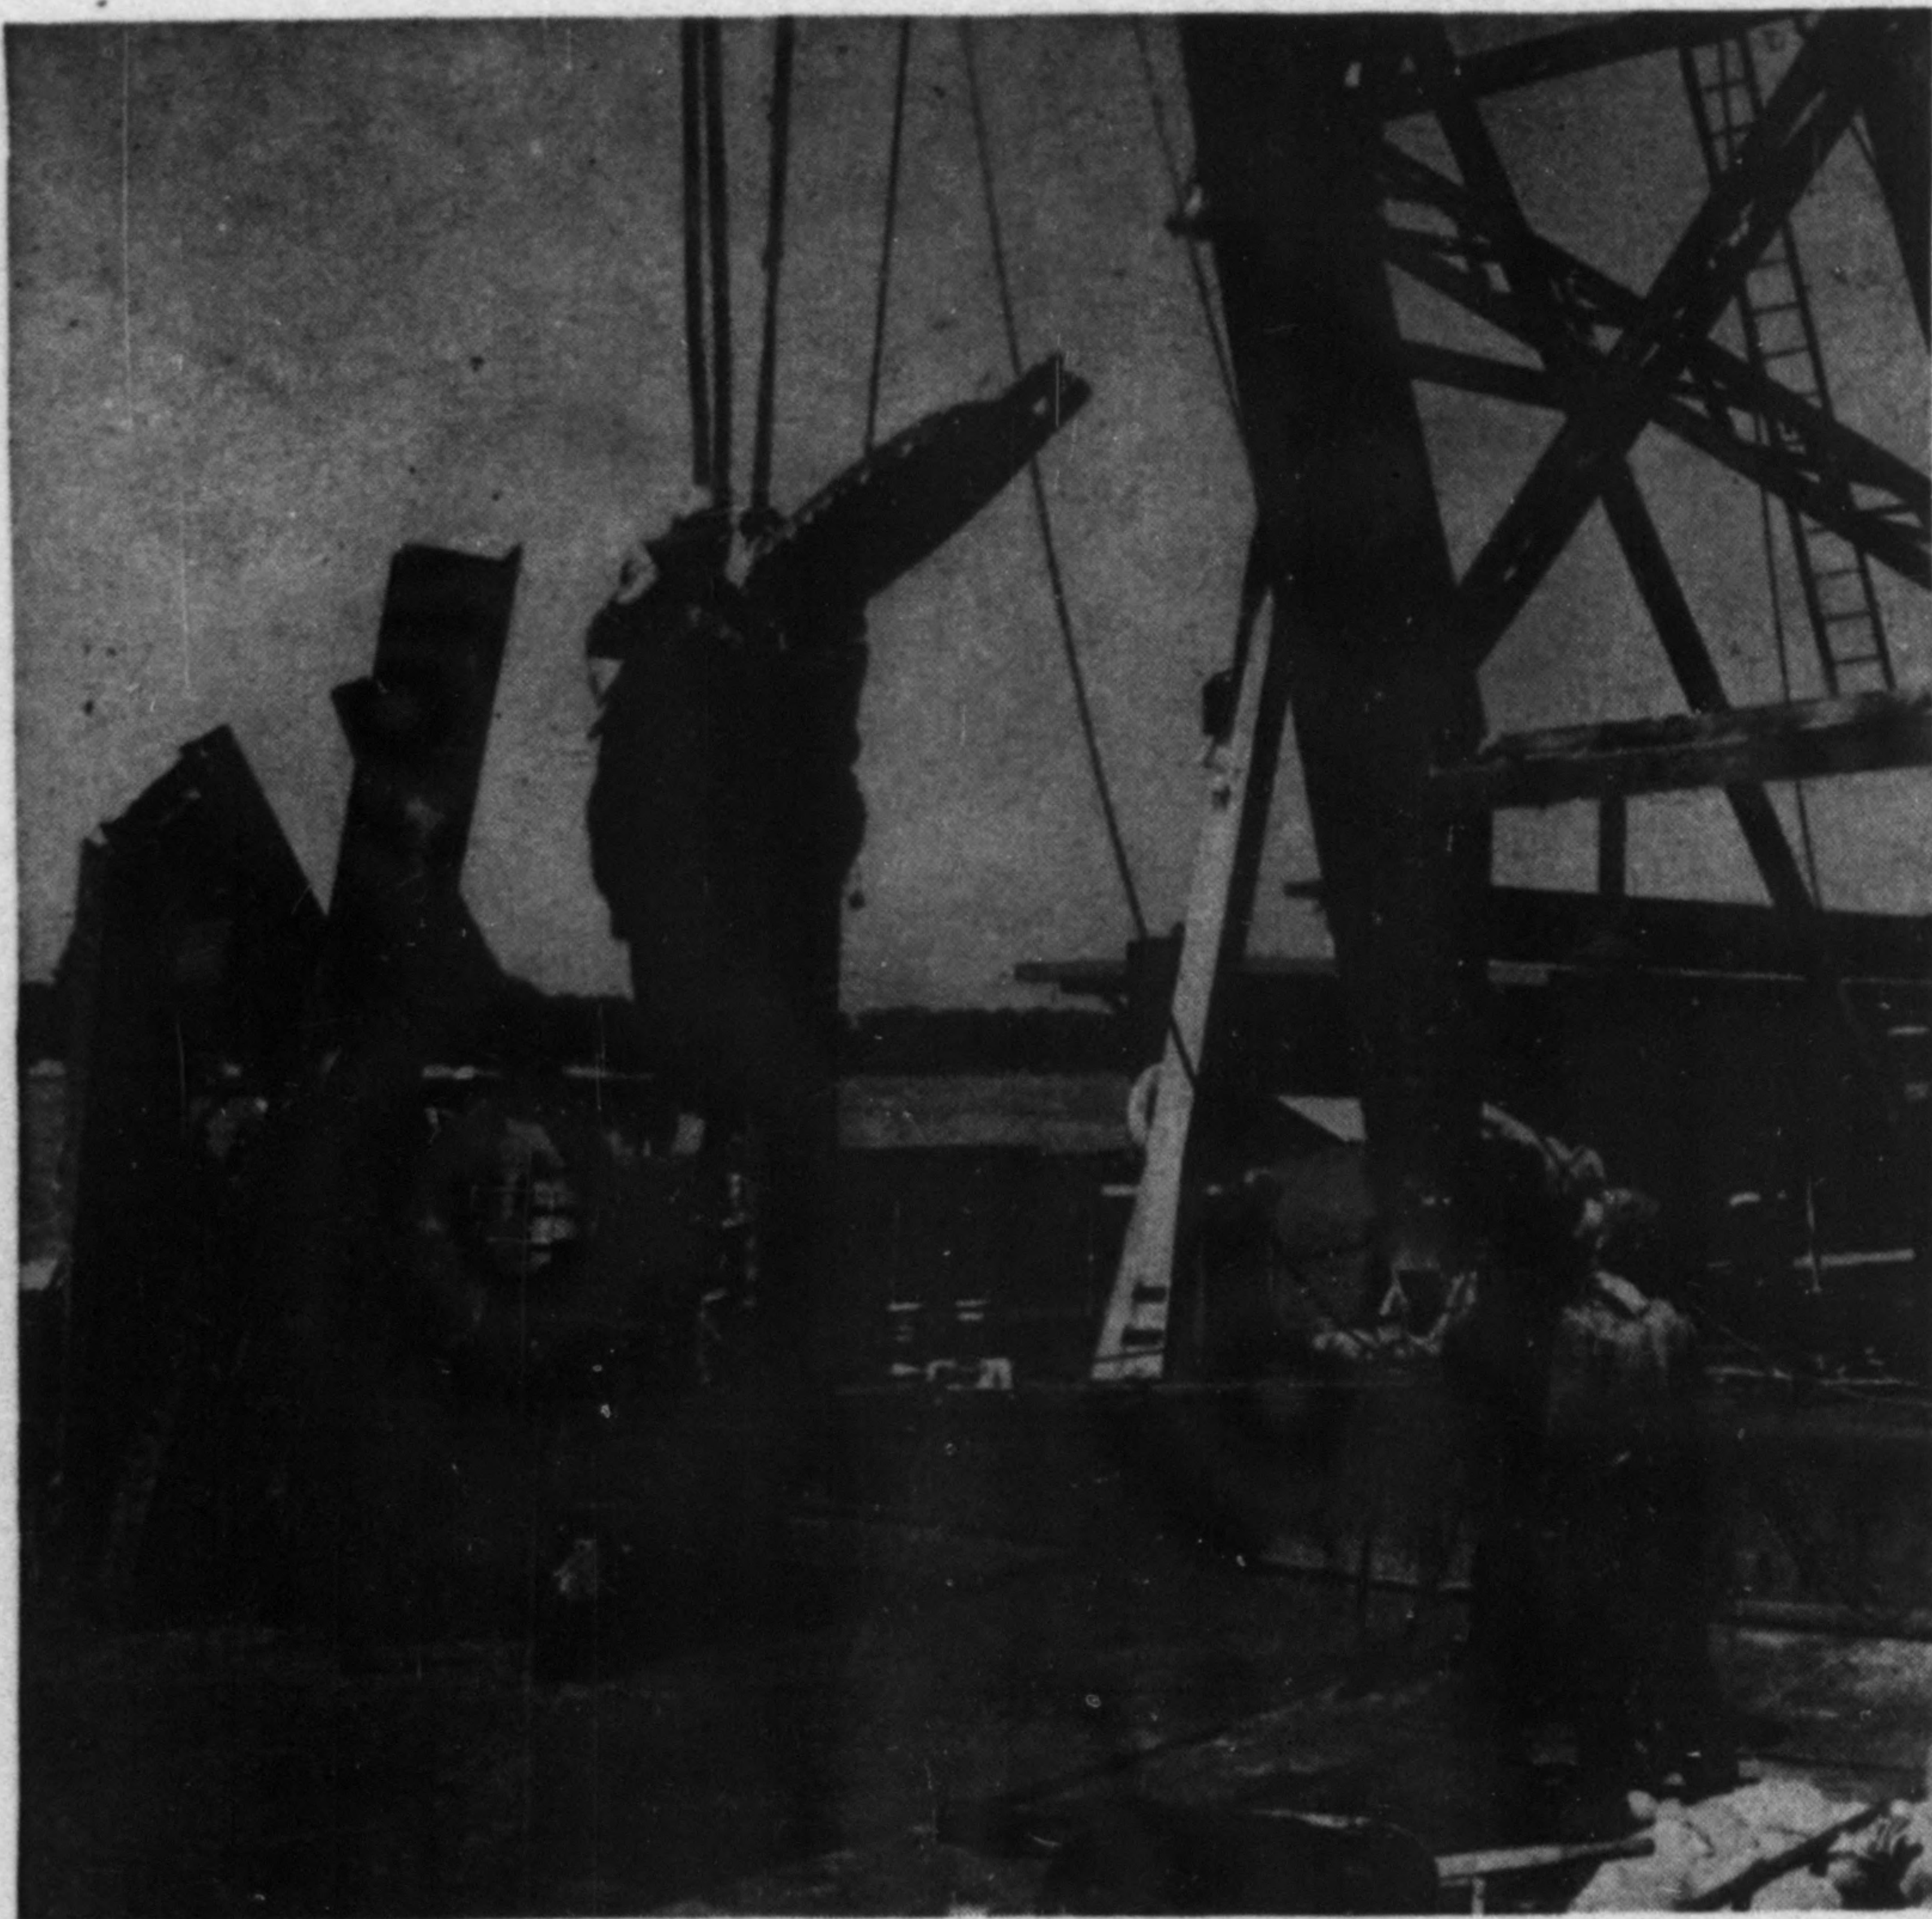
After a twisted mass of dynamited steel was raised above the river, members were burned into convenient lengths for loading onto barges.

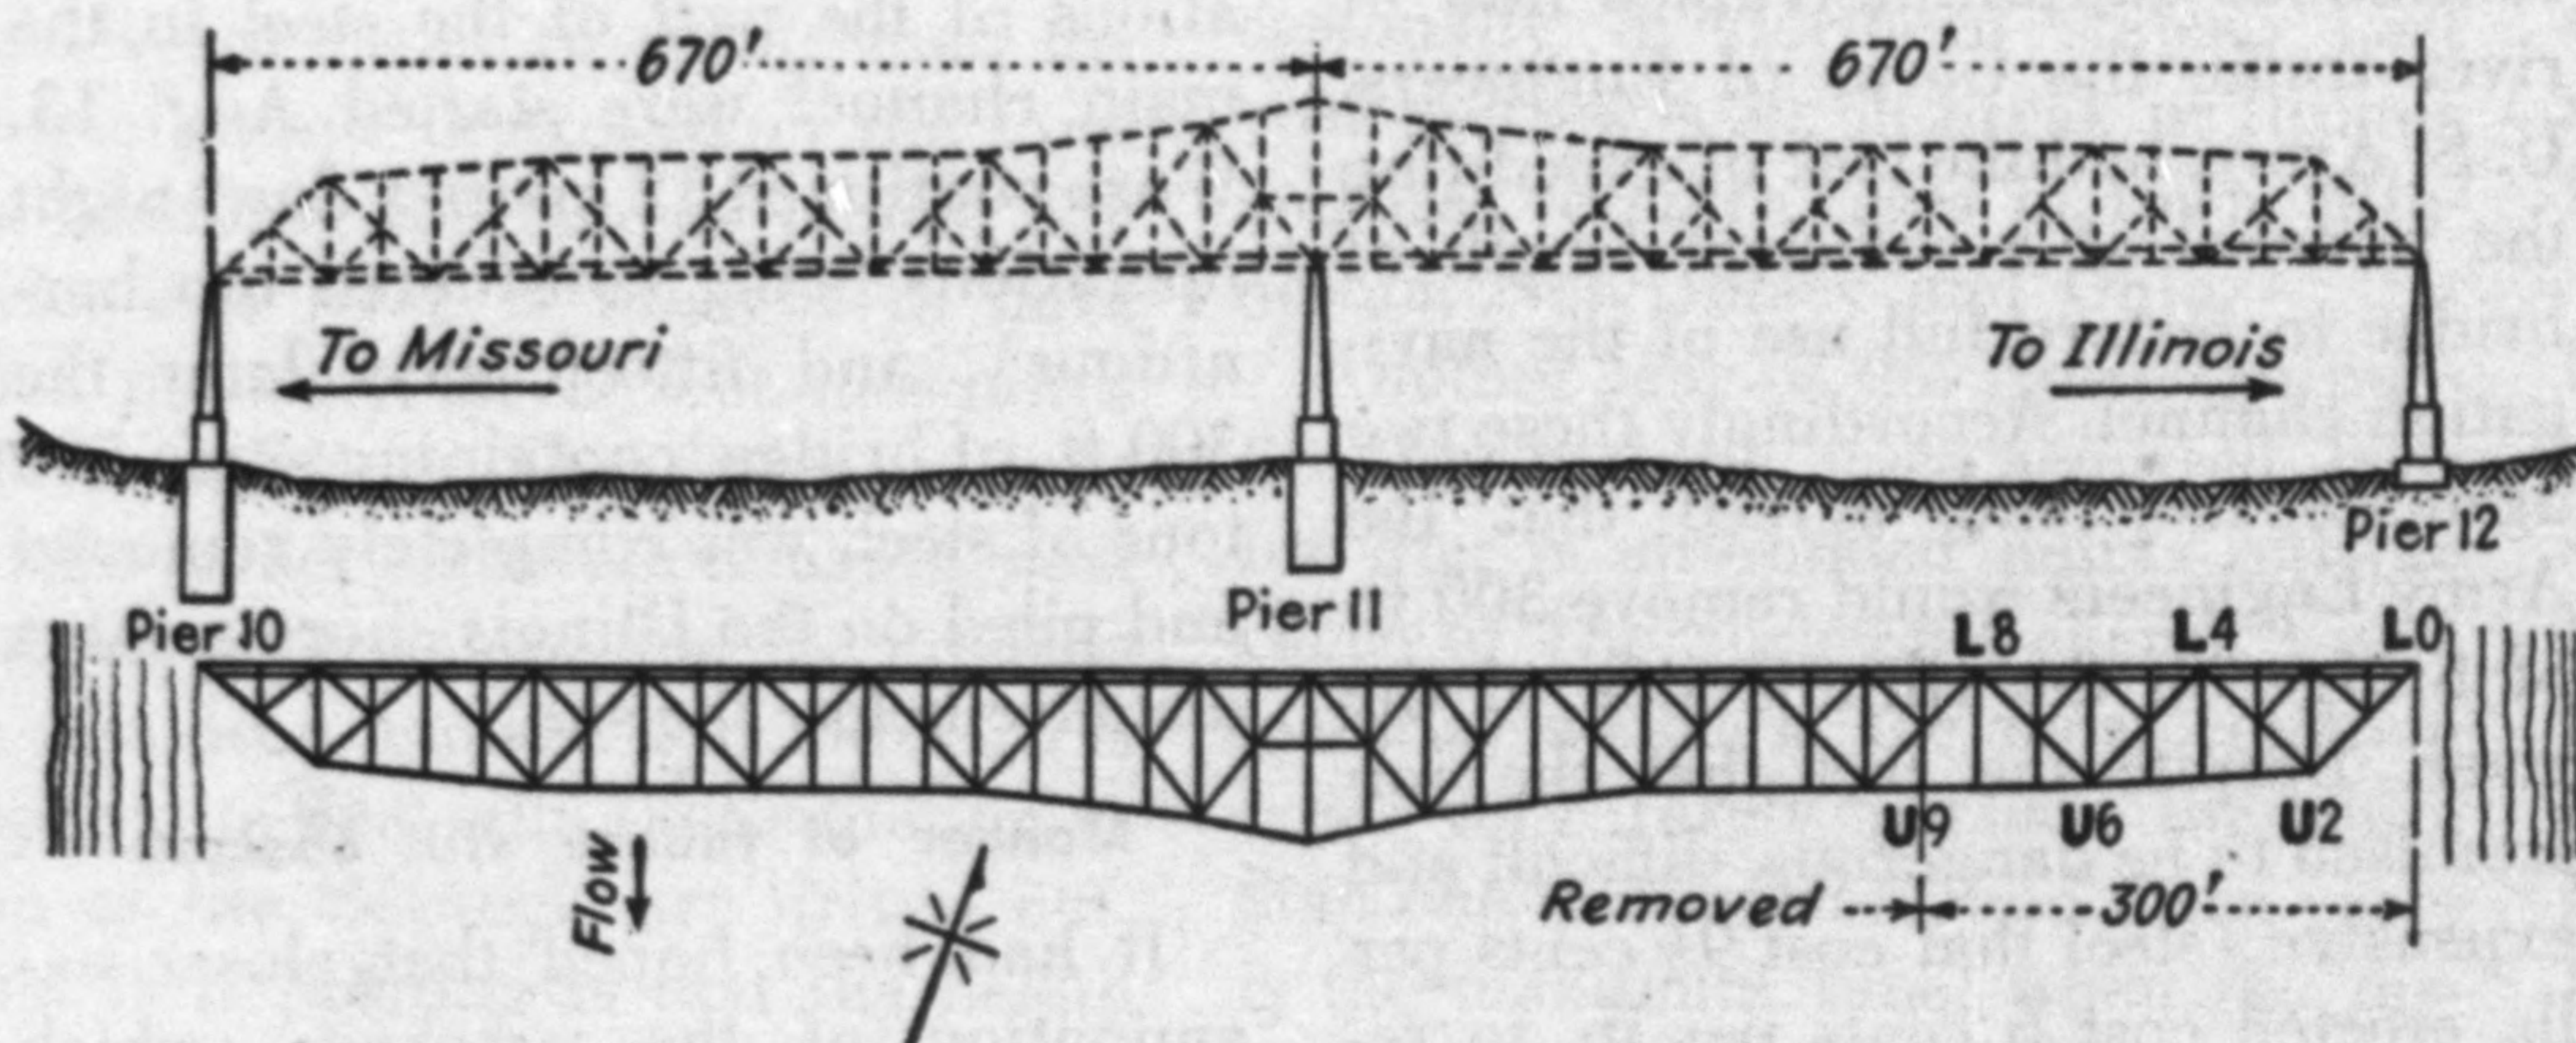
Salvage operations started at L0 and continued toward the center of span to provide a clear navigation channel.

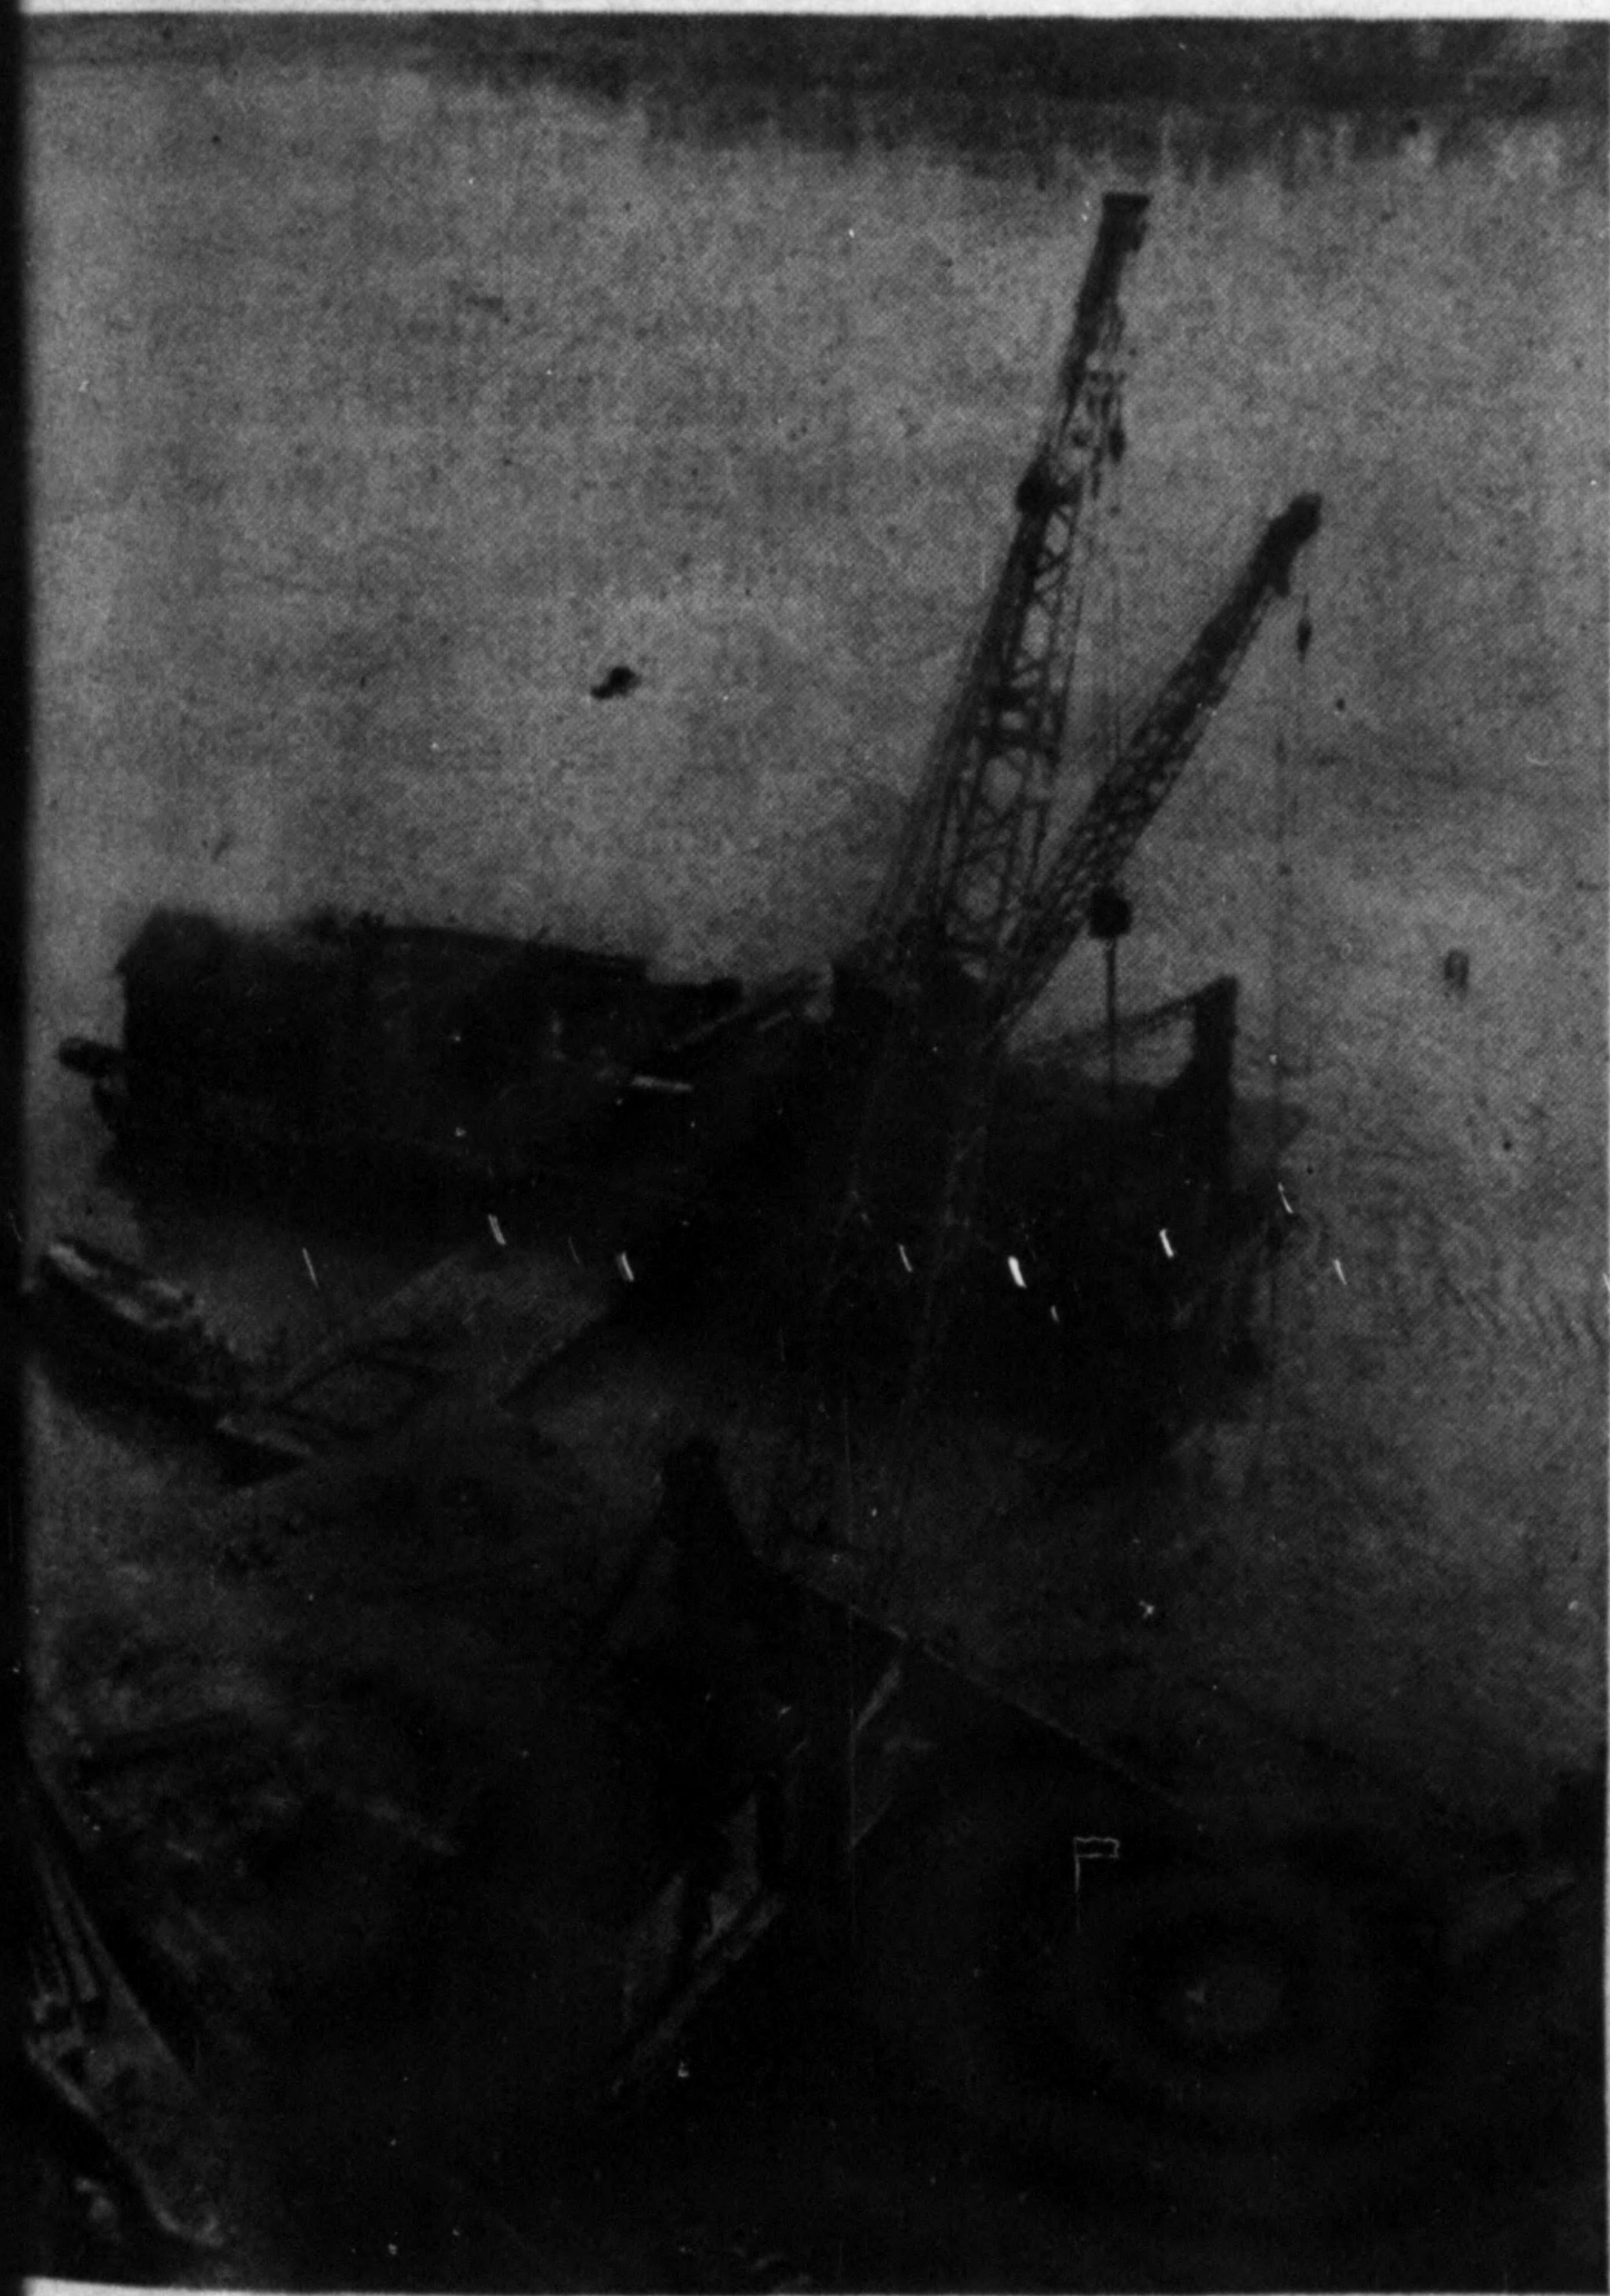
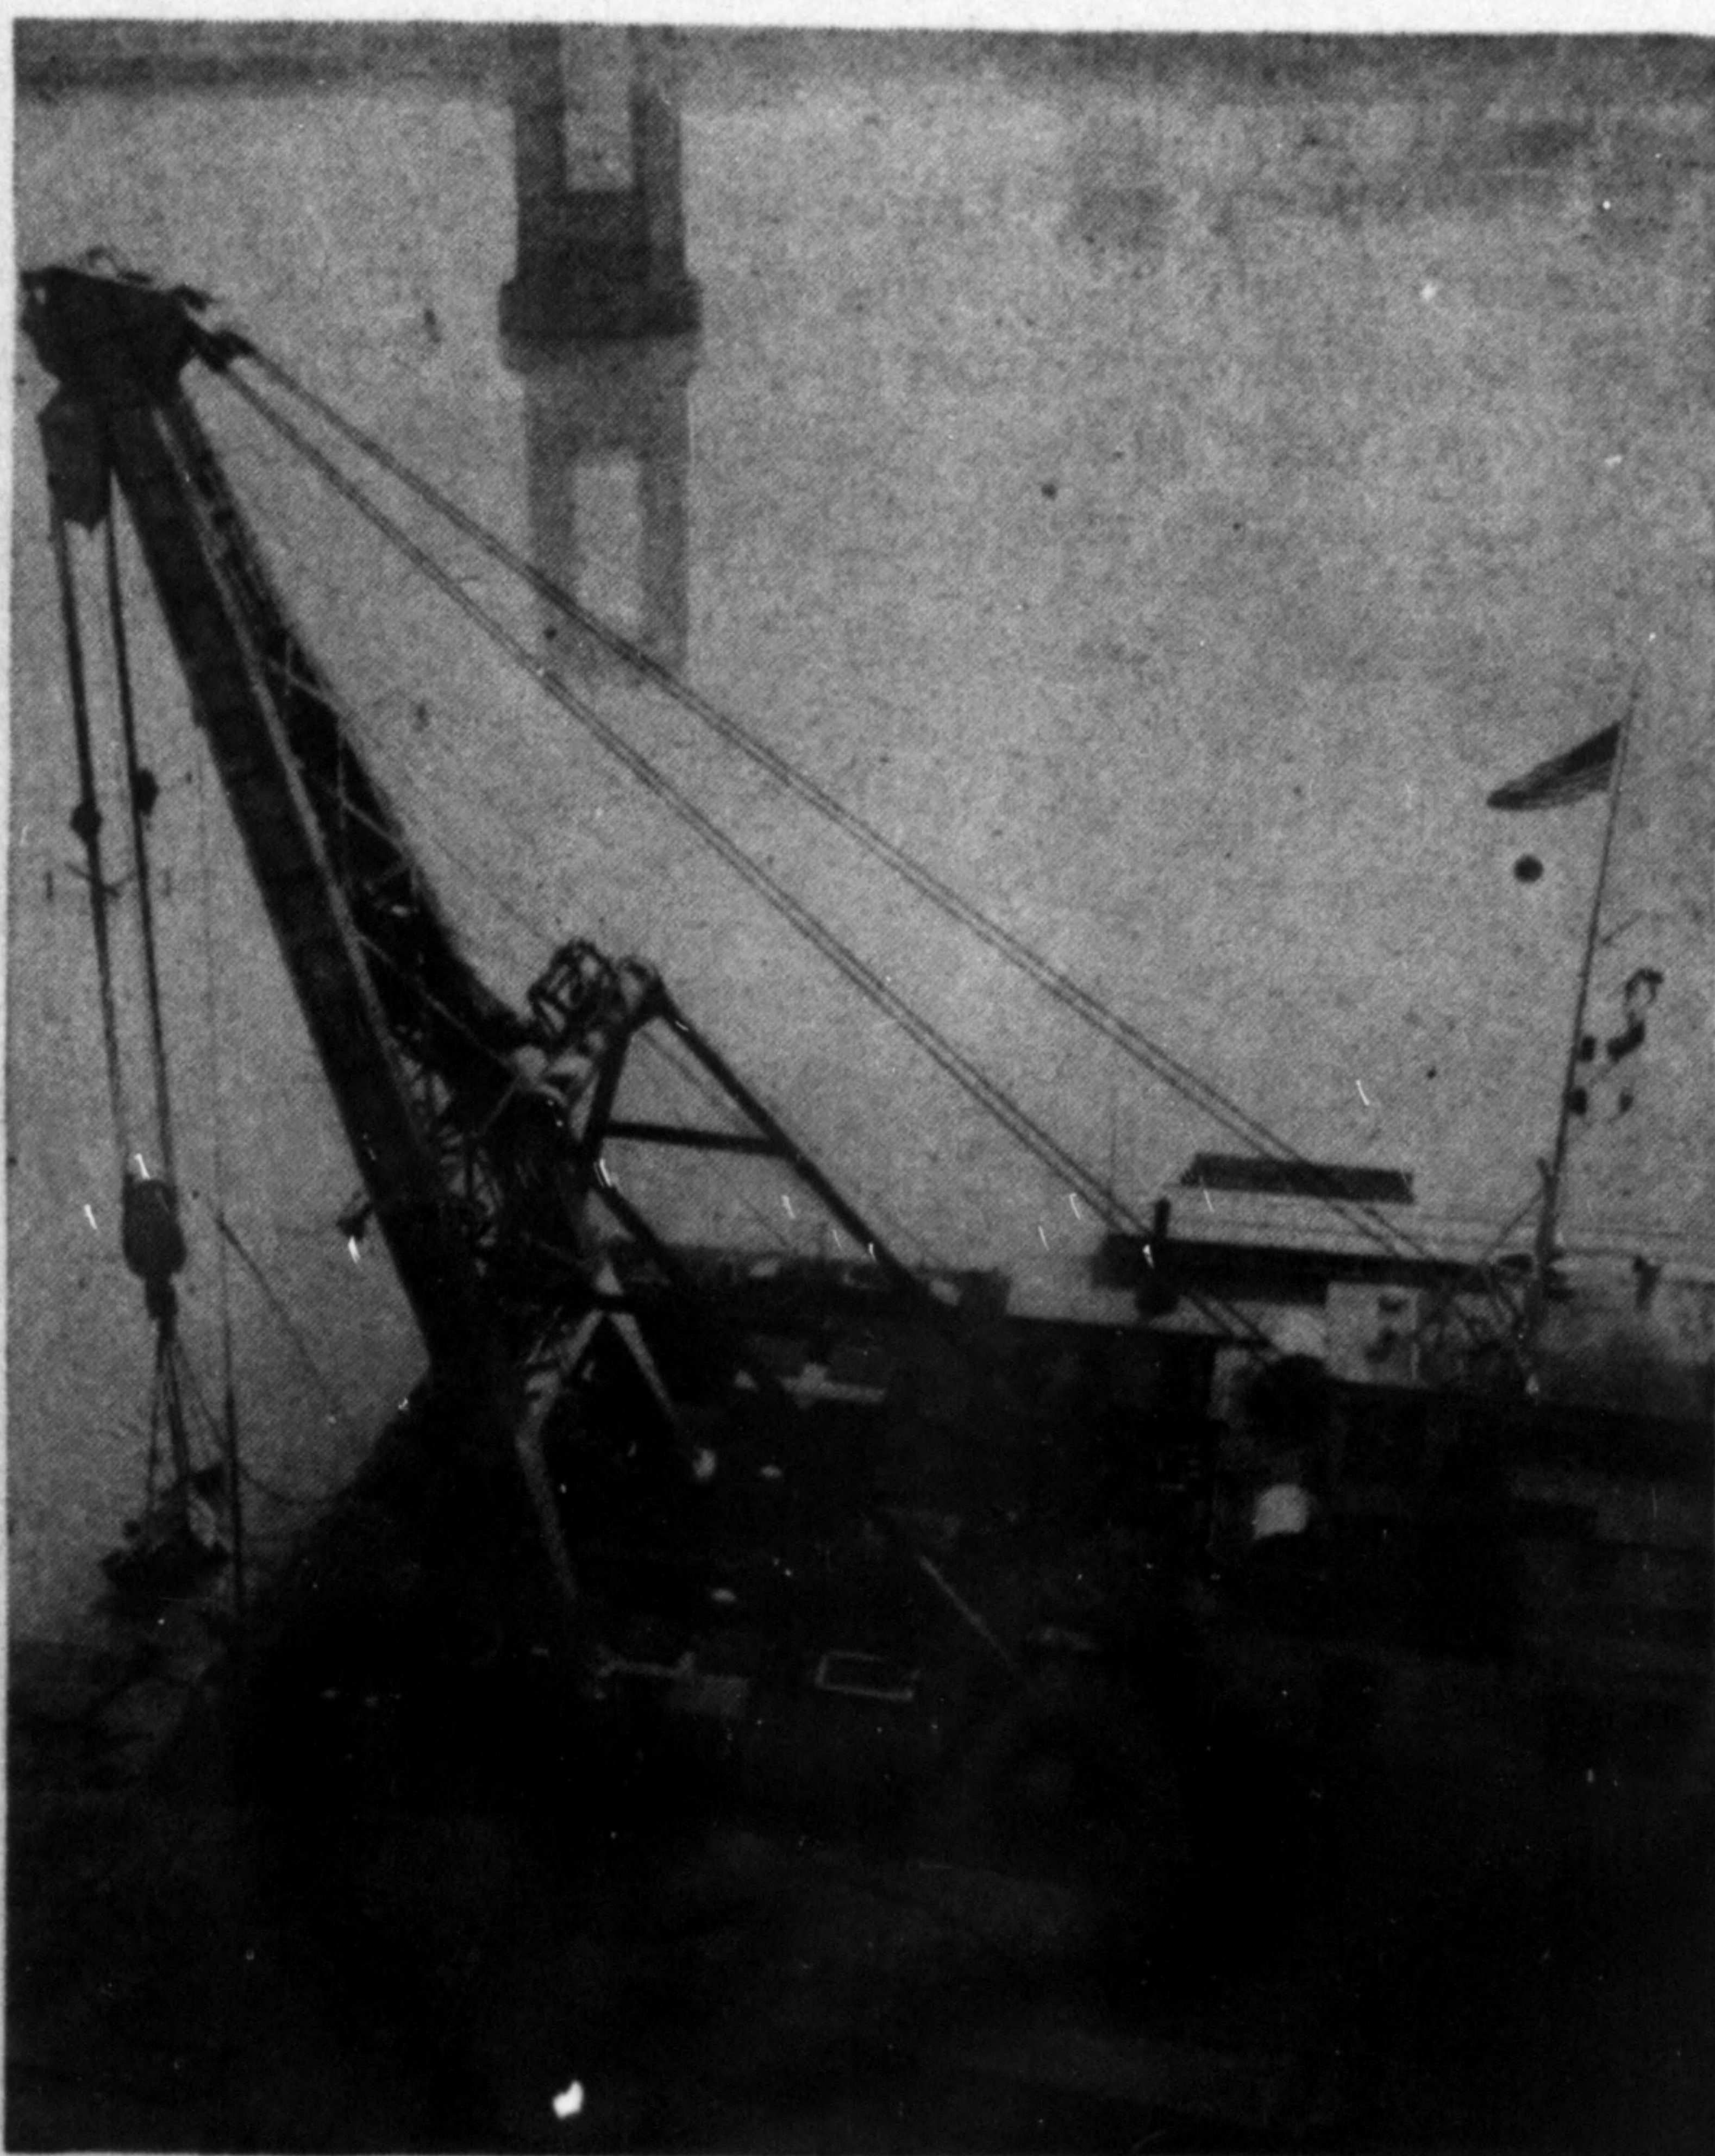
Salvaged steel was loaded on barges by a revolving crane and a crawler crane (left) while the U. S. Army Engineer derrick (right) moved out over the bottom truss chords to do the heavy lifting.

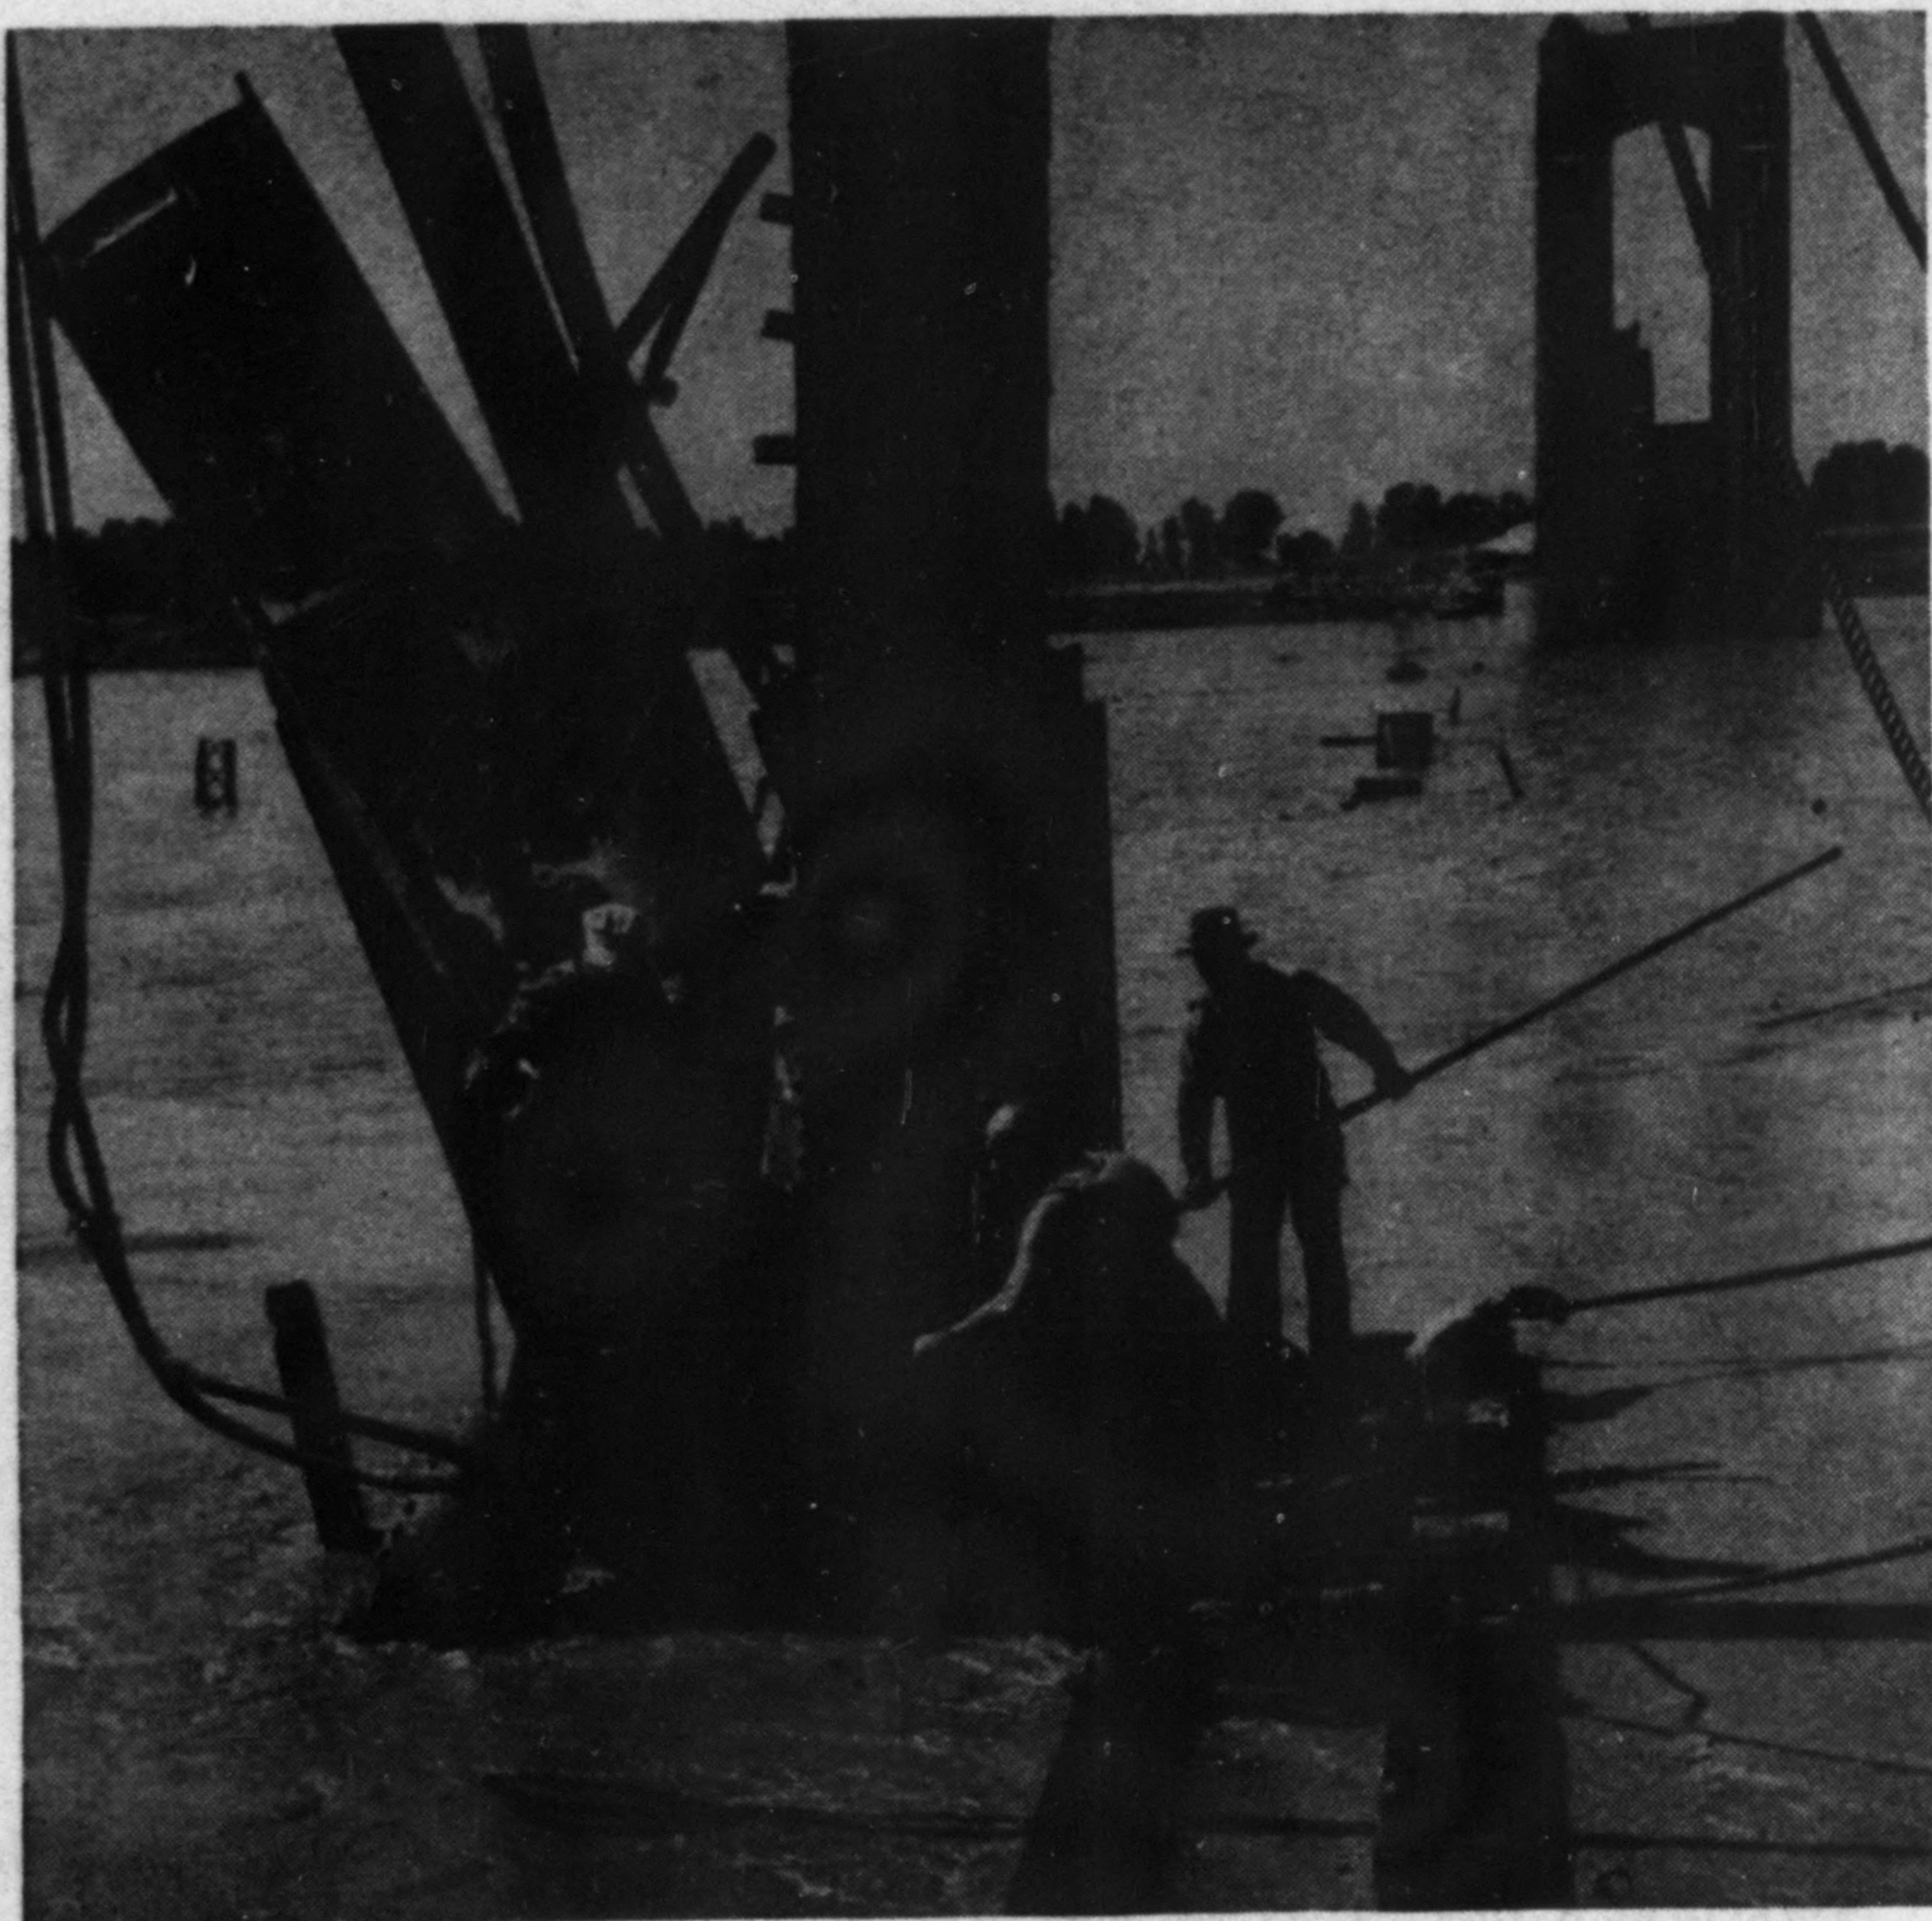
Some idea of the hazards of the work is shown in this action picture of workmen attaching slings preparatory to burning sections for removal.
