Spanning the Mississippi at Chester, Ill.

Removing a Bridge From the Mississippi

Contents in Brief—Heavy marine blasting removes 500 tons of the wreckage of the Mississippi River bridge at Chester, Ill., to provide a 300-ft. navigation channel. Salvage operations completed in 15 days and without mishap, despite unusual hazards. Reason for failure of bridge in wind still unexplained.

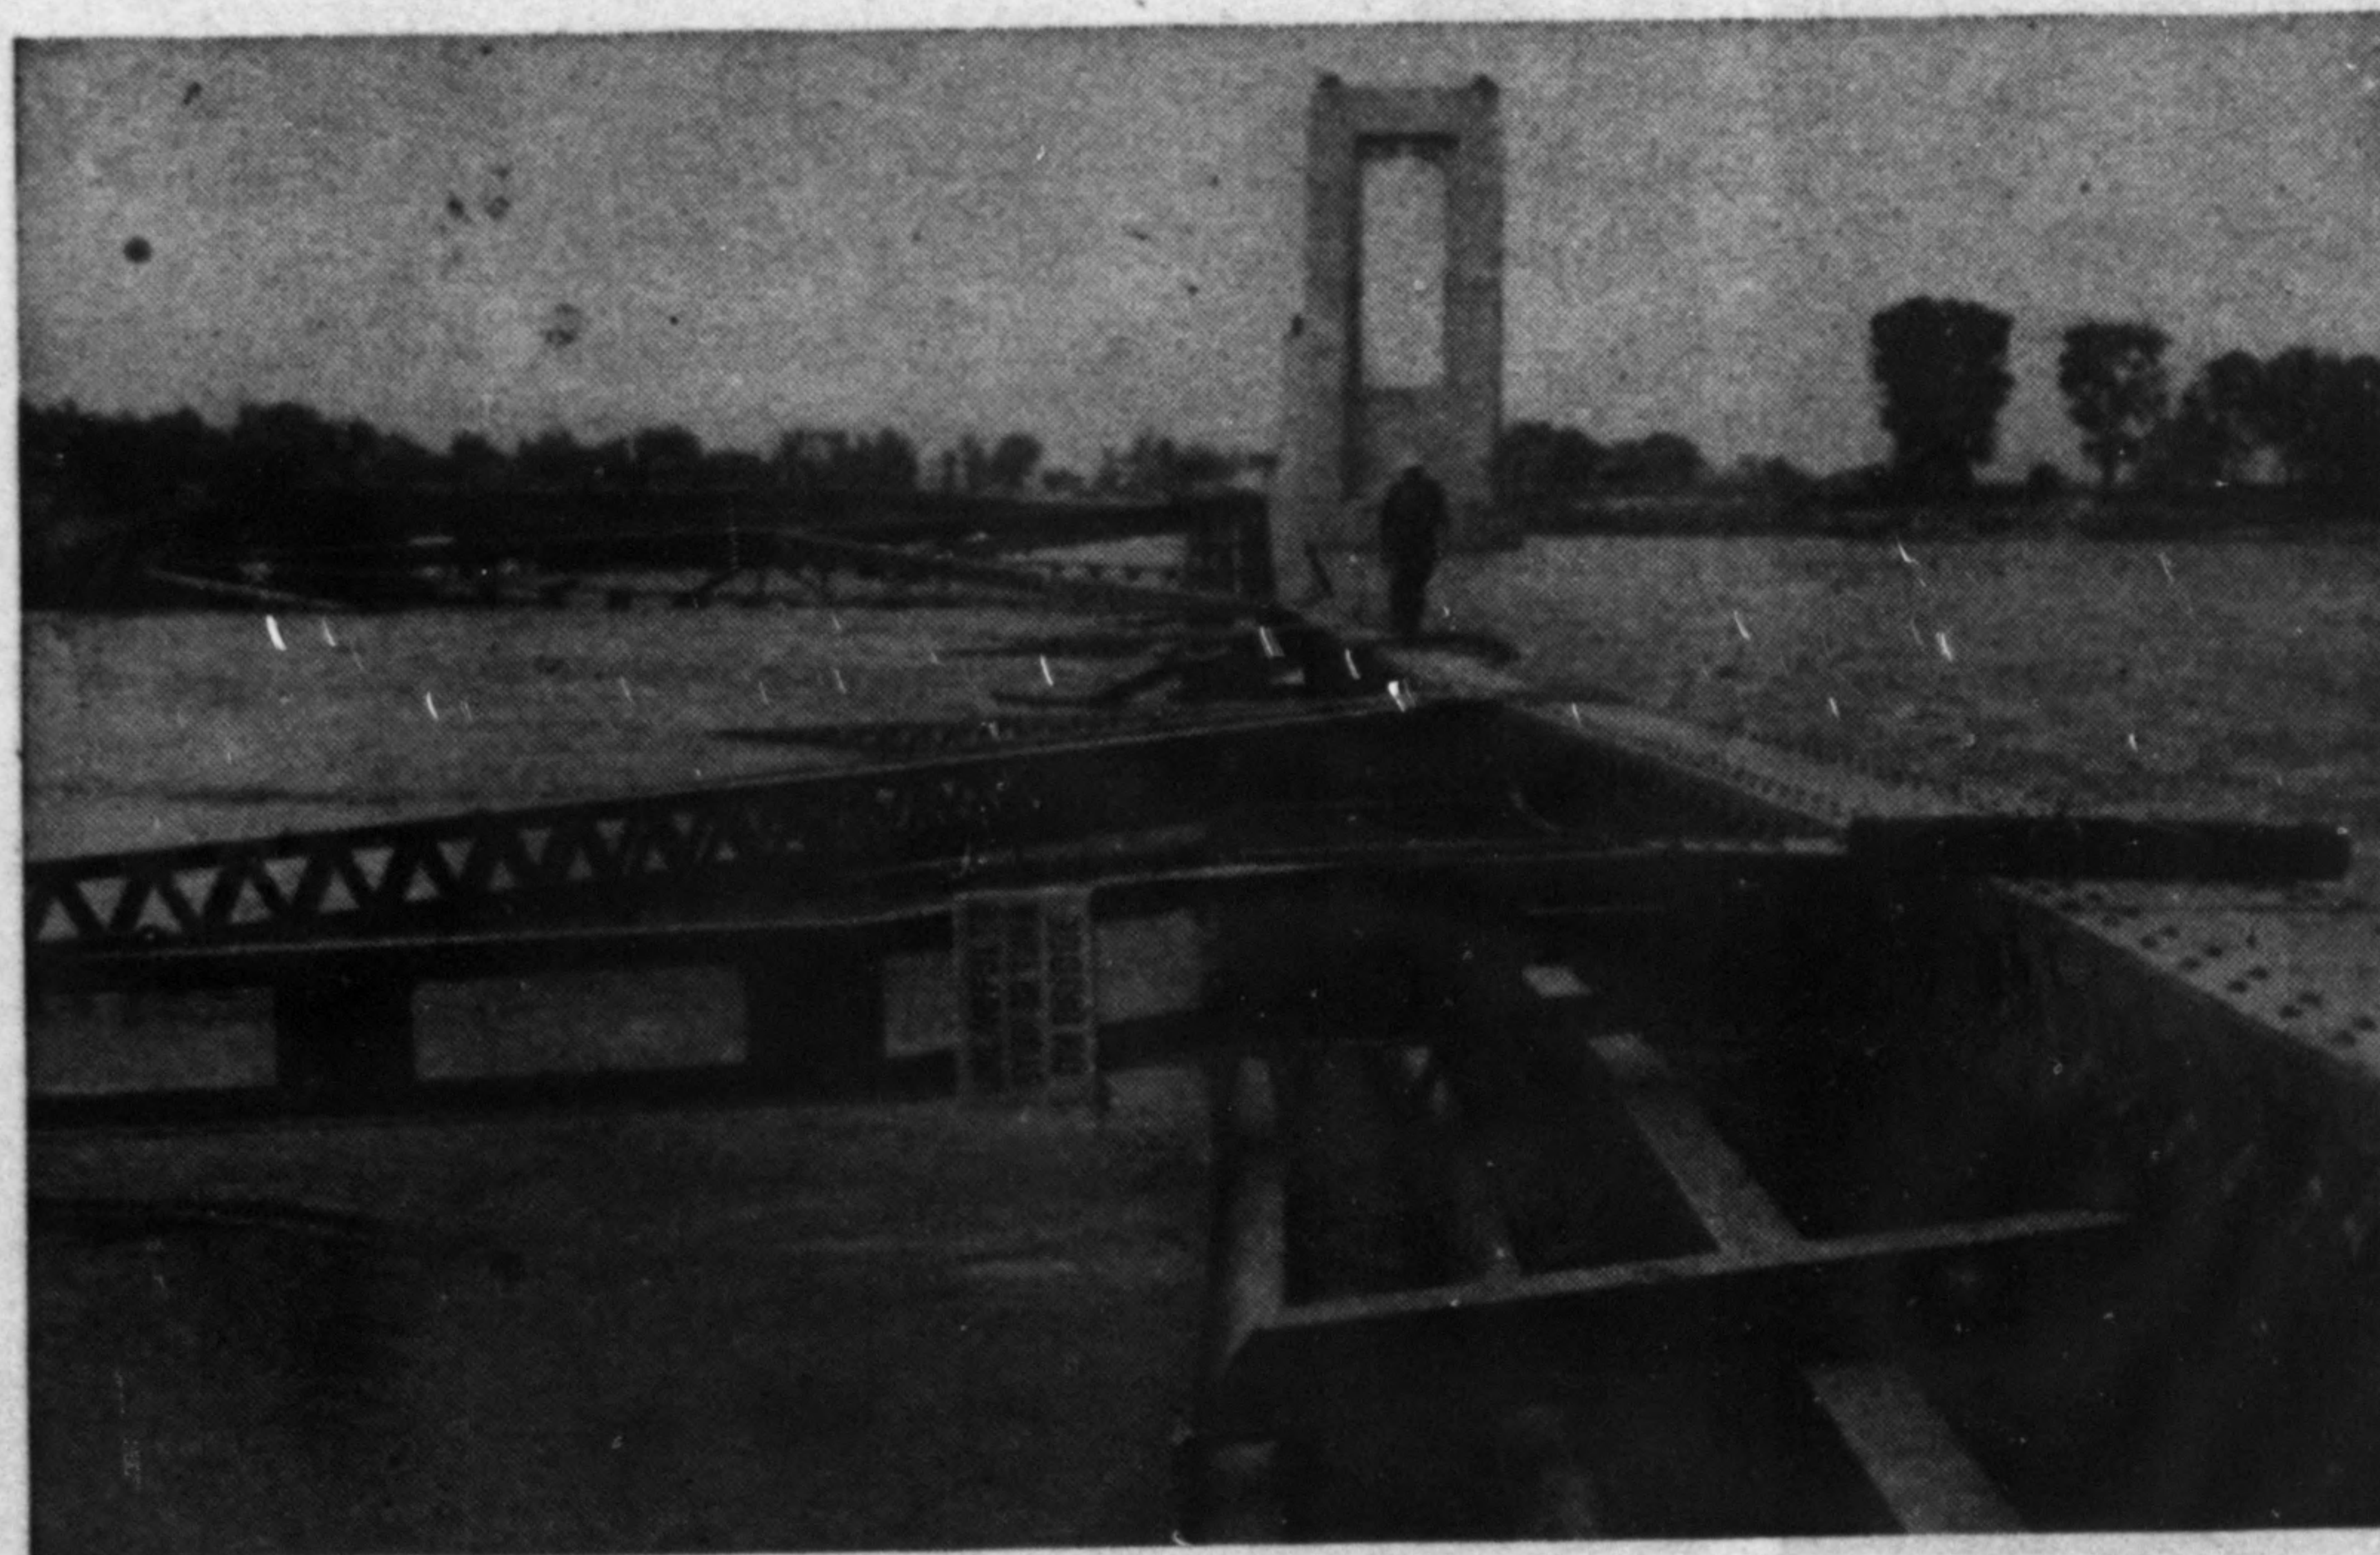
One of the first salvage operations was to cut and remove all steel projecting above the river.

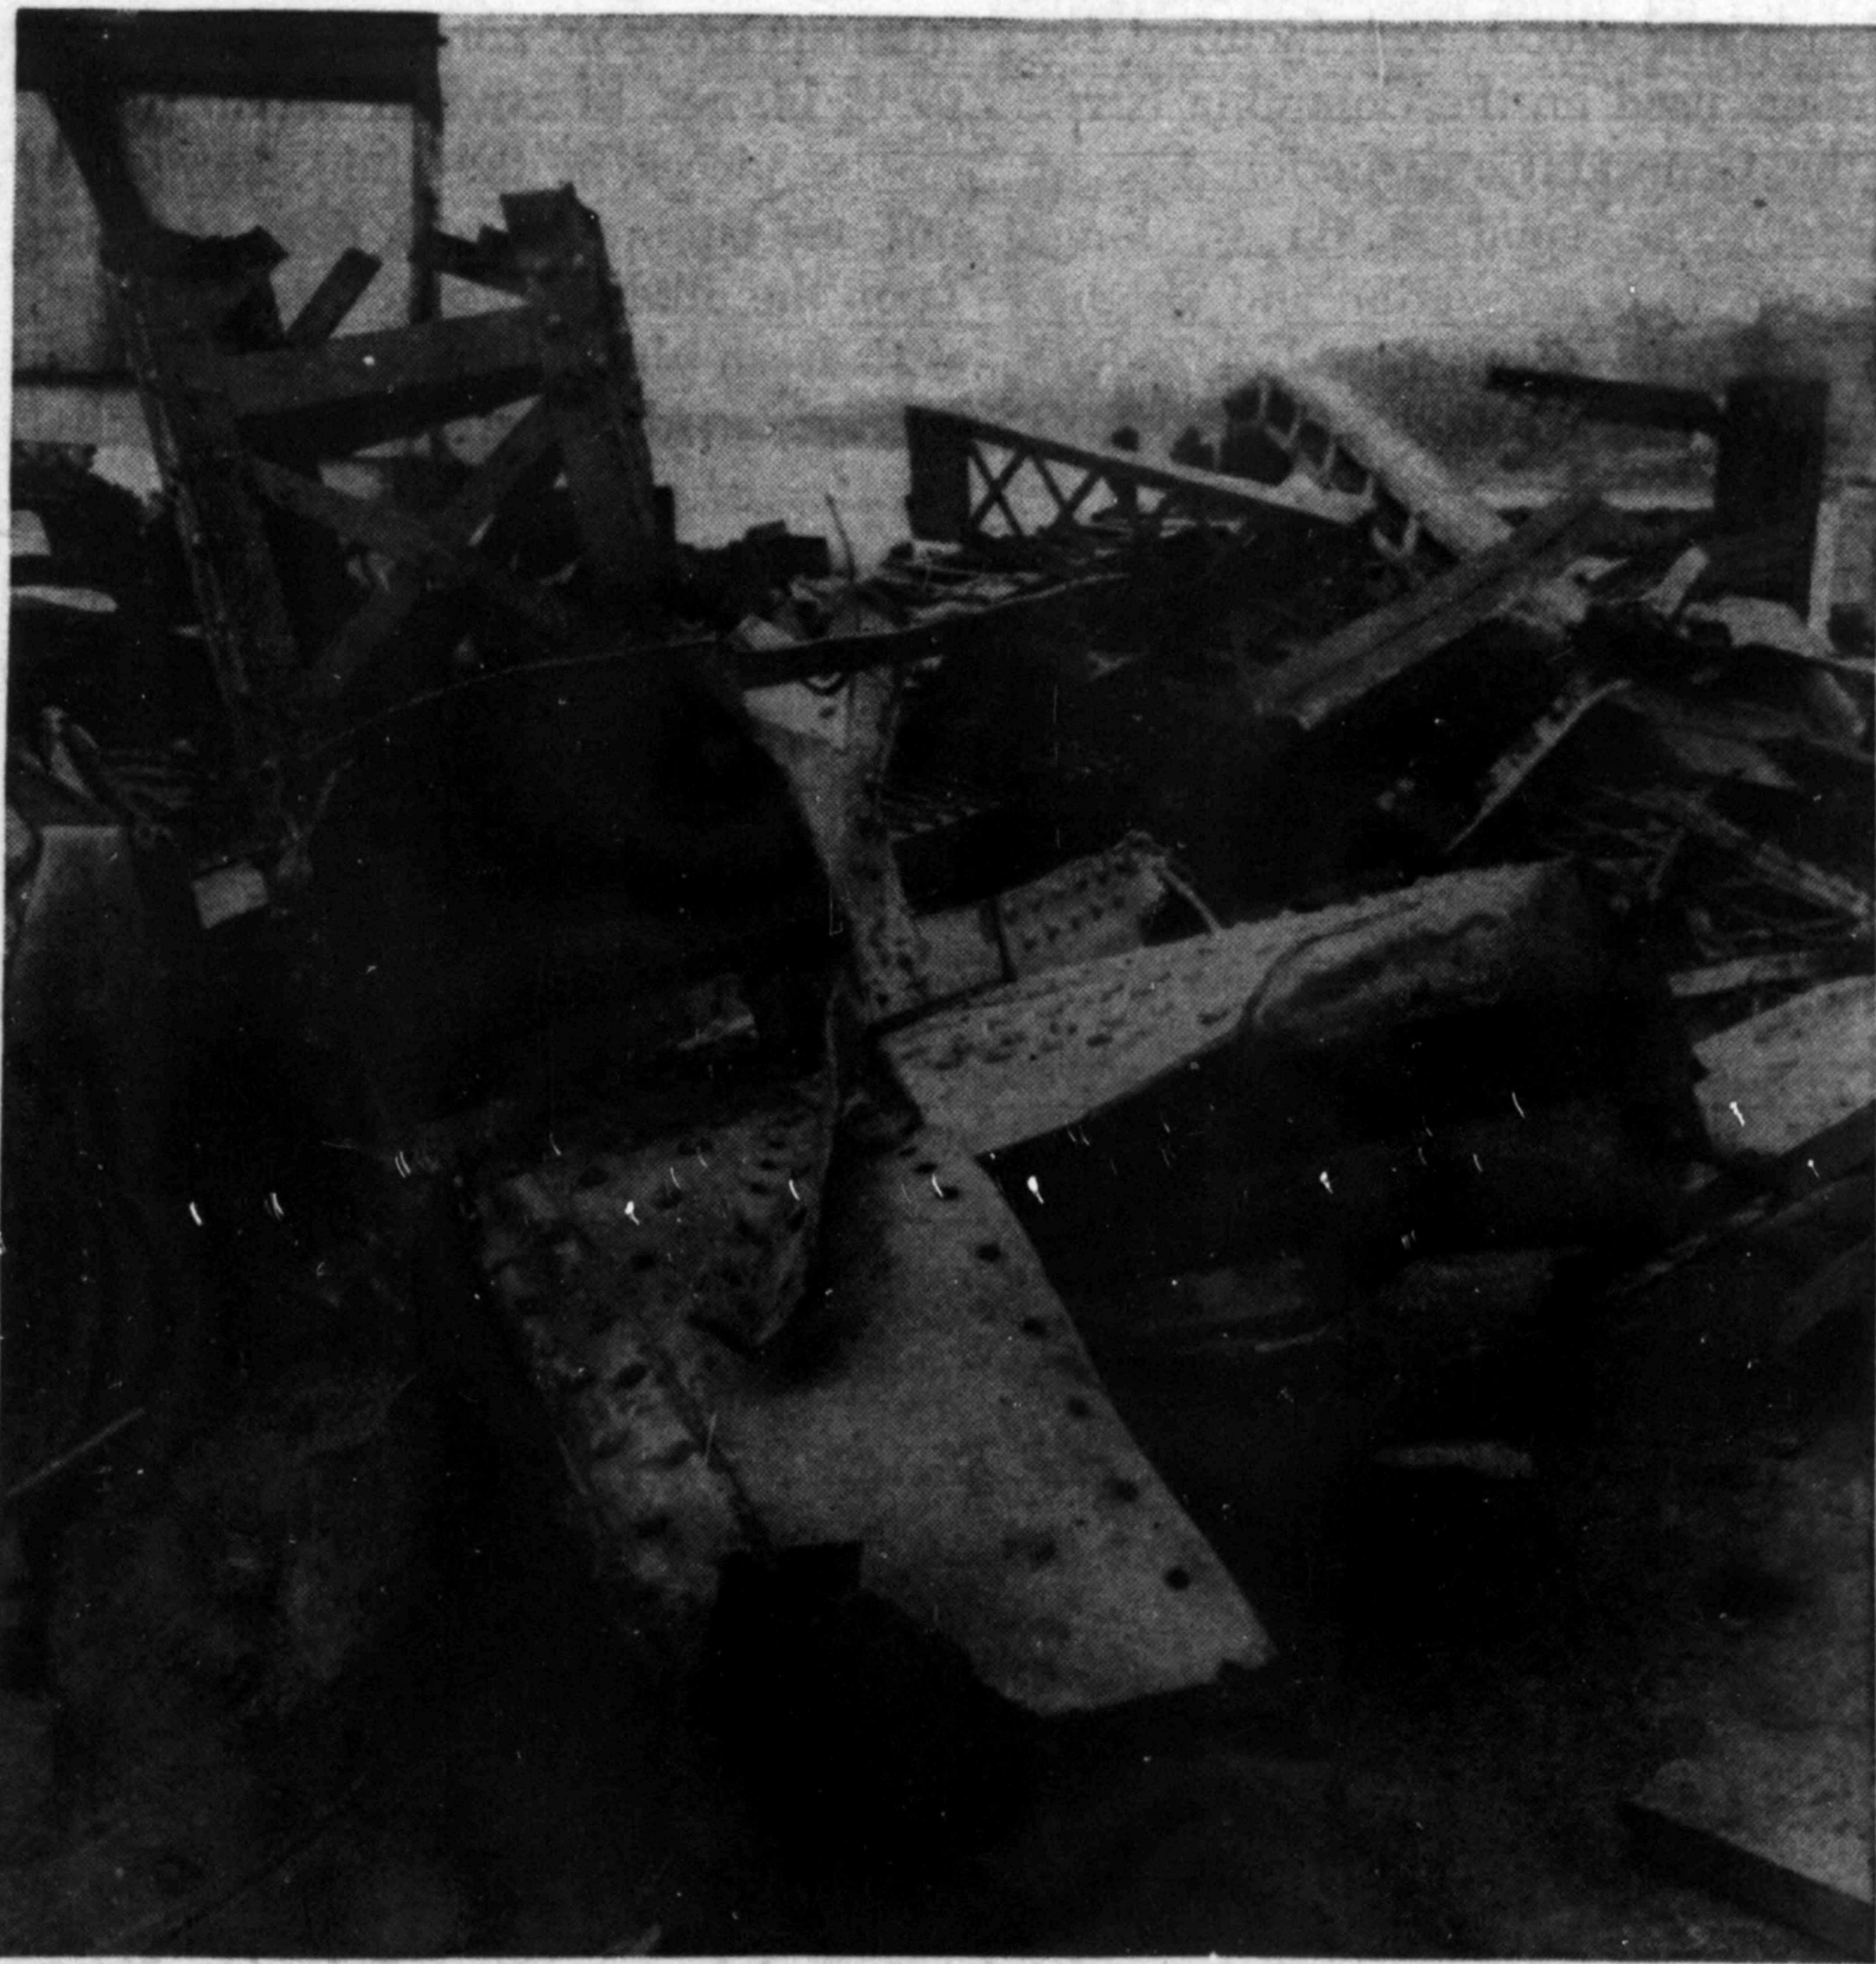
Seldom were the dynamited breaks clean at any joint, but the heavy dynamite charges demolished it sufficiently to permit the tangled steel to be hoisted above water where the different members could be burned off and loaded onto the barges.

A close-up of a truss joint shows the effect of marine dynamiting.
