Executive Summary

Bridge Number: 94246

Bridge 94246, also known as the Northern Pacific Railway Bridge No. 9, carries the Dinkytown Bikeway Connection and a pedestrian trail over the Mississippi River and West River Road, in Minneapolis. The bridge, owned by the City of Minneapolis, is a former double track railroad bridge that was converted into a pedestrian/bicycle bridge in 1999. The bridge is significant for its configuration as a deck truss, which is a rare truss type in the state, and innovative reuse of 1885 pin-connected deck truss spans that were reinforced in 1922 with riveted deck truss spans. Additionally the bridge is significant for community planning and development for its association with a movement in Minneapolis to separate railroad crossings from vehicular and pedestrian crossings.

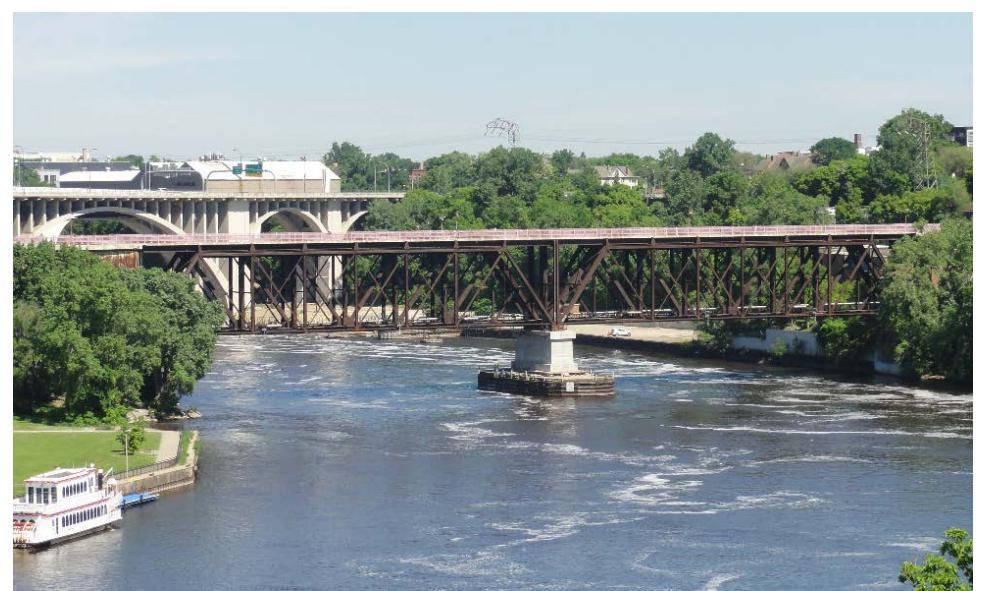
Condition 1: General view of bridge, looking north (note truss spans over Mississippi River and recent pier 4 concrete encapsulation)

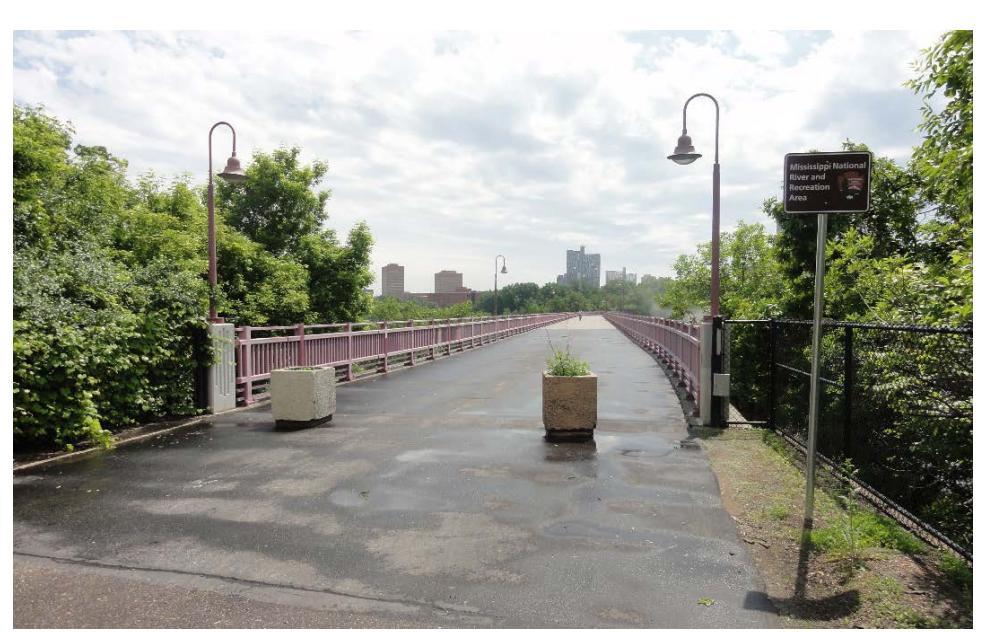
Condition 2: East end of bridge looking west (note planters and asphalt pavement)

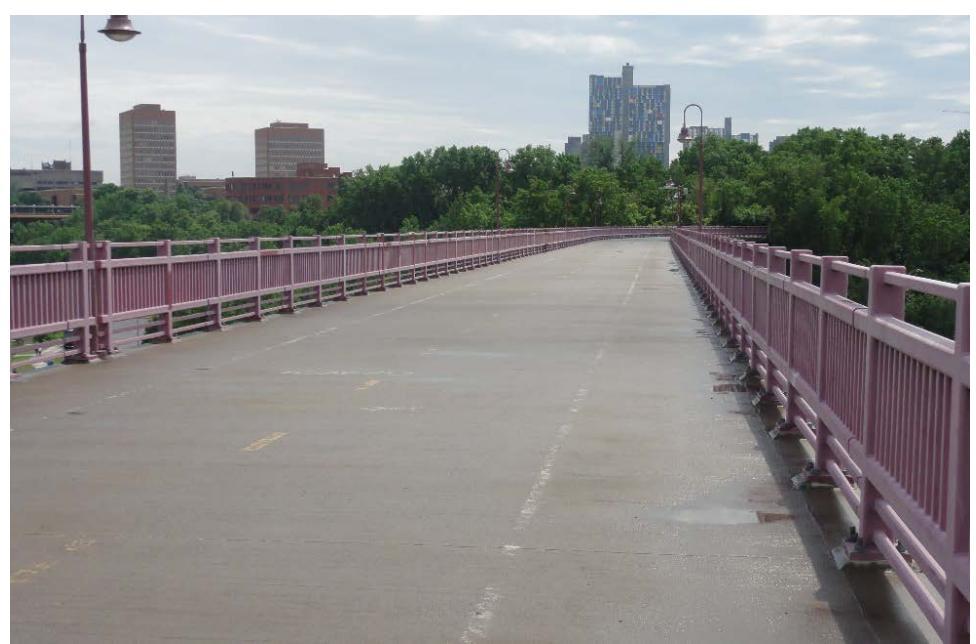
Condition 3: Concrete deck and metal railing on truss spans (note faded pavement marking and minor debris accumulation on deck)

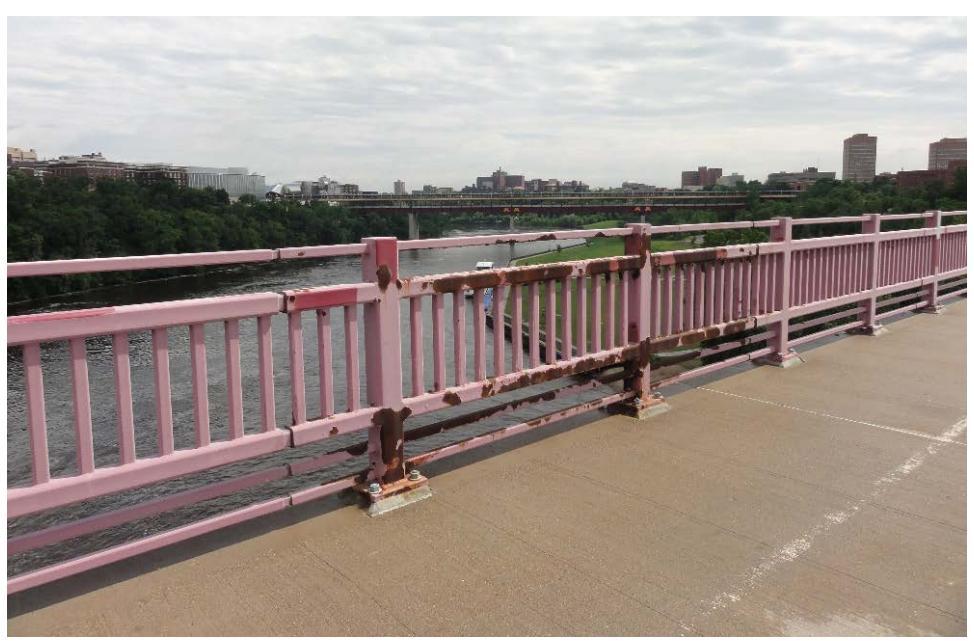
Condition 4: Condition of ornamental railing

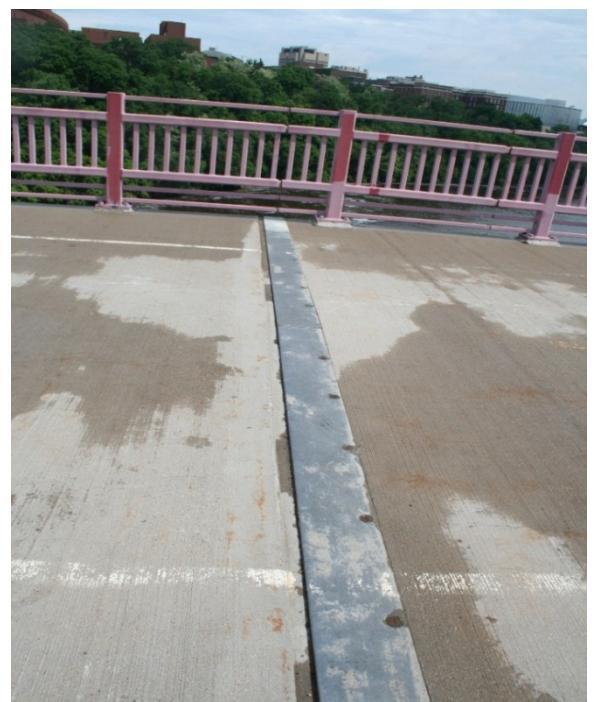
Condition 5: Railing and expansion joint in deck over Pier 4 (note minor debris accumulation in joint and deteriorated paint on railing)

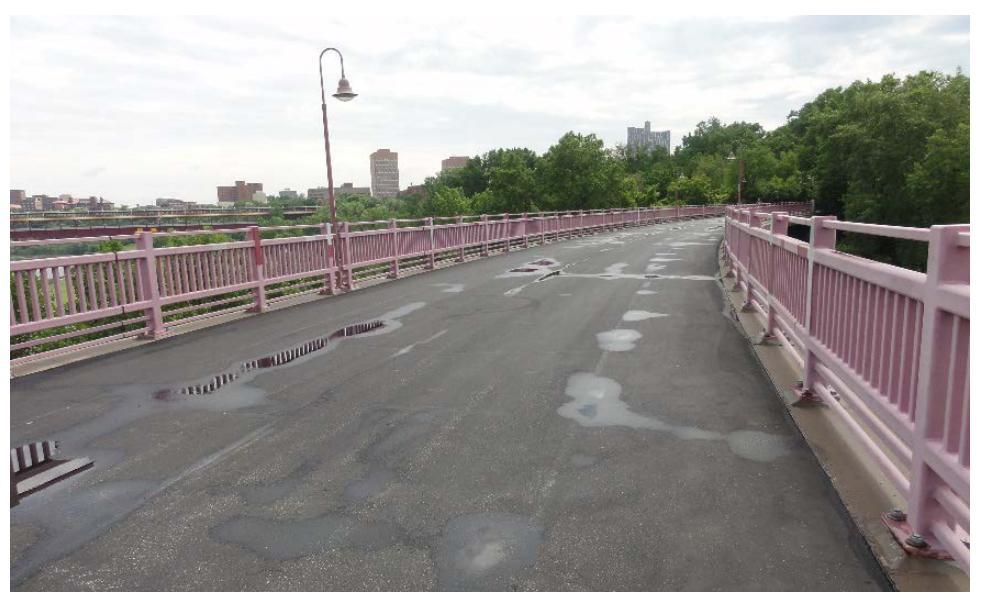
Condition 6: Asphalt surface on west approach spans (note minor map cracking is asphalt and paint condition of railing)

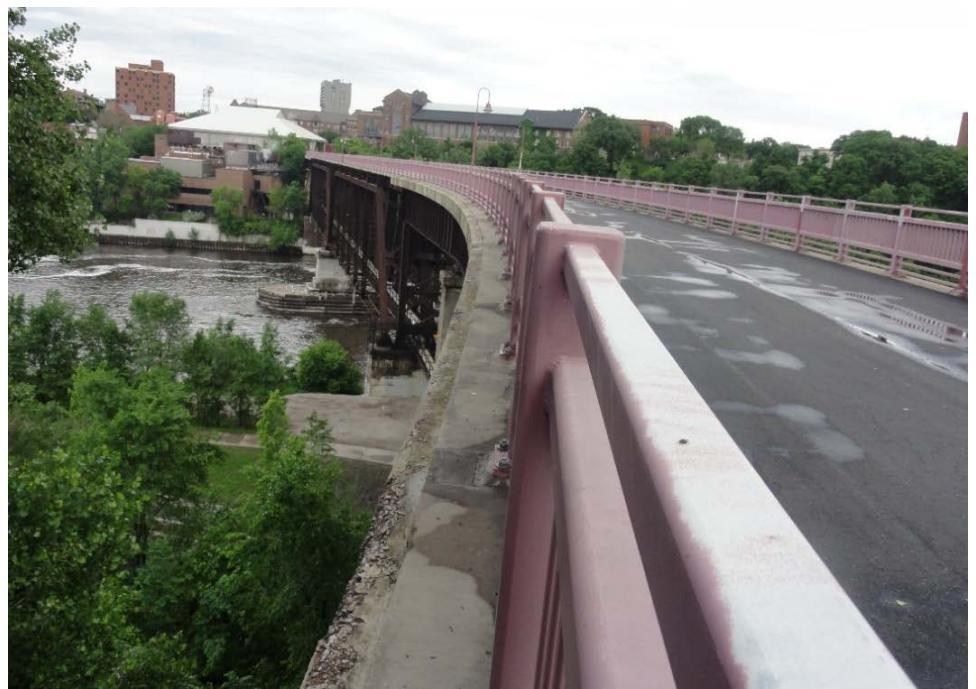
Condition 7: Looking east along north side of bridge (note spalled concrete on outer edge of deck)

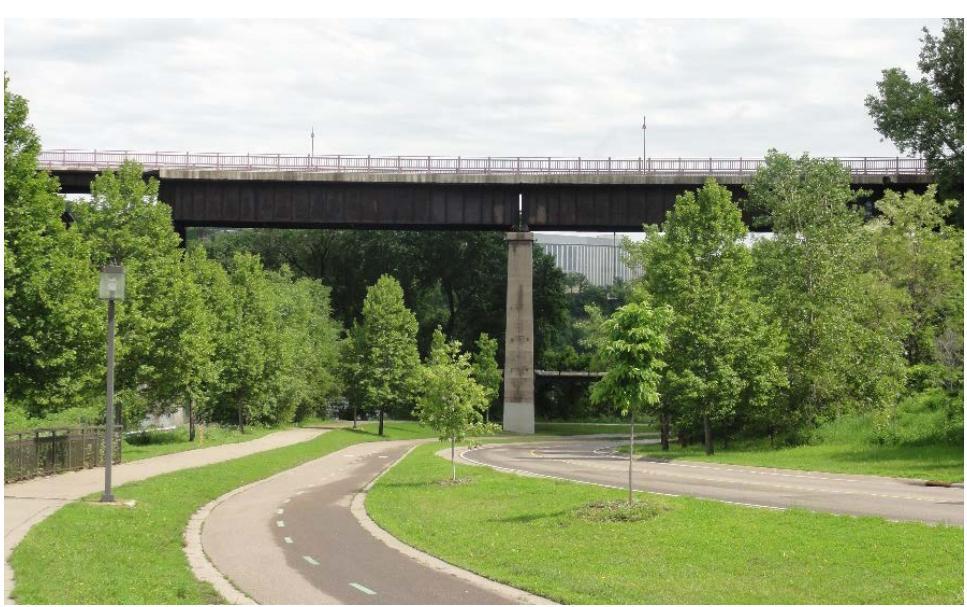
Condition 8: Pier 6, Spans 5 and 6 over West River Road and pedestrian/bicycle paths (note condition of paint on girders)

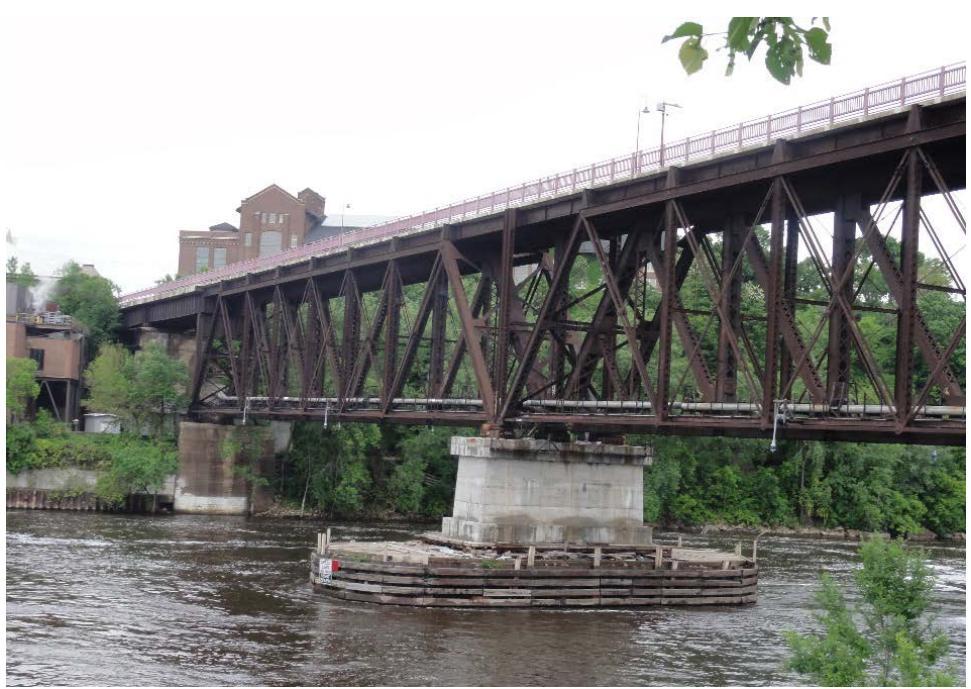
Condition 9: Piers 3 and 4, truss spans 3 and 4; note paint condition of truss spans (note recent work done for Pier 4; similar encapsulation work is proposed for Pier 3)

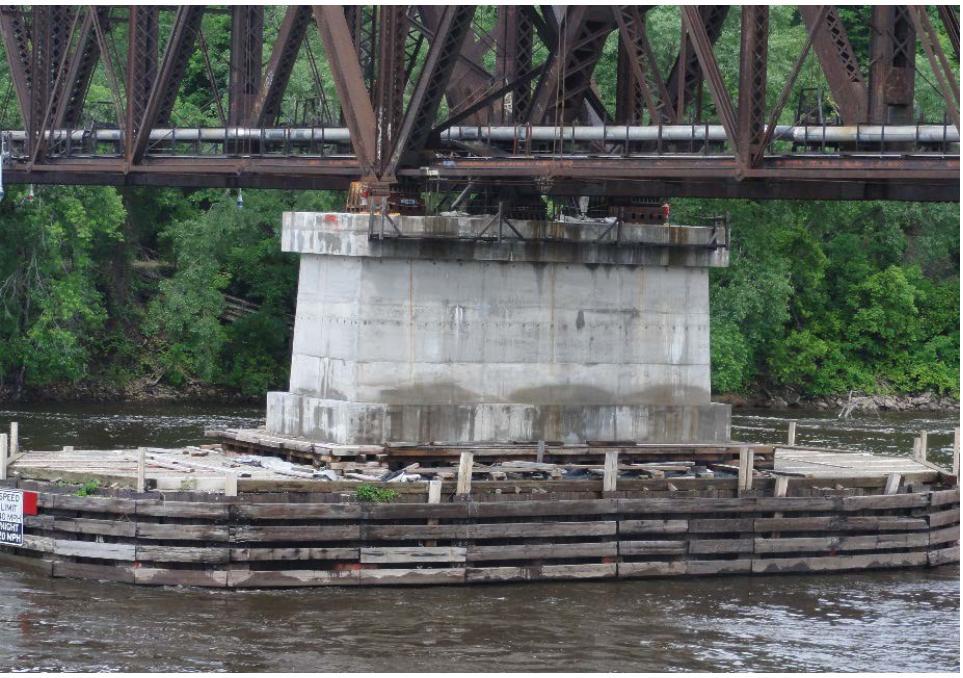
Condition 10: Pier 4 (note concrete encapsulation and timber fenders)

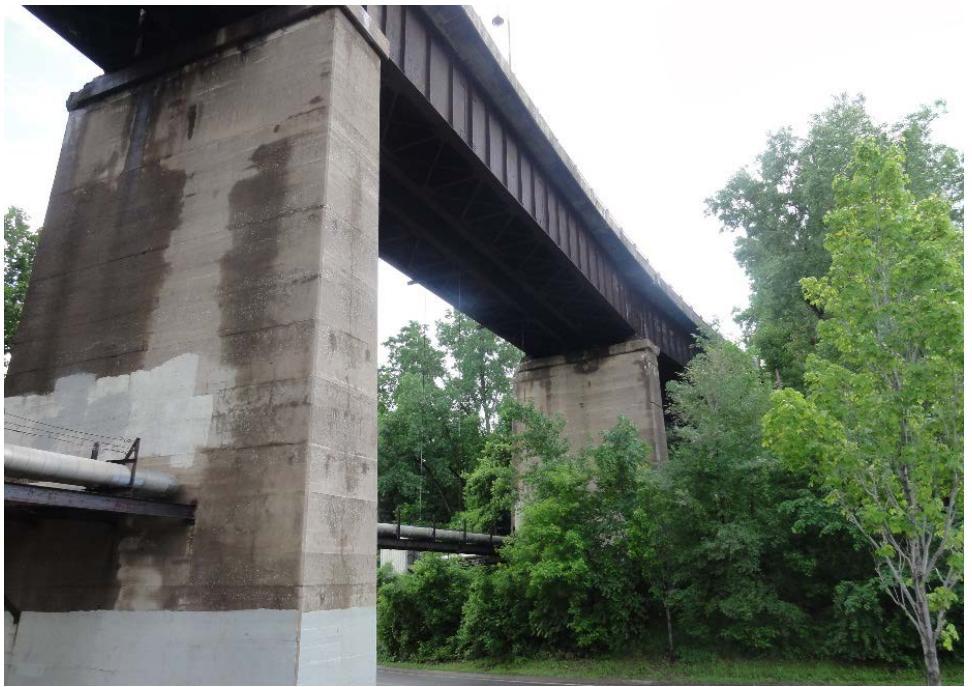
Condition 11: Piers 5 and 6, Span 5 (note steam line)

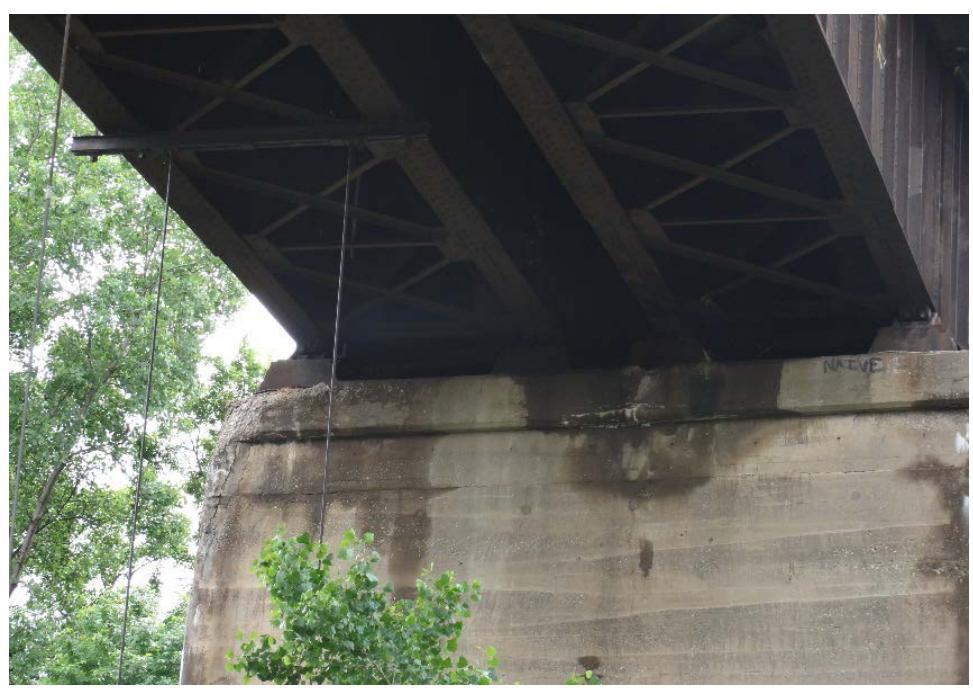
Condition 12: Underside of approach girder span 5 (note condition of structural steel, leakage of water on Pier 6 and deteriorated concrete on top and side of Pier 6)

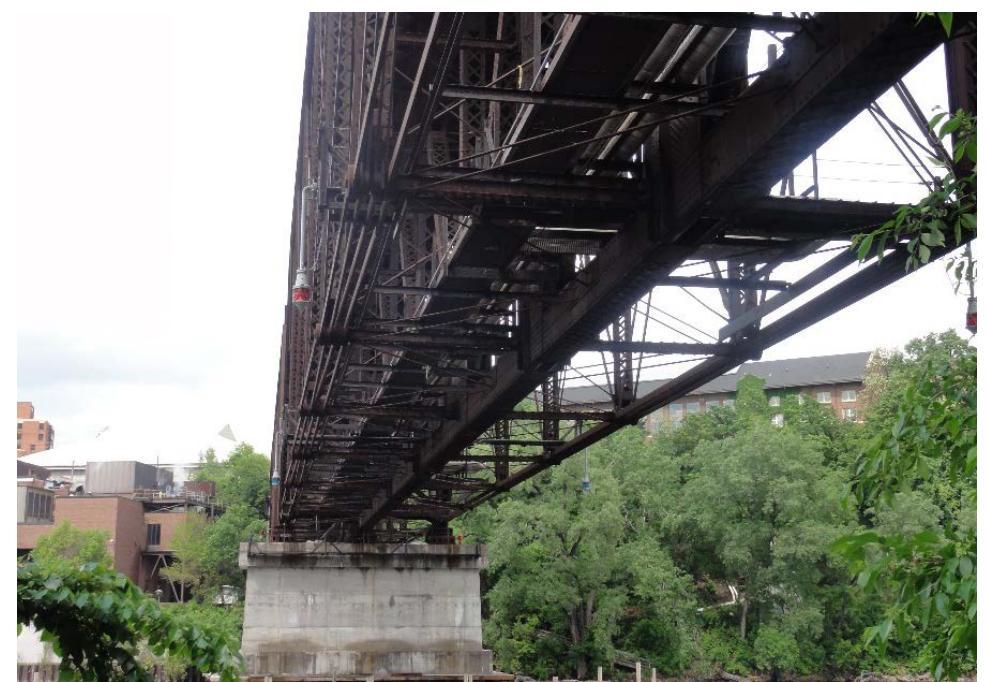
Condition 13: Underside of truss span 4 (note condition of structural steel of truss span)

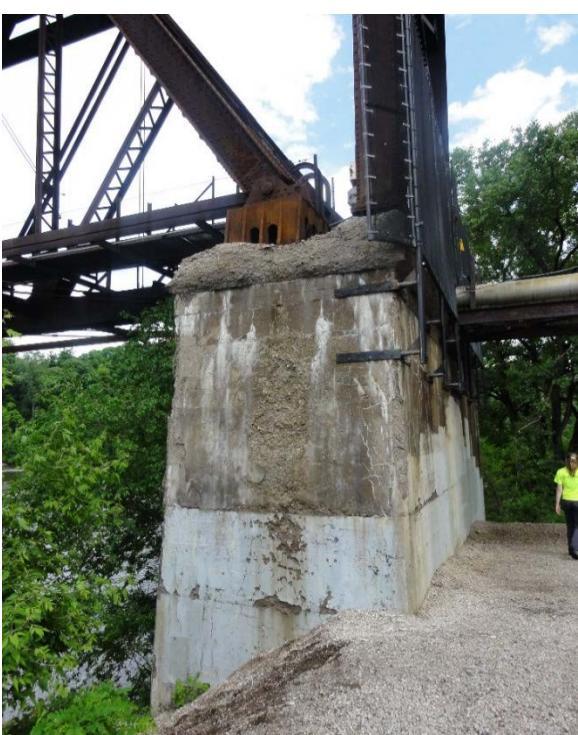
Condition 14: Pier 5, north side (note bearings and condition of concrete)

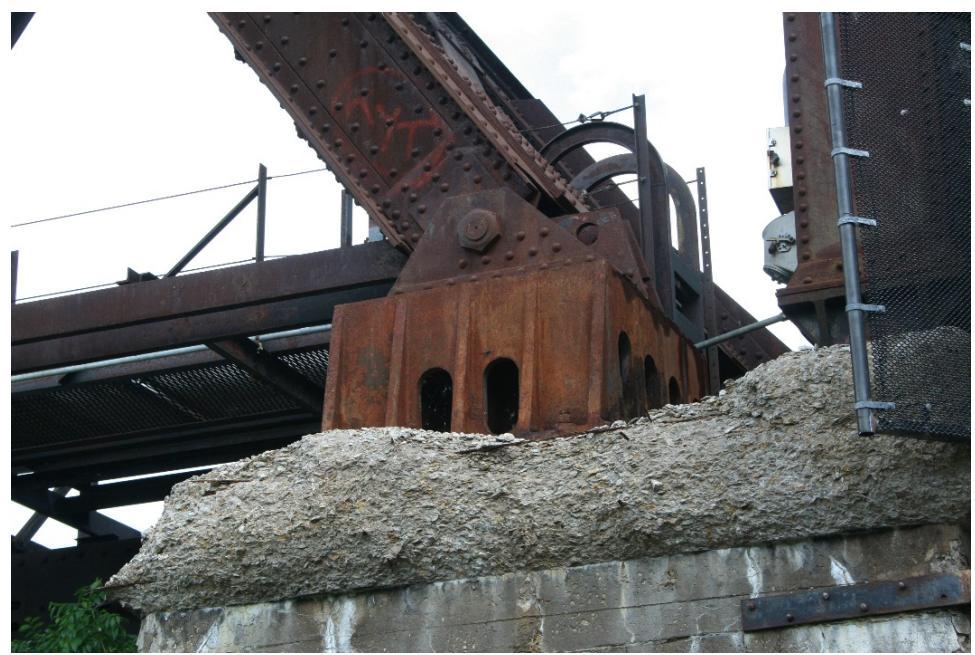
Condition 15: Truss Span 4 bearing on Pier 5, north side

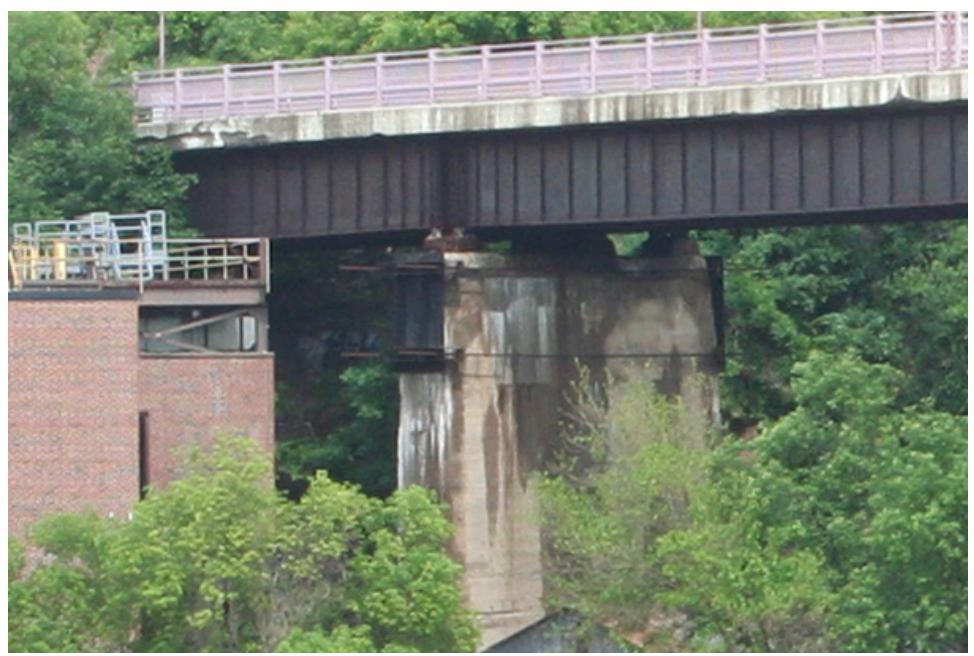
Condition 16: Post-tensioning reinforcement on top of Pier 2 for Spans 1 and 2
