TXDOT District: San Antonio
County: Bexar
Structure ID: 150150B00275001
Facility Carried: Augusta St
Feature Crossed: San Antonio River
Bridge Owner: City or Municipal Highway Agency

Statewide Vehicular Truss Bridge Reevaluation

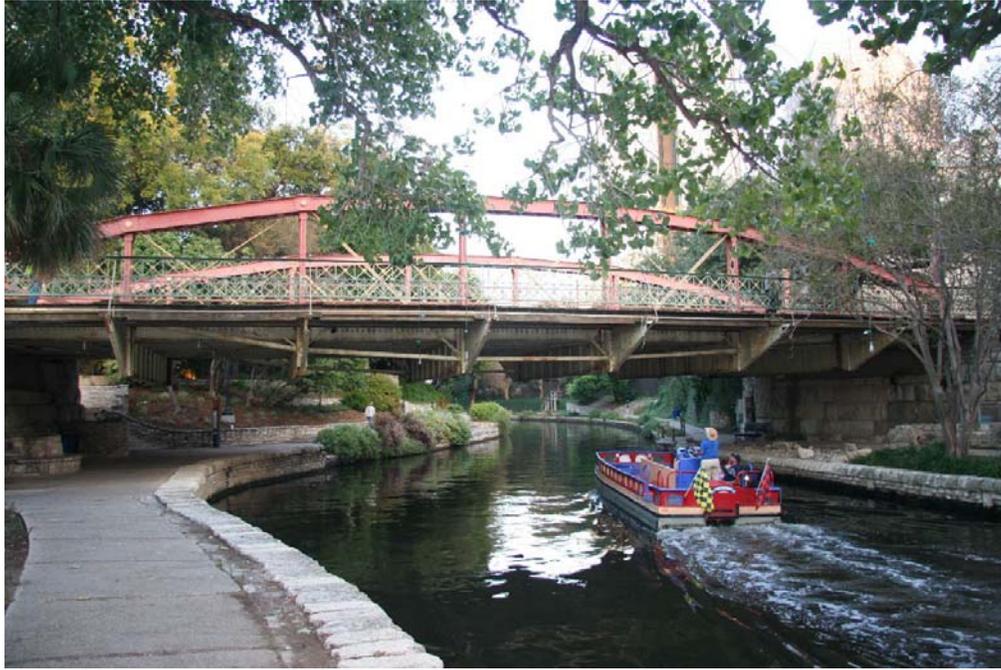
Photo 1: Elevation, facing east, showing the lenticular design of the top and bottom chords that comprise the significant truss type of which this is one of the few known examples in the state

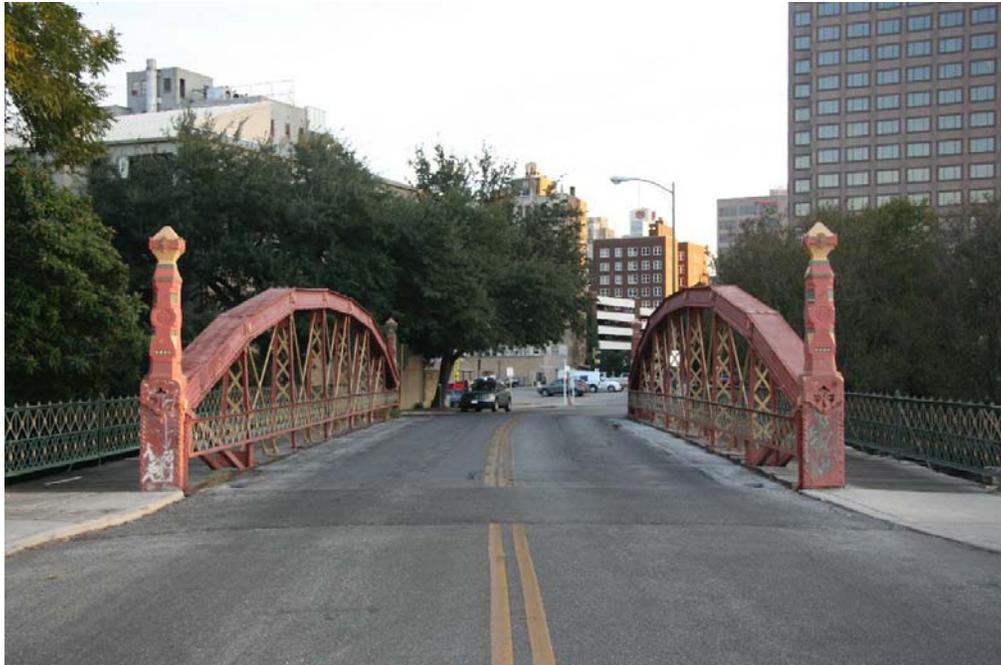
Photo 2: Deck view, facing south

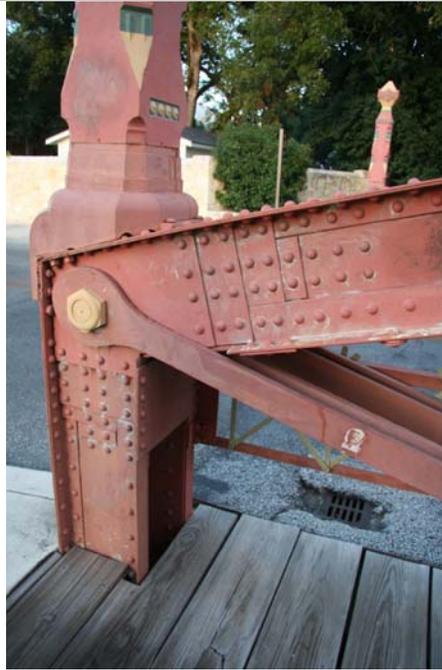
Photo 3: Detail of upper chord pin connection at end post, exterior view

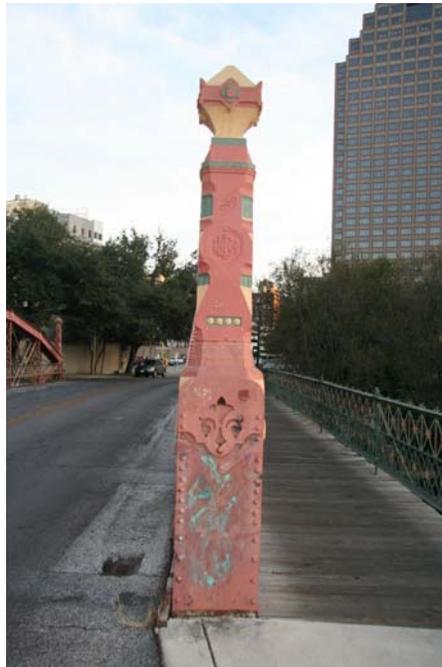
Photo 4: Detail of truss ornamental end post at northwest corner

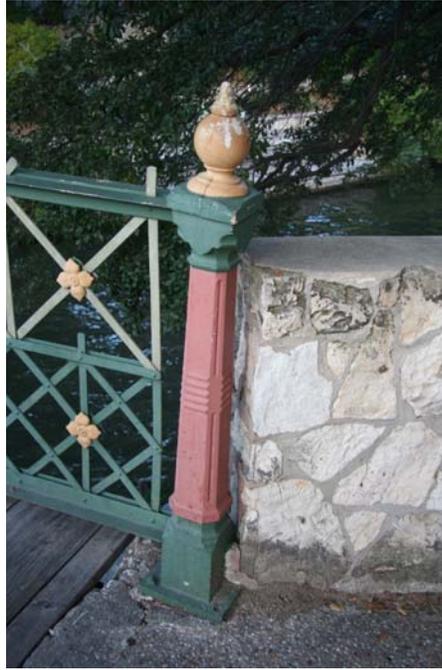
Photo 5: Detail of ornamental railing end panel and end post at southwest corner

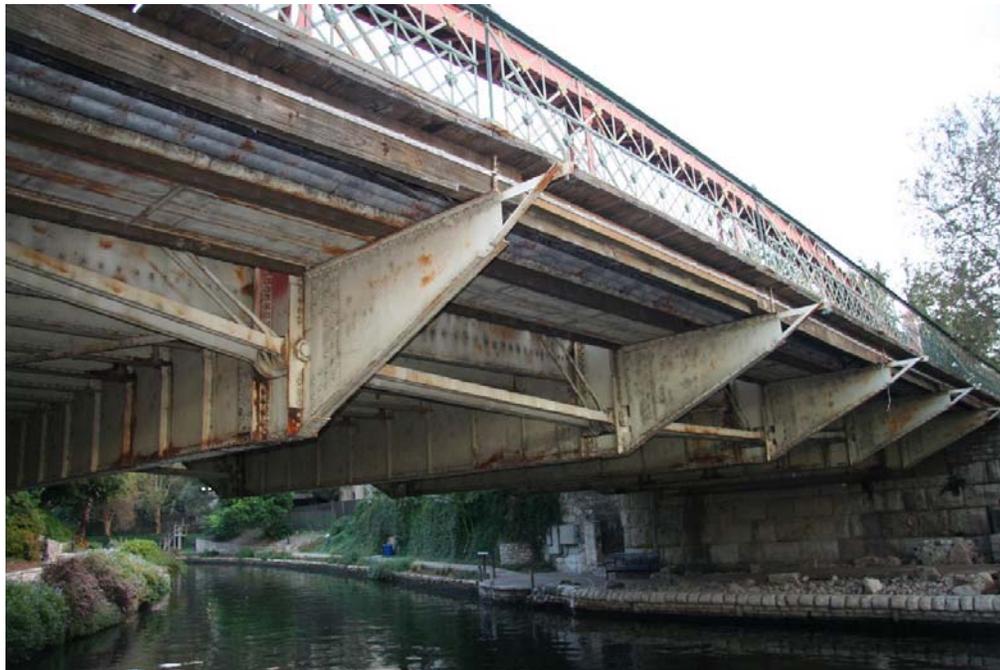
Photo 6: View of underside of truss, facing southeast, including lower chord, built-up floor beams and sidewalk brackets, and stone abutment
