Potomac Edison Company: Chesapeake
and Ohio Canal Bridge
Spanning Chesapeake and Ohio Canal
just South of U.S. 11
Williamsport
Washington County
Maryland

HAER No. MD-23

POTOMAC EDISON COMPANY, CHESAPEAKE & OHIO CANAL BRIDGE (CHESAPEAKE & OHIO CANAL LIFT BRIDGE)

Structural Type: Steel plate-girder span with steel truss vertical lift structure

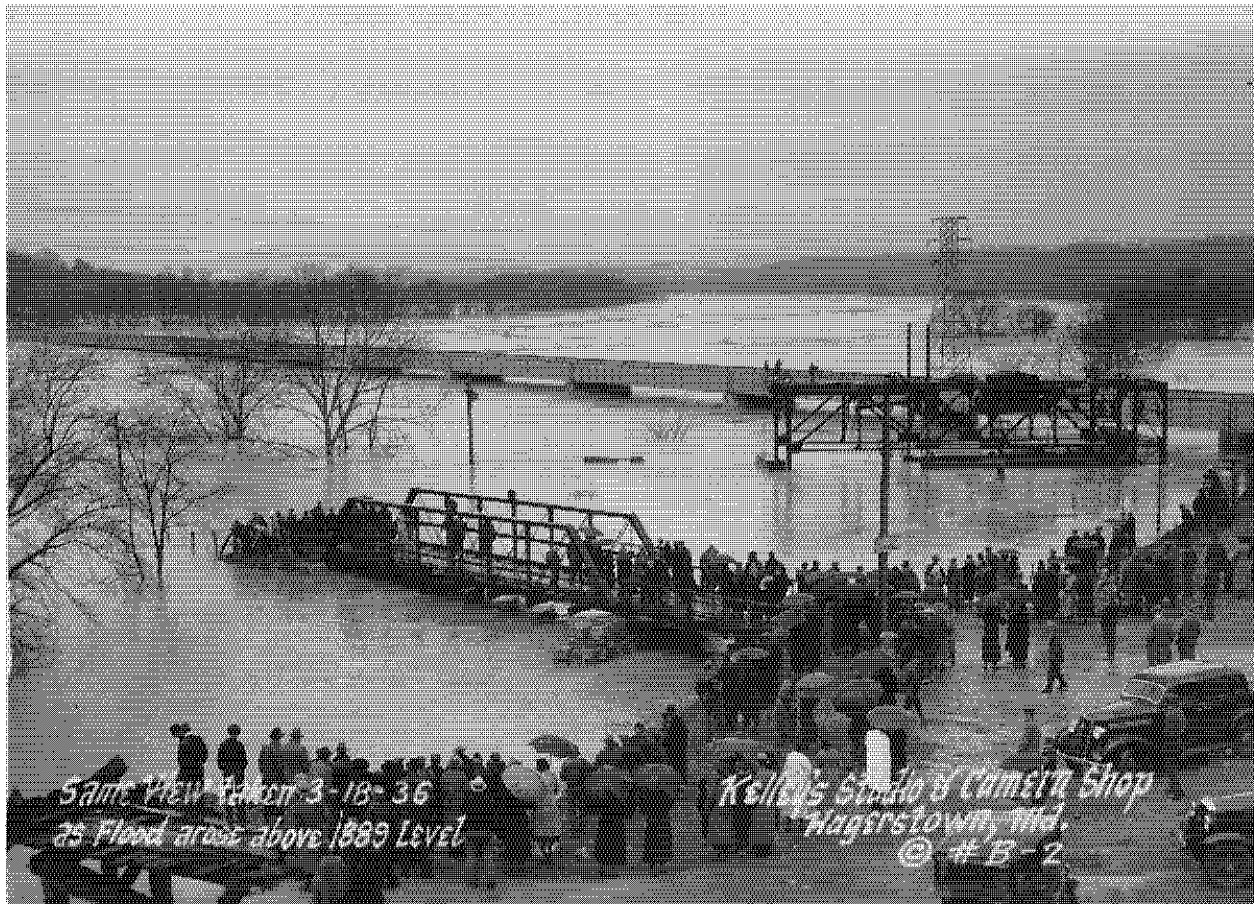
Figure 2. View of C&O Canal Lift Bridge in open position during 1936 flood. Image courtesy Williamsport Town Museum.

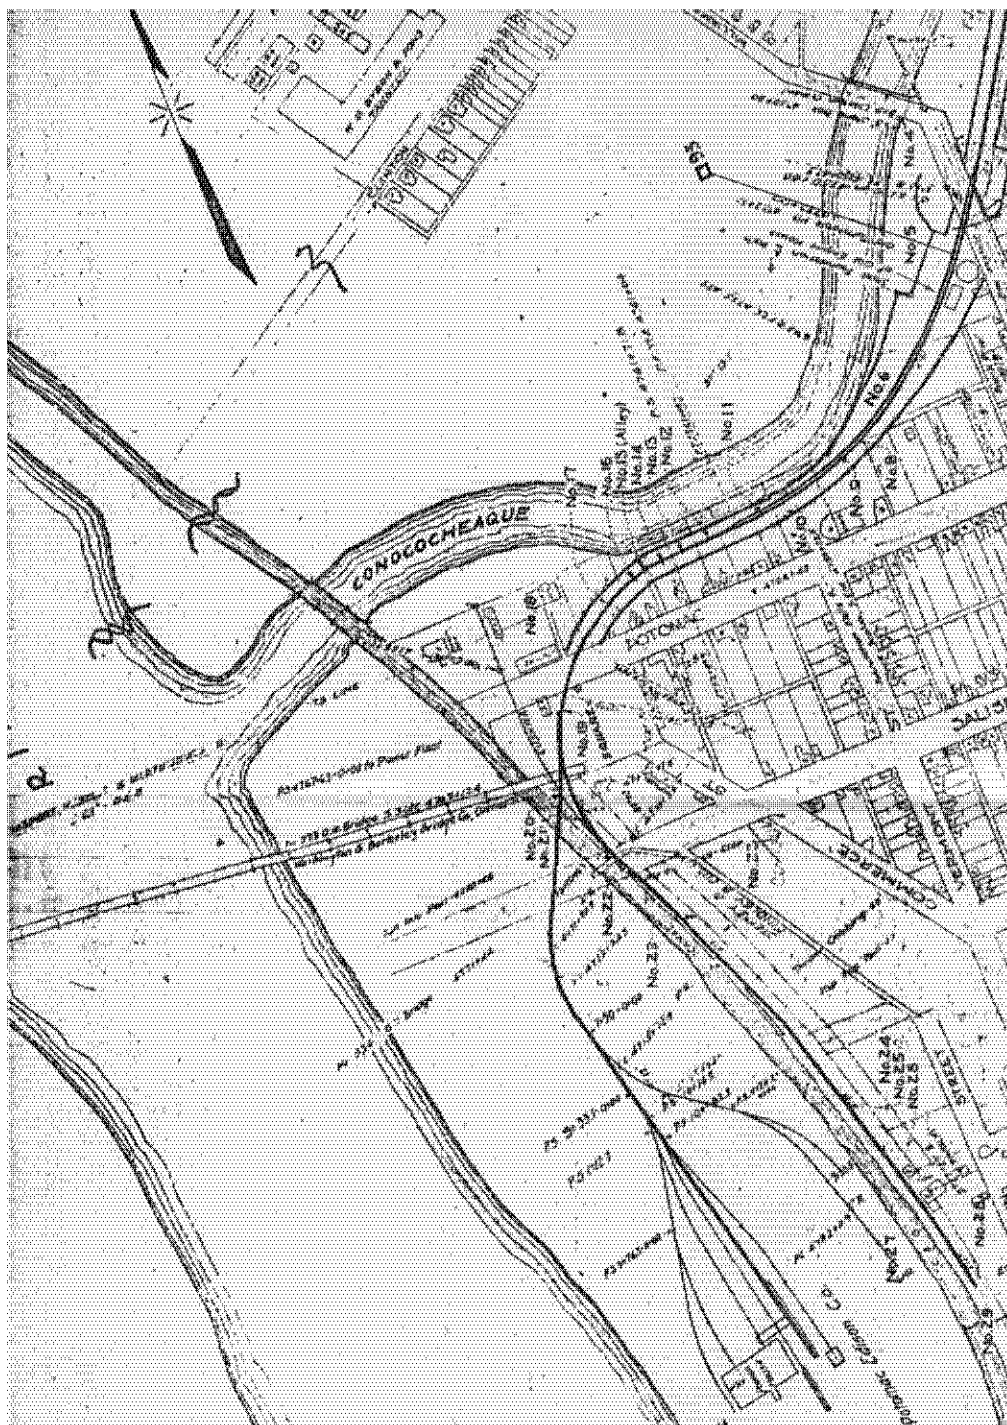
Figure 6. This 1925 map shows both Western Maryland and Potomac Edison trackage in Williamsport. The junction and lift bridge across the canal are at the center of the map. Potomac Edison track is at the bottom, and the Western Maryland double-ended siding extends roughly between Williamsport and Vermont streets at the upper right. Image courtesy Chesapeake & Ohio National Historical Park.

Although there is no documentary evidence that describes the rail operation, what is known about the track layout on both sides of the canal suggests that the Western Maryland normally spotted loaded cars on a double-ended siding on the northeast side of the canal. Potomac Edison Nos. 1 or 2 would cross the bridge to the northeast (more correctly east, due to a curve) end of those sidings, couple to the loaded cars—probably no more than four or five at a time—pull them back out, and then push them across the bridge and into one of the unloading tracks at the power plant. Empty cars would be handled by the reverse of this procedure. The Western Maryland likely spotted cars on its spur alongside the canal's eastern bank from time to time as well. Potomac Edison's locomotive could then pull cars out around a connecting track, then push them to the plant. It is also quite possible that Western Maryland locomotives may have switched cars into the plant on occasions when Nos. 1 or 2 were out of service for maintenance. At least one early photograph shows a Western Maryland locomotive pushing a cut of hopper cars across the temporary bridge. Sanderson and Porter's engineers designed the bridge to carry the railway's several classes of 2-8-0 steam locomotives, weighing up to 600,000 lb. (including tender) that the railroad routinely ran in this kind of local freight service.
