Minnesota Department of Transportation (Mn/DOT)

Historic Bridge Management Plan

Bridge Number: 2440

Bridge 2440 (Third Avenue Bridge) was completed in 1917 to carry Trunk Highway 65 (Third Avenue) over the Mississippi River just above St. Anthony Falls in Minneapolis, Hennepin County. It has an overall structure length on 1,887.8 feet and an out-out width of approximately 82 feet (wider over some piers). It has seven reinforced-concrete main spans, including five open-spandrel, rib-arch spans of 211 feet each, and two open-spandrel, barrel-arch spans of 131 feet each. There are two steel-beam approach spans on the south, and two prestressed I-beam approach spans on the north. The significant design features are the use of the Melan system of steel reinforcing in the main spans and the reverse S-curve of the alignment. The unusual geologic structure of the riverbed necessitated pier placements that resulted in the S-curve. The bridge features Classical Revival detailing, including an ornamental metal and concrete railing added in 1939. A major rehabilitation in 1979-80 resulted in complete deck removal and replacement with reinstallation of the 1939 railing.

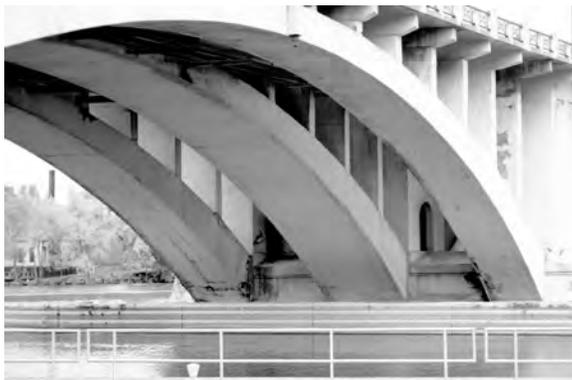
Feature 1. Melan-system reinforced-concrete arches. The Melan system, patented in 1894, uses steel I-beams bent approximately to the shape of the arch axis and laid in a parallel series near the undersurface of the arch. The Third Avenue Bridge has seven large Melan arches, including two barrel arches and five three-rib arches, including the example in this photograph. It is considered to be the last major reinforced-concrete bridge constructed in the Twin Cities using the Melan system.

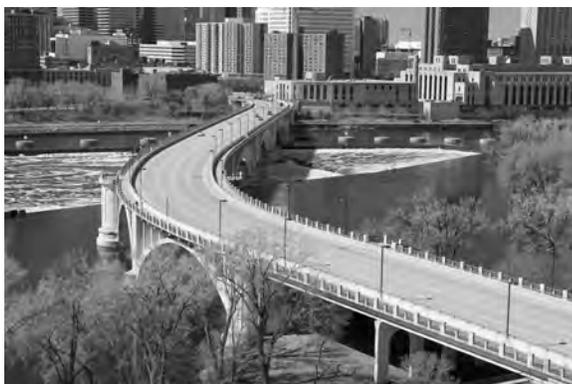
Feature 2. Reverse S-curve alignment. The bridge location lies in an area of the Mississippi River between Nicollet Island and St. Anthony Falls that has an irregular limestone base. The placement of piers and engineering of the spans required considerable engineering analysis to avoid unstable areas. The final plan resulted in a reverse S-curve alignment, which spanned the poor foundation sections and produced an aesthetic form that added to the bridge's overall image as a gateway to downtown Minneapolis.

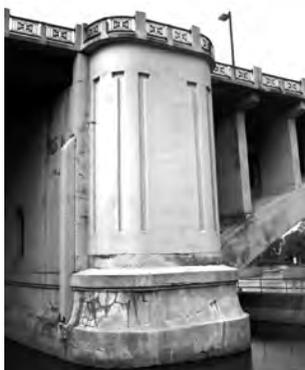
Feature 3. Classical Revival aesthetic treatment. A gateway structure, the Third Avenue Bridge received a Classical Revival aesthetic treatment. Classical elements include piers and the projecting pedestrian bays, which were restored or reconstructed in the 1979-80 deck-replacement project, and the 1939 ornamental railing.

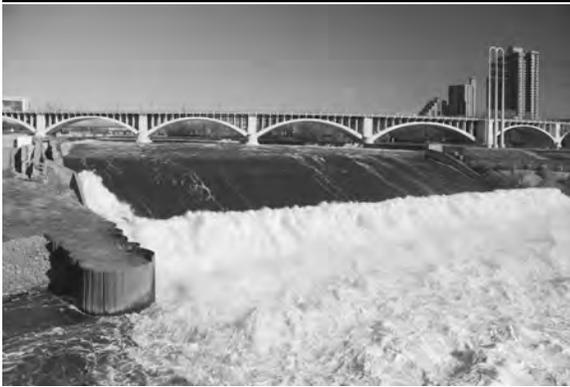
Feature 4. St. Anthony Falls setting. The Third Avenue Bridge is located just above the falls, as visible in this photograph. It spans elements of the V-shaped, upper-dam system that channeled water into east and west mill ponds on the east and west sides of the falls. The ponds provided water to the waterpower canals for the flour-milling district. The bridge is within the St. Anthony Falls Historic District (National Register of Historic Places).

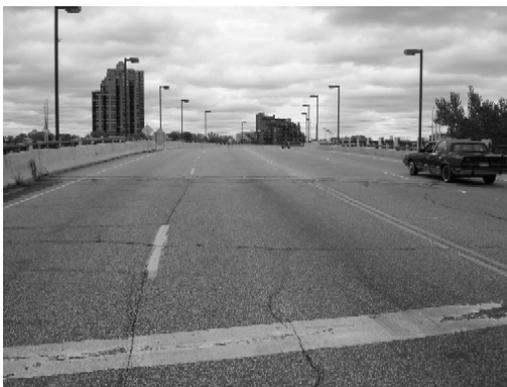
Figure 1. Looking north at the bridge from the south approach. The vehicle barriers are not symmetrical on the south end. A low profile barrier is provided on the east and a taller barrier is provided on the west. The approach roadway pavement is deteriorated and has extensive cracking.

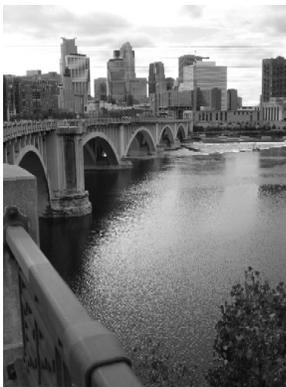
Figure 2. Looking south along the west side of the bridge from the west sidewalk. Stained, deteriorated concrete on the pier below the overlook is visible.

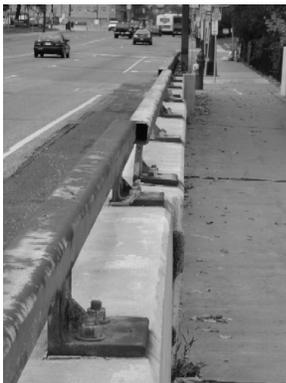
One segment of the east vehicular railing has rotated (top to the east) along the north approach. A horizontal offset of 1-2" is noted at the height of the metal railing.

Figure 4. Looking north at the east vehicular railing on the north approach. Settlement has led to shifting of the barrier both vertically and laterally.

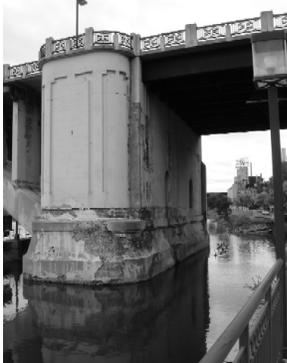
The west and east faces of the south river pier have been repaired and appear to be in better condition than adjacent pier elements.

Figure 5. Looking east at the southernmost river pier. Deteriorated concrete is visible in many locations, primarily near the water line. The weathering steel beams supporting the south approach spans are also visible.

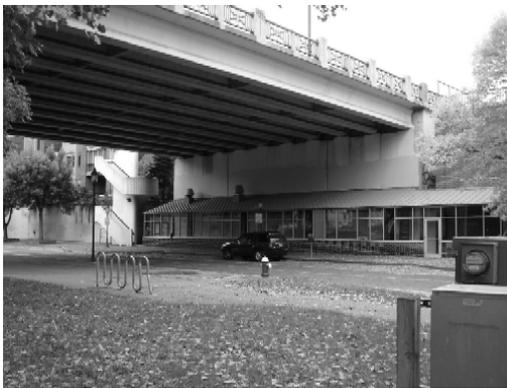
Figure 6. Looking northwest at the north abutment. A recently installed stairway of modern design to access the west sidewalk on the bridge is visible just to left of the building attached to the abutment.

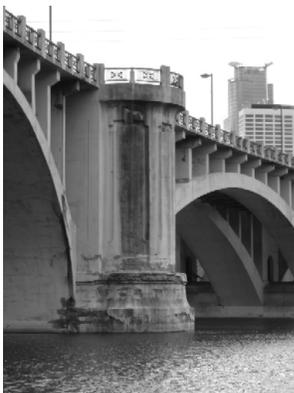
Figure 7. Staining and concrete spalls are visible on the north face of the west end of the pier between the barrel and rib arches.

10. Based on the results of the concrete testing program, identify appropriate repairs for deteriorated regions. Repair deteriorated concrete components subsequent to any electrochemical chloride extraction rehabilitation. Conduct concrete repair using standard Mn/DOT repair methods and in compliance with National Park Service Preservation Bulletin 15 – Preservation of Historic Concrete. Consult with Mn/DOT's Office of Bridges and Structures before making final determination of the means and methods of concrete repairs. Apply Mn/DOT special surface finish to exposed concrete subsequent to the repairs. Apply anti-graffiti coating to the areas of the concrete susceptible to graffiti.
