Engineering News-Record

Self-Anchored Suspension Bridge Built in Missouri

Crossing an arm of the Lake of the Ozarks on a farm-to-market type road and having a main span of 225 ft., the unusual structure was built for \$37,000—Stiffening girders are 33-in. rolled beams, and cables are prestressed twisted strands

By Howard Mullins
*Missouri State Highway Department,
Jefferson City, Mo.*

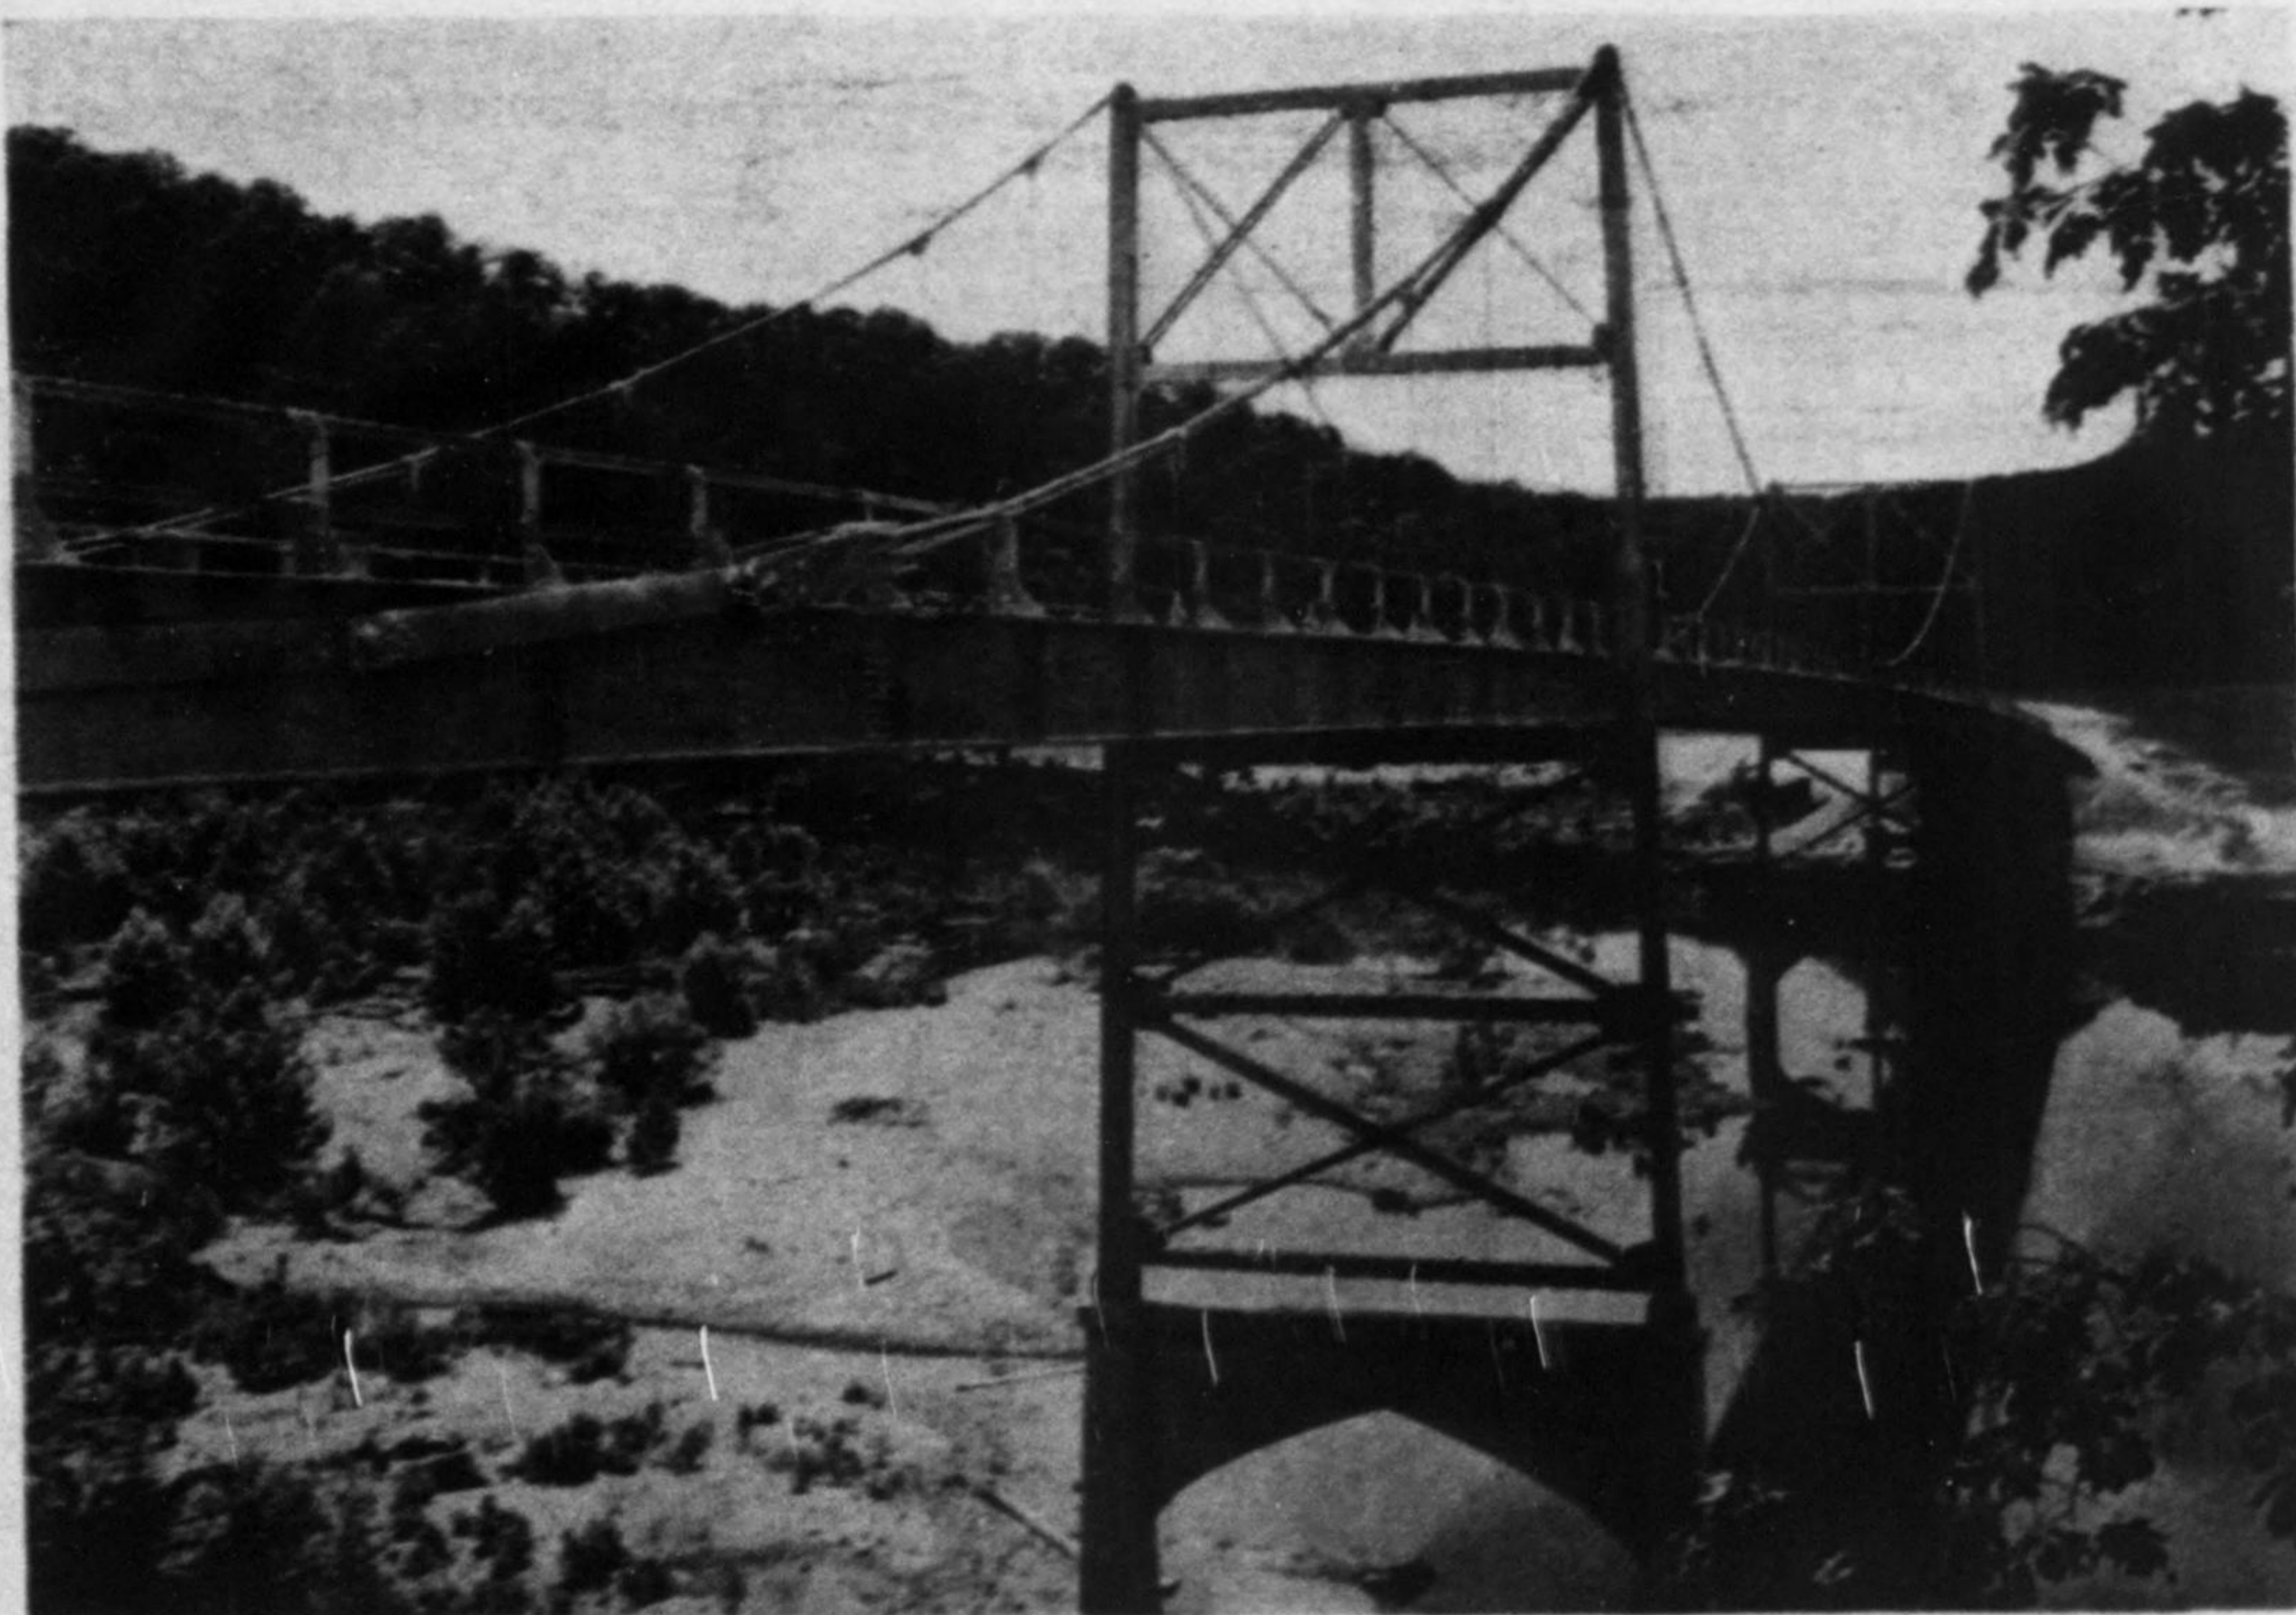
Fig. 1—Short-span self-anchored suspension bridge built by Missouri highway department on a farm-to-market road.

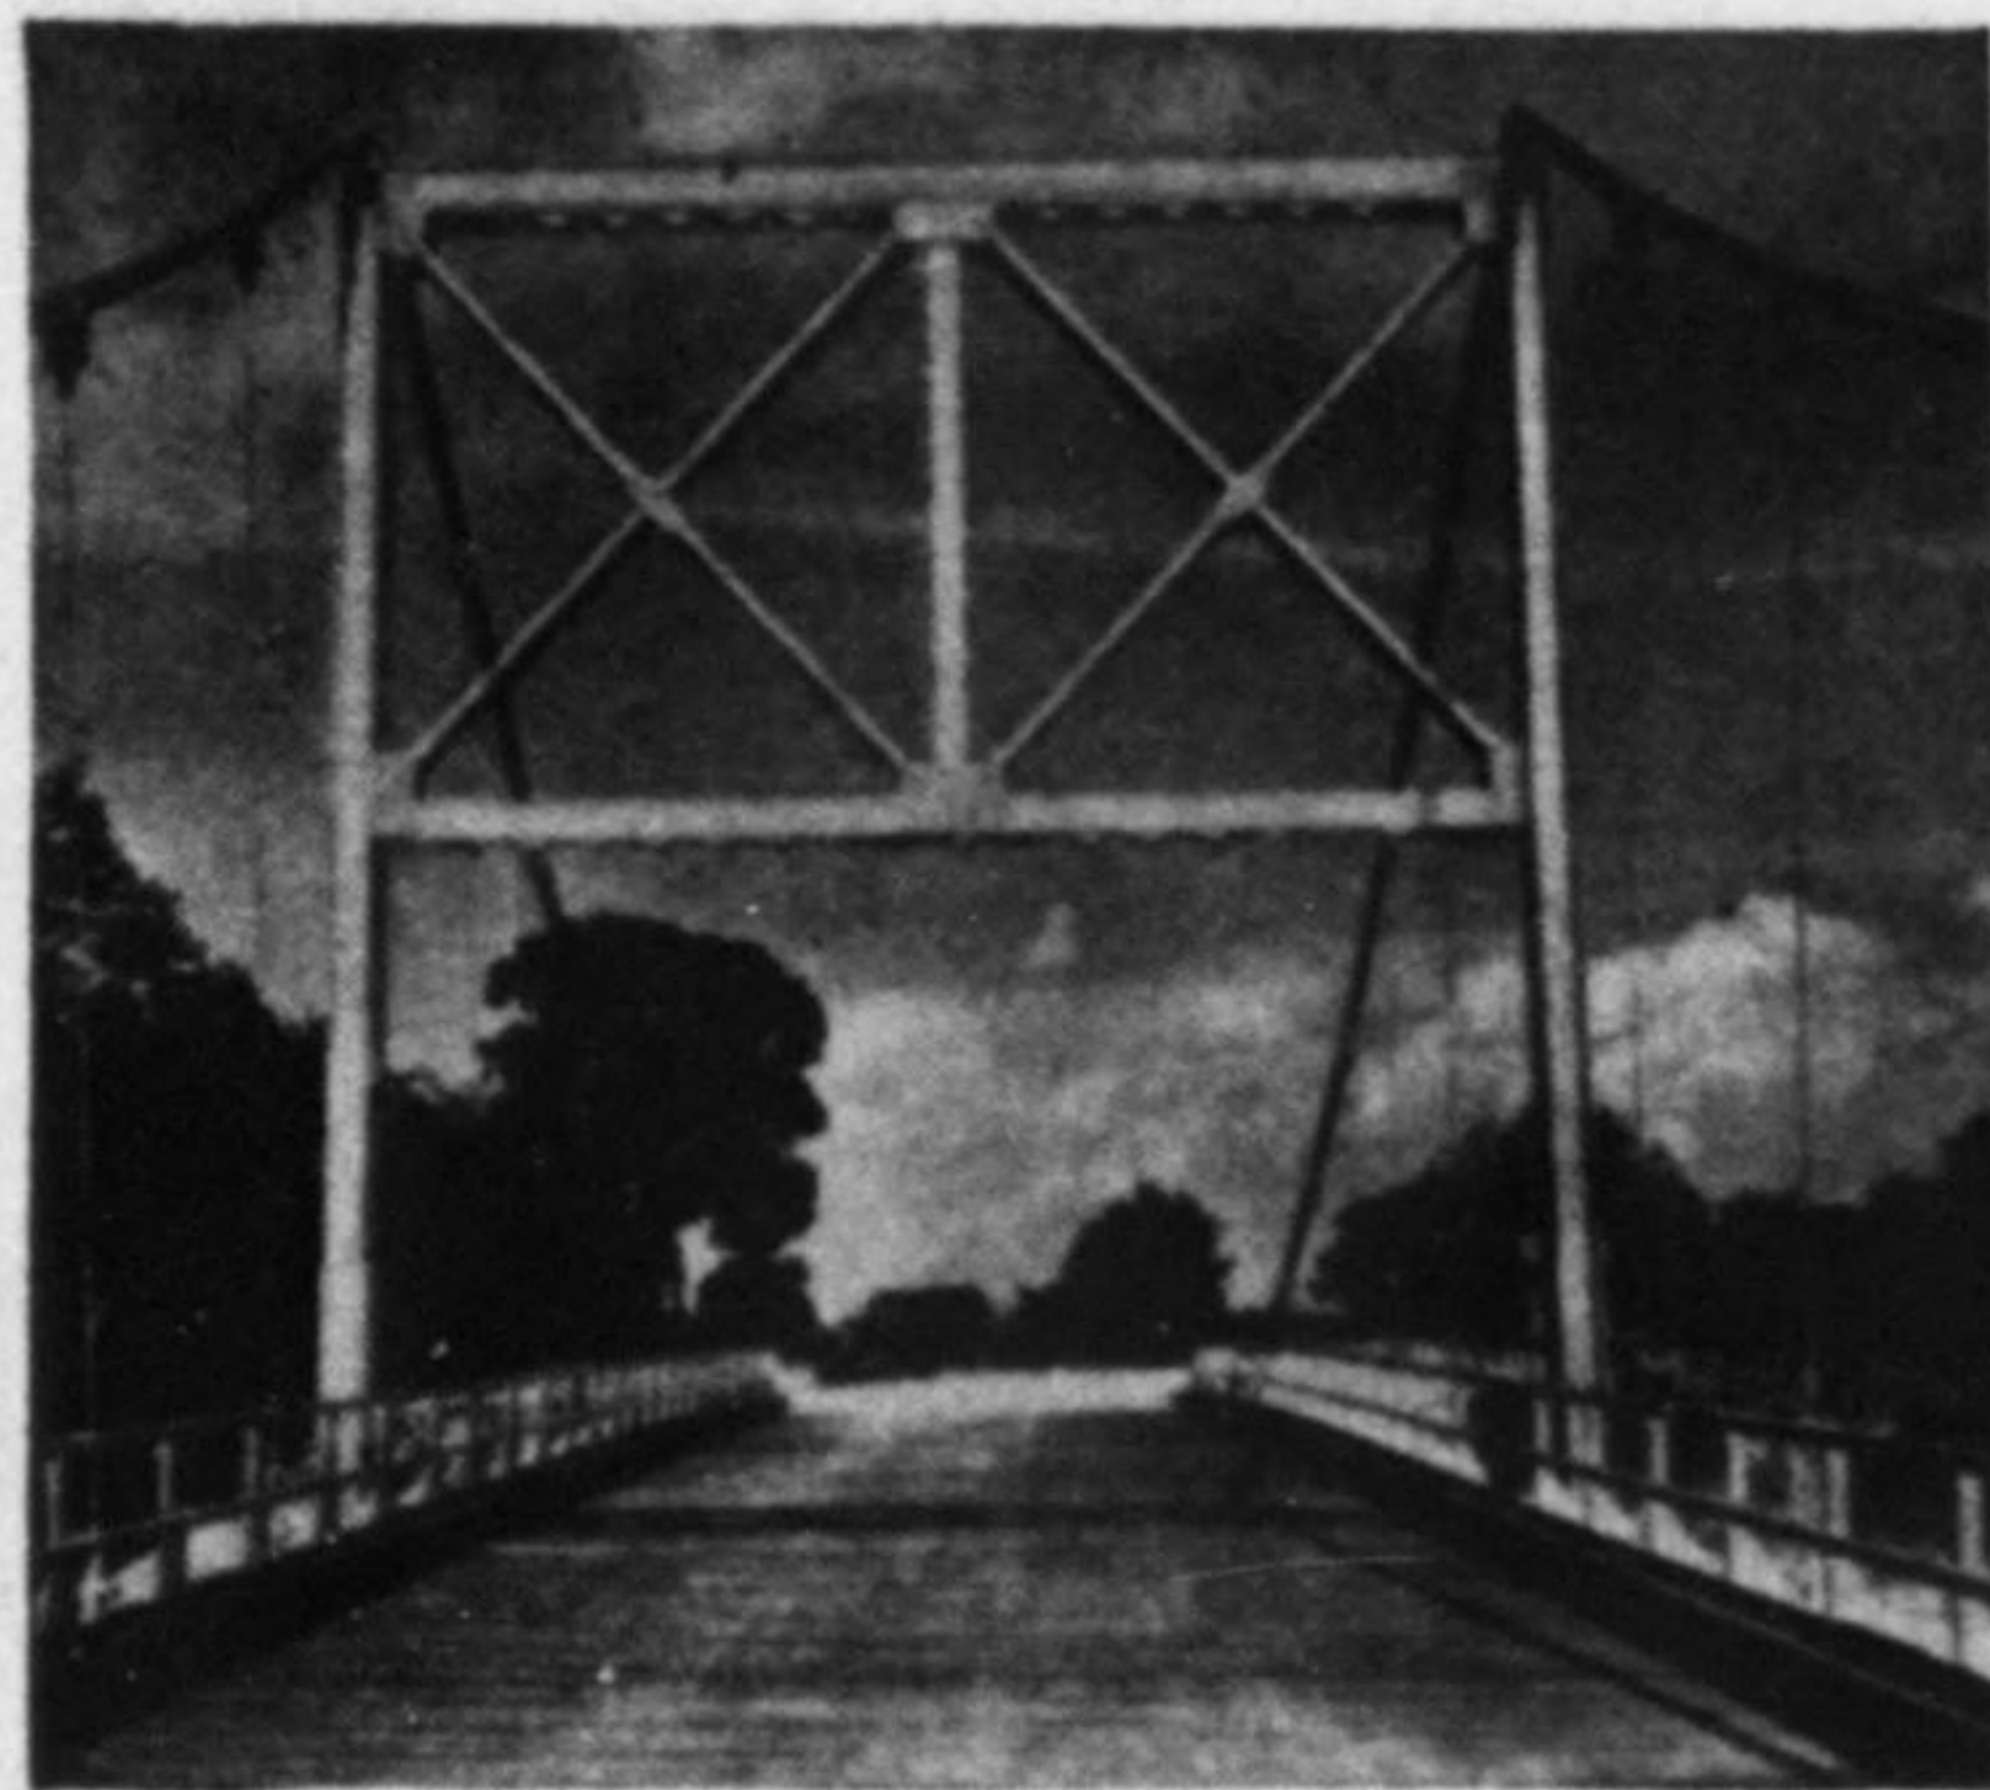
Fig. 3—Bridge roadway 20 ft. wide consists of 2x4-in. creosoted pine boards laid on edge.

The floor consists of 2x4-in. creosoted pine laid on edge and fastened with metal clamps to the stringers, which are 10-in. W.F. sections spaced 4 1/2 ft. These stringers frame into 18-in. W.F. section floor beams spaced 12.5 ft. on centers and framed into the stiffening girders.

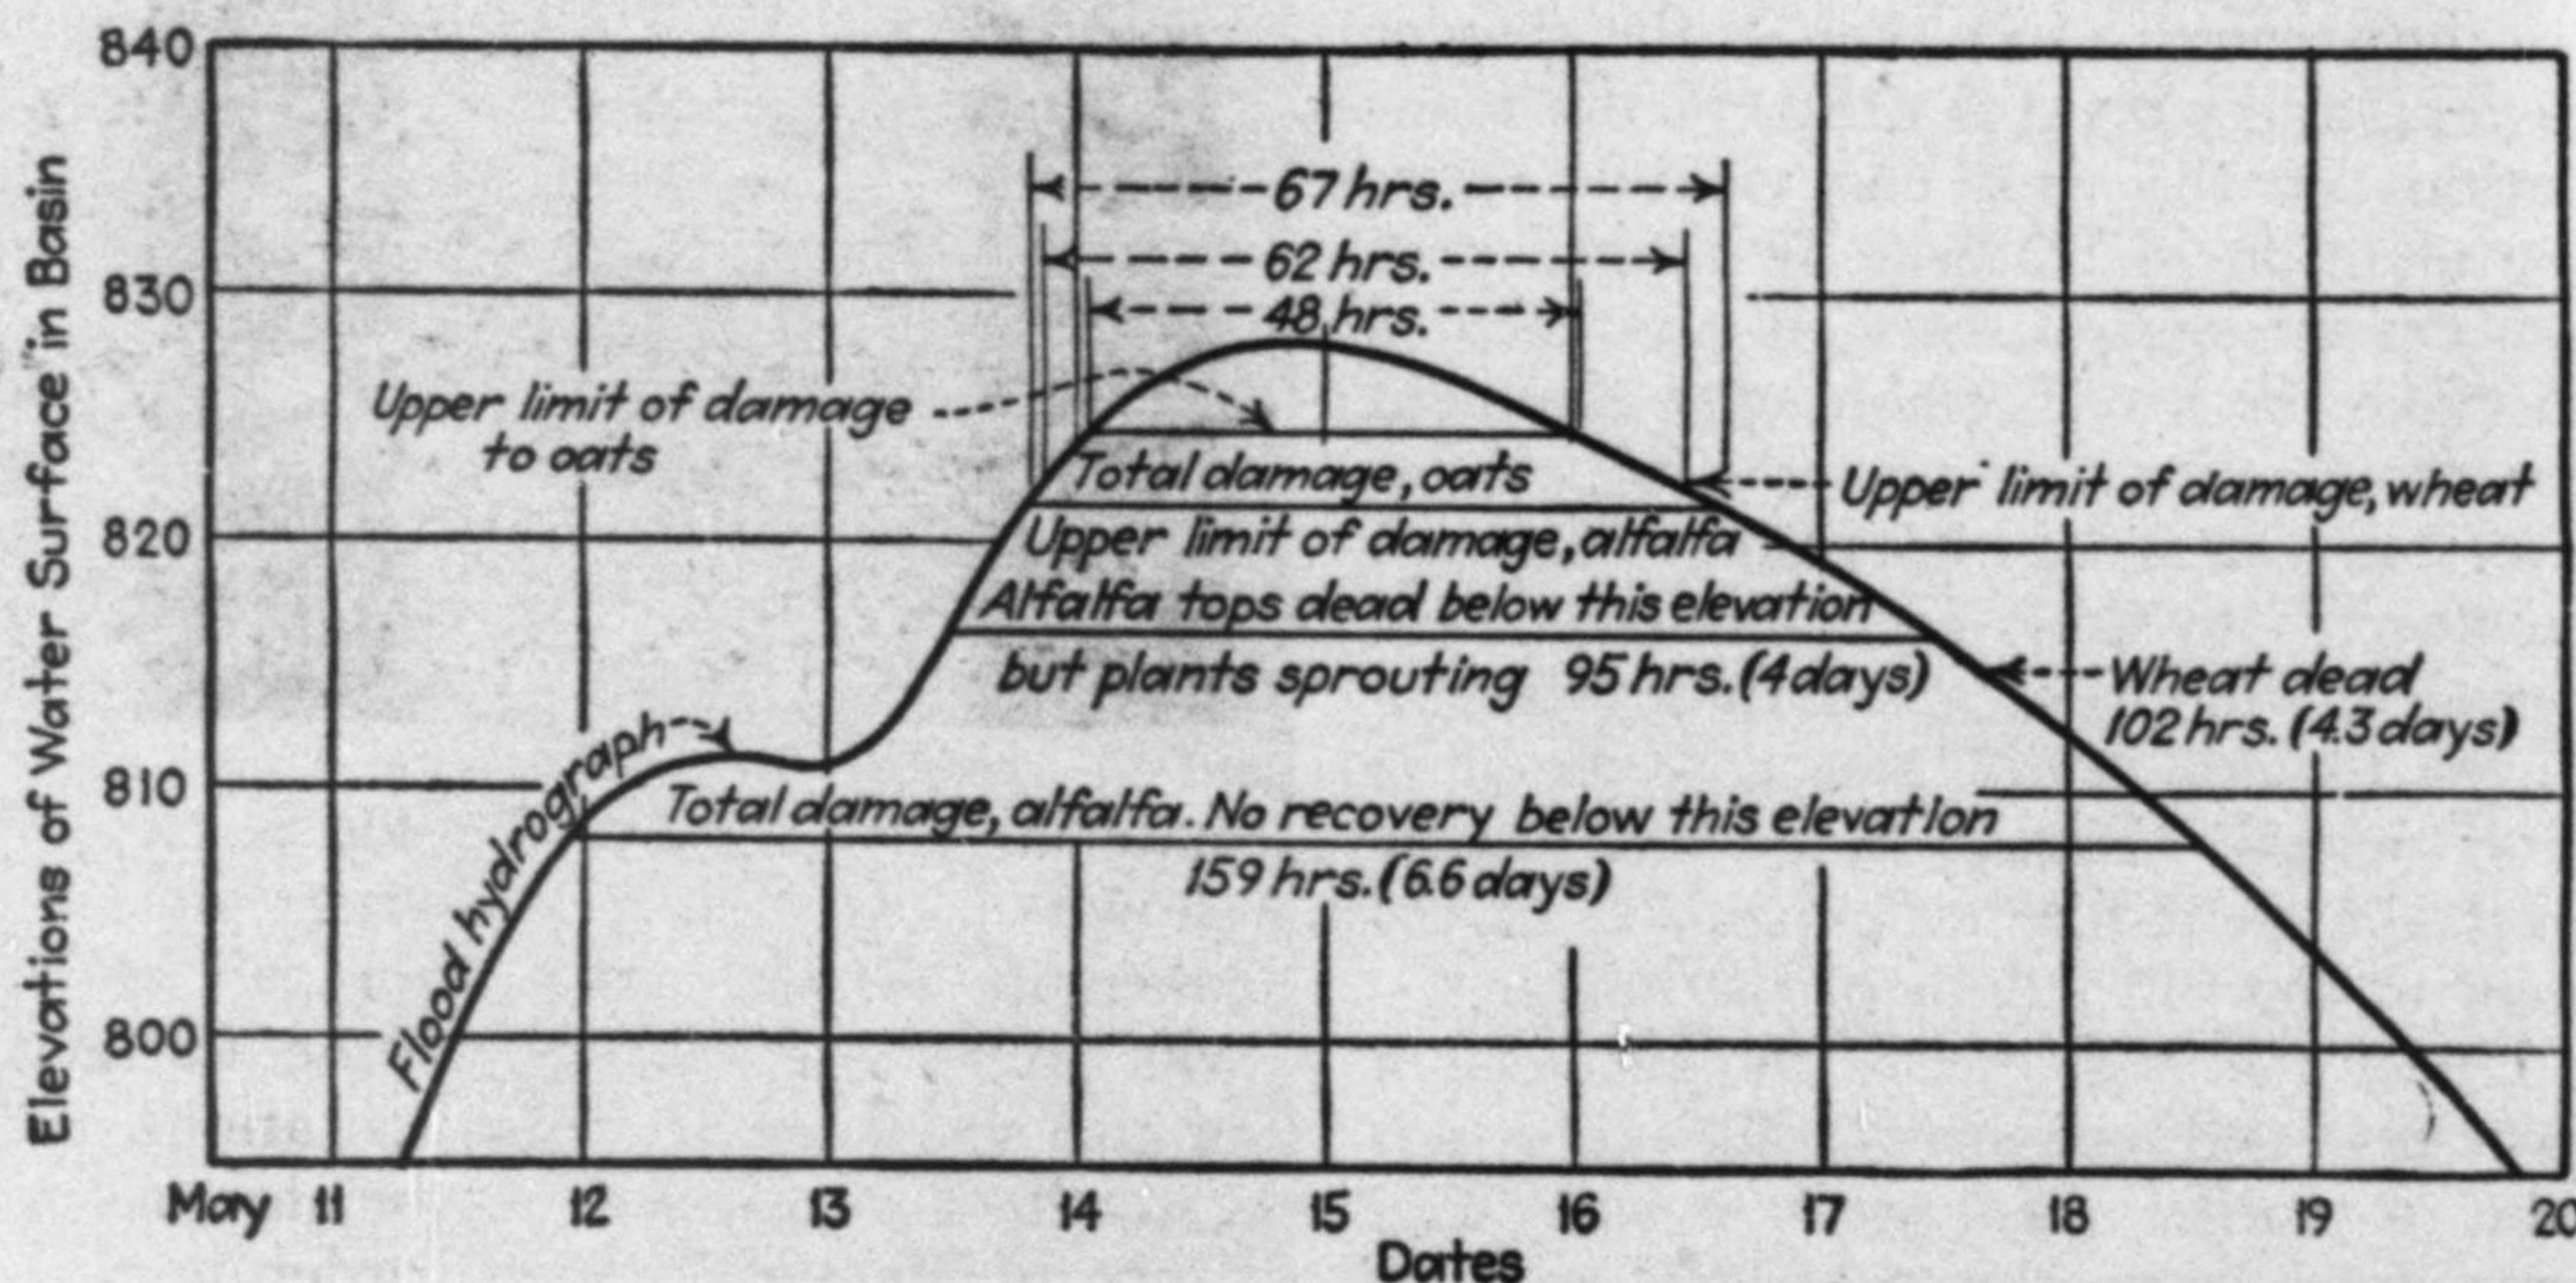
Crops damaged by $2\frac{1}{2}$ to $6\frac{1}{2}$ days' submergence, as shown on May, 1933, flood hydrograph for Englewood retarding basin of Miami Conservancy District, Ohio.
