OHIO DEPARTMENT OF TRANSPORTATION  
HISTORIC BRIDGE SURVEY REPORT

Location: WV BORDER (BRIDGEPORT BRIDGE)

Type: THRU TRUSS

Design: PARKER (PINNED)

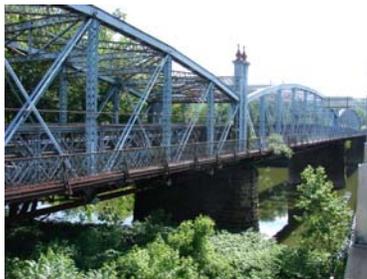
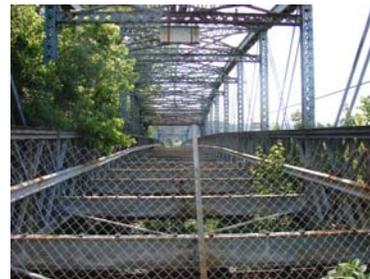
The 3 span, pin-connected Parker thru truss bridge has been strengthened by threading Bailey trusses through the thru trusses to relieve them of live load. In the process, the original built-up floorbeams were cut down or removed to make space for the Bailey trusses. The bridge has eyebar lower chords and diagonals, except for the lower chords in the end panels which are built-up sections from angles and lacing. The upper chords are built-up box-shaped sections with cover plate and lacing. The cantilevered sidewalks are supported on built-up lattice girders with curvilinear bars and decorative, cast-iron end posts. The built-up, vertical end posts of each span have decorative sheet-metal lozenges. The posts extend above the upper chord to support arched lattice portal bracing. Each post is topped by an elaborate finial shaped from sheet metal. The gap between the end posts of adjacent spans is filled with decorative lattice work and sheet-metal cutouts.

Flooring system compromised by removal of original floorbeams. Loss of original fabric from corrosion and loss of some architectural features (parts of finials, sections of railing, etc.)
