National Register of Historic Places  
Registration Form

historic name Tacoma Narrows Bridge

Suspension bridge

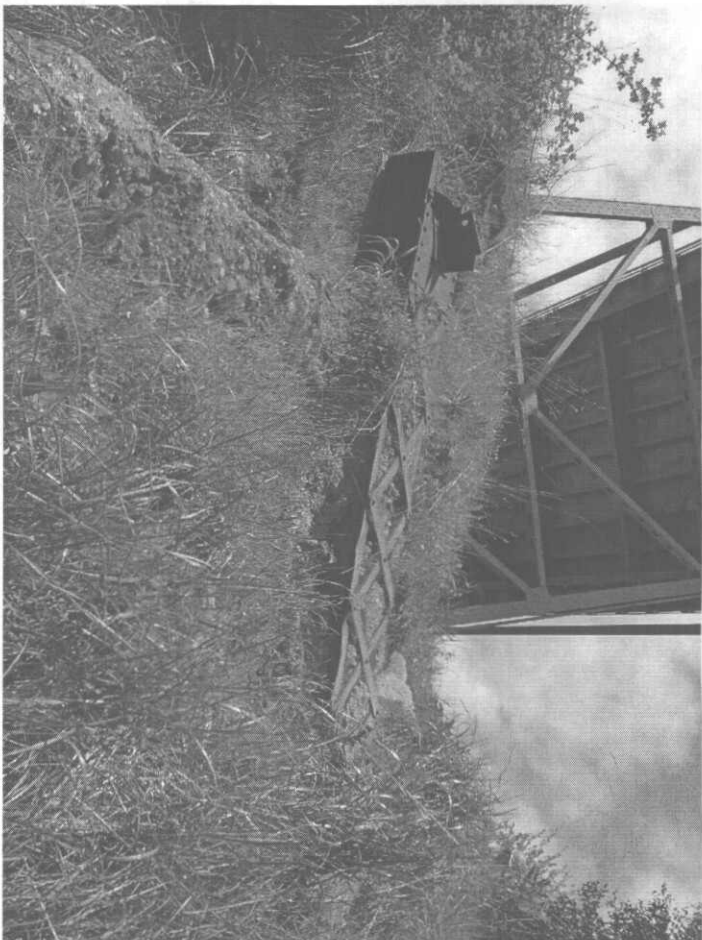
Tacoma Narrow Bridge Rubble. View to Northwest.

The concrete and steel rubble consists of those portions of the original west anchorage that were removed and discarded when the anchorage was retrofitted for the present bridge. This debris is not associated with the bridge superstructure and was not a factor in the failure of the original structure.
