**HEAVY MOVABLE STRUCTURES, INC.
FOURTEENTH BIENNIAL SYMPOSIUM**

**Mystic Bascule Bridge Rehabilitation –
Balance Truss Re-Alignment**

Alan Fisher, P.E.
Cianbro

John Williams, P.E.
Stafford Bandlow Engineering

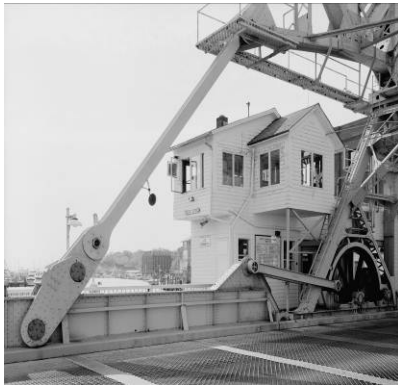
The Brown bascule at Mystic comprises a single leaf 84'-5" in length from heel trunnion to toe. The leaf rotates a full 90 degrees to the fully open position where it provides a clear channel of 75 ft. When closed, the bridge provides a 33 ft. wide roadway and a 5 ft. sidewalk on either side. The leaf is connected to overhead concrete counterweights situated on top of A-frame type support towers located to the approach side of the heel trunnions. Each bascule leaf girder is connected to its independent counterweight via a balance link. The link, which is comprised of multiple sections allowing several points of rotation, was central to Brown's stated intent to "avoid the limitations of parallelism entirely"¹ and to balance the bridge through all position of rotation. While a mathematically accurate balance of a bridge requires a large number of points of rotation, Brown proposed that three or even two points of rotation may produce a balance sufficiently accurate for all practical purposes.²

The actual balance link utilized at Mystic is limited to three sections: the eye bar, the short link and the butt link. The short link, which is rigidly secured to the eye bar through a bolted connection, was provided to facilitate construction and is not a truly independent link. Therefore, the assembled balance link affords two points of rotation. During operation, the balance link pivots about its connection to the girder for the first 38 degrees of leaf rotation at which point the butt link contacts a hard stop on the movable leaf. This contact prevents further rotation of the butt link and forces the balance link to pivot about its connection to the butt link until the leaf is fully open. The net result is that as the span rotates through 90° of motion, the rotation of the counterweight is limited to 69°. Further, the length of

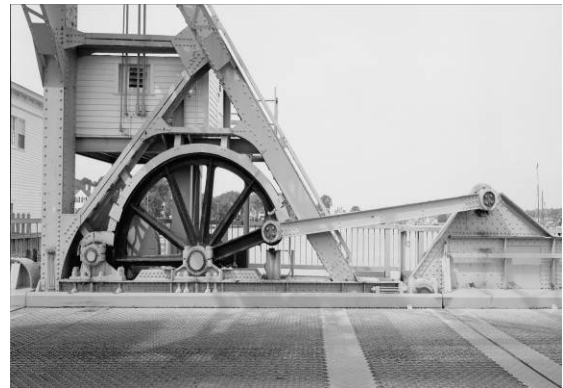
The means of operating the bridge is by a segmental bull-gear connected via operating strut to the bascule girder. The linkage was so arranged to provide the smallest angle between segmental gear and operating strut in the fully lowered and fully open position so that the members act as a toggle. This arrangement was chosen to provide the following stated benefits: to generate the greatest leverage in the lowered position to provide maximum power in starting the span from its seat, to form an effective lock to hold down the movable span on its seat when lowered, and to provide the greatest leverage in the fully open position to hold the leaf against the wind pressure. Further, the incorporation of worm gearing into the operating machinery provided the stated benefit of allowing the drive machinery to be placed below the bridge floor and thereby eliminate the need for machinery houses.⁴

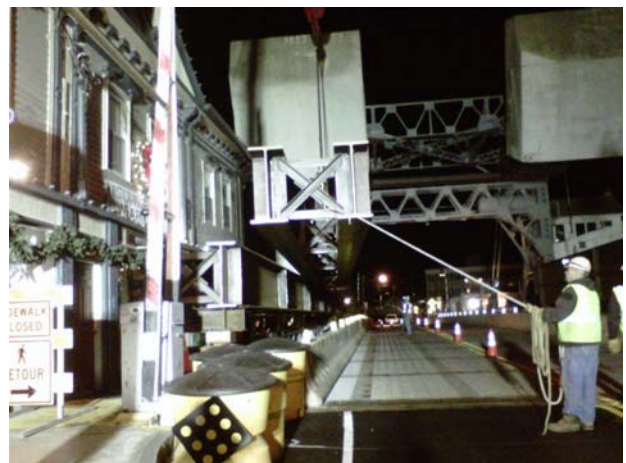
A safe and efficient erection begins with a thorough plan. Consideration of what rigging is available and how the pieces can be configured assures that the erection proceeds smoothly and without any oops. The installation of the girder pairs required extended traffic closures and was therefore accomplished at night. The transverse support frame and the counterweight saddles required shorter duration road closures and were able to be installed during the day shift. The installation of the jacks, shim plates, and containment blocking followed accordingly.

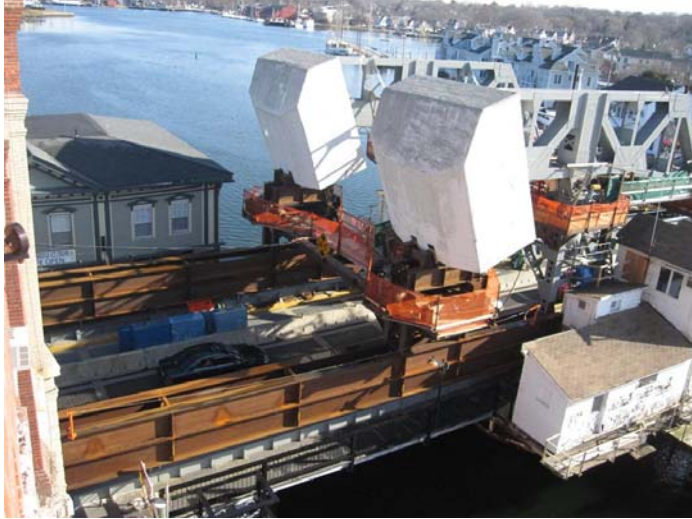
The day came when we were ready to start our jacking operations. The goal was to re-establish the centerline between the counterweight trunnions to be parallel and square to the centerline between the leaf trunnions. This meant rotating the entire counterweight-balance truss assembly about the south trunnion 0.3 degrees or 2.36 inches east at the north trunnion. The north trunnion needed to be lifted 3.13 inches up and the south trunnion 0.97 inches up. Finally, the entire upperworks assembly needed to be moved 1.77 inches south. We initially thought that leaving the counterweight links attached between the

Somehow the counterweights seemed to have grown larger, the closer the falsework came to them. As we approached the day to start jacking the counterweights they seemed to loom over us menacingly. We hoped we had estimated their center of gravity correctly and that it wasn't behind the supports which would mean the counterweights and balance truss would flip over backwards when we cut the balance links.

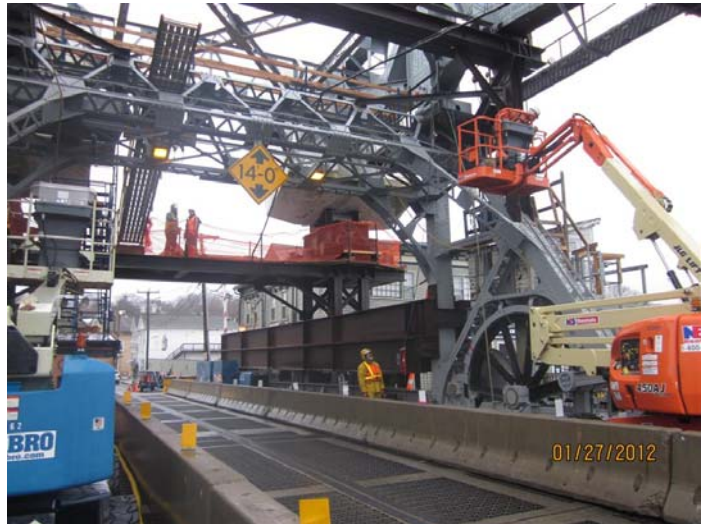
With the balance links still attached, thinking that this would help us square up the upperworks with the leaf, we began jacking east at the north counterweight to rotate the upperworks about the south trunnion bearing. The south trunnion bearing still had one 2 inch bolt left in place to act as a pin about which to pivot the upperworks. Simultaneously, we began jacking south at the two forward falsework support points to further encourage the upperworks to rotate as desired. Initially it seemed like things would work. We moved the north counterweight about 1/2 inch east easily, but then found that moving became difficult fast. The pushing at the forward locations was likewise not showing any success and when we released the pressure on the jacks found that the upperworks followed us back to all but that first half inch of movement. Regrettably, the balance links had to go. In the back of my mind I had counted on the balance links as a backup stability load path: the upperworks couldn't go very far as long as they were still attached. Without them, the stability of our 500 tons of counterweights and balance truss depended exclusively on the transverse stiffness of our falsework, which as was noted above was looking much smaller in reality than it did on paper. More importantly, when we went to start pushing the upperworks

leaf and the balance truss would help us align things. As we lifted the counterweights to start taking their load onto the support falsework, we found that the upperworks truss rotated about the trunnions and the links were bottoming out on at the leaf and actually pushing back against us. We lifted the upperworks assembly at the forward falsework support points and found we had to juggle our jacking to keep the jack loads balanced. Once we had observed that we had lifted all load off the trunnion bearings we removed the bolts holding the bearings to their supports. Next came the wedges that had held the upperworks longitudinally. Time to try some moving:

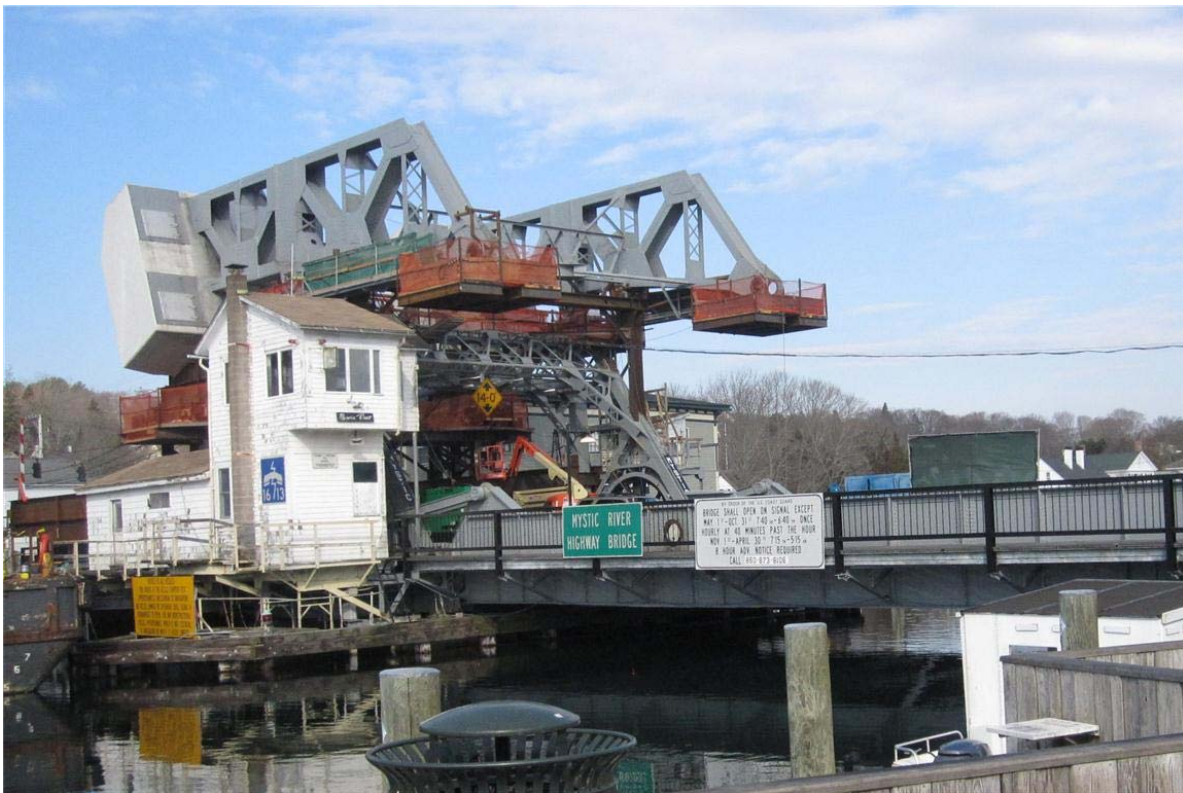
With the counterweights and upperworks securely blocked in position, we now began the fateful step of removing the counterweight link bars. On January 31, 2012 the two sets of link bars were cut and removed from the upperworks. We closely monitored the upperworks with a total station while the links were cut. The south side truss moved about 1/8 inch longitudinally and less than 1/16 inch transversely and vertically. The north side truss moved less than 1/16 inch in all three axes: our blocking was doing its job.

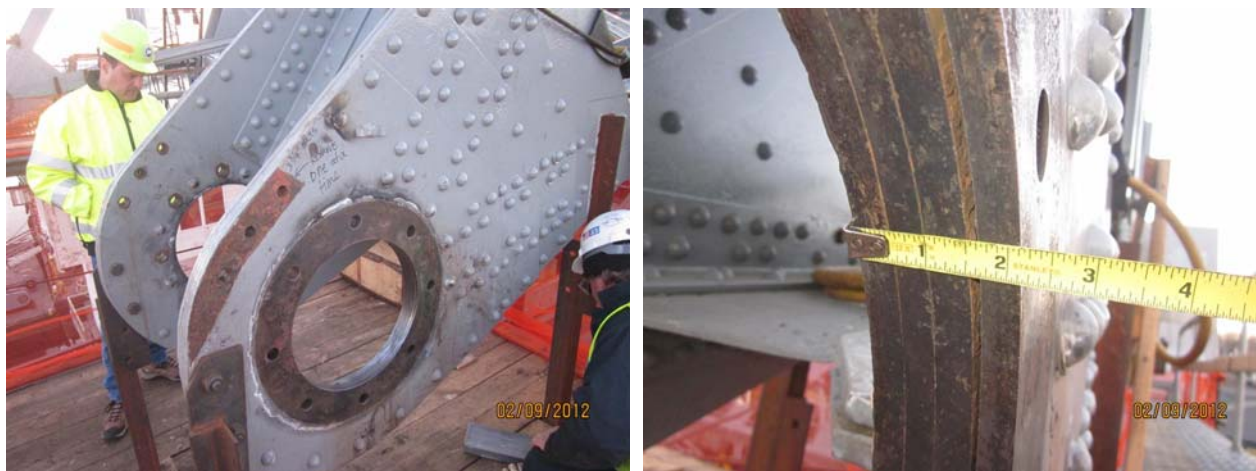
Pack Rust

When the bearing housings for the upper balance link pins were removed from the truss, there was a significant amount of pack rust discovered which had separated the plates which built up the web. It was necessary to remove additional rivets. Using heat and hammering to vibrate loose the corrosion that had built up between the plates the plates were then drawn back together before machining the bores.

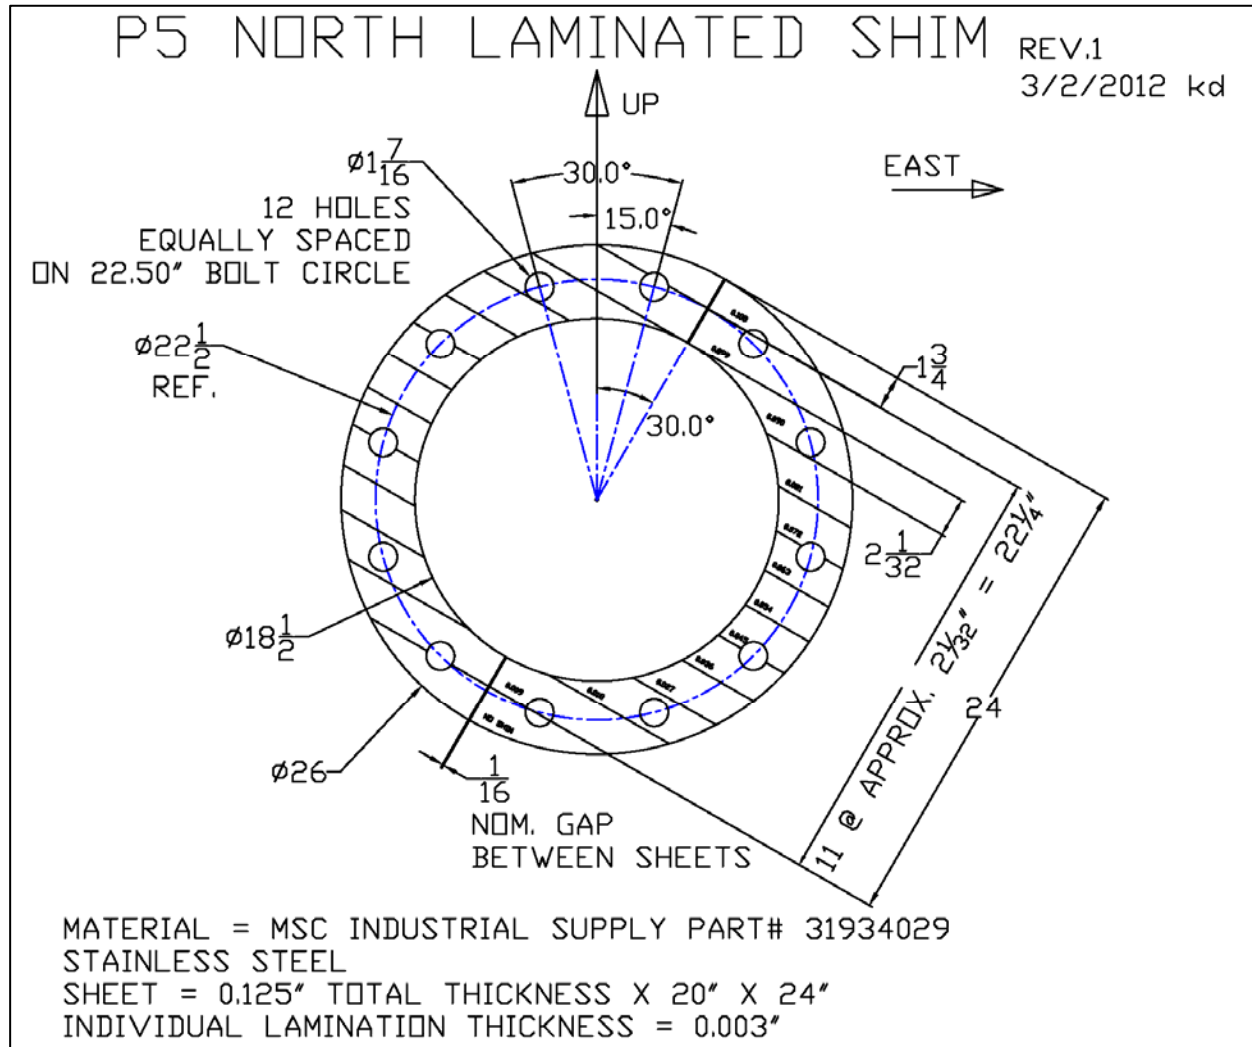
Web Plate Misalignment at Upper & Lower Balance Link Pins

Another problem with the installation of some of the new bearing housings was the finding that the webs of the girders and trusses were not parallel. There was a provision for shims at all of the bearing housings for the balance links. The solution in this case was to utilize laminated shims that could be stepped to quickly fabricate a very accurate feathered shim without the time consuming process of machining them. Using the stepped laminated shims the bearing housings were able to be installed so that the bearing bores were properly aligned parallel to the axis of rotation.

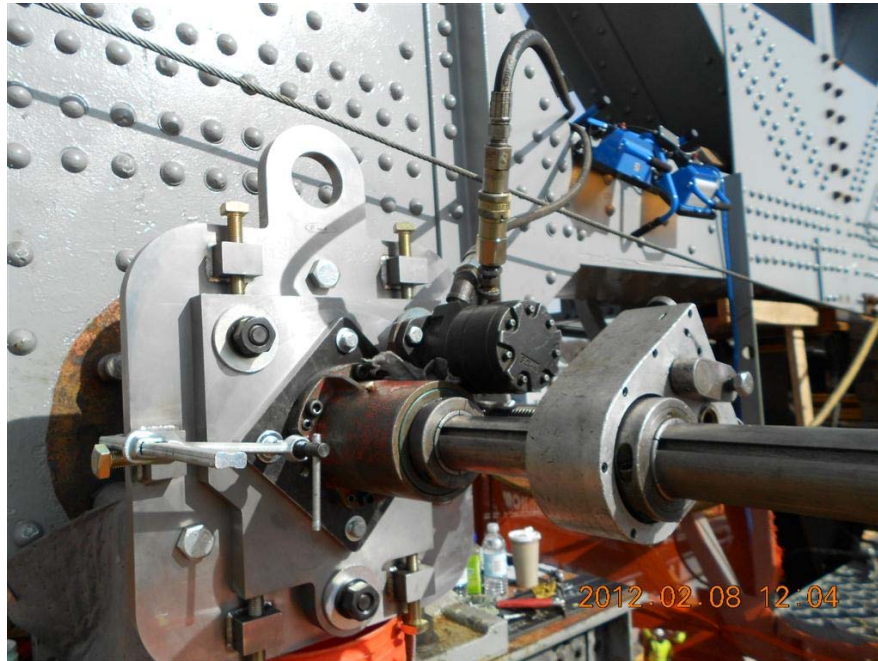
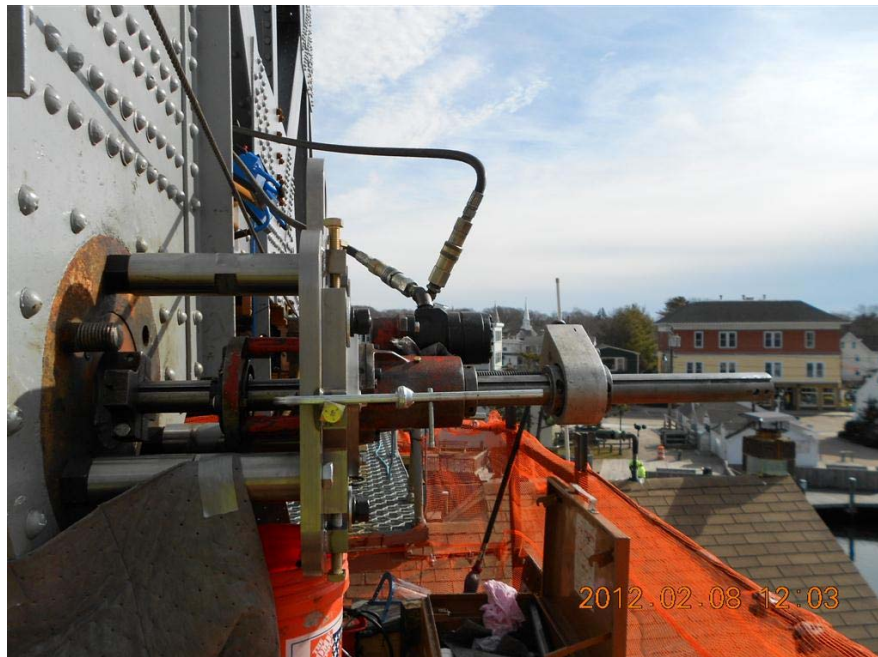
Web Plate Misalignment at Counterweight Trunnions

A similar issue presented itself at the web plates for the counterweight trunnions: Once the truss was re-aligned it was found that the pre-existing misalignment had plastically deformed the web plates so that they were skewed relative to the axis of the trunnion. It was impossible to compensate using feathered shims due to the fact that the original design did not include any shims at this location. In this case it was necessary to bore and face the web plates to produce the proper final alignment of the counterweight trunnion. Fortunately with the field machining crew already mobilized to perform the boring operation they were able to quickly transition and perform the facing operation without significant delays to the project.

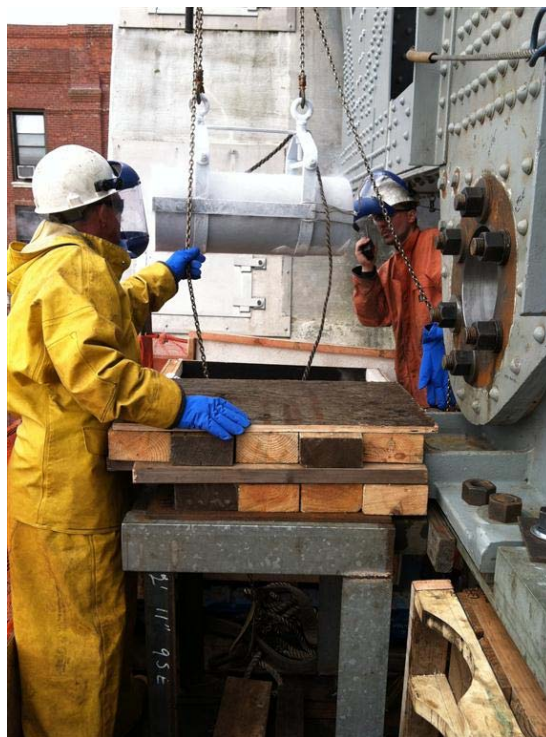
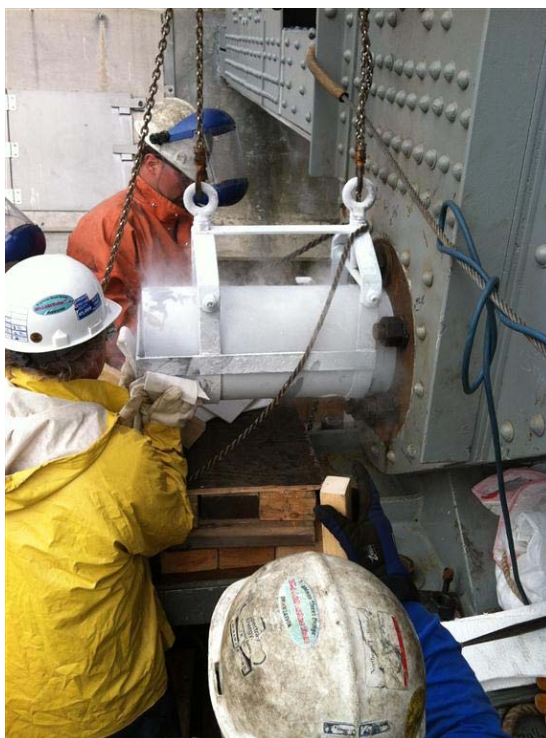
Counterweight Trunnion Pin Shrink Fit.

After re-aligning the trusses and finishing the boring and facing operation on the web plates, one of the final steps of re-assembling the structure was to install two large counterweight trunnion pins, one at each truss. These pins transfer the dead load of the upper balance truss to the trunnion sleeve which is supported in a plain bronze bearing at the top of the tower. The requirement was to install the 12 inch diameter, 30 inch long forged pins with an ANSI FN1 interference fit. The combination of the location of the components at the tops of the towers, the access at that location, the size of the components and the horizontal orientation of the parts made this a relatively difficult interference fit. The Specification imposed a restriction on the Contractor: The pin was not allowed to be cooled using liquid nitrogen. The prohibition on the use of liquid nitrogen has become commonplace in the movable bridge industry primarily as a result of several well-known historical incidents at the Miami Avenue Bridge and the Brickell Avenue Bridge where trunnions cooled in liquid nitrogen and installed in their hubs cracked the hubs during temperature normalization. Cianbro felt that the use of liquid nitrogen as a cooling media was the only method that would shrink the pins adequately to allow enough time to install the pins into the truss bore. They felt that dry ice cooling would warm too quickly and requested permission to use nitrogen instead.

Upon review of the research performed by FDOT evaluating the risks and benefits of using liquid nitrogen it was determined that this was a situation where there were not significant risks associated with using liquid nitrogen based on the configuration of the truss and the fact that there was a relatively light interference fit used. Cianbro also performed a test-cooling using one of the old pins which had been removed from the truss. This test showed that the nitrogen cooling had not affected the old pin and that the amount of time that elapsed before the pin resumed its original size would be adequate to get the new pin into the truss bore. Permission was given with the restriction that the trunnion pin was not permitted to be placed into direct contact with the liquid nitrogen until the temperature differential between the pin and liquid nitrogen was 200 degrees or less (i.e. the pin had reached -121 degrees) in order to avoid large thermal gradients of the order of 300 to 400 deg. F.

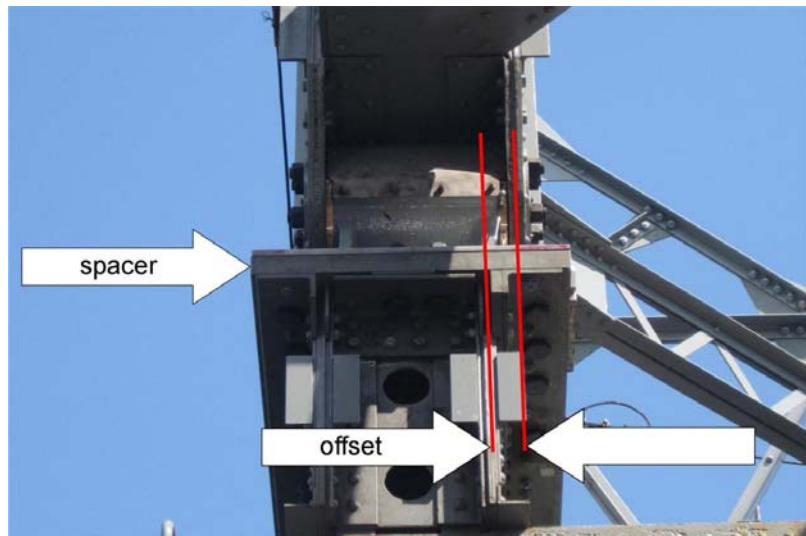
**North Counterweight Trunnion
Bearing Final Condition
(Transverse to roadway)**

On March 27, 2012 the supports under the counterweights were jacked down and the counterweight links were once again loaded while being monitored with strain gages to confirm equal loading. A final precision survey was performed of the counterweight trunnions to decide if the adjustments which had been made had survived the re-loading process. The survey revealed that the counterweight trunnion pins were now within 0.01 inch of being at the same elevation; within 0.02 inches of being at their desired north-south location; and within 0.06 inches of being at the same east- west location. This was all in all a remarkable feat of construction engineering, and ironworker and millwright craftsmanship. The photos above depict the final connections between the counterweight trunnion bearings and the towers. The varying thickness of the spacers installed between the tower and the bearings and the visible offset between the tower column and the bearing illustrate the amount of movement that was required to re-establish the correct alignment of the balance truss.

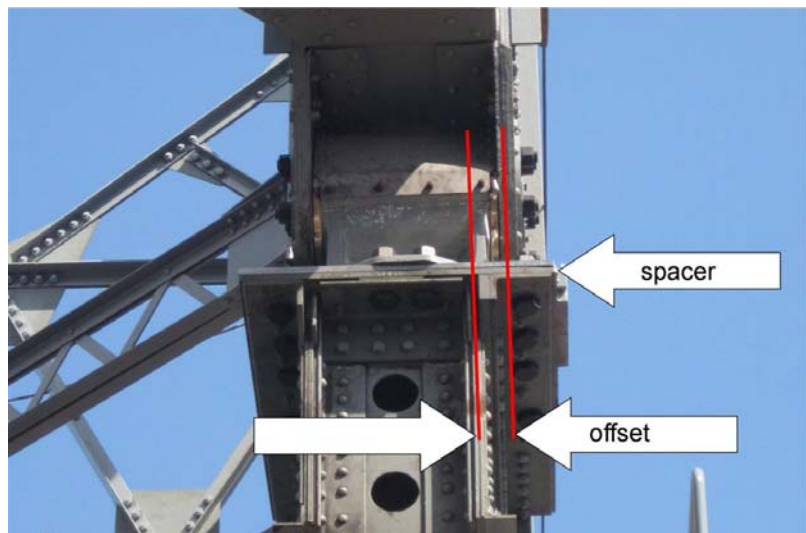
**South Counterweight Trunnion
Bearing Final Condition
(Transverse to roadway)**
