Counterweight Repair of Historic
St. Charles Air Line Bridge

Owner
CN

Prime Contractor
Vector Construction Inc.

Repair Contractor (Sub)
Sitar Construction

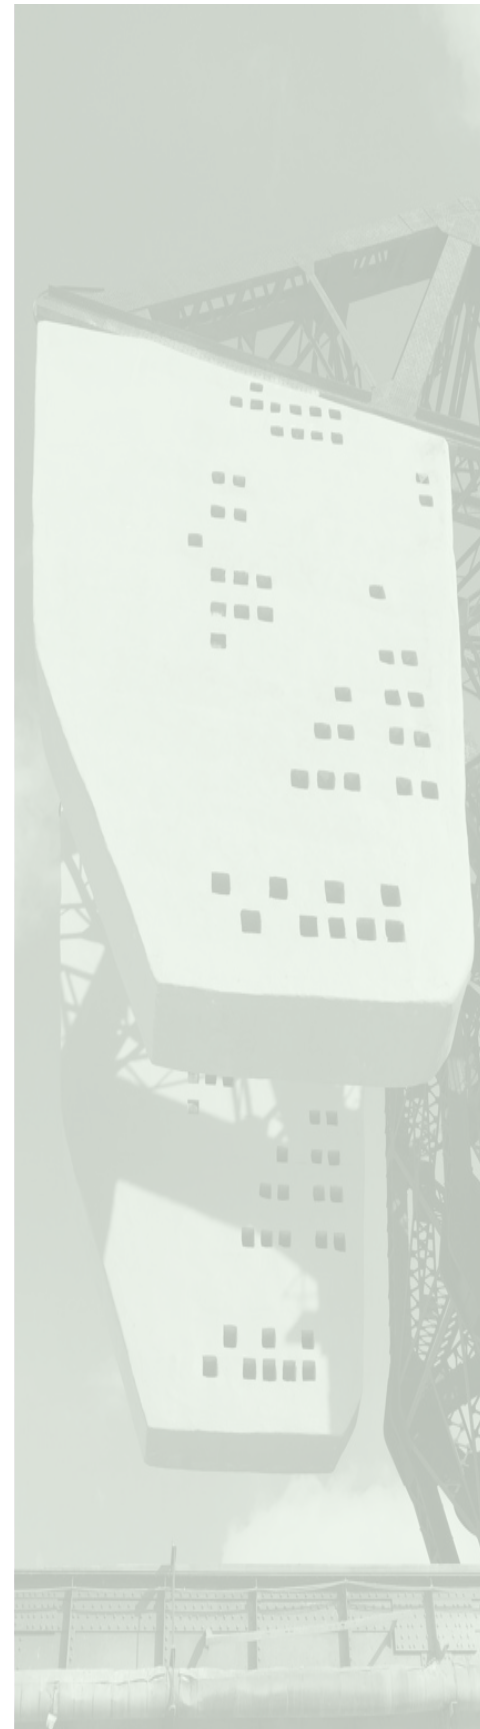
Figure 3 - The South Branch of the Chicago River was Straightened and the Bridge Relocated in 1930

When it was originally constructed, the St. Charles Air Line Bridge held the record as the longest bascule bridge at 260 ft. in length. However, the bridge was constructed with the foresight that it would be moved and shortened after the eastward bend in the Chicago River was straightened to make room for the construction of a railroad terminal.

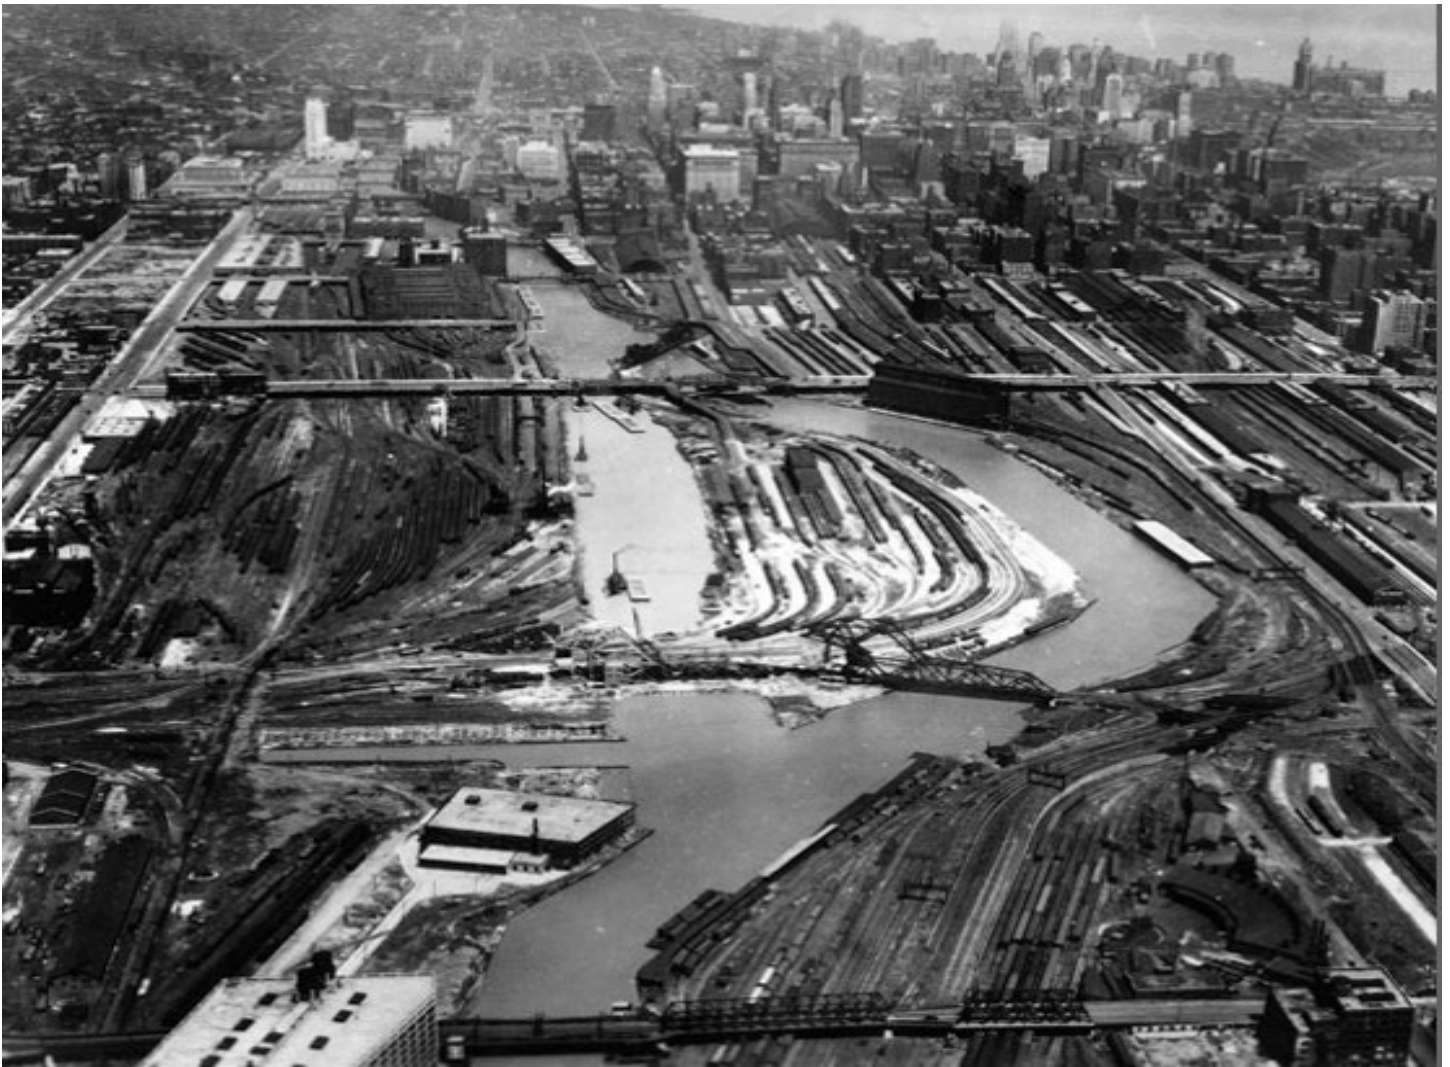
The south branch was straightened between 1927 and 1929. In 1930, the bridge was moved $\frac{1}{4}$ of a mile to the west and shortened to approximately 220 ft in length to span the narrower relocated riverbed. At that time, the bridge also received newly constructed concrete counterweights to rebalance the bridge.

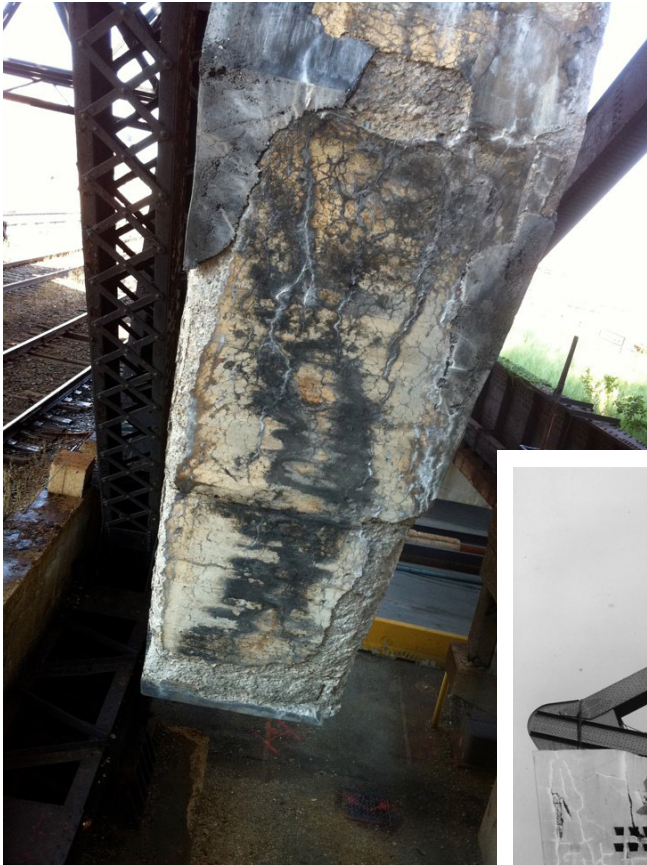
The concrete counterweights are subject to surface scaling and freeze-thaw damage. Deteriorating and falling concrete is a safety hazard to people and property below and can cause the bridge to be out-of-balance, thus not raising or lowering in a smooth fashion.

Figure 6 - Condition of the Winged Concrete Counterweight

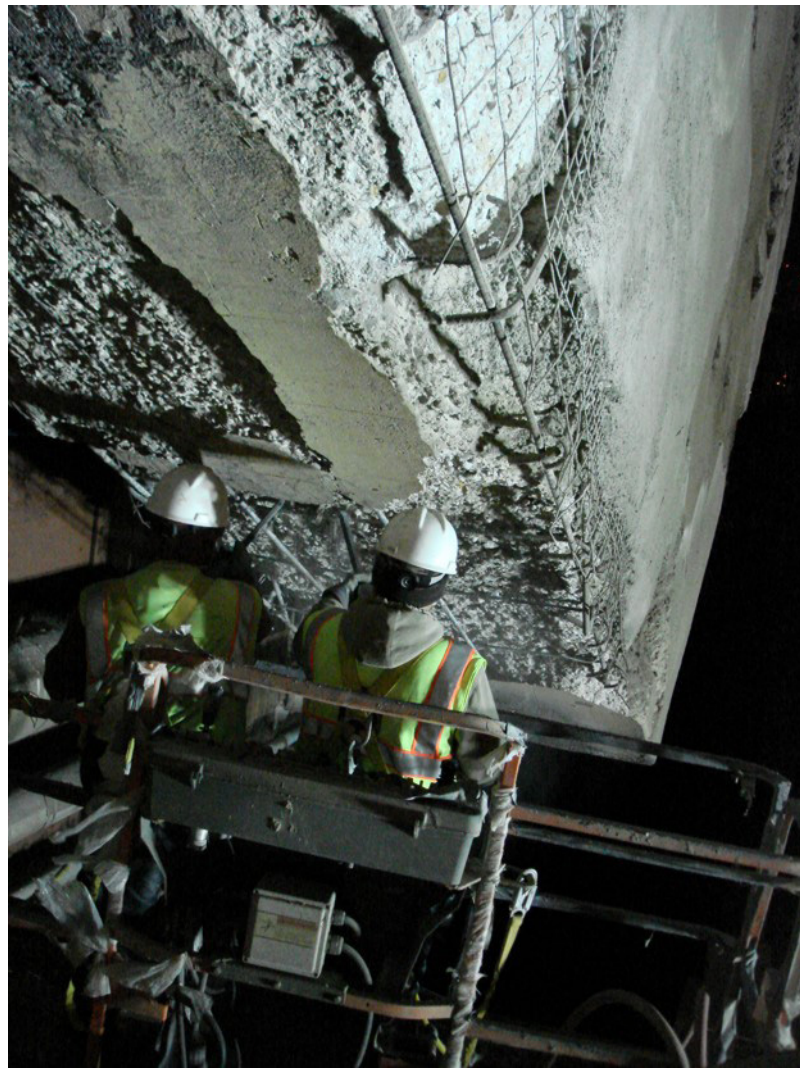
Figure 9 - Concrete Removal was Limited to 3 yd³ to Maintain Balance During Repairs

The repairs were completed using a regular nightly schedule to work during a 10-hour window when there was less train traffic including no Amtrak trains and no river traffic. In order to maintain the bridge balance, a maximum of 3 cubic yards of concrete could be removed at one time.

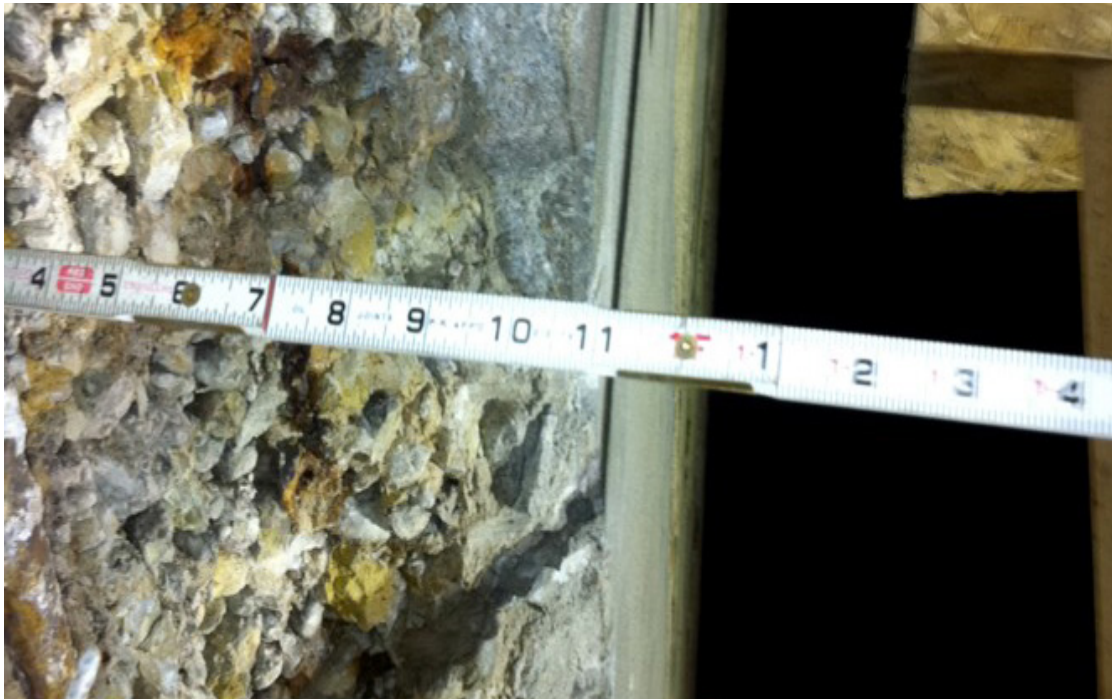
Figure 10 - The Depth of Concrete Repair was 10-12"

Based on previous experience, the repair depths were expected to be 10-12". Each evening the bridge would be raised to lower the counterweight working height allowing access to the bridge by a boom lift with a platform height of 80'. Vehicular traffic was detoured to create safe working conditions.

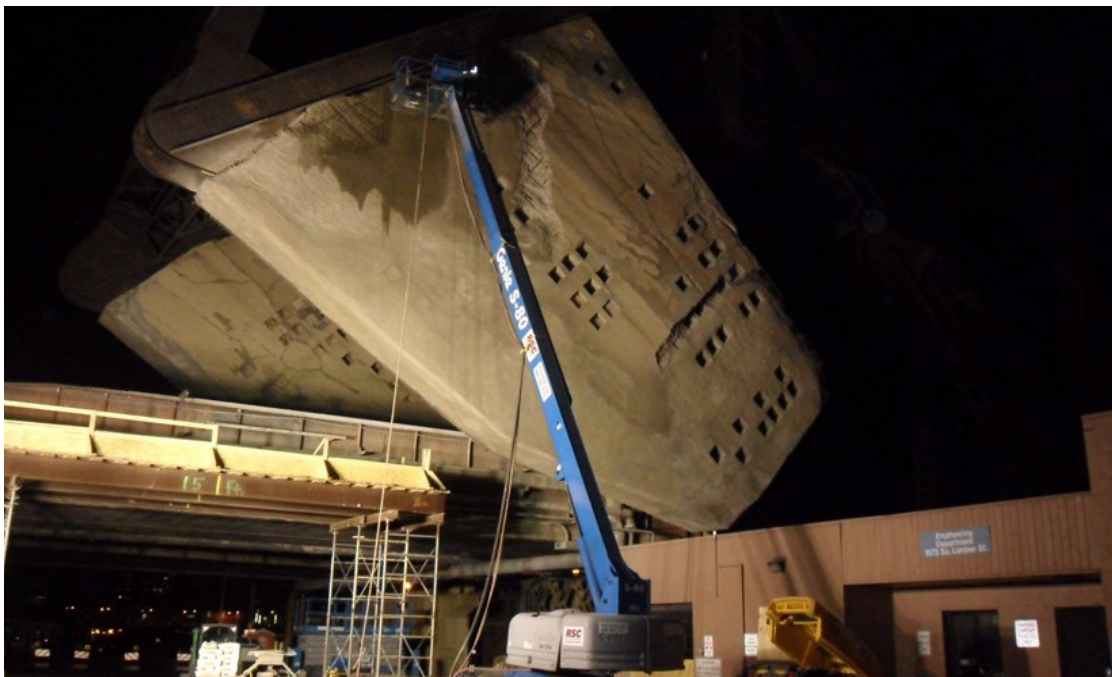
Figure 11 - The Bridge was Raised at Night to Allow Counterweight Access by Boon Lift

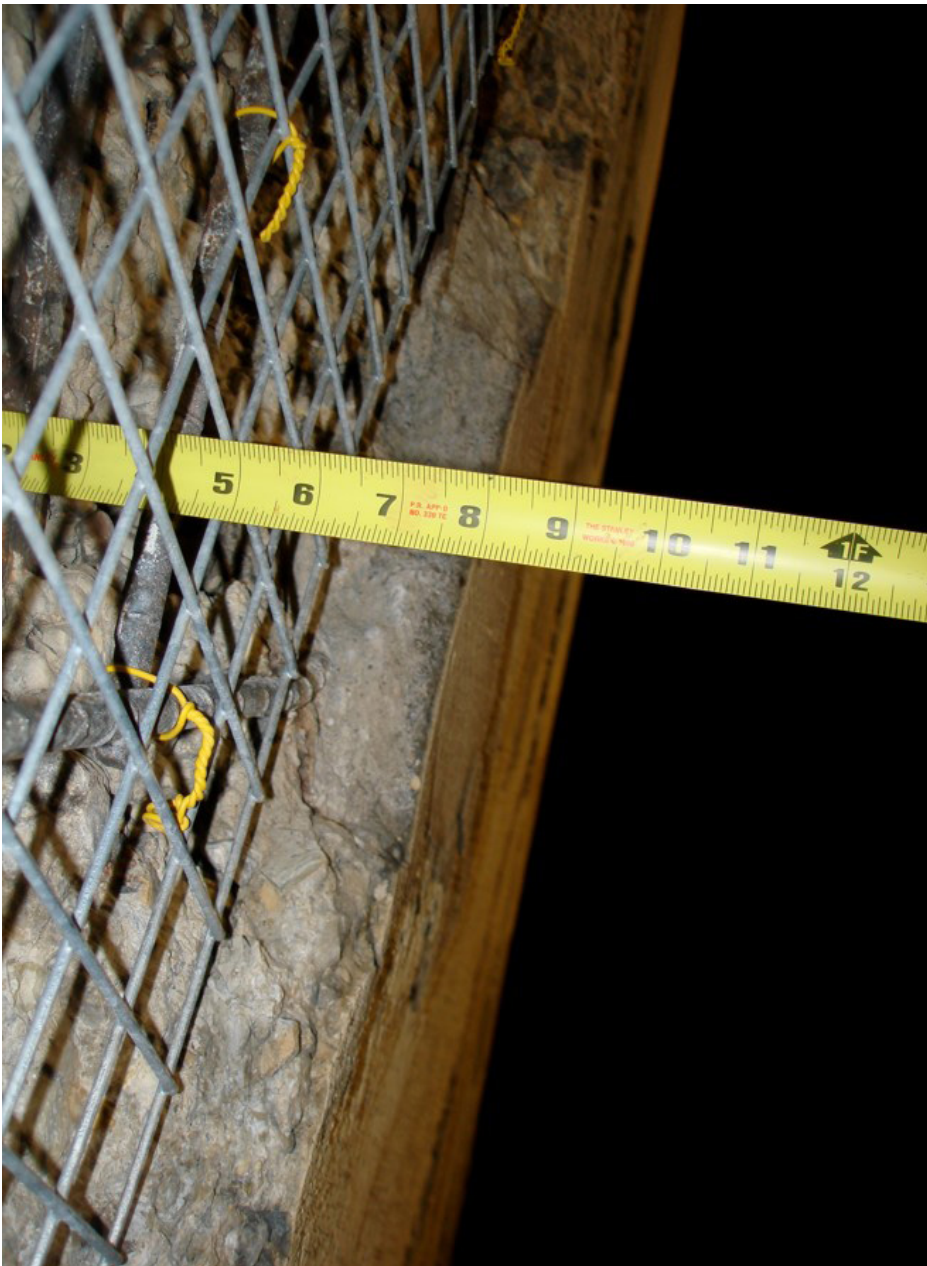
Figure 12 - Installation of 2"x2" Galvanized Welded-Wire Fabric

03:00 Place supplemental steel (2"x2" galvanized WWF)

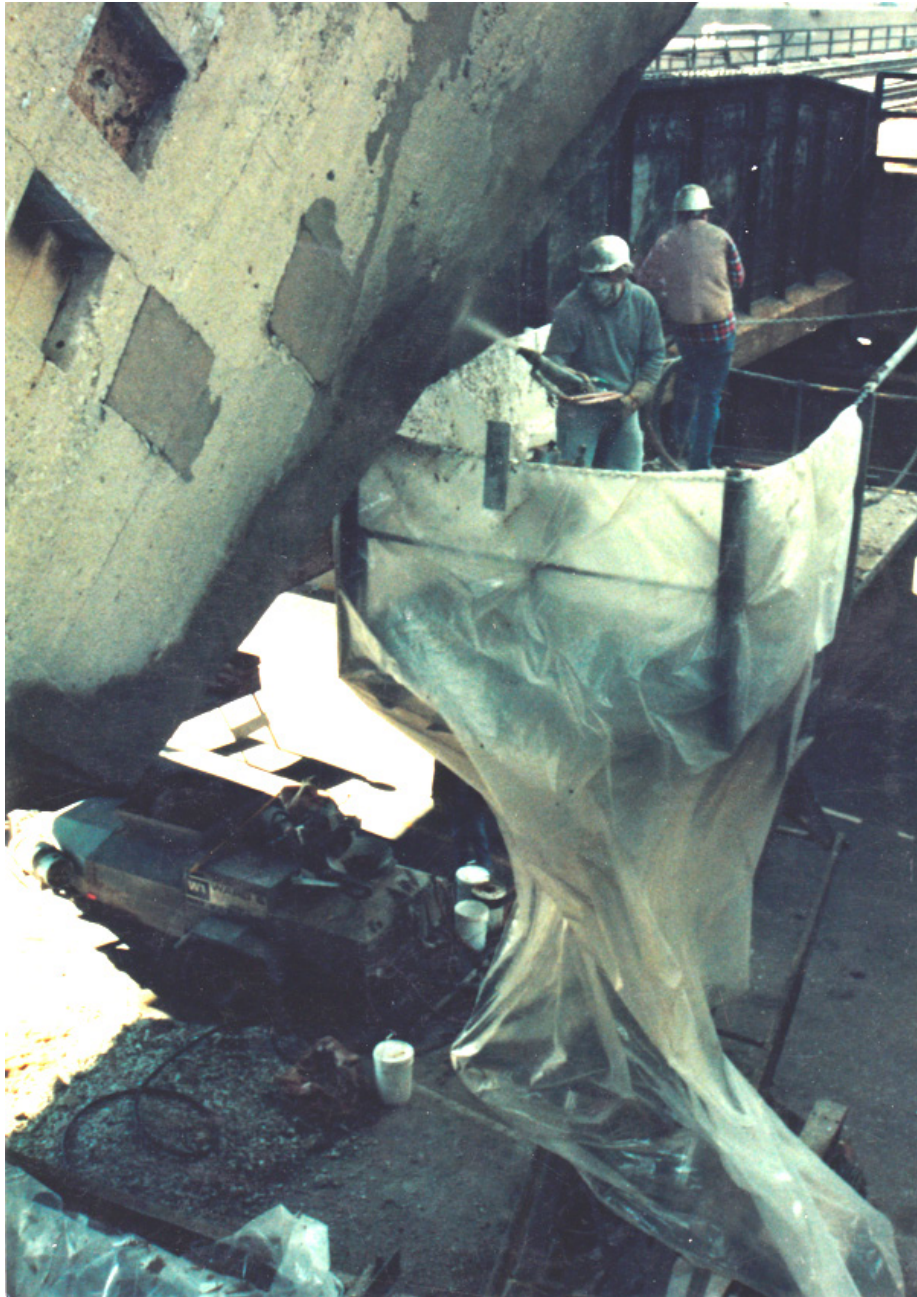
Figure 13 - Wet Mix Shotcrete was Selected for the Repairs

Wet mix shotcrete was selected as the repair method using custom-designed equipment that allows for vertical pumping and placement at heights up to 100'. The pressure pump contains internal agitators to keep the wet mix shotcrete fluid and allows for instant on/off control by the nozzleman.

A prepackaged wet shotcrete mix was selected for the repairs as it offered the convenience of reduced material handling as well as excellent product quality. The selected shotcrete was a superplasticized 5,000 psi mix, 20% added 3/8" pea gravel, with accelerator added at the nozzle. After the shotcrete was replaced, it was cut back and finished level with the existing counterweight surface.

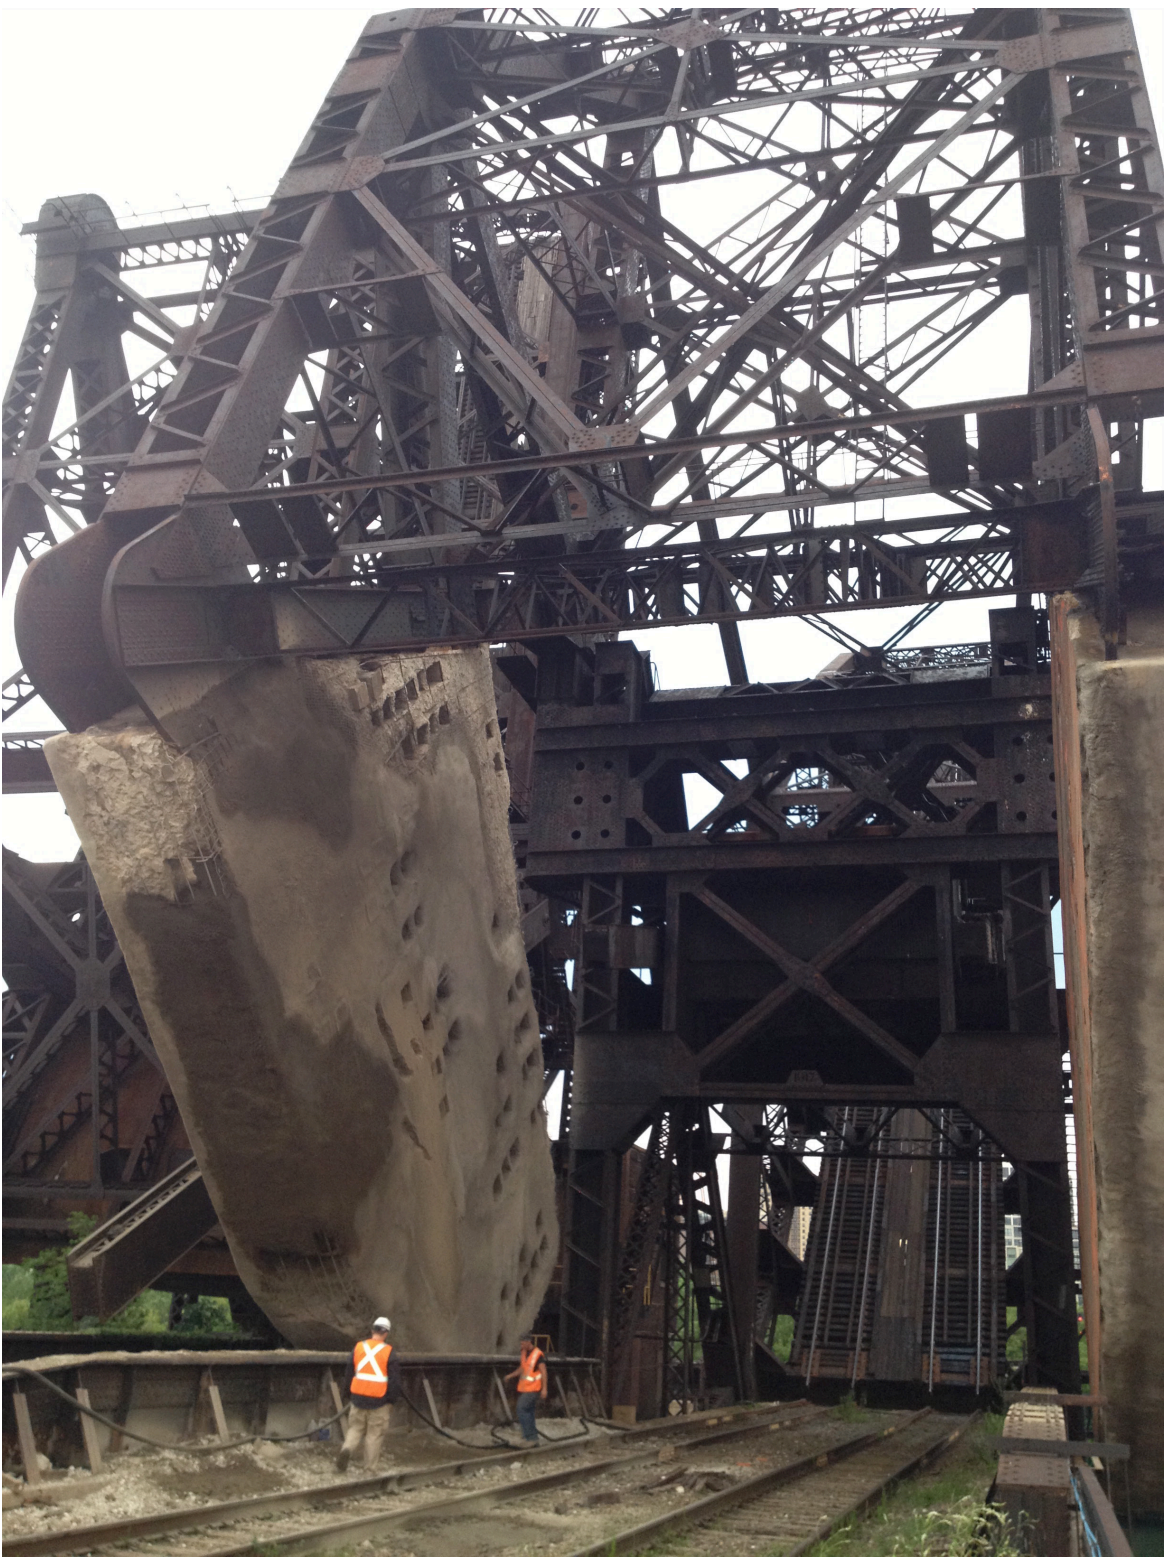
Figure 14 - 2014 Repairs in Progress

This plan was executed via separate contracts in 2011 and 2014. The 2011 project scope was to repair the outer counterweight surfaces and the 2014 project included the inner counterweight faces and the FRP system addition.

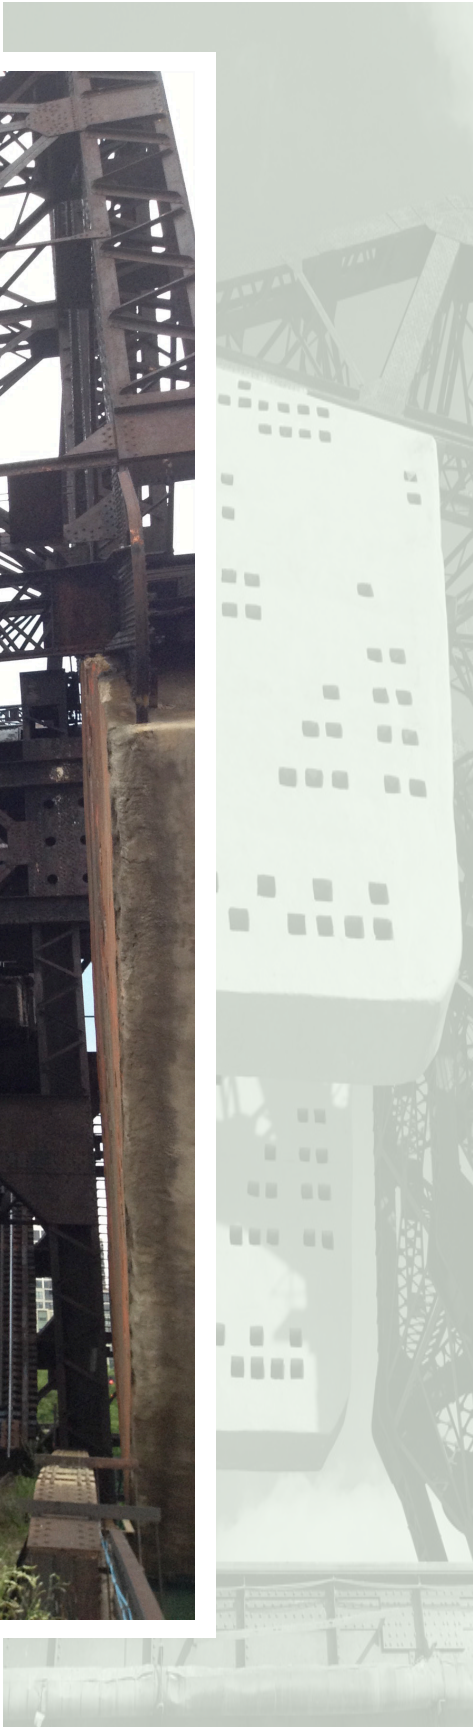
Figure 15 - The Completed Repair With Surface Applied FRP and a Light Gray Acrylic Topcoat

Over a 5 month project duration, the inner counterweight surfaces were repaired with 6,000 cubic feet of wet mix shotcrete and 100% of the counterweights' surface area was protected with glass fiber FRP. The project was successfully executed with no injuries, accidents, delays or damage to the owner's property while maintaining an operational and balanced bridge.
