Thamesville Bridge

A Unique Heritage Truss Bridge

HistoricBridges.org

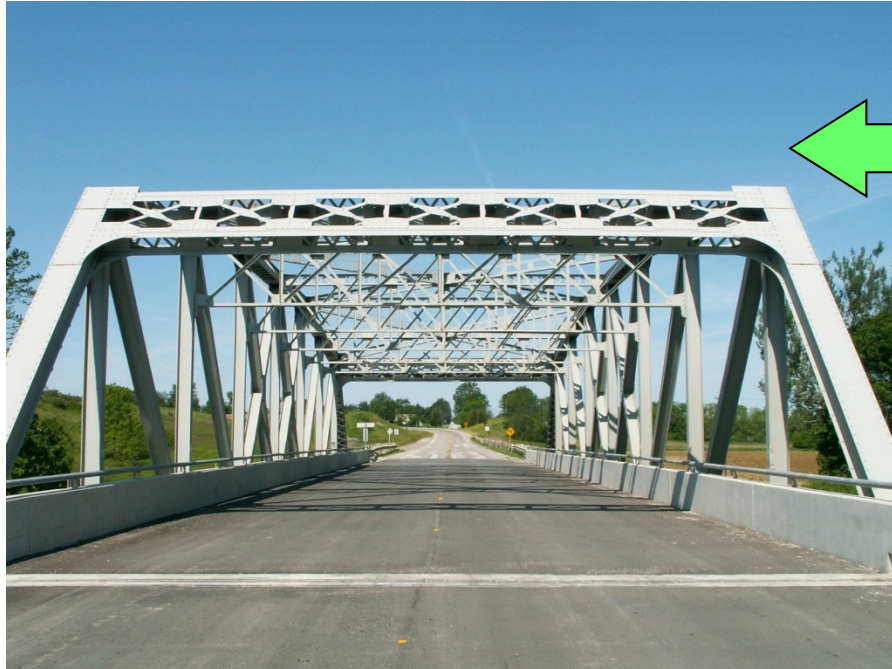
← **Through
Truss**

Longer truss bridges need overhead bracing to stabilize them and are called through trusses. Shorter spans without overhead bracing are pony truss bridges.

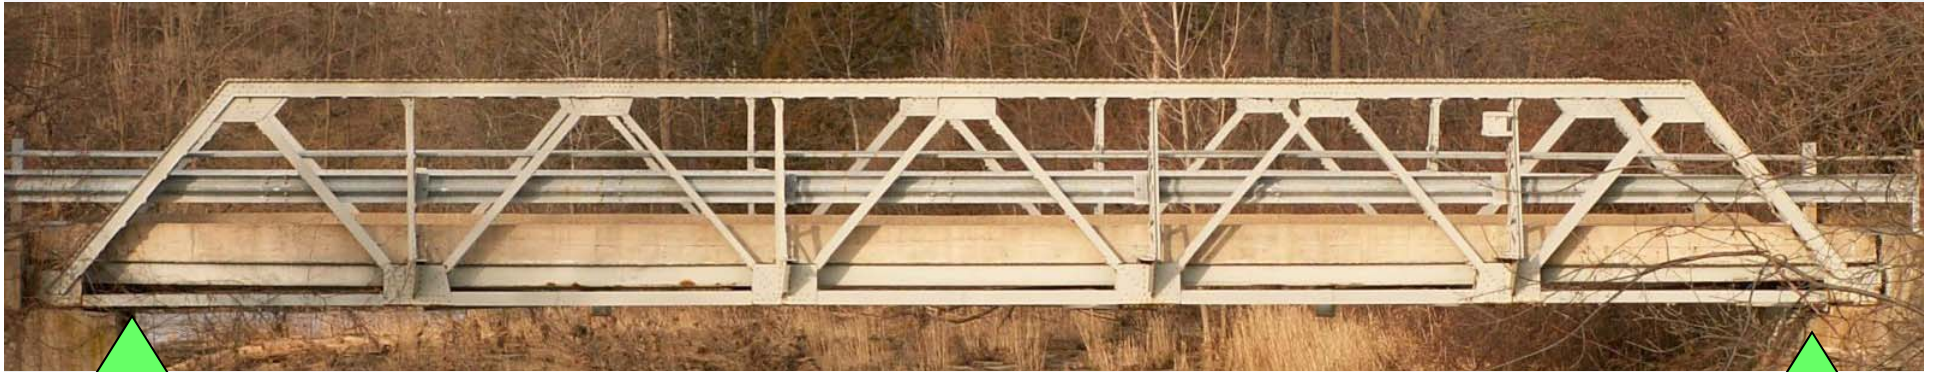
Warren truss (repeating "V's")

Truss designs are classified by how the "diagonal members" are positioned. The two most basic types are shown.

Pratt truss (pointing bottom, center)

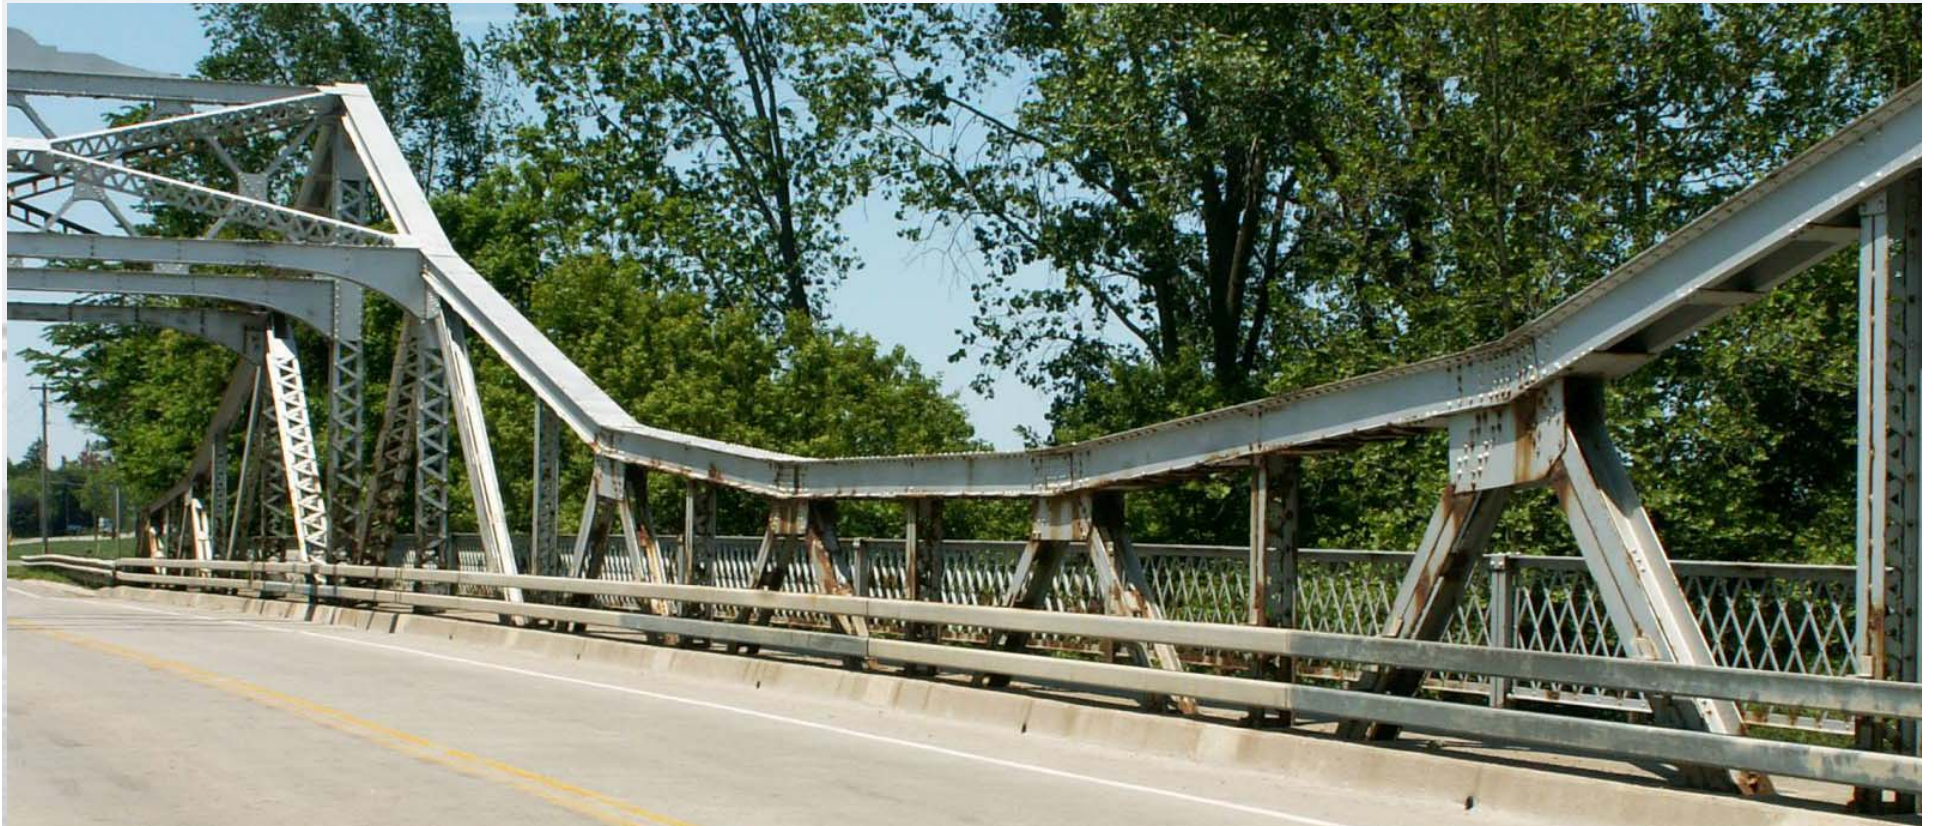
The Thamesville Bridge's trusses follow a Warren through truss design.

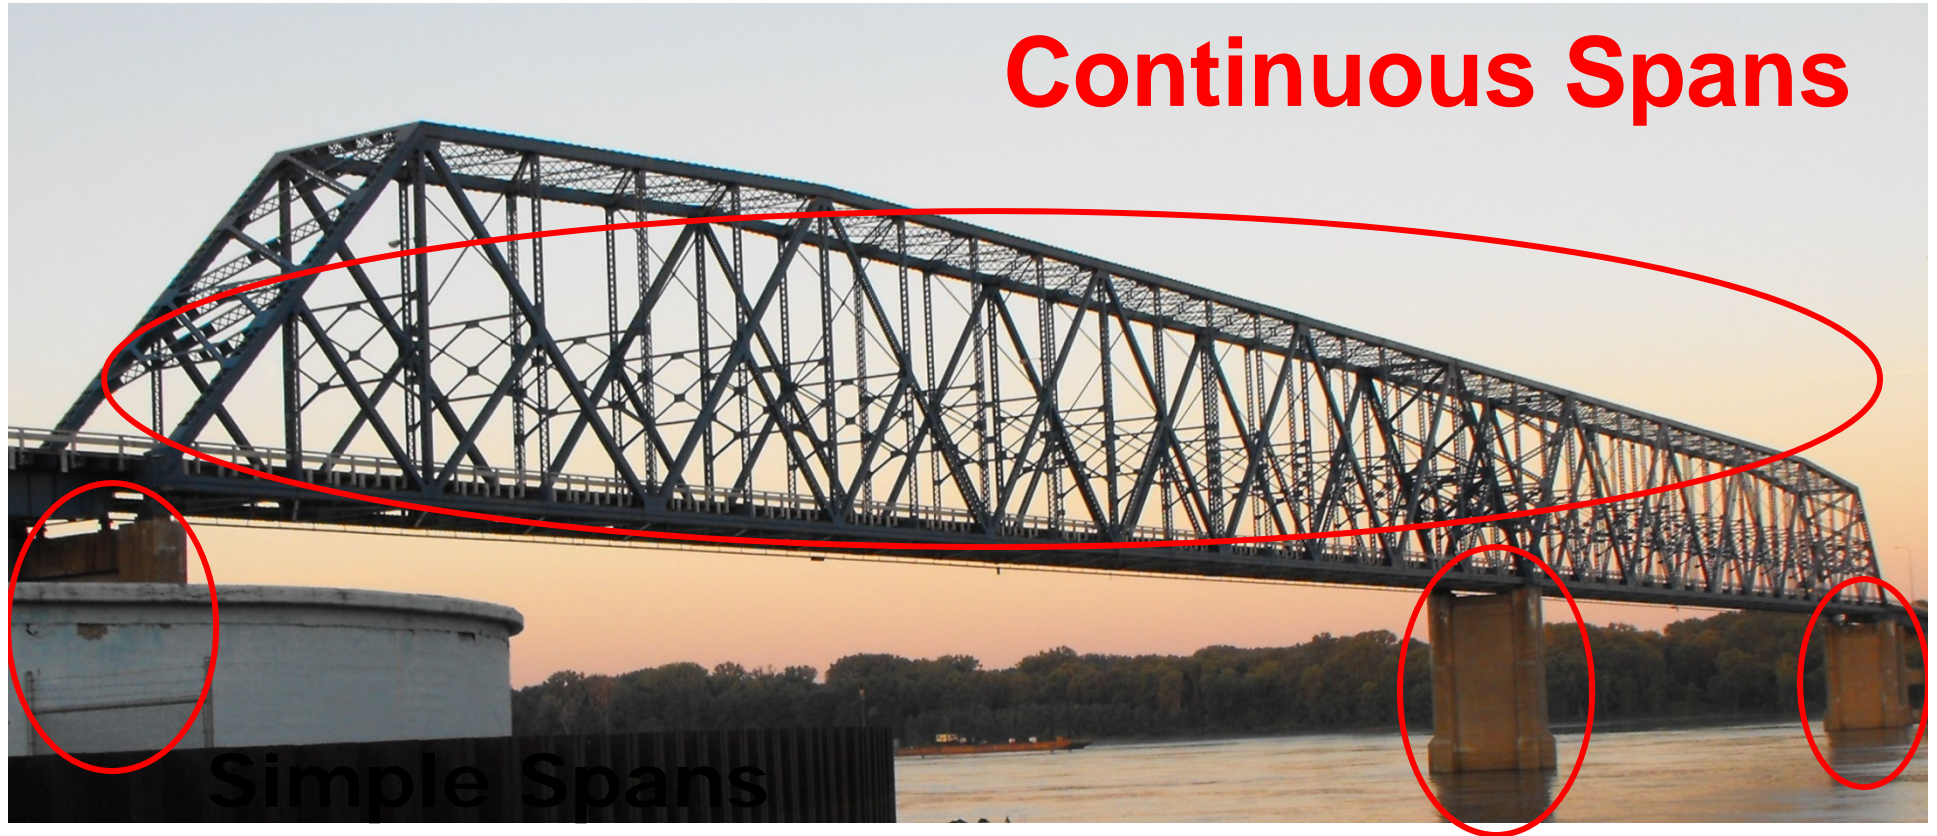
Continuous Spans

Continuous spans are interconnected with their surrounding spans and require the presence of the surrounding spans to function correctly

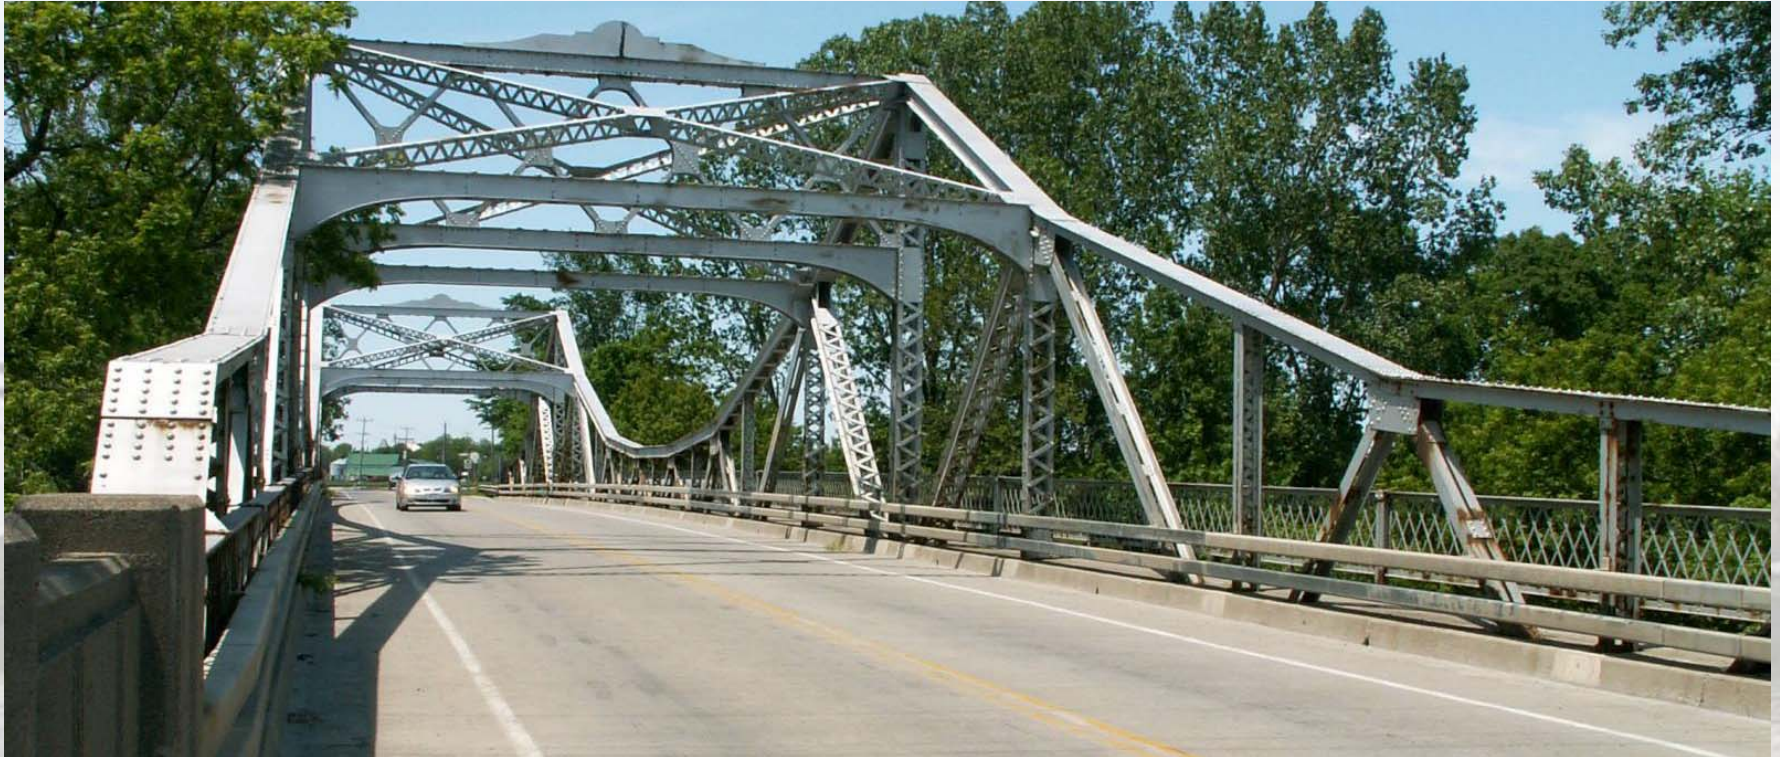
Thamesville Bridge

Bridge is a continuous through truss constructed using the cantilever method.

The center span is 160 feet; each side span 80 feet; total 320 feet, continuous over four supports. Erected, during high-water period, by cantilever method. The bridge carries a roadway 30 feet wide, and one 5-foot sidewalk.

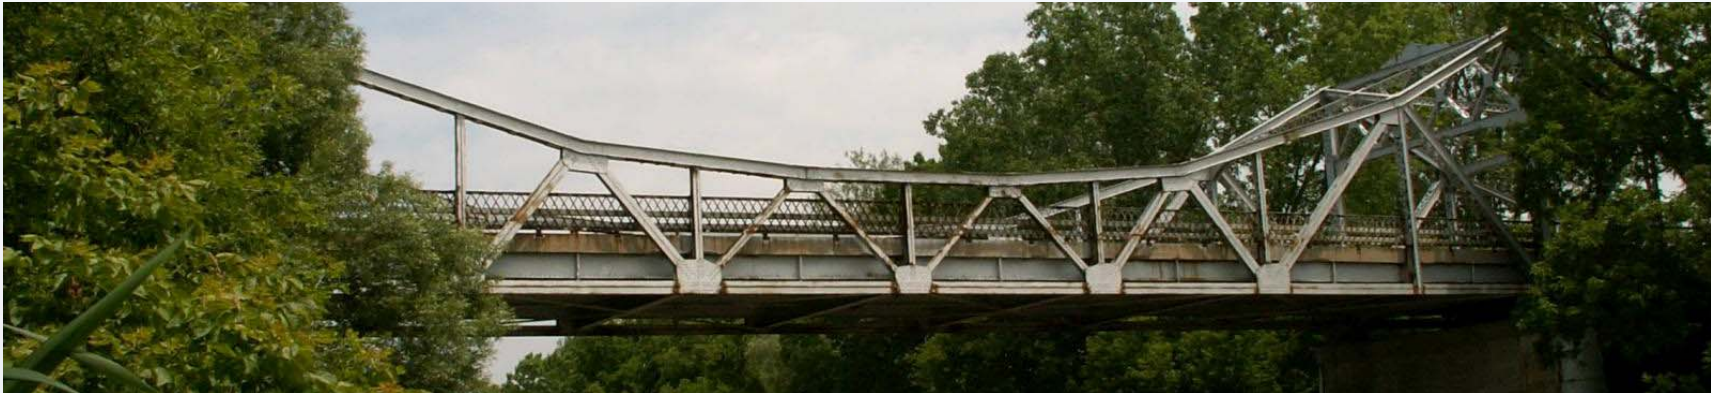
Thamesville Bridge

- **Built in 1937**
- **Builder: Canadian Bridge Company of Walkerville, Ontario**
- **Designer: Ontario Department of Highways under Arthur Sedgwick. (Sedgwick is credited with introducing the rigid-frame bridge to Ontario.)**
- **320 Feet (97.5 Meters) in length.**

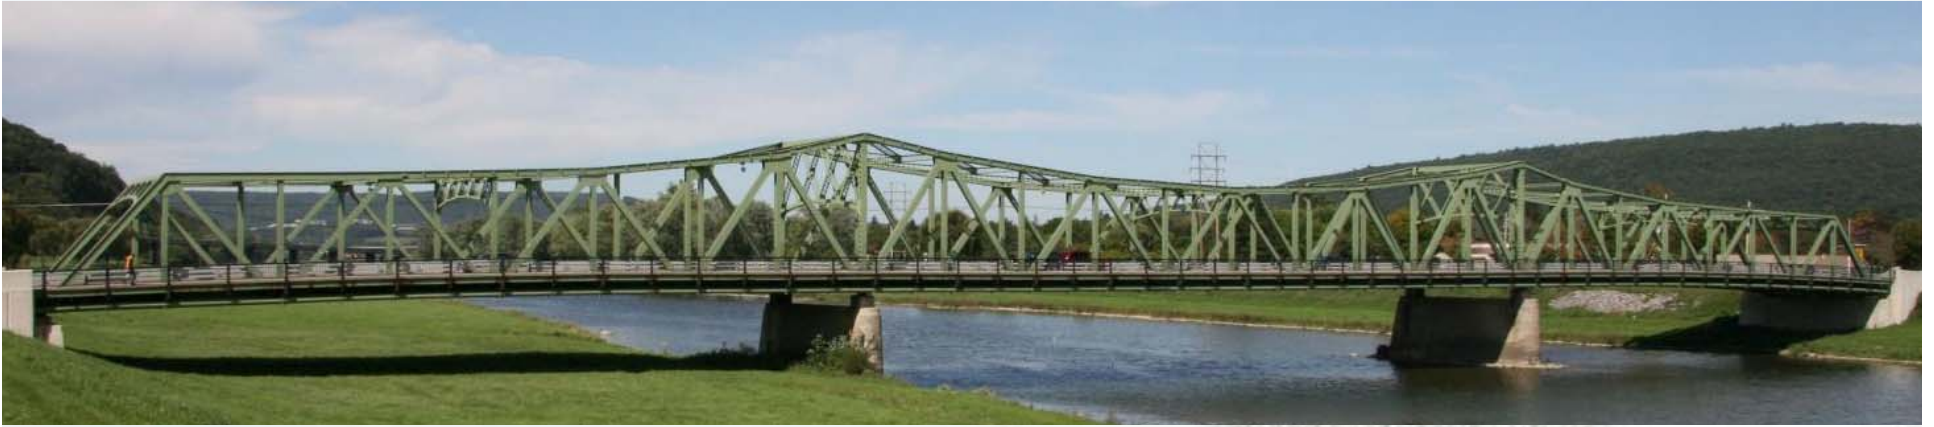
Bridge in Corning, New York, 1937. Main Span: 223 Feet (67.9 Meters)

- Bridges of this design were usually reserved for very large river crossings.
- This is one of the smallest examples of this design I have encountered. The Thamesville main span is 160 Feet (48.8 Meters).

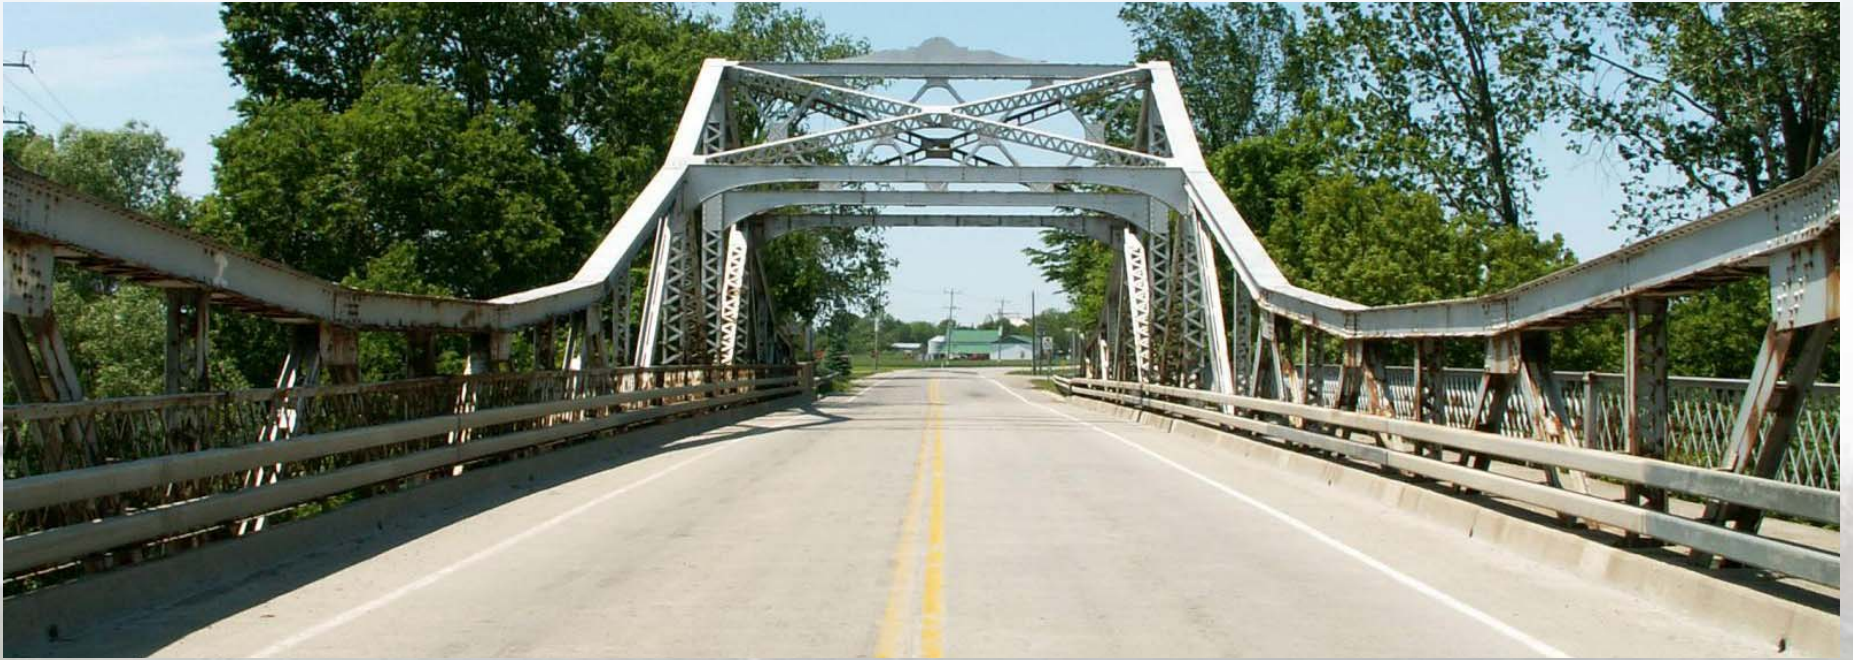
Heritage Significance: Engineering

- **Large or small, the Thamesville Bridge is the only bridge of this type in Chatham-Kent.**
- **No known similar bridges in terms of size and design in Ontario.**

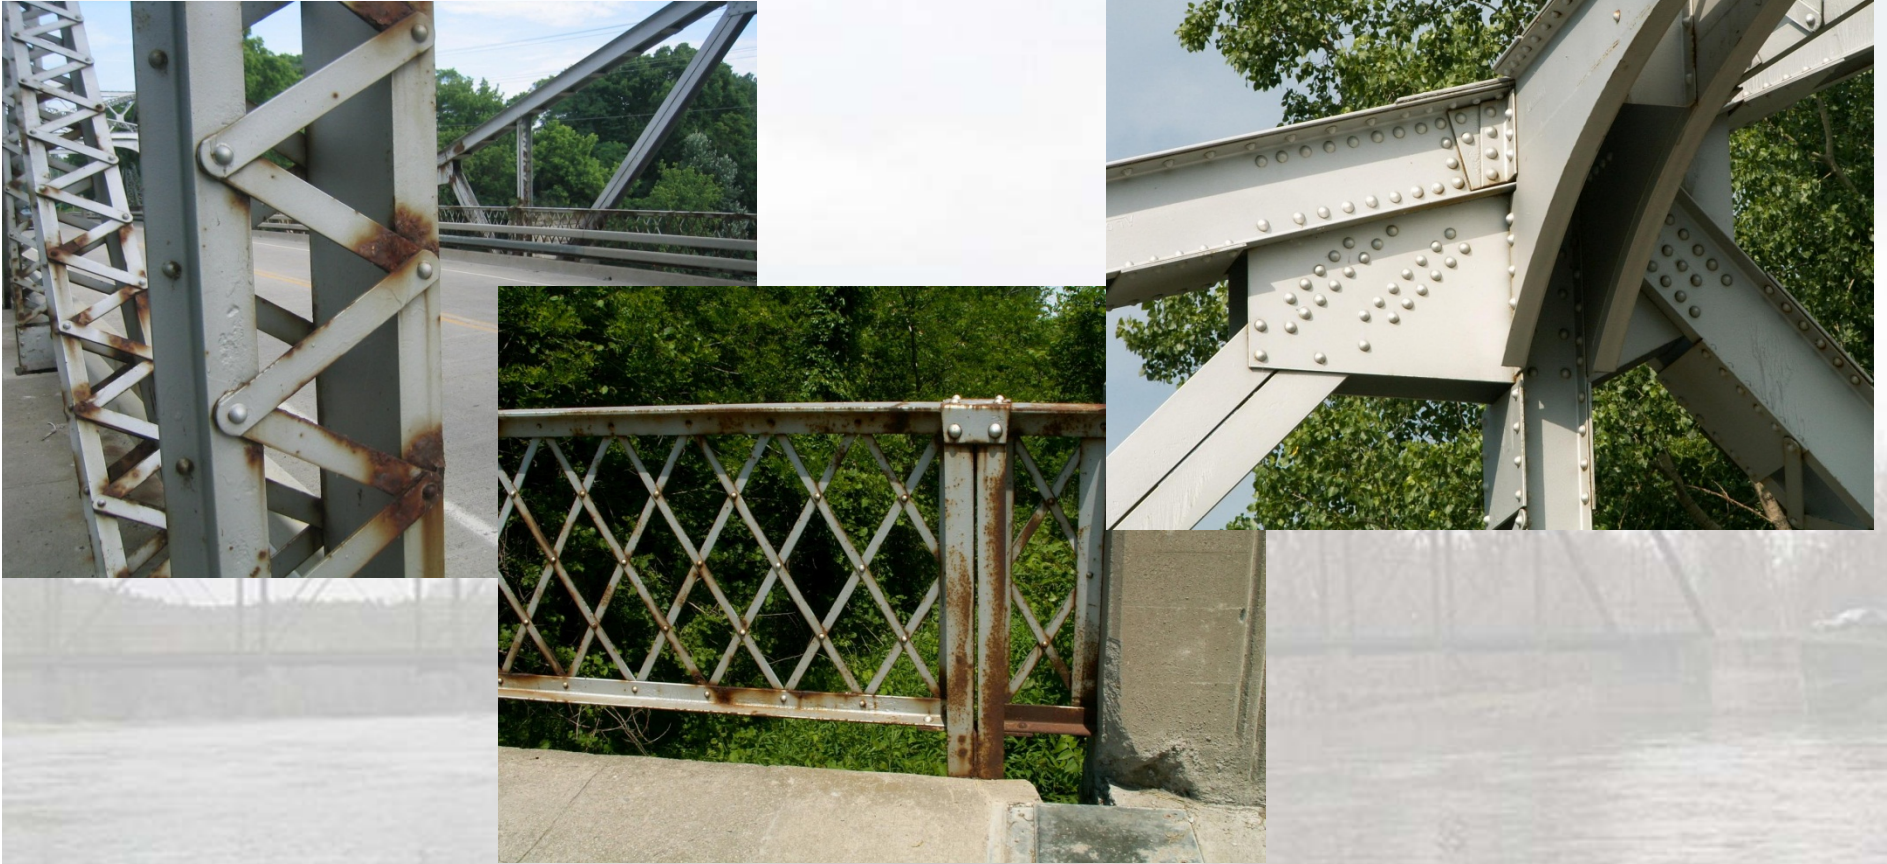
The Thamesville Bridge's trusses appear to be largely unaltered, retaining original design and materials. This adds to the heritage significance of the bridge.

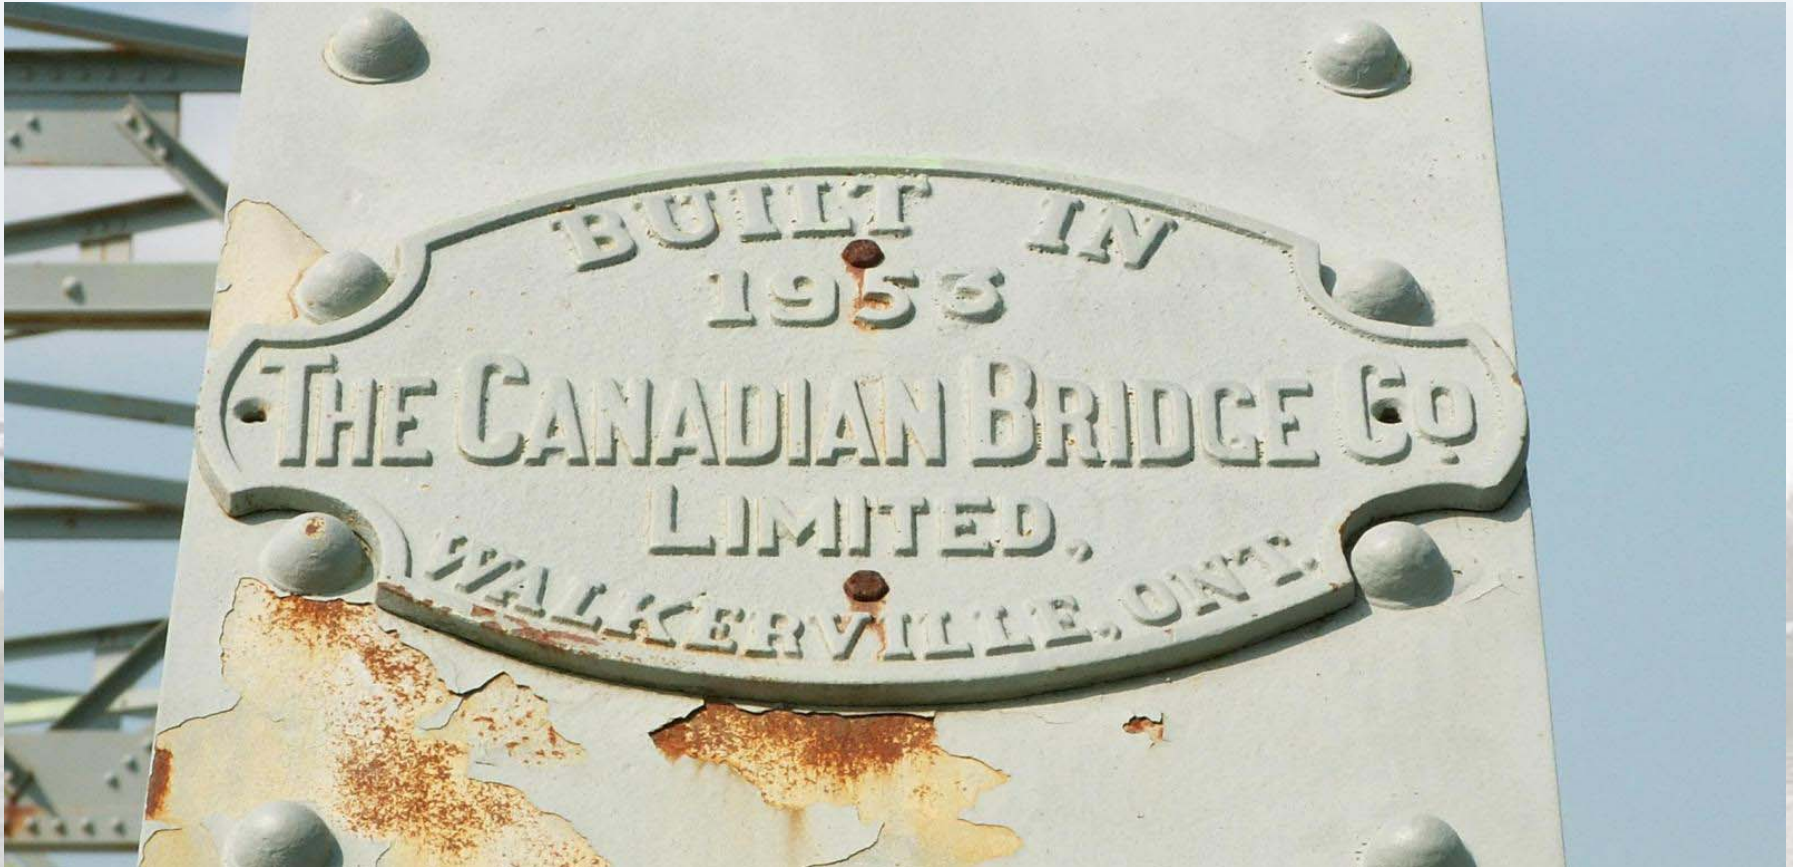
An intact end post plaque on another bridge built by the Canadian Bridge Company suggests what the Thamesville Bridge end post plaque might have looked like.

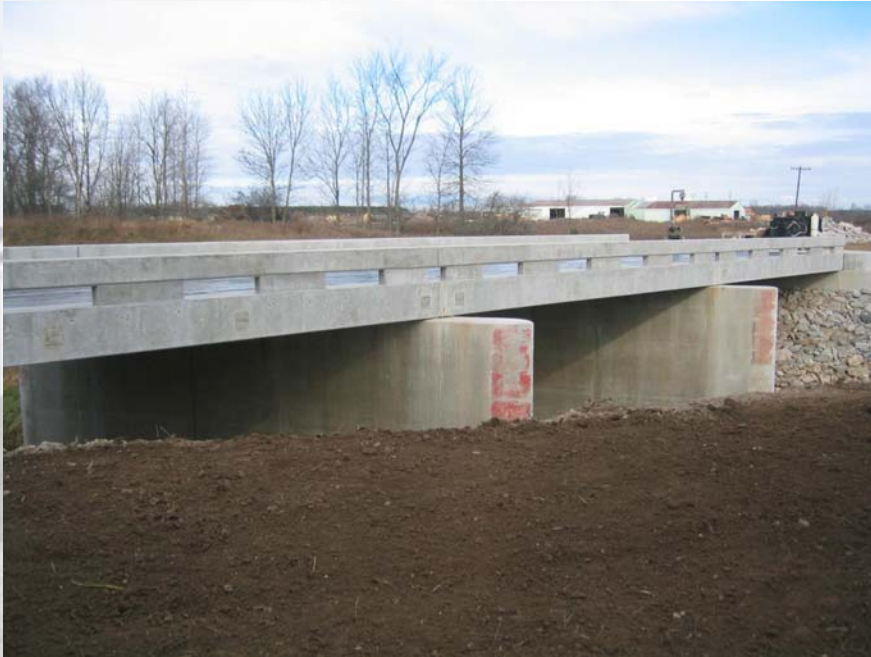
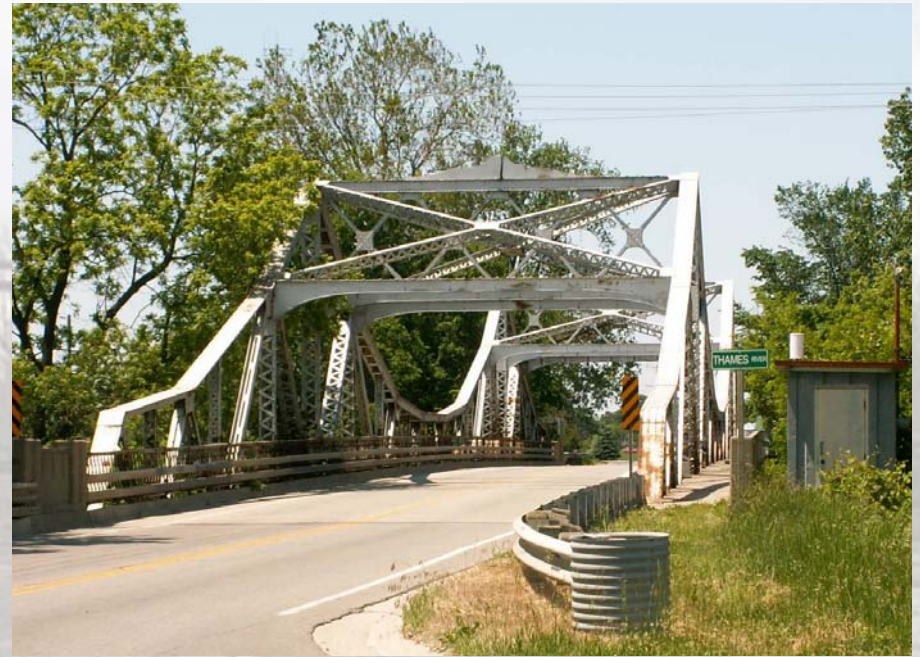
Thamesville Bridge has a more intricate and detailed design than modern bridges. These details both reveal the work of craftsmen and offer aesthetic qualities as well.

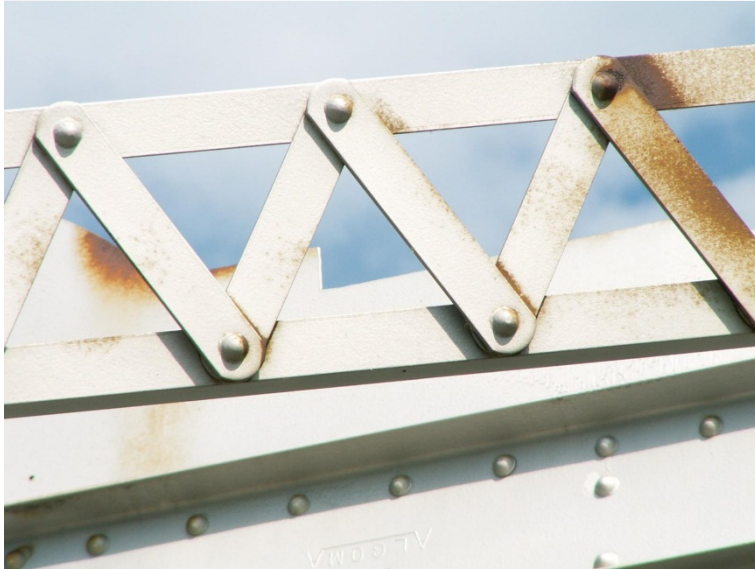
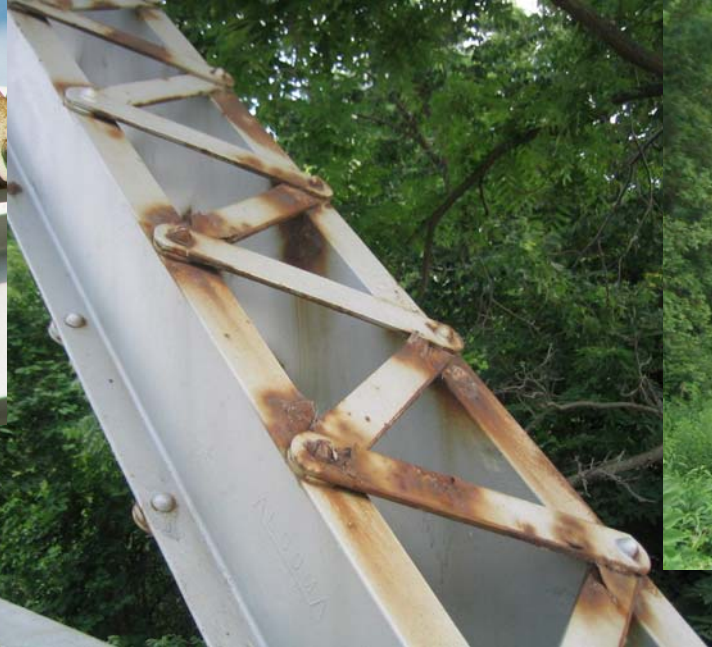
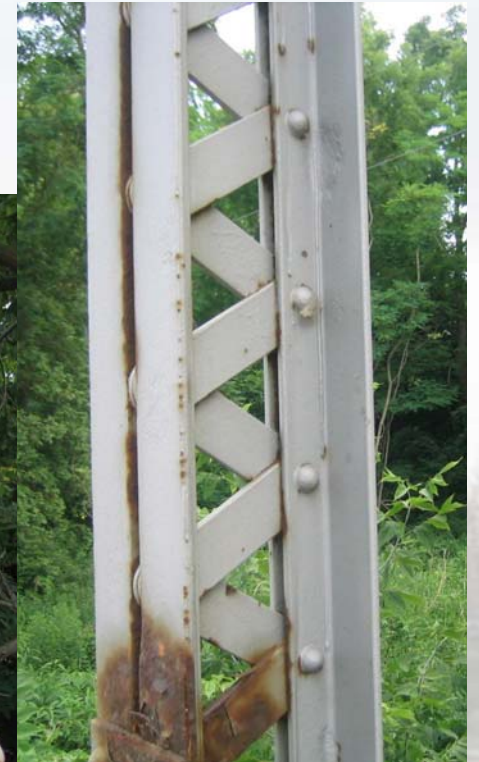
Unlike modern bridges, this bridge's trusses are carefully "built up" from smaller parts like angles, channels, and v-lacing. All are held together by many rivets.

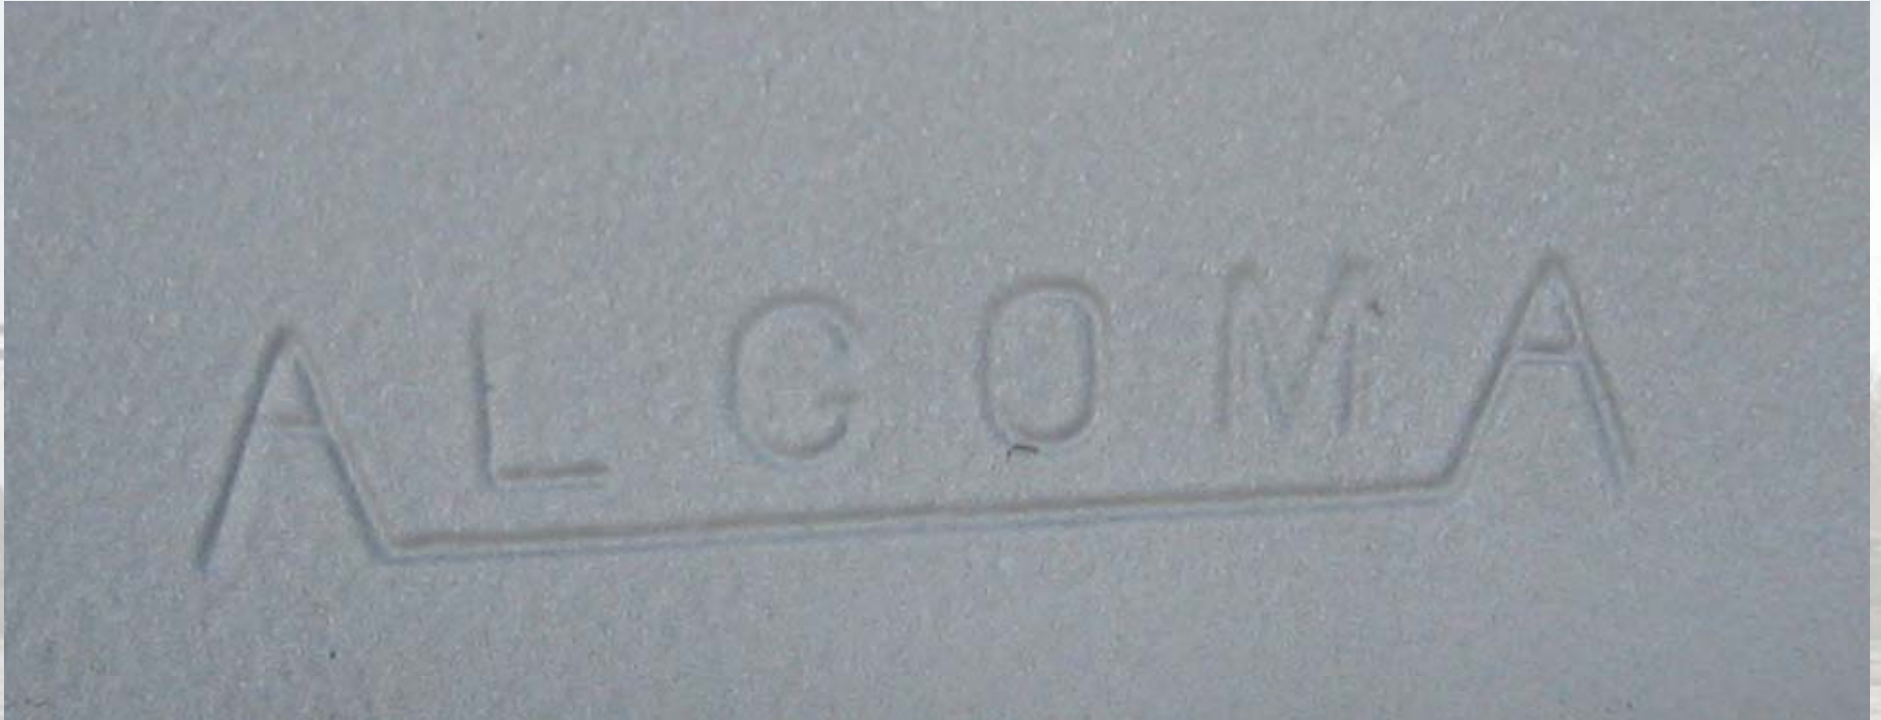
Steel mill “brands” on the bridge indicate that at least some of the steel came from Algoma, a Canadian steel company.

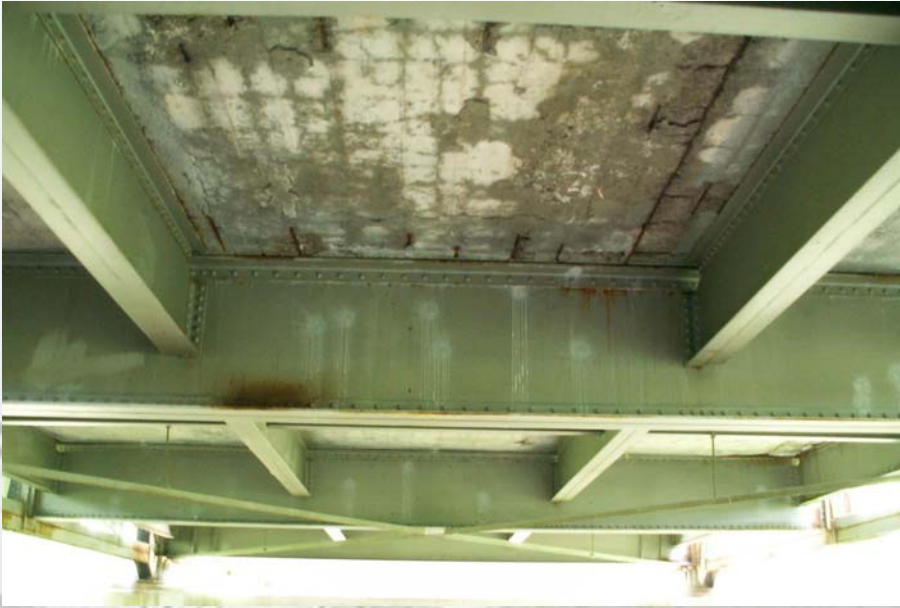
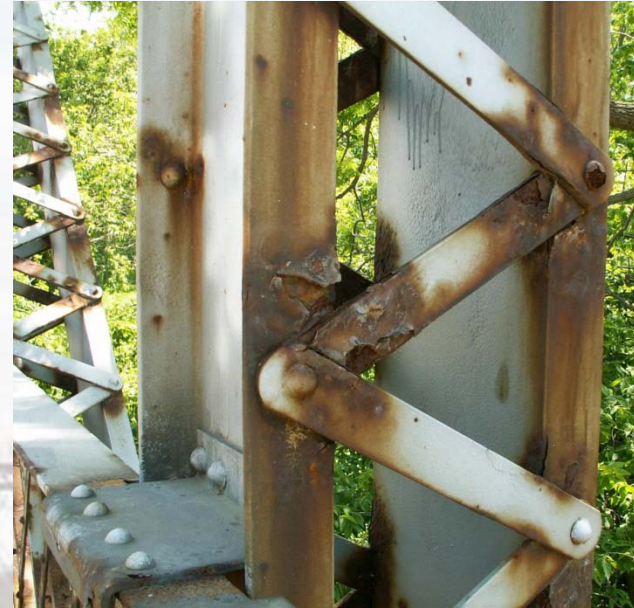
Possible Rehabilitation Overview

- Repairs to abutments and piers.
- Repairs and selective replacement of truss members and rivets.
- New deck (floor beams / deck stringers too?)
 - Blast clean and repaint trusses

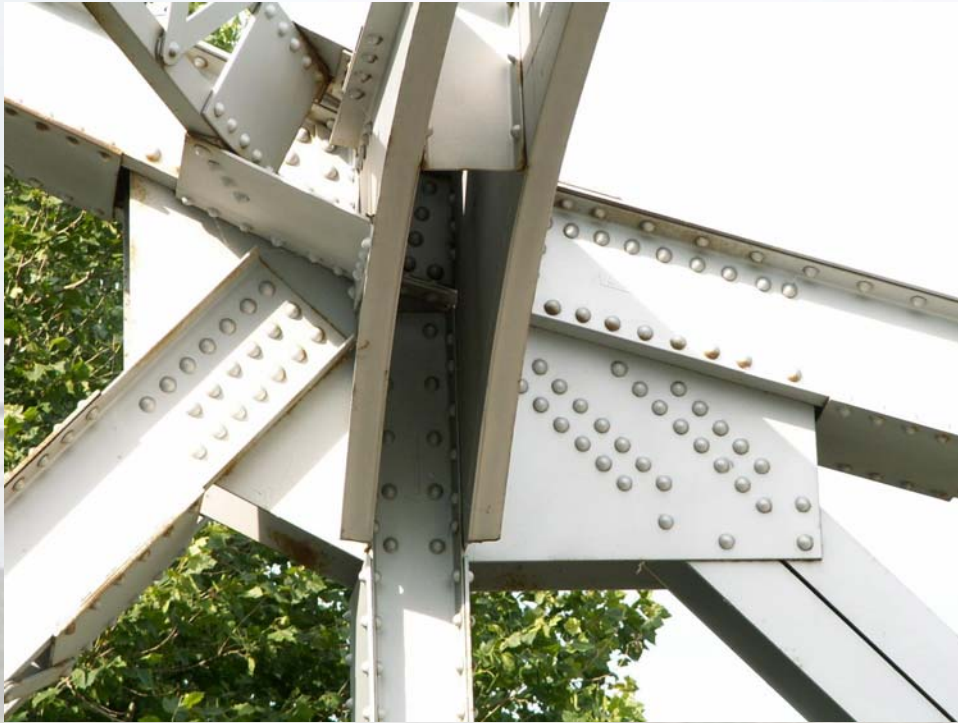
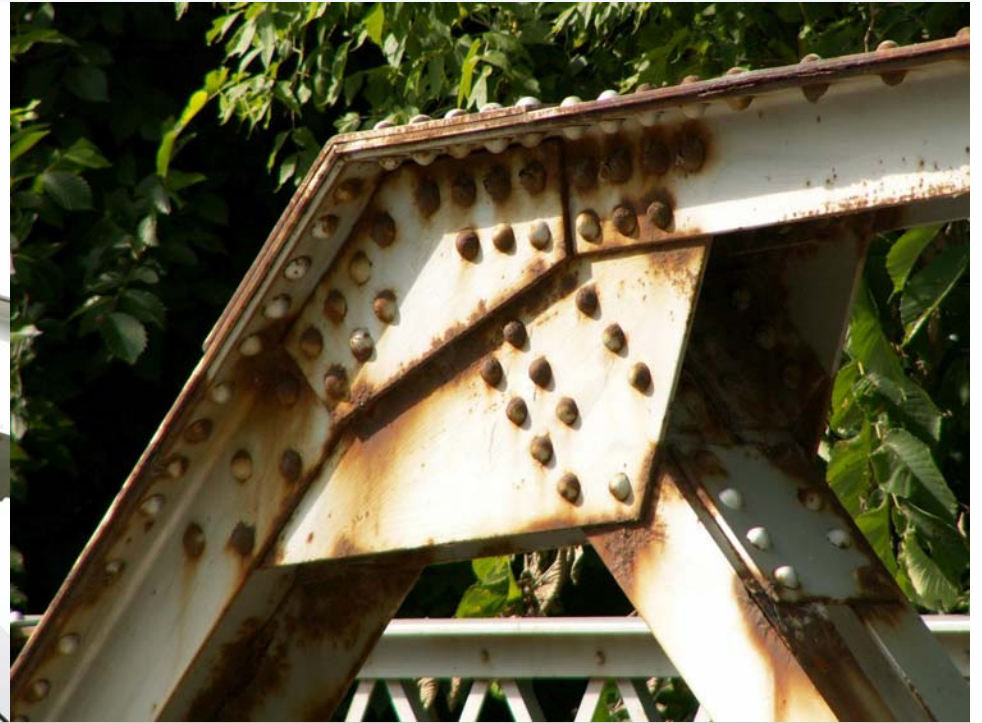
Like the majority of heritage truss bridges, deterioration is worse in areas that are exposed to water and salt. Lower portions of the truss are far more deteriorated than the upper parts.

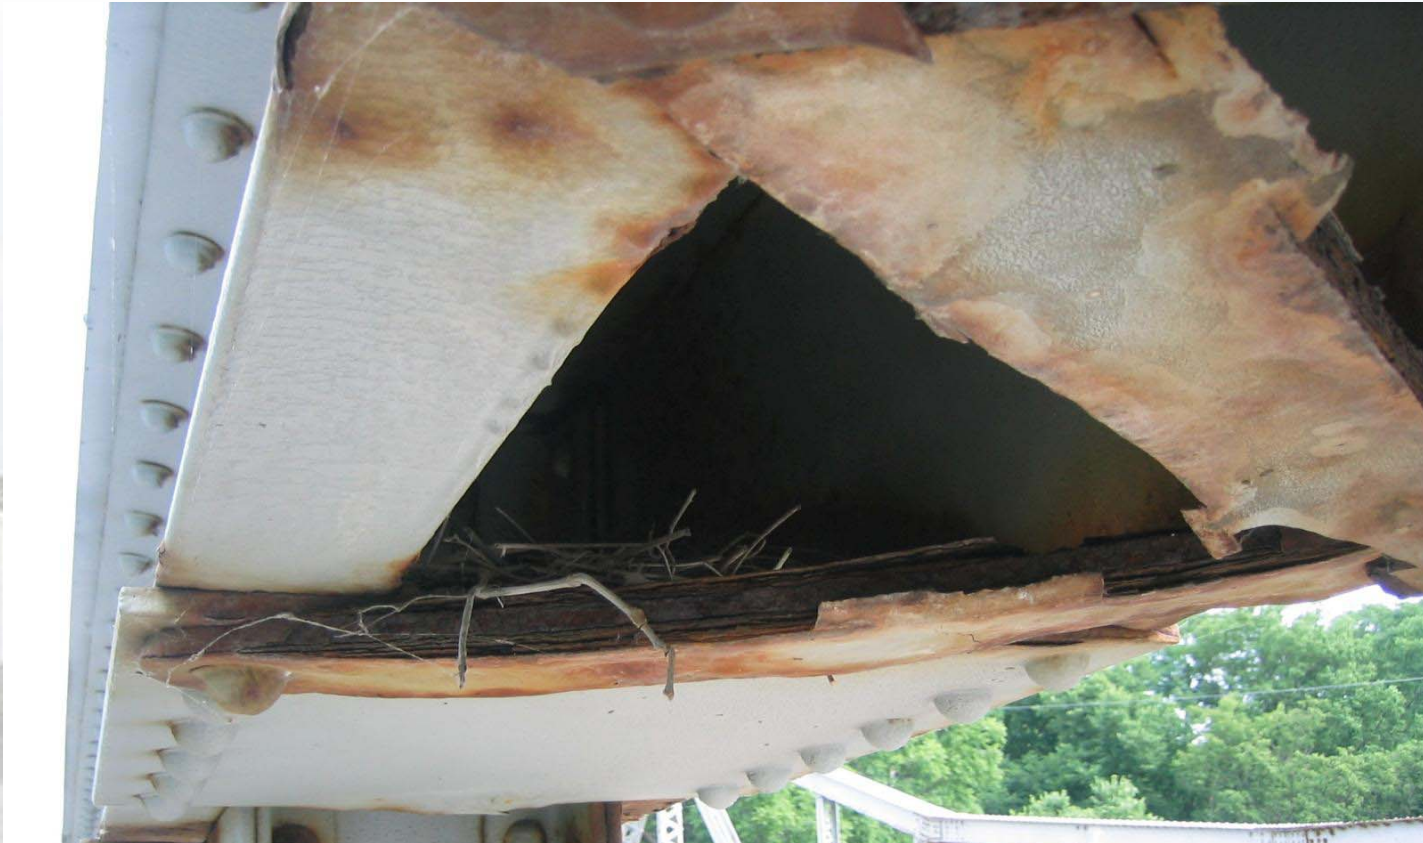
It may not be necessary to replace an entire beam that has deterioration. Here, some lacing bars and plates are deteriorated and may need replacement, but the other parts of the beam might be possible to retain.

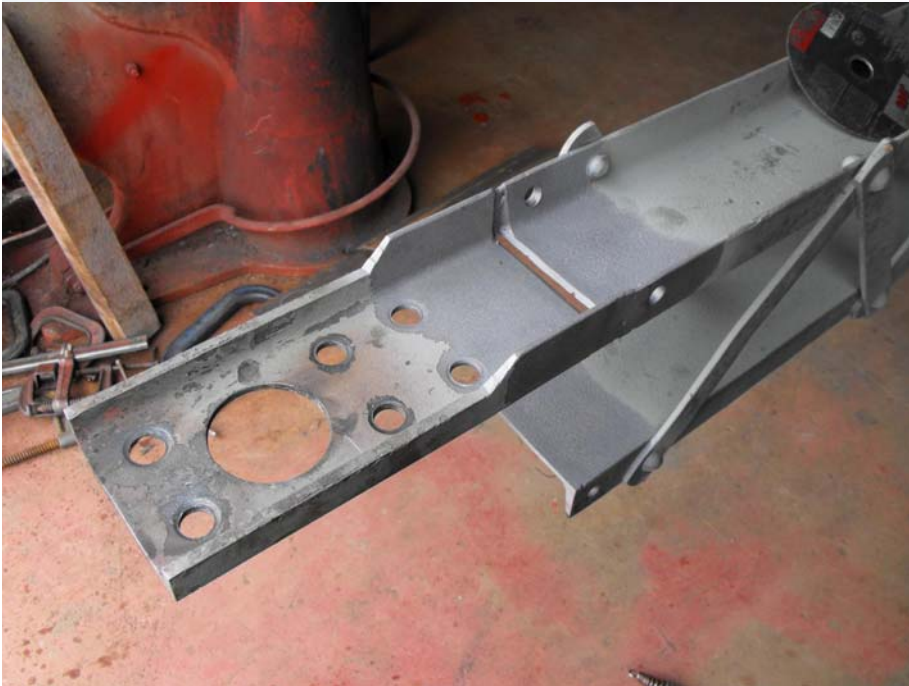
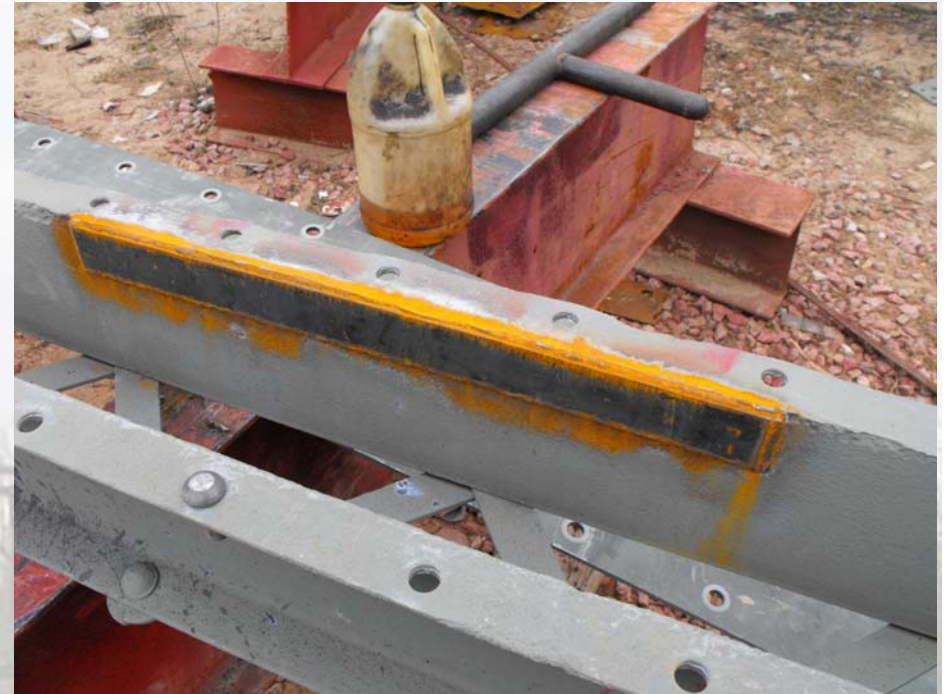
- If one section of a truss beam is deteriorated, that section can be replaced with a new section which is welded on.
- Plates or even welds can be applied to “patch” deteriorated areas.

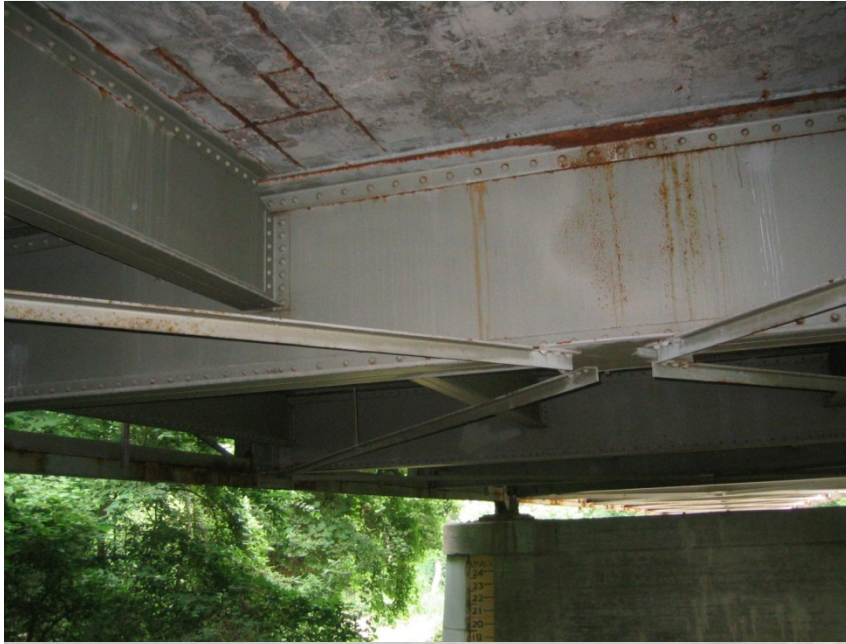
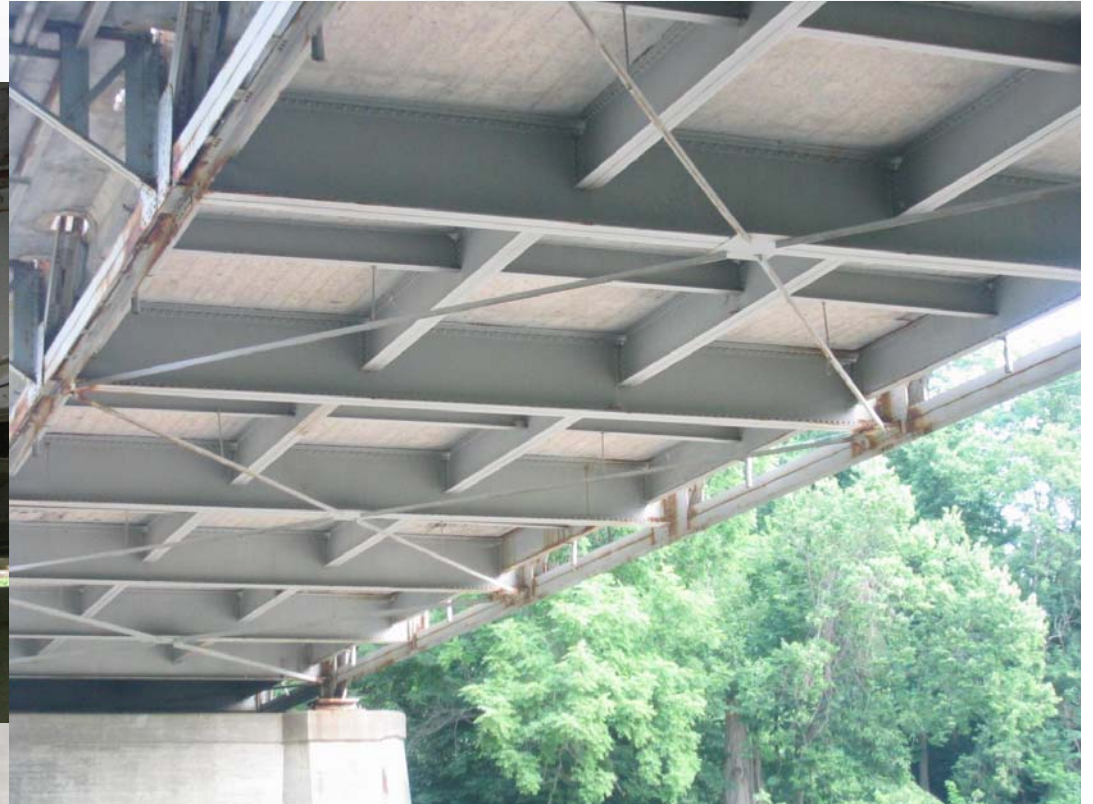
Original deck stringers and floor beams, typical trouble areas, are in surprisingly decent condition. Its not uncommon to replace these elements in rehabilitation, but is it really needed here?
