Thamesville Bridge

A Unique Heritage Truss Bridge

HistoricBridges.org

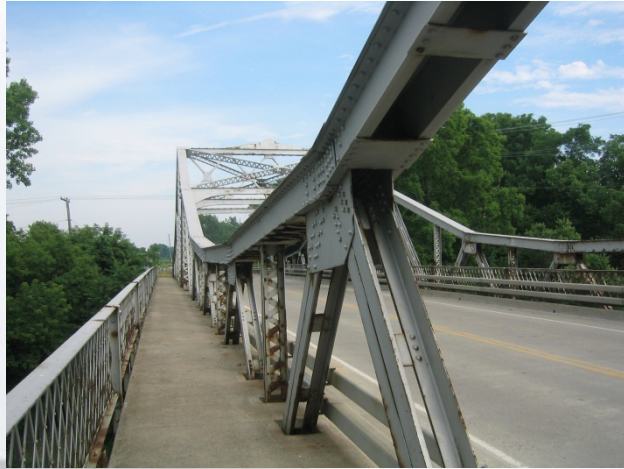
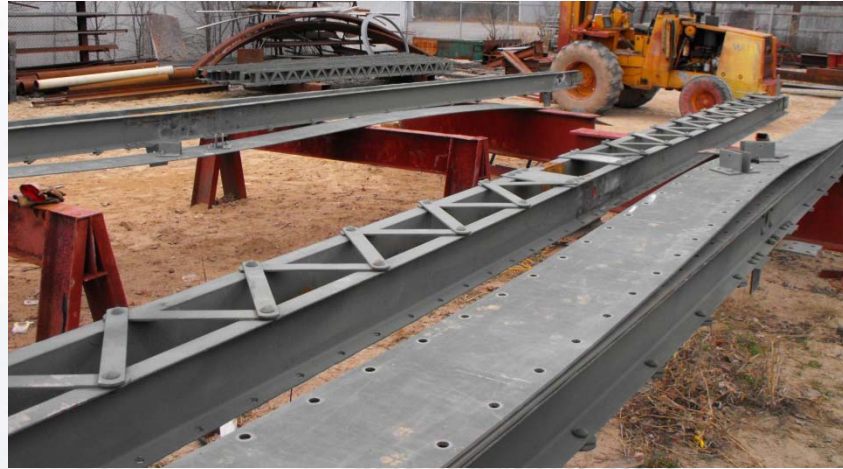
Possible Rehabilitation Challenges

Is any of the paint on the bridge lead based? If rehabilitated over the river, containment may be needed.

If rehabilitated over the river what falsework might be needed?

Alternatively, is bridge feasible to dismantle, and rehabilitate in a shop despite its size and design?

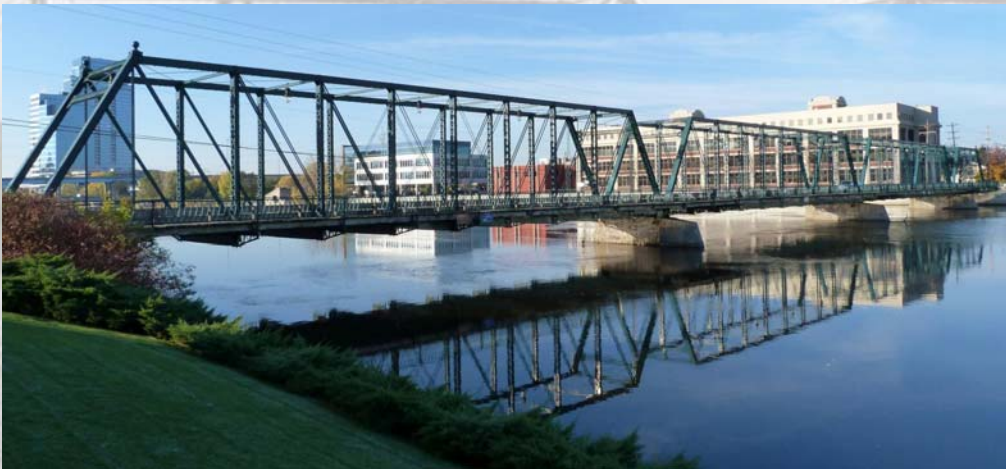
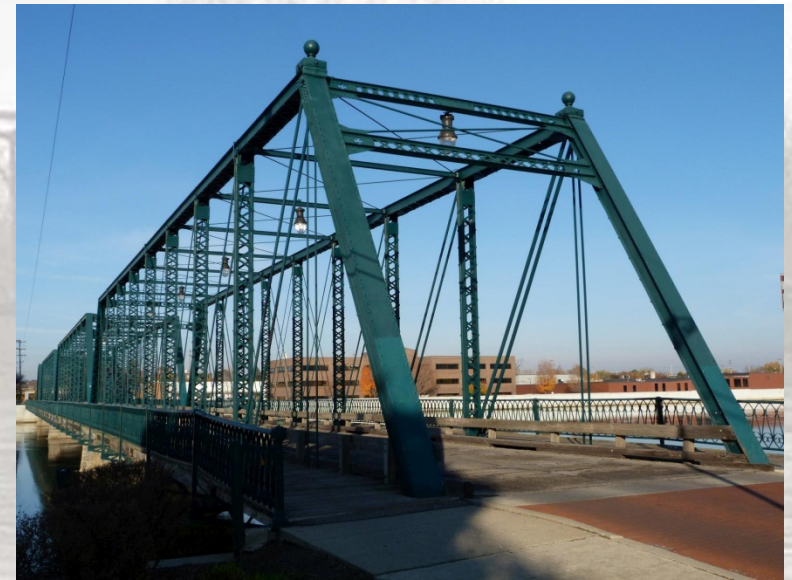
Case Study: 6th Street Bridge

The 6th Street Bridge in Grand Rapids, Michigan is a bridge that has been well maintained. It is much older and more lightweight than the Thamesville Bridge.

Built: 1886

Length: 544.7 Feet (166 Meters)

Roadway Width: 18 Feet (5.5 Meters)

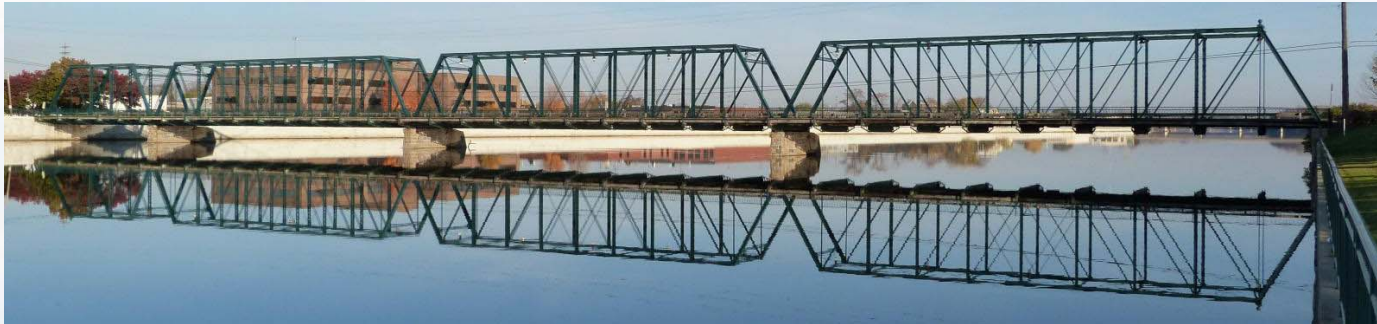
Case Study: 6th Street Bridge

1979 Rehabilitation To Repair Substructure and Superstructure, and Blast Clean and Repaint: \$585,570.

2002 Repainting Project: Full Blast Clean and Paint: \$823,000

2012 Rehabilitation To Replace Deck, Spot Paint, and Repair Superstructure and Substructure: \$2.2 Million

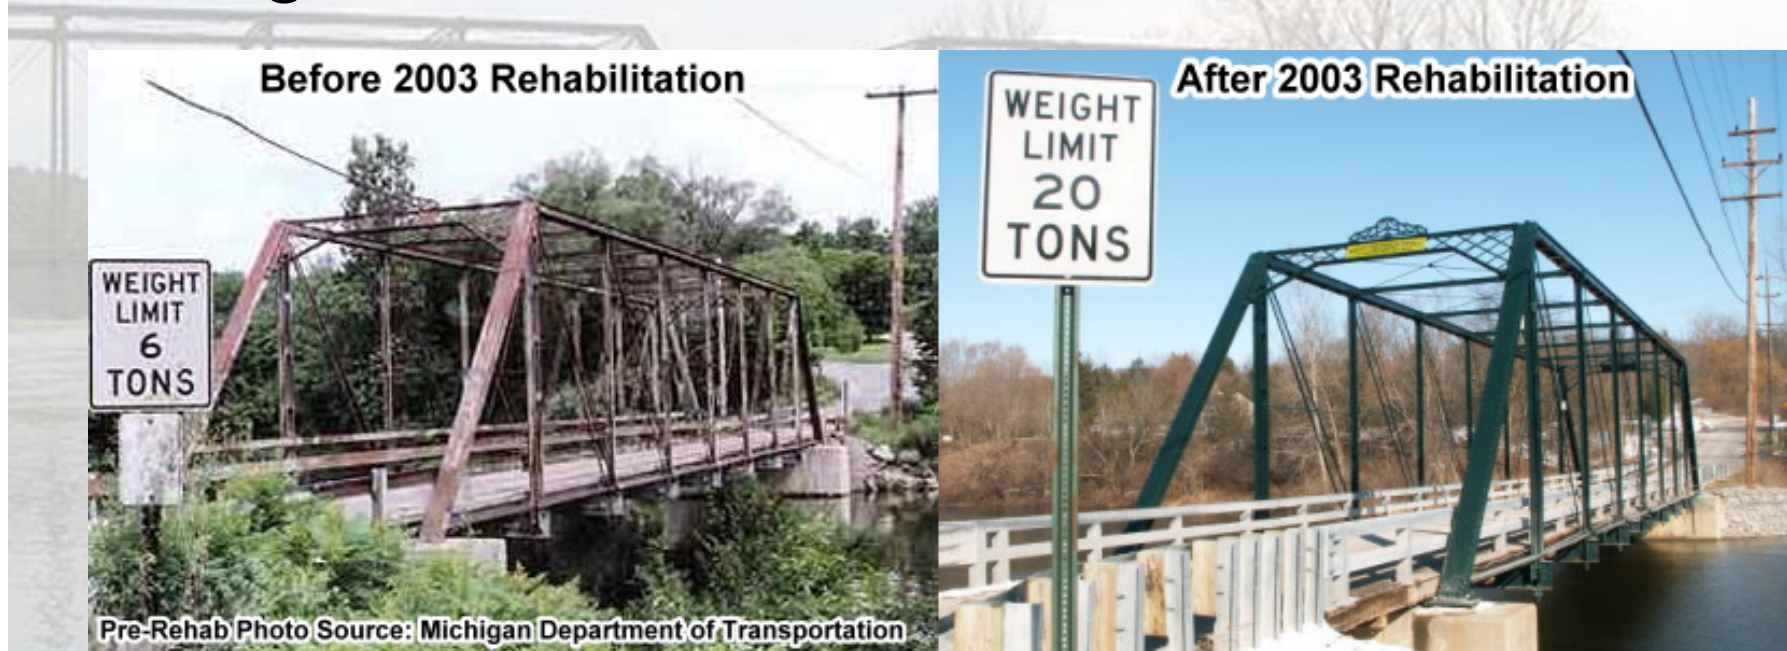
Maple Road Bridge, Ann Arbor, Michigan

2003 Rehabilitation: Cost: \$525,000

Weight limit increased from 6 tons to 20 tons.

Demolition and Replacement cost estimates started at \$1 Million and went up to \$4 Million.

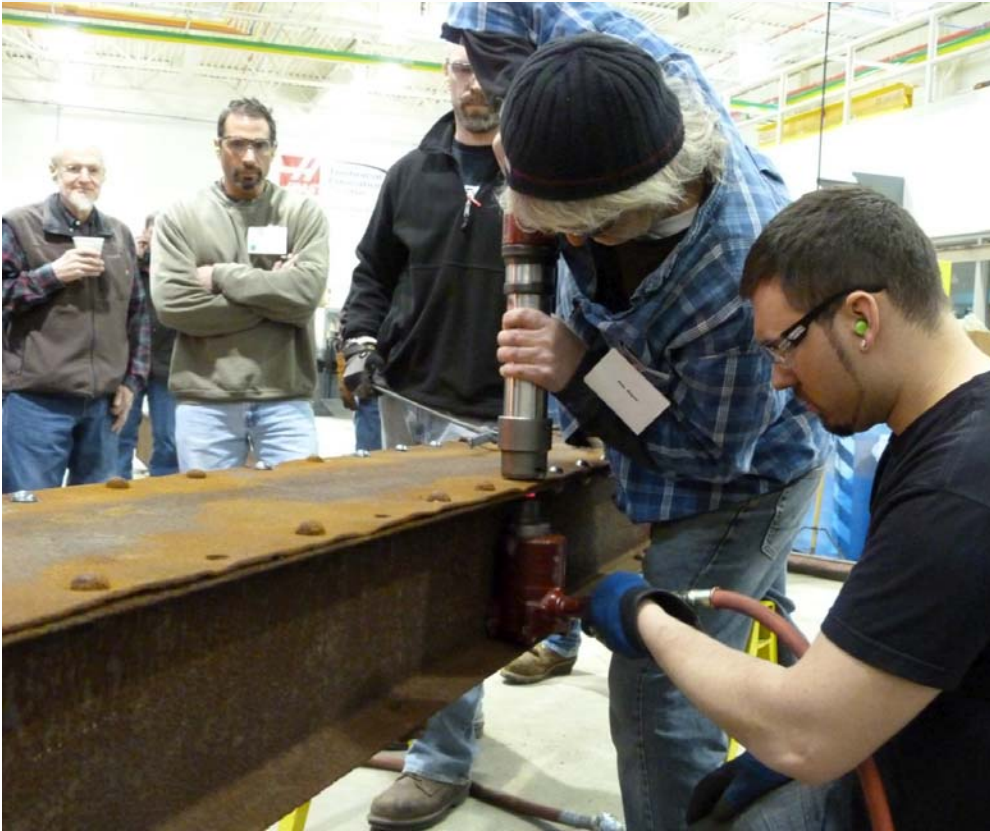
Many engineers think that failed rivets must be replaced with modern bolts. This is not true. Riveting is not a “lost art.” It is not costly or time consuming to do, and replacing rivets with rivets maintains the original design of the bridge.

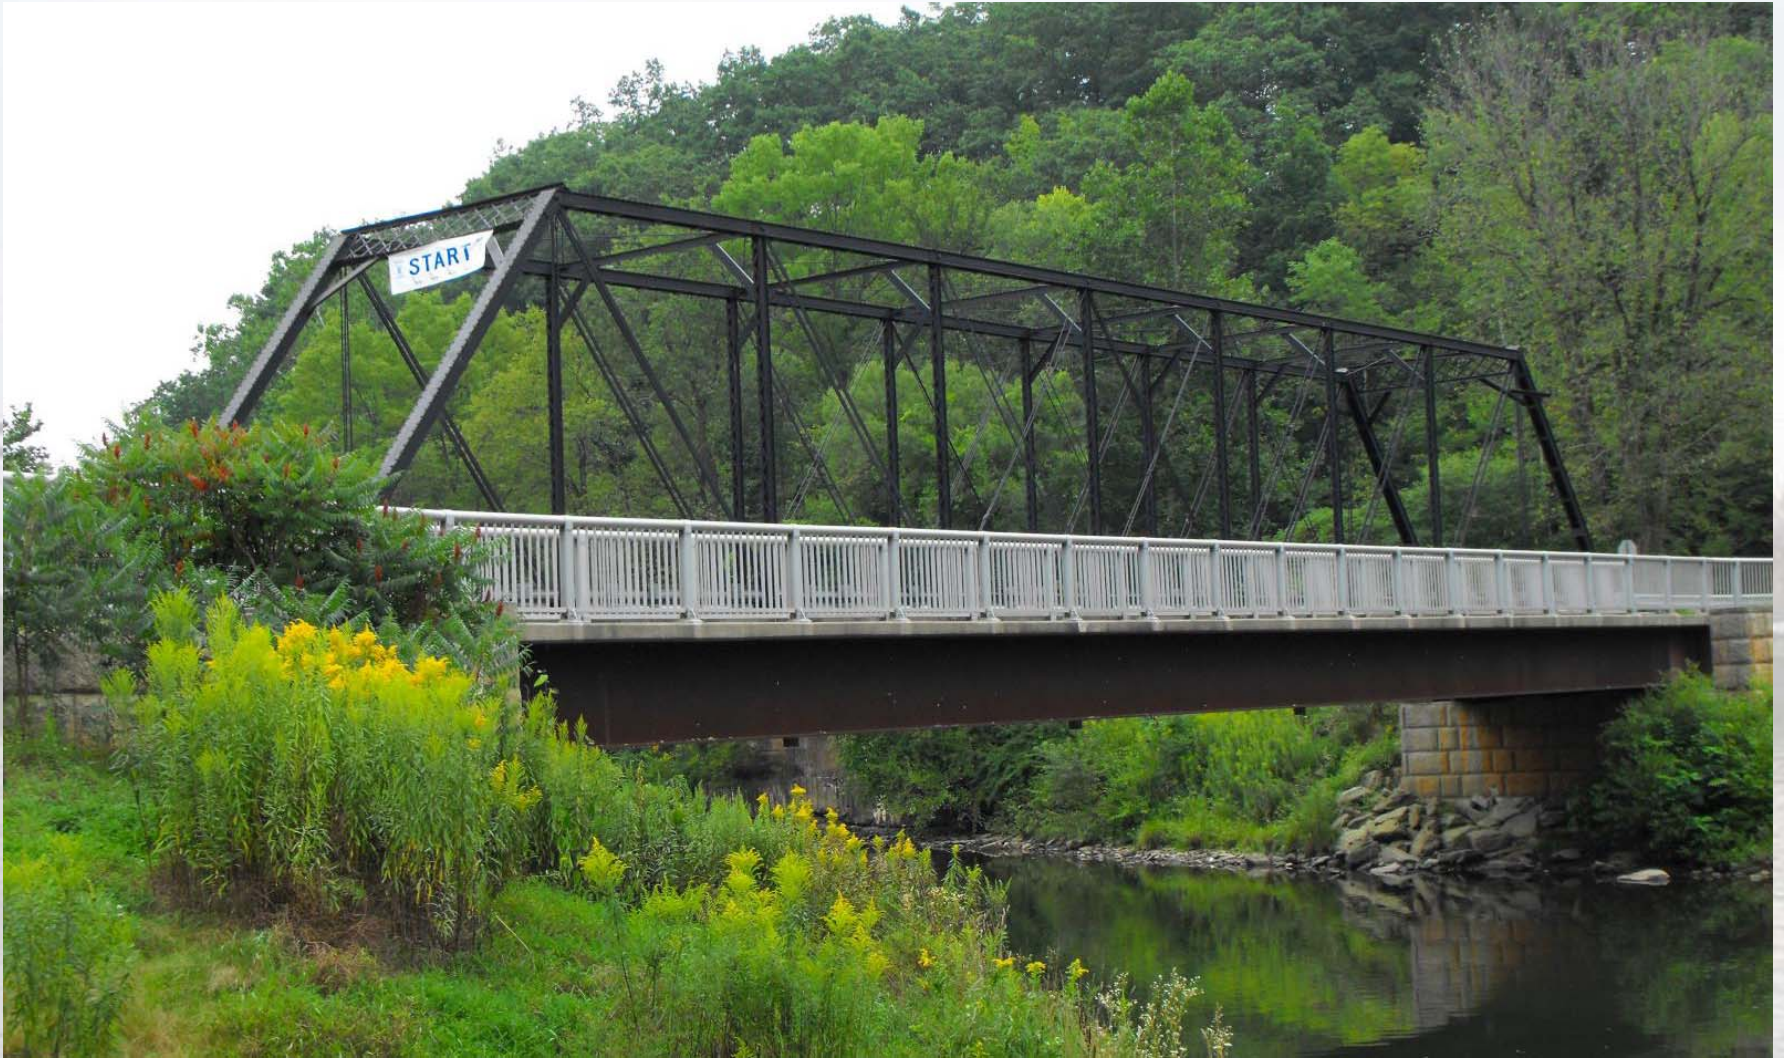
An independent load-bearing system could be installed under the bridge.

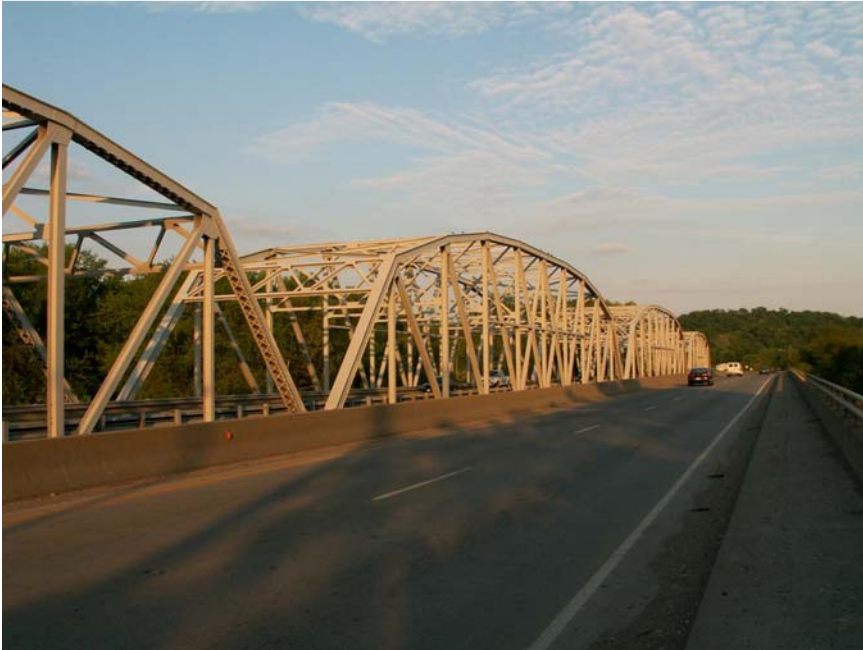
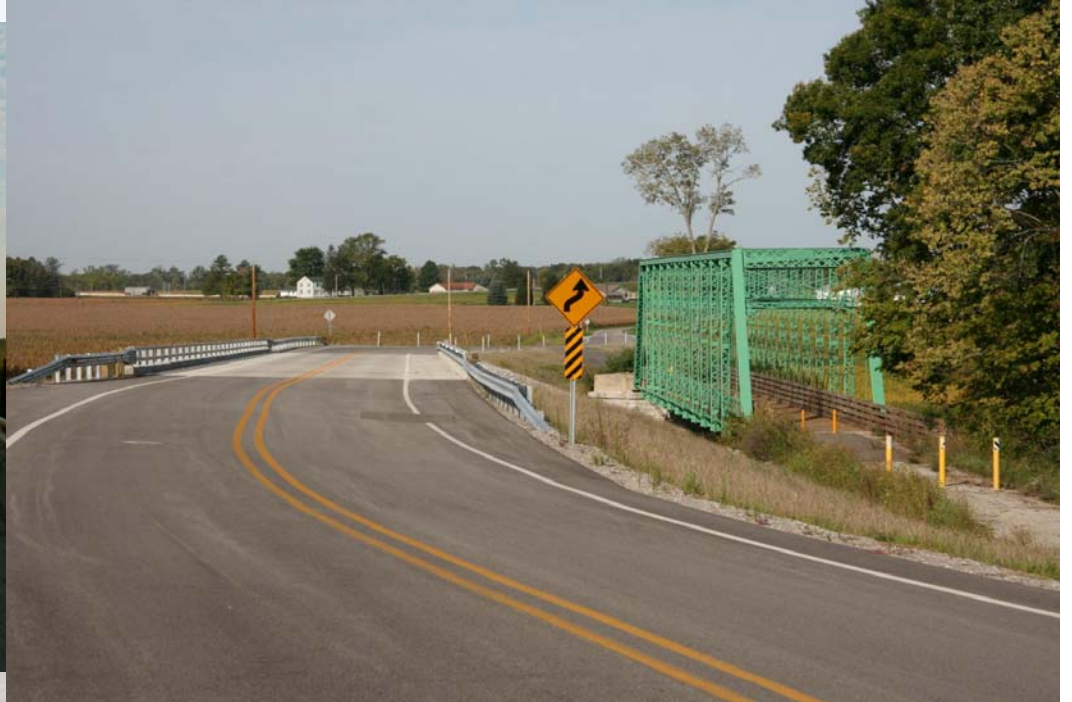
Build a new bridge beside the heritage bridge to either form a one-way couplet, or leave heritage bridge in place for pedestrians only.
