Preservation: Why Not In Pennsylvania?

Presented By: Nathan Holth

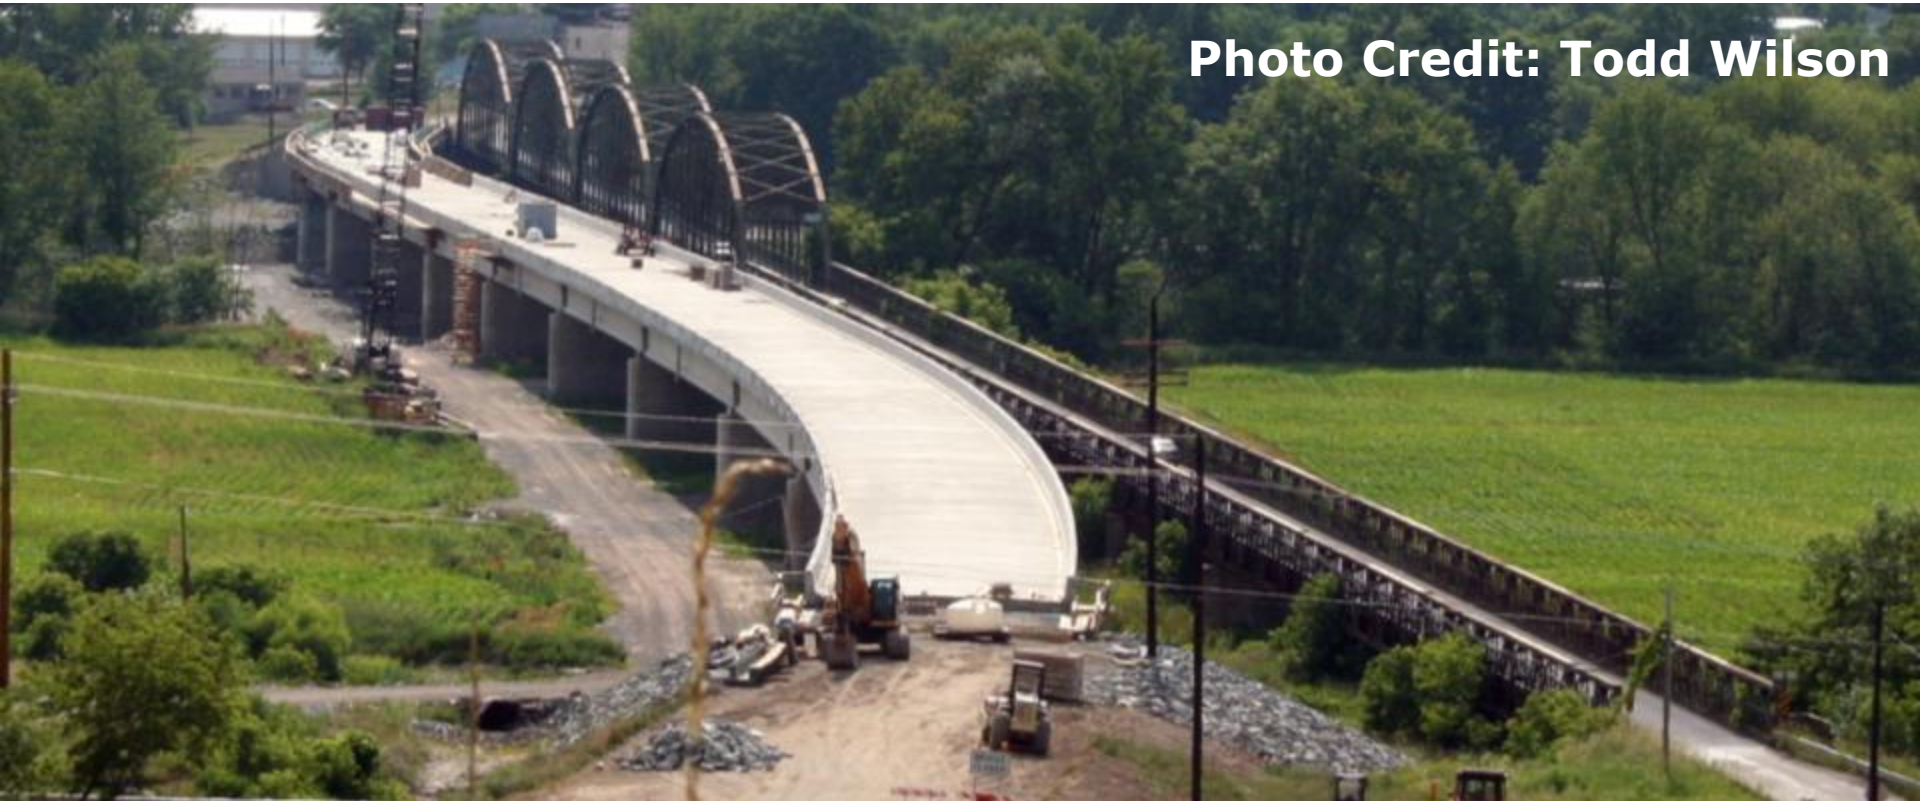
Demolition Next To Replacement

The majority of historic truss bridge replacement projects in Pennsylvania build the new bridge next to the replacement. The historic bridge is then demolished, even though it is not in the way of the replacement.

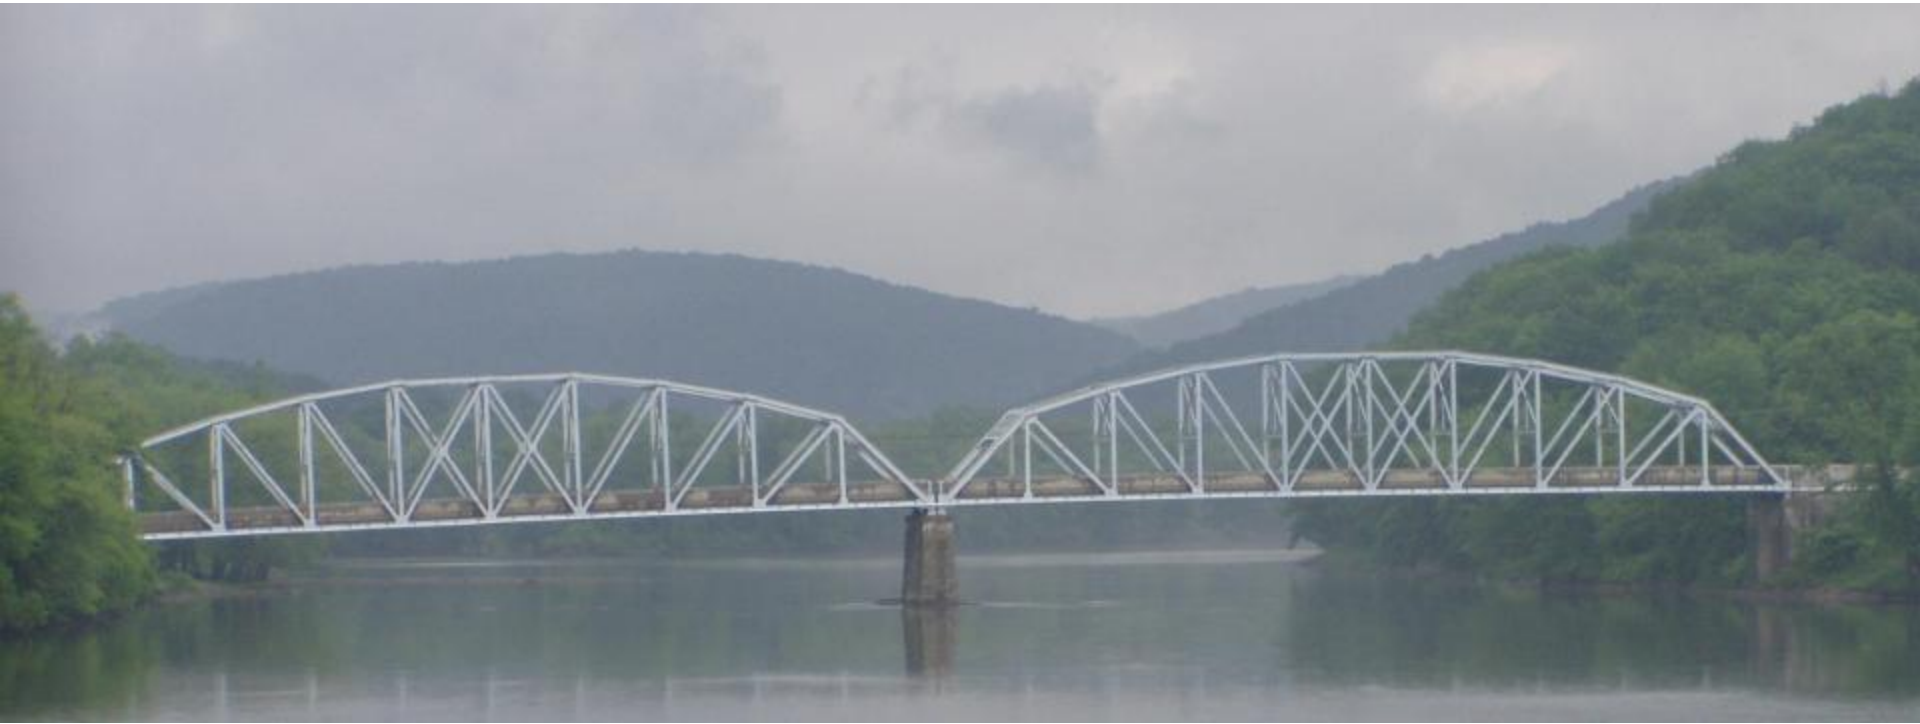
State Standard Truss Bridges

Standard plan truss bridges built mostly in the 1930s in Pennsylvania were all evaluated as non-historic in the inventory. These beautiful and impressive bridges display fabrication techniques and designs that stopped being used at least 40 years ago.

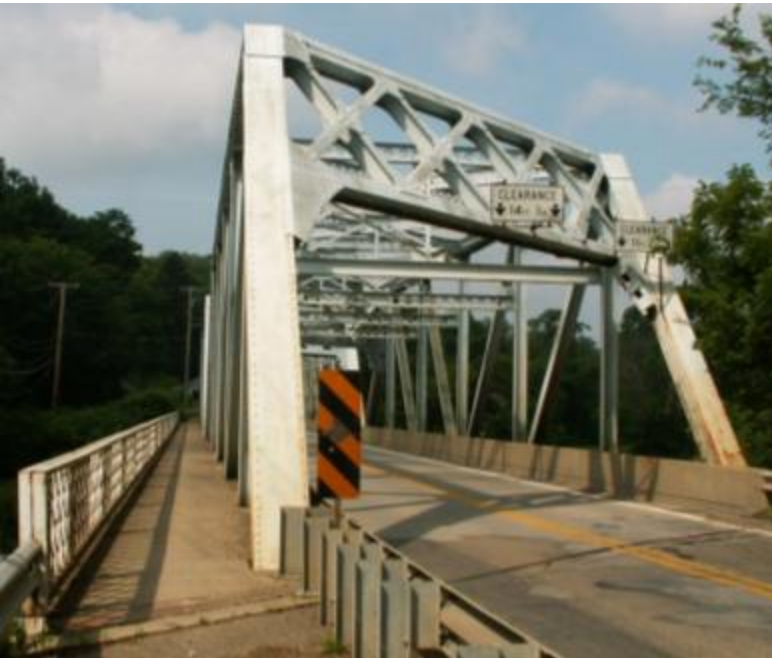
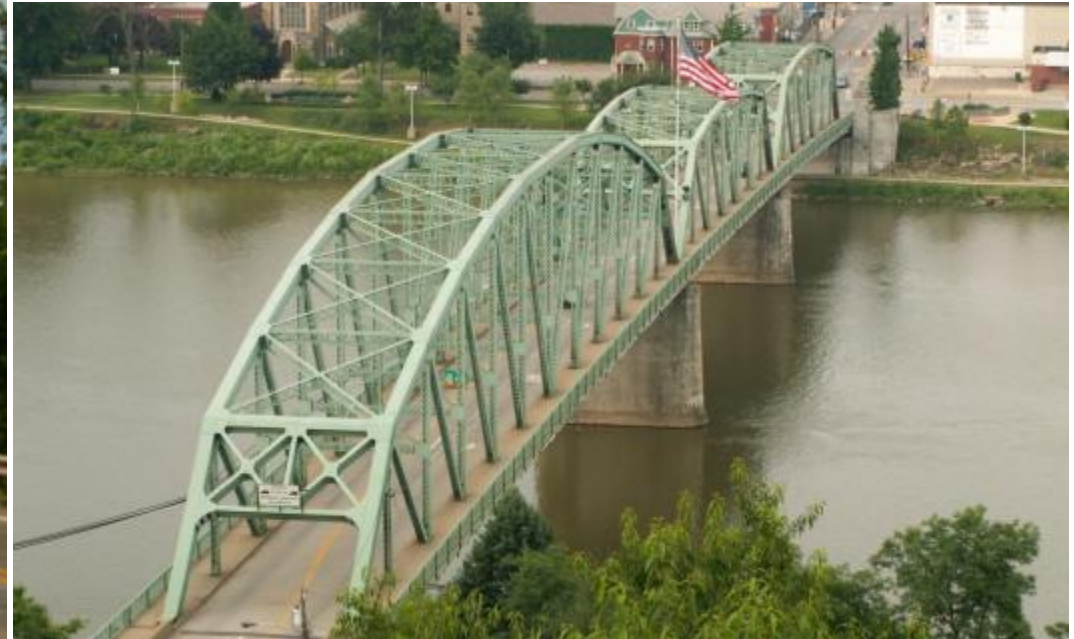
State Standard Truss Bridges

State standard bridges, like all old truss bridges, are disappearing rapidly and are worthy of historic status and preservation. They should be considered for historic preservation now when the best examples can be picked out from the bunch, instead of waiting until most are demolished, limiting preservation choices.

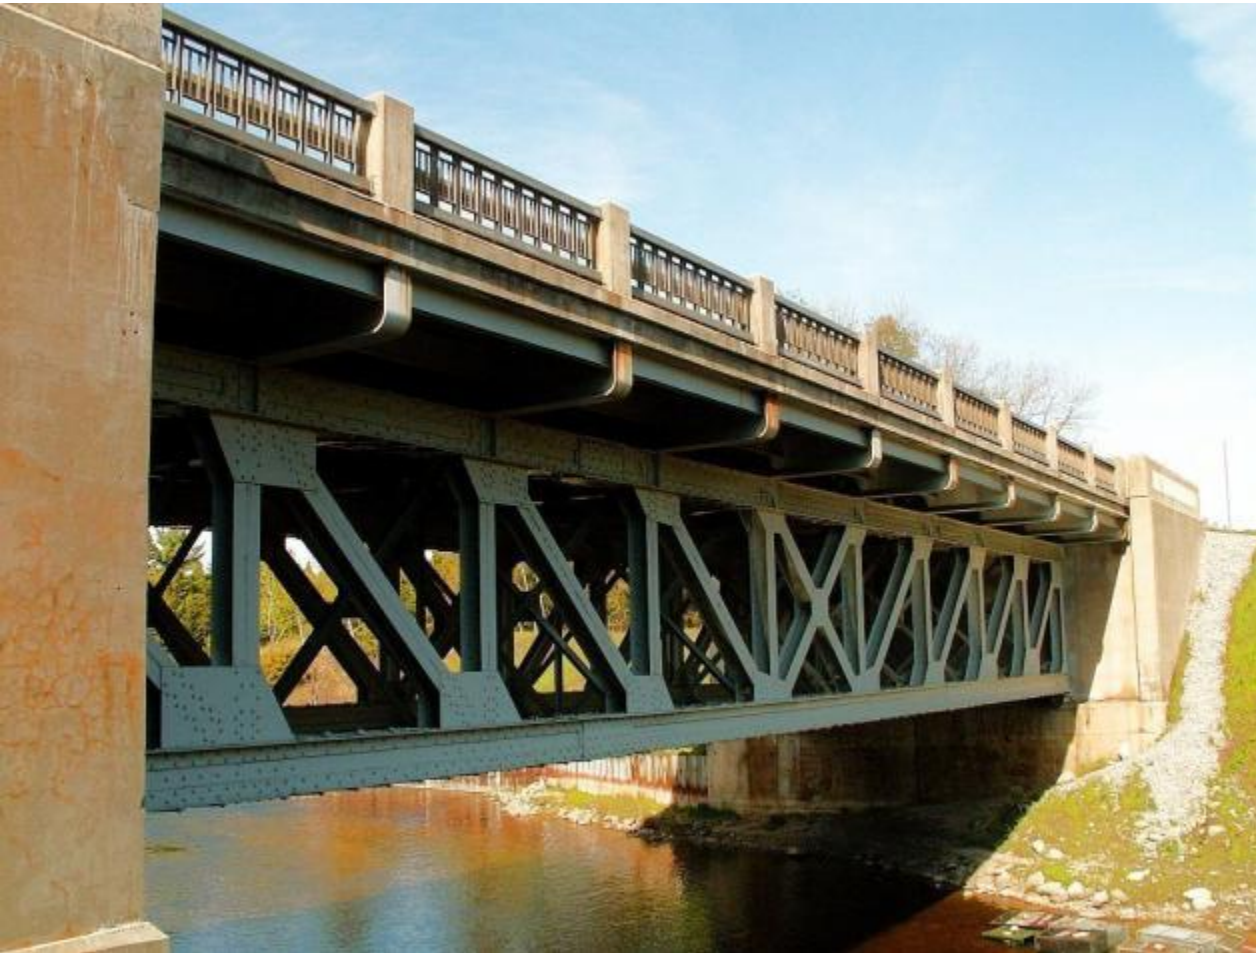
Continued Vehicular Use

This historic bridge was restored and continues to serve traffic on a primary highway, US-23 in northern Michigan. It is not posted for weight limits.

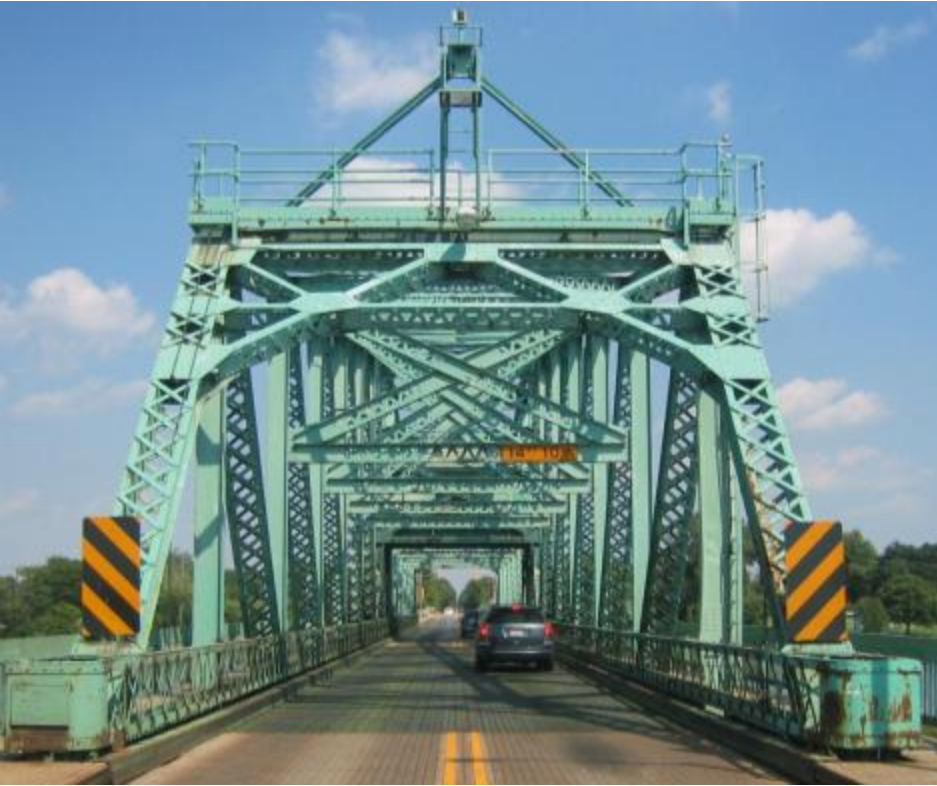
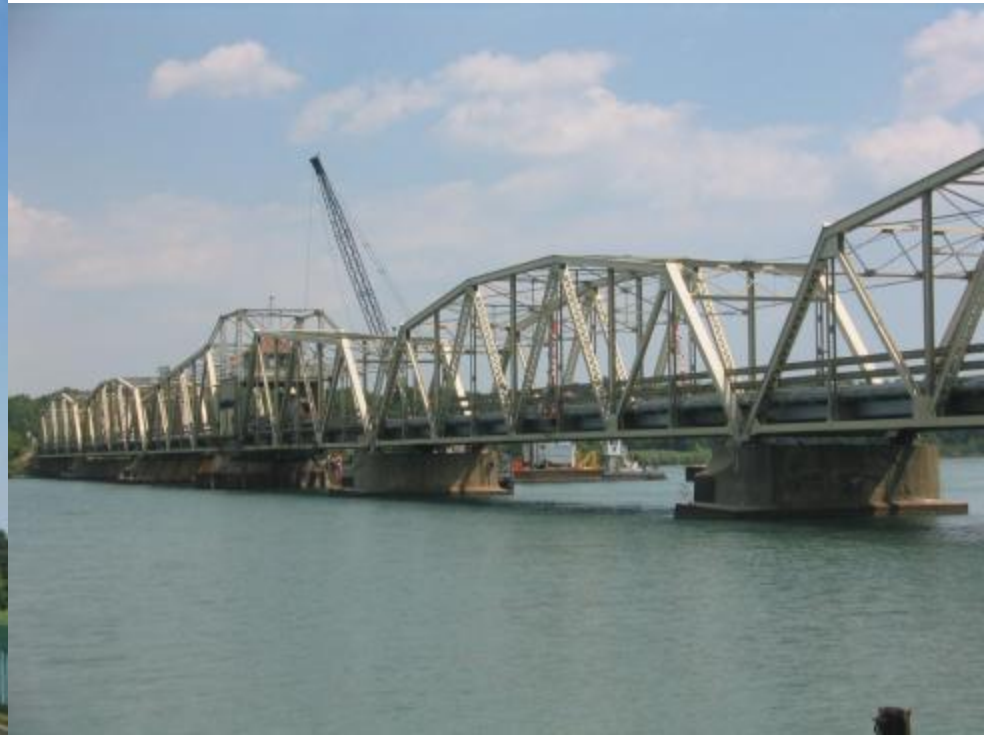
Grosse Ile

This island in the Detroit River is home to 10,894 people all of whom rely on the only two bridges to the island: both historic truss bridges, which have been carefully maintained for vehicular use.

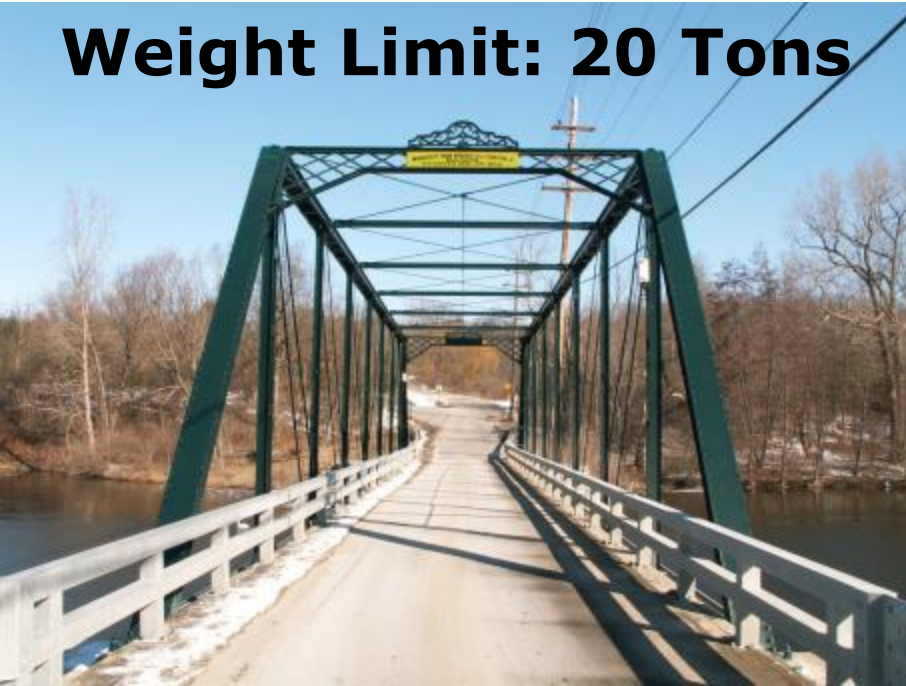
Weight Limit: 20 Tons

Full legal loading on a bridge is **NOT** always a requirement, especially for residential or rural bridges. Two pin-connected truss bridges in Washtenaw County were selected for rehabilitation preservation for continued posted vehicular use.

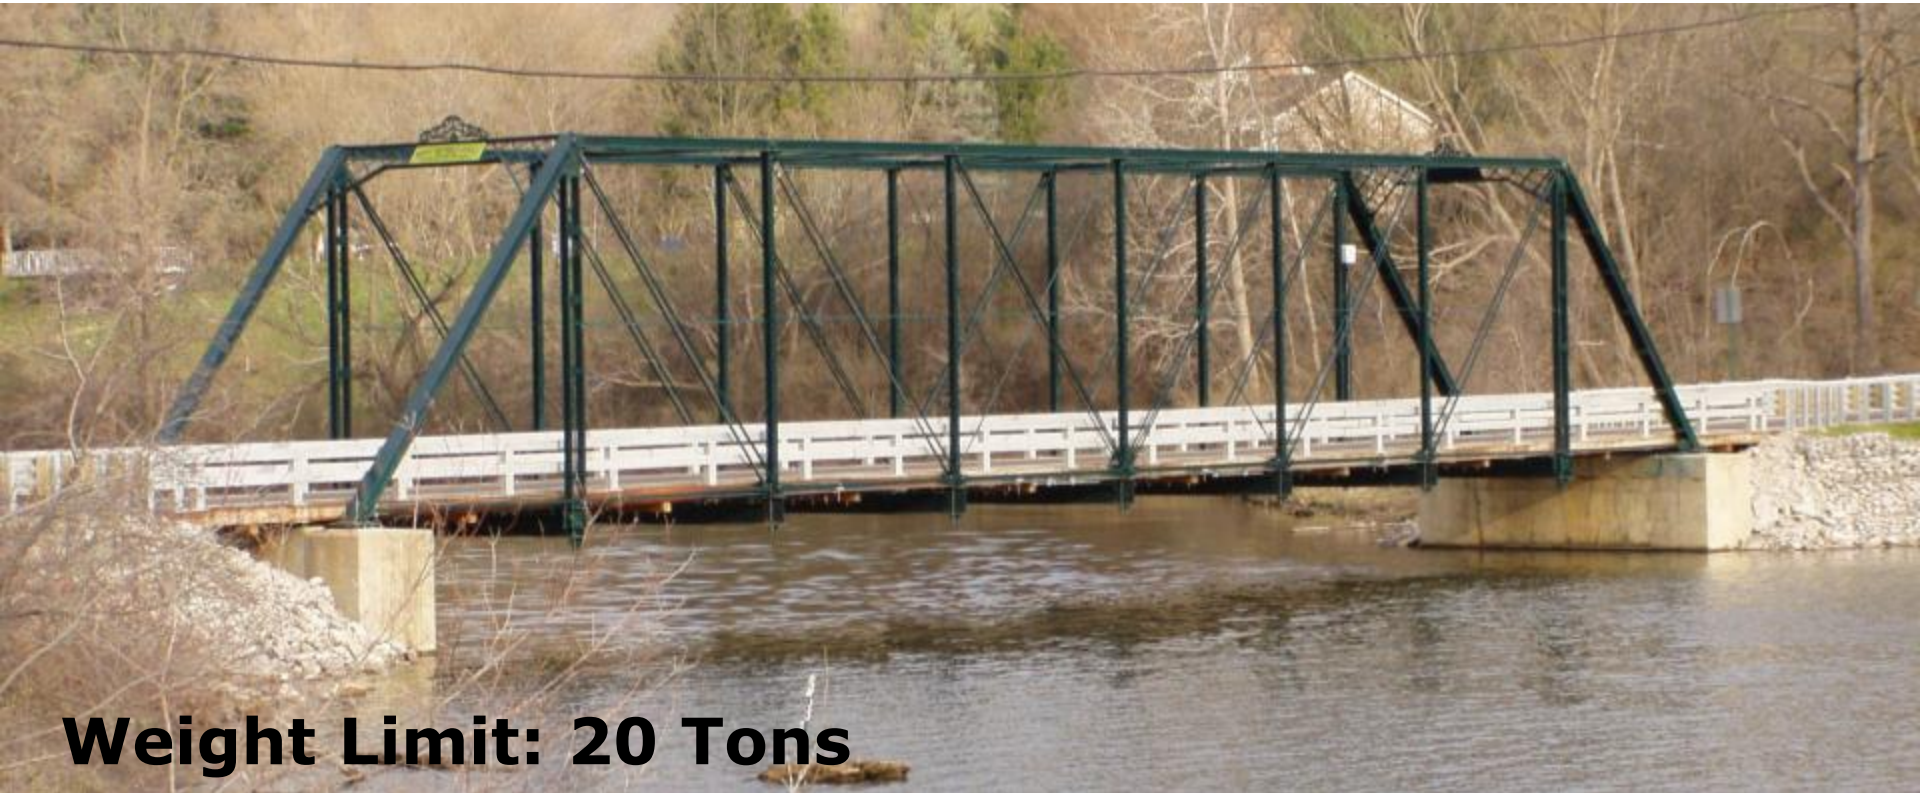
Washtenaw County

Rehabilitation of this bridge, the Maple Road Bridge near Ann Arbor, cost about \$500,000. Expected demolition/replacement cost had been estimated at \$1,000,000

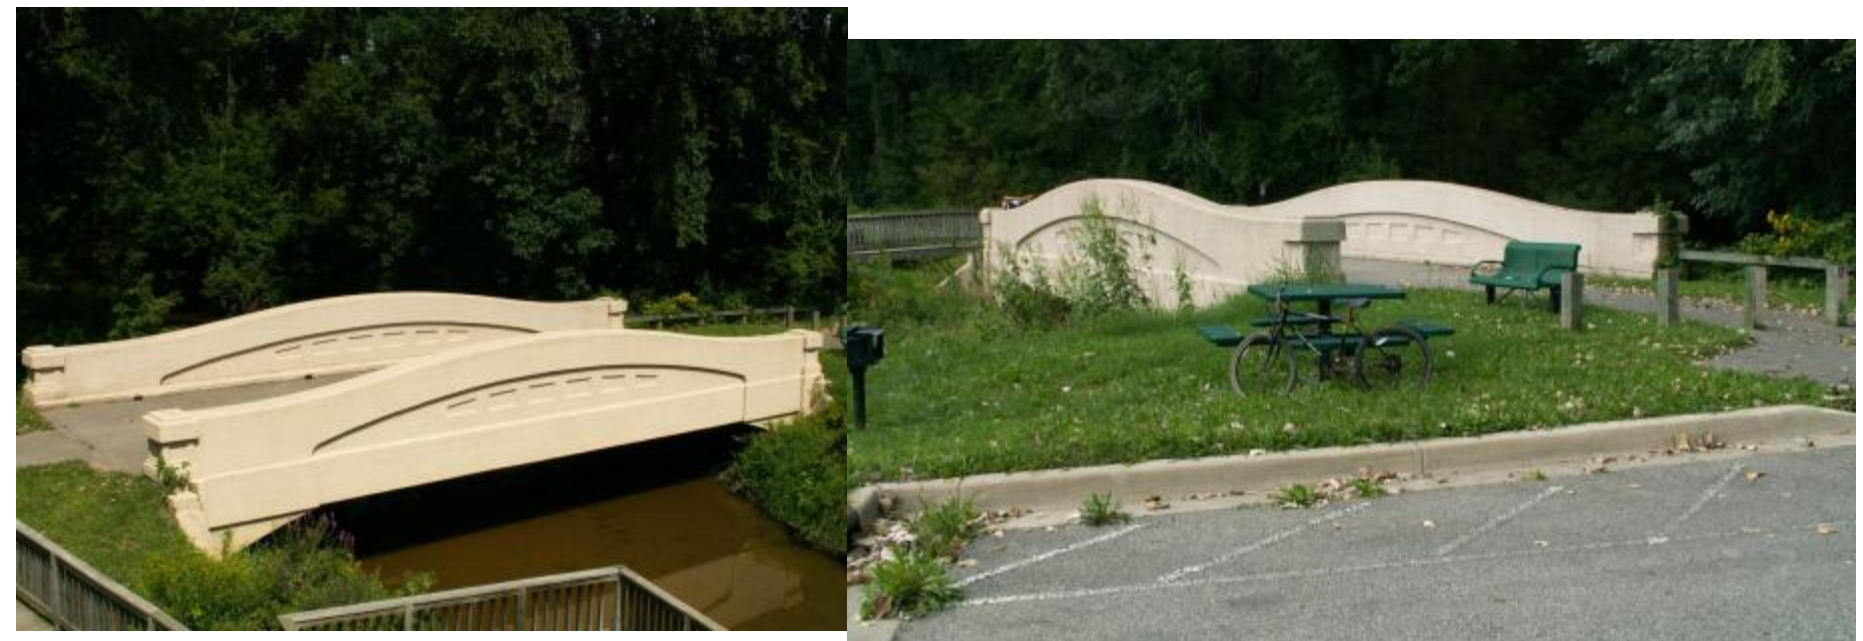
New Troy, Michigan

Bridges can create centerpieces for parks, enhancing the beauty and experience of the park. The township and tiny community of New Troy preserved this historic concrete curved chord through girder “concrete camelback” bridge next to a new bridge that was constructed and created a small park around the bridge.

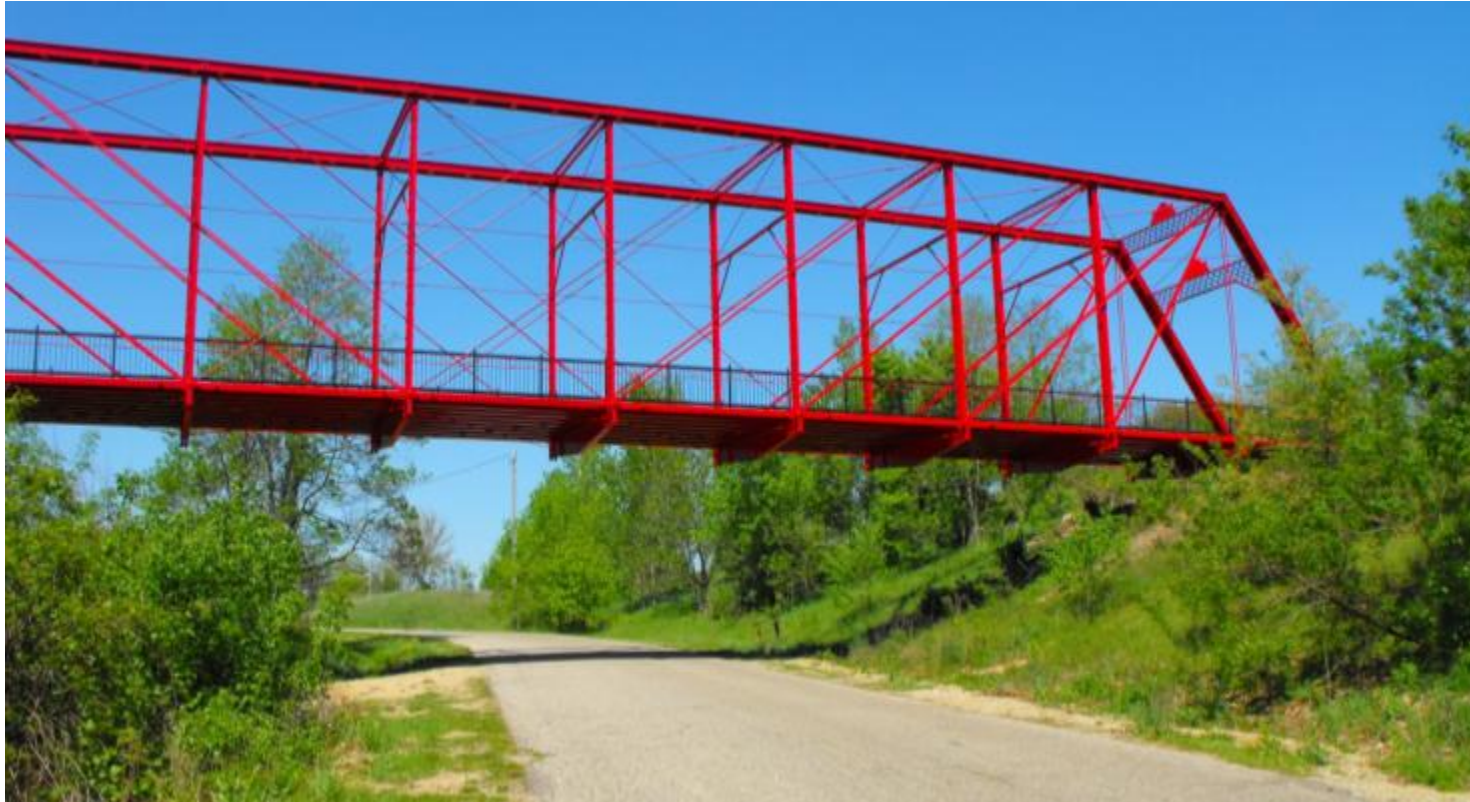
Bridge Park: Charlotte Highway

Section loss and fatigue: Severe structural deficiency to portions of a bridge should not prevent restoration. The Charlotte Highway Bridge was restored despite severe floor beam section loss.

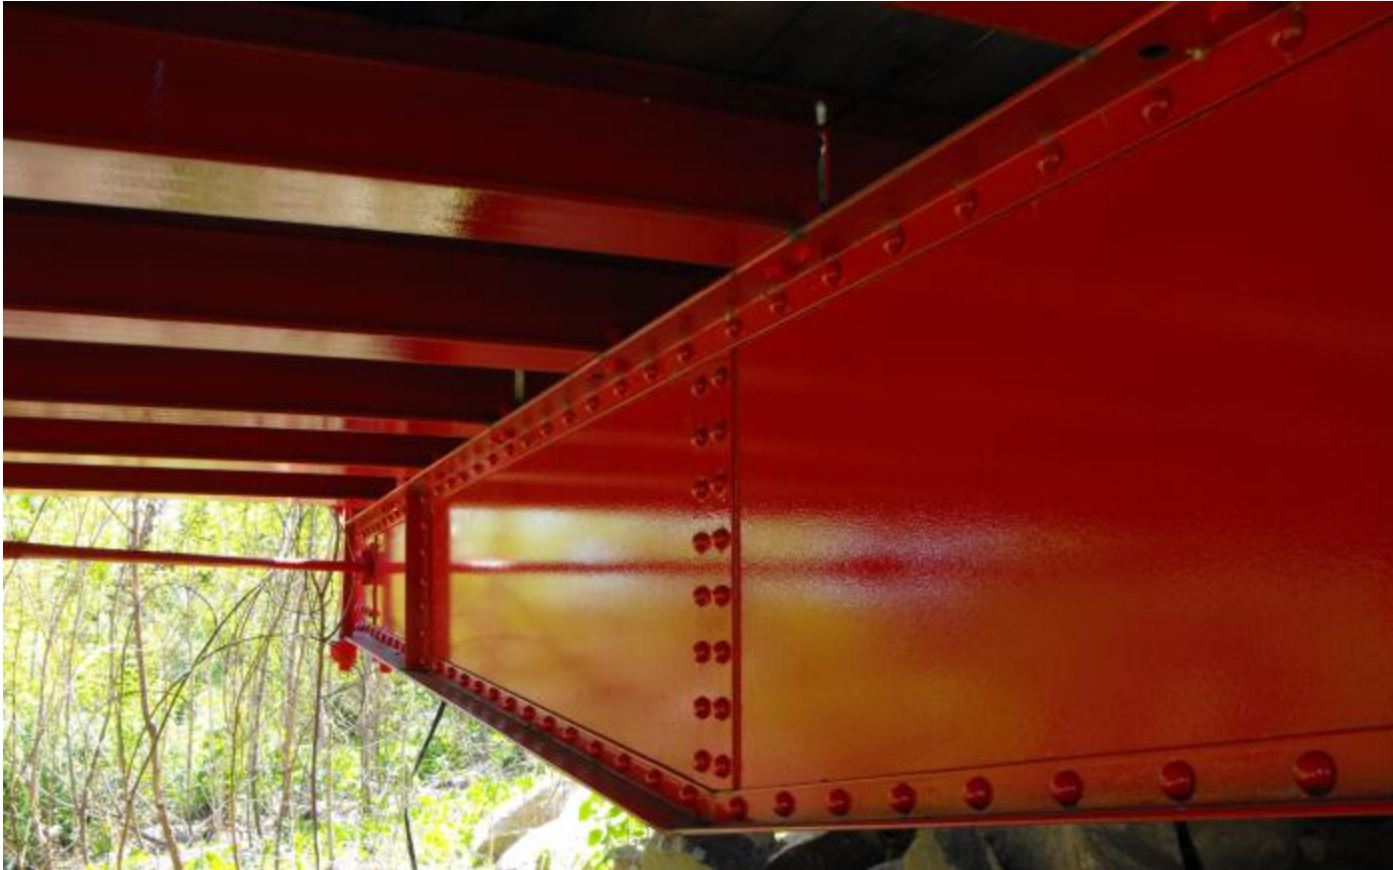
Bridge Park: Charlotte Highway

The floorbeams on this bridge were replicated right down to the shape and use of rivets to create an exact copy, eliminating all deficiencies in this part of the bridge.

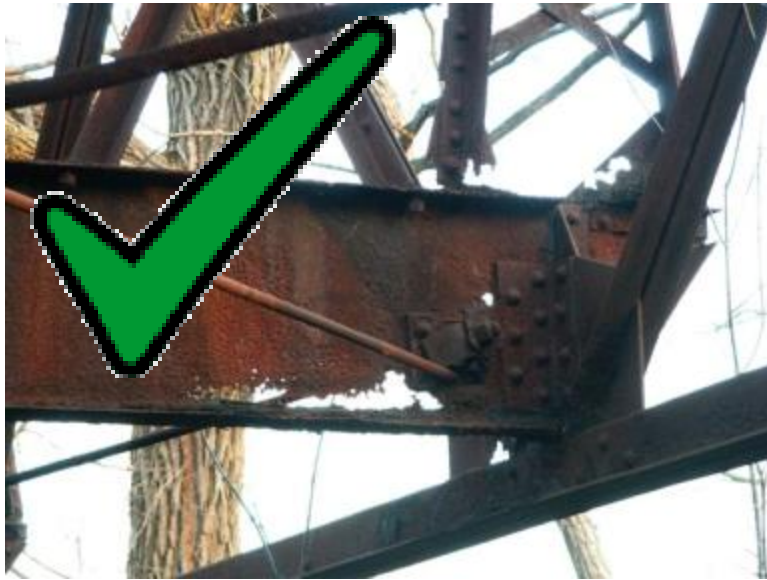
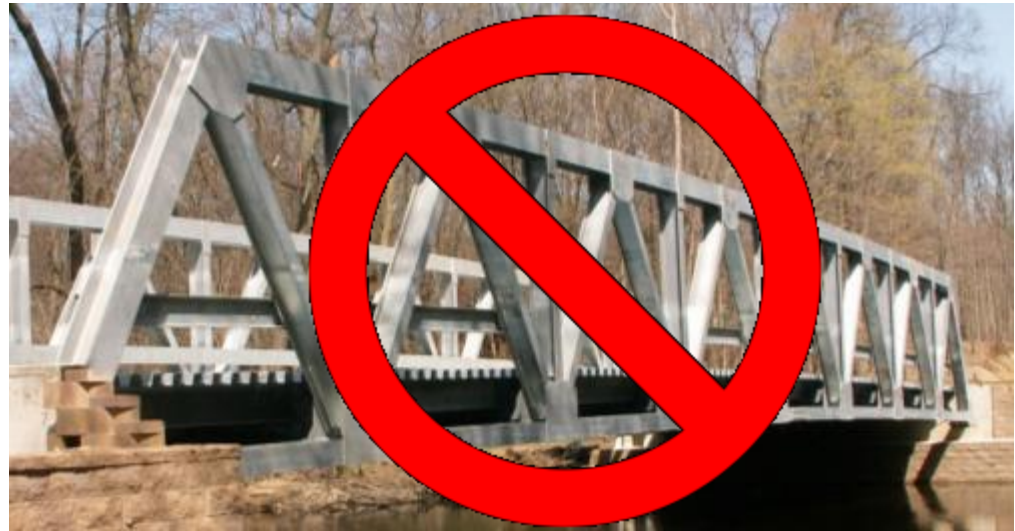
Replication Issues

Replication is a tool for difficult and severe issues on a historic bridge like metal fatigue and section loss. It remains the goal of preservation to retain original materials whenever possible.

Also, note that replication does **NOT** mean constructing a modern truss bridge in place of the historic truss bridge.

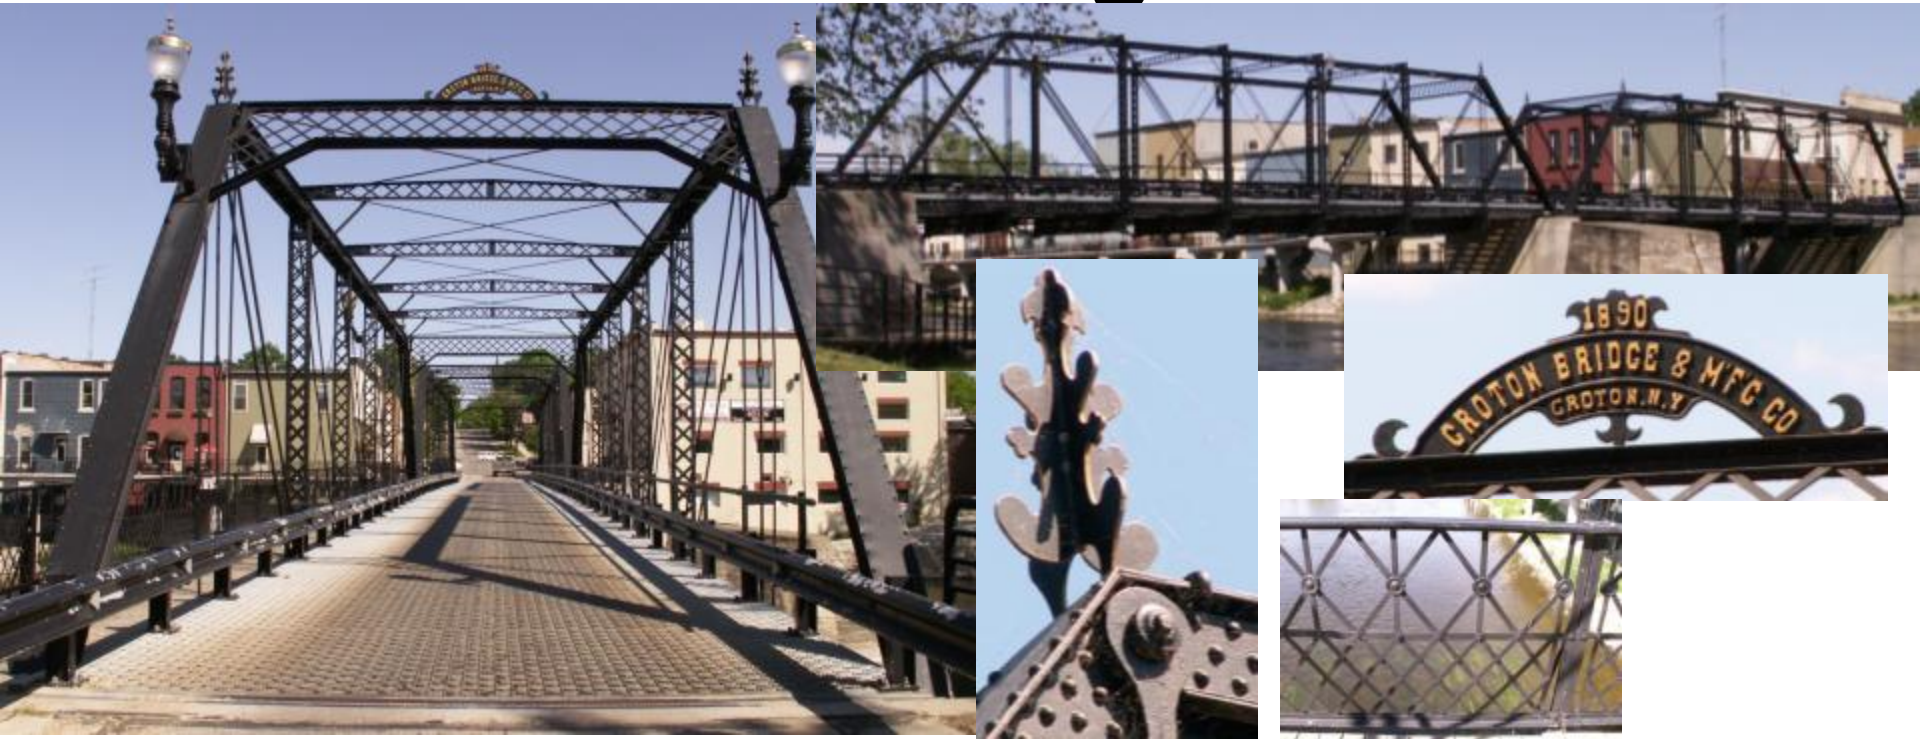
Portland: Bridge Street

The Bridge Street Bridge, an 1890 two-span pin-connected Pratt through truss was preserved in place for continued one-way vehicular use. It is a stunning gateway into the downtown, and an attraction for a small riverside park.

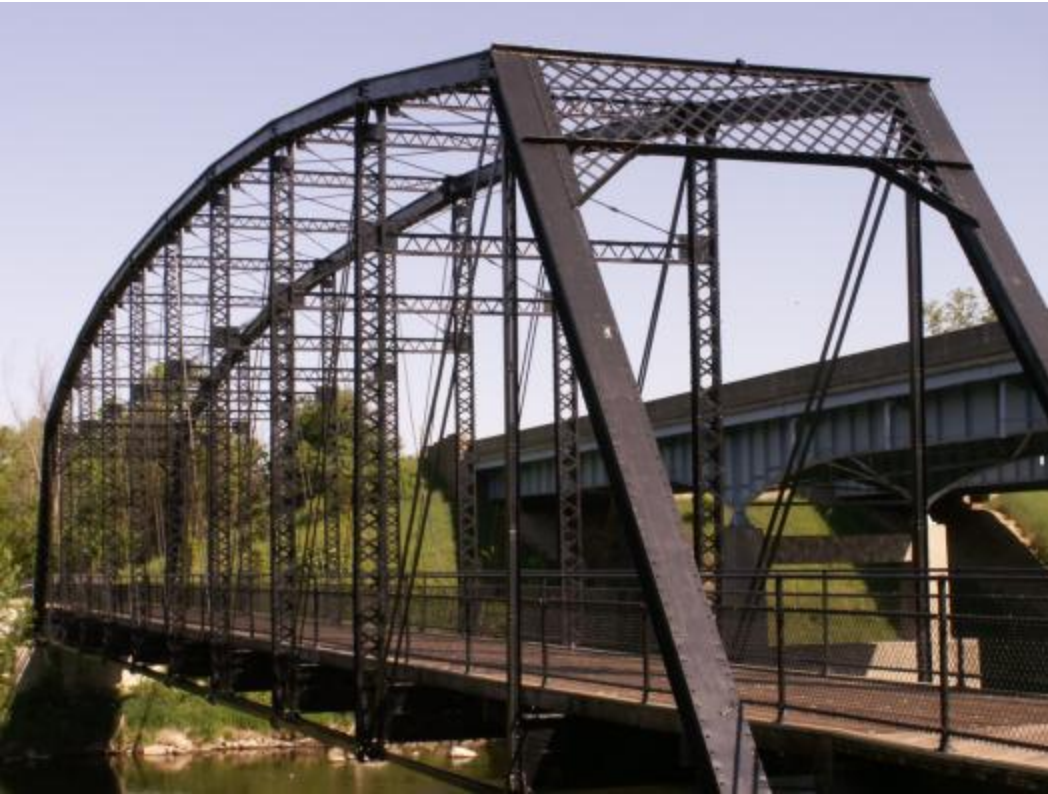
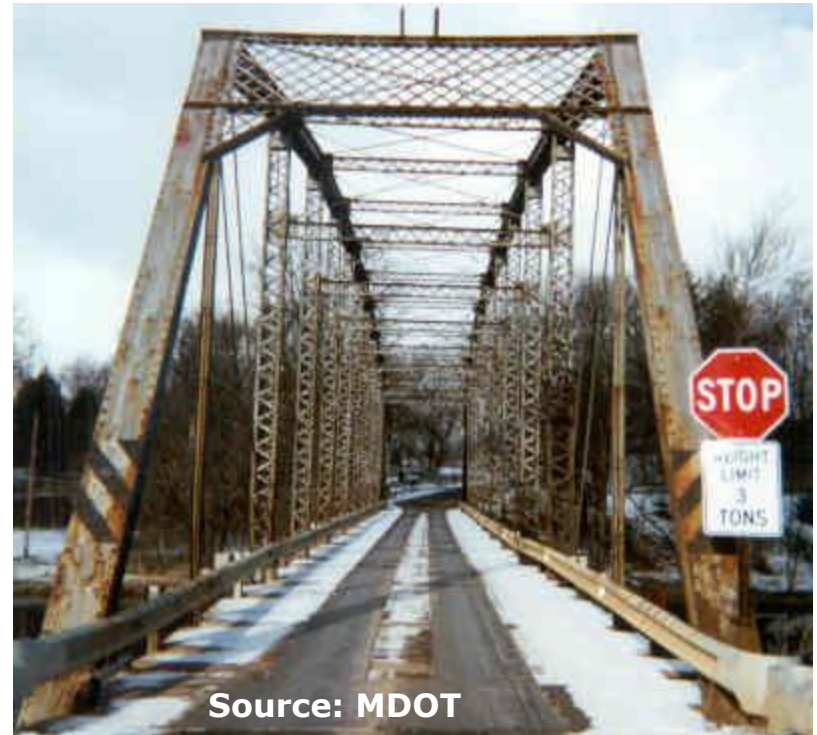
Portland: Kent Street

The Kent Street Bridge was relocated from its original location to a nearby location to serve as a crossing for the city's non-motorized trail system. It is an impressive 1904 pin-connected Parker through truss.

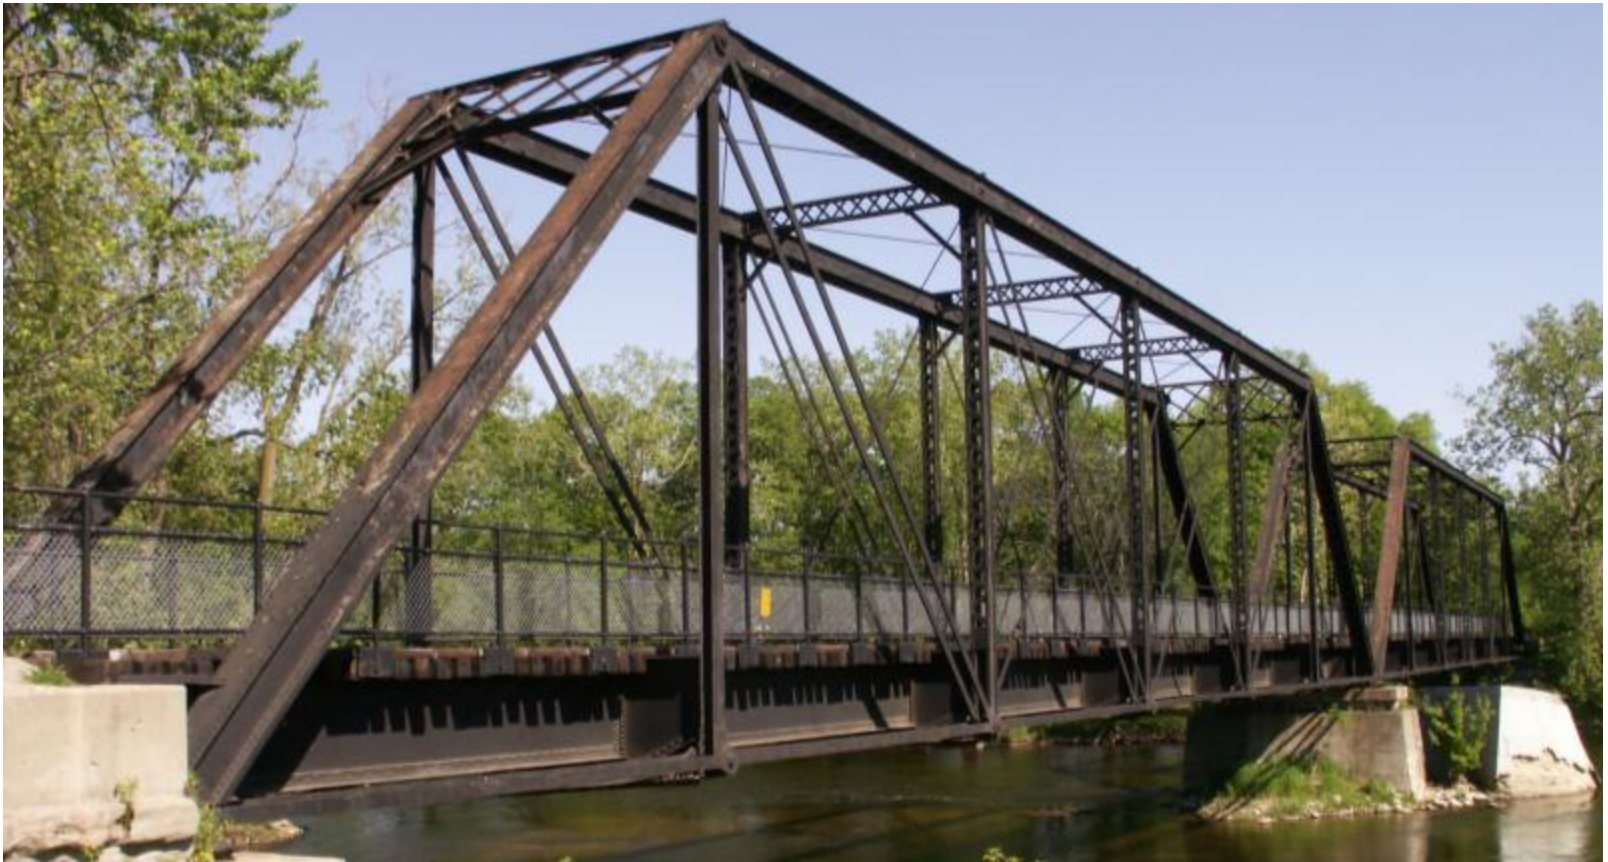
Portland: Railroad Bridge

This bridge, a two-span pin-connected Pratt through truss on an abandoned railroad was re-decked for non-motorized use on the city's non-motorized trail system.

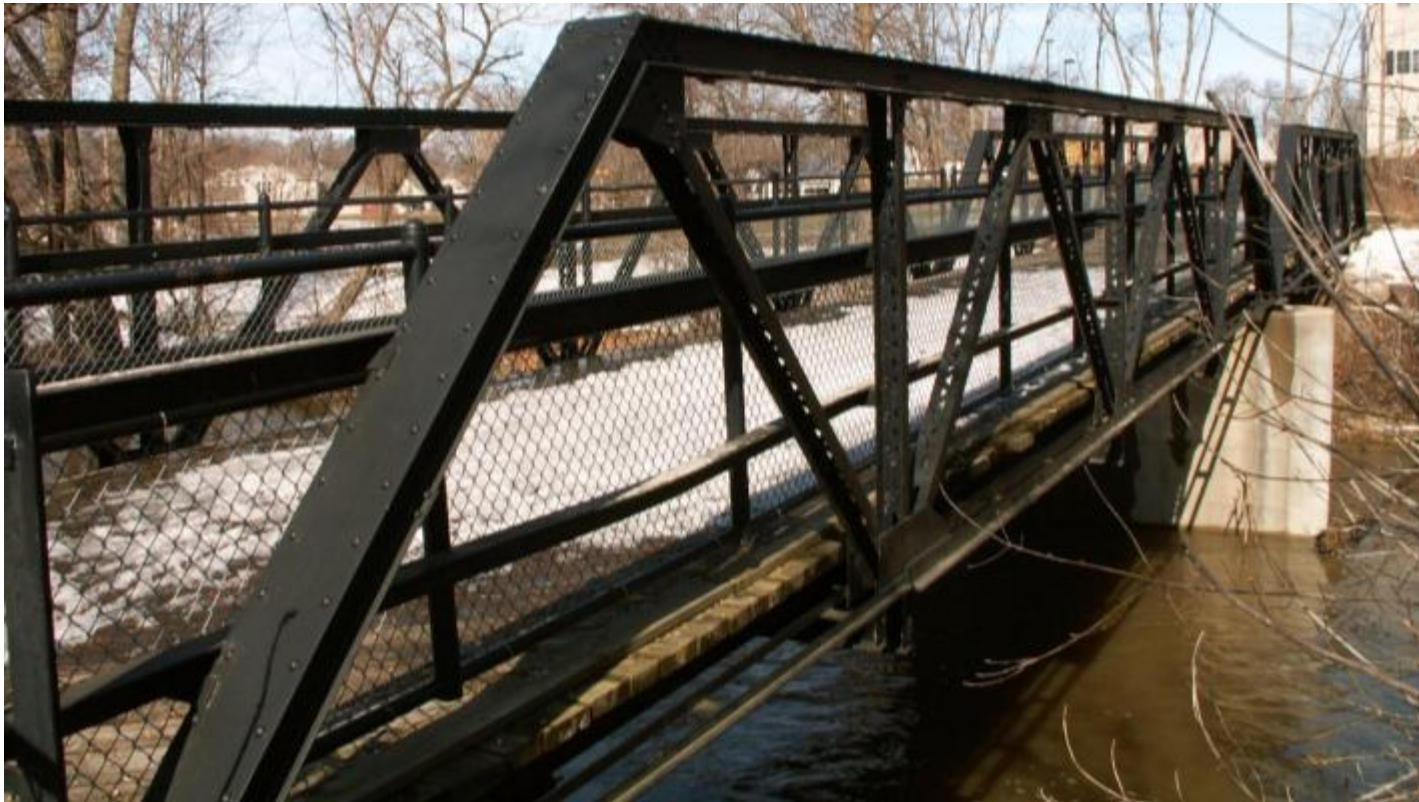
Portland: Burroughs Road

This bridge, a two-span riveted Warren pony truss on was relocated from rural Burroughs Road in neighboring Kent County and preserved on the city's non-motorized trail system.

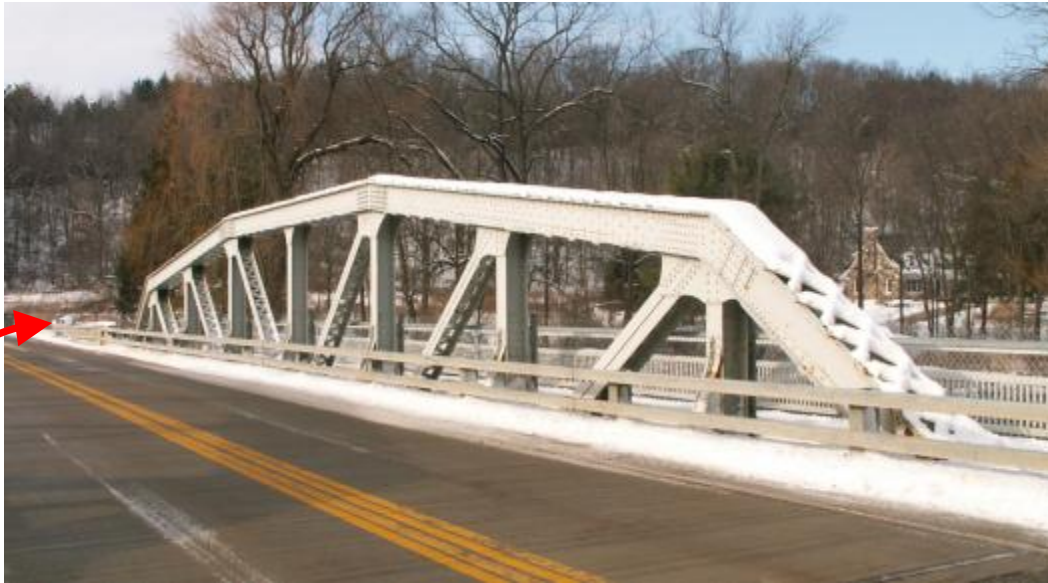
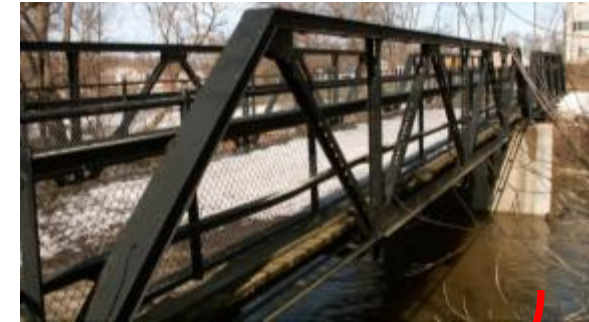
Kent County: Burroughs Road

The relocation of the Burroughs Road Bridge to Portland made room for Kent County to relocate a stronger and wider historic truss bridge that was being replaced in Wayne County onto Burroughs Road for vehicular use. This bridge, the Belleville Road Bridge is a riveted parker pony truss built in 1924 to state standard plan.

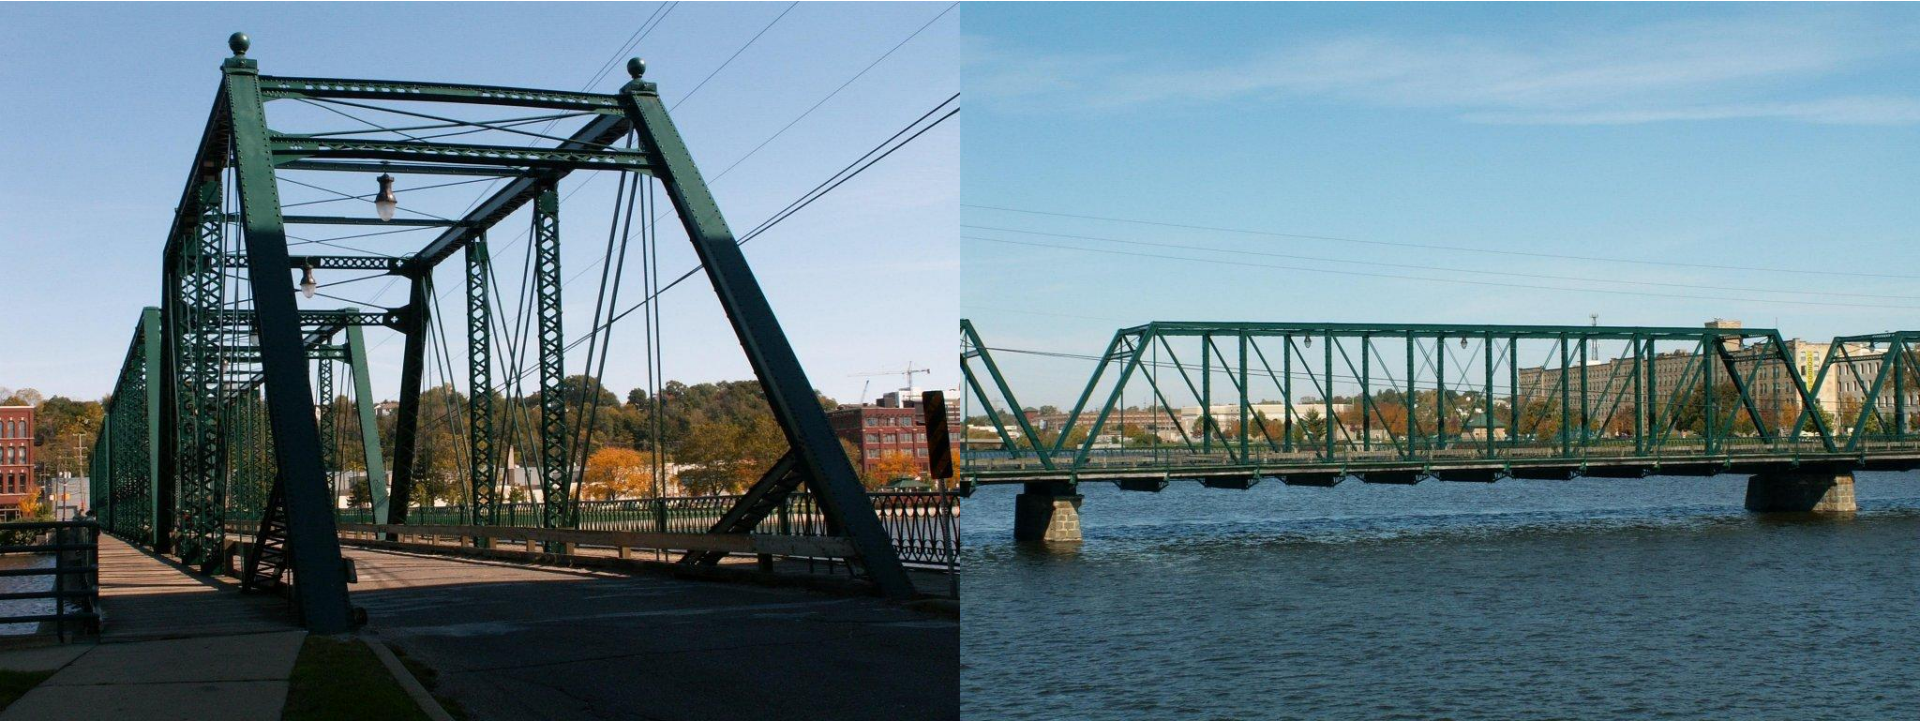
6th Street Bridge

Located in Grand Rapids, this is the longest pin-connected truss bridge in Michigan. This four-span structure retains excellent historic integrity and continues to serve vehicular traffic just north of downtown.
