Preservation: Why Not In Pennsylvania?

Presented By: Nathan Holth

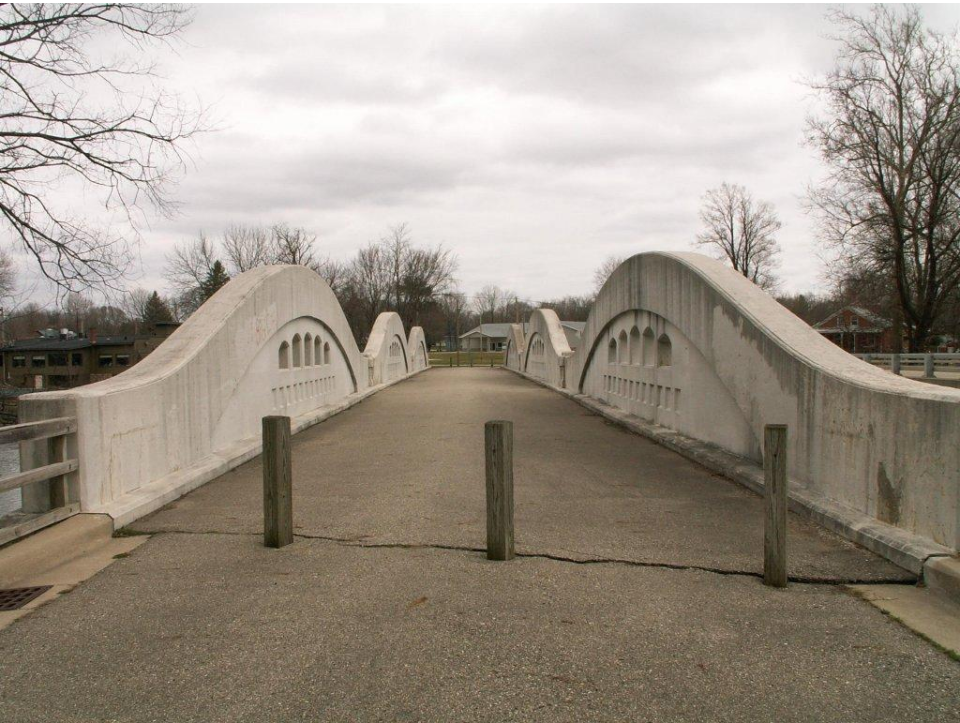
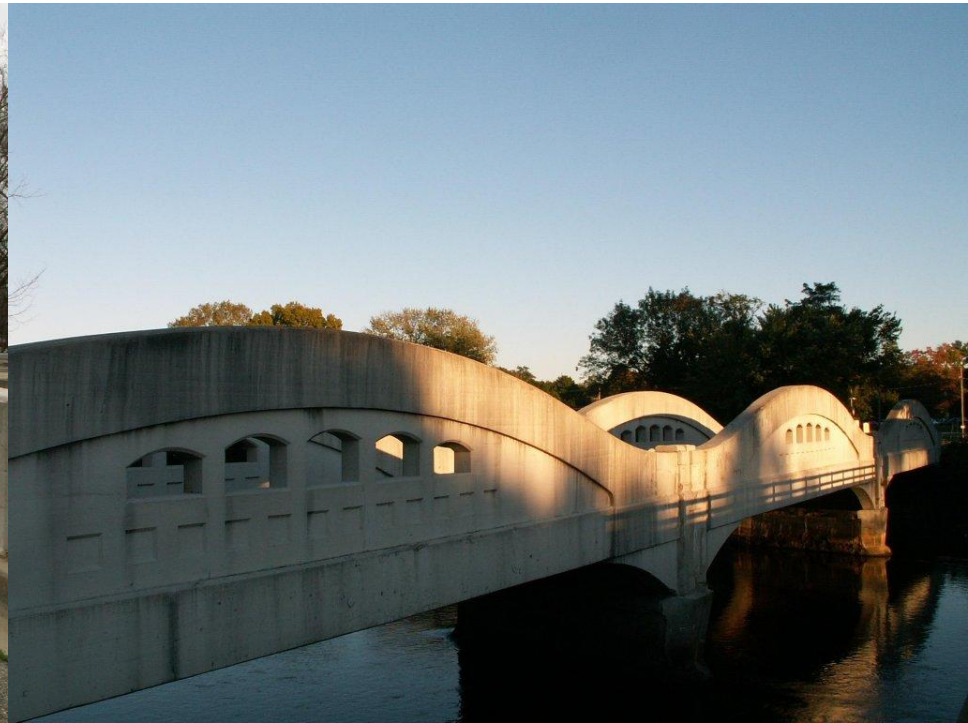
Mottville Bridge

Located in St. Joseph County, MI, this is the longest concrete camelback bridge in Michigan and one of the only multi-span examples remaining. It has been bypassed and preserved by MDOT.

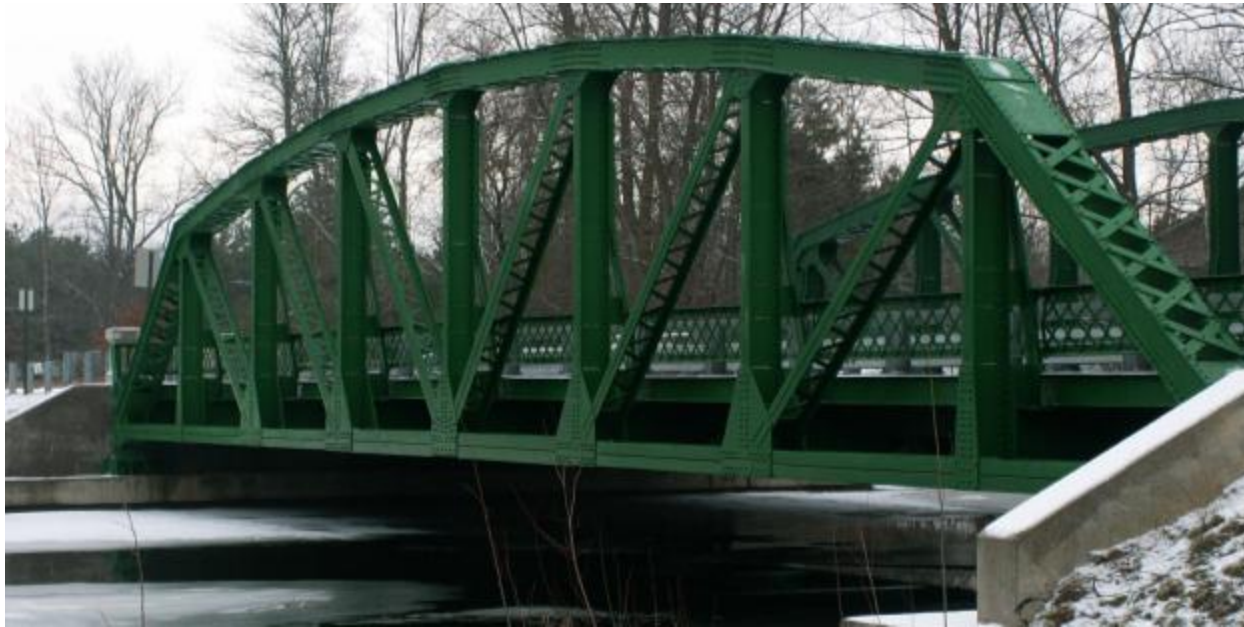
North Saginaw Road Bridge

This riveted Parker pony truss bridge was located on a busy road for which it was functionally obsolete. Midland County relocated and restored it on a more quiet road than where it was originally. They also chose not to alter the bridge to bring it up to full legal loading, so it remains a posted bridge, albeit at a generous 62 tons.

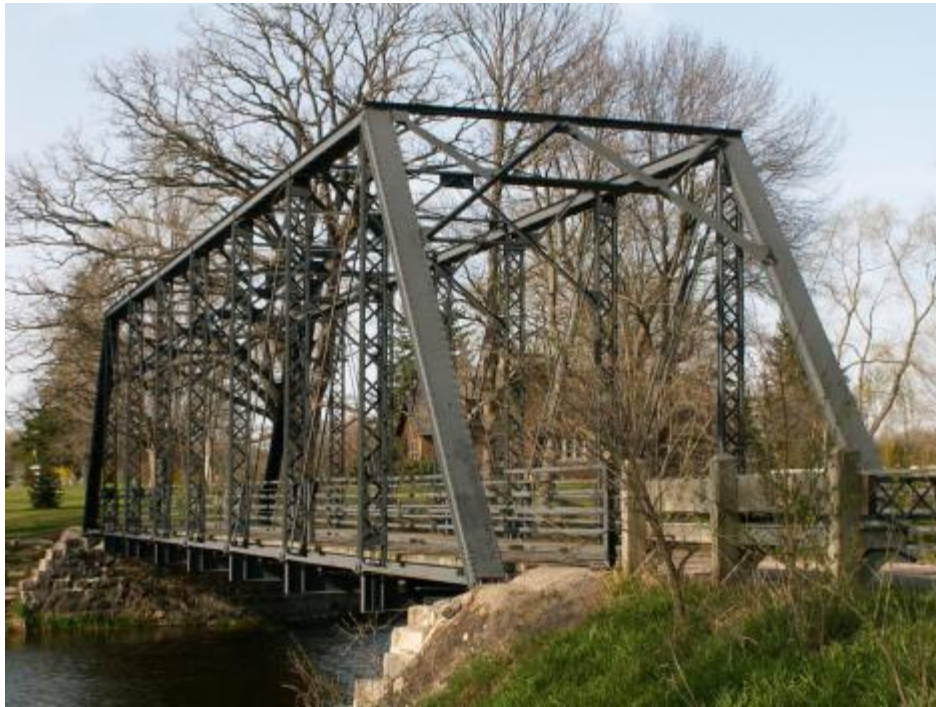
McKeowen Road Bridge

This pin-connected Pratt through truss was bypassed by a modern bridge. Rather than demolish it after the new bridge was complete, the county owners decided to preserve the bridge and create an attractive park around the county's last remaining truss bridge.

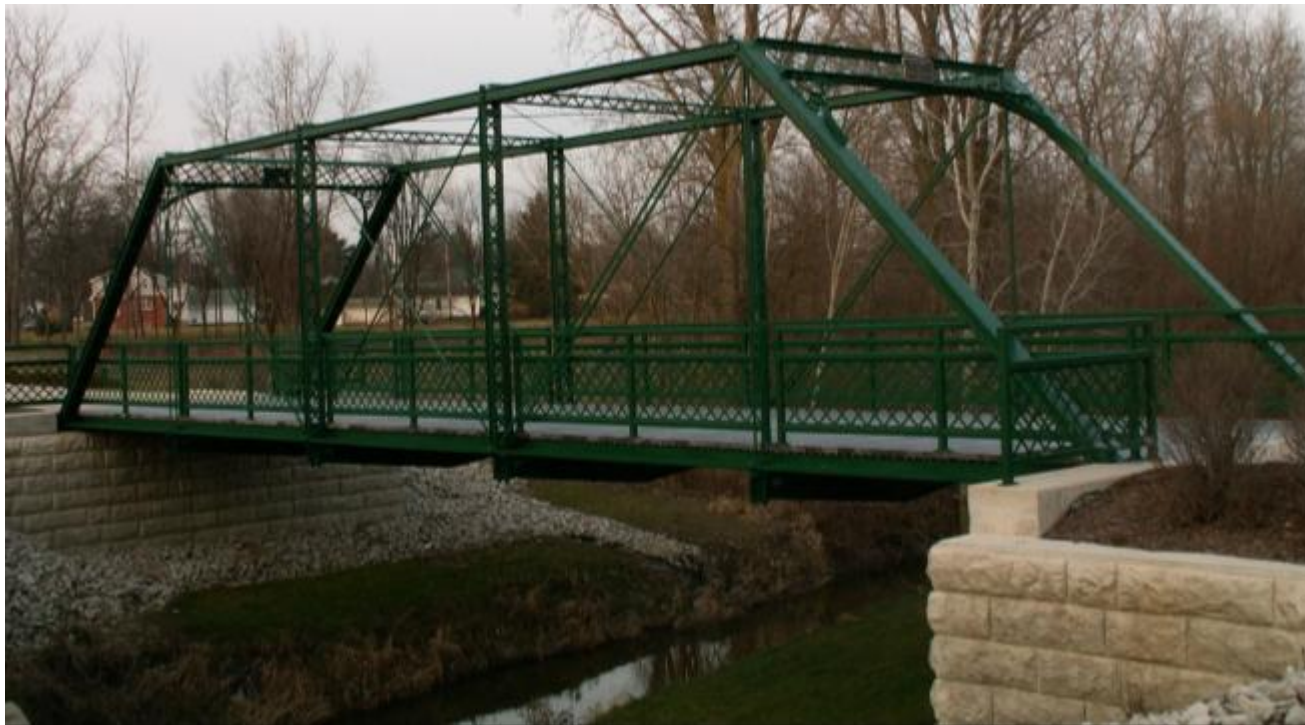
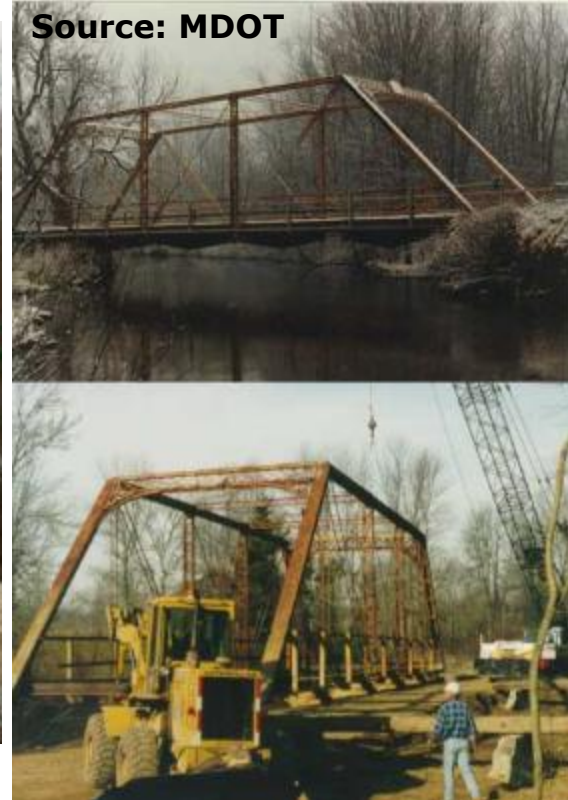
Sterling Road Bridge

This historic pin-connected Pratt through truss was relocated from the adjacent county to Morenci, Michigan right near the Ohio border. It provides a crossing for a sidewalk that parallels a state highway.

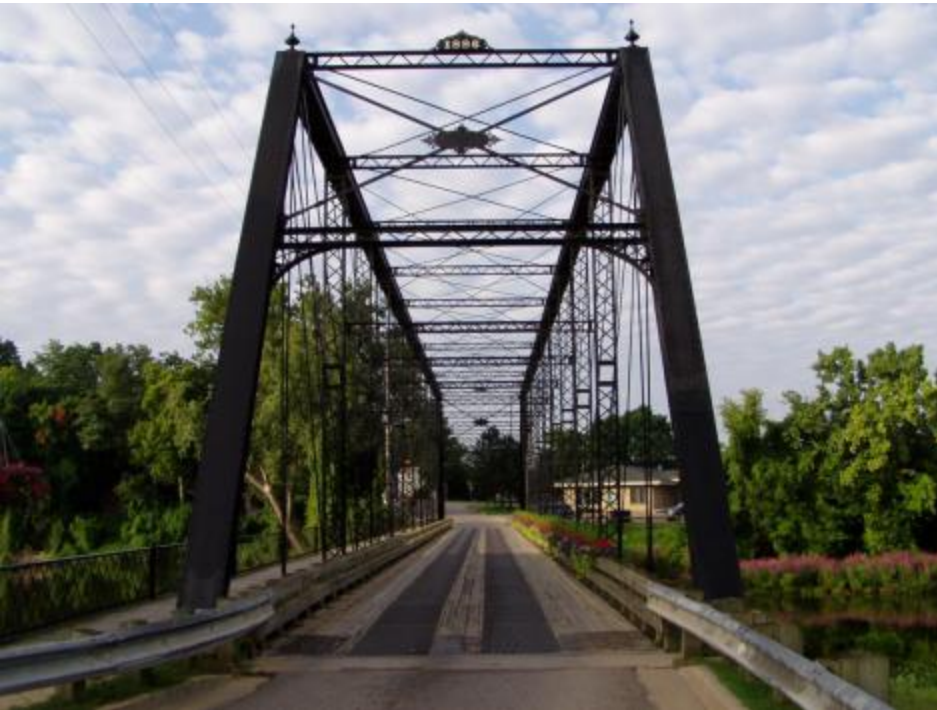
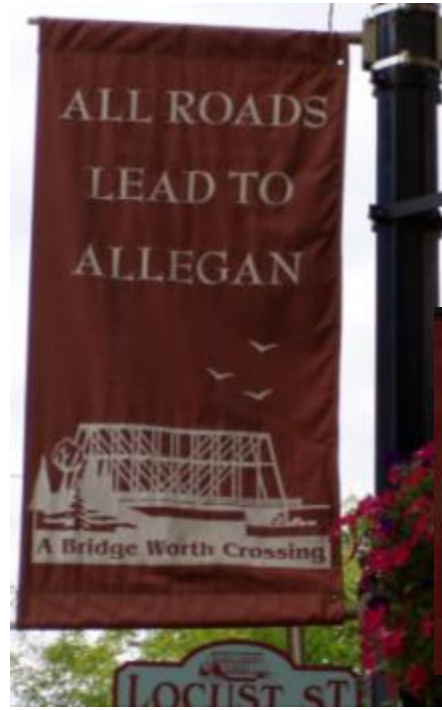
2nd Street Bridge, Allegan, MI

This 1886 historic Whipple through truss was rehabilitated in 1981 in response to community support for the bridge, representing an early commitment to historic bridges. City logos, banners, businesses, and even manhole covers feature this treasured bridge.
