Maryland Inventory of Historic Properties number: AL-I-A-083

Name: US40 over Fifteen Mile Creek

Maryland Inventory of Historic Properties  
Historic Bridge Inventory  
Maryland State Highway Administration  
Maryland Historical Trust

**SHA Bridge No.** 1036    **Name:** US 40 over Fifteen Mile Creek

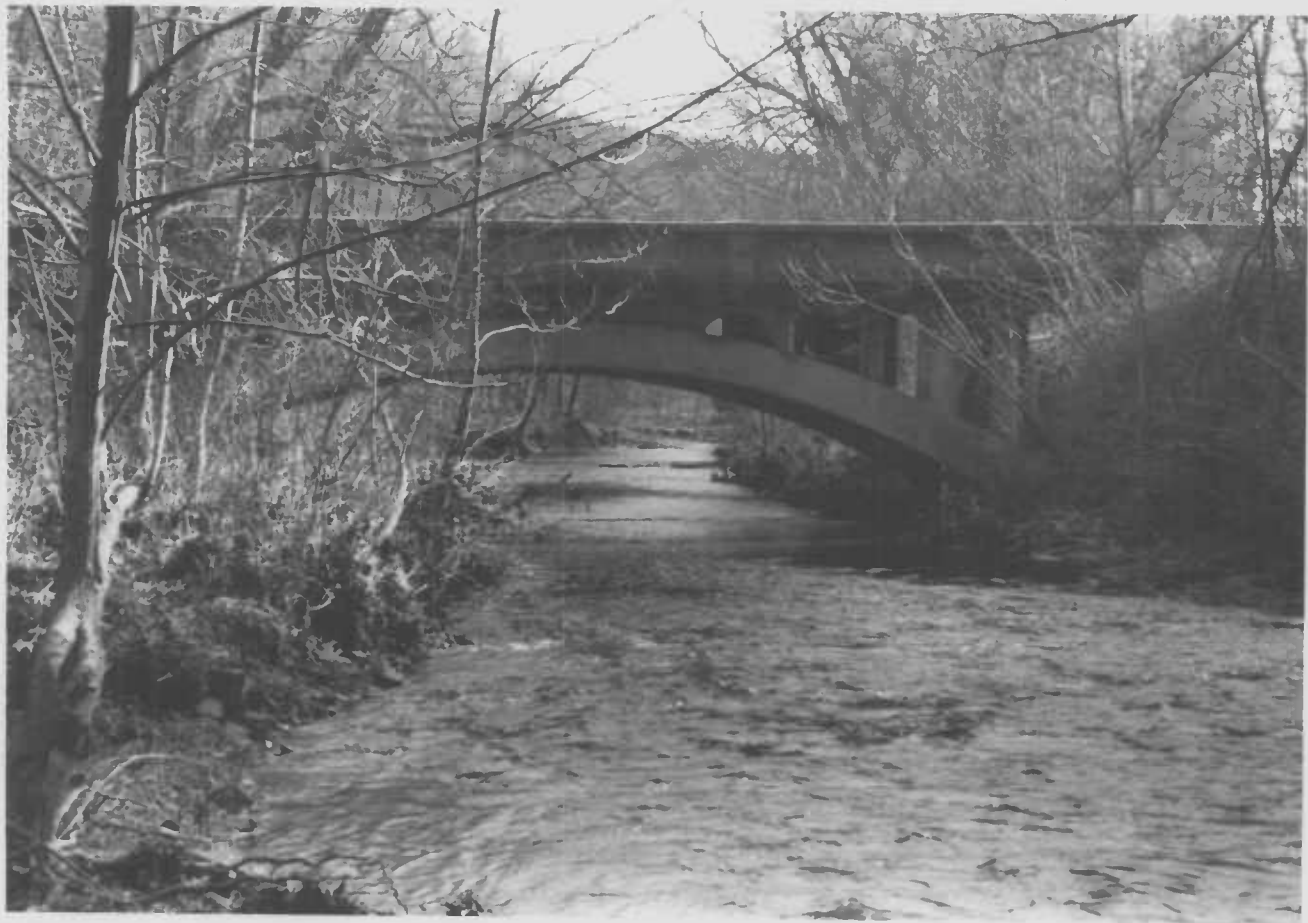
1. AL-1-A-083
2. US 40 over Fifteen Mill Creek
3. Allegany Co., MD
4. Wallace, Montgomery & Assoc.
5. 12/97
6. MD SHPO
7. Elevation looking downstream
8. 10 F 4

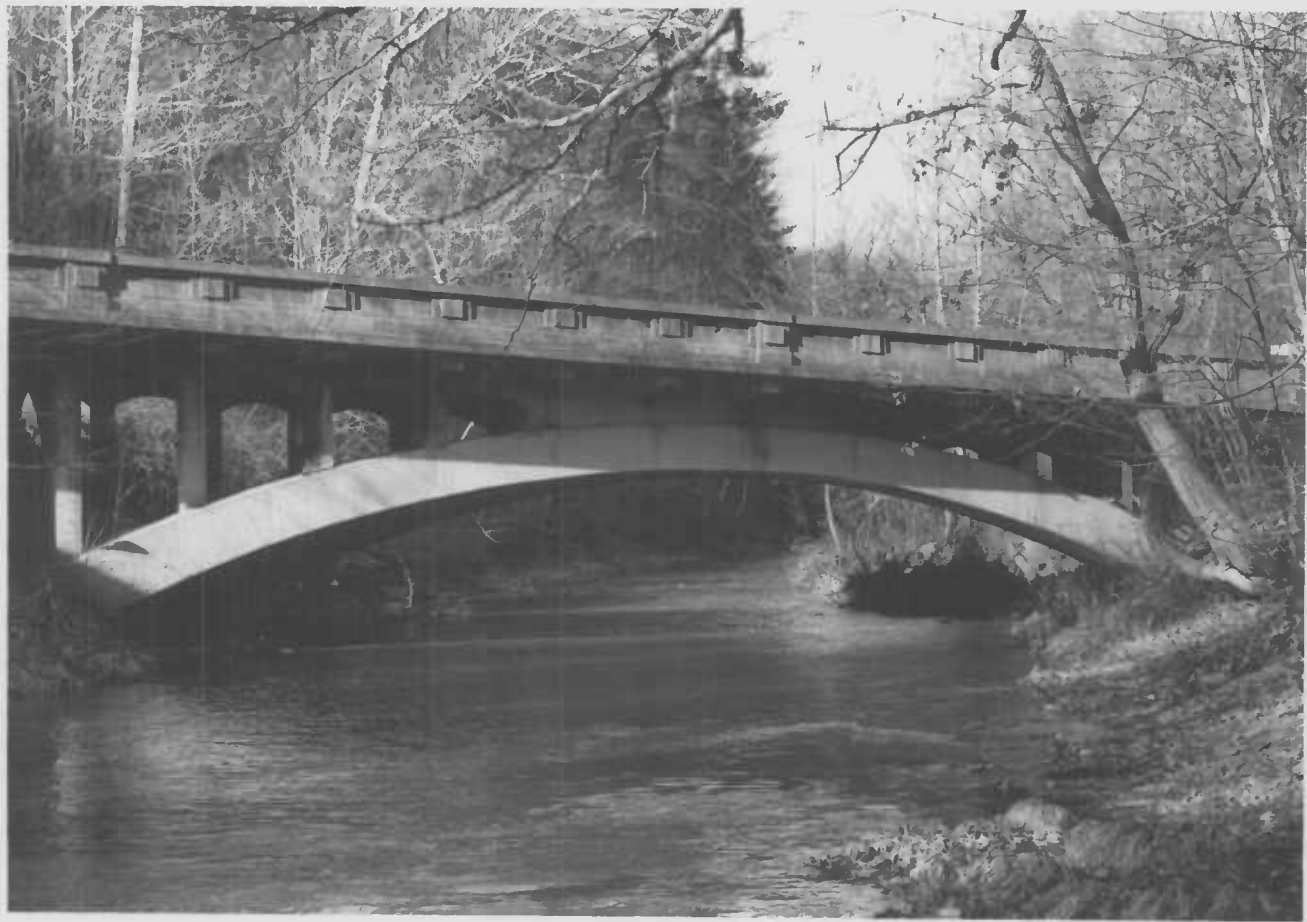
1. AL-1-A-083
2. US 40 over Fifteen Mill Creek
3. Allegany Co., MD
4. Wallace, Montgomery & Assoc.
5. 12/97
6. MD SHPO
7. Elevation looking upstream
8. 2 of 4

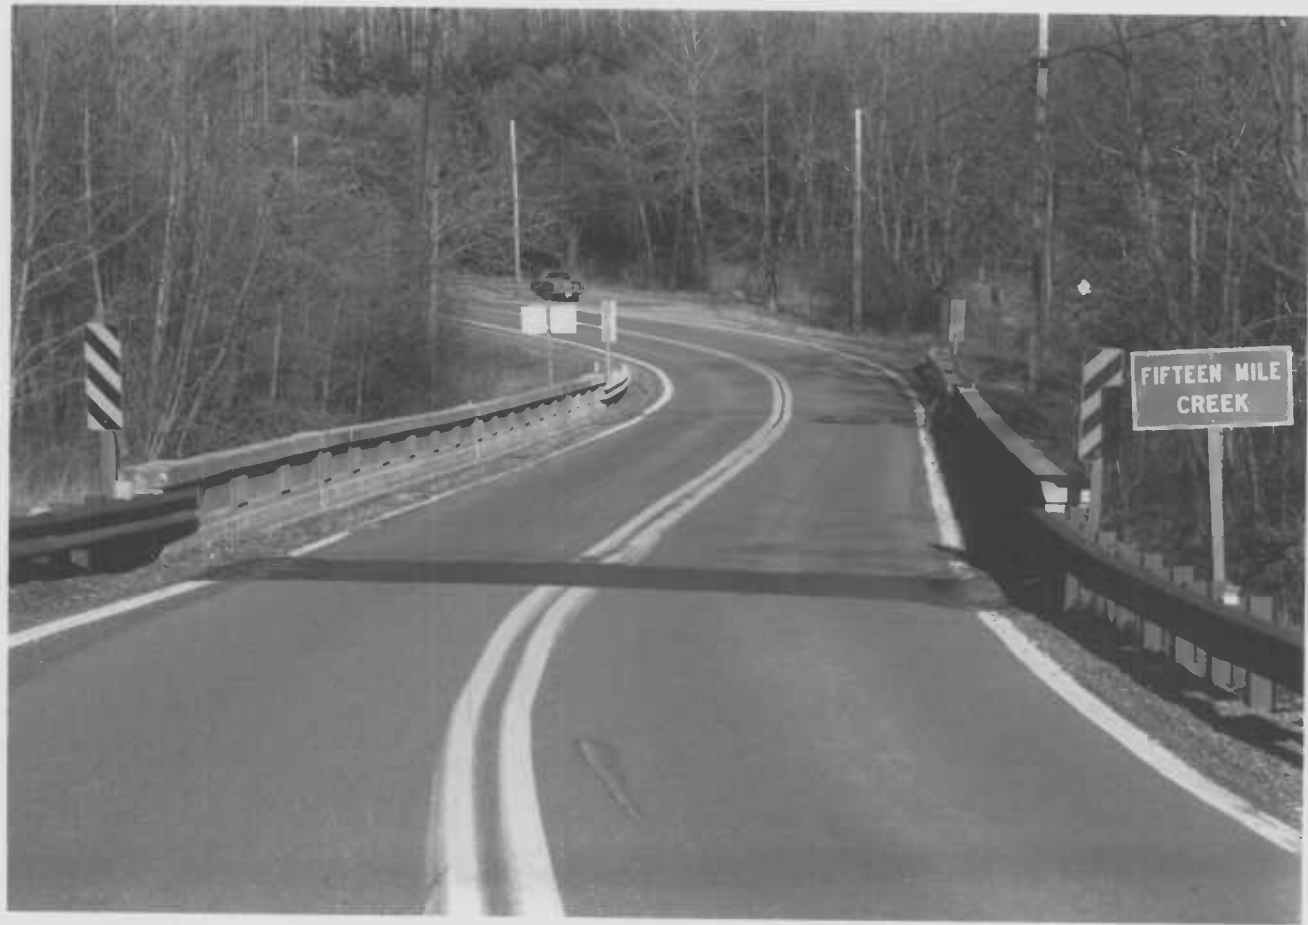
1. AL-1-A-083
2. US 40 over Fifteen Mill Creek
3. Allegany Co., MD
4. Wallace, Montgomery & Assoc.
5. 12/97
6. MD SHPO
7. Looking East
8. 3 of 4

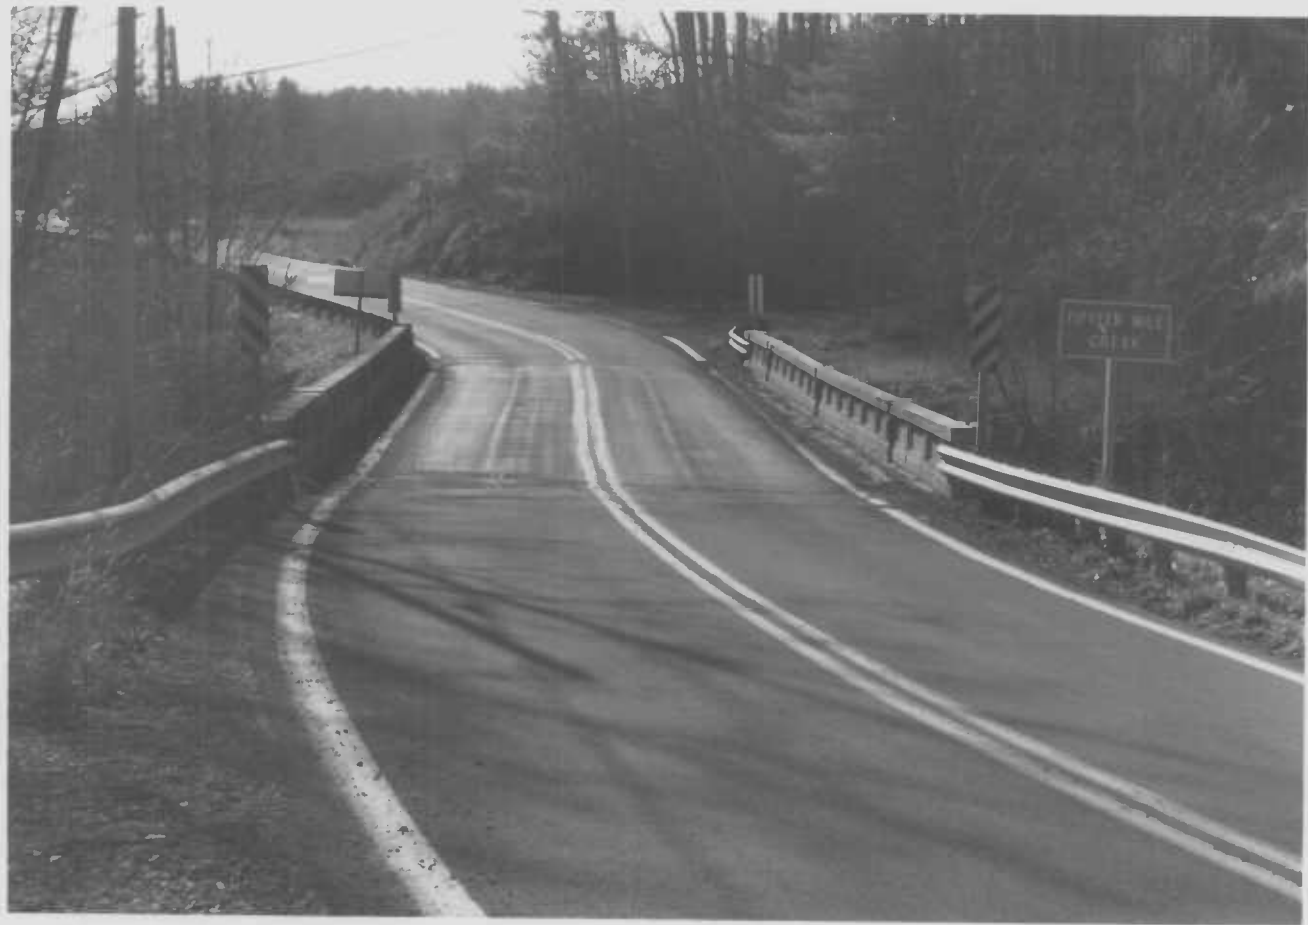
1. AL-1-A-083
2. US 40 over Fifteen Mill Creek
3. Allegany Co., MD
4. Wallace, Montgomery & Assoc,
5. 12/97
6. MD SHPO
7. Looking West
8. 4 of 4

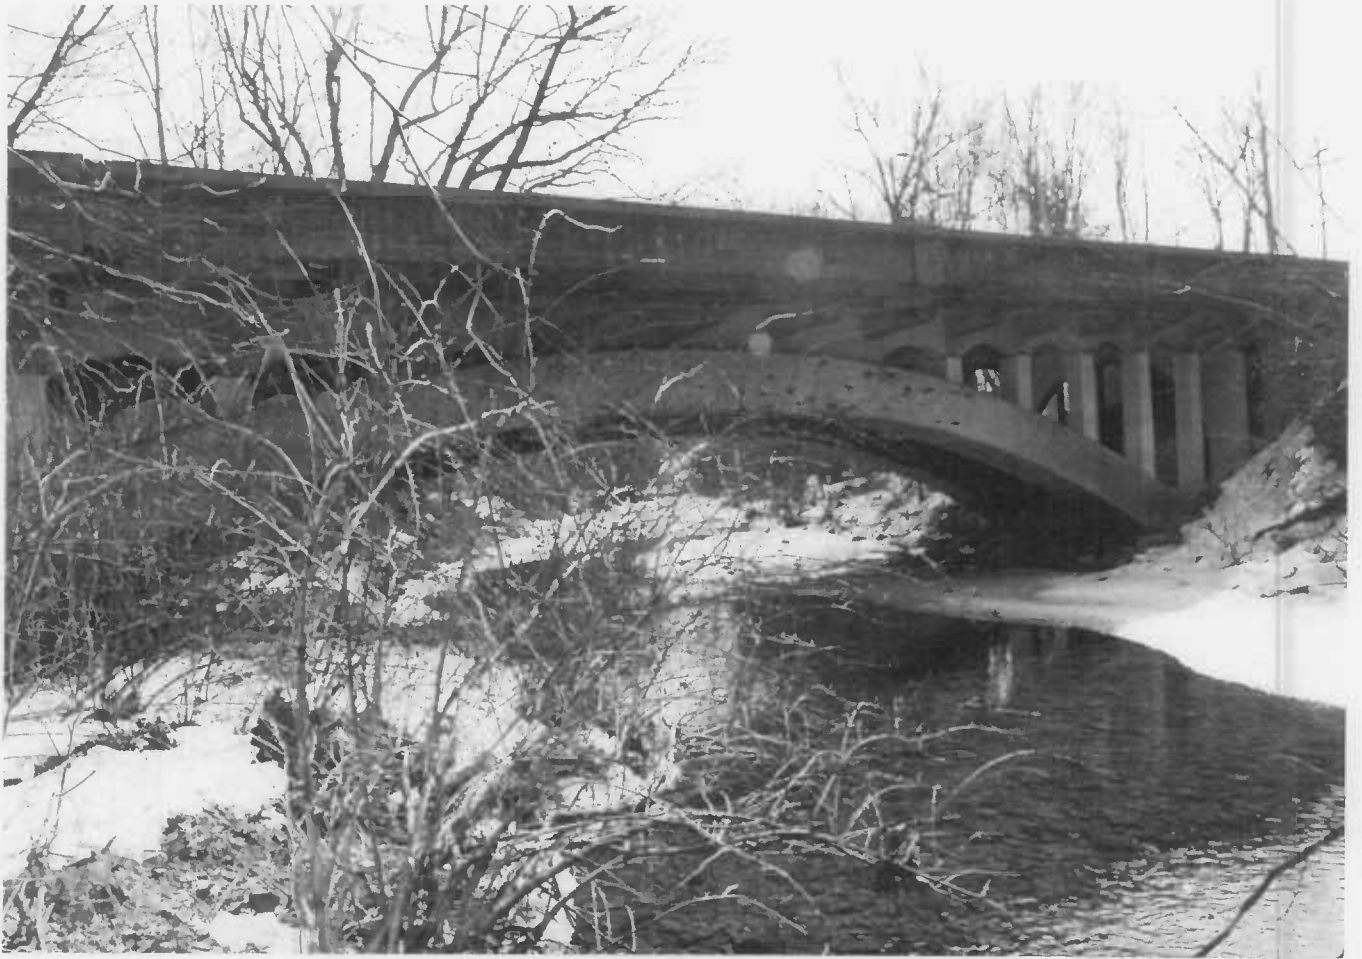
View of SHA Bridge # 1036 (AI-I-83).
