# Engineering News

## The St. Louis Municipal Bridge

By S. W. BOWEN\*

The St. Louis Municipal Bridge, now being built across the Mississippi River, connects the cities of St. Louis, Mo., and East St. Louis, Ill., and is being constructed by the city of St. Louis as a combined railway and highway structure.

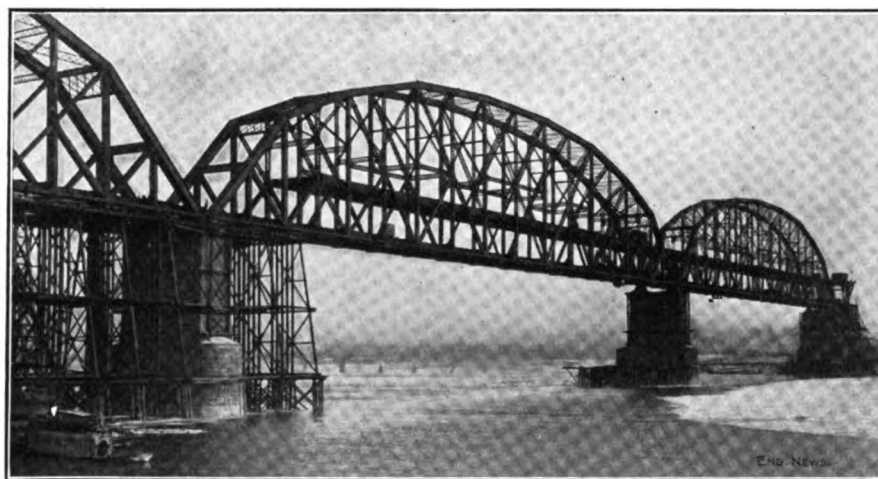
FIG. 13. COMPLETED EAST SPANS OF MUNICIPAL BRIDGE, AT ST. LOUIS  
(From a photograph taken about the middle of January.)

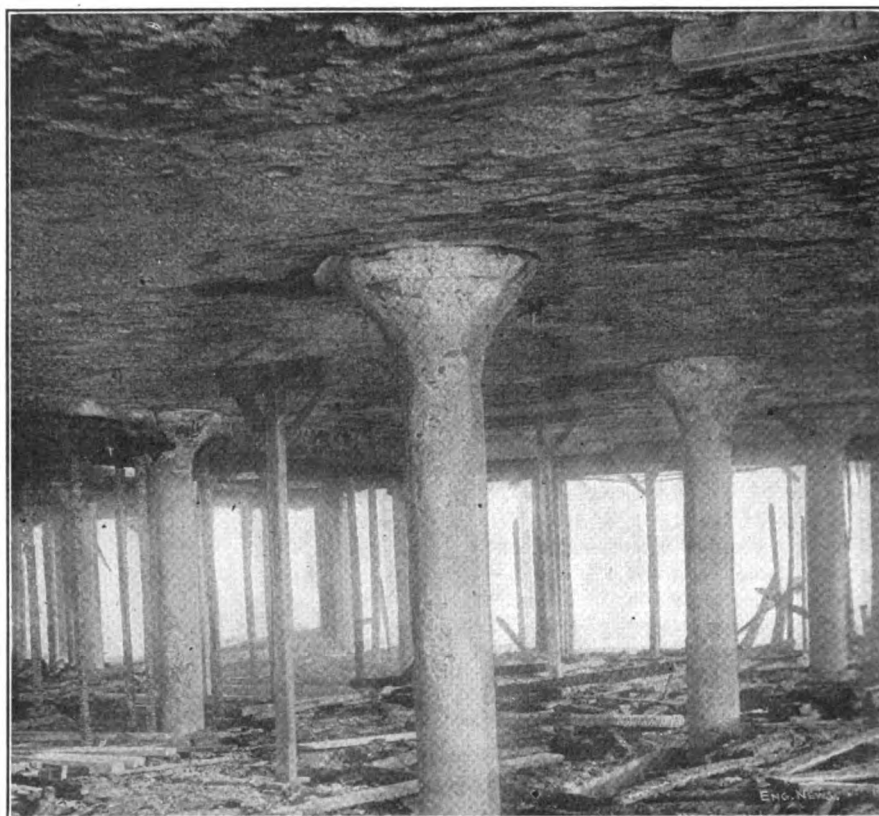
A FLOOR OF A CONCRETE BUILDING AFTER A FIRE WHICH BURNED OUT ALL OF THE FALSEWORK

The accompanying halftone is a view of the second floor of the Swift-Canadian Co.'s building at Fort William, Ont., taken after a fire, on Dec. 15, 1911, that completely burned out the centering and falsework supporting the second and third floors of the building, then under construction. The concreting was being carried on through the very cold weather common in that part of Canada in December and the usual precautions for heating the interior of the building and the concrete were observed. On Dec. 7 the col-

The concrete was damaged only by a slight surface spalling and the slabs and columns stood up under their load without any apparent crack or sag, although the concrete had had only about eight days' set in very cold weather.

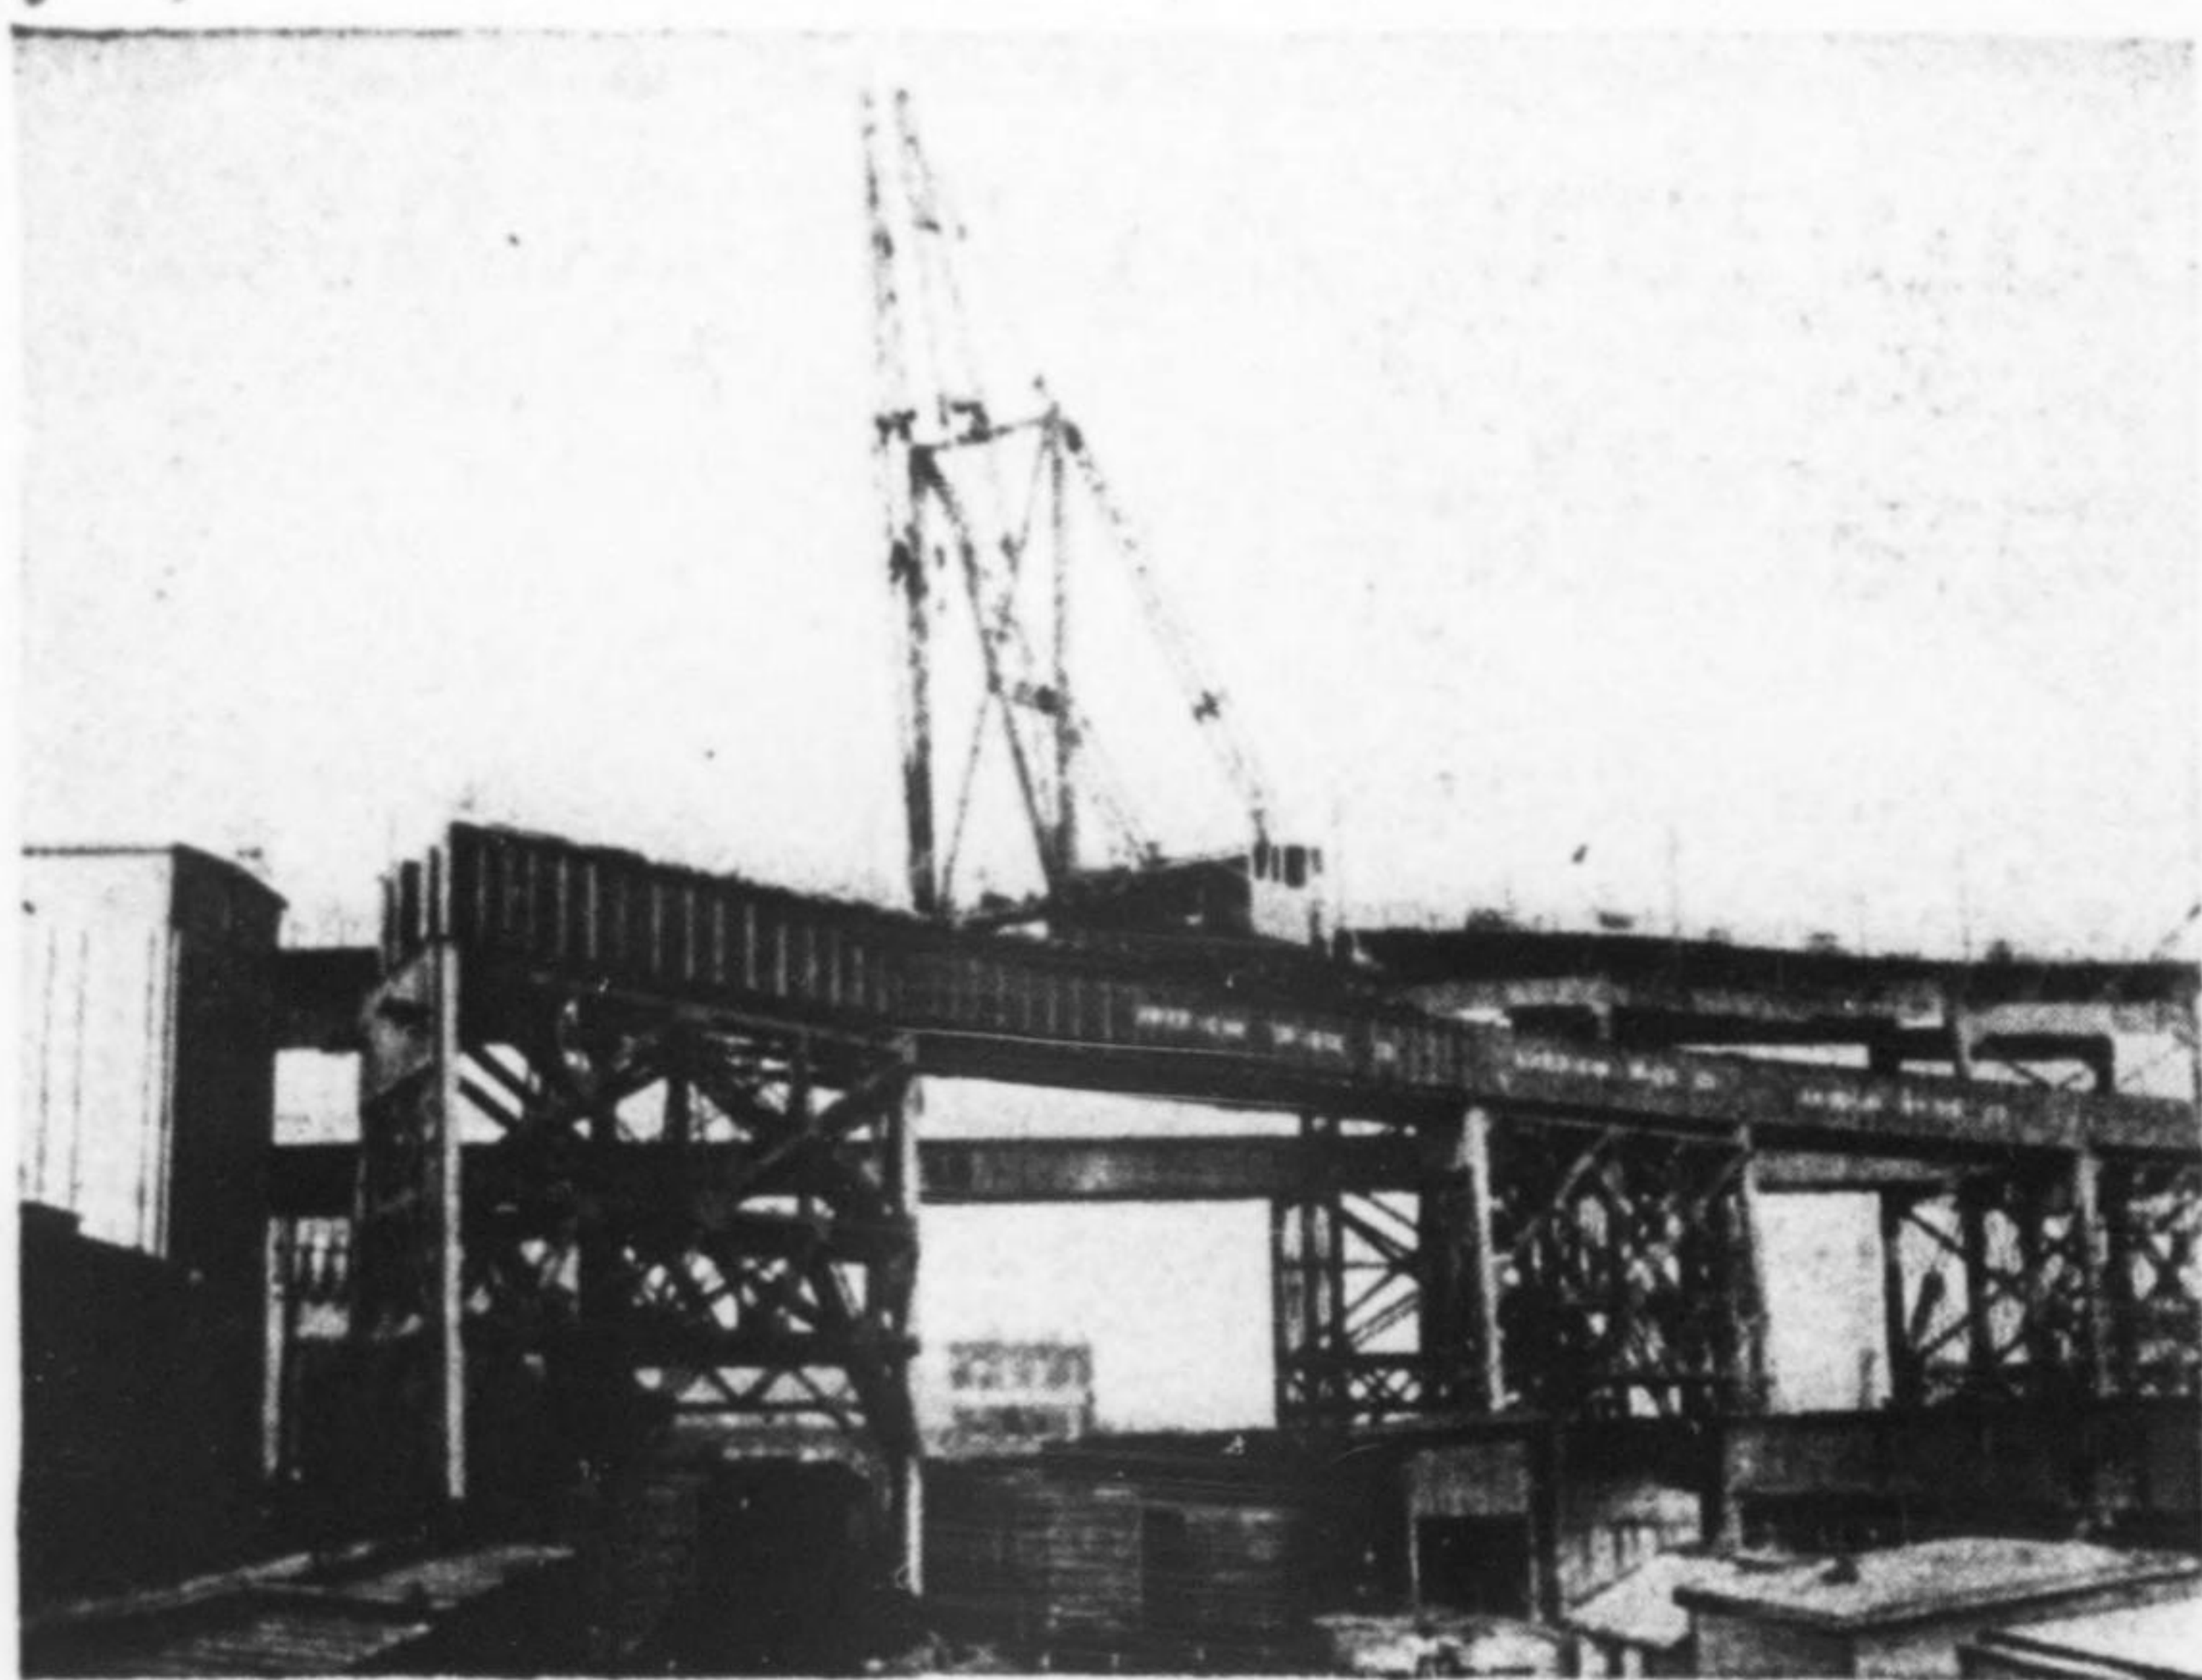
FIG. 2—NEW SOUTHERN APPROACH TO ST. LOUIS MUNICIPAL BRIDGE  
Bridge in background has railway on lower deck and highway on upper deck.

MANY interesting and complicated problems entered into the design and construction of the new southern approach to the railway deck of the municipal bridge across the Mississippi River at St. Louis, as the approach passes through a closely built-up industrial district. This approach, completed recently and consisting mainly of a steel viaduct incline, connects the west end of the city's bridge with the Manufacturers Railway (a local line), the St. Louis Transfer Railway (a riverfront line owned by the city and operated by the Terminal Railroad Association) and also with the Missouri Pacific Railroad in its Lesperance St. yard. Fig. 1 is a plan of the bridge and its several approaches, while viaduct construction on the curved connection to the bridge is shown in Fig. 2.

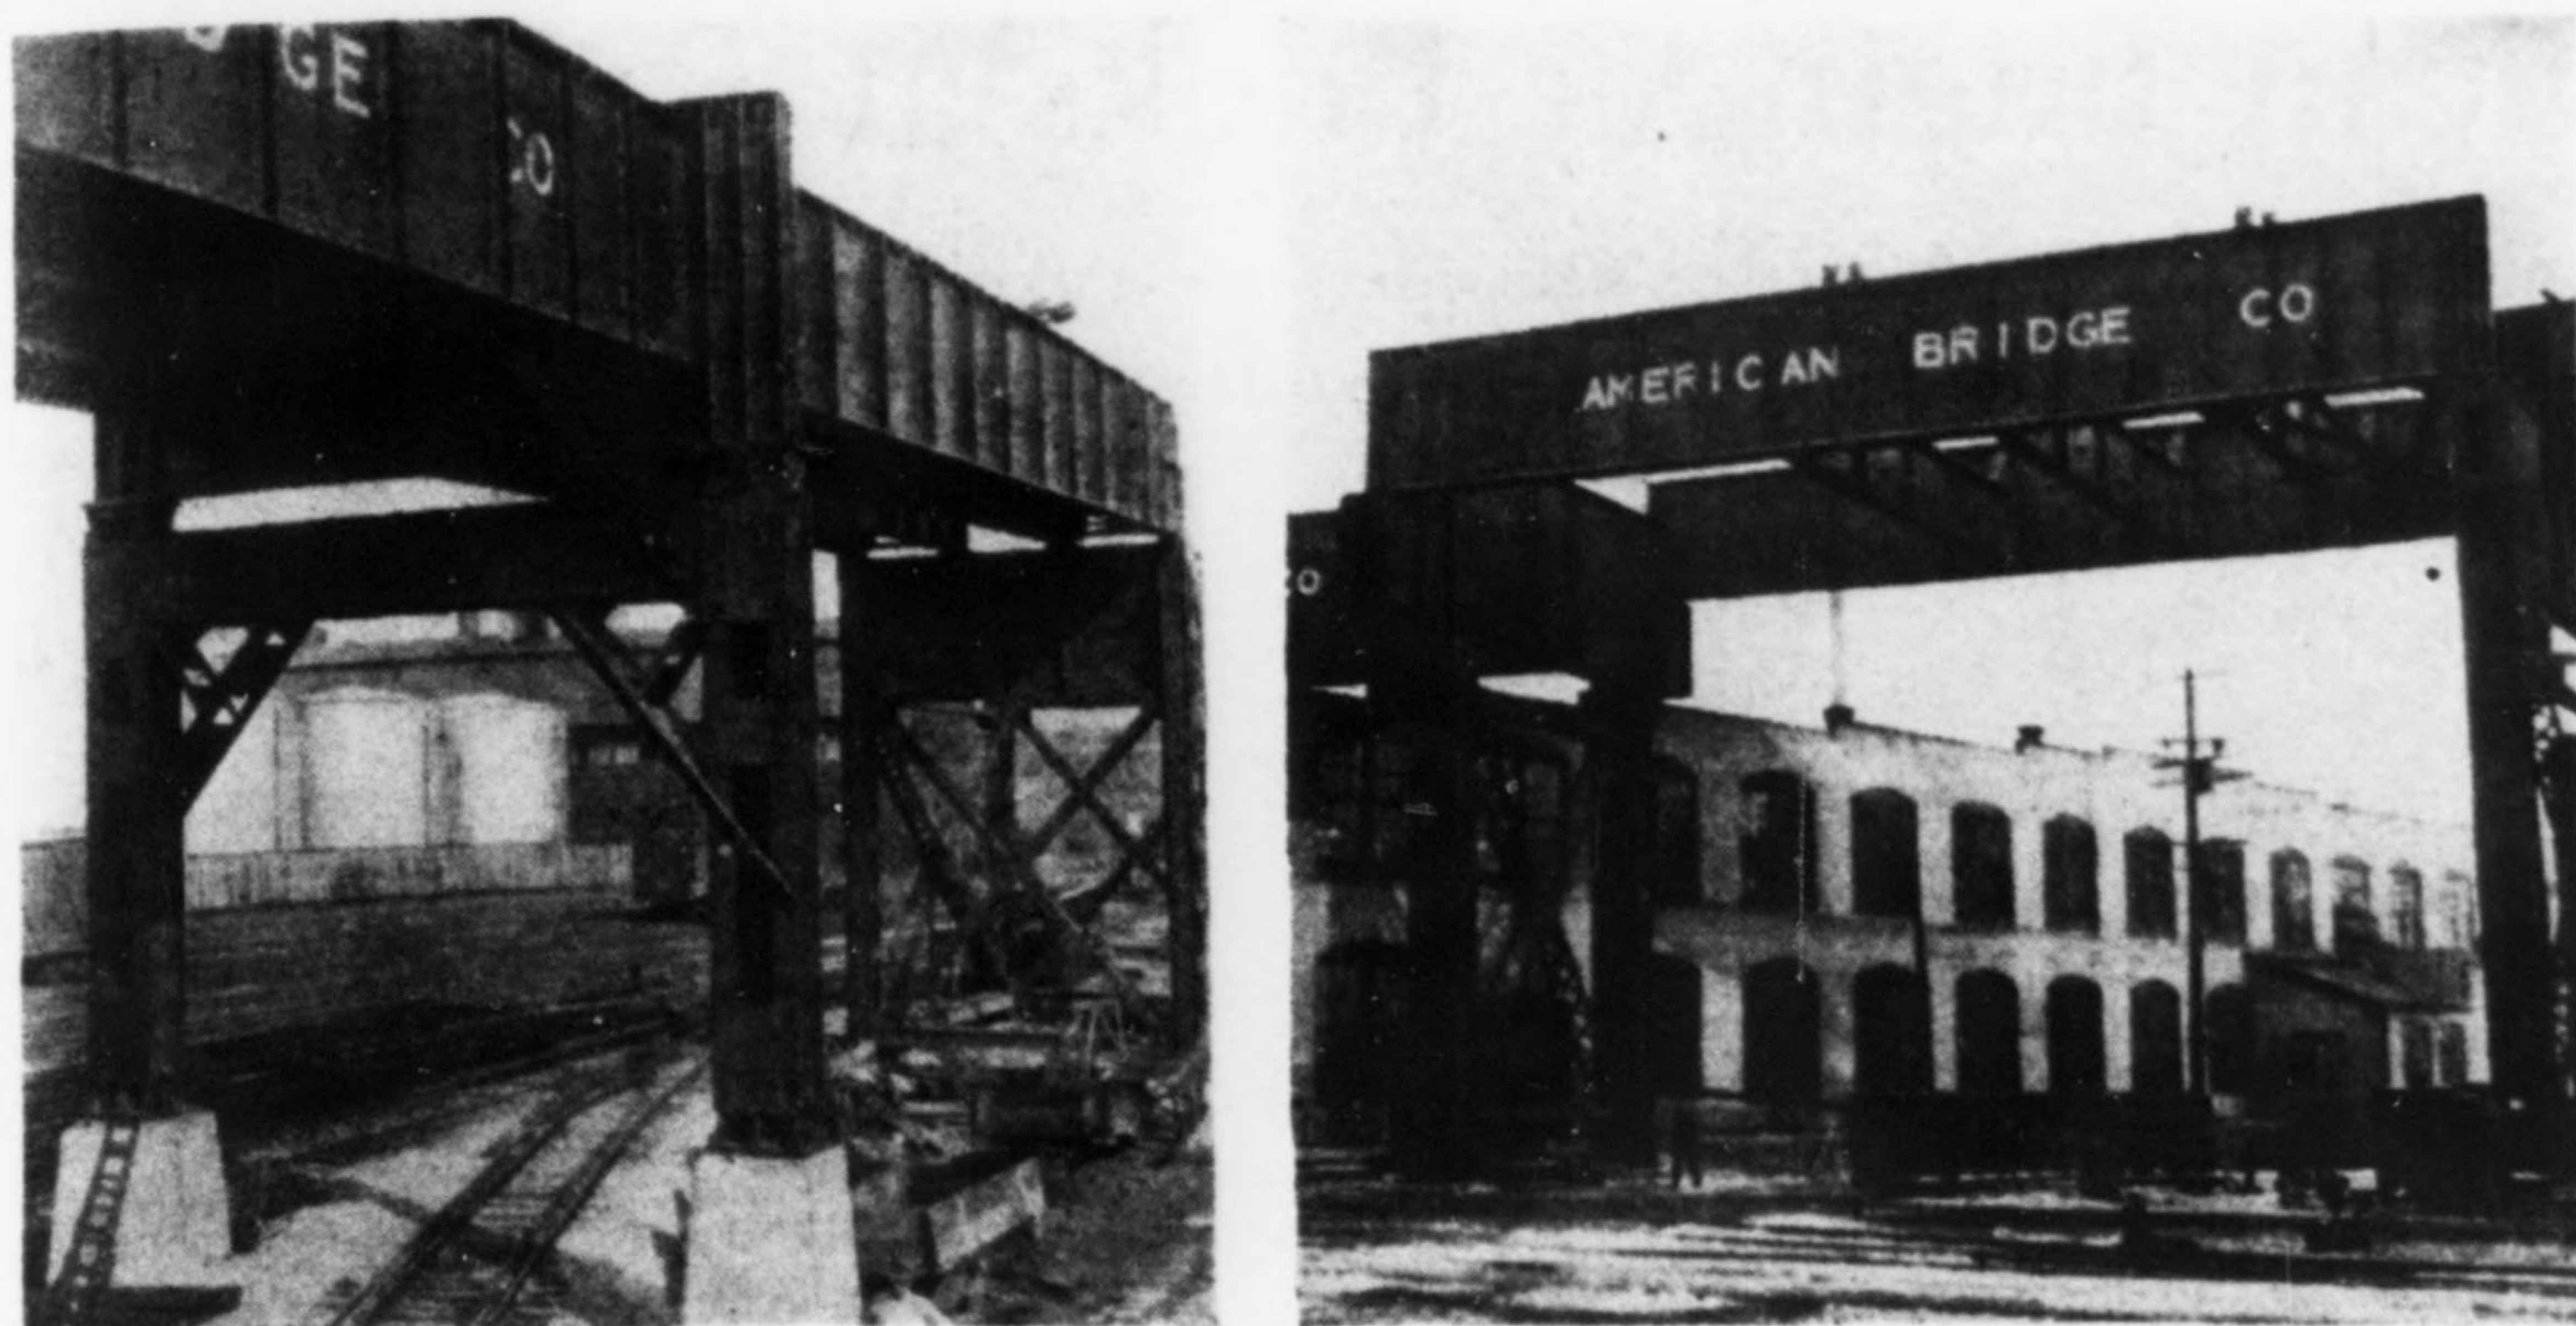
FIG. 5—PIN-CONNECTED VIADUCT BENTS  
Note cantilever ends of cross-girders.

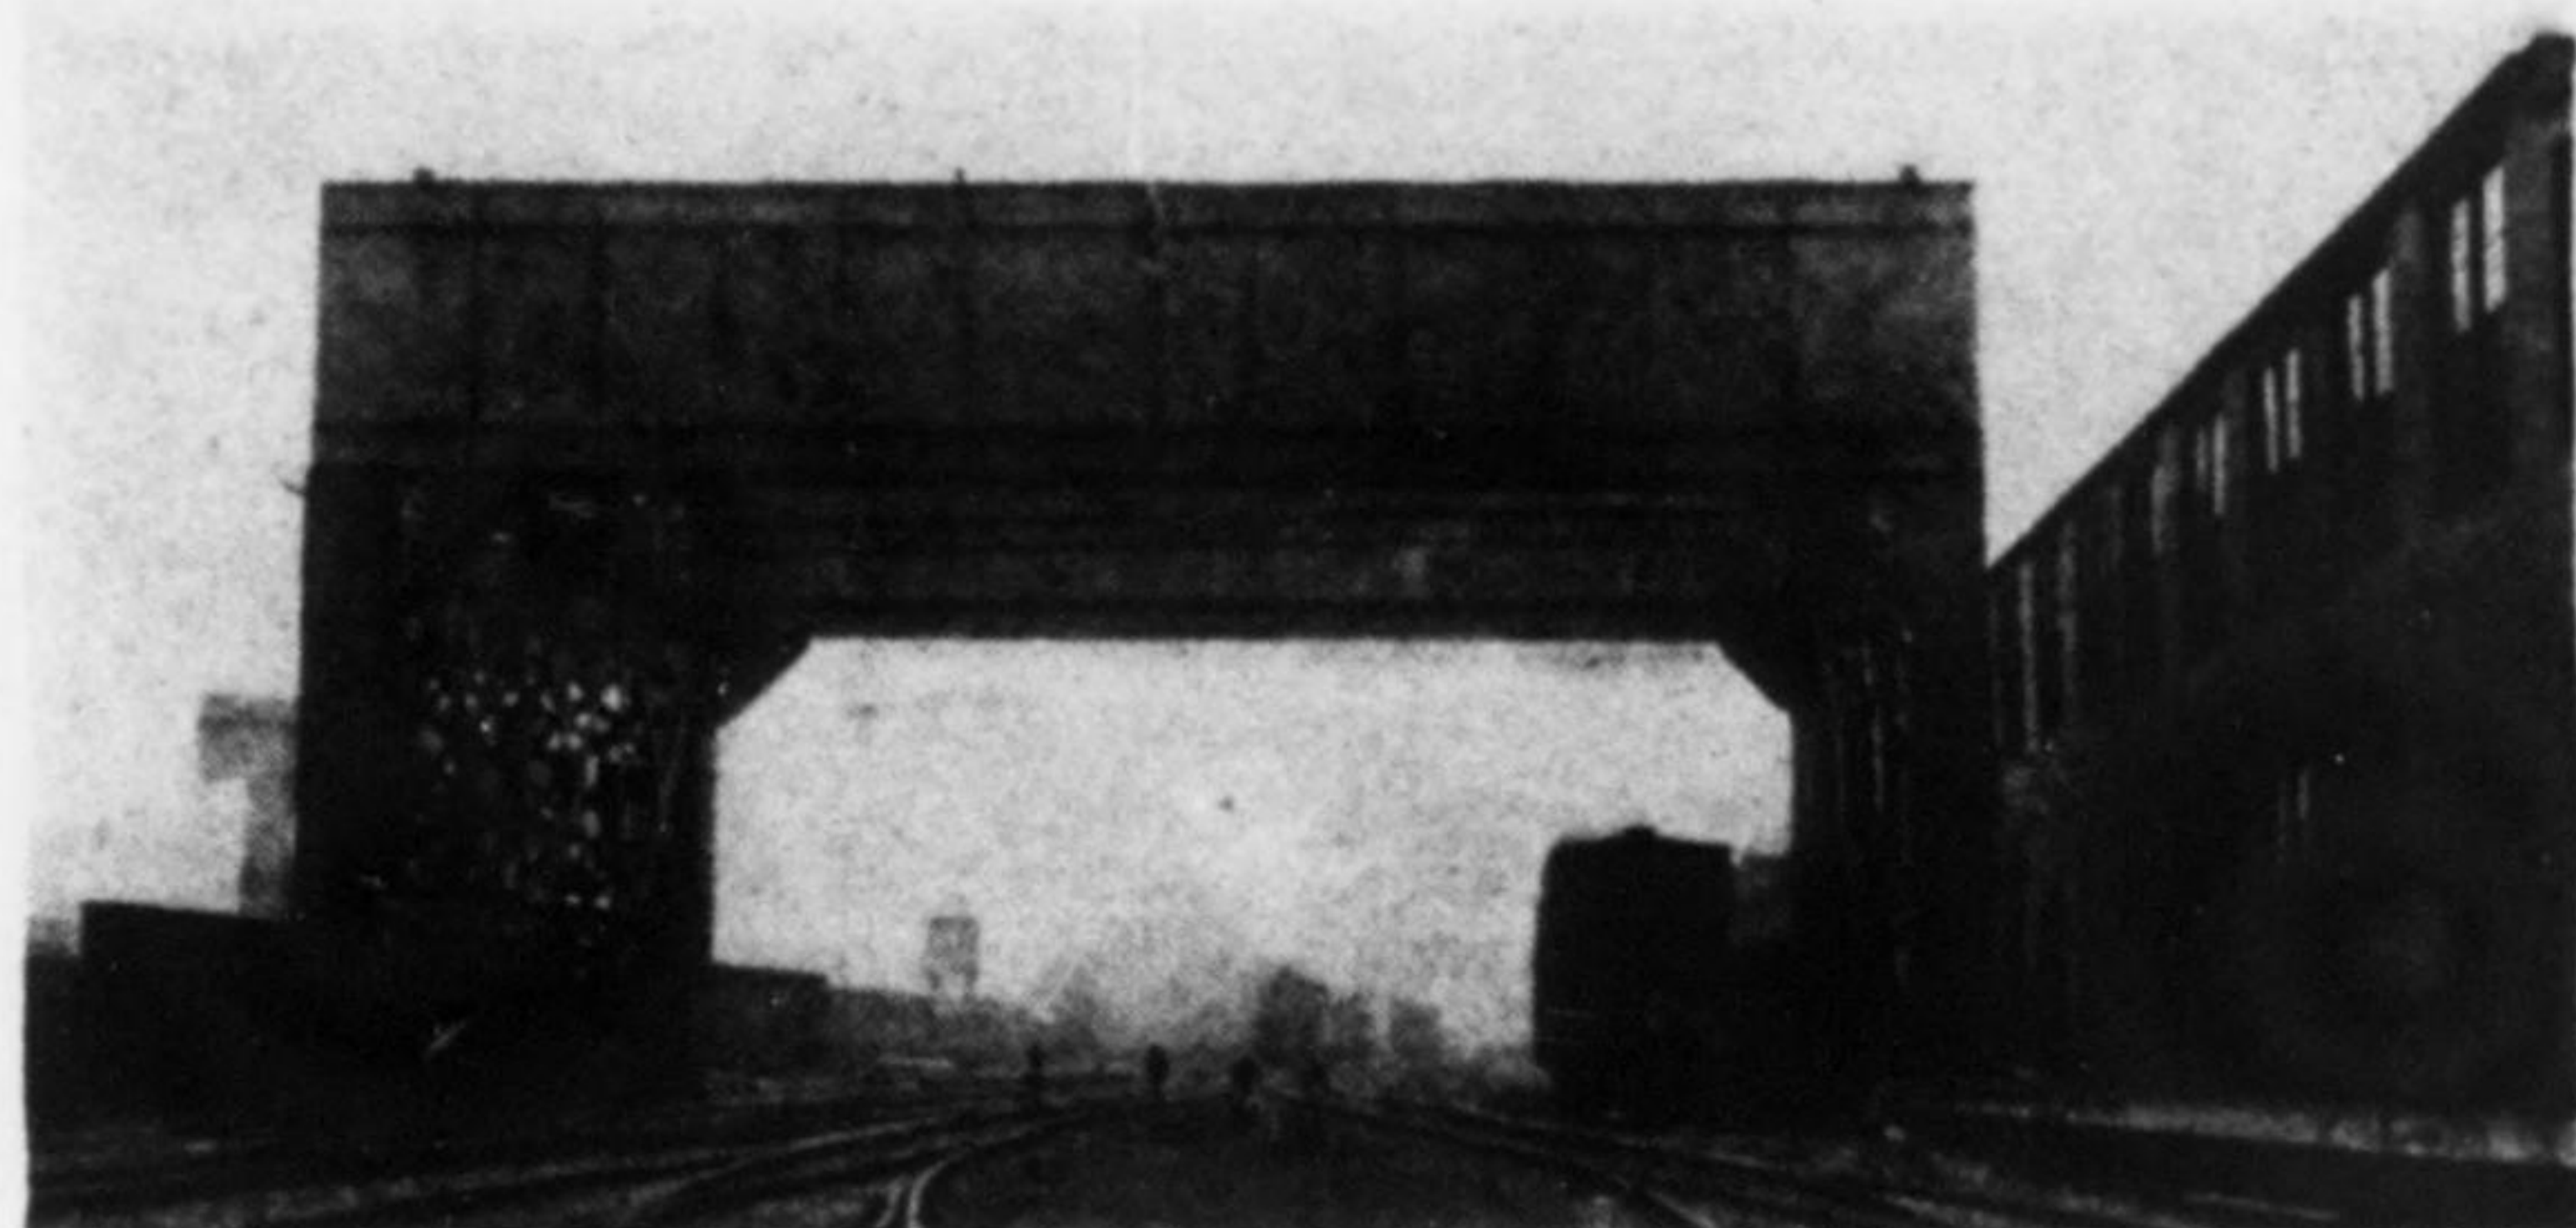
FIG. 6—SPECIAL VIADUCT CONSTRUCTION  
Above—Bent at left has farther column braced longitudinally and bent at right is braced laterally; the next bent is skewed and two A-frames carry the cross-girder. Below—Two bents form square tower, across which the track stringers run diagonally.

An example of one of the special problems encountered is illustrated by the bent, No. 21, in the upper view of Fig. 6, which carries a 100-ft. through span and a 68-ft. deck span. Because of the surface tracks on which a locomotive crane must operate with top of boom 42 ft. above the ground, the columns had to be spread 40 ft. c. to c. With the very tall columns, it was necessary to brace the bent in the manner shown to provide for both lateral and longitudinal stability against traction and centrifugal forces in addition to wind and sway. The next bent, No. 22, also shown in the upper view of Fig. 6, is a badly skewed A-frame to permit a roadway to pass under the structure.

Immediately south is an almost square tower, shown by the lower view in Fig. 6, consisting of two bents (23 and 24 in Fig. 3) spaced 55 ft. c. to c. and having their columns 57.5 ft. c. to c. These bents span four busy tracks of the Missouri Pacific Railroad. The tower forms a table on which rest the 61½-ft. girders that carry the deck, these girders lying diagonally across the tower and the span being partly on tangent and partly on curve. A deck-truss span (Fig. 7) was found advisable in passing diagonally over a foundry building in which no sup-
