Documentation of the Historic North River Bridge

Bridge No. K0073
Marion County, Route 168
September 2012

Historic and Photographic Documentation

HISTORIC DOCUMENTATION
BRIDGE K0073
Over the North River, Route 168, Marion County

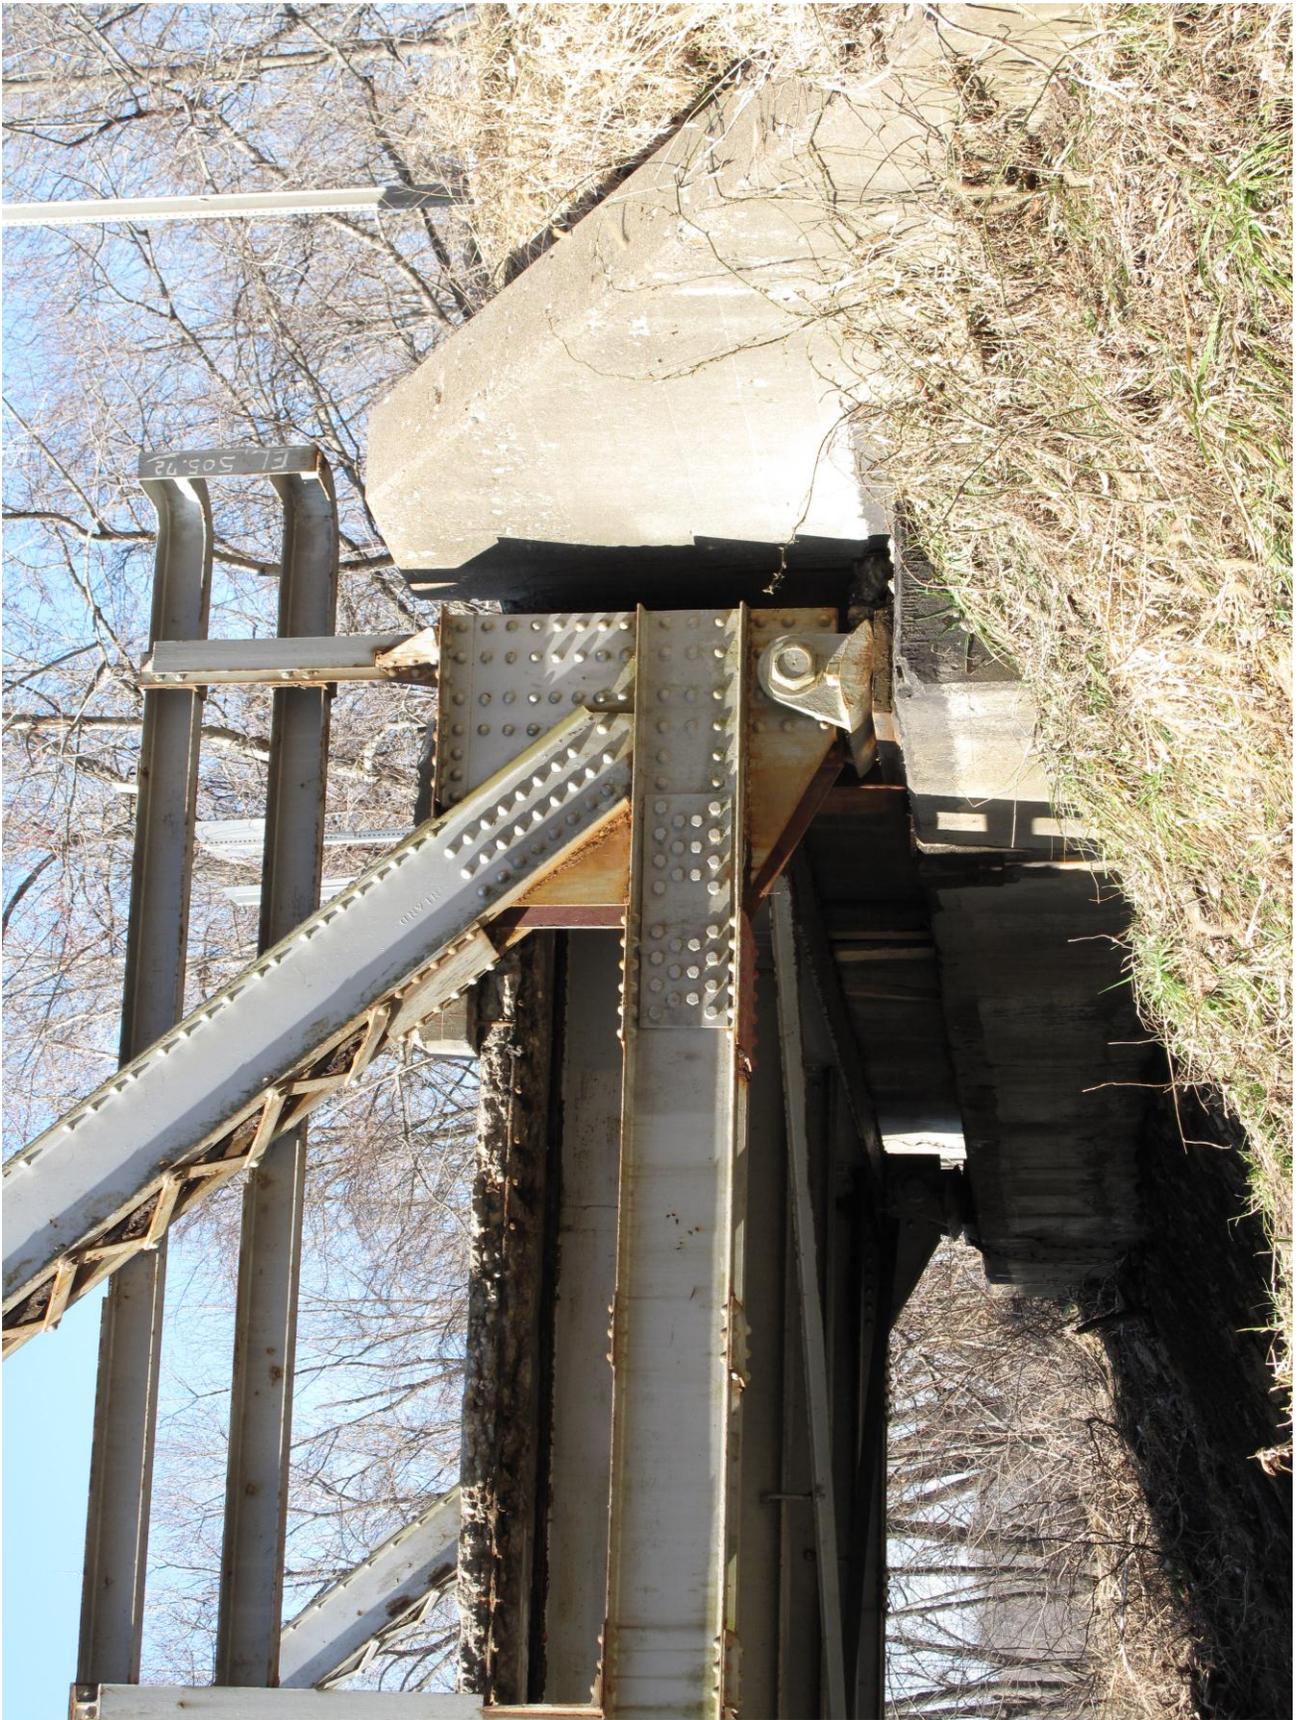
#16 of 40. Bridge K0073. Bent 1 abutment. View to northwest.

Bent 1 is the abutment on the north end of the bridge. The footings of bent 1 are set into rock at an elevation of 472' 6" above mean sea level, and are 5' wide, 11' 3" long and 2' 6" thick. Rising from the footings are two columns that are 23' 4-3/4" high and which taper from 9' 3" deep at the footing to 3' 5" deep at the top of the shaft. Joining the shafts to the bent cap are shoulders which taper 18" wider than the shafts on each side and which are 18" tall. Atop the shaft is a bent cap with the bridge seat and attached wing walls. The bent cap is 2' 6" below the bridge seat and has a 4' 2" high backwall. It is 44' 9" wide from the outer (lower) edges of the wing walls to 13' 6" wide at the top of the wing walls. The bridge seat is 2' 5" deep and the back wall is 12" deep. The height varies from 18" at the outer edge of the wing walls to 7' 5" at the top of the wing walls. The total height of bent 1, from the bottom of the footings to the top of the backwall, is 32' 6-3/4". A stone revetment is located between the bent and the river. There is one 12" X 2' expansion plate centered above each shaft.

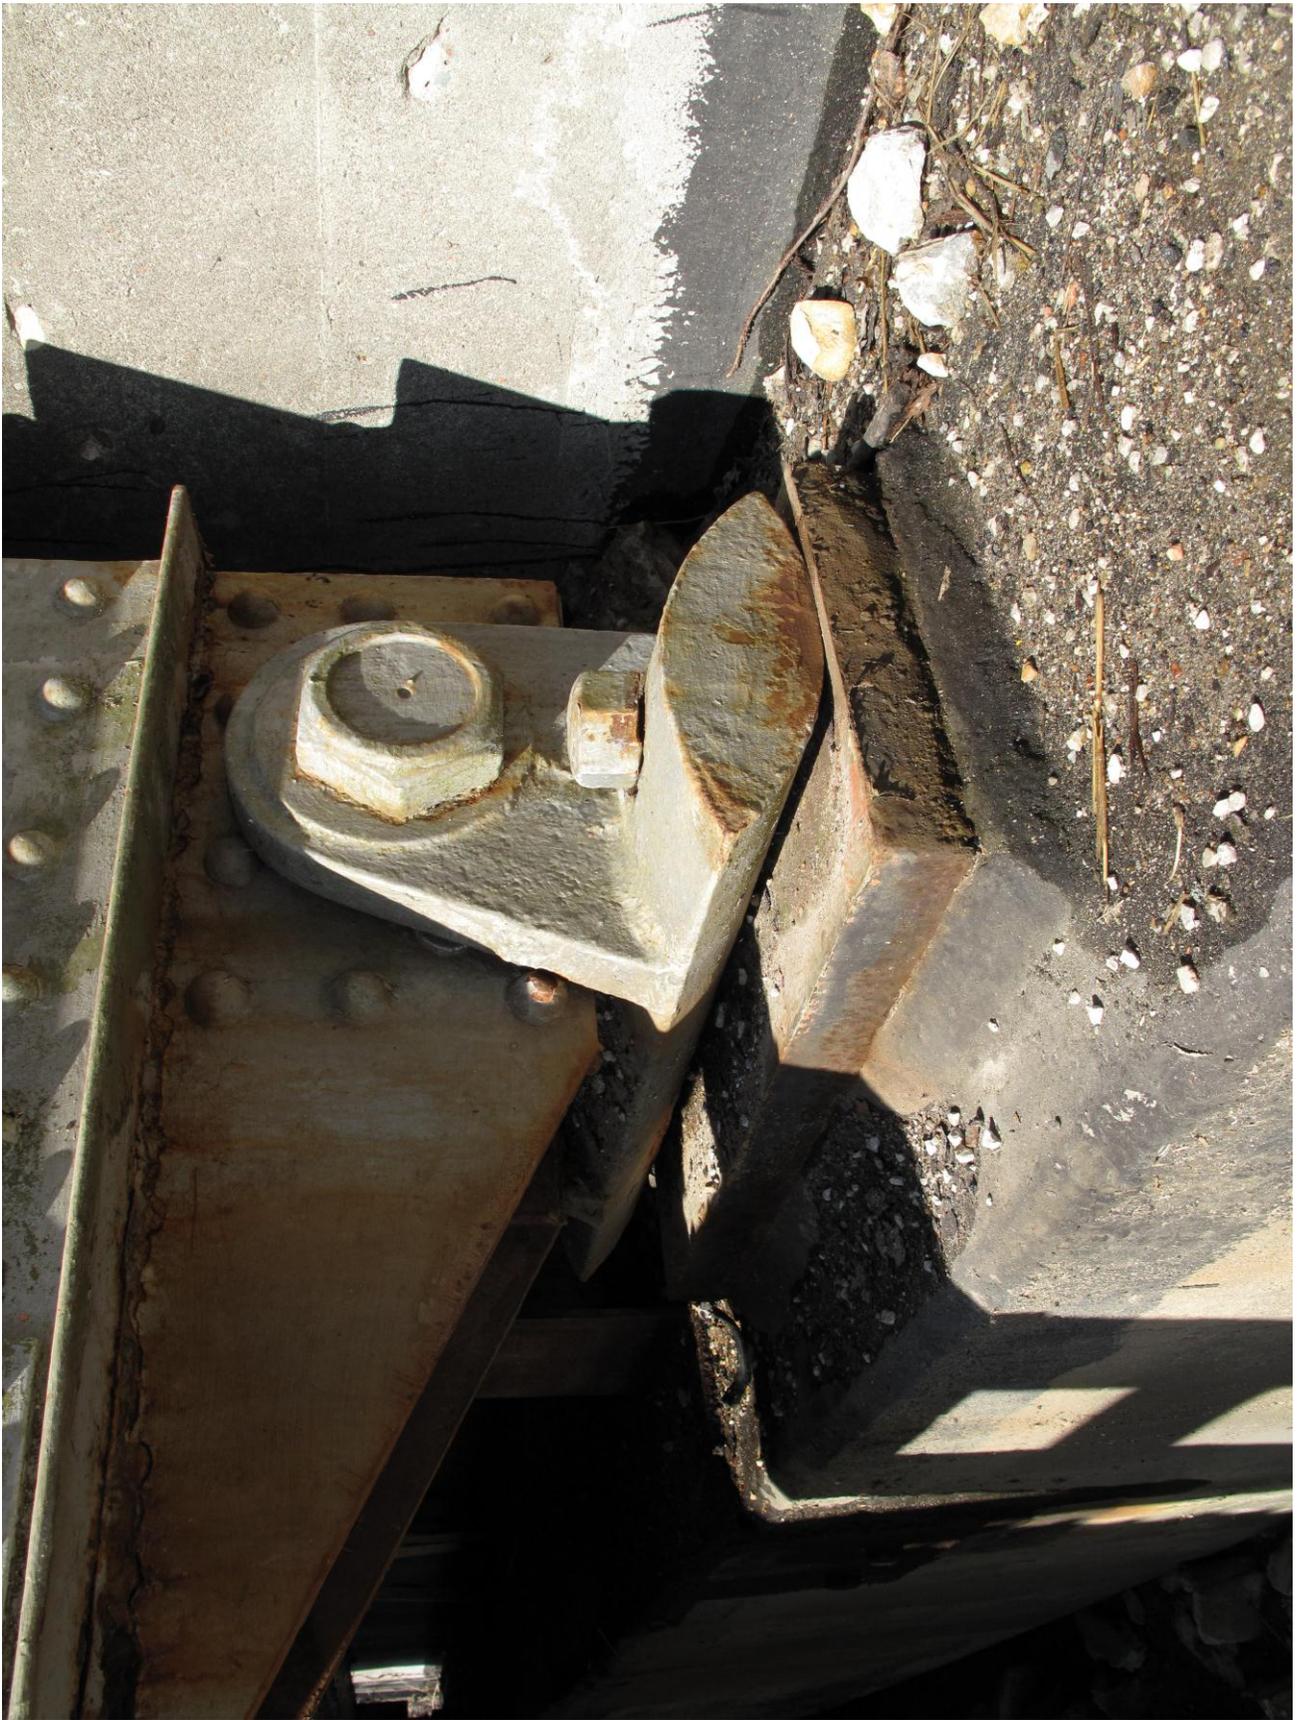
#17 of 40. Bridge K0073. Rocker bearing at Bent 1. View to northwest.

For details of shoes and rockers for truss spans see Std. S-808.

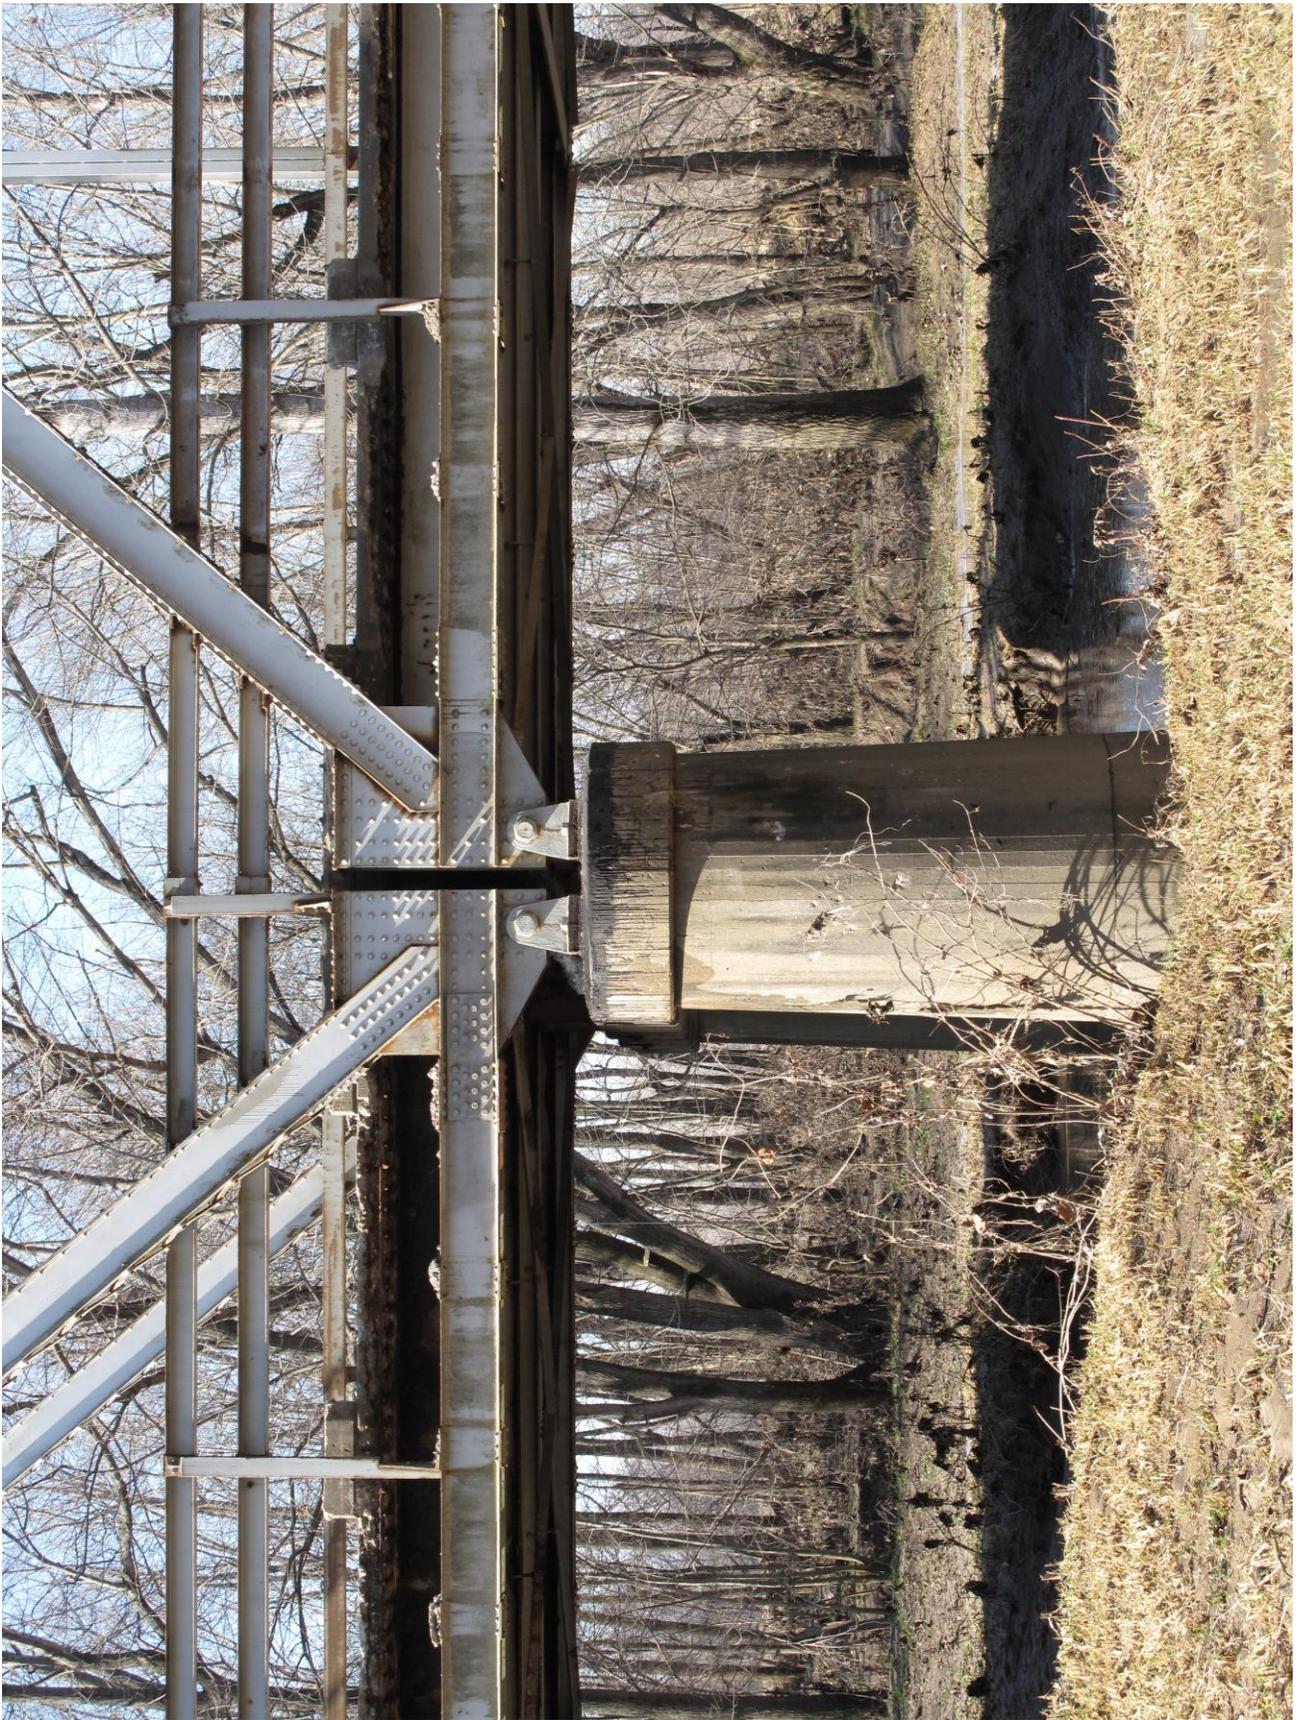
#20 of 40. Bridge K0073. Pier 2. View to west.

Pier 2 has two footings, laid to rock at an elevation of 473' 6" above mean sea level, that are 8' 3" wide and long and 5' thick. Atop each footing is a column which tapers as it rises. The columns taper from 6' 1" at the bottom to 4' 4" at the top. The center points of the columns were located 24' 4" apart. A web wall connects the two columns and begins 6' 6" above the top of the footings and rises to the top of the columns. The bent cap is 18" thick and cantilevers 6" over the columns and the web wall. The total height of the pier is 31' 10". There are two 12" X 2' fixed bearing plates on each column.

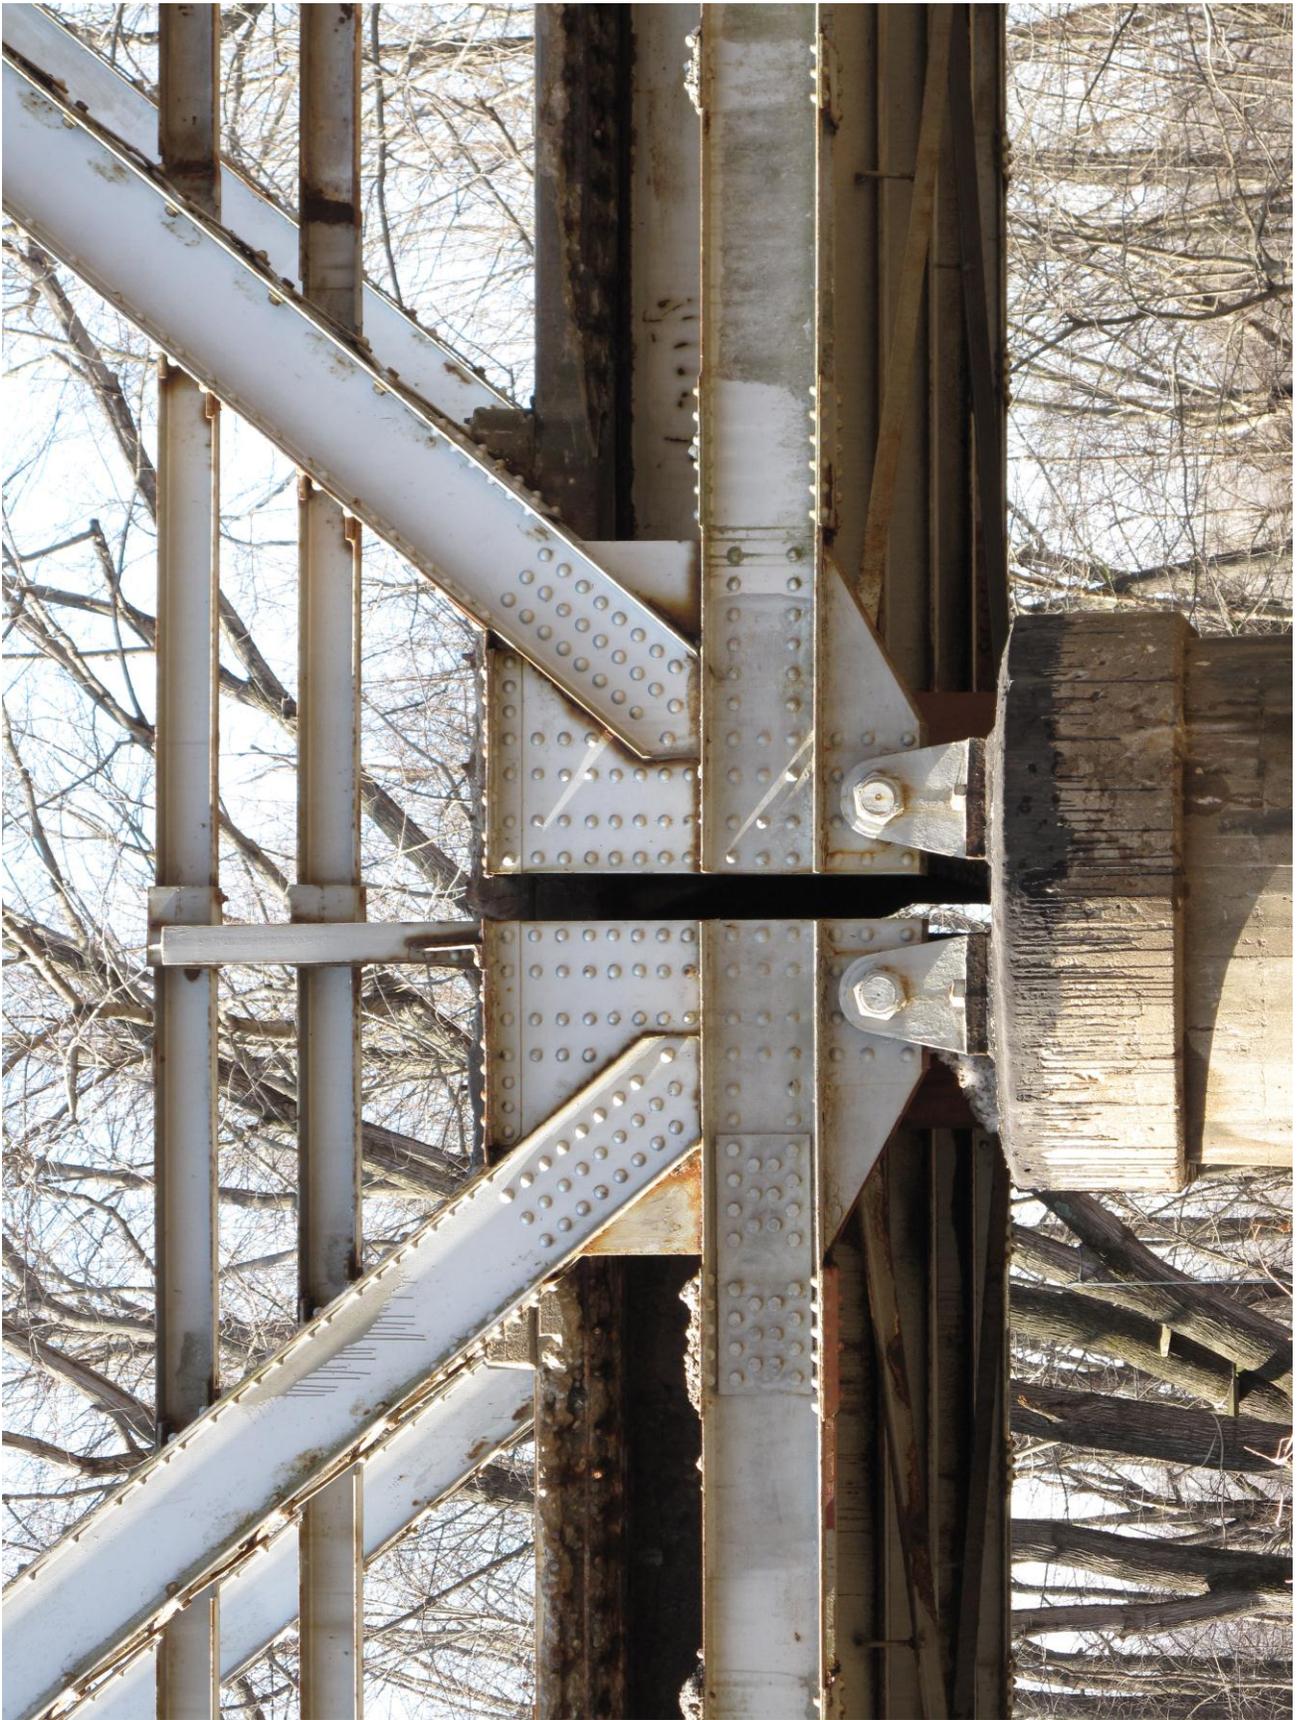
#21 of 40. Bridge K0073. Pier 2 detail. View to west.

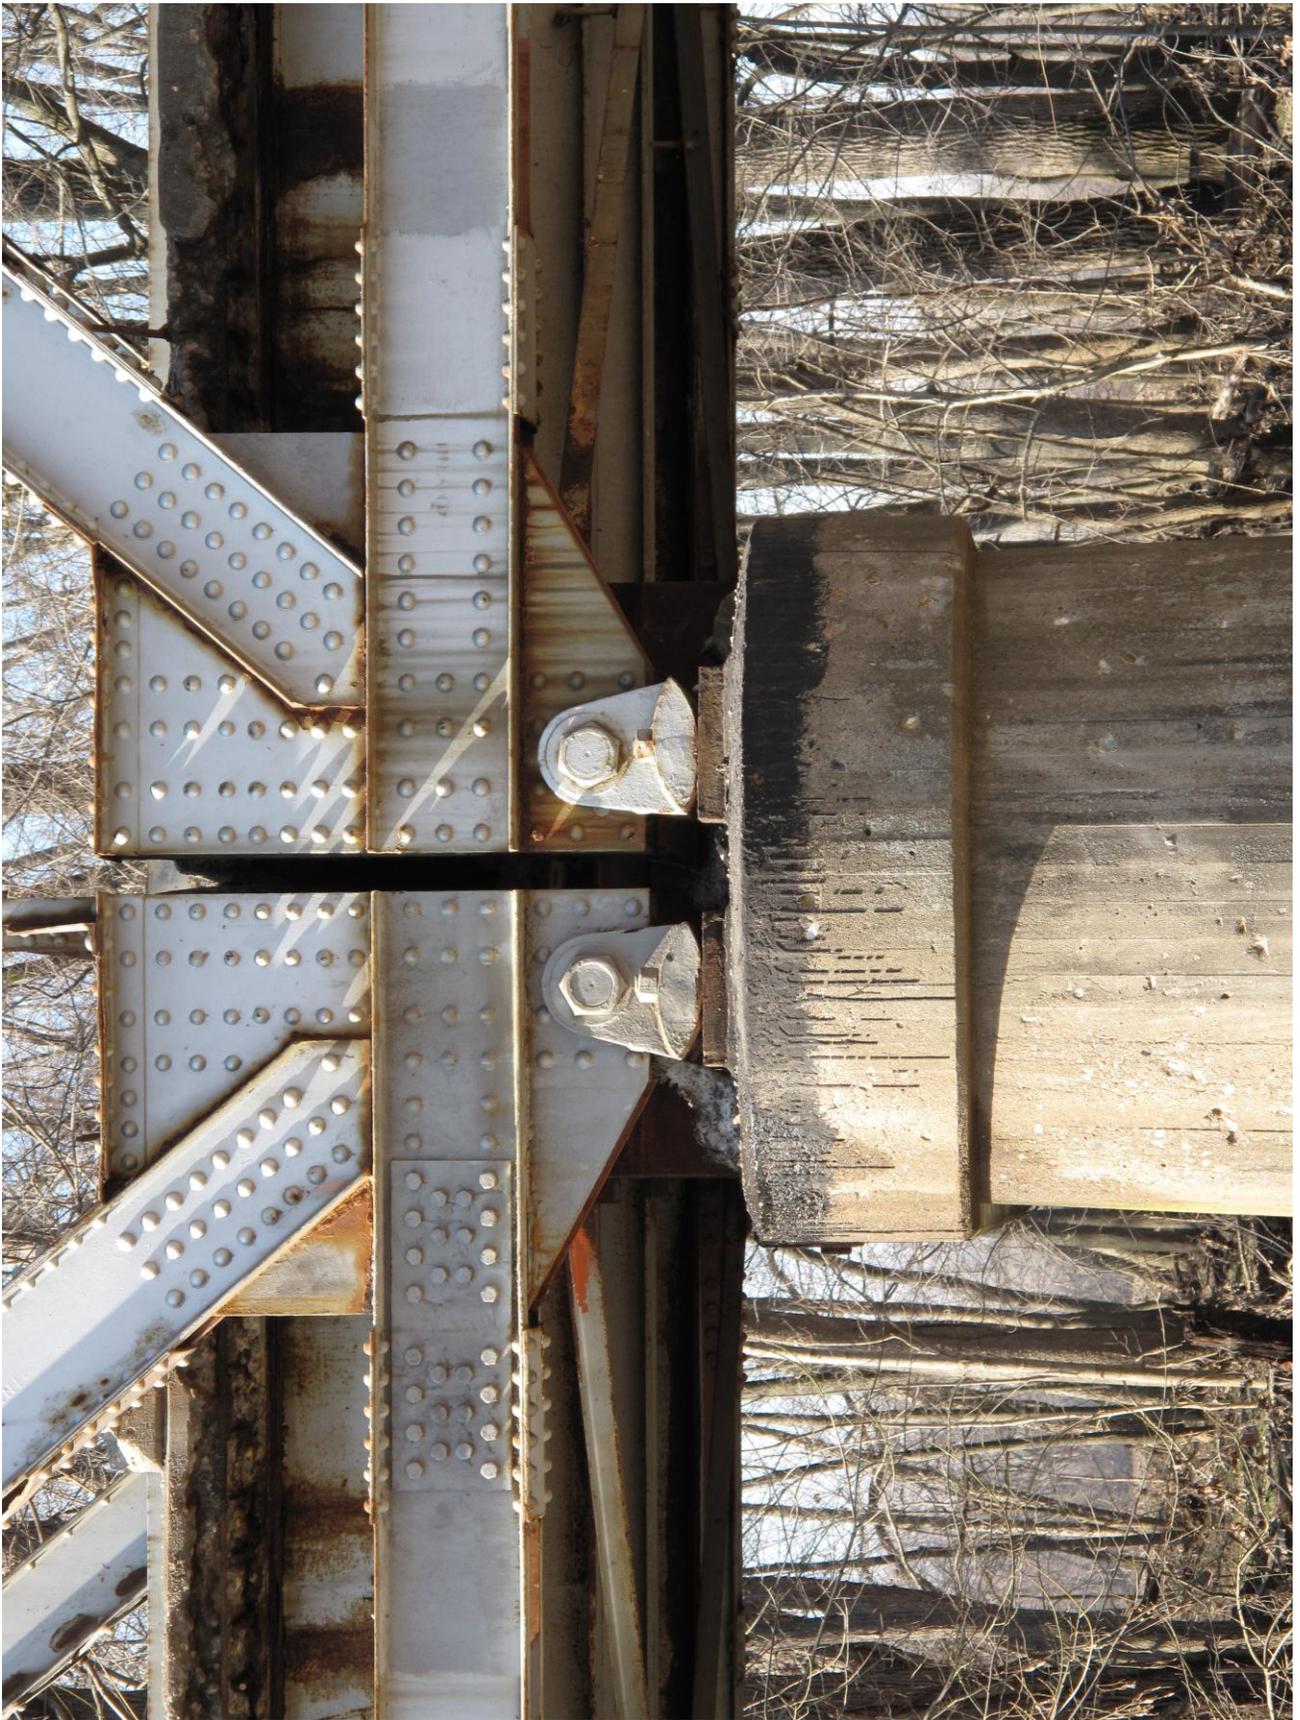
#24 of 40. Bridge K0073. Pier 3 detail. View to west.

Pier 3 has two footings, laid to rock at an elevation of 473' above mean sea level, that are 8' 3" wide and long and 5' thick. Atop each footing is a column which tapers as it rises. The columns taper from 6' 2" at the bottom to 4' 4" at the top. The center points of the columns were located 24' 4" apart. A web wall connects the two columns and begins 7' 1" above the top of the footings and rises to the top of the columns. The bent cap is 18" thick and cantilevers 6" over the columns and the web wall. The total height of the pier is 32' 5". There are two 12" X 2' expansion plates on each column.

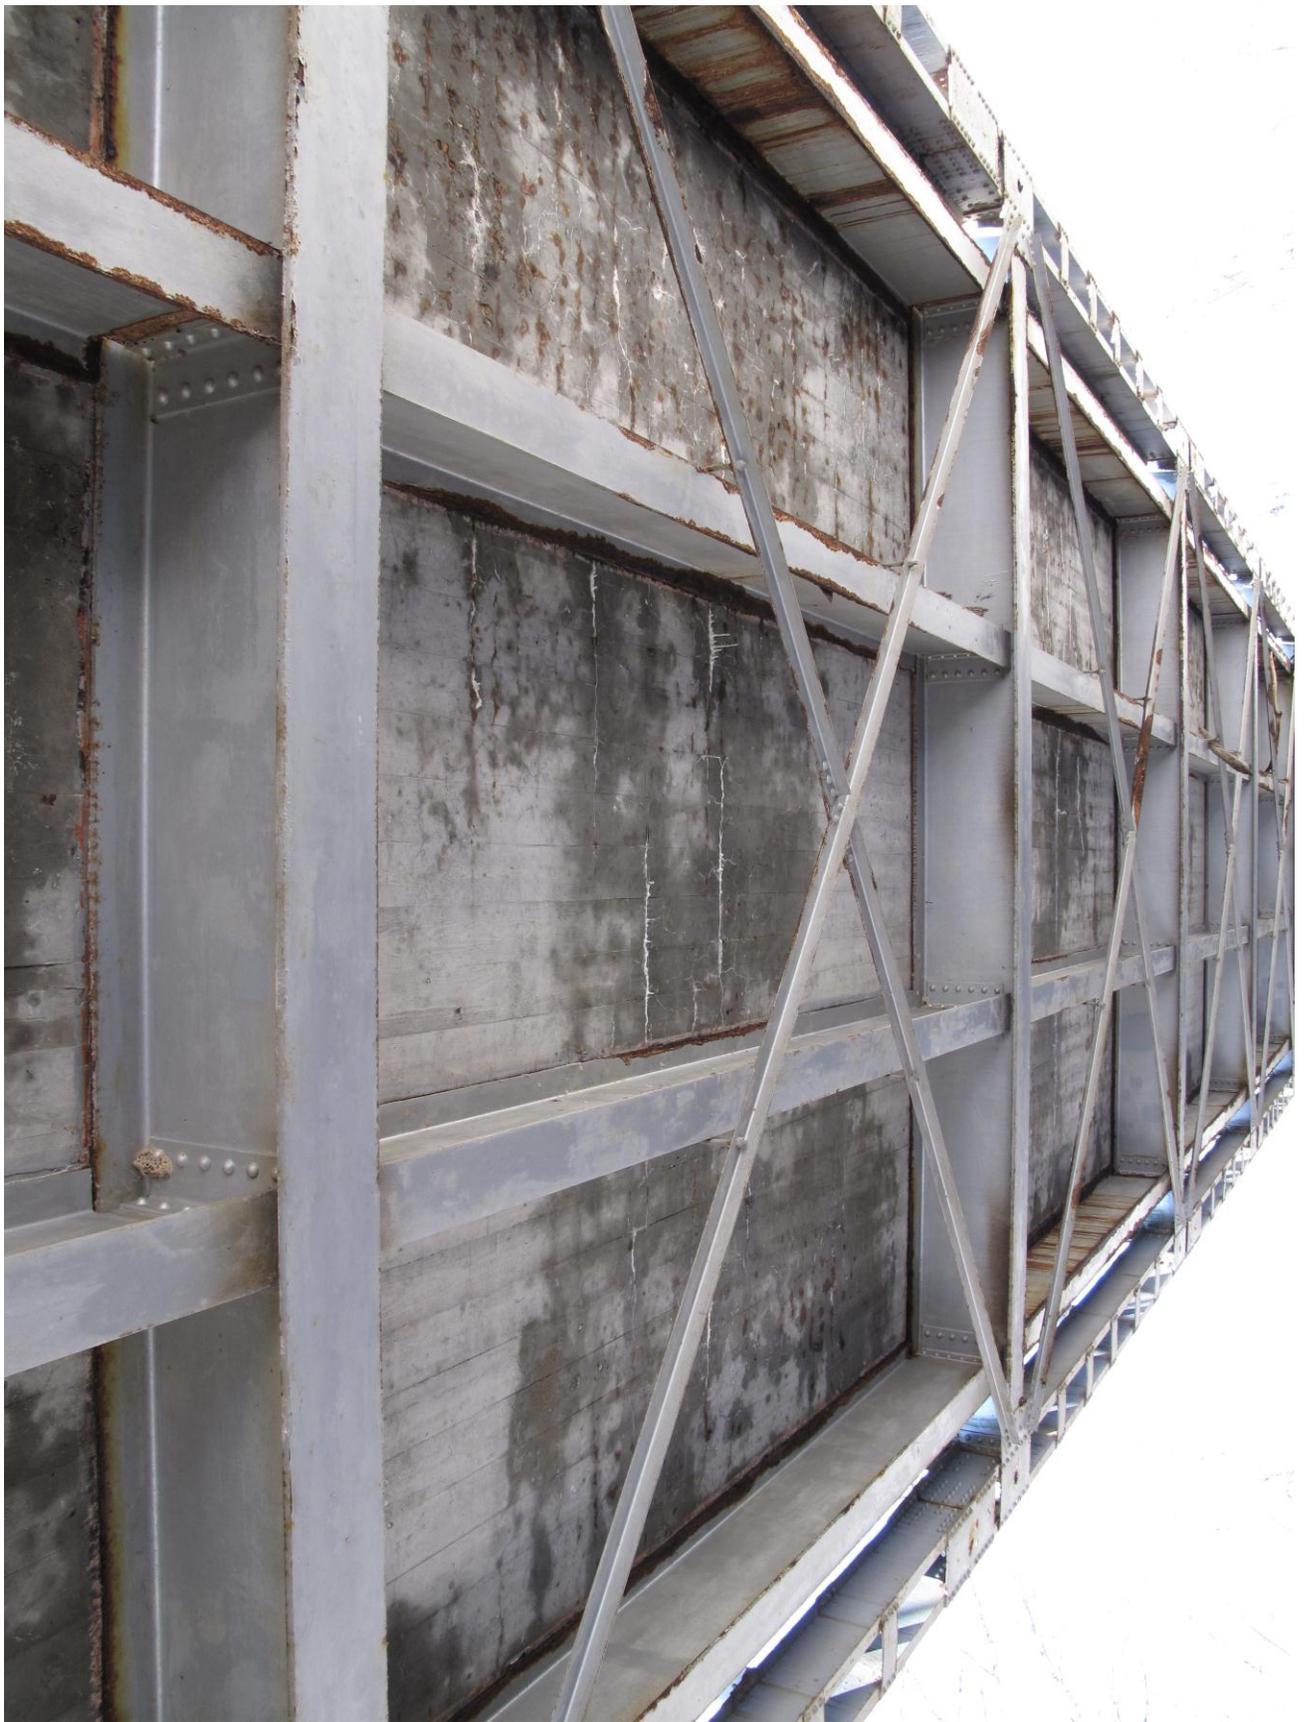
#26 of 40. Bridge K0073. Span 3 subdeck. View to south.

The bottom chord of the bridge is composed of back to back channels with plates on top and bottom. The bottom lateral bracing is formed by two angles which cross between each floor beam. Each truss has two end floor beams and six intermediate floor beams. The floor beams are composed of 24" high I-beams. There are four stringers which run between the floor beams on each truss. The stringers are 21" high I-beams that are joined to the floor beams with riveted angles.

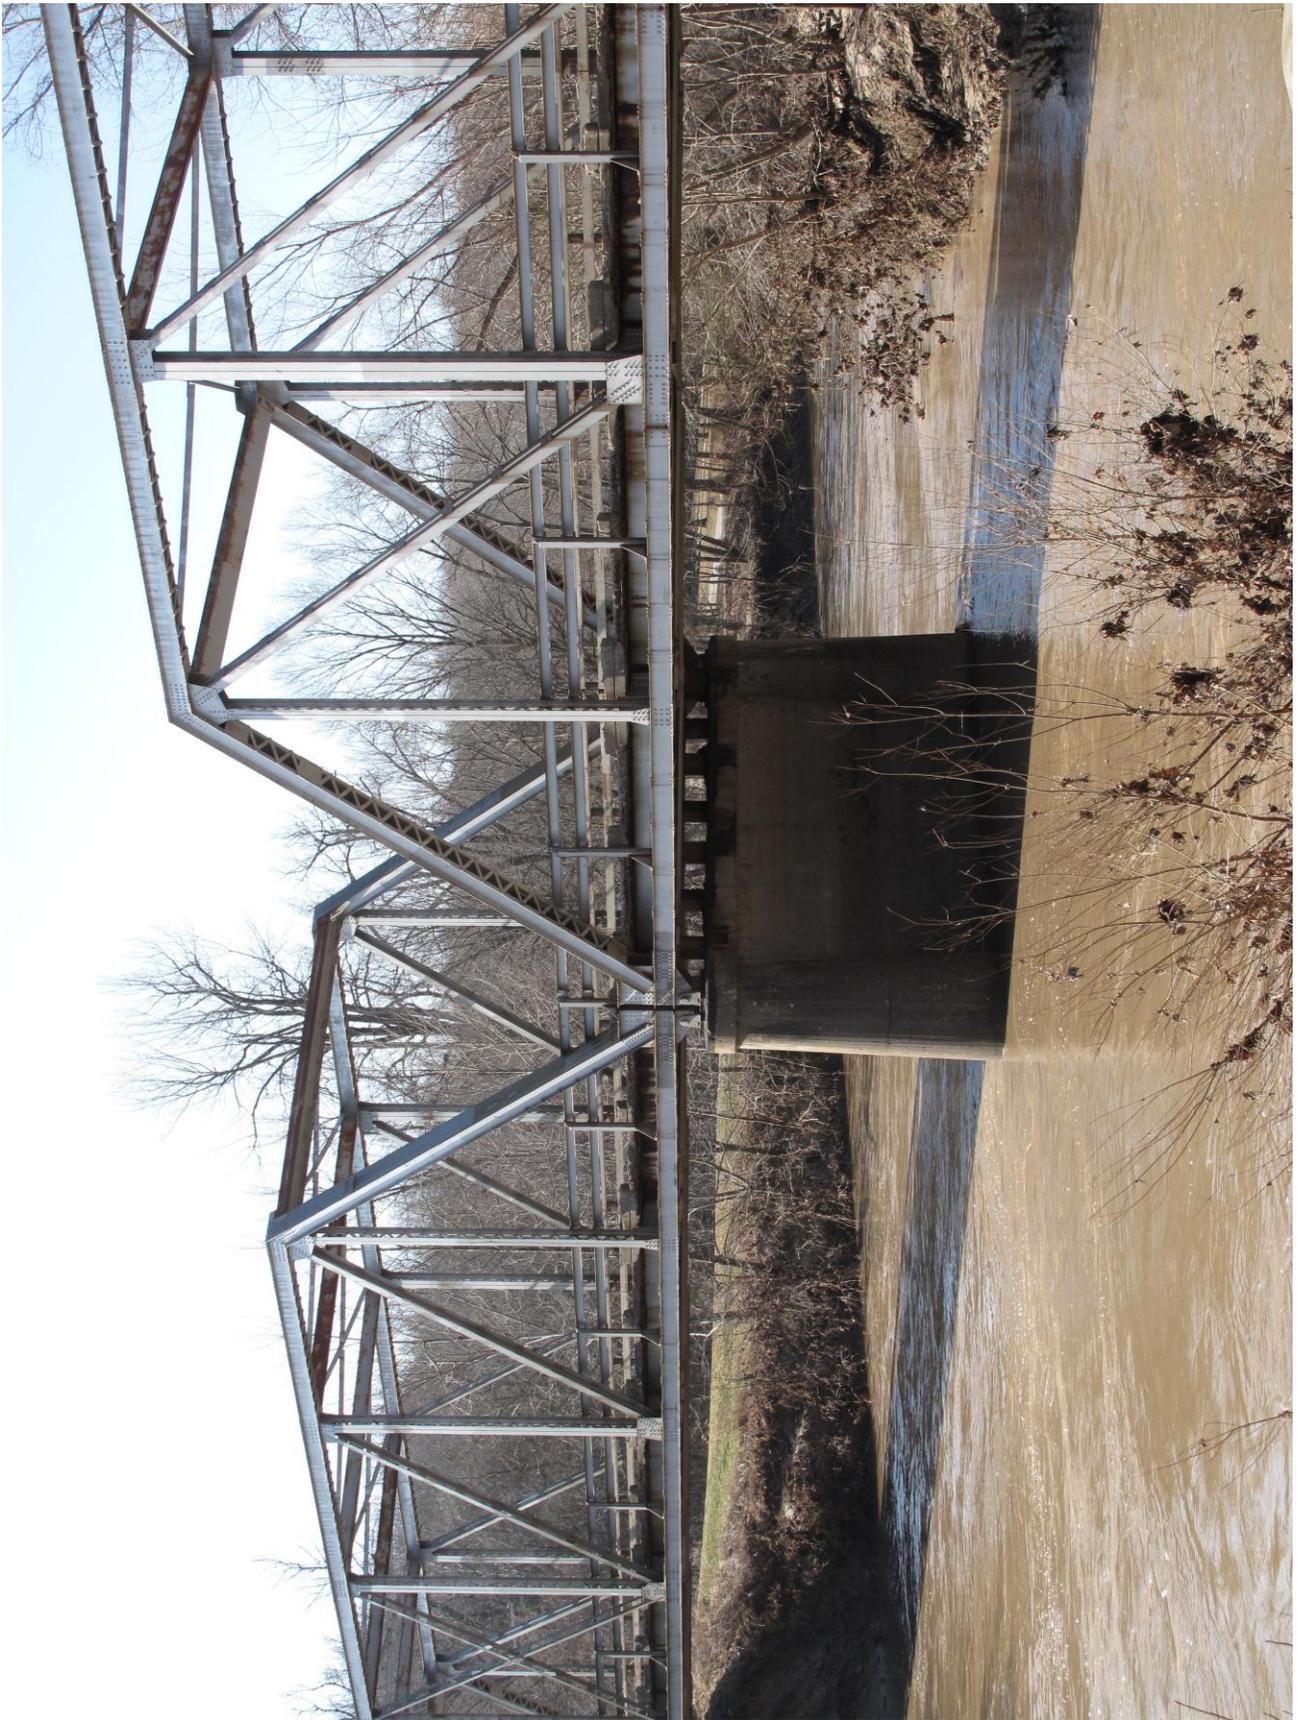
#29 of 40. Bridge K0073. Pier 4. View to southwest.

Pier 4 has two footings, laid to rock at an elevation of 473' above mean sea level, that are 8' 3" wide and long and 5' thick. Atop each footing is a column which tapers as it rises. The columns taper from 6' 2" at the bottom to 4' 4" at the top. The center points of the columns were located 24' 4" apart. A web wall connects the two columns and begins 6' 11-3/4" above the top of the footings and rises to the top of the columns. The bent cap is 18" thick and cantilevers 6" over the columns and the web wall. The total height of the pier is 32' 3-3/4". There are two 12" X 2' fixed bearing plates on each column.

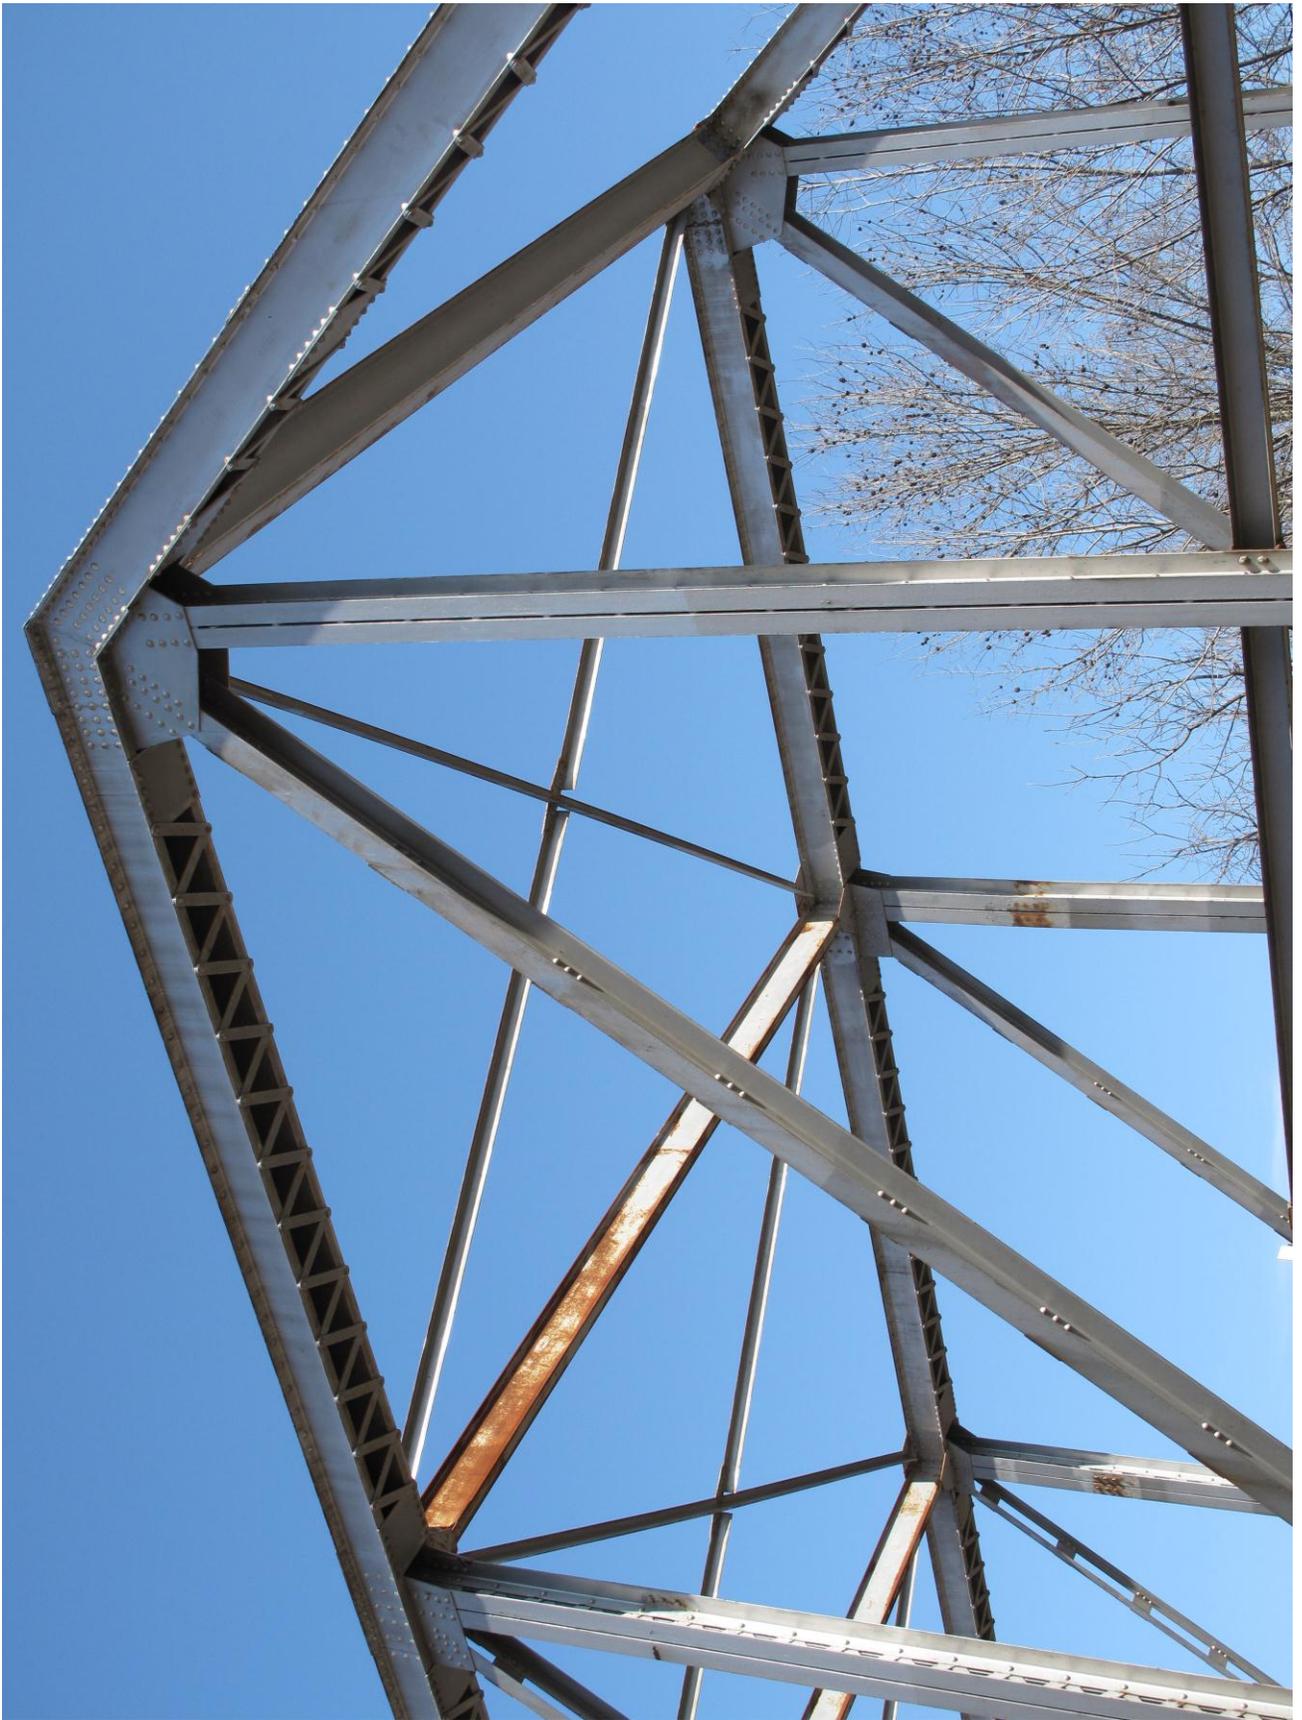
#39 of 40. Bridge K0073. Span 4 truss detail. View to northeast.
