# Erecting a 750-Ft. Steel Arch Without Falsework

Contractor utilizes cable tiebacks and temporary cable-bent towers to build each half as a cantilever arm on Croton Lake structure in Westchester County, N. Y., longest three-hinge design on record

By W. FREDERICK WELSCH  
Division Engineer, Western Division,  
Westchester County Park Commission  
Pleasantville, N. Y.

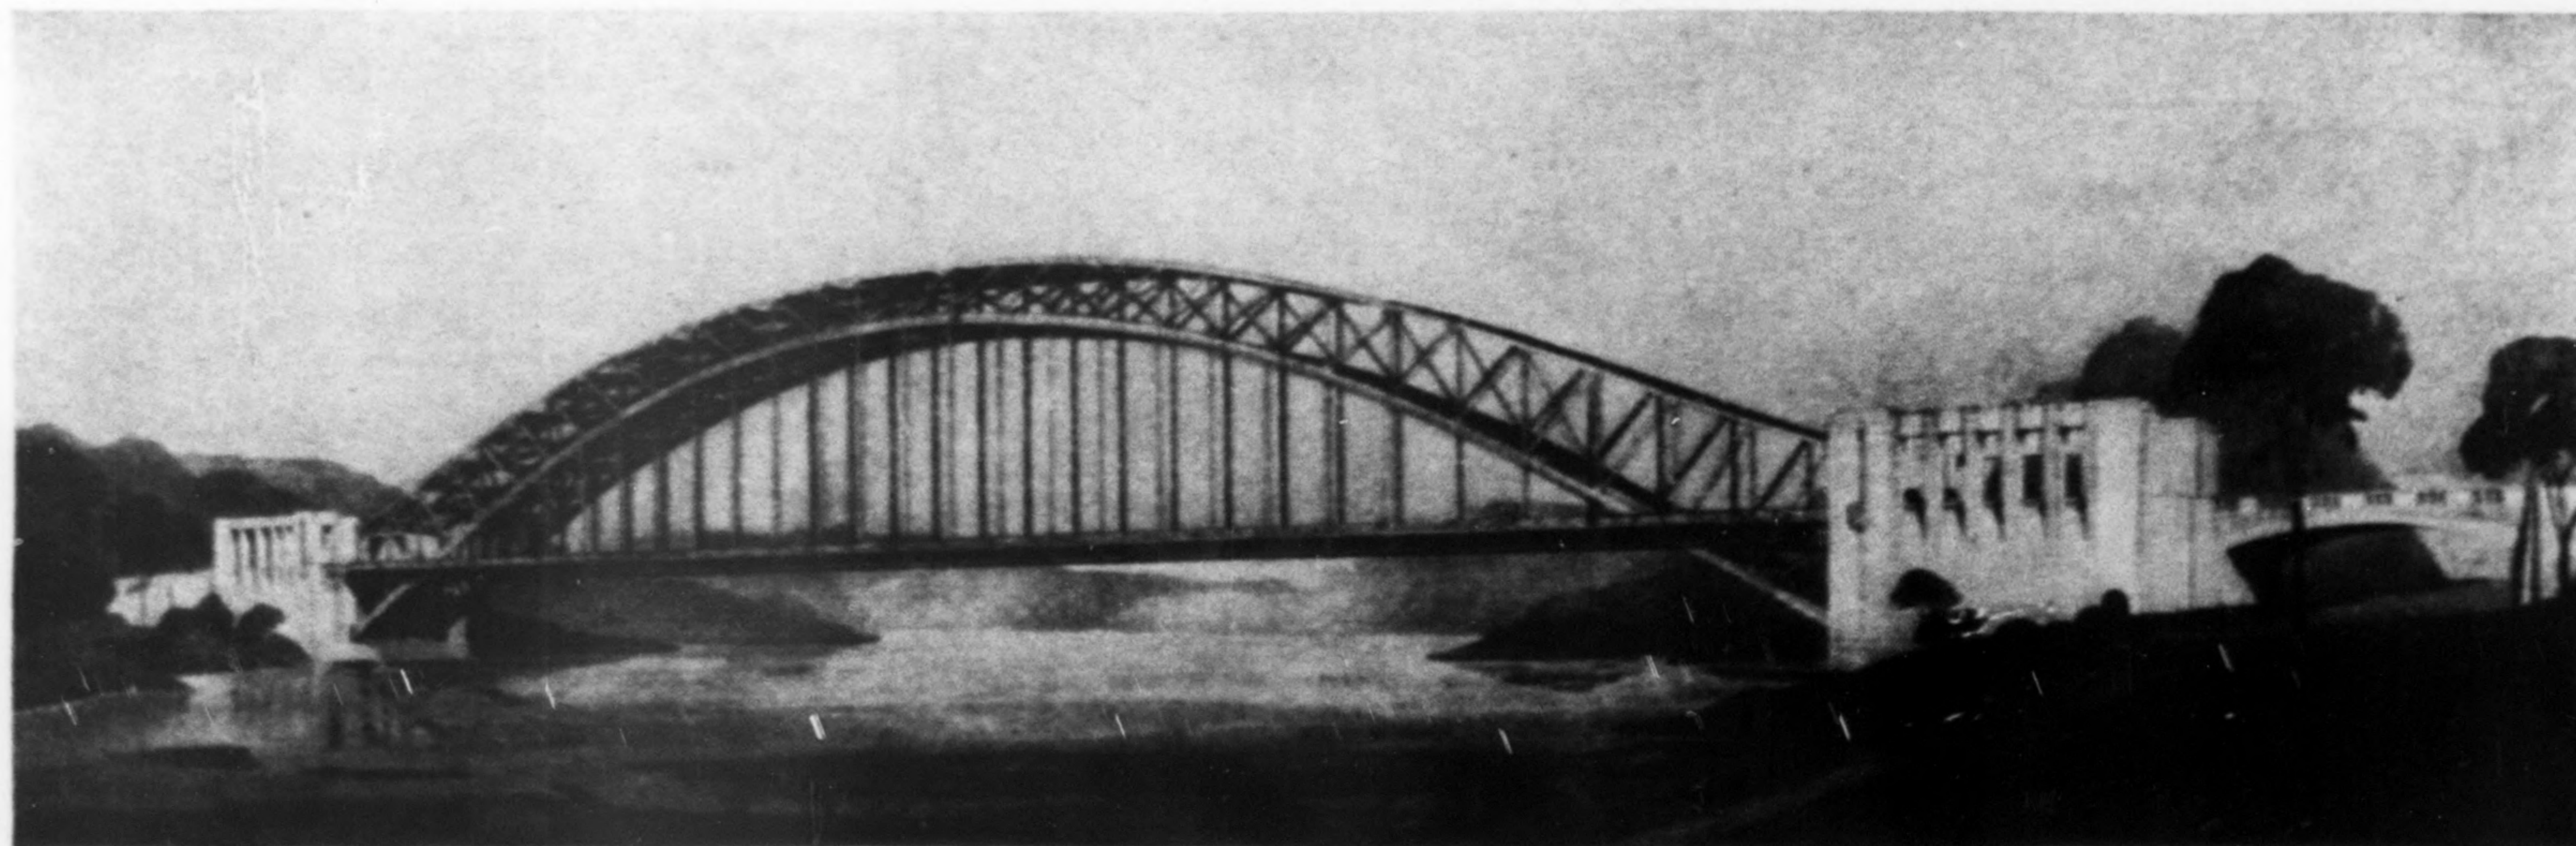
Fig. 1—New Croton Lake crossing of Bronx Parkway Extension in Westchester County, N. Y.

The monumental character of the abutment design is indicated in Fig. 1, on architect's wash drawing. These abutments as well as the flanking spans on the approaches are of concrete, unfaced, but with accentuated form-marks (Fig. 4). All pilasters and columns in the abutments are precast concrete blocks, and the concrete blocks for the balconies are made of cast stone of approximately the same color as the wall concrete.

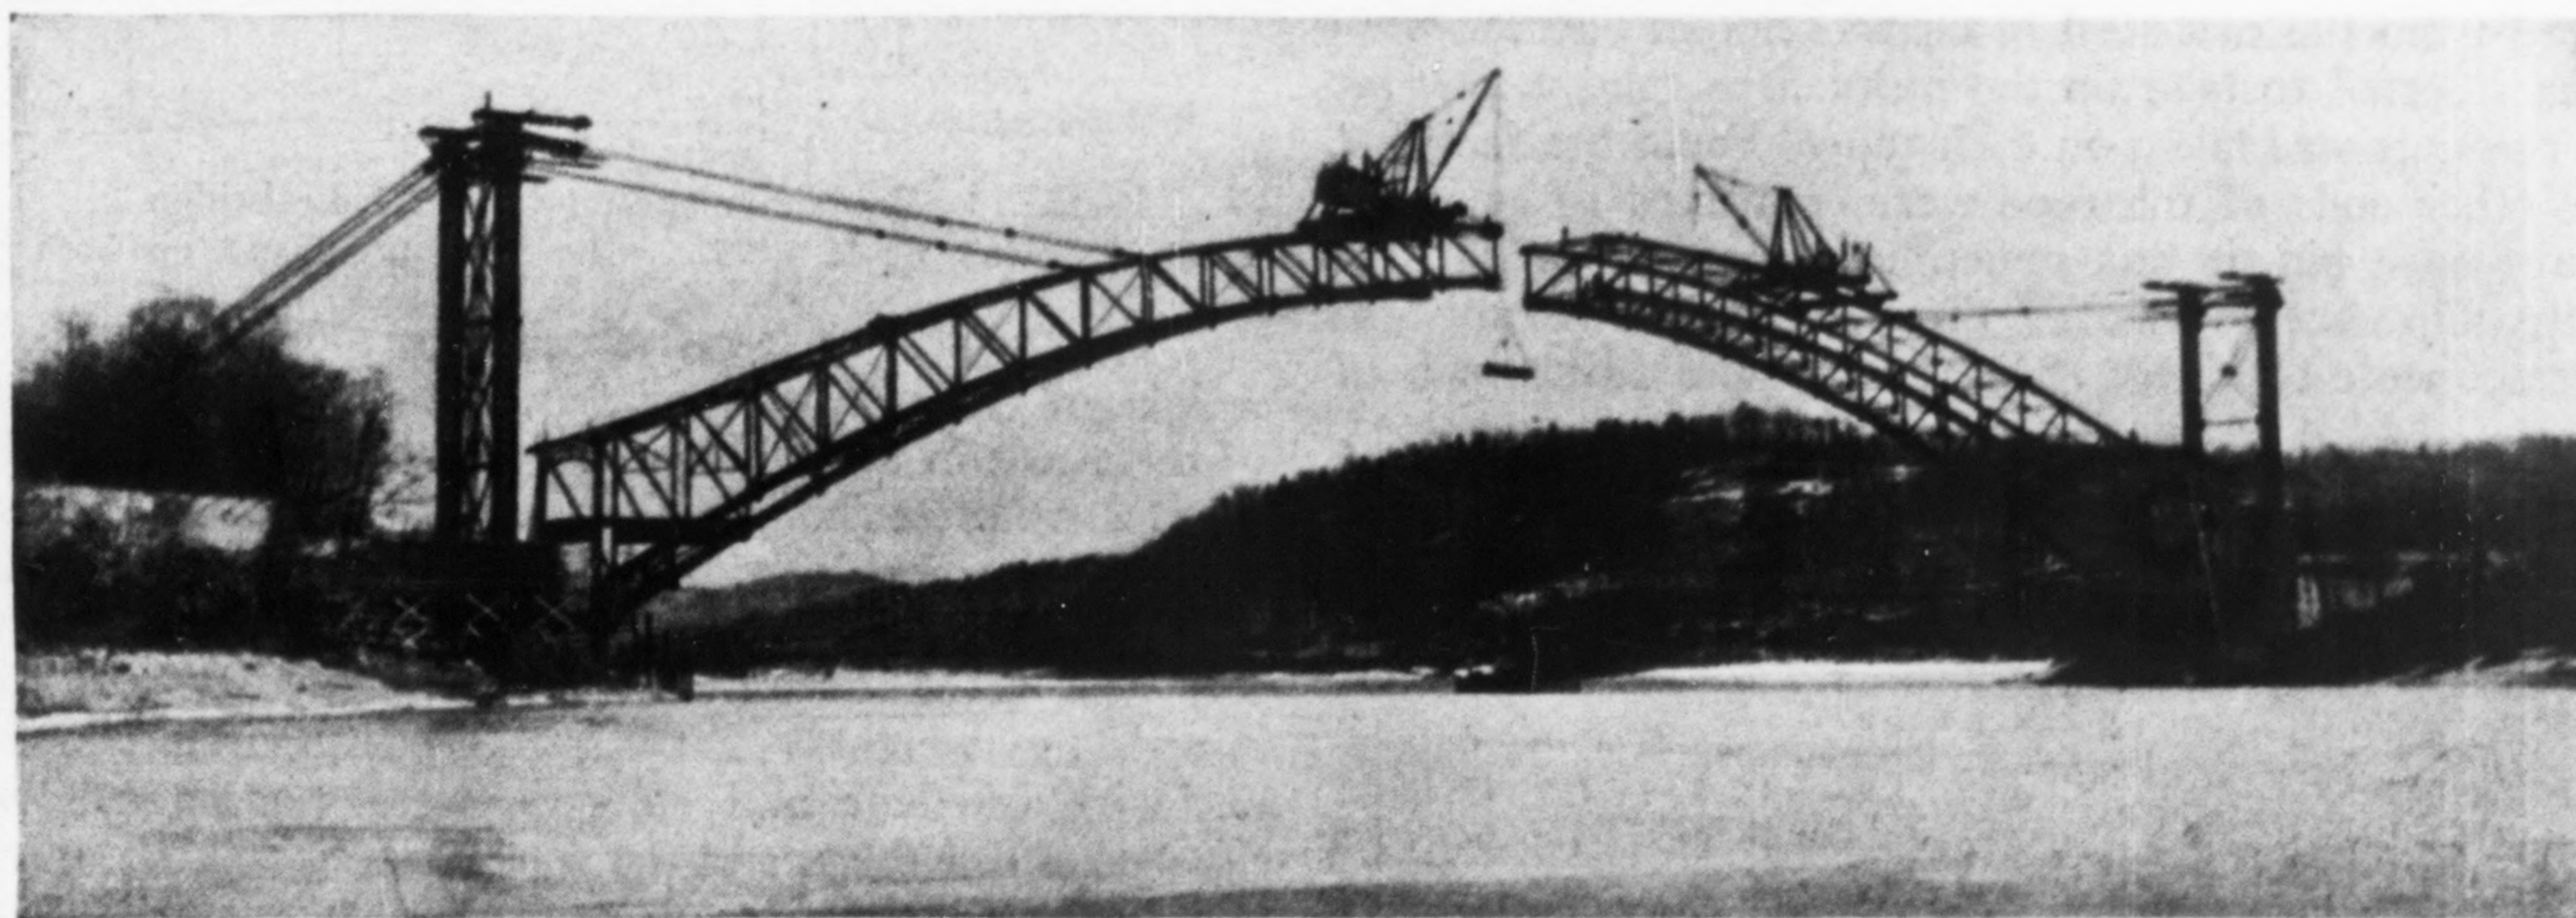
Fig. 3—Deep water and presence of water-supply aqueduct under bed of lake dictated adoption of cantilever erection without falsework

abutment made the use of ordinary falsework impracticable; the use of steel cylinder piers was not advisable because of the difficulty of securing good footings. Another objection to supporting the arch from the bed of the lake was the uncertainty as to the location of the old Croton aqueduct near the south end of the bridge. This aqueduct, which carries part of New York City's water supply, is buried only a few feet beneath the bed of the lake; and since an injury to it would be serious, it would have been necessary to make a subaqueous excavation to locate the aqueduct before placing bents for the support of the arch.

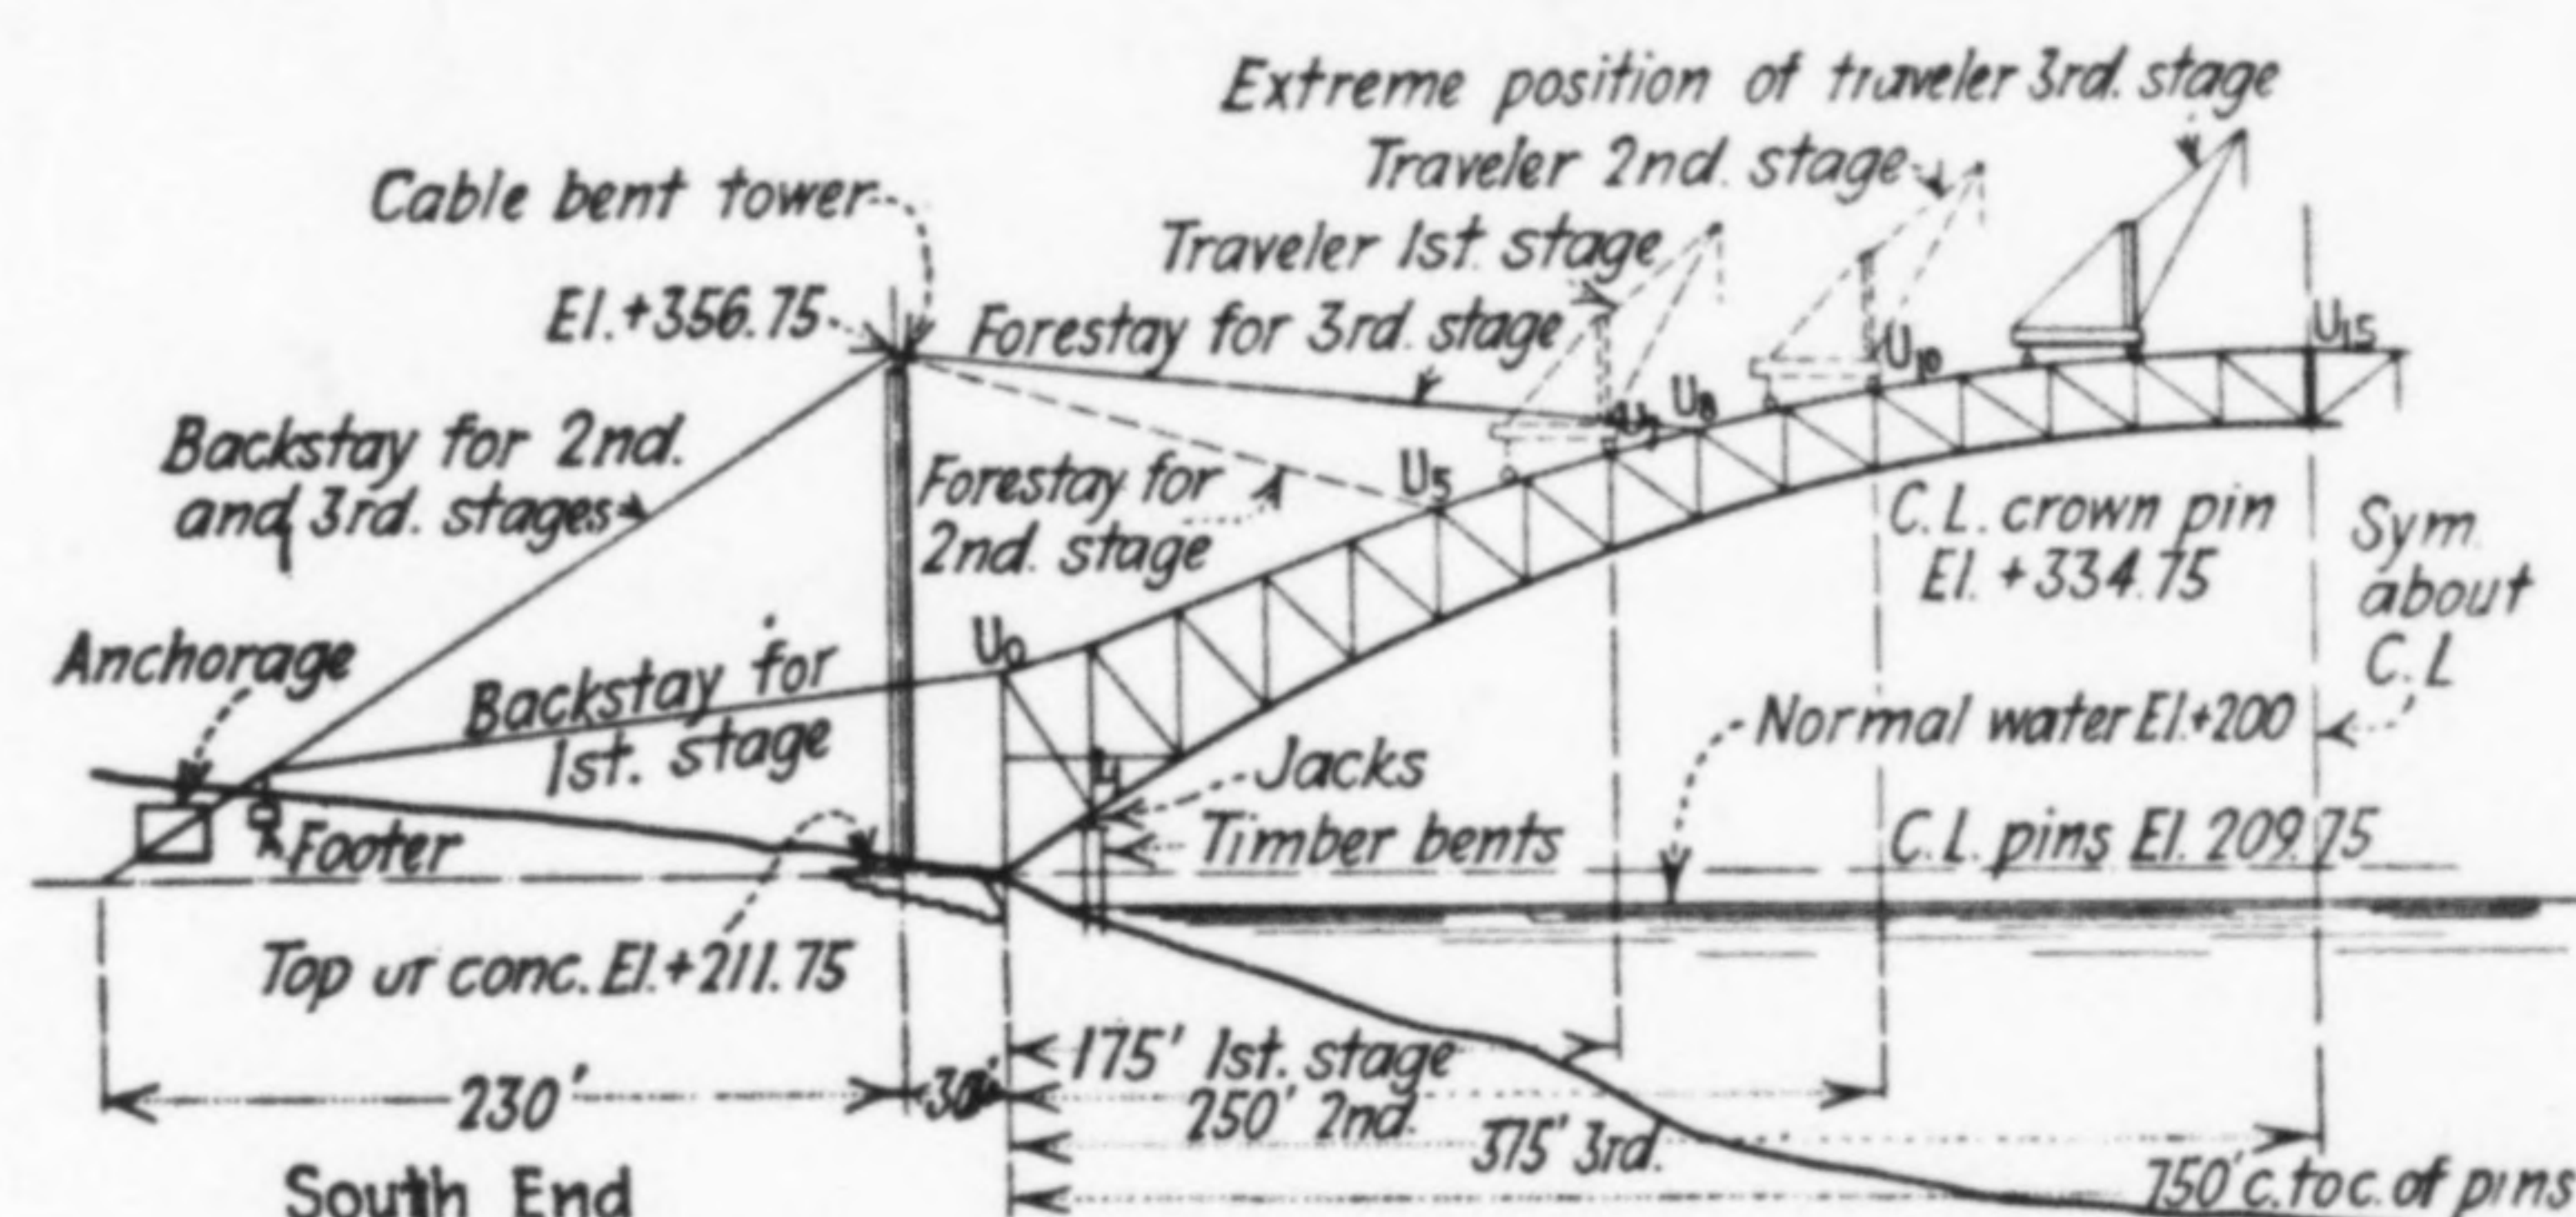
Fig. 5—Erection diagram, Croton Lake bridge

Closure was made at  $L_{15}$ . Erection procedure on both arms was similar.

The plan finally chosen involved a system of tie-backs and heavy concrete anchorages buried in the earth some distance back from each end of the bridge. From these anchorages the cable tiebacks were connected to three points on the top chord of the arch (Fig. 5). The first tieback ran from the anchorage direct to point  $U_0$ . The other two ran from the anchorage to the top of a 147-ft. cable-bent tower, supported on the arch abutment, from where forestay cables ran to points  $U_5$  and  $U_8$ . The tower was designed to rock in the plane of the cables

(by machining the base of the tower to a radius equal to the height of the tower) so as to avoid bending stresses. Each half-arch was erected as a separate operation, with closure at the center. Steel was erected with two steel travelers, each equipped with a stiff-leg derrick and steam hoisting engines.

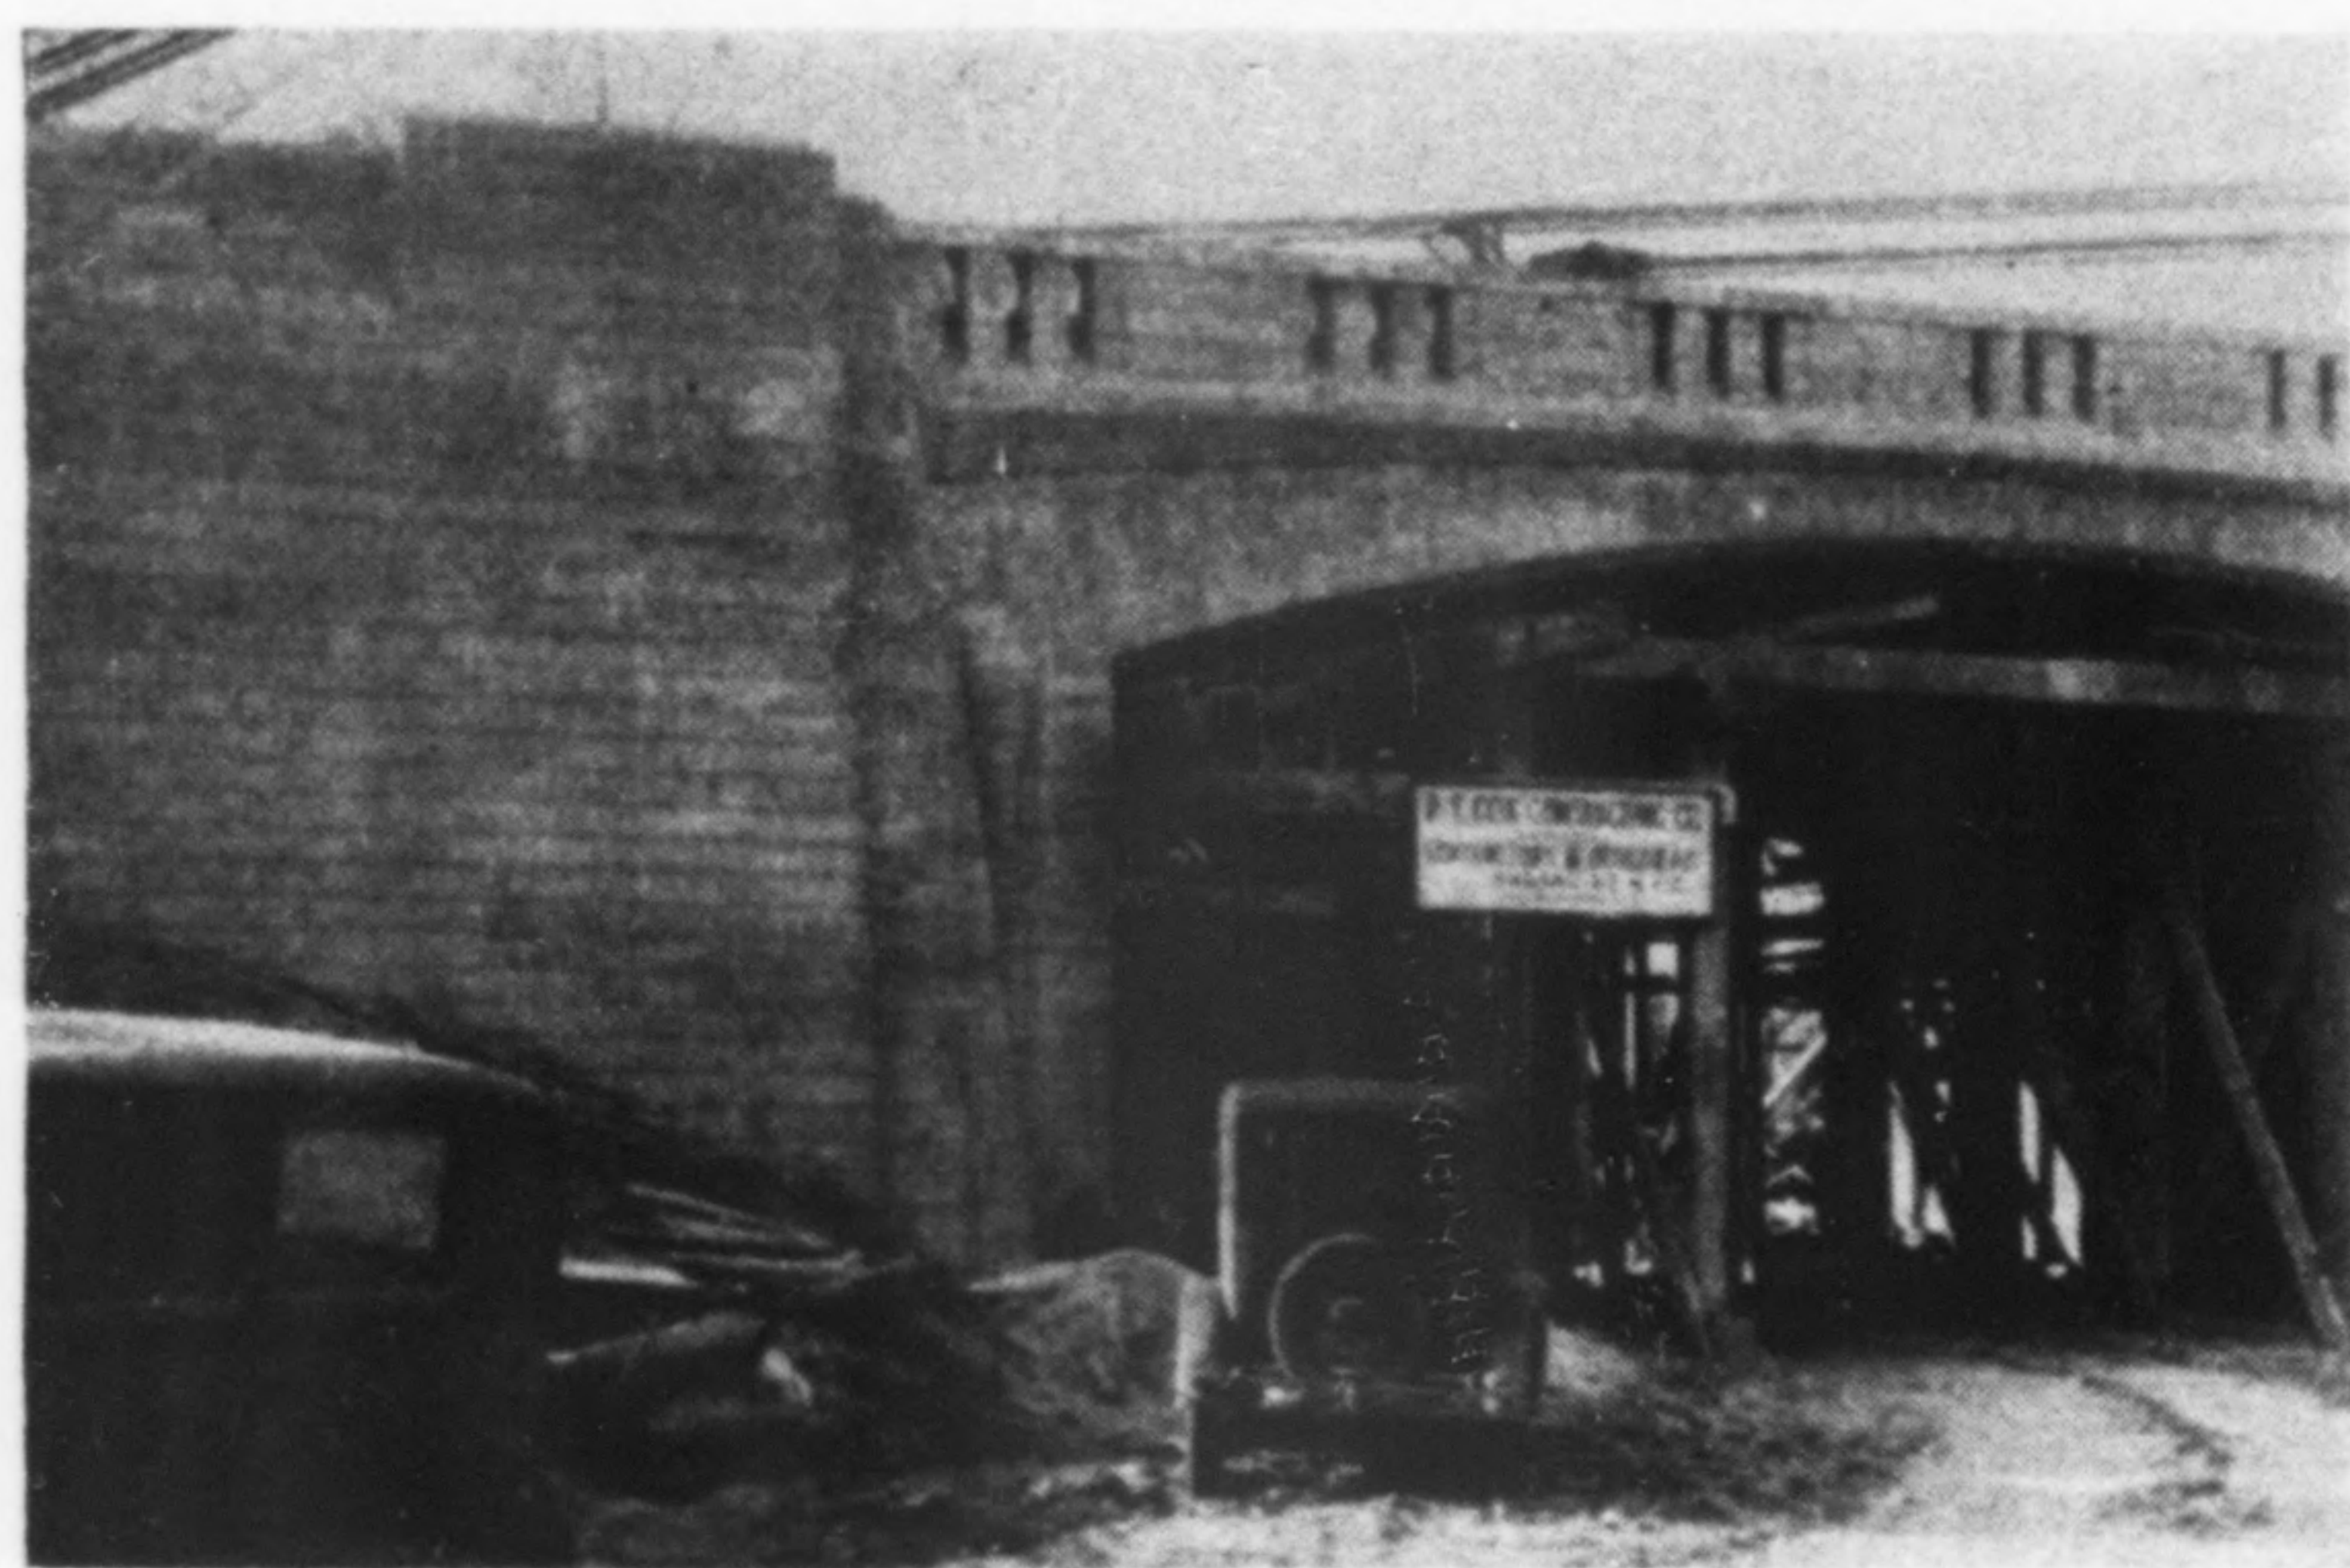
Fig. 4—Accentuated form-marks decorate faces of concrete abutments and approach spans

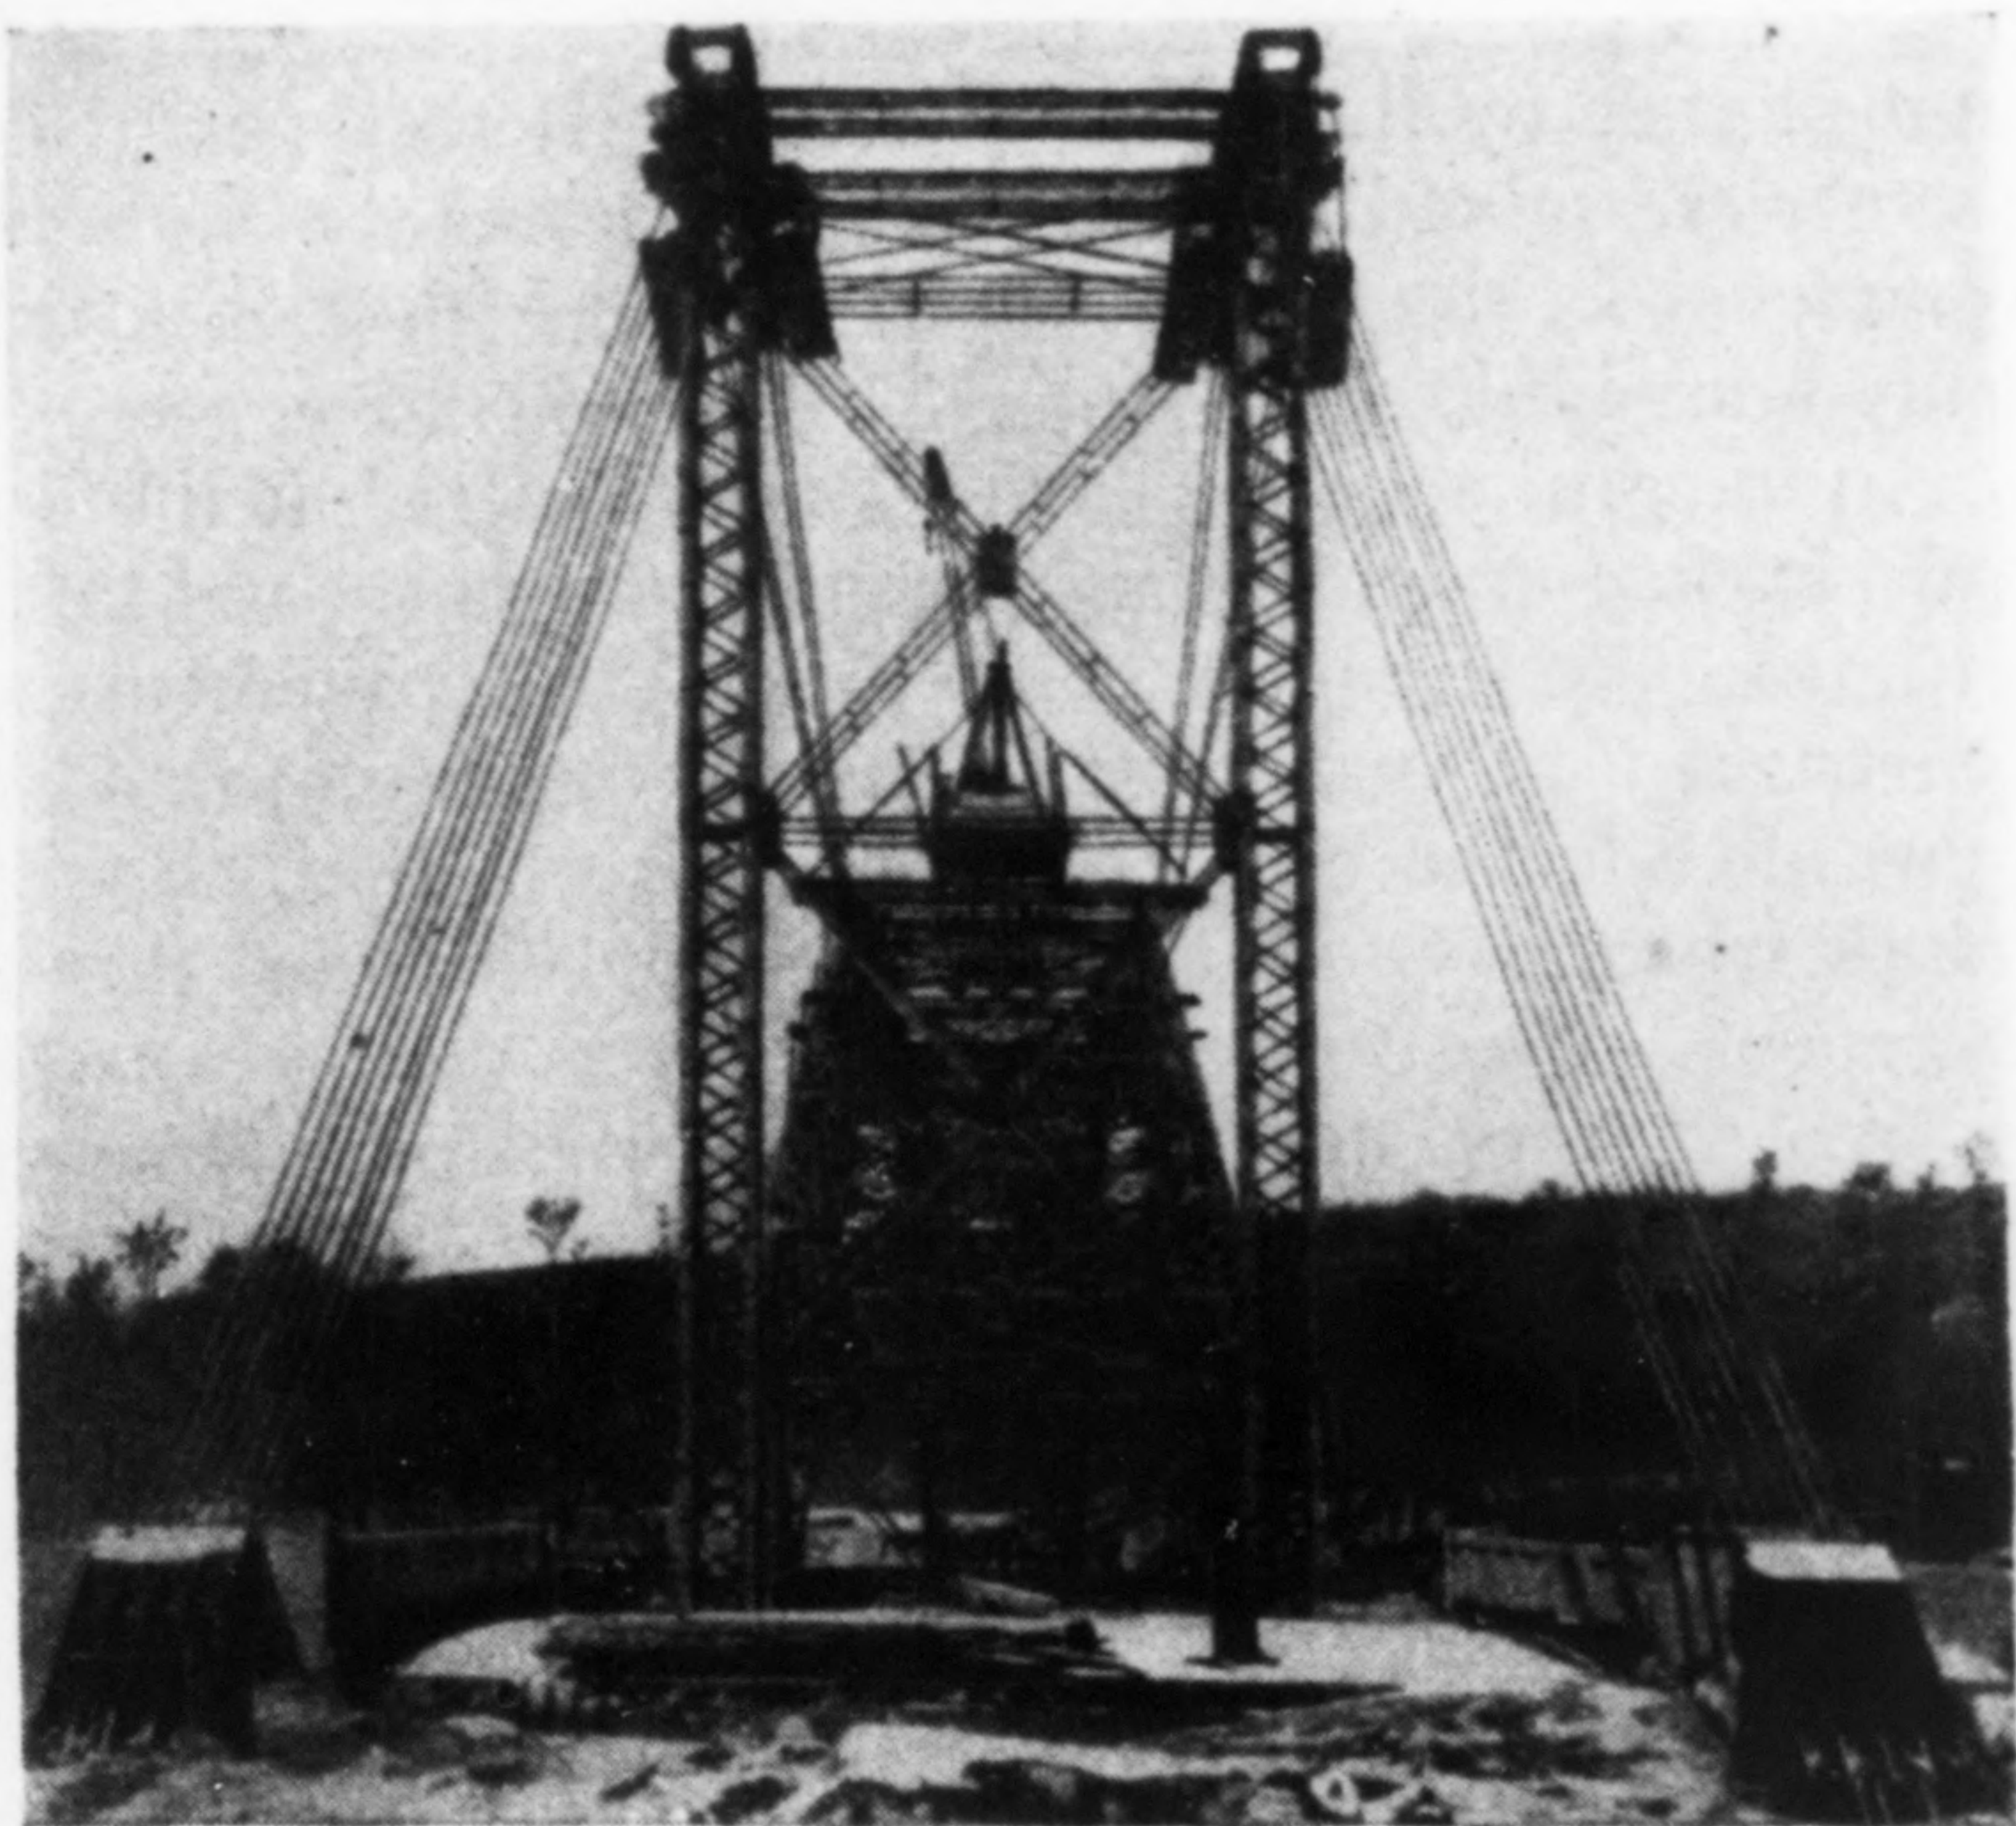
Fig. 6—Backstay cable anchorage and cable-bent tower

**Erection Towers**—The cable-bent towers were built from the floor beams of the bridge. There were two pairs of posts in each tower, and each post was made up of three floor beams on end, one on top of the other. A special structural-steel base and top were fitted to the ends of these lines of floor beams. Each pair of posts was laced together with angles to form a tower leg; and floor-beam hangers, which were made of four angles, battened, were used as bracing between the legs.

of these eyebars coming to the lower rear corner of the block of concrete. The upper ends of the eyebars came above the subgrade of the roadway and were connected by a pin to a structural-steel shoe that rested on top of a structural-steel bent. The same pin connected them also to the plate hitches of the backstay cables. The structural-steel bent at this point was necessary to take the vertical reaction of the first-stage cables, which were not in line with the direction of the eyebars.

Both north and south anchorages consisted of a block of concrete 15 ft. high, 20 ft. wide and 60 ft. long, reinforced along the bottom and the vertical side farthest from the bridge with  $\frac{3}{4}$ -in. square bars, 8 $\frac{1}{2}$  in. on centers. Embedded in this concrete block were 6-in. eyebars, one group on the center line of each truss, the bottom end
