Bridge Street Bridge

Beacon, New York

A Historical Review, Existing Condition Report and Recommendations for Rehabilitation.

June 2018

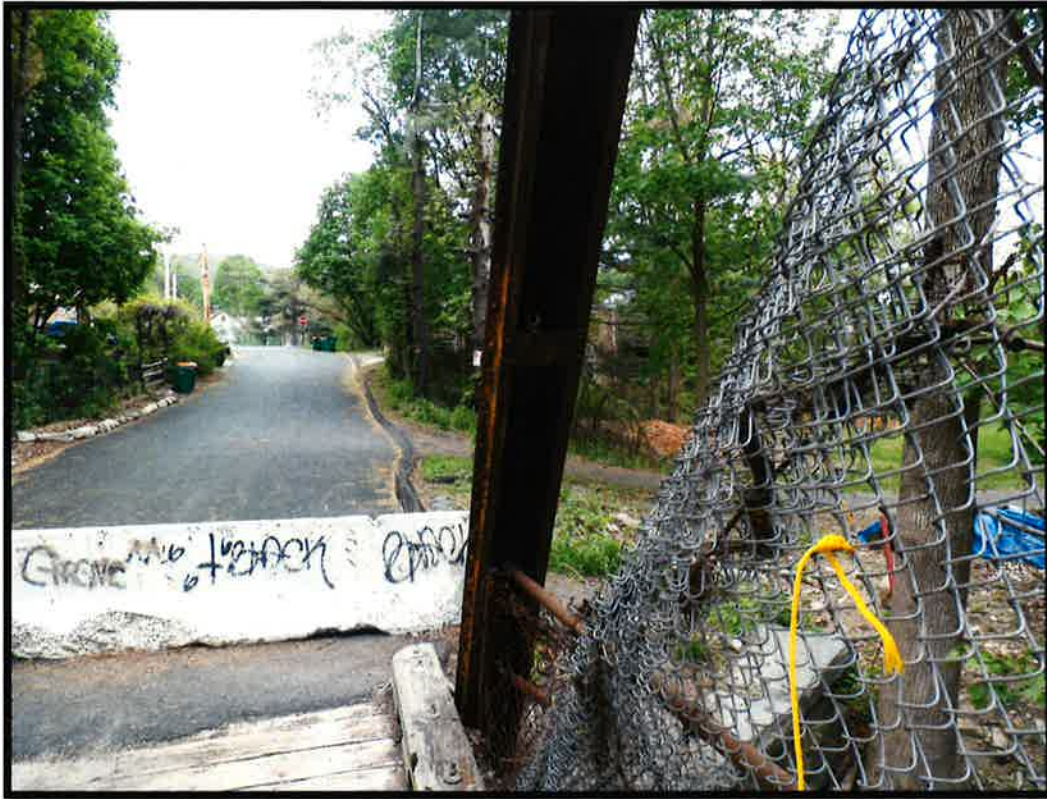
Inclined End Post (top chord identical) L0-U1, L8-U7

These bridge elements consist of a pair of 8" Phoenix Iron Company channels topped with a 12" x 1/4" plate. On the lower flanges of the channels 5" x 12" x 1/4" plates spaced at 4'-0" are used to maintain the spacing of the channels

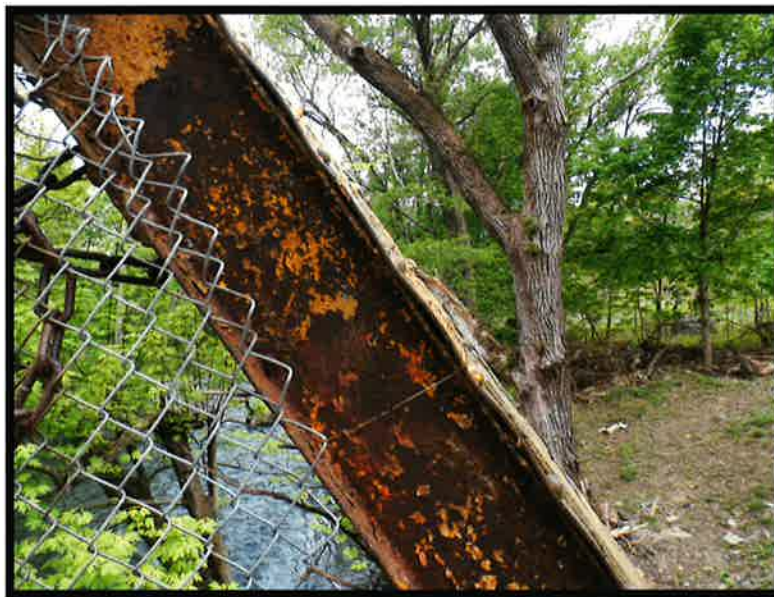
Inclined end post showing rust bulge, pack rust between top plate and channels, lead paint shown.

5. Flatten all rust bulges on the top chords and inclined end posts using a method similar to that shown on the YouTube---<https://www.youtube.com/watch?v=k3qC-pXYqqw>.

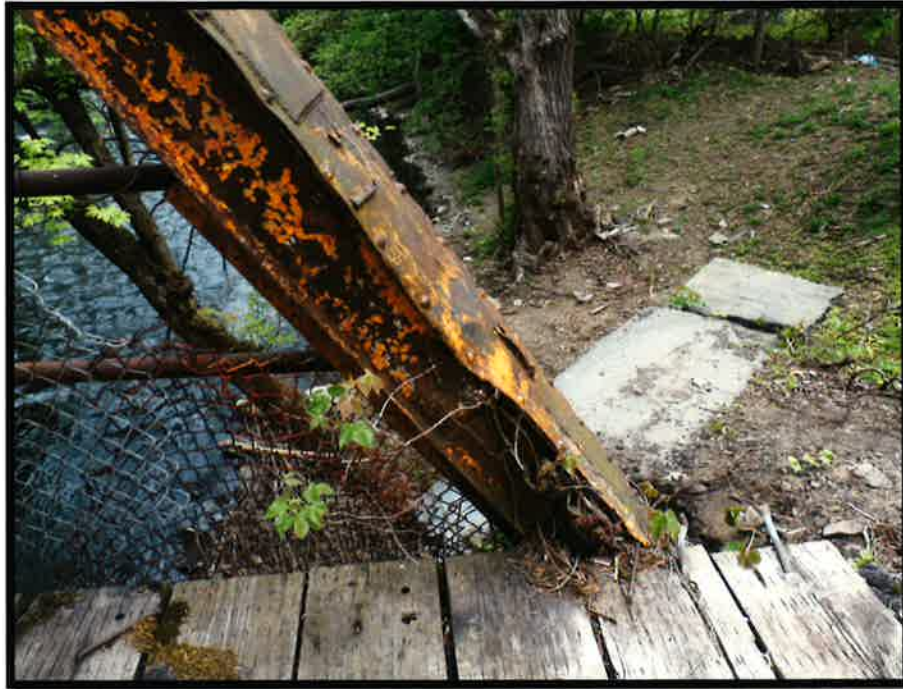
Damaged Inclined End Post, Southwest corner of bridge

2. At the lower ends of the northwest, northeast and southeast inclined end posts weld 8" x 32" x 1/4" mild steel plates to span the corroded portions. (I would suggest a 3/32" - 7018 electrode.) On the southwest inclined end post weld an 8" x 32" x 1/2" plate to add bearing area to replace the bearing area on the lower flange of the channels. Weld new under lattice plate at the southeast bridge seat. Remove angle iron on the top chord of the northeast and southeast ends of the trusses.

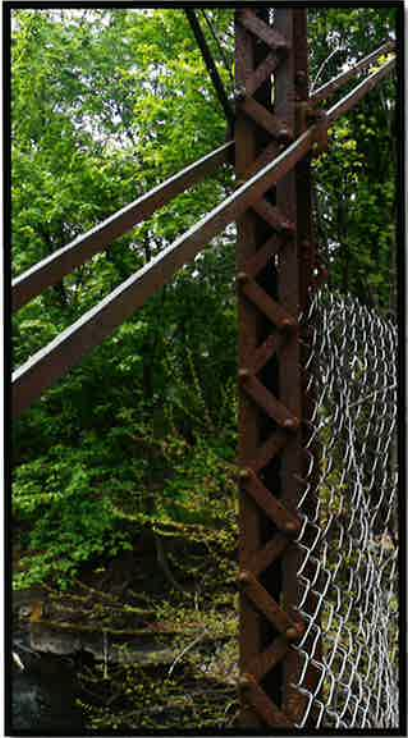
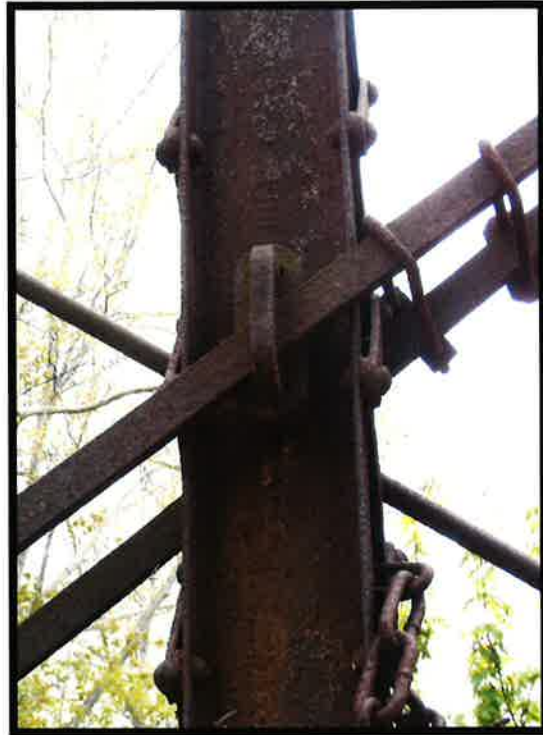
These posts consist of two 5” channels riveted together with single lattice bars. At the top end and bottom end of the channels slots were cut and semicircular holes were drilled to engage the 2” diameter pins. These views also show that there is no physical connection between the verticals and the diagonals. They also show the method used to keep the diagonal spacing.

Vertical Posts and brackets for diagonals

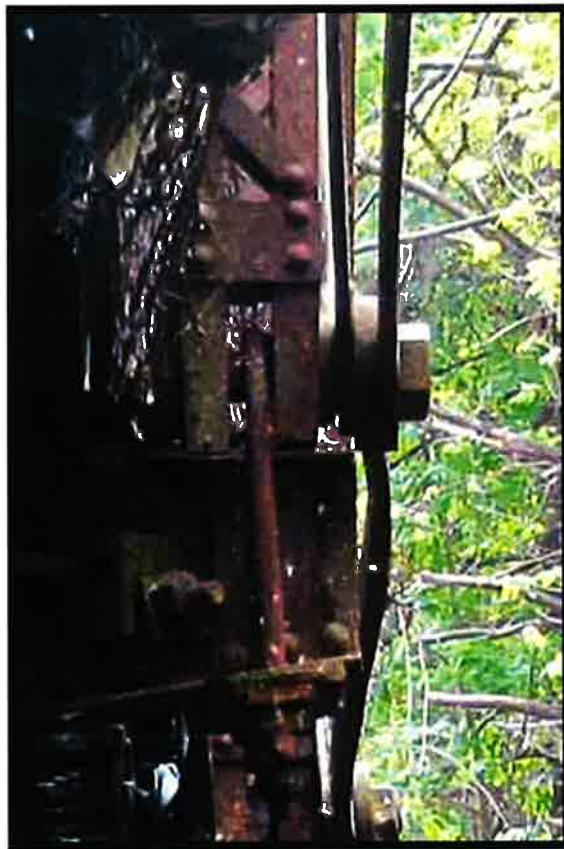
Bottom of posts setting on lower chord pins, and U-Bolts (note bent lower chord member)

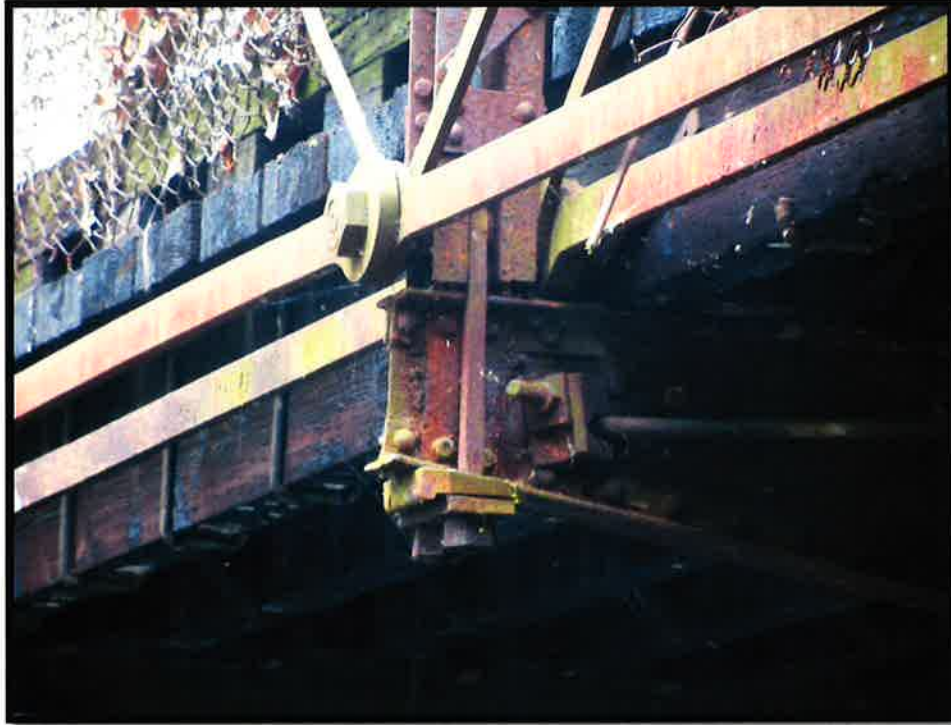
Lower chord eyebars, diagonals, post, diagonal cross bracing, tapered washer and J-bolts to anchor curbing to stringers. L2, L6 (typical) (the web plate at the ends of some of the beams show some section loss at the very ends of the beams).

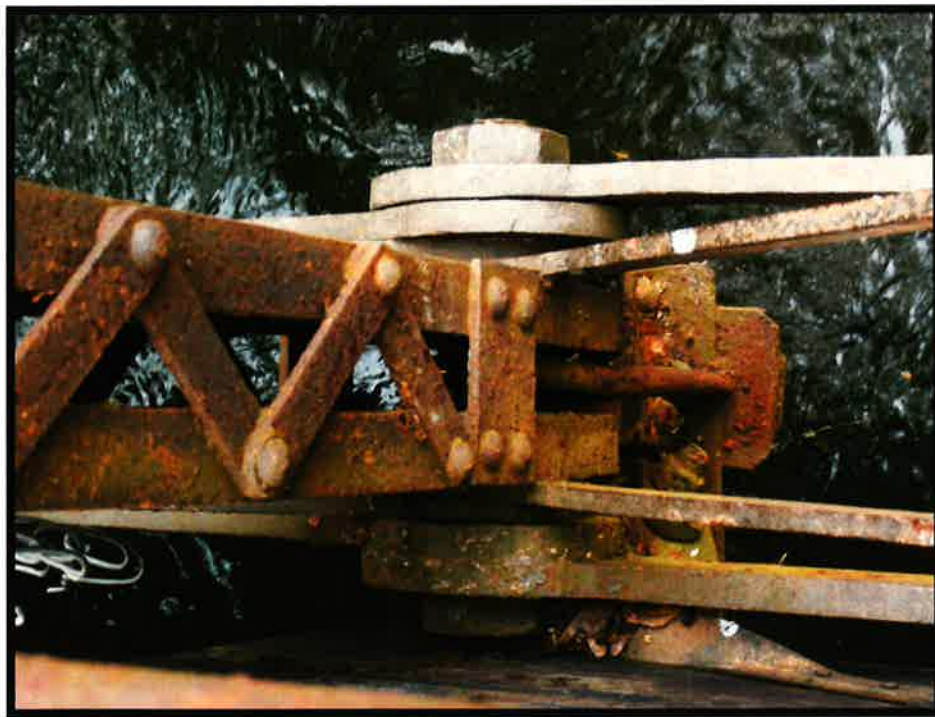
Top view lower chord eyebars, diagonals, vertical post, latticing and floor beam connection

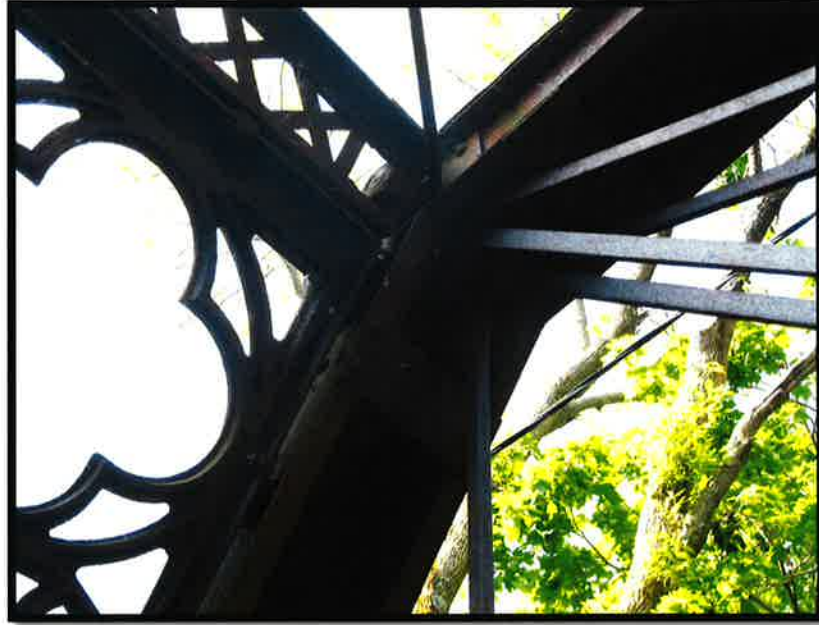
Connection between inclined end post and top chord showing diagonals, vertical and cast iron portal bracing and cross truss.

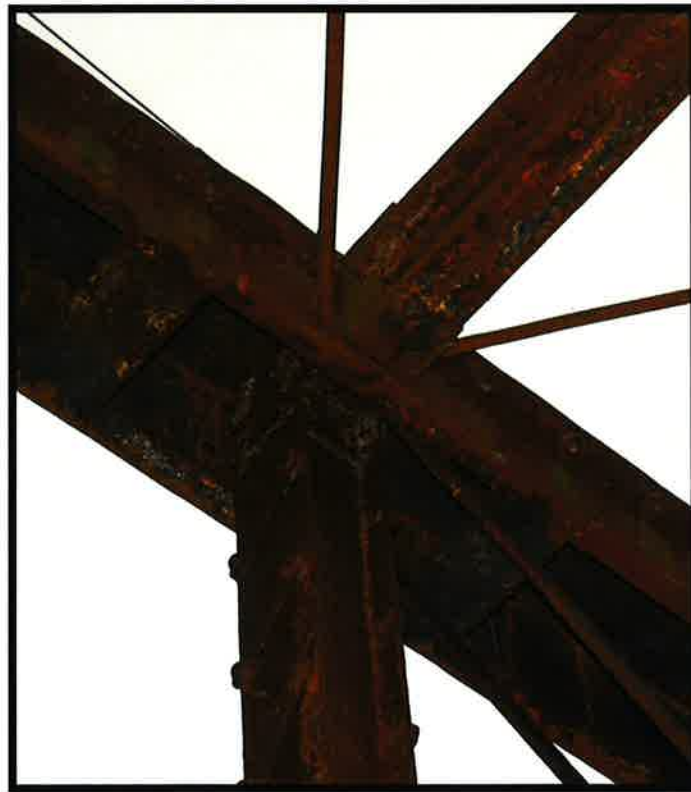
Connection vertical post and top chord showing top chord bracing beam and diagonals.

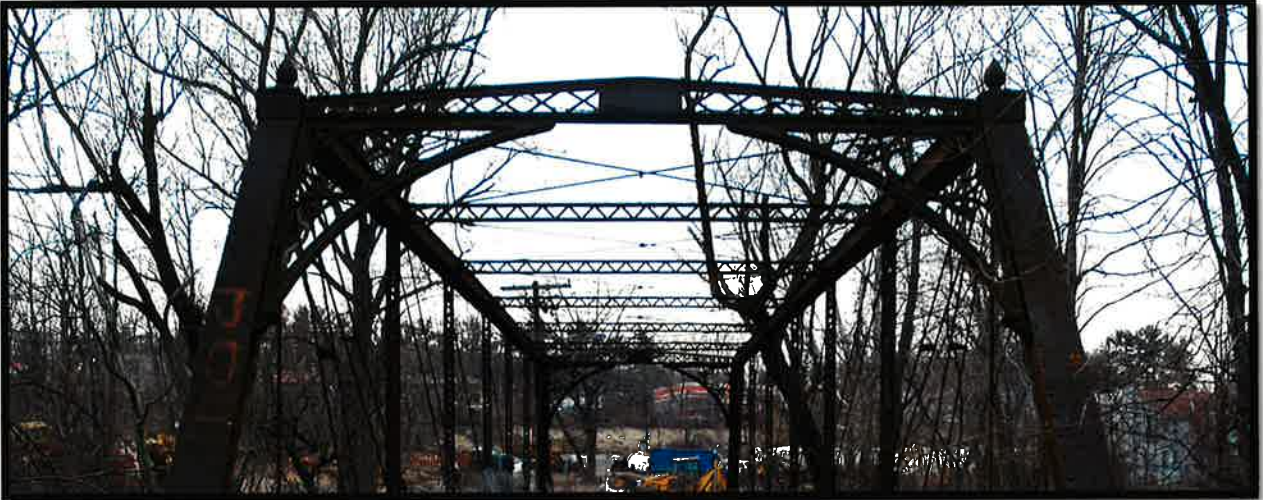
Portal Bracing, wrought iron truss and ornate cast iron tracery (Knee braces)

This bracing consists of a variable depth cross truss, built up with angles and double laticing. This cross truss also supports the bridge plaque. Cast iron tracery connects (bolts) to both the inclined end posts, on brackets riveted to the member, and the bottom flanges of the cross truss. In combination these elements keep the main trusses in a vertical position.

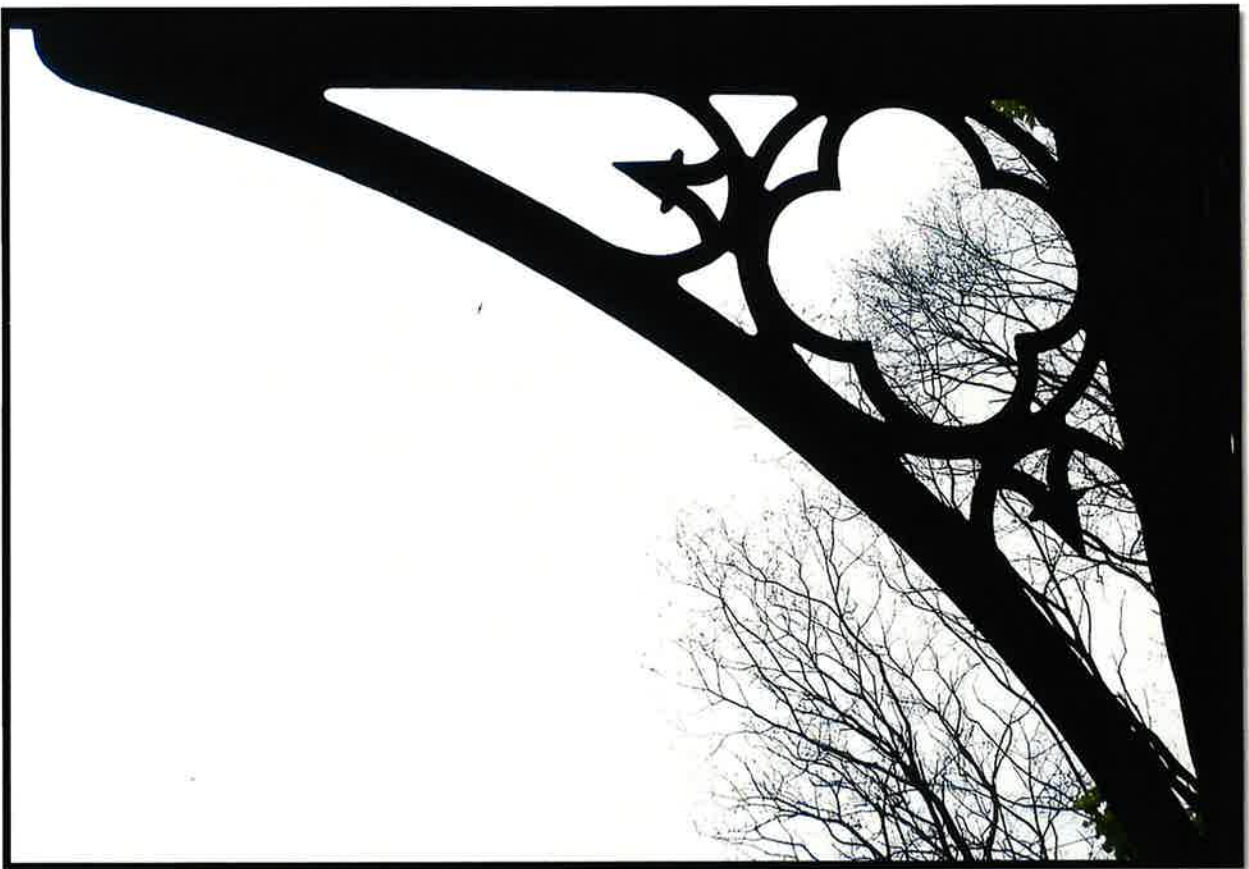
Cast Iron Tracery - Bolted to Cross Truss and Inclined End Post.

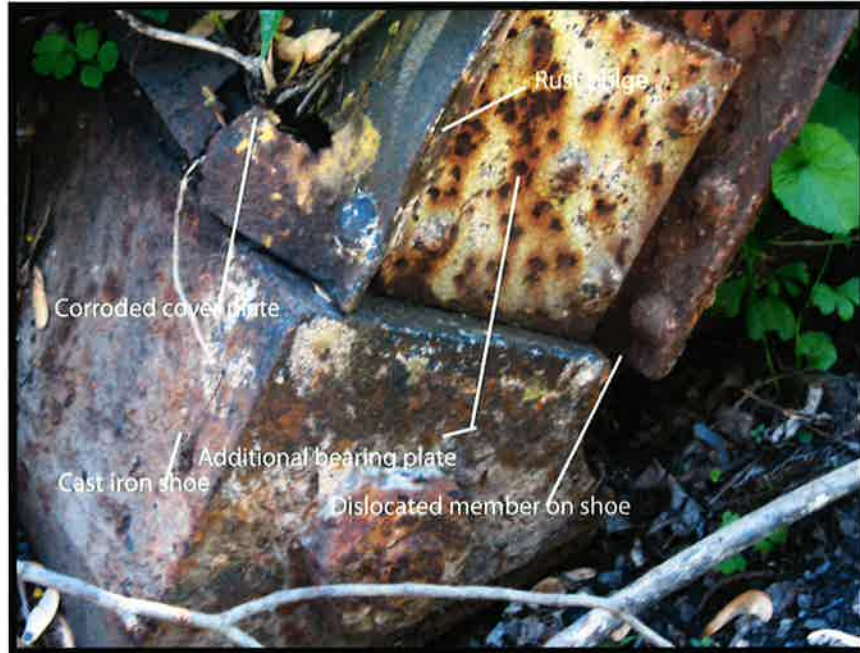
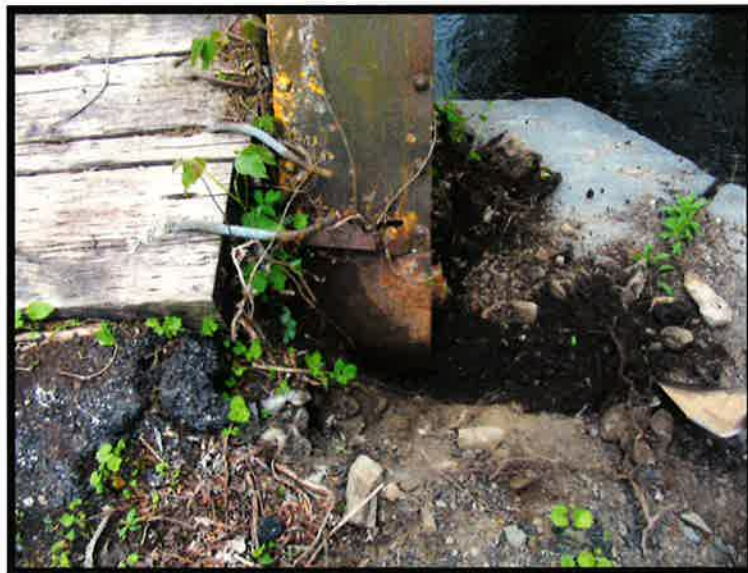
The cast iron bridge seats connect the ends of the lower chord eyebars, with a pin, and the inclined end posts. As can be seen below the webs of the inclined post channels have been reinforced with 6" plates riveted in place to increase the bearing area of the member. An unusual feature of the bridge is that its seats are not anchored to the masonry or sitting on a nest of rollers which was common at the time. In other words the bridge sits on masonry with no physical connection other than gravity.

Southwest bridge seat end and side views

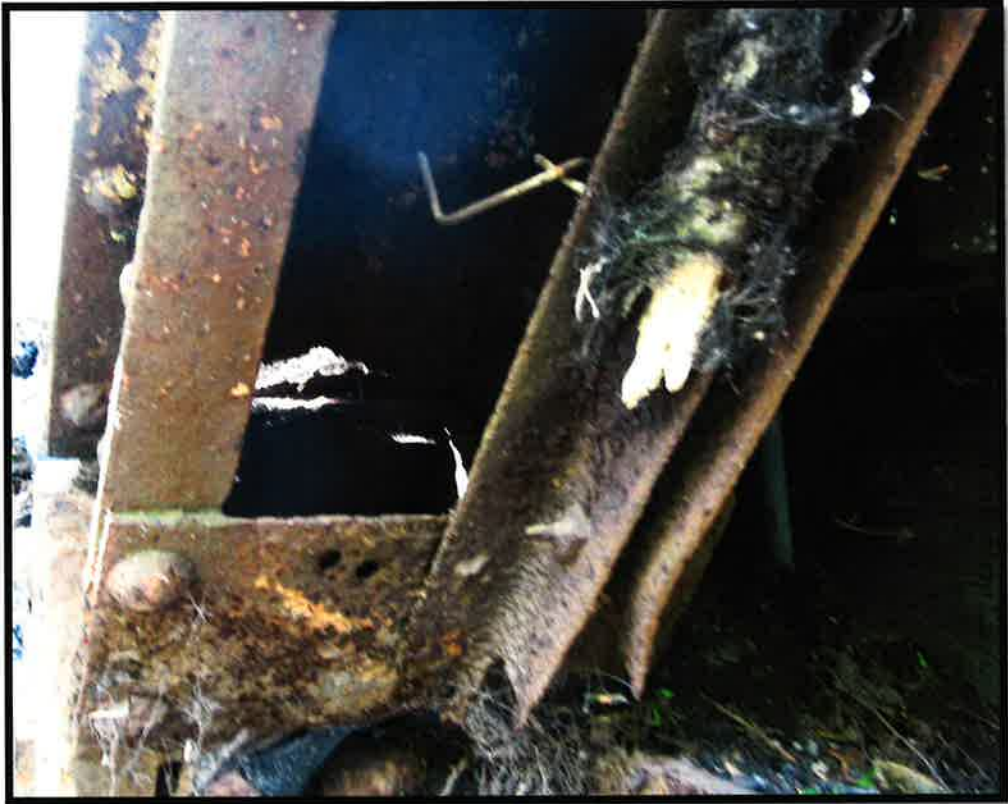
Southwest bridge seat under view (note poison ivy root system)
Northwest Corner

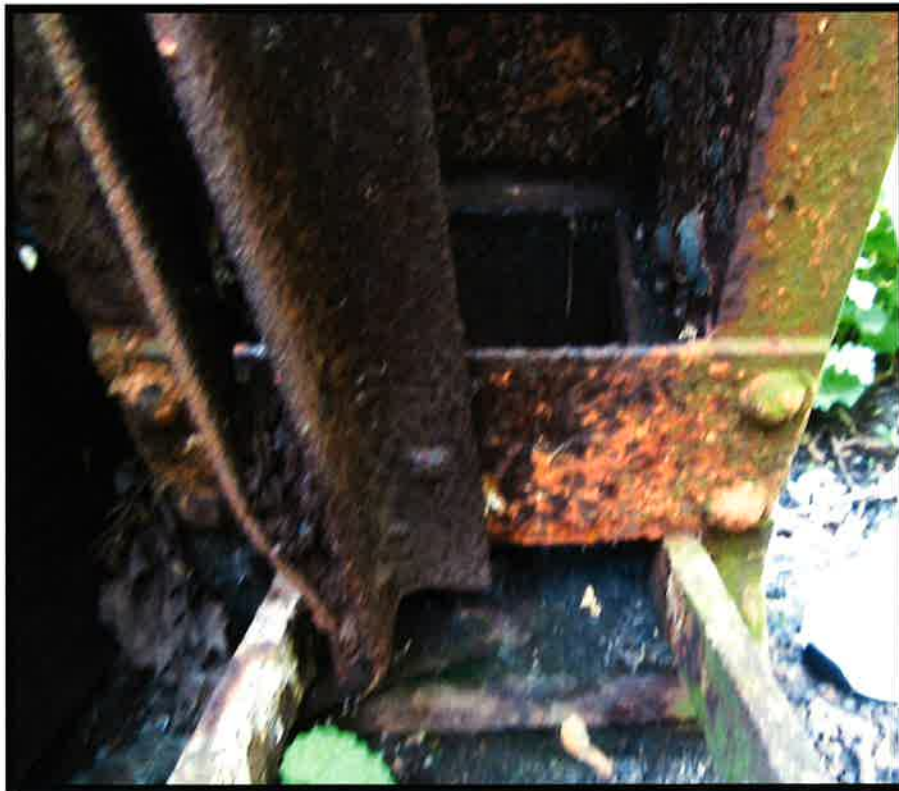
Image under northwest bridge shoe showing bearing surface on cast iron shoe, lower chord links. Note there is no additional bearing plate added to inside face of channels. Pin behind cross plate. Angle on bottom to receive hand railing

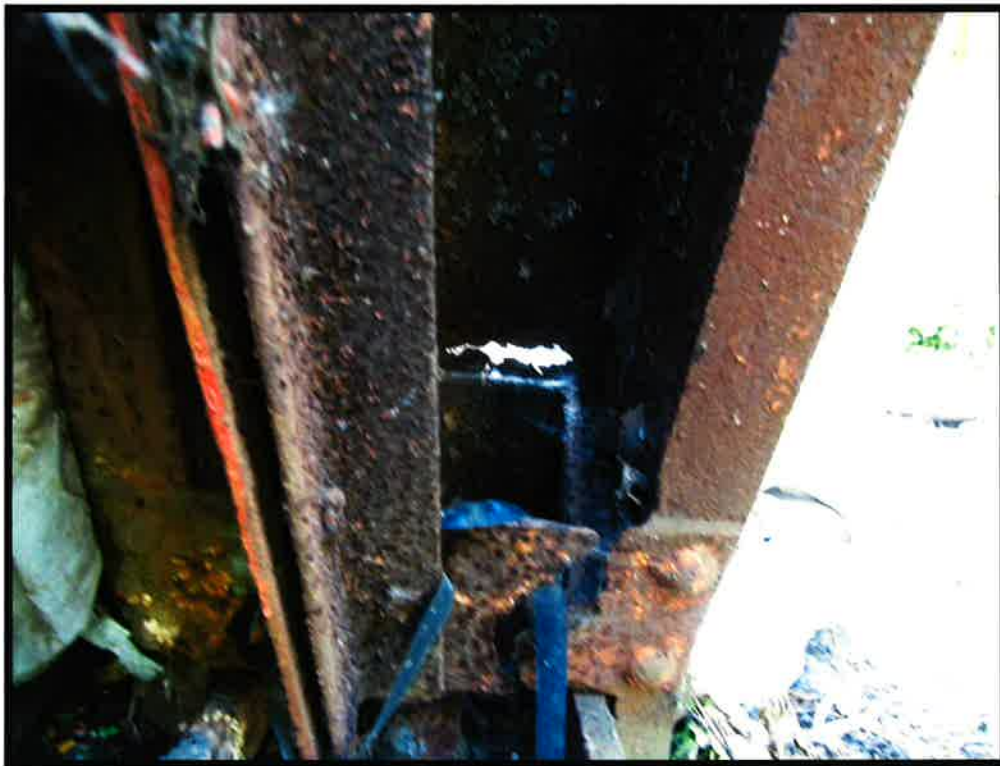
Underside of Southeast bridge seat. Note broken 5 " x 12" plate that should be replaced with new plate farther up the member.

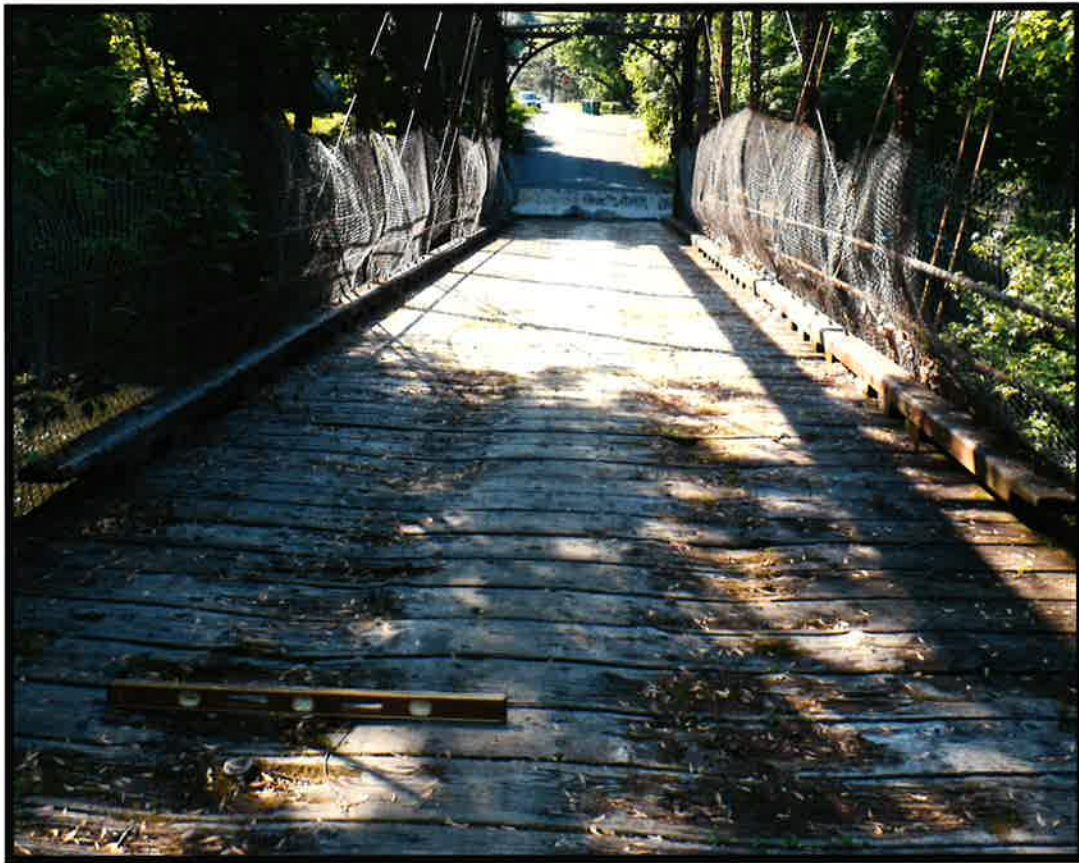
The decking is worn in two tracks and some members are rotting on the surface but generally the wood is sound and firmly attached to the stringers. The maximum depth of rut is approximately 1 1/2" with the edges of the planking and along the centerline at, or near, original elevation. The centerline of the southerly rut is about 6' in from the edge with the centerline of the northerly rut another 4+ feet to the north.

Deck with ruts, with some decay in the rut where water puddles. Depth of rut ~1 1/2".

1. Pressure wash decking removing any material between the deck planks as well as any decayed wood on the planks. Drill holes in each plank at the low spot of the ruts to permit drainage.

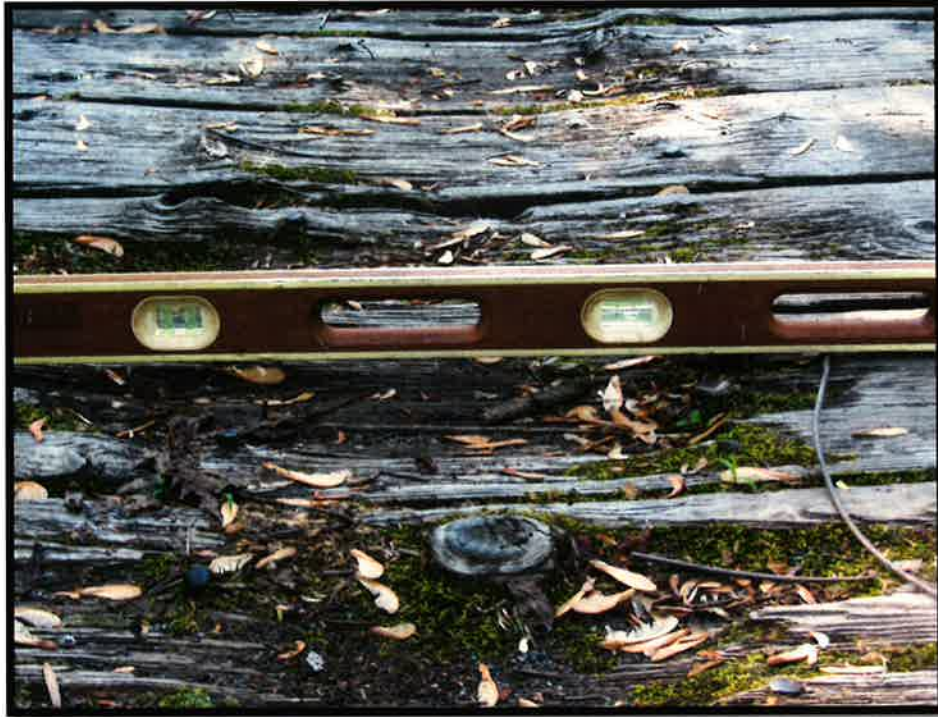
Rut on northerly side of centerline of the bridge showing ~1 ½" depression.

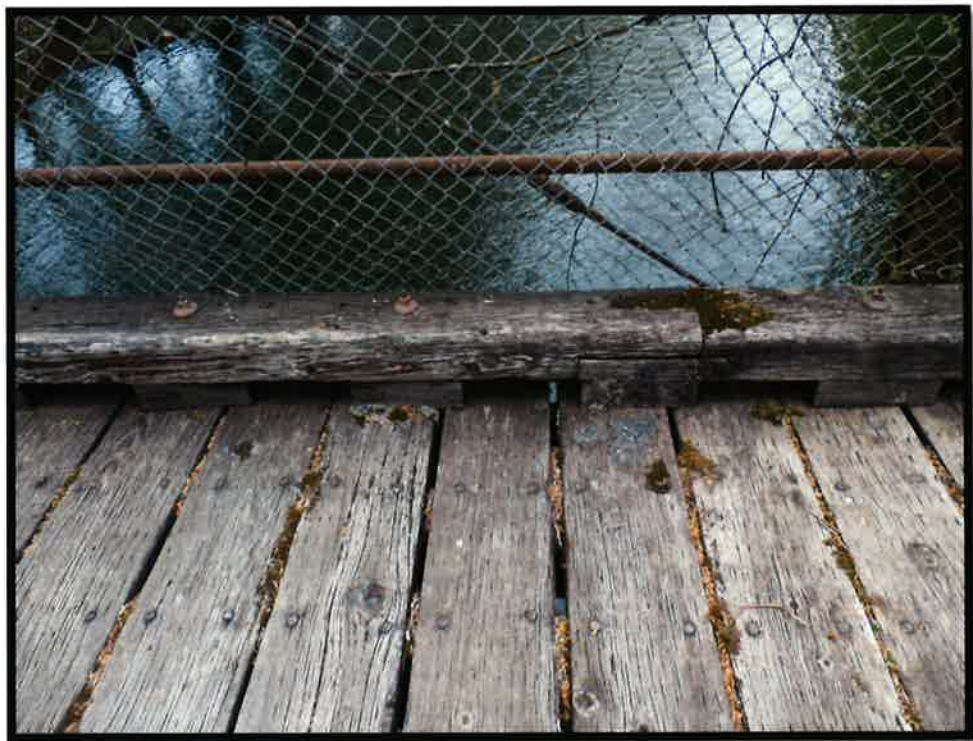
Wooden decking, curb and pipe railing, diagonal, note little decay along edges of decking. Note also organic material collecting in joints. It will be noted later on that this material should be power washed away to minimize further decay in the joint.

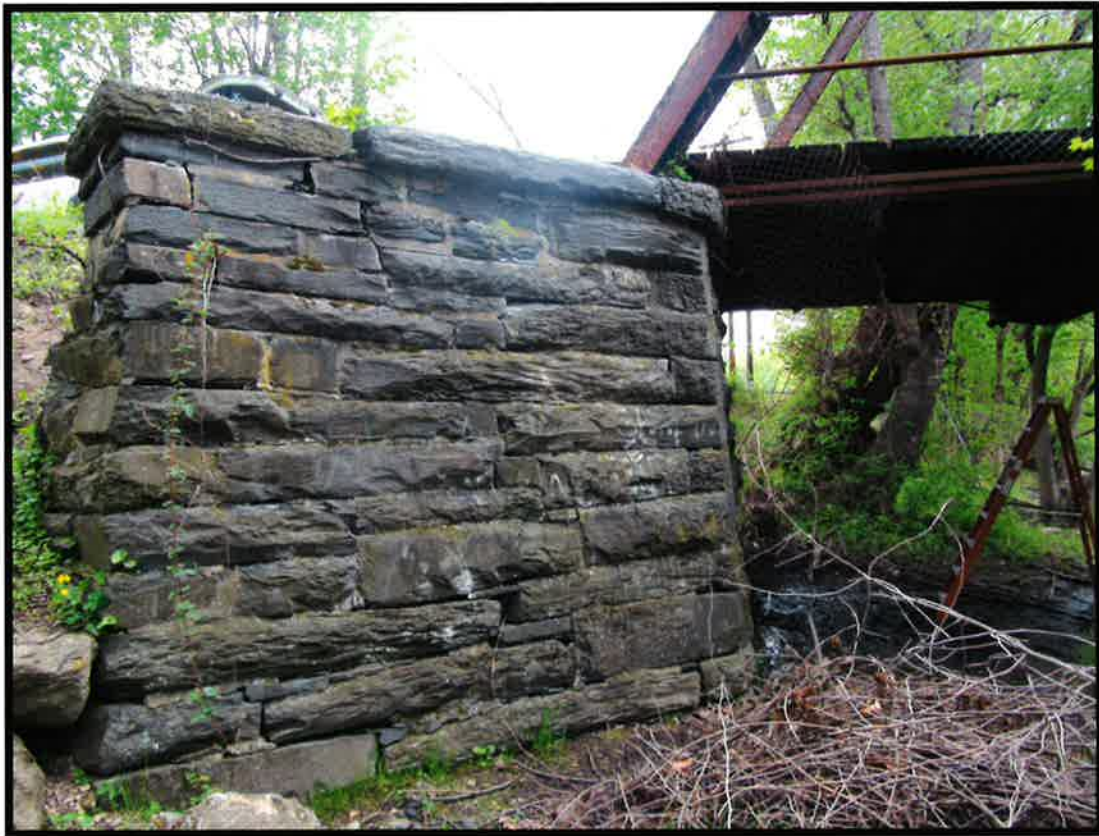
This abutment is built of cut stone and the joints mortared up. It is 21' 3" wide with wing walls of 11' 4" on the south and 15' 5" on the north. Exposed stone varies from 7' 0" to 10' 7" high. The end of the truss is set back ~2' 3" from the face of the wall.

Southerly Wing wall, showing good line of face of abutment

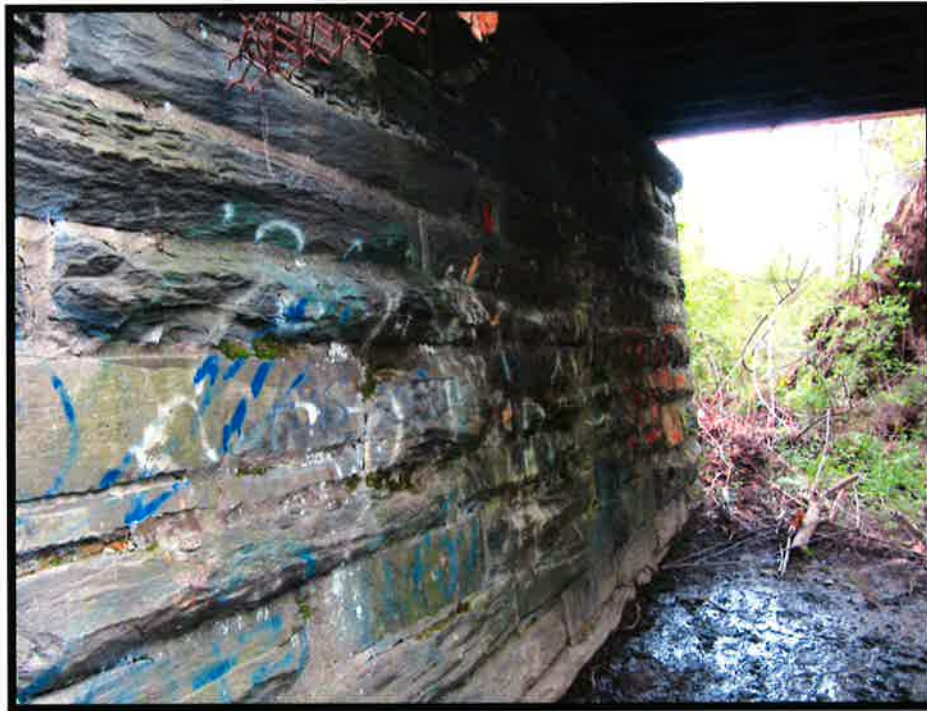
Face of west abutment showing pointed stonework

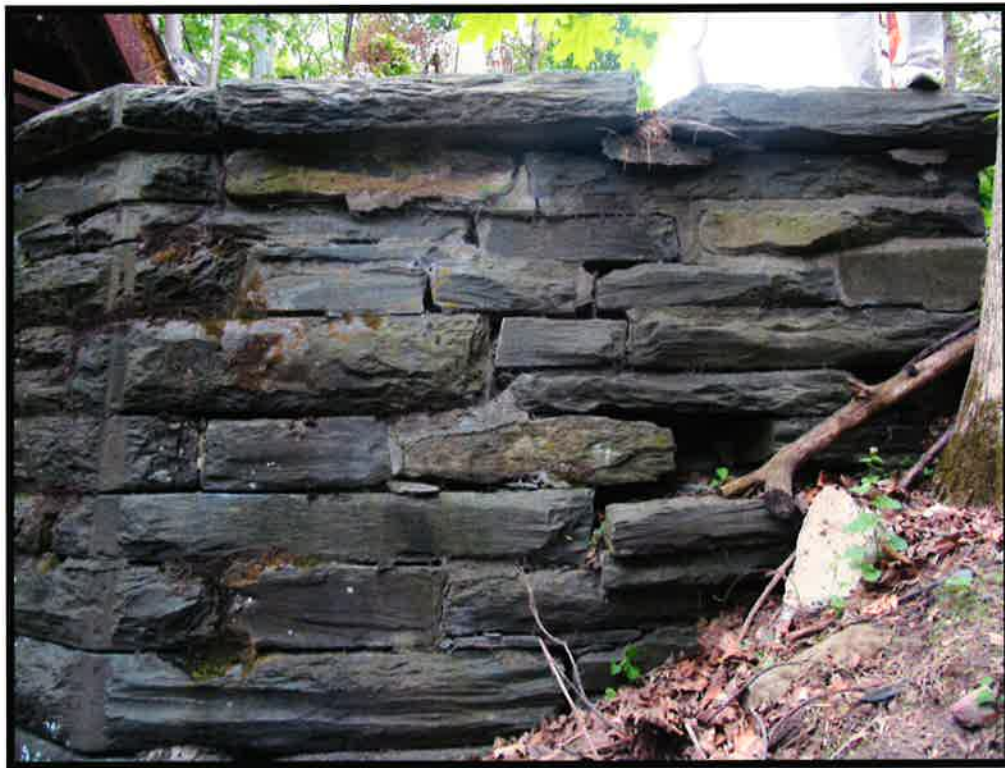
Southerly wing wall, tree should be removed as it is displacing the stonework and stone pushed back to original position

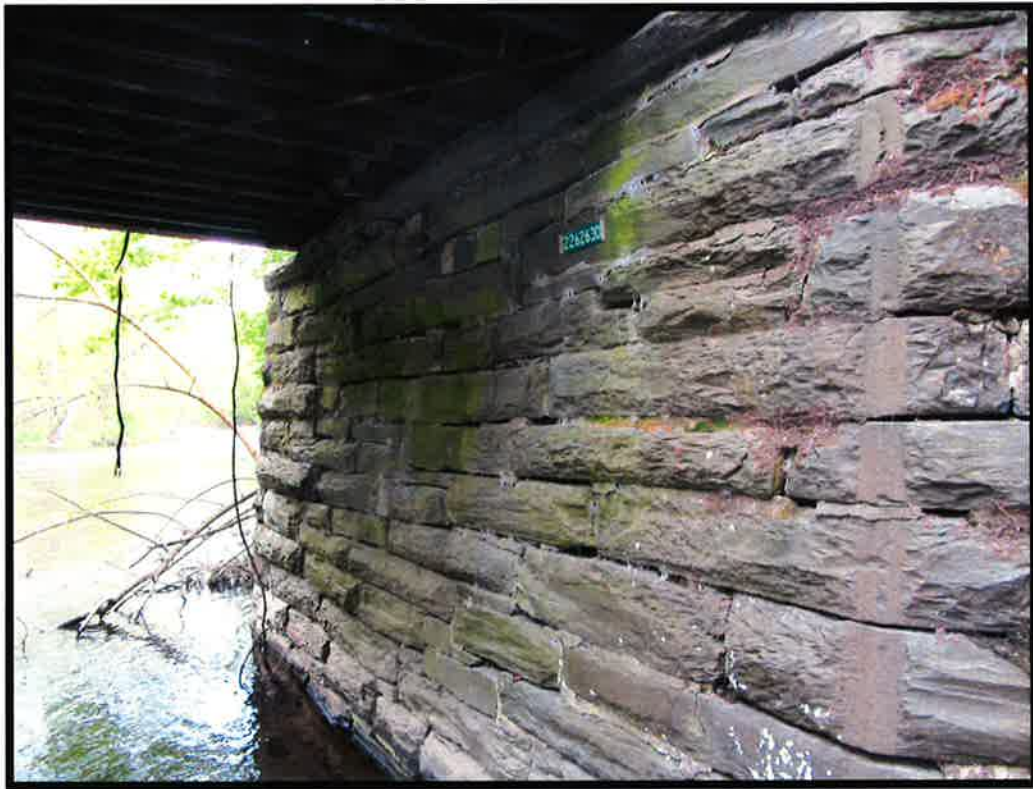
Face of easterly wing wall, excellent condition

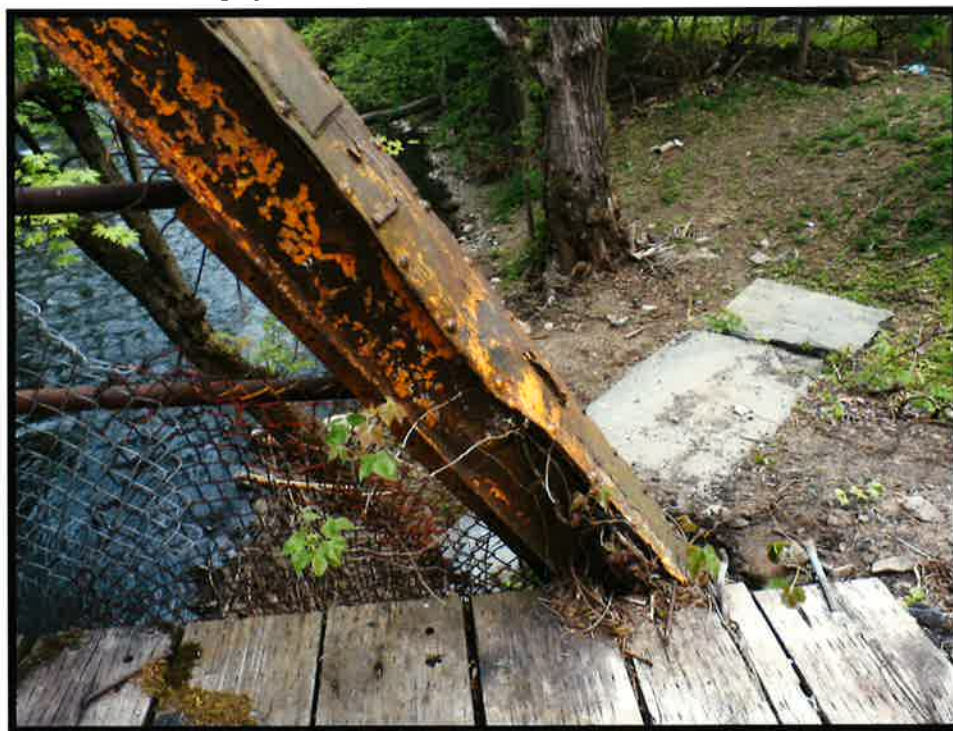
Damaged inclined end post, southwest corner of bridge. Also previously welded plate at top end of image. Some yellow lead paint remains. The lower ~8' of the inclined end posts were painted yellow for visibility purposes

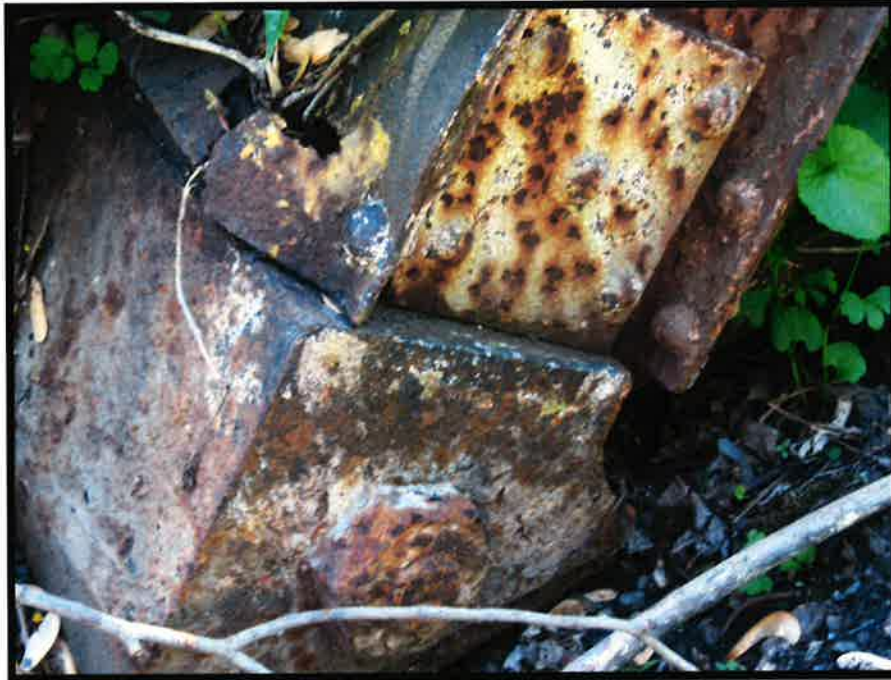
End post shifted on cast iron shoe resulting in less than full bearing. Note web plate riveted on web of channel to increase bearing still has full bearing. Member was not deflected transversely, only longitudinally.

On the other three inclined posts, where they connect with cast iron shoes, the top plate of the member had partly corroded through as can be seen above. This corrosion is mainly cosmetic and does not greatly impact the load carrying capacity of the inclined end chords, as the top plate's primary function is to maintain the orientation and separation of the two channels. One quarter inch $\frac{1}{4}$ " cover plates should, however be welded on the existing top flange plates as described below. The angle iron on the northeast and southeast inclined end post should be removed in order to place new cover plates. On the southwest end the plate should be $\frac{1}{2}$ " thick and in direct contact with the cast iron bridge shoe to make up for some of the bearing area lost on the lower flange of the channels.
