**BRIDGE INVENTORY FORM
NEW YORK DEPT. OF TRANSPORTATION**

1. BRIDGE NAME(S): New York and Ogdensburg Railway bridge over Raquette River

7. BRIDGE TYPE: Hilton lattice deck truss

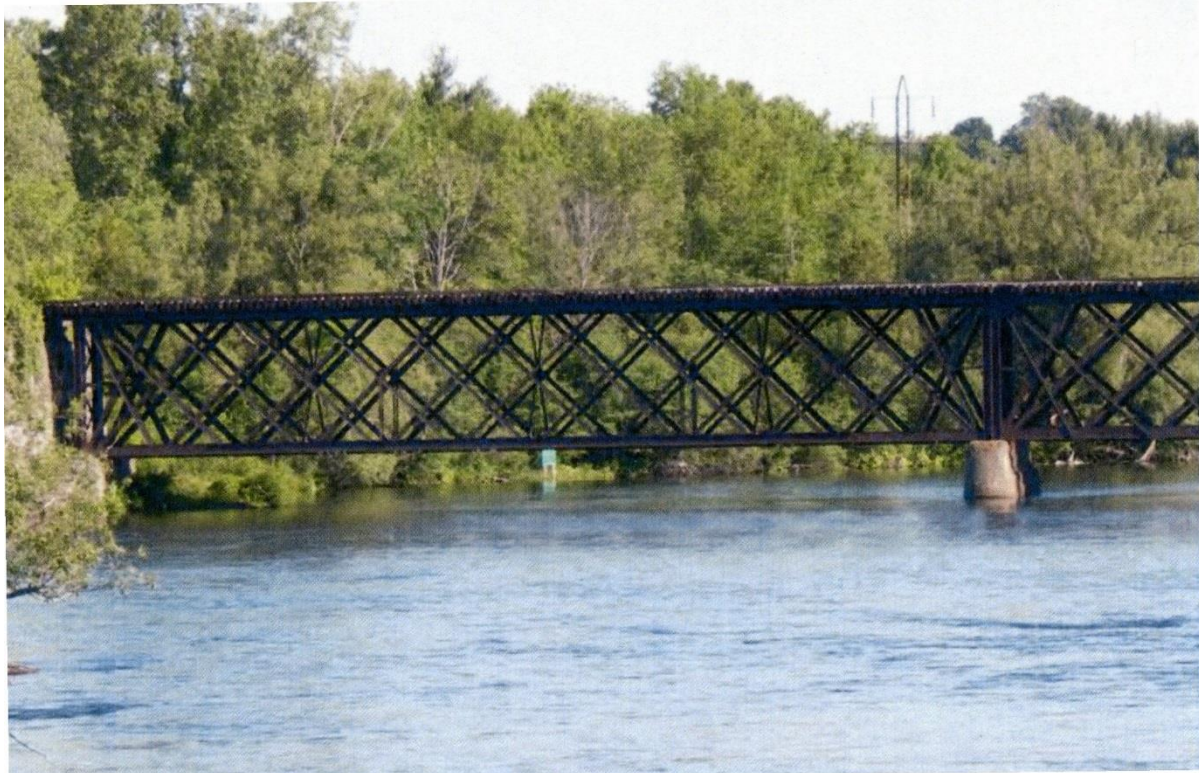
Photo 1. View of the New York and Ogdensburg Railway (NYOG) Bridge No. 80 east (south) elevation Span 2, looking north (Parsons 2015 Inspection Report, Photograph B, page 10).

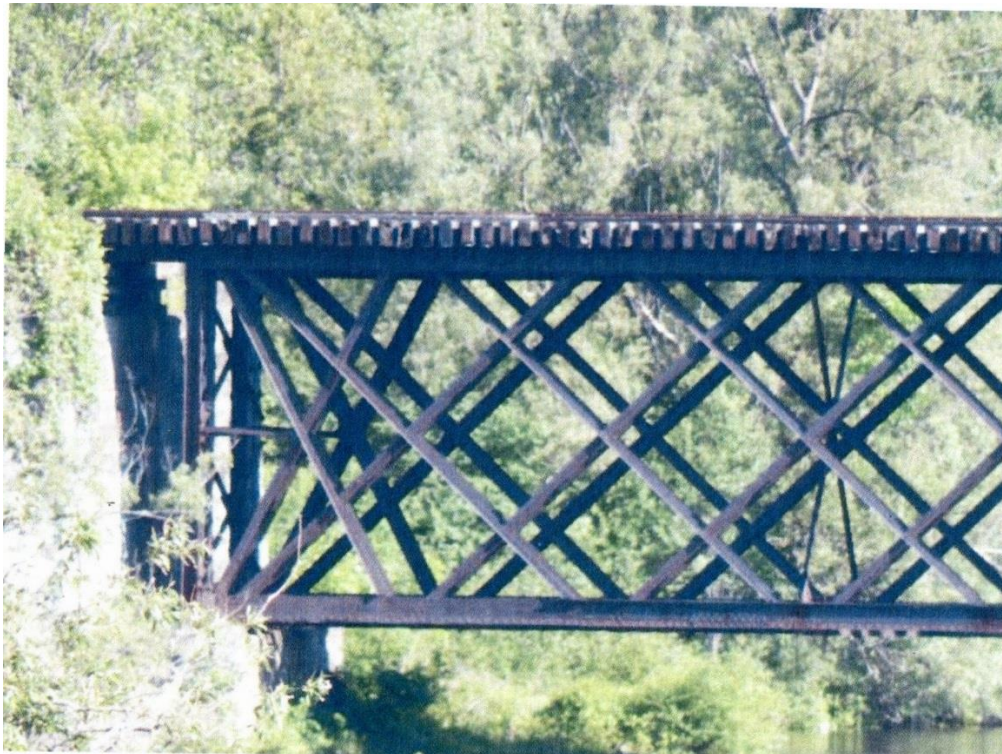
Photo 2. View of the NYOG Bridge No. 80 east (south) elevation, Span 2, at the south abutment. The bridge is a Hilton lattice truss, featuring quadruple intersection diagonals and end posts acting as tension hangers (Parsons 2015 Inspection Report, Photograph 3, page 24).

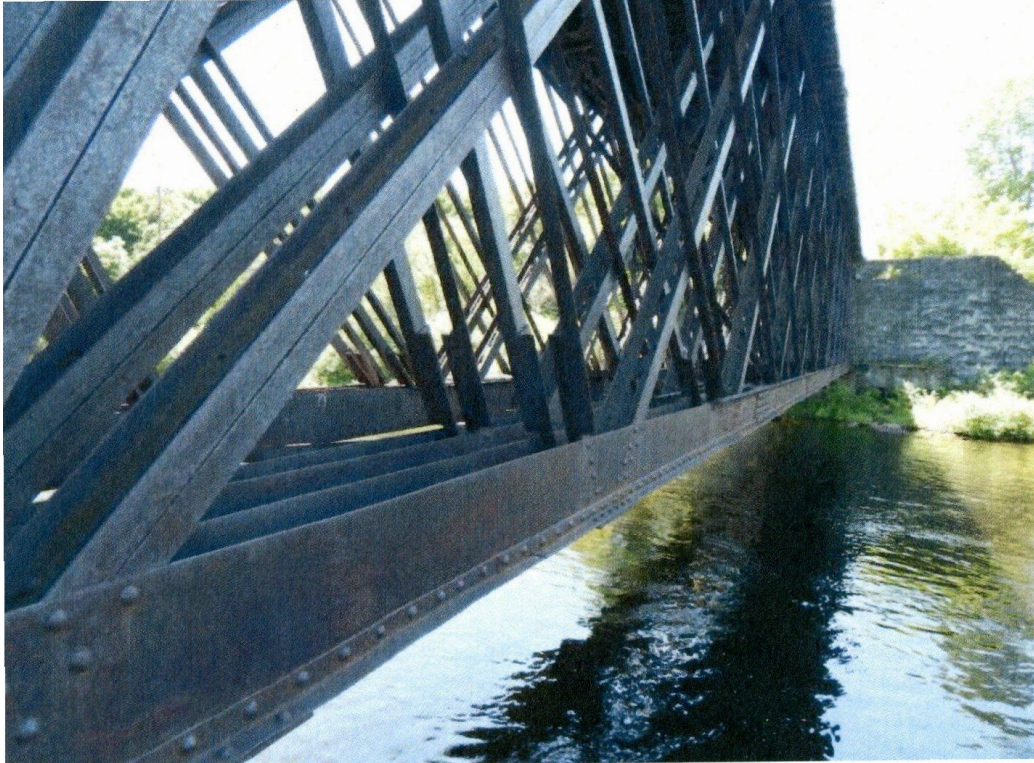
Photo 3. View of the NYOG Bridge No. 80 west (north) elevation, Span 2, showing the double truss. (Parsons 2015 Inspection Report, Photograph 28, page 38).

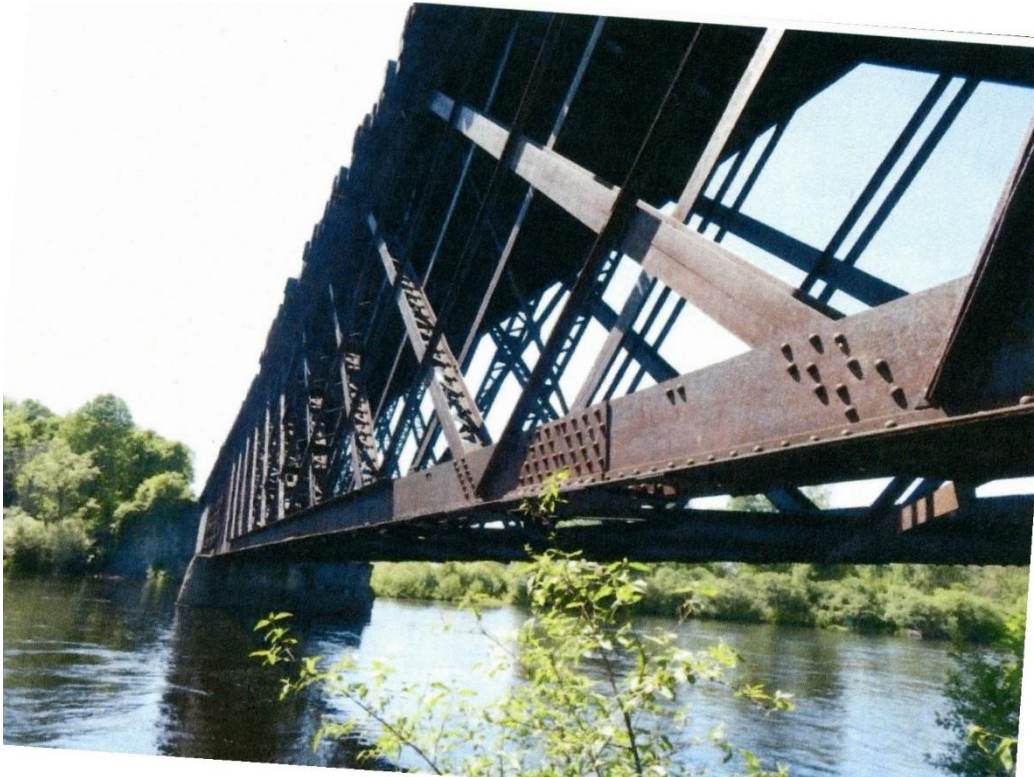
Photo 4. View of the NYOG Bridge No. 80 east (south) elevation, Span 3, showing the single truss. (Parsons 2015 Inspection Report, Photograph 28, page 38).

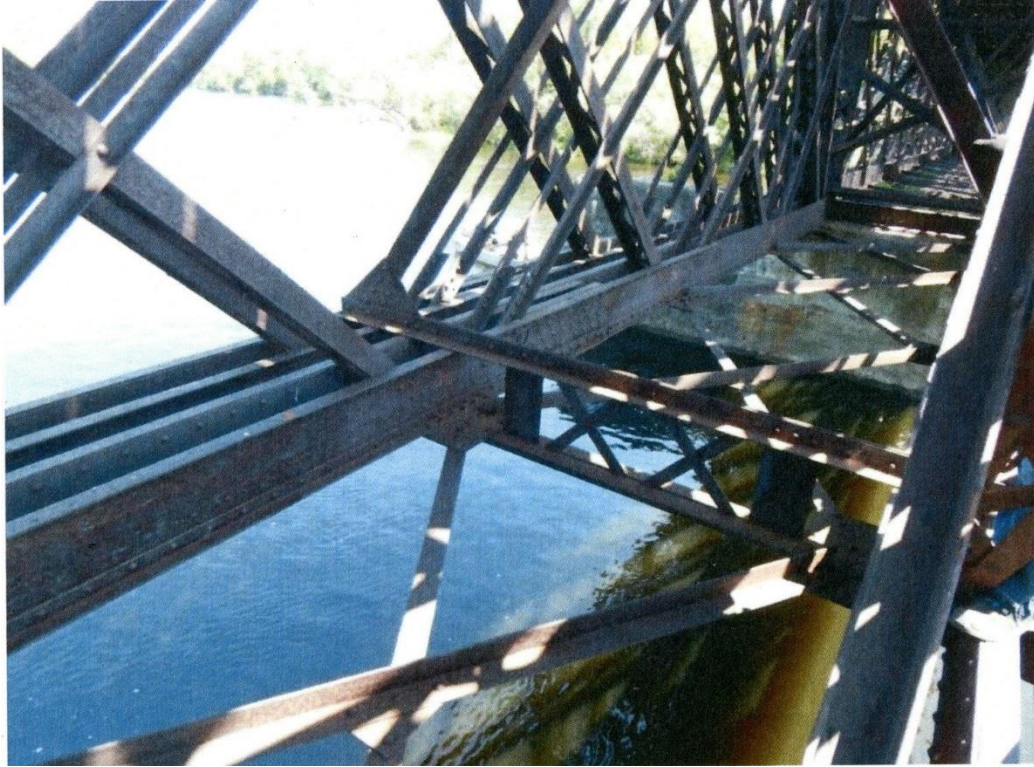
Photo 5. View of the NYOG Bridge No. 80, Span 2, showing the lower chords and laterals (Parsons 2015 Inspection Report, Photograph 31, page 39).

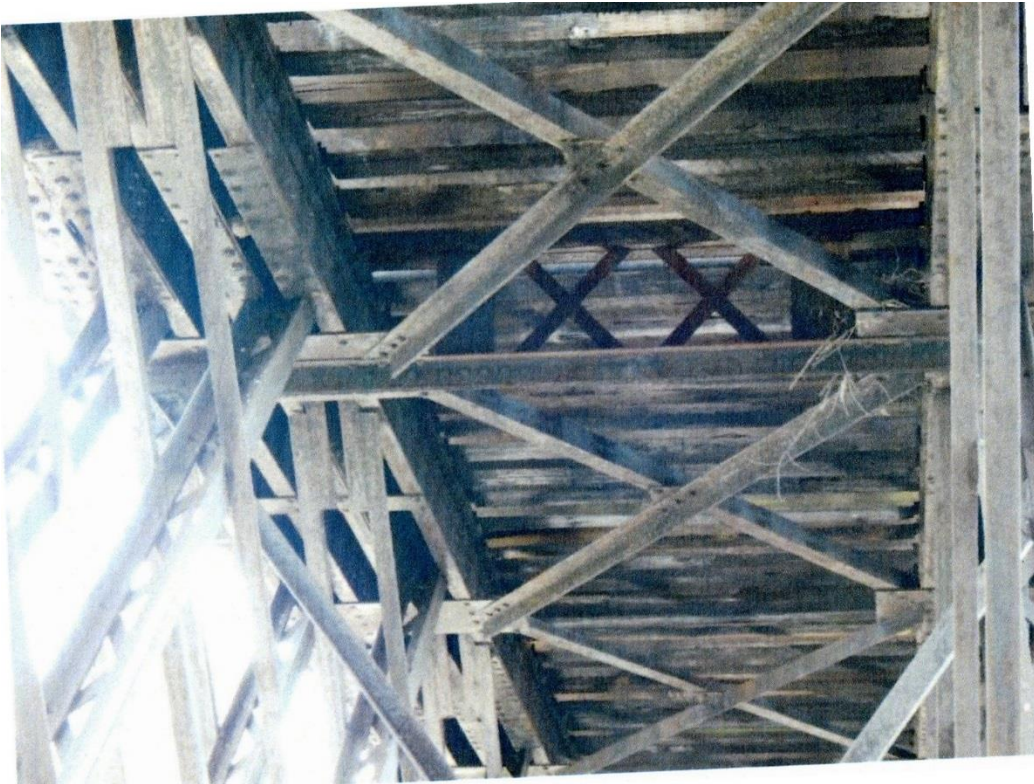
Photo 6. View of the NYOG Bridge No. 80, Span 2, showing the upper chords and laterals (Parsons 2015 Inspection Report, Photograph 34, page 41).

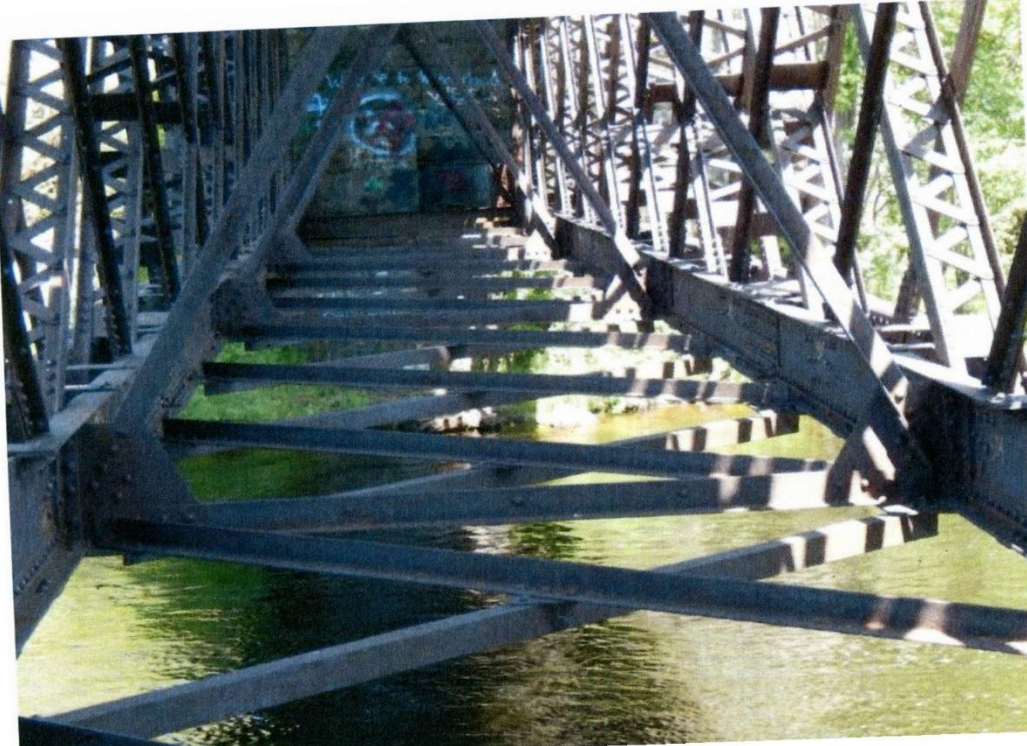
Photo 7. View of the NYOG Bridge No. 80, Span 3, showing the lower chords and laterals (Parsons 2015 Inspection Report, Photograph 35, page 41).

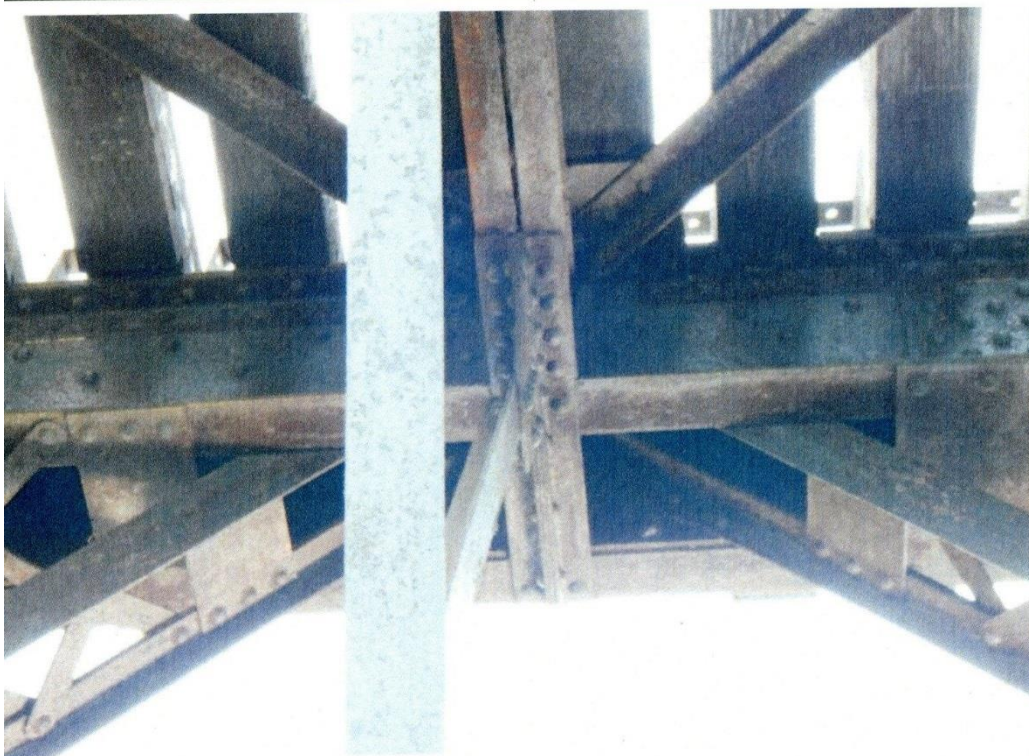
Photo 8. View of the NYOG Bridge No. 80, Span 3, showing the upper chord and laterals (Parsons 2015 Inspection Report, Photograph 30, page 39).

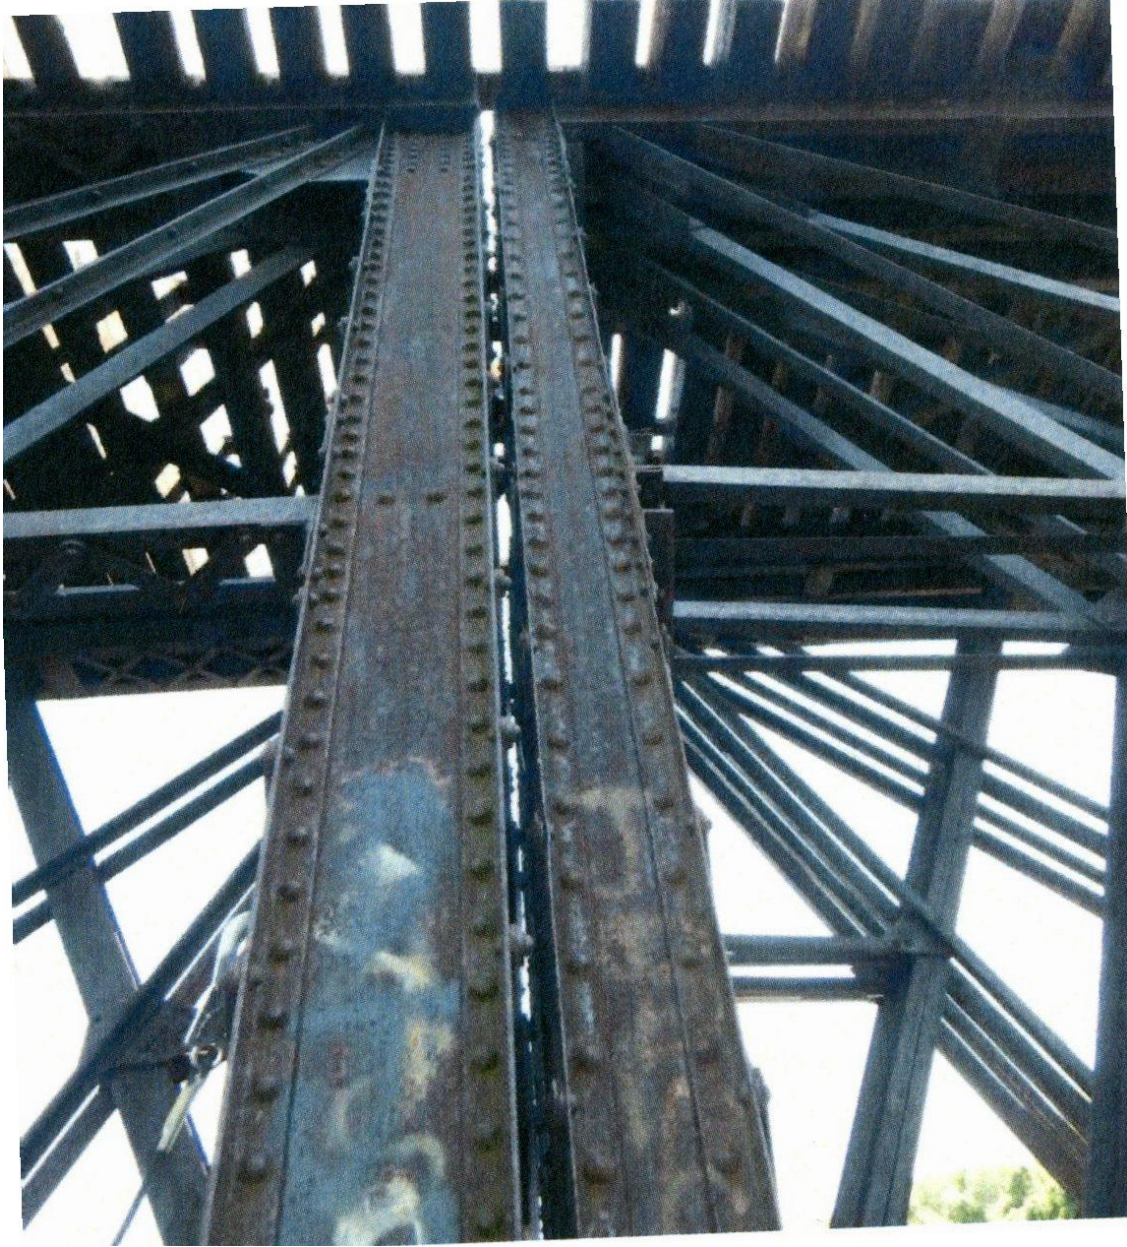
Photo 9. View of the NYOG Bridge No. 80, end posts of Span 2 (right) and Span 3 (left) at center pier, showing the comparative sizes of the posts. (Parsons 2015 Inspection Report, Photograph 33, page 40).
