**OHIO DEPARTMENT OF TRANSPORTATION
HISTORIC BRIDGE SURVEY REPORT**

SFN #: 6533159 **County:** PICKAWAY **Municipality:** CIRCLEVILLE TWP
NR Rec: Eligible **Previous Inventory/Date:** FIRST INVENTORY, 1981 **Status:** Select

Feature On: CR 4 (COMMERCIAL POINT ROAD)

Type: THRU TRUSS **Design:** CAMELBACK (PINNED)

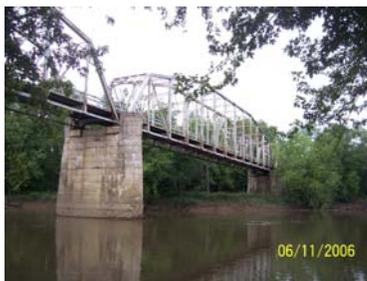
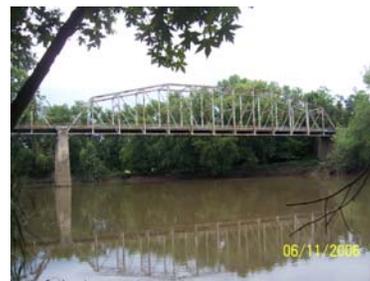
The 3 span, 710'-long, pin-connected Camelback thru truss bridge is traditionally composed of built-up compression members and eyebar tension members. It is supported on concrete abutments and piers.

Rehabilitated, 1984. Floorbeams strengthened with coverplate. Deck replaced.
