Bridge Work in Connection with the Elimination of the Grade Crossings of the Nickel-Plate at Cleveland, Ohio.

The New York, Chicago & St. Louis R. R., commonly called the "Nickel Plate," traverses the city of Cleveland and its suburbs for a distance of 16.94 miles. Its course is intersected by 120 highways, 20 of which either did not cross at grade, when the road was constructed in 1882, or had been separated from the grade of the railroad prior to 1909. In the latter year operations were begun to eliminate the grade crossings, and this article treats of the bridge work required for the elimination of these crossings. The ornamental features of the bridges are of special interest. The data contained in the article were taken from a paper by Mr. A. J. Himes, engineer of grade elimination, in Vol. 15, No. 160, Bulletin of the American Railway Engineering Association.

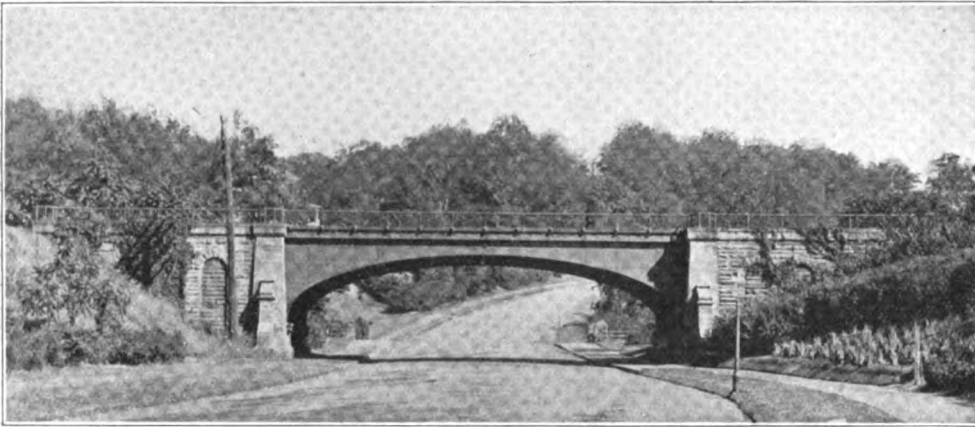
Fig. 1. Old East Boulevard Three-Hinged Steel Arch, Cleveland, O.

The former East Boulevard Bridge of the Nickel Plate (Fig. 1) was considered a very handsome structure, and the people of East Cleveland, in the hope of beautifying their city, demanded the construction of similar arch bridges. To this the company objected strongly, but it was finally arranged to build such bridges on a few particular streets. There was no material difference in weight between the plate girder and arch bridges. There was a considerable difference, however, in the volume of masonry in the foundations. The rock surface was about 12 to 16 ft. below the surface of the streets, and the foundations of the arch bridges were designed to carry the arch thrust to the rock. This increased the volume of concrete materially above what was needed for the plate girder bridges.

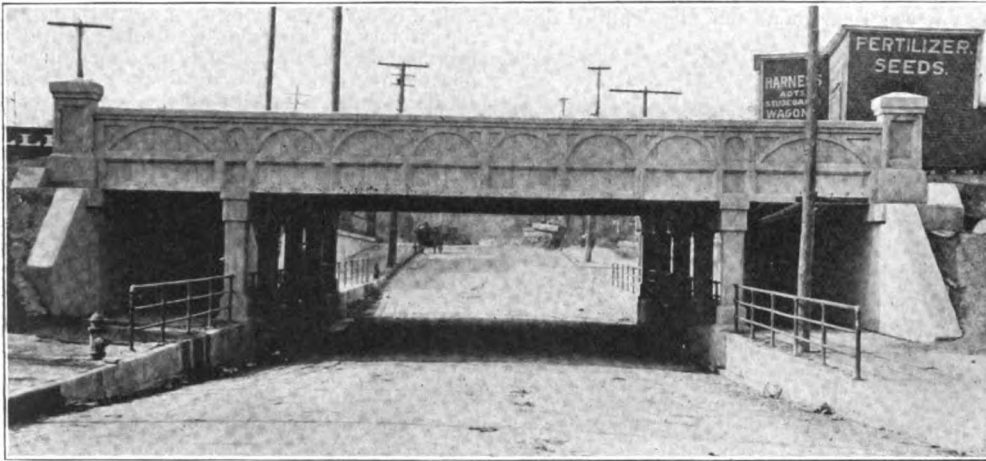
Fig. 7. Mayfield Road Bridge—Plate Girders Masked by Concrete.

The elevation of the concrete fascia of the Mayfield Road Bridge (see Fig. 7) was designed in the office of Robert Hoffman, chief engineer, Department of Public Service. In this case the concrete fascia is built directly upon the outer girder, and it was desired to cover the stiffer angles and to secure a

pleasing effect without the use of too large a mass of concrete.
