County of Simcoe
Vigo Bridge No. 000211 Improvements
Municipal Class Environmental Assessment

Public Information Centre

February 13, 2013

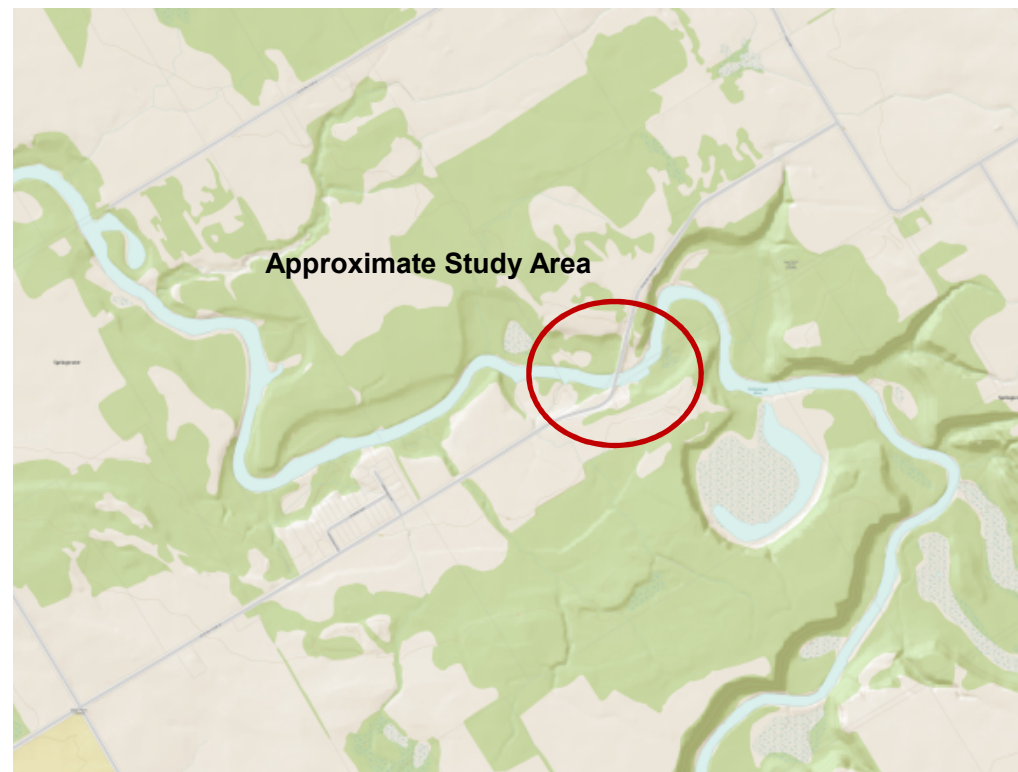
- Vigo Bridge (No. 000211) spans the Nottawasaga River along Flos Road 4 West, 3.16 km east of the Flos – Sunnidale Townline, and 4.4 km north of the village of Edenvale, in the Township of Springwater.
- The Study Area includes a radius of approximately 350m from the bridge.

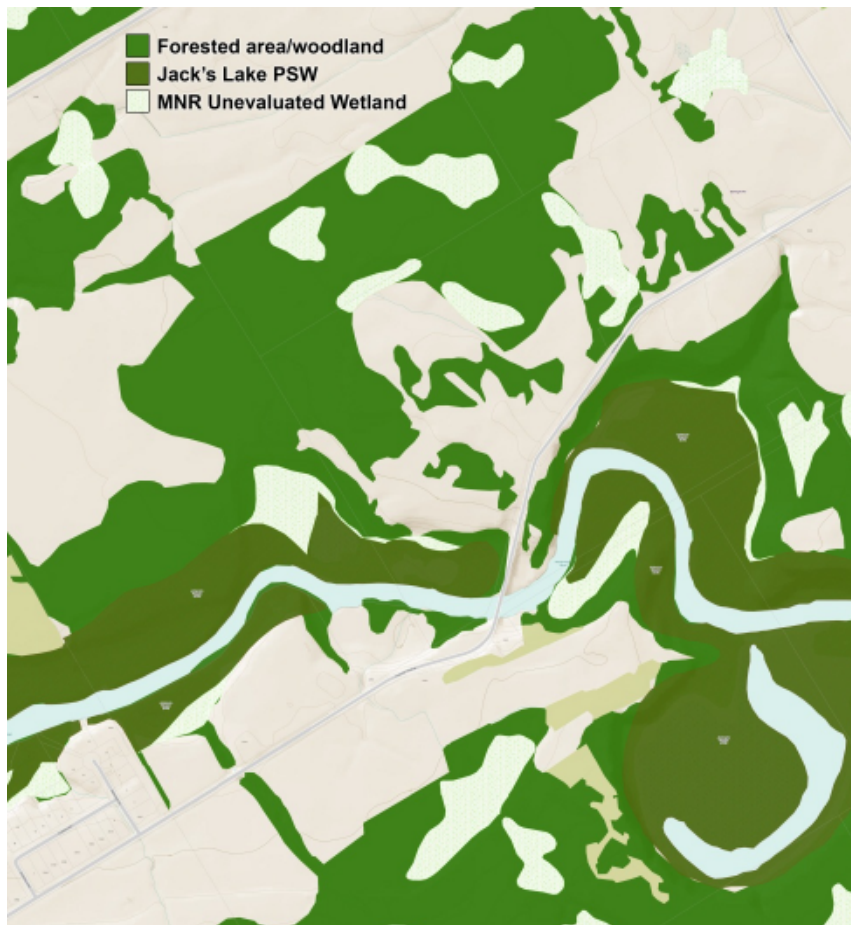
Natural Heritage Features in the Study Area

- The Nottawasaga River is managed as a warm water fishery
- Jack's Lake Complex Provincially Significant Wetland (PSW)
- County Official Plan wetlands
- Ministry of Natural Resources unevaluated wetlands
- Forested Area/Woodlands
- Area sensitive birds, provincially imperiled and vulnerable plant species and bird Species At Risk have been identified within 1 km of the Study Area

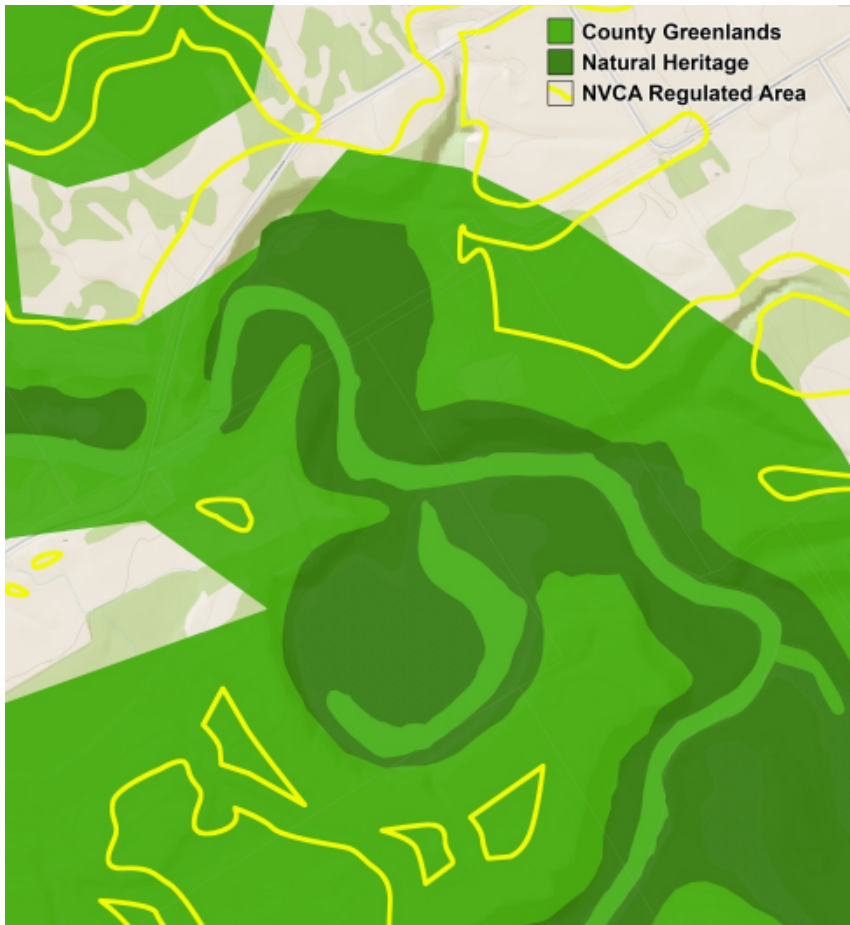
Designated Lands in the Study Area

- Lands regulated by the Nottawasaga Valley Conservation Authority
- Greenlands designation (County)
- Natural heritage and Rural lands designation (The Township of Springwater)

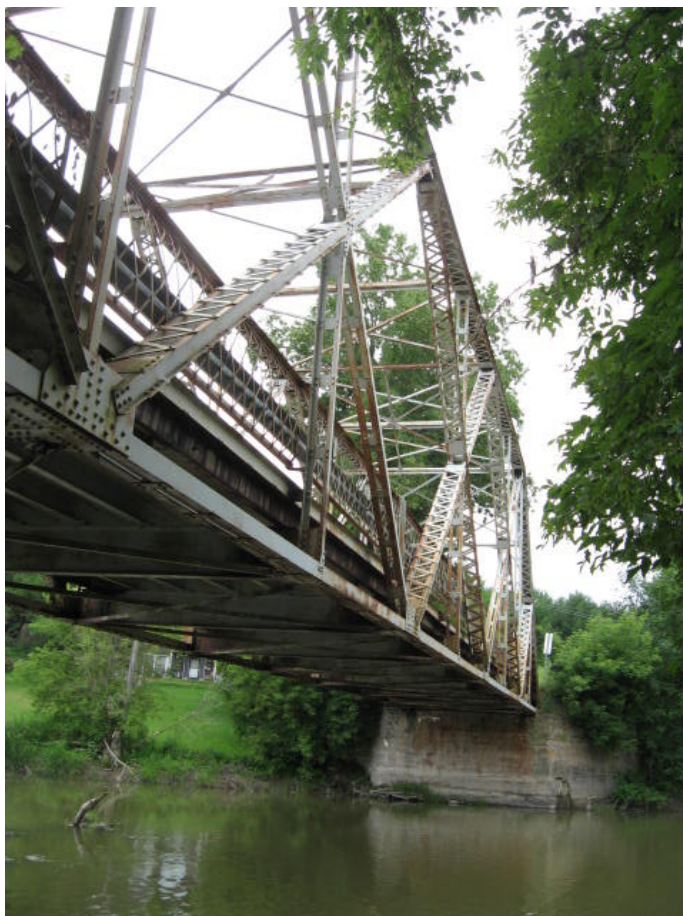
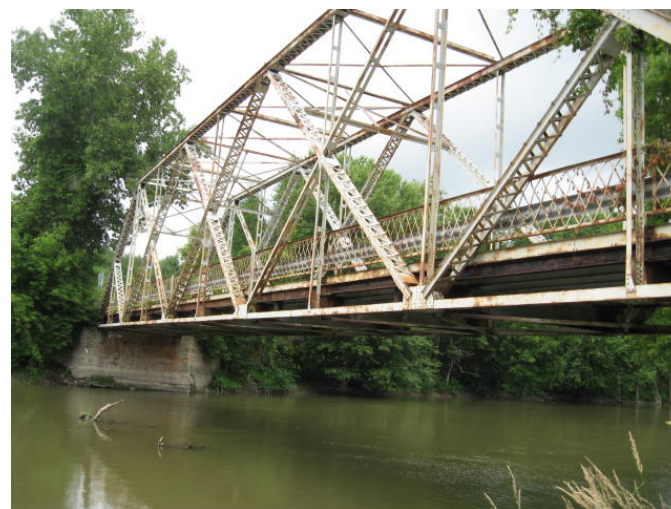
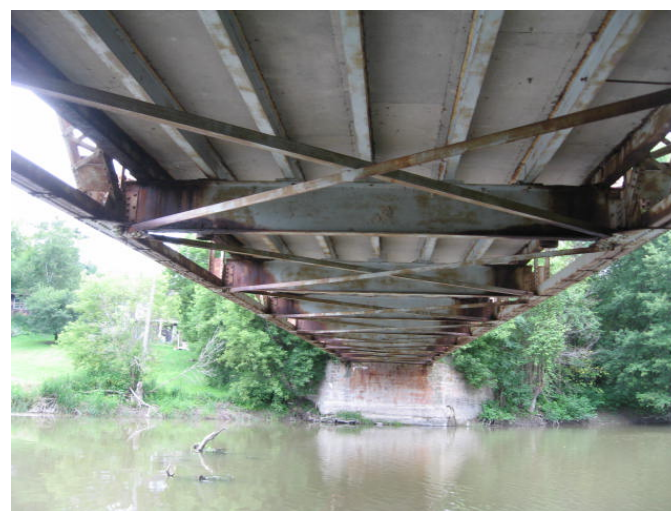
Existing Technical Environment Conditions

- Existing single lane, steel through truss bridge with an existing load restriction.
- Deteriorating components of the existing truss has resulted in a single load posting of 14 tonnes.
- The existing bridge cross-section geometry and road alignment does not conform to the current County or Municipal standards.
- Further load restrictions and the eventual closure of the bridge can be expected if the deterioration is allowed to continue unabated.
- The current barrier system does not comply with the current code requirements for the safety of road users.
- The site requires a minimum Performance Level 1 barrier system.
- The current horizontal alignments of the approaches to the bridge do not meet the requirements of MTO's Geometric Design Standards.
