**HERITAGE IMPACT ASSESSMENT**

**BRIDGE 4-WG  
5<sup>th</sup> Line over a Tributary of the Speed River  
Lot 5, Concessions V and VI  
Township of Centre Wellington, Wellington County, Ontario**

ASI File: 18CH-130

October 2019 (Revised November 2019)

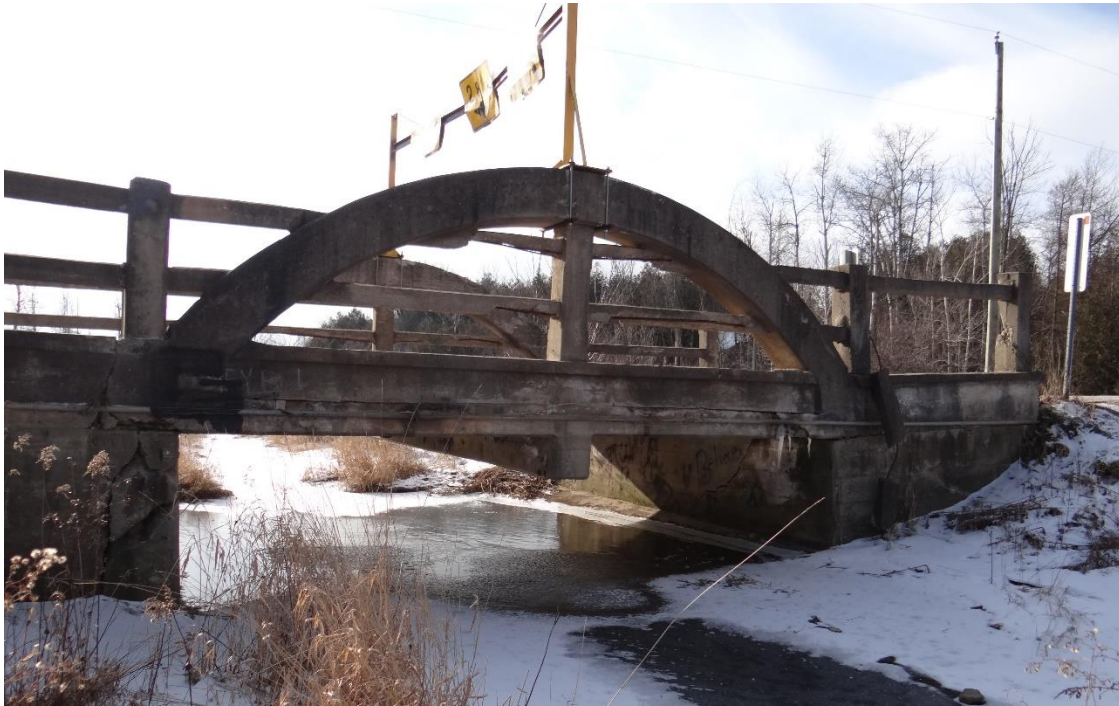
Figure 2: East elevation of the subject bridge, looking west

Bridge 4-WG (historically known as the Bain Bridge) is a single-span concrete bowstring arch structure resting on concrete abutments. The bridge carries two lanes of northbound and southbound 5<sup>th</sup> Line vehicular traffic over a tributary of the Speed River approximately 550 metres south of County Road 18 in the Township of Centre Wellington. The bridge was designed by A W. Connor & Co., Engineers from Toronto and built by the construction firm of Quinn and Wilson in 1923. The structure measures 7.3 metres in length, 6.2 metres in overall width, and has a roadway width of 5.3 metres.

The substructure of the subject bridge features cast-in-place concrete abutments on the north and south elevation. The abutments rigidly support the concrete deck. The abutments appear to be original to the 1923 construction and bear the impression of the board-formed molds from construction. The abutments were cracked and appeared to be in poor condition at the time of field inspection.

The superstructure of the subject bridge is a cast-in-place concrete bowstring arch rigidly integrated with the concrete abutments. The superstructure features a thin slab cast-in-place concrete deck with an asphalt wearing surface. The underside of the deck features impressions from the wooden board formwork used to cast the structure. The concrete deck is supported by a single longitudinal cast-in-place concrete floor beam that is integrated to the bottom chord of the concrete bowstring arch. A single vertical truss member connects the top chord at the apex of the arch to the bottom chord and is placed in the same location as the floor beam. The top chord of the arch is a cast-in-place concrete arch with a rectangular cross-section. The top chord lacks concrete lateral bracing, however, a metal brace was bolted onto the structure at the time of field inspection and is assumed to strengthen the truss in light of the identified structural deficiencies. Several areas of the concrete superstructure exhibited localized spalling and exposed rebar at the time of field inspection.

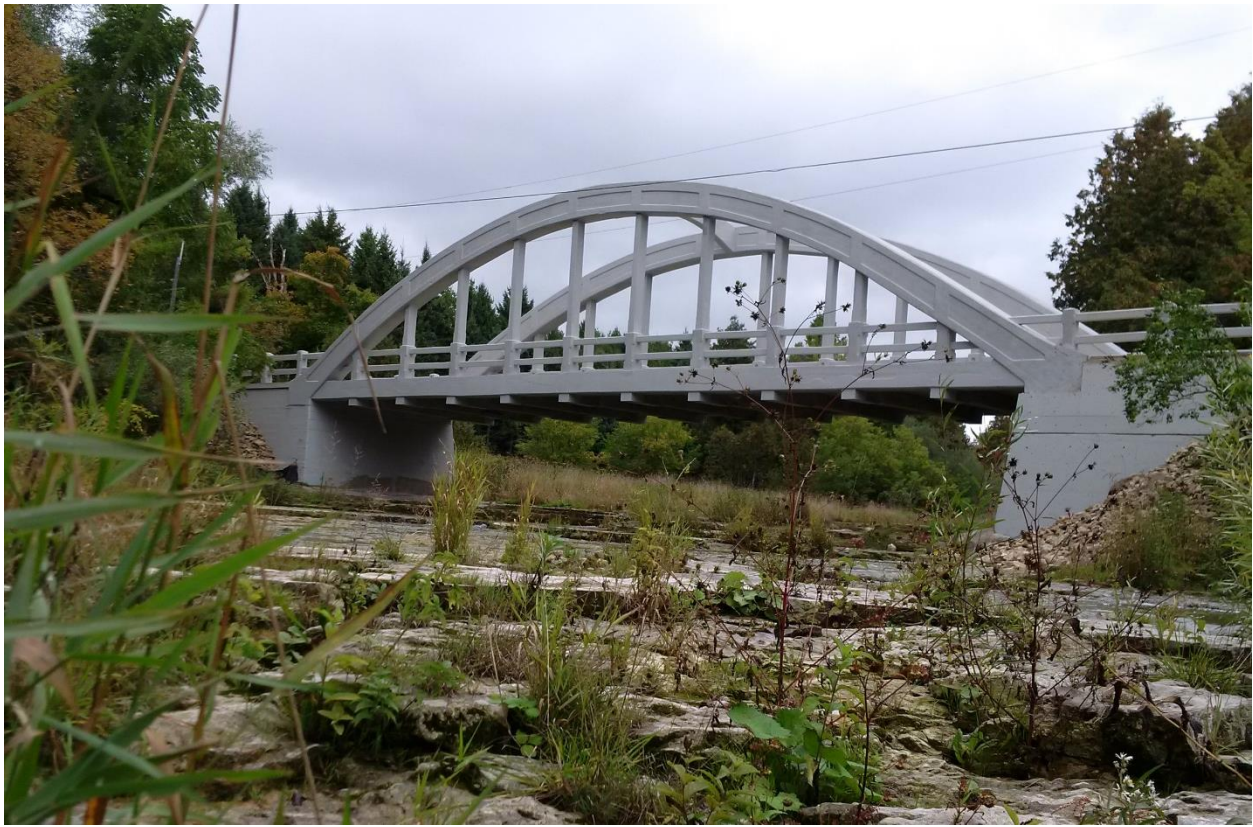
Figure 7: Bridge 9-N after rehabilitations in 2016, a representative example of a concrete bowstring arch bridge Designated under Part IV of the Ontario Heritage Act (CIMA+ email communication 5 December 2018).
