# **Balls Bridge: Truly Rare, Truly Significant**

## ***Preservation For History, Beauty, and Community***

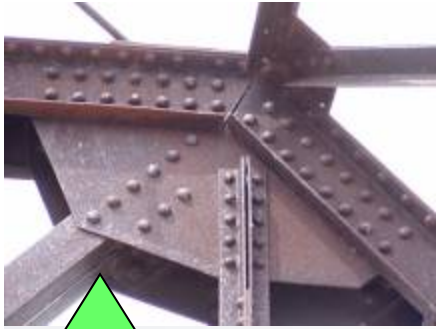
Riveted connections

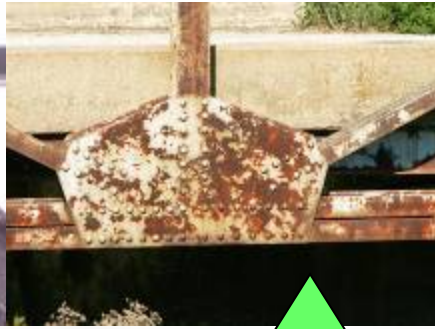
Pinned connections

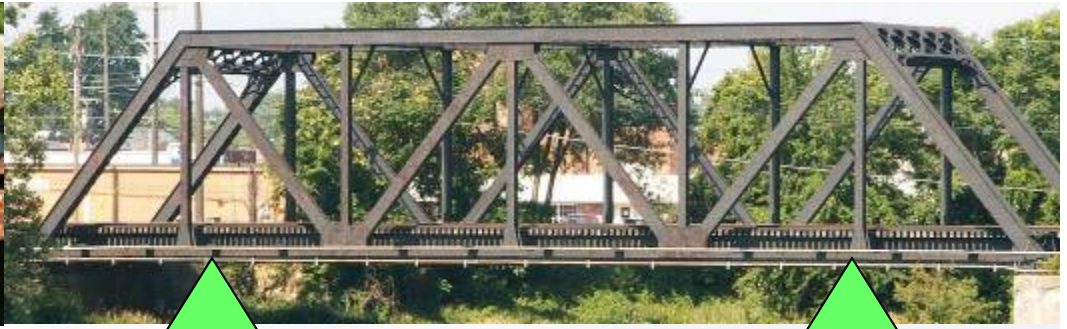
Warren truss

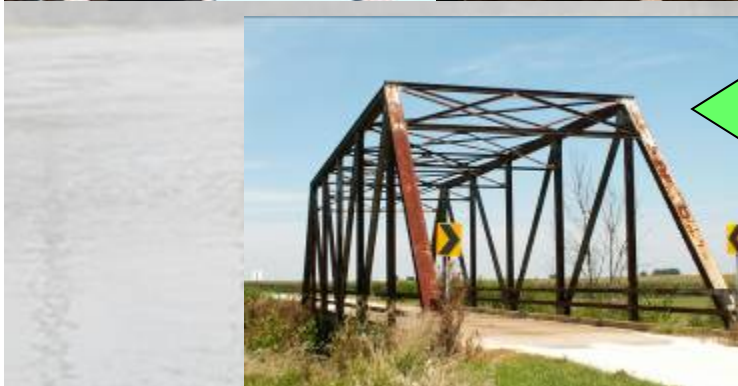
Through Truss

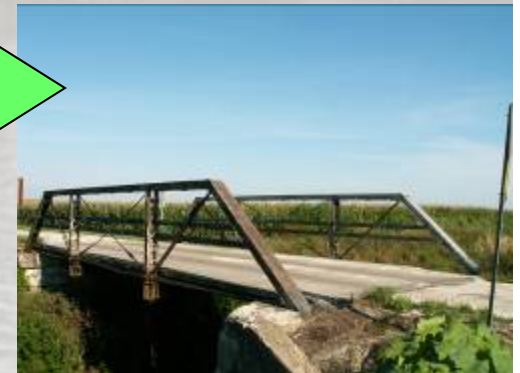
Pony Truss

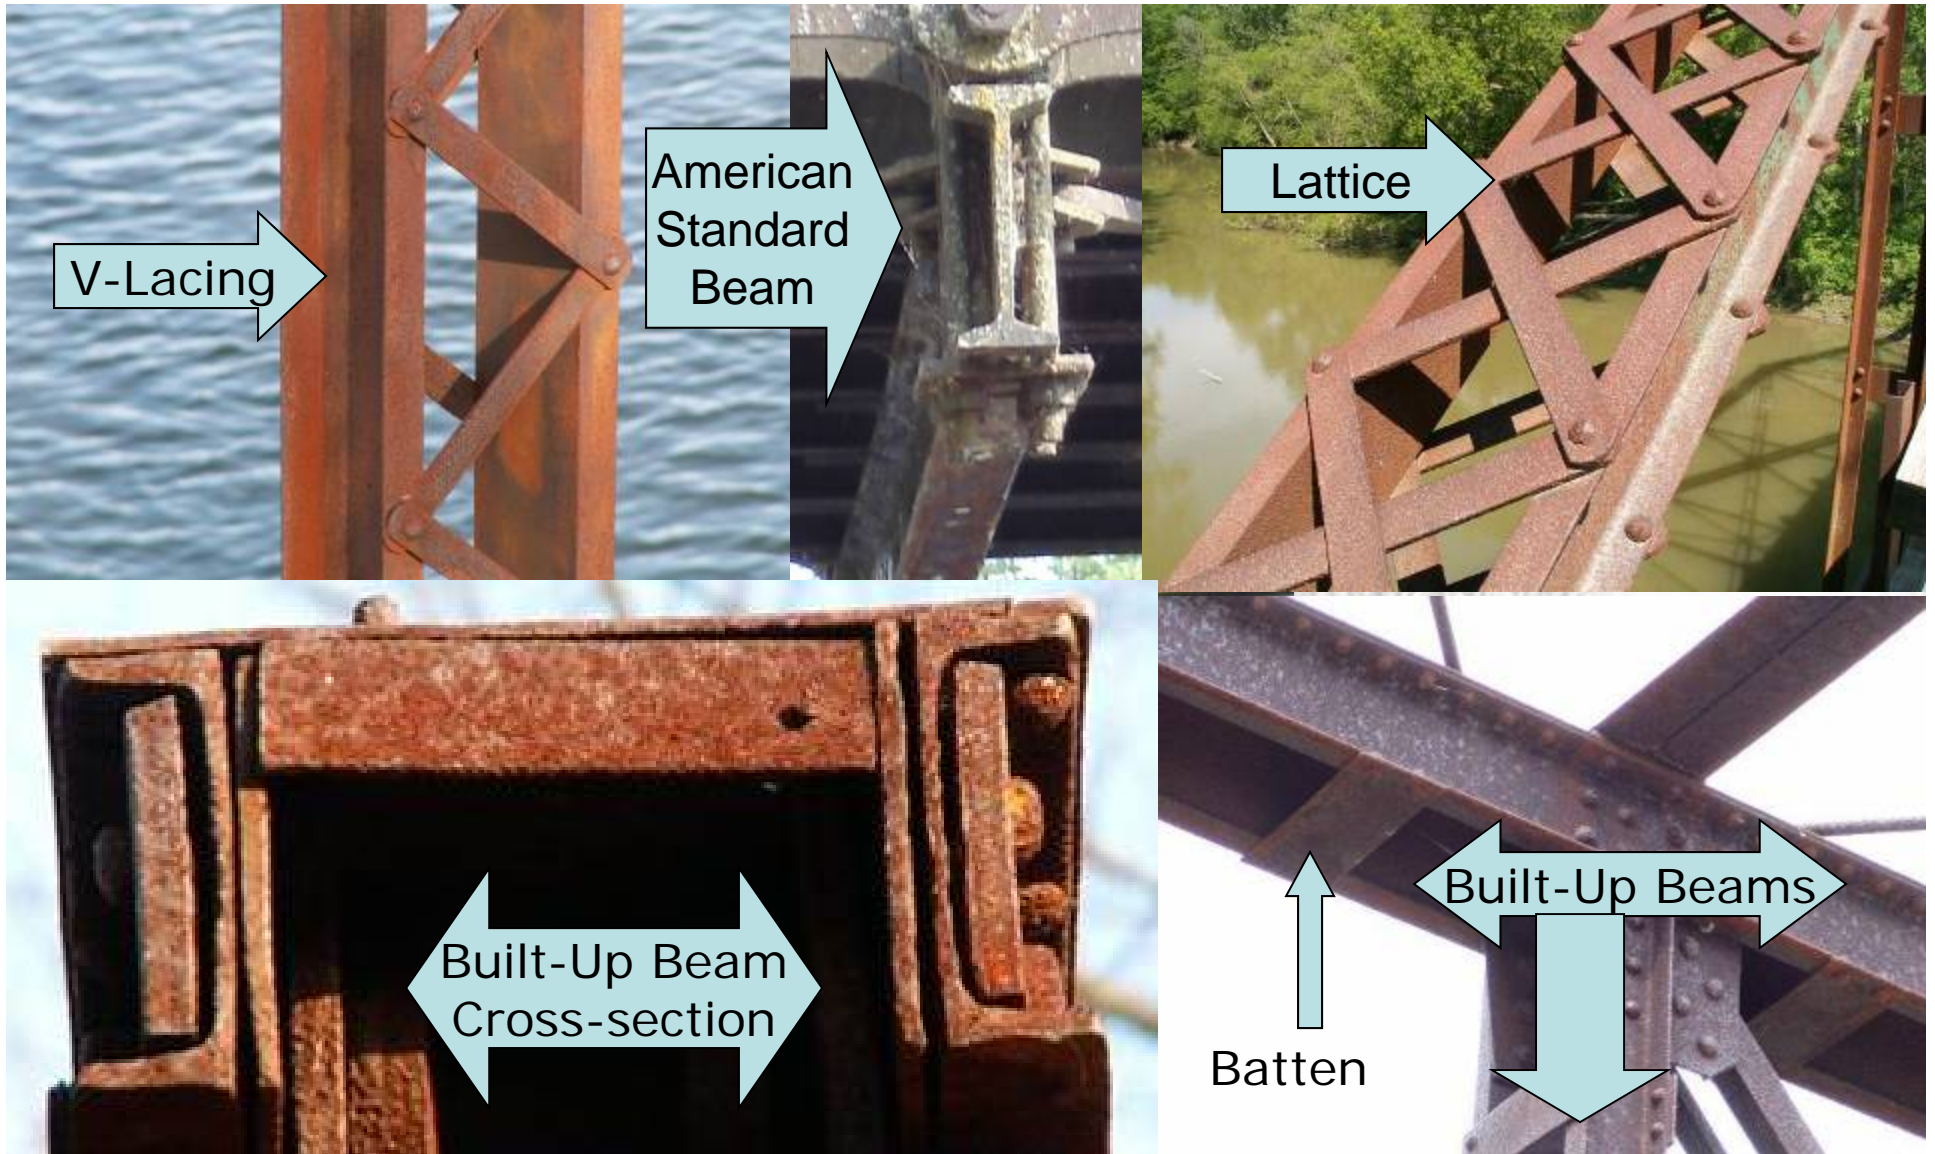
Pin-connected truss bridges are also a snapshot of materials used in the period. Most truss bridges make use of built-up beams that feature rivets and v-lacing, lattice, or battens which hold metal parts together to form a larger, complete beam. They also may have old-fashioned i-beams called American Standard Beams.
