Badley Bridge (Metcalf Street) Elora,  
County of Wellington

# **Revised and Final Supplementary Cultural Heritage Evaluation and Heritage Impact Assessment Report**

Prepared for BT Engineering

April 2019

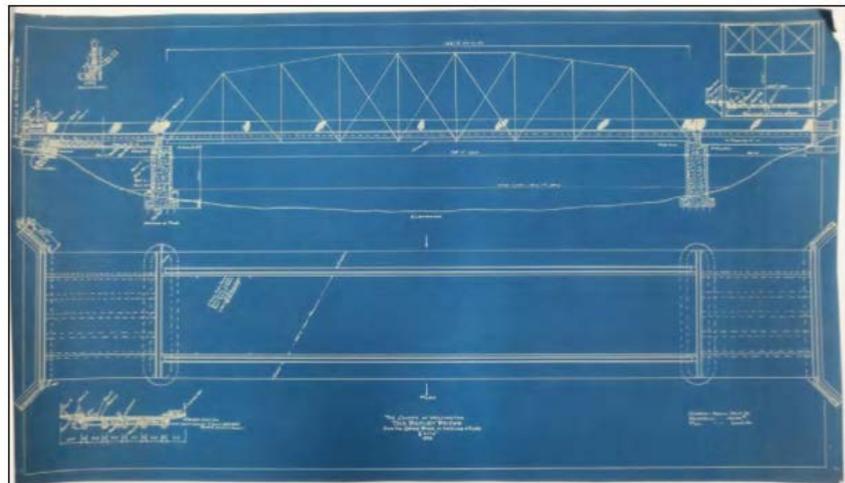
**Figure 1: Blueprint plan for Badley Bridge, 1952 (Source: Wellington County Museum and Archives, MAP 536)**

In order to determine the heritage value of the design executed in the construction of the Badley Bridge in 1952, (opened in 1953) it is important to understand the intent and merits of the Camelback bridge design that was chosen for this crossing of the Grand River. Image taken from MHBC report of the original design drawings.

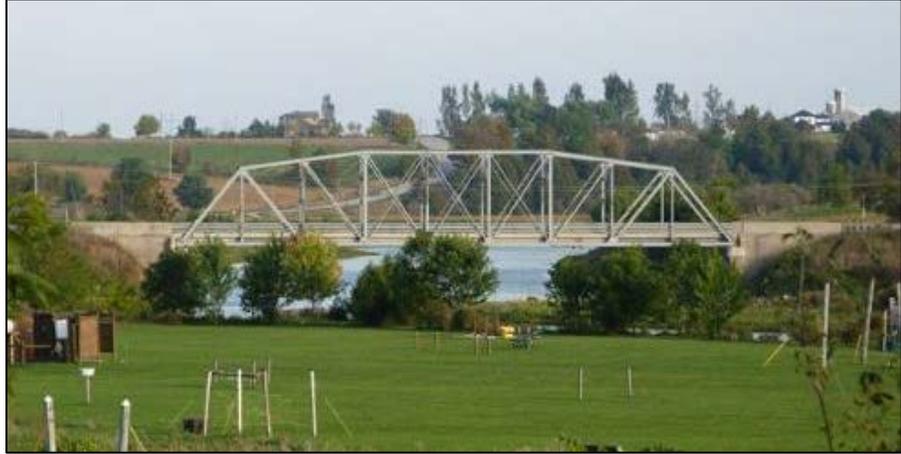
**Photo 3: Princess Elizabeth Bridge, Wellington County**

Bridge located on Wellington Road 12 near Third Line. Research into the historic County Council records provides a glimpse into the rationale for bridge construction. After the war, the County had a “vigorous policy of bridge construction as rapidly as conditions permit. The investment was in new and adequate bridges as an excellent and lasting achievement for many years to come.” (June 17, 1952 County Road Committee Report.) The construction of the Badley Bridge was part of this policy. The choice of bridge design was based on adequacy rather than aesthetics.

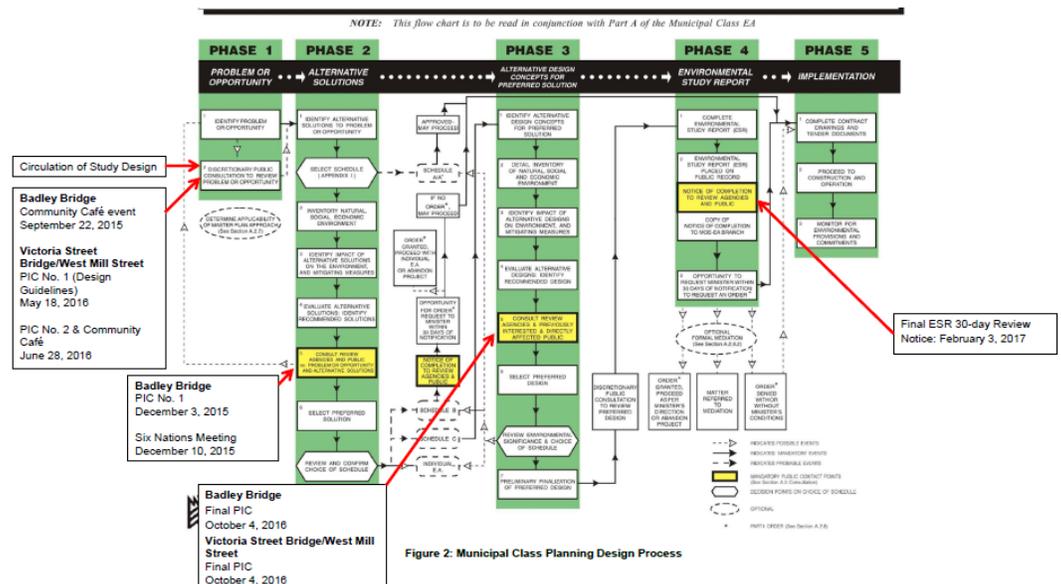
**Figure 5: Municipal Class EA Process**

The following summary describes the Environmental Assessment process mandated by the Province of Ontario for municipalities managing infrastructure projects. The sequential decision-making process of the Class EA is illustrated below.

The Municipal Class EA had previously considered alternatives including: do nothing, close the bridge, rehabilitation, or replacement of the existing bridge crossing over the Grand River. These approaches were initially considered as Planning Alternatives and this was followed by a

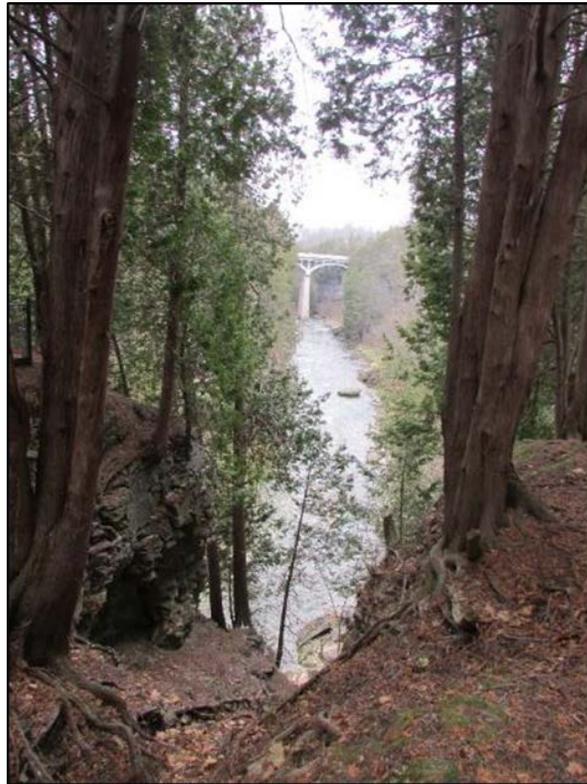
**Photo 5: View of David Street Bridge from Victoria Park**

A second bridge in proximity to the Badley Bridge is the David Street Bridge. This bridge is also visible from Victoria Park and consists of a distinctive natural stone centre pier supporting two open spandrel concrete arches. This bridge is the fifth bridge that has been constructed in this location. The earlier designs included a cantilevered type, a timber truss with a polygonal top chord, a double Pratt through truss bridge with the centre pier built in 1867-1868 and in 1875, and an inverted steel truss reusing the centre pier. (Allan, 1982). The David Street Bridge crosses Irvine River and is at a high elevation from the river in a similar manner as the Grand River Bridge. The height accentuates the visual depth of the gorge. Recent work on the bridge has added a decorative concrete balustrade type railing in keeping with the highly visible bridge. The design and rehabilitation work that has been completed on this bridge respects the scenic view of the bridge. A nearby commemorative plaque interprets the history of the bridge for the community. The David Street Bridge is visible from Victoria Park. The central pier and arched elements contribute to the scenic view.

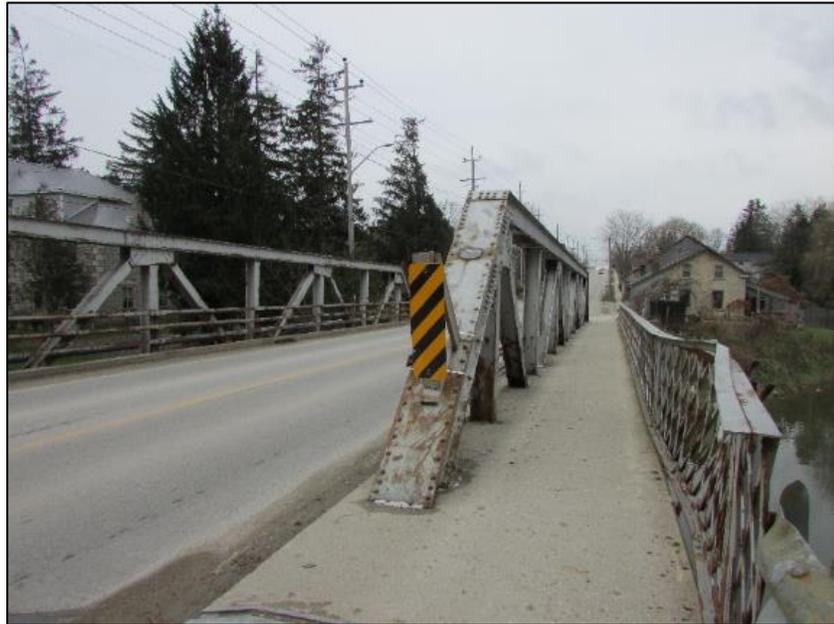
**Photo 7: The Pony Truss Bridge**

and lower in elevation (within four metres of the river surface) than the Grand River and David Street Bridges. It is located close to historic stone mill buildings and residences. The pony truss design is a type of truss design where the bridge deck is carried on the lower beams resulting in a lower height of the truss components above the deck closer to eye level. There are no overhead connections. The pony truss bridge design is utilitarian and functional with the individual parts, rivets and connections open to view. There is no ornamentation or intent to make this bridge a scenic component of its setting. The Pony Truss Bridge in Salem was built in the same period as the Badley Bridge. It has no overhead connection elements.

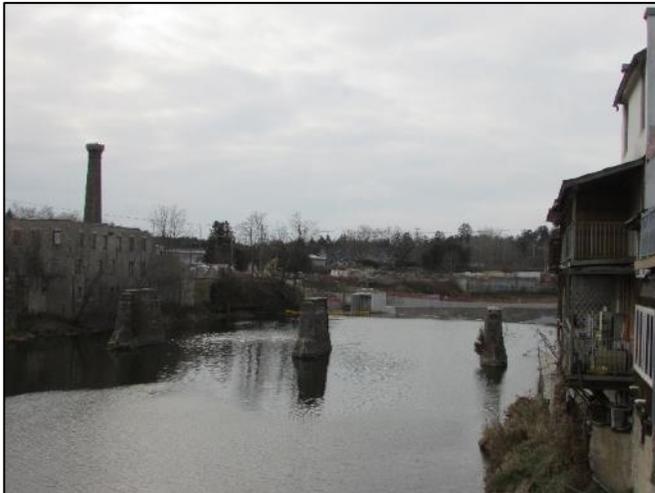
**Photo 9: Stone Piers of the Victoria Street Bridge**

Prior to the demolition of its deck, the Victoria Bridge was a key part of the cultural heritage landscape of Elora. It provided the only core area link for vehicles and pedestrians until it was demolished. The stone piers of the Victoria Street Bridge are visible from the Badley Bridge.

The remaining piers are a significant component to the cultural heritage landscape and the new pedestrian bridge will integrate them in the new plan for this section of the crossing.

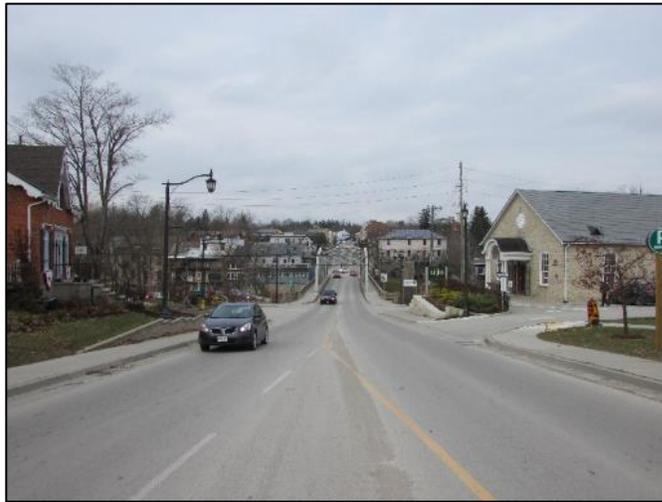
**Photo 11: Badley Bridge South Side View**

A second view to the north is from the area in front of the former drill hall (now the LCBO) on Metcalfe Street. Prior to the construction of the bridge, this view contained a panoramic view north towards the village core along the unopened road allowance. After 1953, the Badley Bridge added to the composition forming part of the foreground of this view. The Badley Bridge is located within the view across the wide river valley. The former drill hall and historic buildings frame the view on the south side of the river.

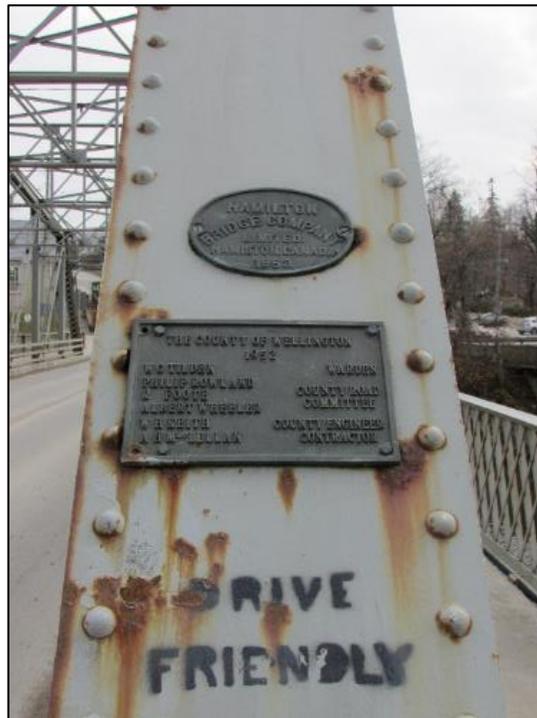
**Photo 20: Condition Assessment Report – Bridge Deterioration**

The actions required to prolong the life of the Badley Bridge are determined by the existing structural condition of the bridge. The Structural Condition Assessment report completed in 2014-2015 by MMM Group Limited is a comprehensive review of the bridge, including past repairs, the individual components and its overall condition. The condition assessment revealed that many structural components of the bridge have deteriorated and require replacement. The Environmental Study Report process undertook a detailed evaluation of the potential alternatives as described in Section 3.1 of this Supplementary Report, in order to determine the recommended alternative solution.

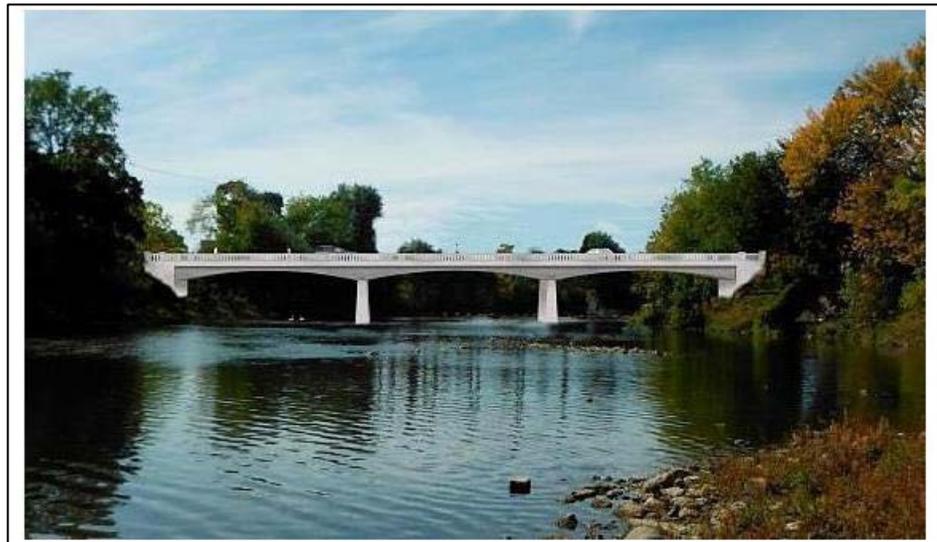
**Photo 21: Rendering of Badley Bridge Recommended Plan**

The Recommended Plan for the Badley (Metcalf Street) Bridge is illustrated below.

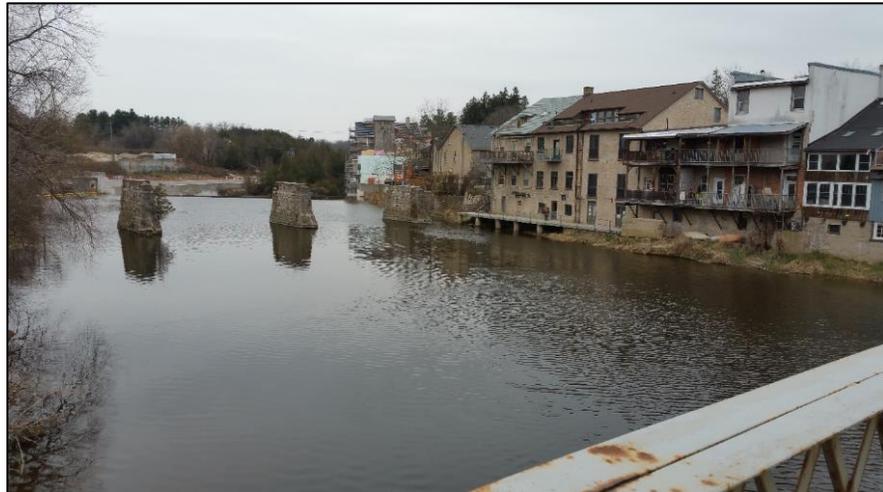
**Photo 22: View looking West from the Badley Bridge**

This view looking west from the Badley Bridge, showing the back of Mill Street buildings overlooking the river setting, as well as the piers from the historic Victoria Street Bridge (to be re-used for proposed new pedestrian bridge “A”) and the dam just beyond (where the proposed new pedestrian bridge “B” will cross) shows the composition of the amalgam of built form that defines one of the character elements of the CHL. This forms a scenic “stage” of cultural landscape character. This character will change with the two new pedestrian bridges soon to be built.

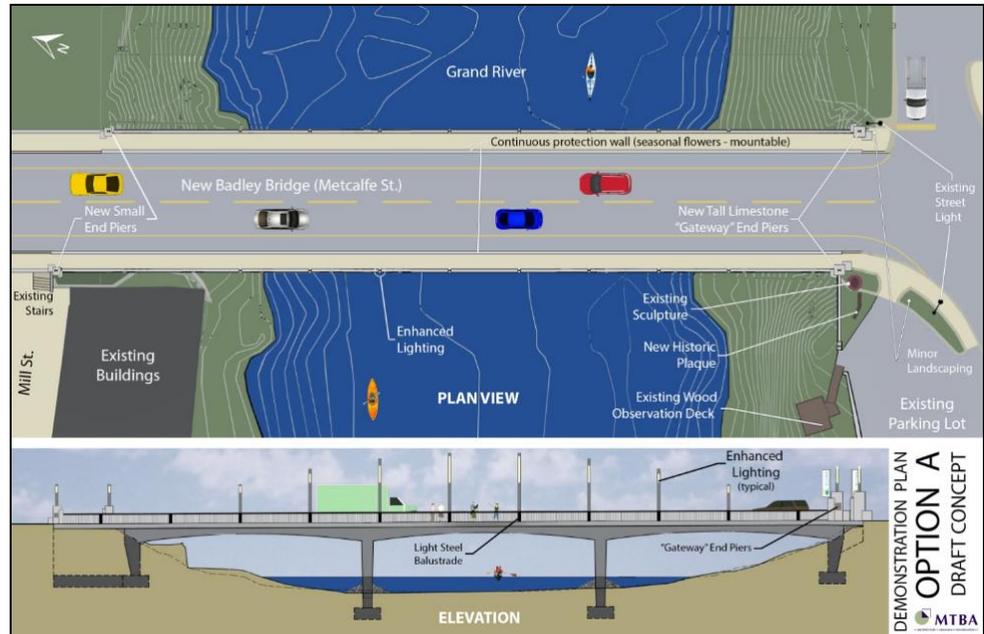
Figure 8: Option “A”

The most minimal of interventions, this option seeks to be open and light by using a visually light steel balustrade. This is accomplished by running a continuous protection wall between bike lanes and pedestrian sidewalks. In order to have the bridge acknowledge its important gateway function, this option relies on new tall limestone end piers at the south to provide the gateway. Smaller limestone piers mark the north end of the bridge. The limestone relates directly to the geology of the gorge. Enhanced street lighting is used to trace the Camelback outline of the former bridge, which adds an historic interpretative element while also adding some whimsy and fun to a very minimal design.

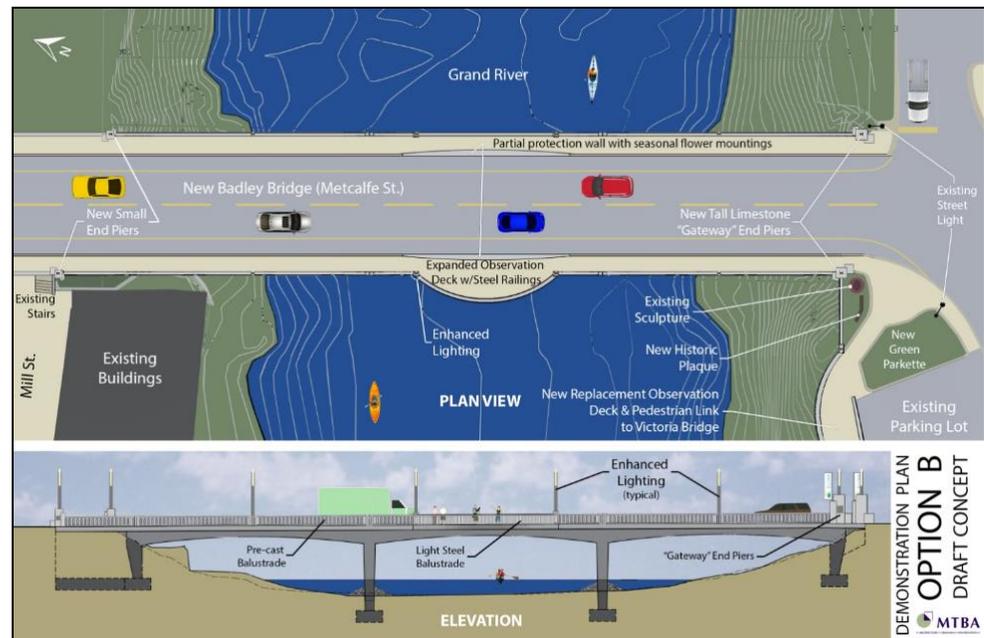
Figure 9: Option “B”

- standard precast balustrades with narrow openings;
- an observation deck or belvedere on the west side at mid-span, large enough for a family or two to stand for photos and views while out of the way of passing pedestrians; this includes partial protection walls to guard against the light steel railings used at the belvedere;
- replacement of the existing wood observation deck on the south bank with a new enhanced parkette and new observation deck with connectivity to the Victoria Bridge (would require negotiation with private owner); and
- simpler new enhanced lighting.

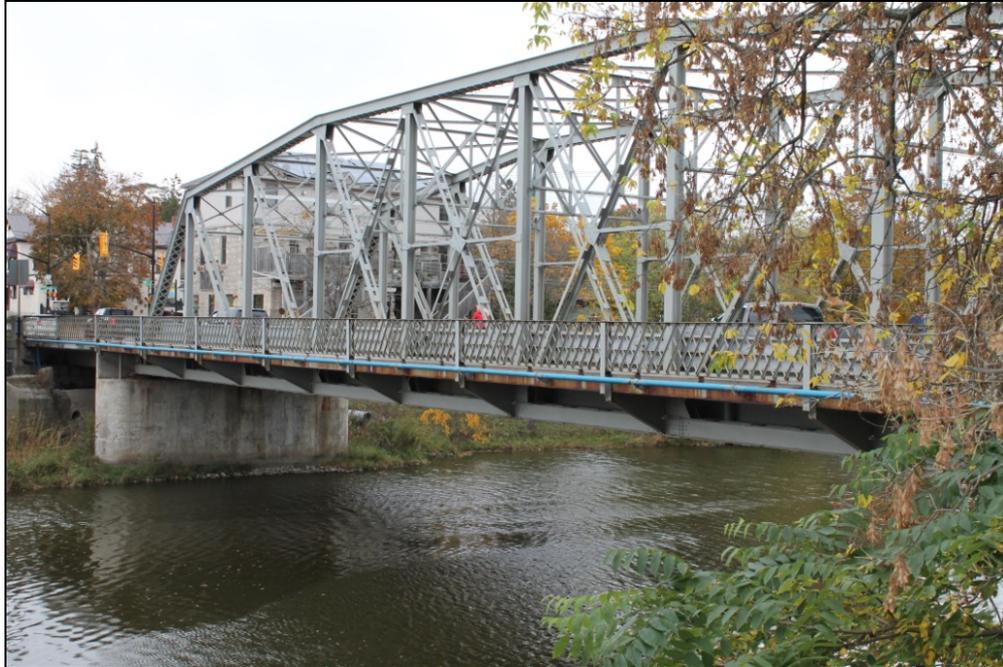
**Figure 14** - View of Badley Bridge from Victoria Street Bridge Pier south observation area. (MHBC October, 2015)

The Badley Bridge (Metcalf Street Bridge) has sidewalks on both sides, which allows for use by pedestrians and vehicles alike. Located directly to the west of Badley Bridge are the stone piers of the former Victoria Bridge, which was partially demolished in 2005 due to its deteriorating condition. The Victoria Bridge was designated under Part IV of the *Ontario Heritage Act* but the designation was repealed in order to remove the bridge.

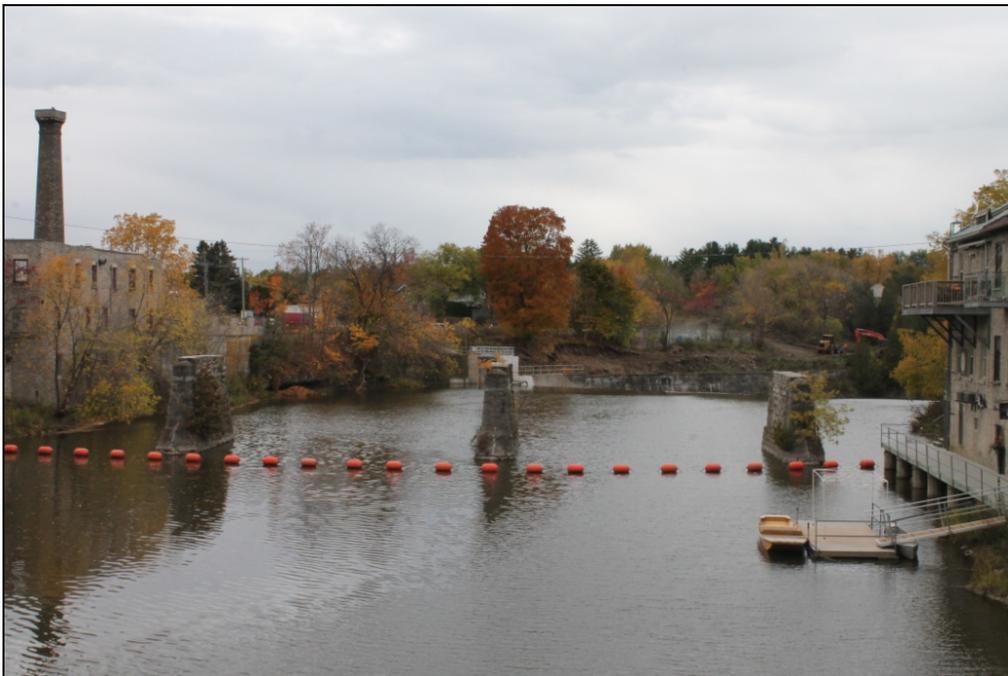
**Figure 17** - View of Victoria Street Bridge Piers from centre of Badley Bridge (MHBC October, 2015)

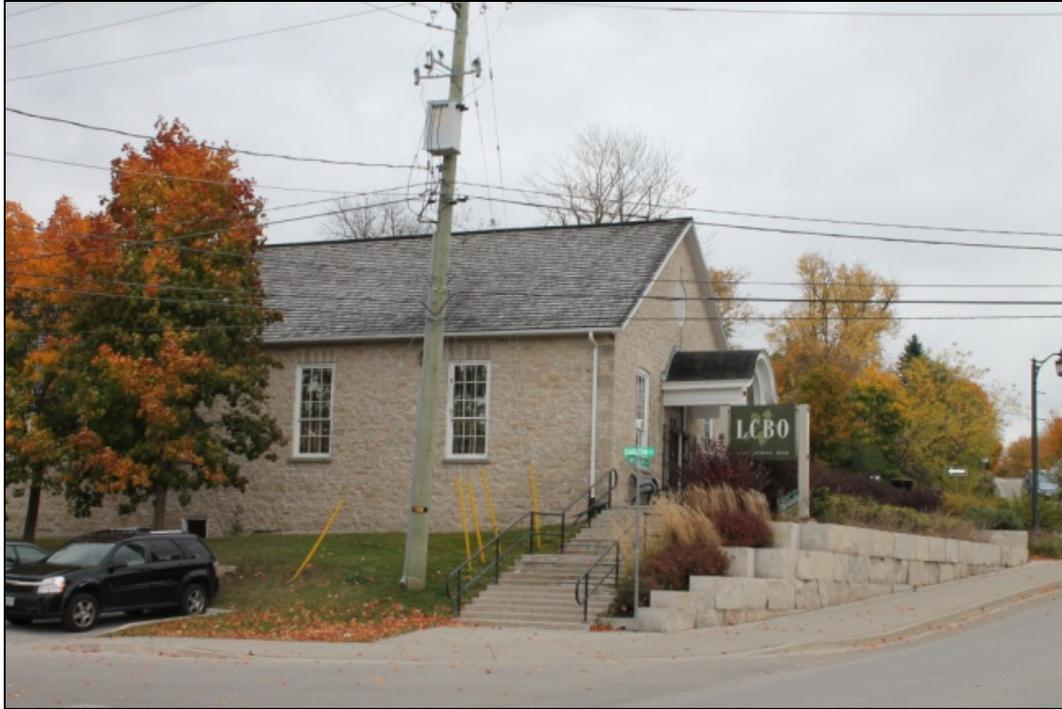
**Figure 19** - Former Drill Shed, 23 Metcalfe Street (formerly High Street) (MHBC, 2015)

The property located at 23 Metcalfe Street (formerly High Street) was designated under Part IV of the *Ontario Heritage Act* in 2013. The property was designated as a National Historic Site under the Historic Sites and Monuments Act and was listed on the federal Register on March 13, 2009. The designating by-law for the property identifies its significance as the former Armoury Hall, or Elora Drill Shed, a mid-19<sup>th</sup> century stone building constructed as a military training facility and hall to serve the needs of the local community. The Drill Hall (constructed in 1865) is noted to have been of better design and construction quality than other such halls found in areas with lower rates of military enrollment (Town of Elora, Parks Canada). The designating by-law cites this as the community's desire to build a structure that would provide opportunities for re-use in the future, beyond military training (Town of Elora). The hall has a neoclassical design with semi-circular fanlight above the entrance and oculus in the gable. The hall is associated with the history of the Canadian military. It was one of many drill sheds constructed in areas near the American border in response to the American Civil war and threat of Fenian Raids. The hall was constructed before standardization of drill hall design by the Department of Defence (Township of Centre Wellington, Parks Canada).

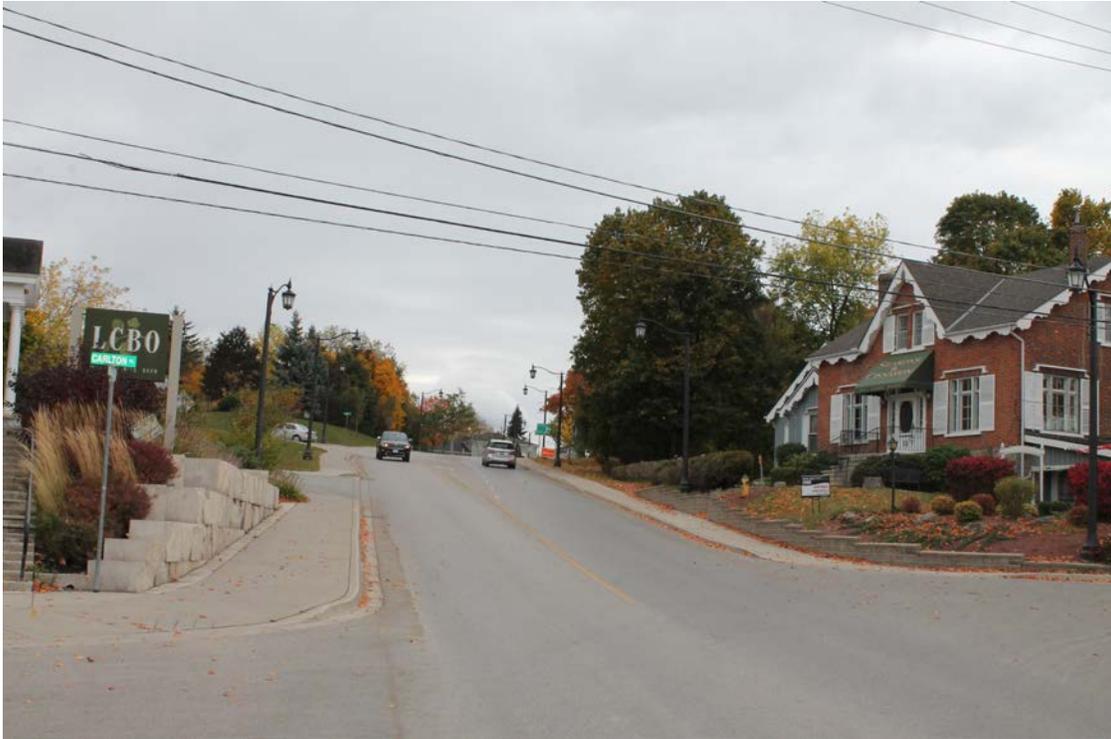
**Figure 21** – View of 22 Metcalfe Street (right) looking north along Metcalfe Street across from 23 Metcalfe Street (L.C.B.O) (MHBC, 2015)

The property located at 22 Metcalfe Street is thought to have been constructed in 1852. It is of red brick construction, using Flemish bond pattern and sits on a stone foundation. The former dwelling demonstrates design/physical value having influence of the gothic revival architectural style, evident in the one and one half storey massing with centre gable and symmetrical facade.

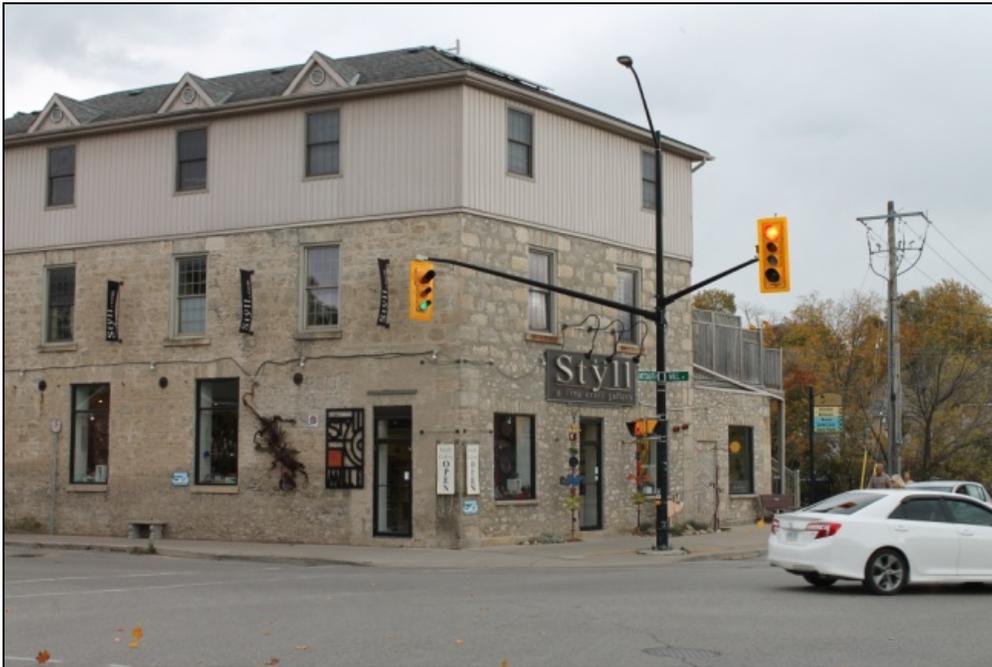
**Figure 22** – View of 5 East Mill Street, a former mill built in 1865 with cut stone, low hip roof, reflects Village’s early history. The property is listed on the Municipal Heritage Register (MHBC, October 2015)

The structure is thought to have been constructed in 1865 as a mill. Assessment records in 1890 list Thouson Williams, a glover, as the owner of the property. Fire insurance maps identify the building as "GRO", typically the abbreviation for a grocer, suggesting that there may have been several uses on the site and that they likely evolved over time.

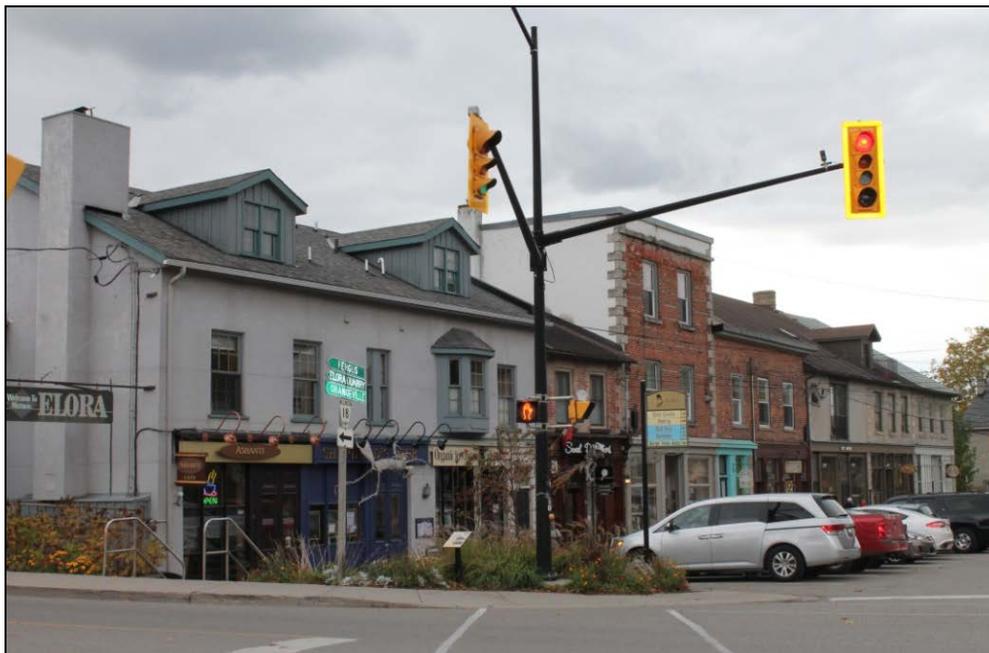
**Figure 23** - View of West Mill Street from northeast corner of Badley Bridge (Metcalf Street Bridge) intersection. Note the structure in the foreground, 8-12 Mill Street West, which is listed on the Municipal Heritage Register (MHBC October, 2015)

The property located at 8-12 West Mill Street is thought to have been constructed in 1859, and is a two and one half storey brick structure built to a rectangular plan with three commercial units. The building has been altered over the years with stucco/EIFS covering the brick construction and replacement windows. Replacement storefront windows generally follow the pattern of traditional commercial storefronts.

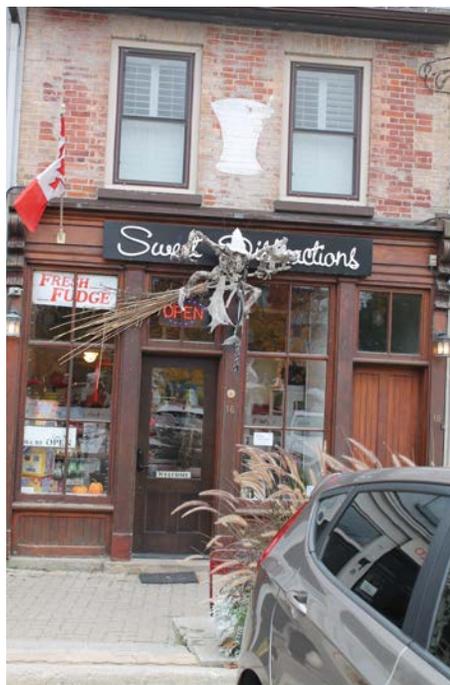
**Figure 24** - View of 16-18 West Mill Street looking south from West Mill Street (MHBC October, 2015)

According to the Township of Centre Wellington Heritage Register, the property located at 16-18 West Mill Street is a 2 storey commercial building with apartments above, thought to be constructed in 1860. The building displays grey brick quoins, low gabled roof and stretcher bricks.

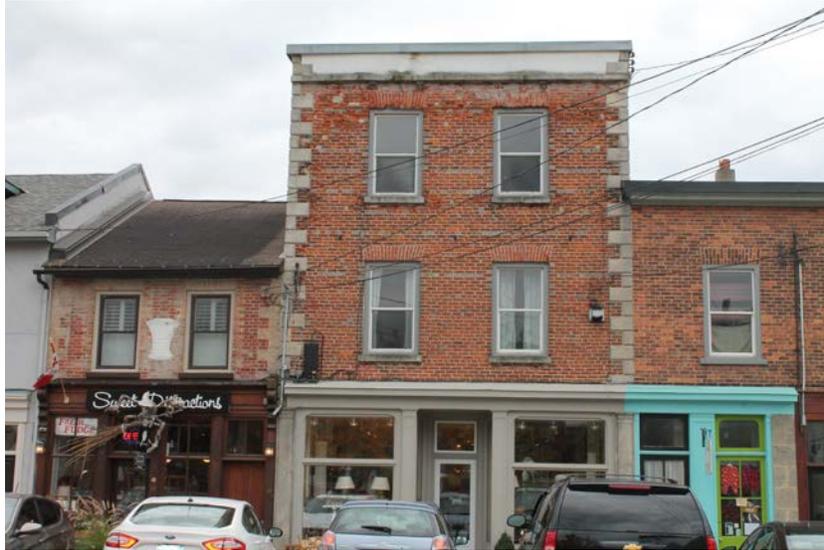
**Figure 25** - View of 22-30 West Mill Street looking south from West Mill Street (MHBC October, 2015).

According to the Township of Centre Wellington Heritage Register, the building located at 22-30 West Mill Street is a 3 storey brick commercial building with apartments above. The building is thought to have been constructed in 1885 and displays stretcher bricks and grey brick quoins.

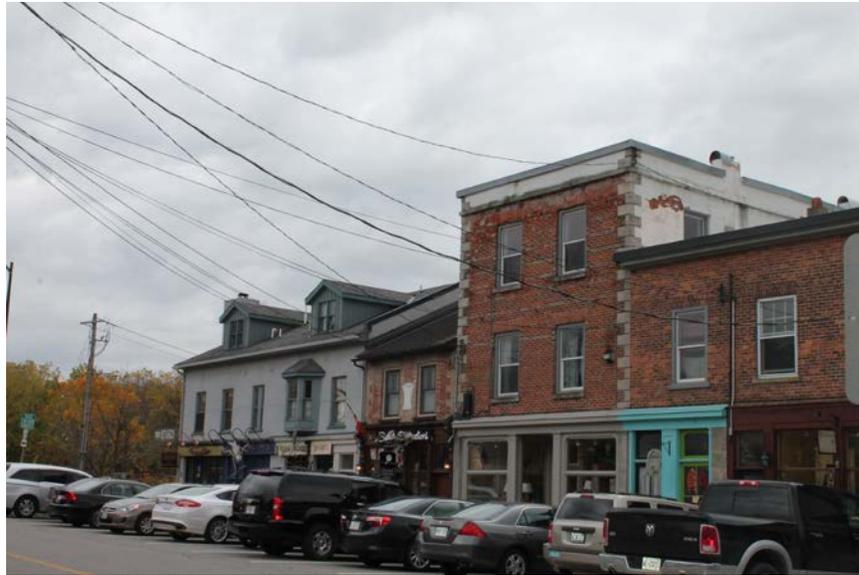
**Figure 26** - View of West Mill Street looking south-east from north side of West Mill Street (MHBC October, 2015)

According to the Township of Centre Wellington Heritage Register, the building located at 36 West Mill Street is a 2 storey brick commercial building with apartments above. The building is thought to have been constructed in 1866 and displays stretcher bricks with a flat roof.

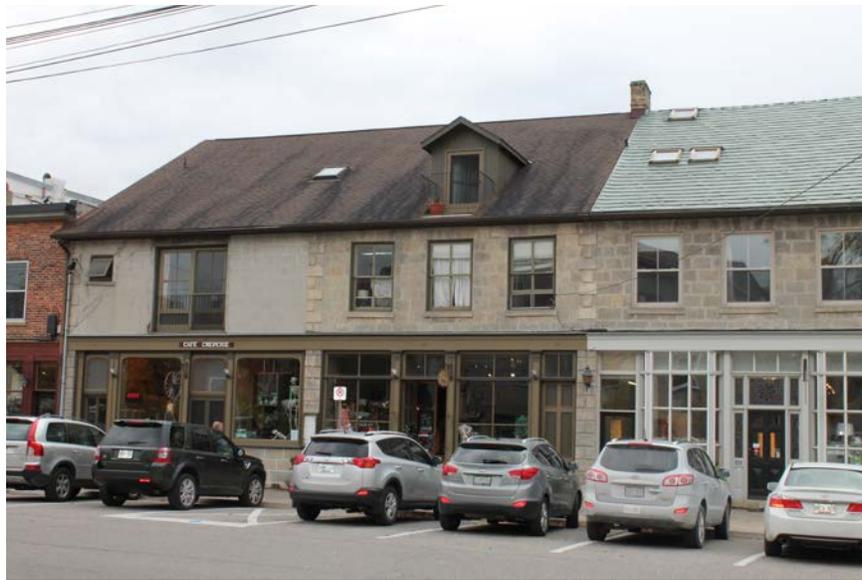
**Figure 27** - View of West Mill Street looking south-east from the north side of West Mill Street (MHBC October, 2015)

According to the Township of Centre Wellington Heritage Register, the building located at 38-40 West Mill Street is a 2 storey commercial building. The building is of stone construction, with a gabled roof, constructed in 1870. The building displays a commercial storefront with one dual-set of windows and one smaller window to the east. These windows may not be original to the building, or have been adapted.

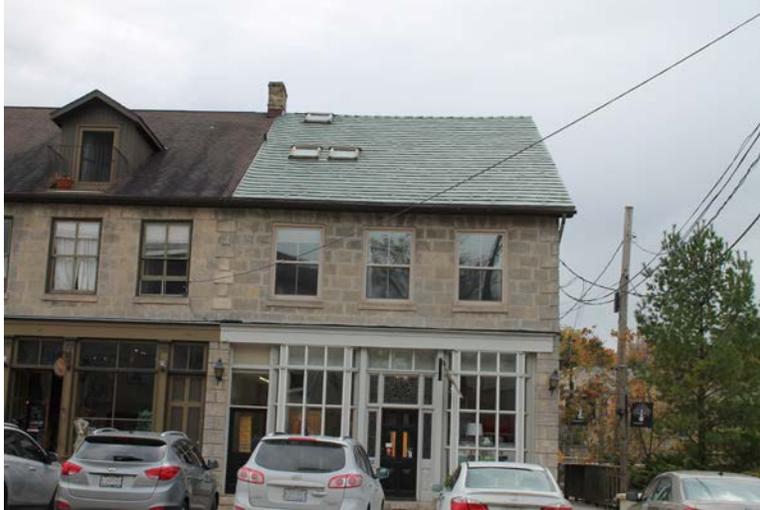
**Figure 28** - View of 46-48 West Mill Street looking south from north side of West Mill Street. (MHBC October, 2015)

The building exhibits design/physical value as a representative example of a 3-storey 3-bay Georgian commercial building with a commercial storefront constructed in 1867. The facade displays local cut limestone with rubble stone sides and rear facades, with chamfered quoins. The front entrance displays two bay windows on either side of the front entrance with transom and sidelights, detailed with stained glass. The building has retained its original window and door openings. The limestone materials complement the materials of adjacent buildings. The property includes a side yard with a wooden deck and stairs to access a lower boardwalk adjacent to the river.

- Height, scale and massing of original 1867 three storey building (two storeys at the front);
- Medium pitched end gabled roof with projecting eaves;
- Cut and chamfered (beveled) quoins;
- Cut stone lintels and flat arch radiating voussoirs over windows on north and west facades;
- Size and pattern of window and door openings;
- Front entrance including storefront windows on either side of front doorway, with detailed wood millwork and muntins, transom and sidelights around front door with stained glass; and
- Transom above apartment entrance to the east on the front facade.

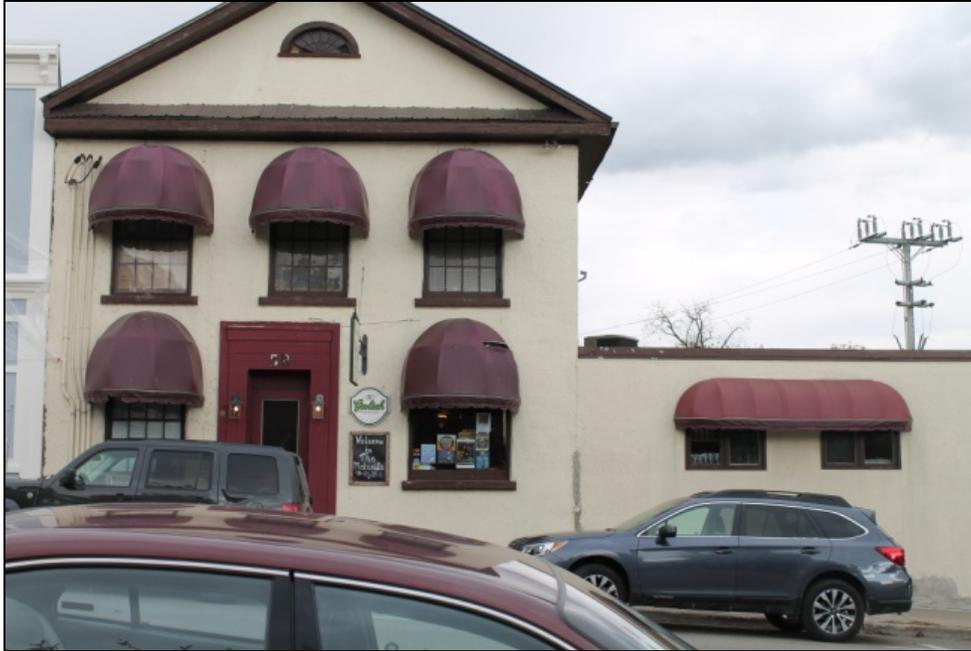
**Figure 29** - 59 Metcalfe Street, a stucco-clad building built in 1910. The property is listed on the Municipal Heritage Register (MHBC, October 2015)

The structure demonstrates some influence of architectural features found in the Classical Revival style, including pedimented roof with semicircular window and three bay facades that is nearly symmetrical. The style pre-dates what would appear to be an early 20<sup>th</sup> century construction date, but many classical decorative features became popular again in the early 20<sup>th</sup> century.
