Cultural Heritage Evaluation Report – Credit River Bridge

Final Cultural Heritage Evaluation Report:

Credit River Bridge

Metrolinx Electrification Project

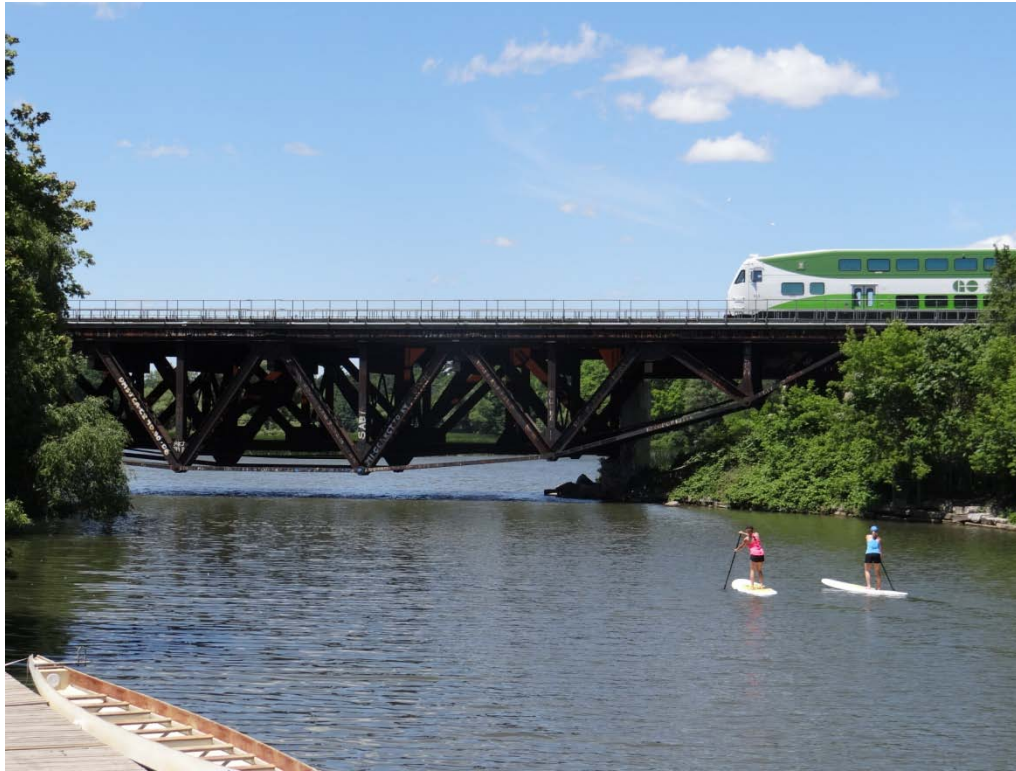
Figure-1-2: South elevation of the Credit River Bridge in the City of Mississauga, Ontario

The Credit River Bridge is located at Mile 13.27 of the GO Transit Lakeshore West rail corridor, and is located in the City of Mississauga (Figure 1-1 and Figure 1-2). The bridge, built in 1903 and twinned in 2008, carries three tracks of rail traffic in an east and west direction across the Credit River, between Stavebank Road and Mississauga Road. While rail traffic travels in an east-west direction, it should be noted that at this segment of the rail corridor, the bridge and corridor is on a northeast-southwest alignment, and the Credit River flows northwest to southeast under the bridge. The Credit River Bridge is located within Metrolinx-owned parcel PIN 13456-0580.

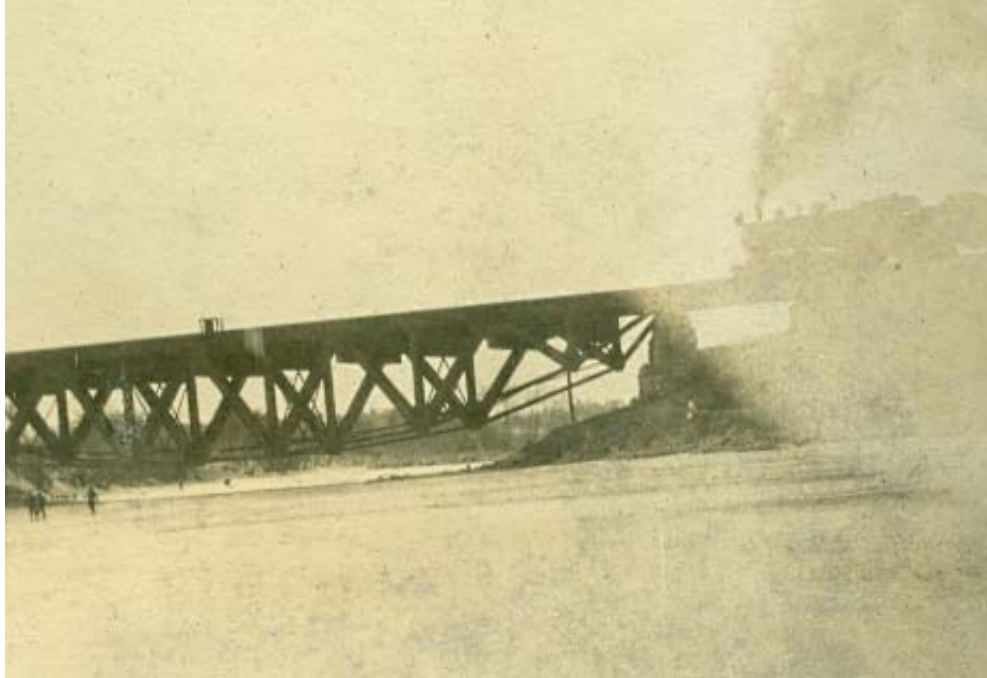
Figure 9-7: View of the new iron bridge at Port Credit, looking north, date unknown (provided by Mississauga Heritage Foundation)

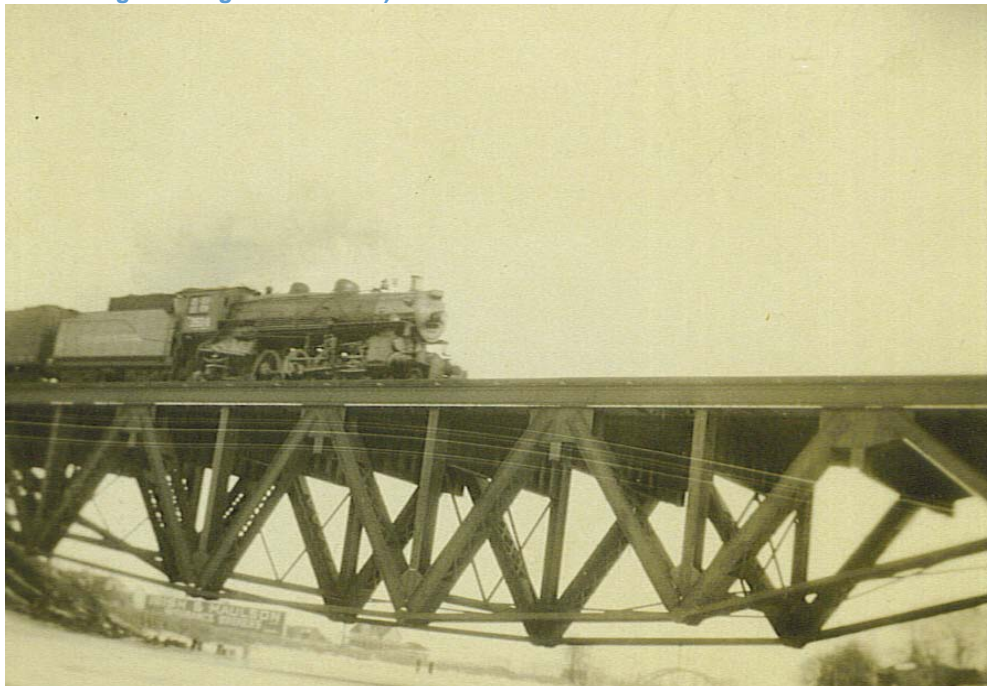
Figure 9-8: View of the Credit River Bridge, looking south, c.1910 (provided by Mississauga Heritage Foundation)

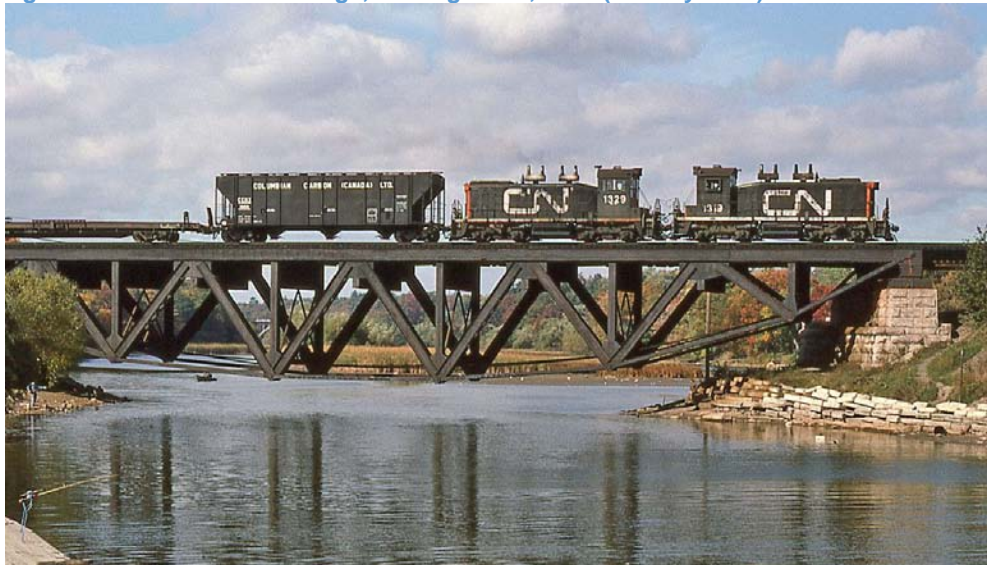
Figure 9-10: Credit River Bridge, looking north, 1978 (Adeney 1978)

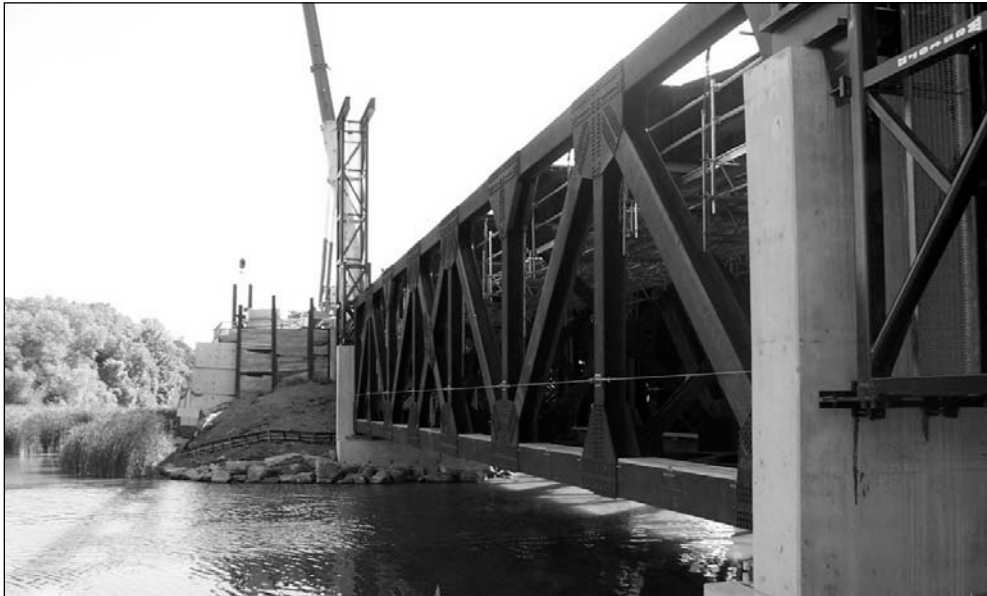
Figure 9-12: View of the new bridge to accommodate a third track, looking east, 2008 (Reynolds 2011)

In 1951, the CNR undertook repairs to the bridge abutments and bridge seats. This work involved precast reinforced concrete slabs for backwalls of the east and west abutments. In 2007-8, the bridge was widened with the addition of a three-span bridge to the north side of the existing 1903 bridge, to accommodate a third track. This new steel structure rests on concrete piers and abutments and features a middle deck truss span with two approach deck plate girder spans.

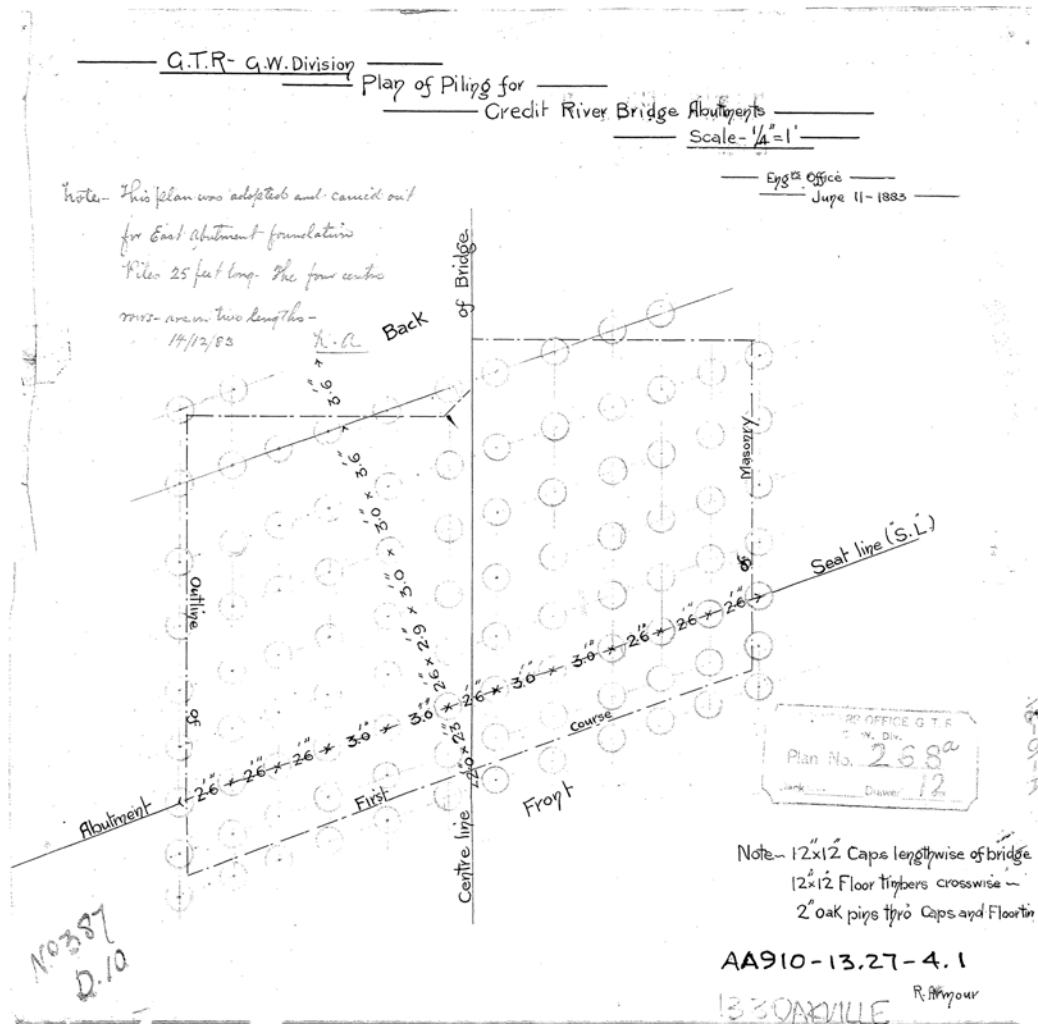
Figure 9-13: Plan of Piling for Credit River Bridge Abutments, 1883 (GTR 1883)

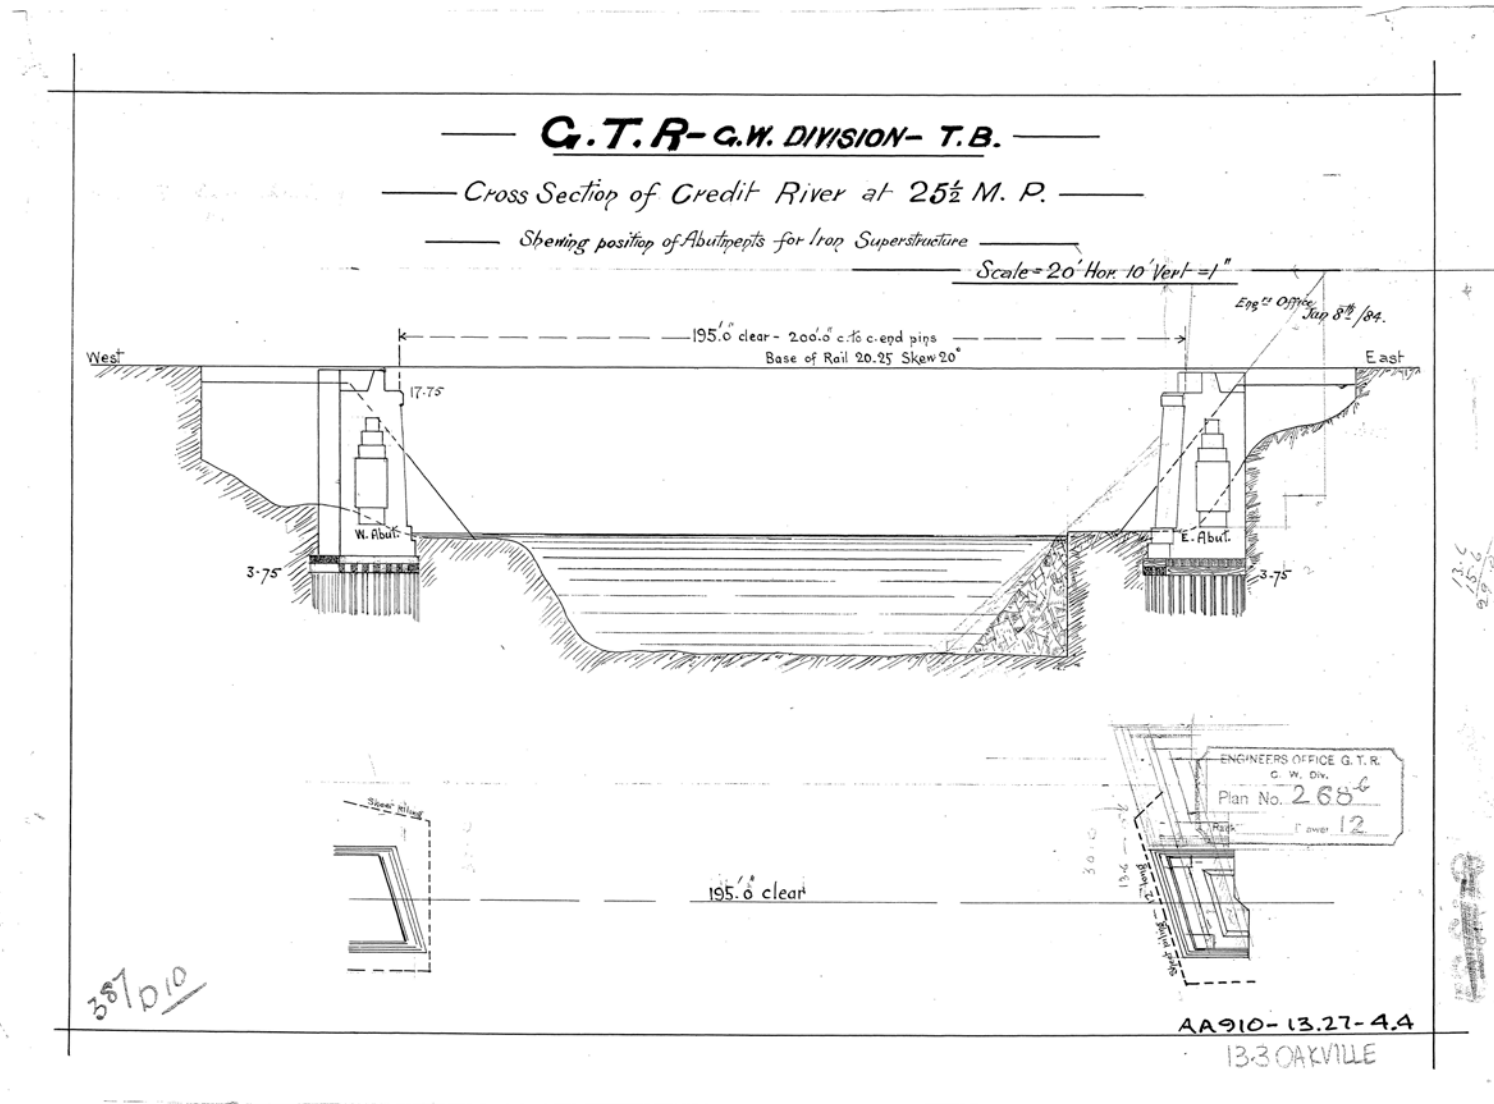
Figure 9-14: Cross Section of Credit River at 25 ½ M.P. showing position of Abutments for Iron Superstructure, 1884 (GTR 1884)

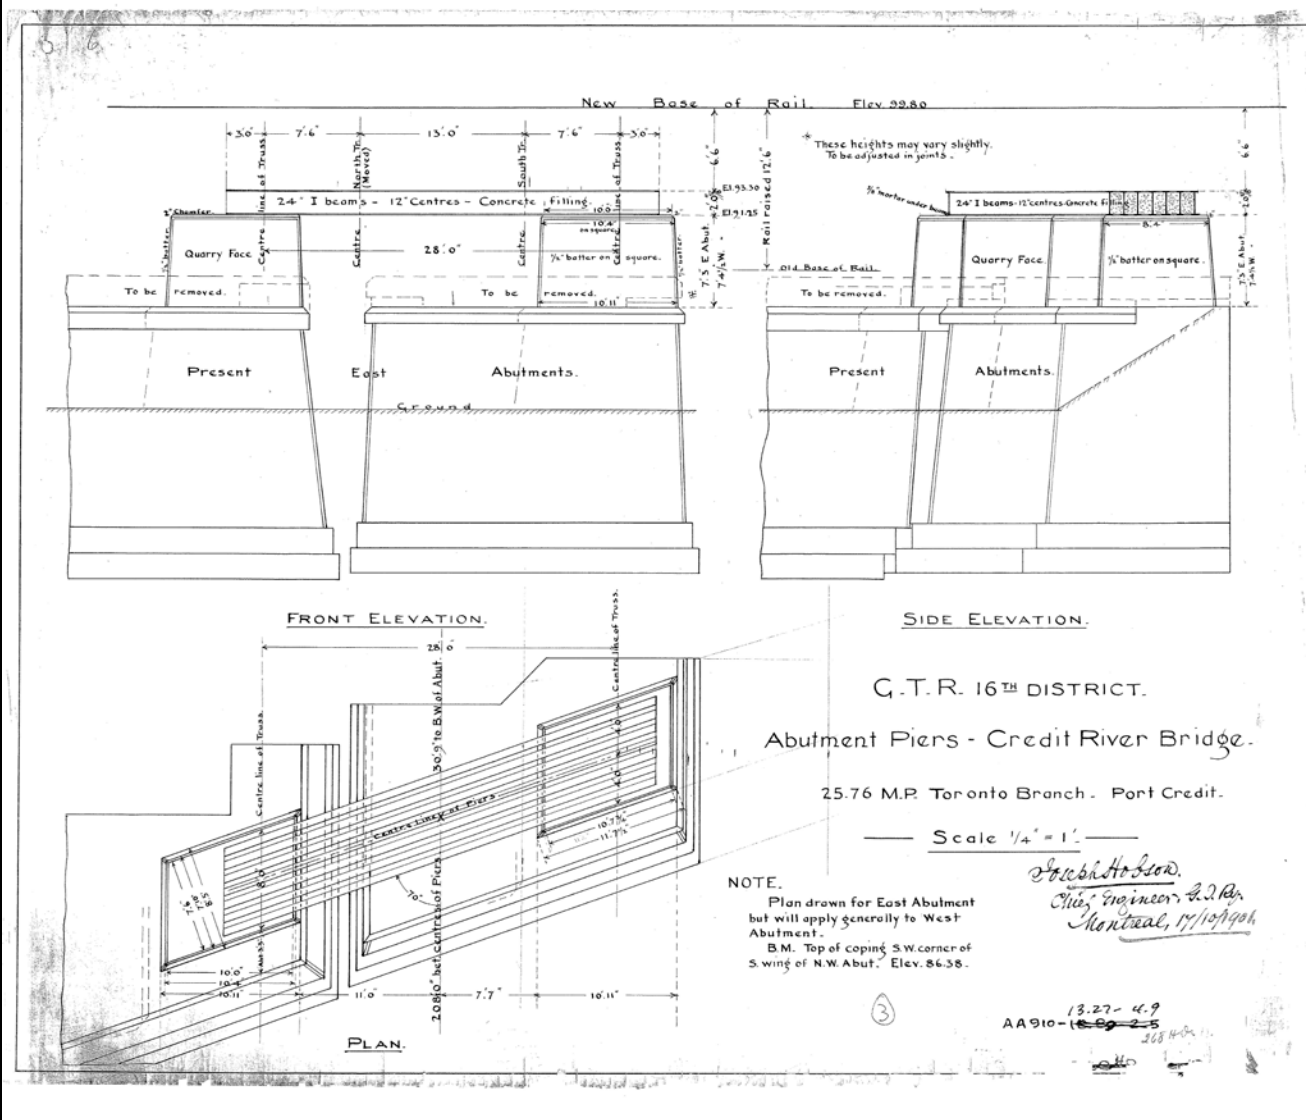
Figure 9-15: Abutment Piers – Credit River Bridge, 1901 (GTR 1901)

Drawings for the “Double Track Bridge over Credit River, Toronto Branch, Port Credit” were drawn in 1901 by the GTR and signed by Joseph Hobson, Chief Engineer. These included details regarding the repairs necessary to the existing abutments, and demonstrated how the new bridge would raise the base of the rail by 12 feet.

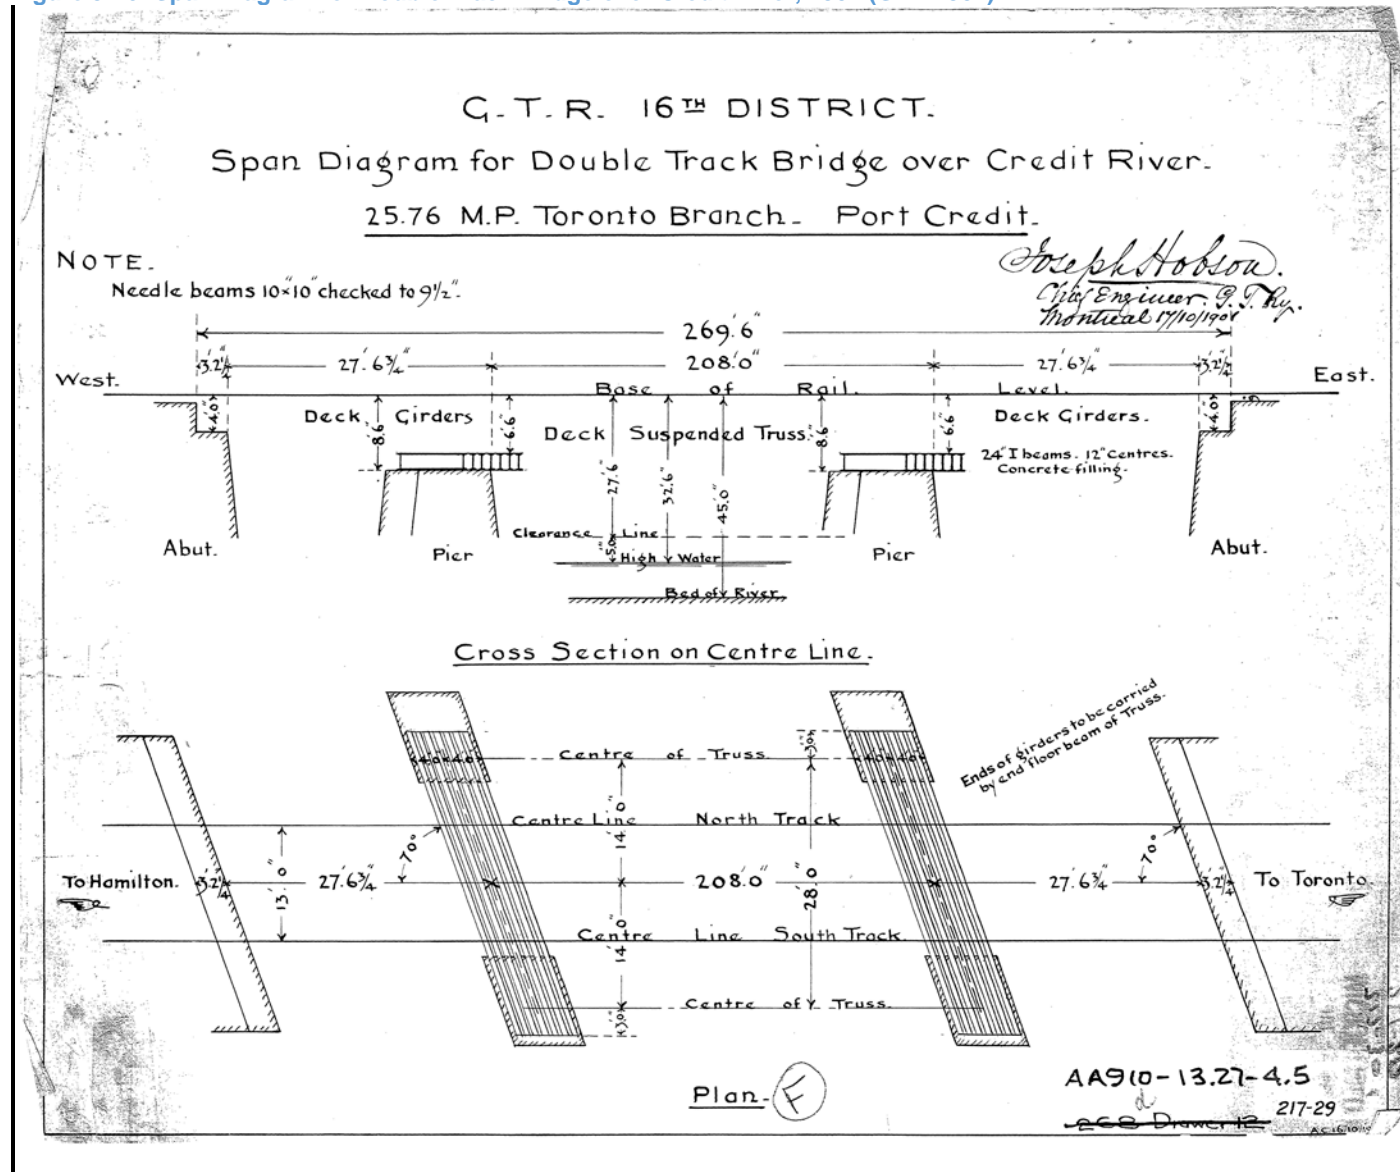
Figure 9-16: Span Diagram for Double Track Bridge over Credit River, 1901 (GTR 1901)

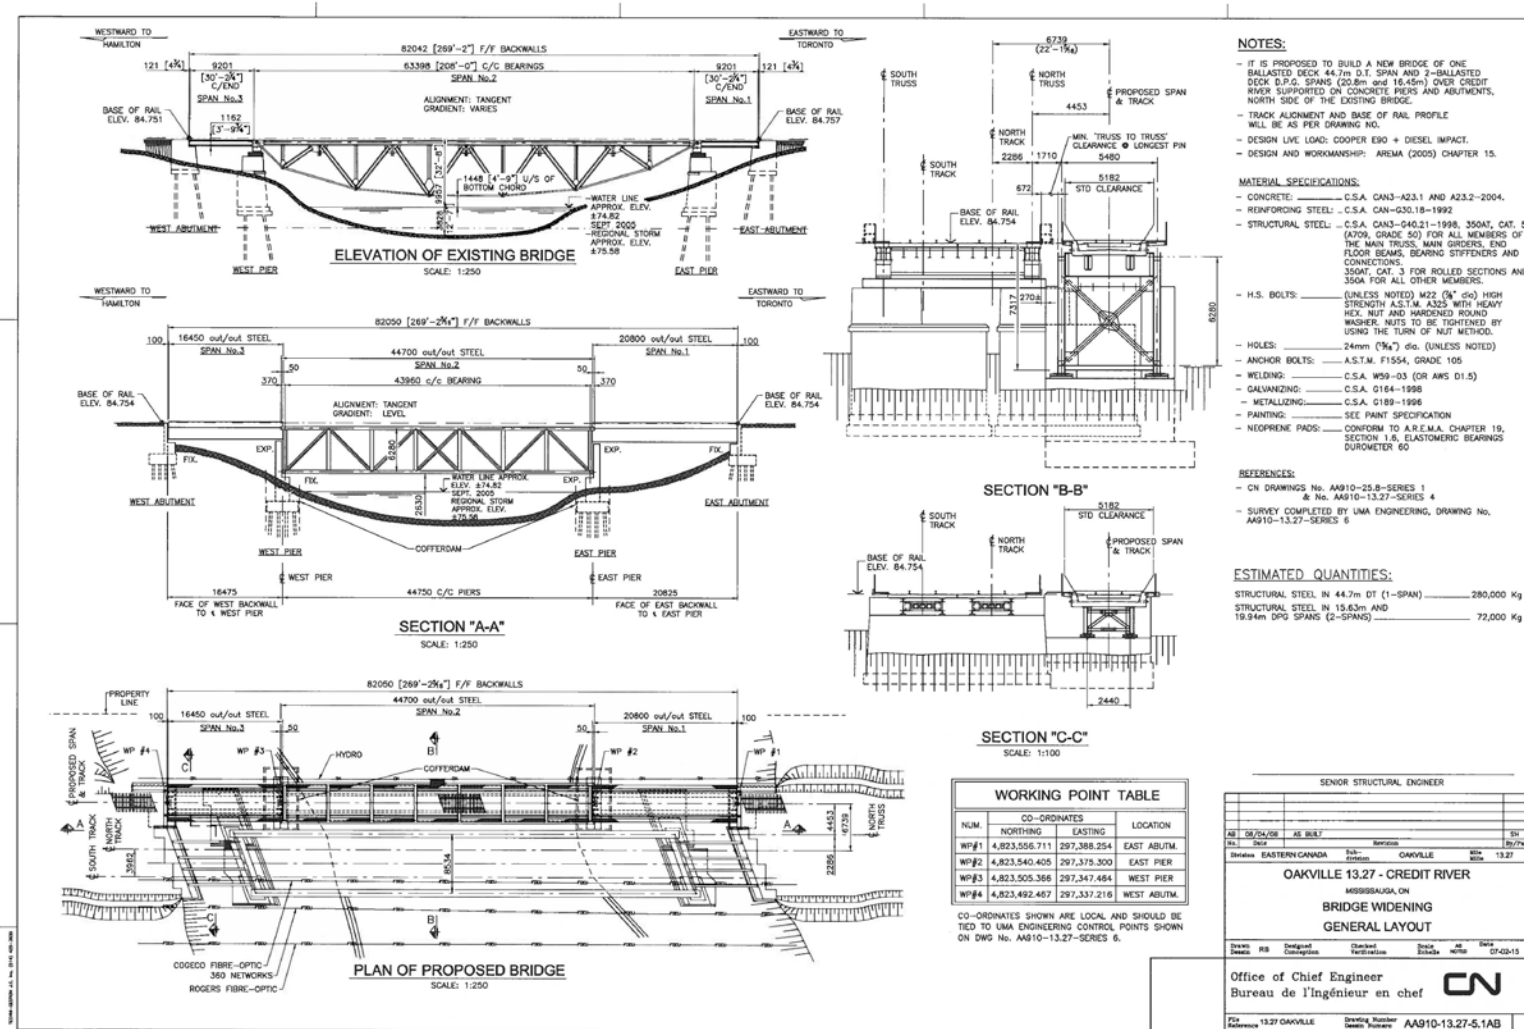
Figure 9-18: Credit River Bridge Widening, General Layout, 2008 (CN 2008)

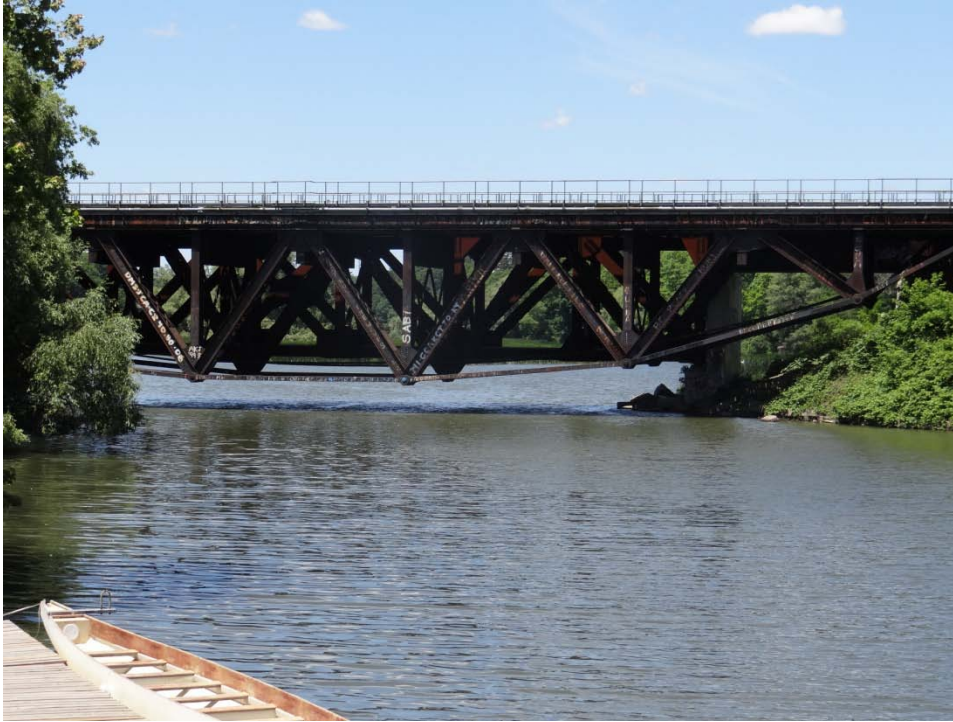
Figure 9-19: View of south elevation, from west bank.

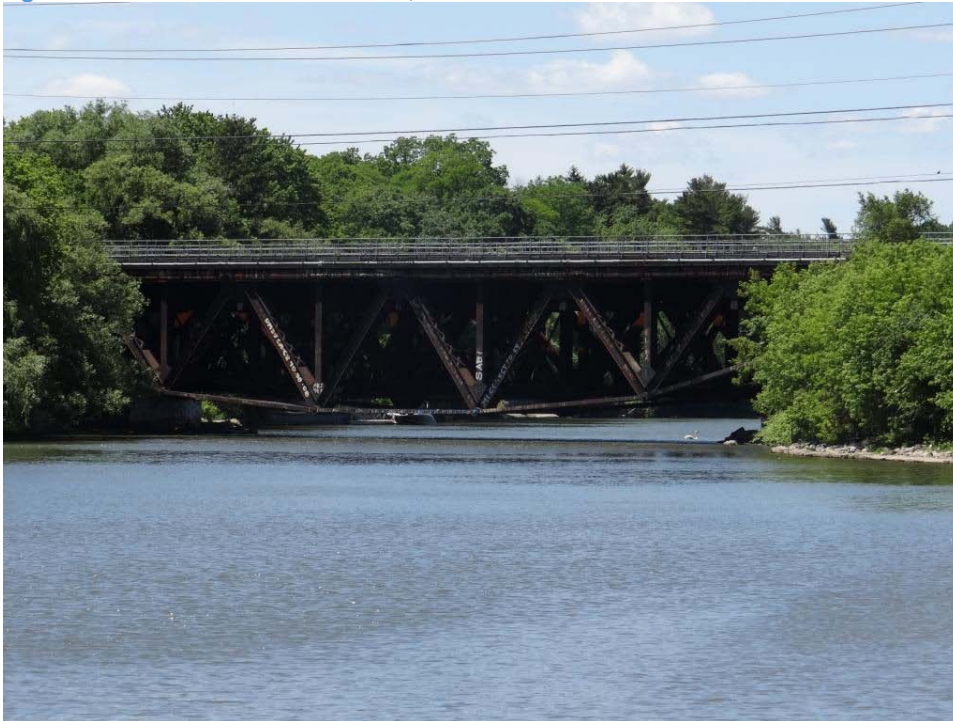
Figure 9-20: View of south elevation, from Lakeshore Road West

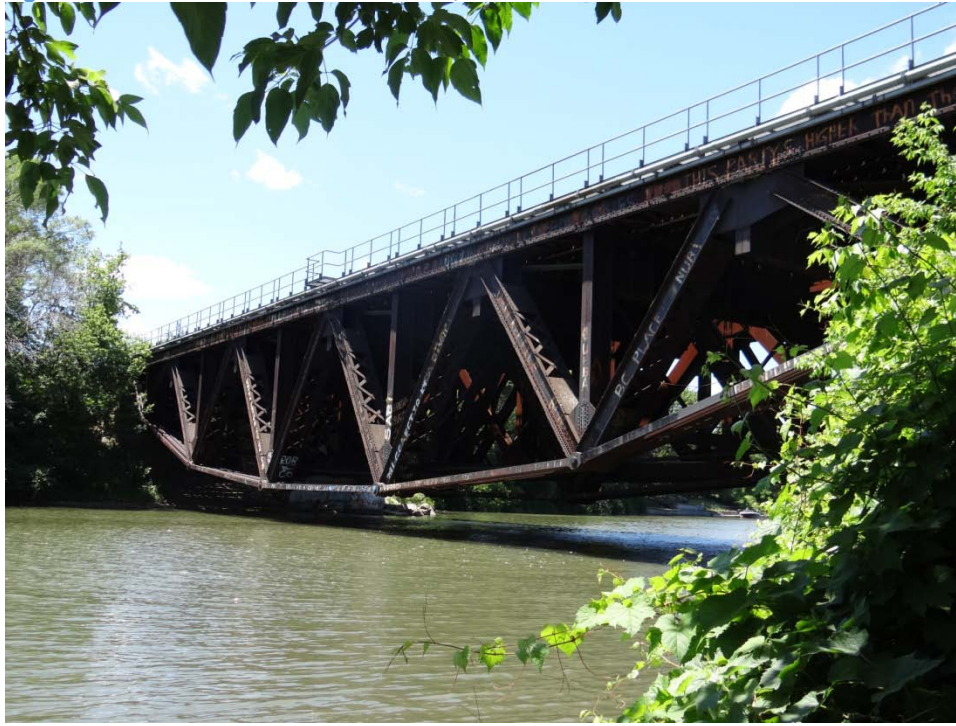
Figure 9-21: View of the south elevation, from east bank.

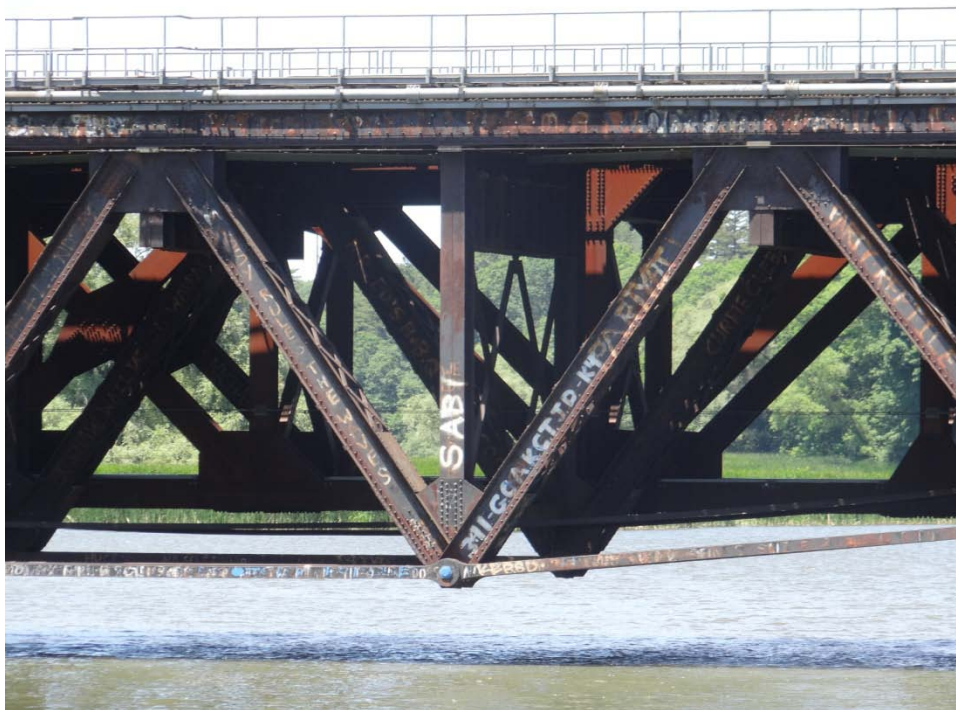
Figure 9-22: Detail of the central section of the deck truss, south elevation.

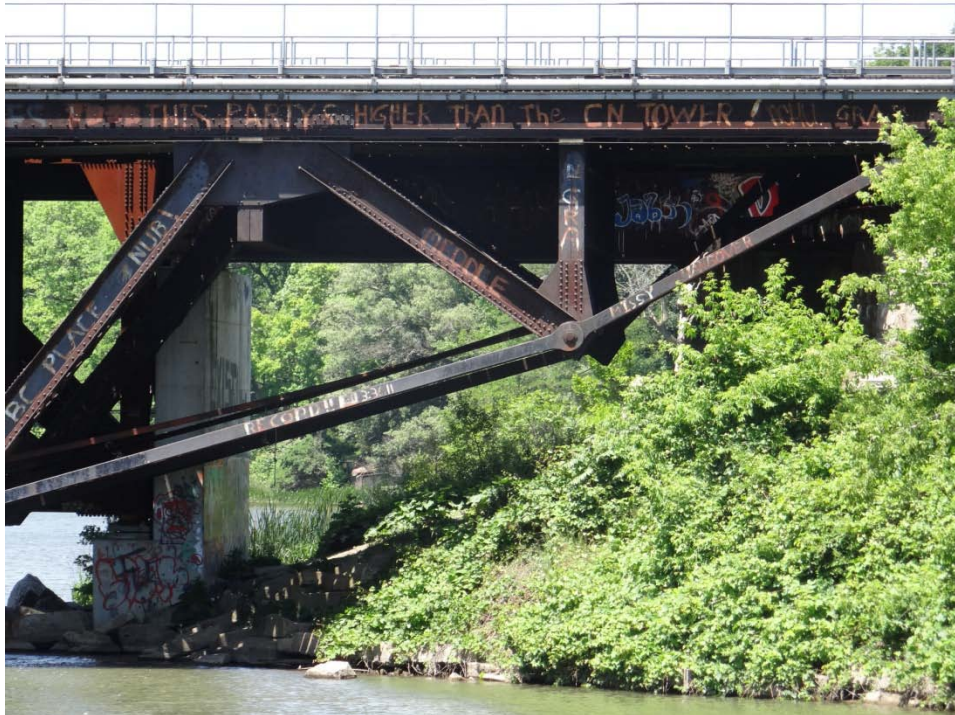
Figure 9-23: Detail of eastern-part of the deck truss, south elevation.

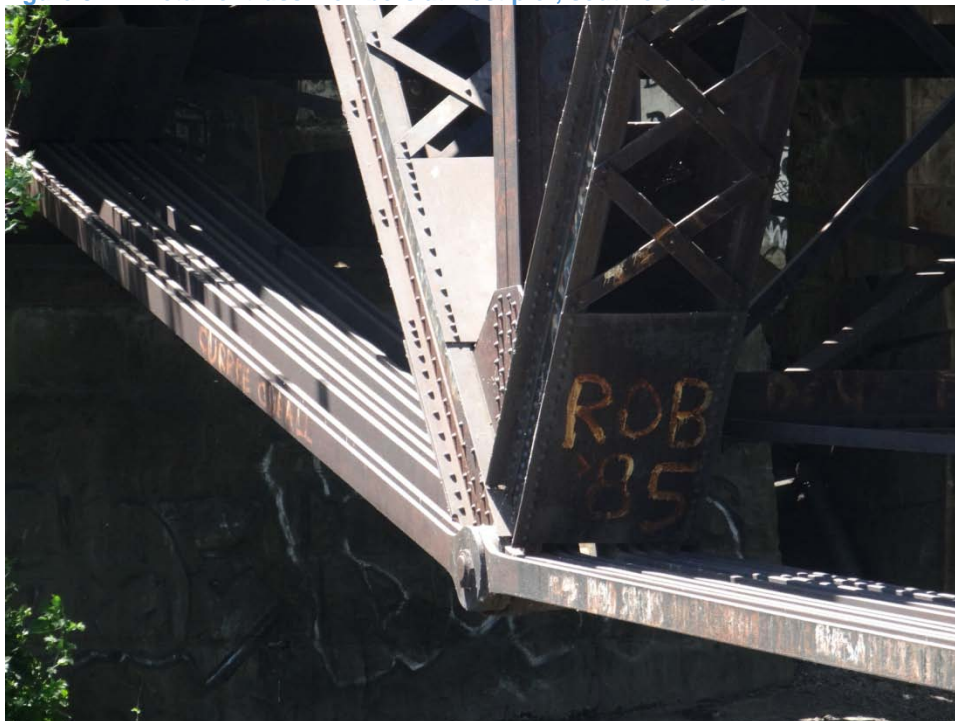
Figure 9-24: Detail of truss members at west pier, south elevation.

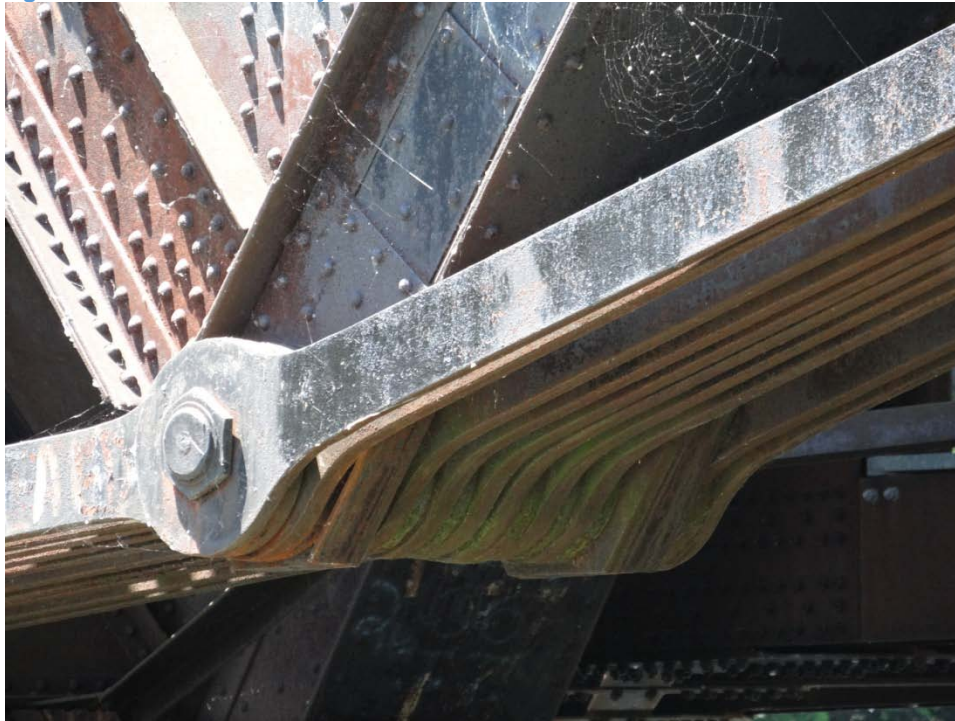
Figure 9-25: Detail view of eyebar bundles.

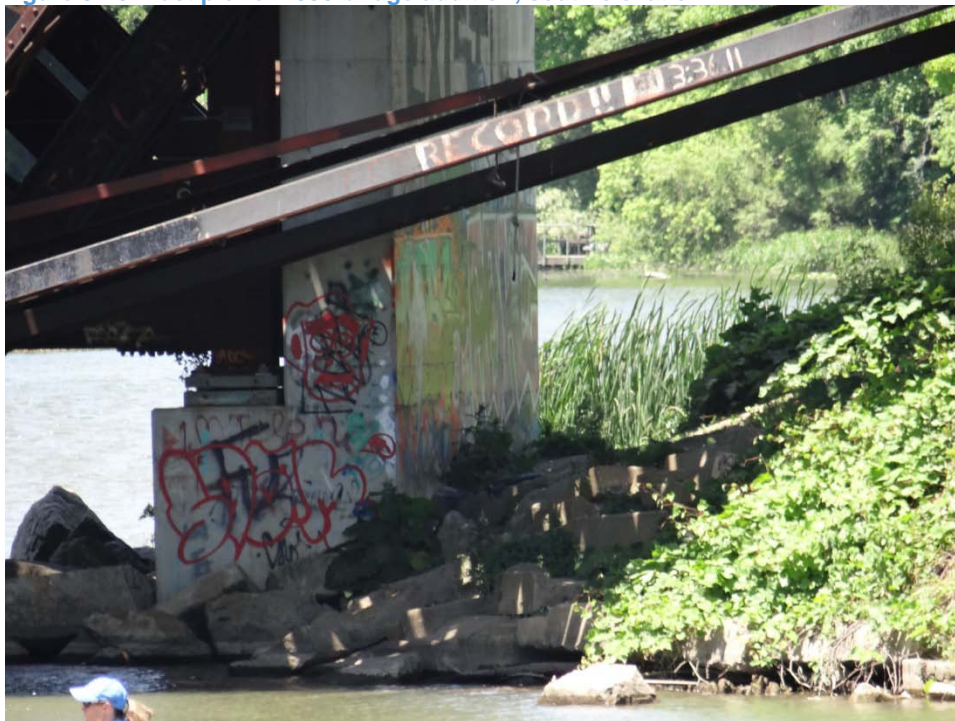
Figure 9-26: East pier of 2008 bridge addition, south elevation.

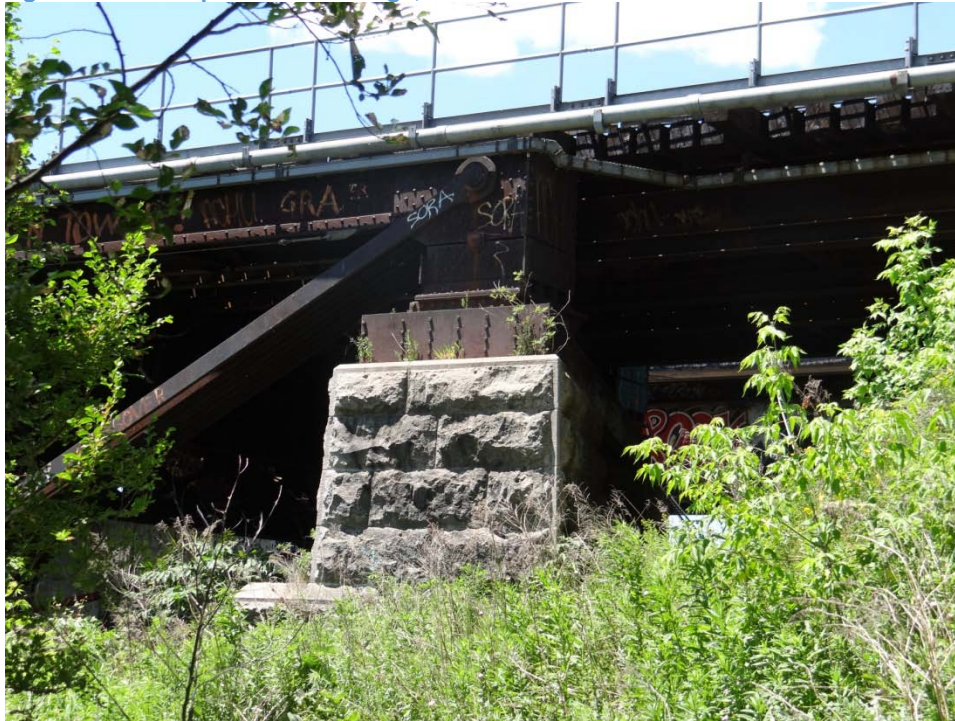
Figure 9-27: East pier of 1903 bridge, south elevation.

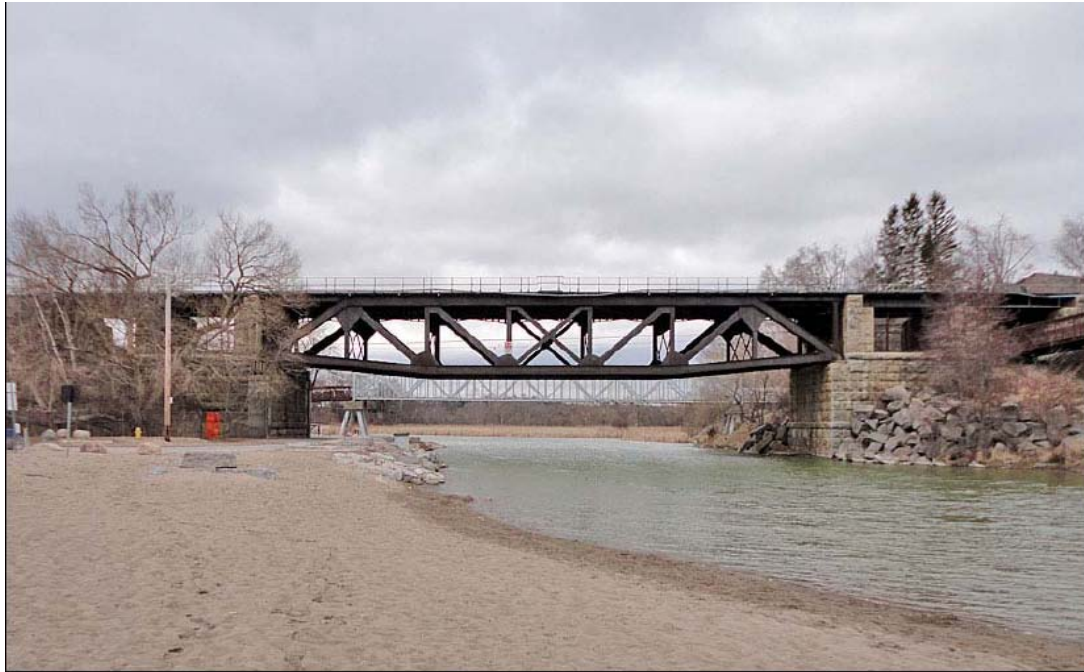
Figure 9-28: Rouge River Bridge, Lakeshore East rail corridor, City of Toronto, Ontario (ASI 2015)

Based on this review, the subject bridge is not considered to be the oldest example of a deck truss, or significant in terms of individual span length or overall bridge length. However, the inverted bowstring arch design appears to be unique to Ontario, and possibly rare in North America. A significant example of this bridge type is found in the Little Hell Gate spans of the Hell Gate Bridge in New York, which was built in 1916 to the designs of engineer Gustav Lindenthal and built by the American Bridge Company of New York (Holth 2013).

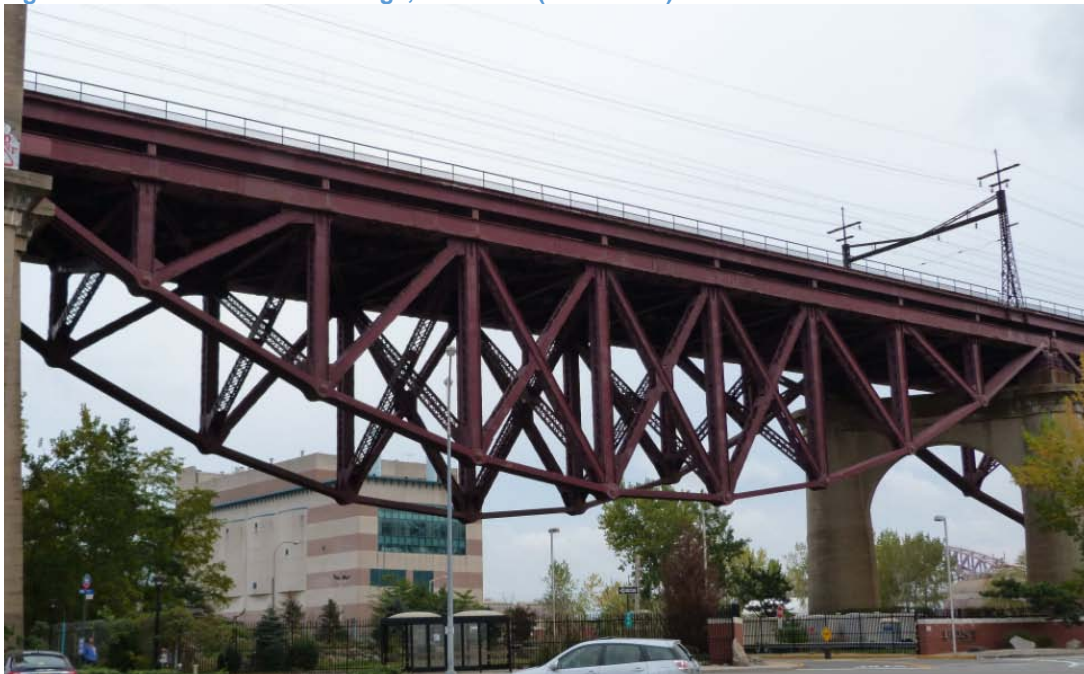
Figure 9-29: Little Hells Gate Bridge, New York (Holth 2013)

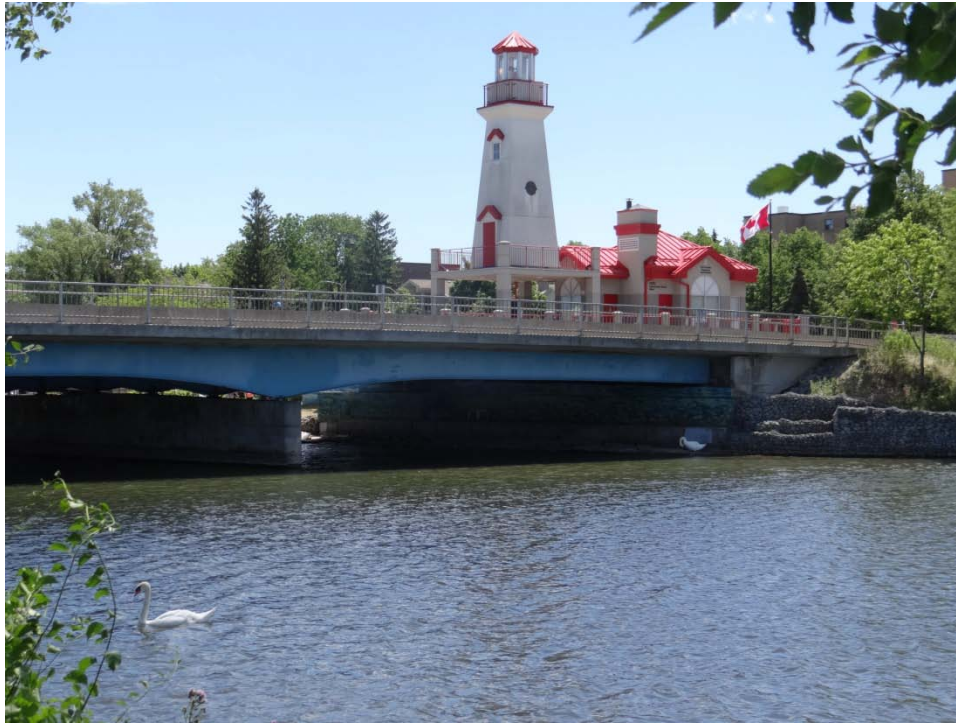
Figure 9-30: View of the c.1960 Lakeshore Road West Bridge, north elevation (ASI 2016)
